**HISTORIC BUILDING SURVEY REPORT:  
MANOR TOP FARM, LACEBY, NORTH EAST LINCOLNSHIRE**

Planning Reference: DM/1028/18/FUL  
NGR: TA 2275 0536  
AAL Site Code: LATF 19  
North-East Lincolnshire Museum Service Accession Code: GRIMS:2019.006  
OASIS Reference Number: allenarc1-351121

By  
Allen Archaeology Ltd  
Report Number AAL 2019064

May 2019

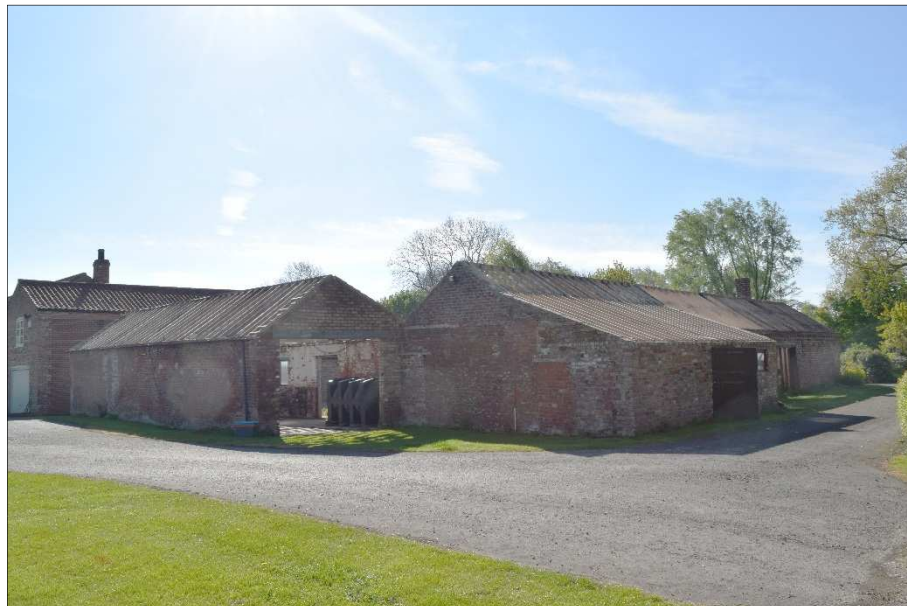
*Plate 1 (shot 1): General view of Building A to the right and Building B to the left. Looking southeast, 1m scale*

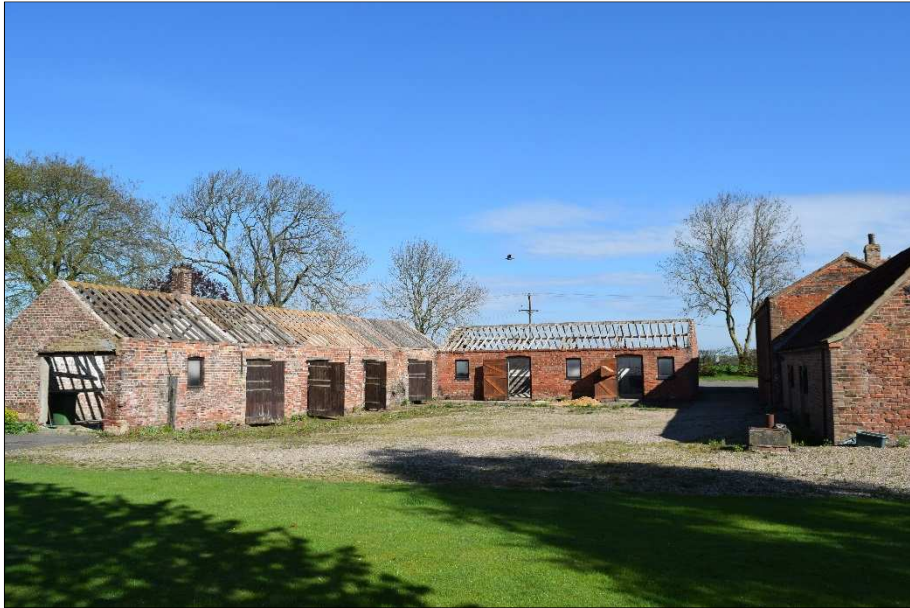
*Plate 2 (shot 10): General view of the buildings from the south, showing the courtyard*

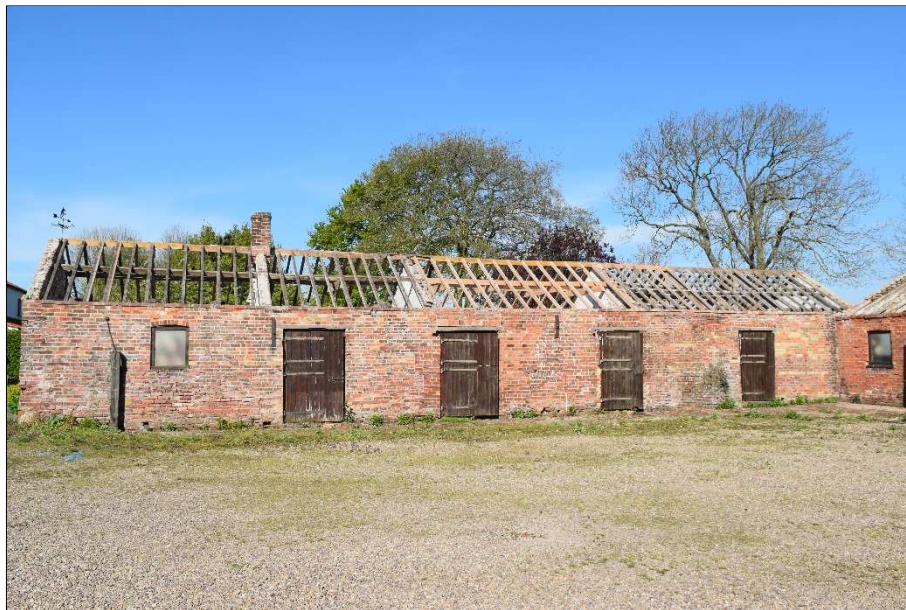
- 7.4 The east elevation is in English Garden Wall bond with five courses of stretchers between each row of headers (Plate 4). It has four plank and batten doors braced but not ledged. They appear to be later additions, with no beading between the planks, a feature otherwise common for plank and batten doors of 18<sup>th</sup> – early 19<sup>th</sup> century date (Hall 2005). The doors are double hung on four modern pintles and four strap hinges with plain ends. Above each door is a lintel, some of which have mortices suggesting they are reused. A soldier arch is present above the south central bay door. The doors open up to a concrete path in front of the courtyard.

*Plate 4 (shot 13): East-facing elevation. Looking northwest, 1m scale*

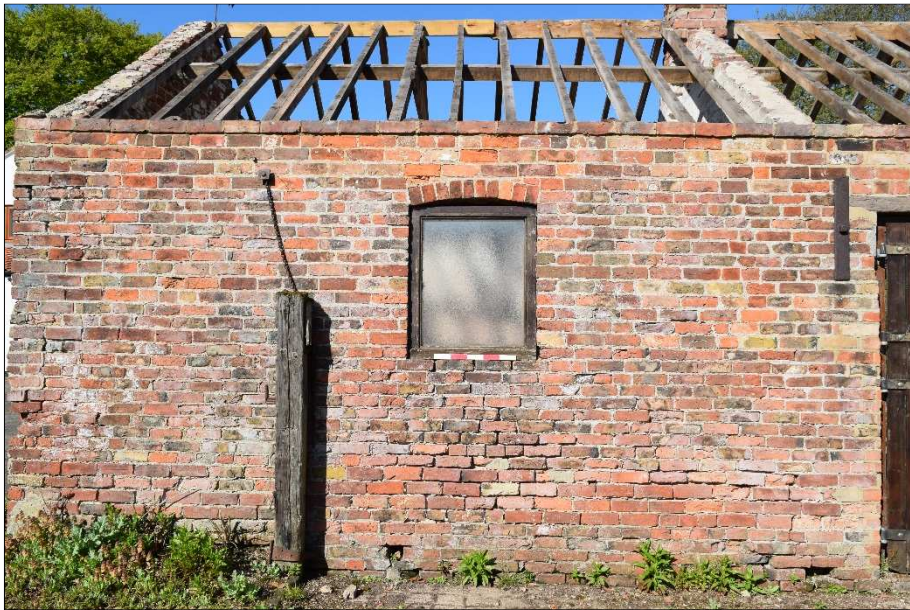
- 7.5 The northernmost stable door has an adjacent blocked up window with segmental arch above, similar to the extant window in the south bay (Plate 5 and Plate 6). The north stable bay also has a drainage hole towards the ground surface, north of the stable door. None was observed on the south side of the door, despite the presence of an internal drainage channel.

*Plate 6 (shot 14): East-facing elevation of the south bay, showing window with segmental arch. Looking west, 0.5m scale*

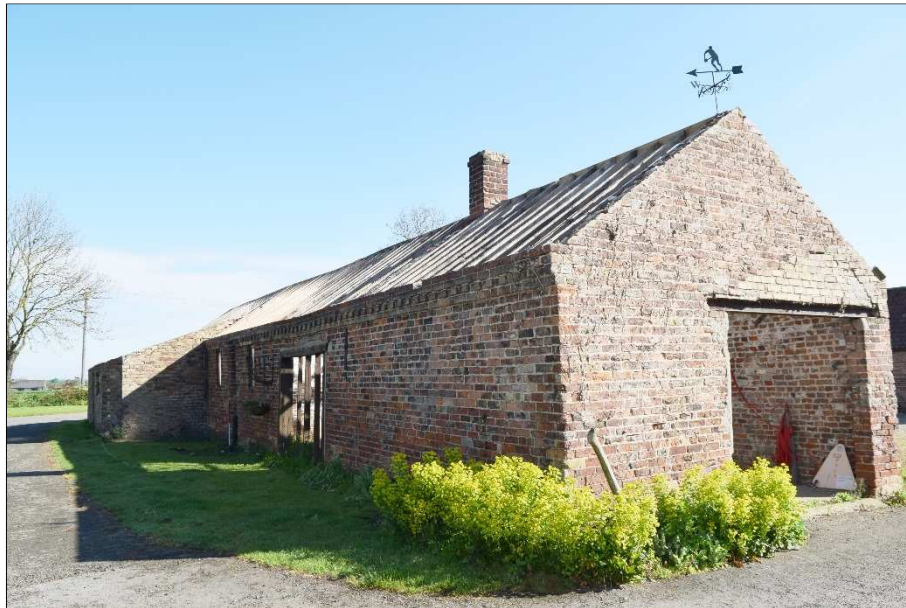
- 7.6 The southern bay does not have a door on the east elevation, instead it is accessed from a large modified opening in the south elevation (Plate 7). A square brick chimney stack protrudes through the apex of the roof, at the north end of the southern bay, suggesting it may have been a harness room (English Heritage 2013, p36).

*Plate 7 (shot 6): South and west elevations of Building A. Looking northeast, 1m scale*

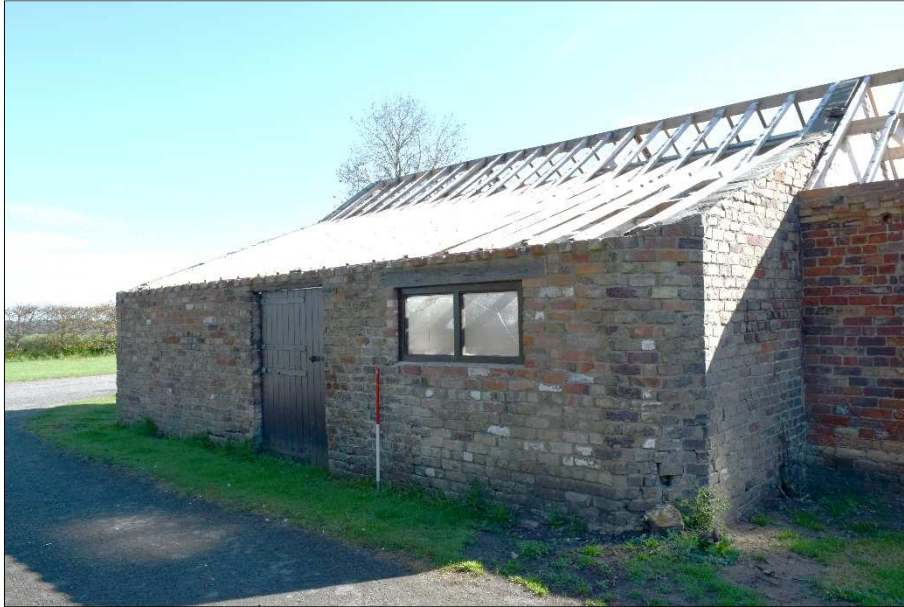
- 7.9 The northwest lean-to largely followed an English Garden Wall bond with five rows of stretchers between each row of headers. The door and window frame on the west elevation follow the same modern style as those on the east elevation, although in this instance, the window features two fixed window panes (Plate 9). This structure has also a dentil course under the eaves.

*Plate 9 (shot 5). West elevation of northwest lean-to. Looking northeast, 1m scale*

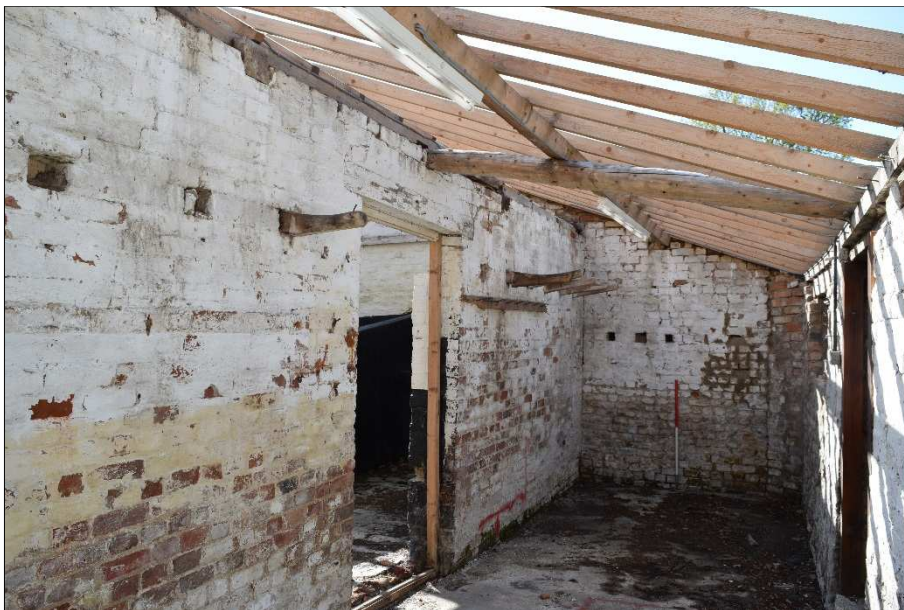
- 7.10 The northwest extension appears to have been used as a tack room and has white washed/painted walls (Plate 10). On the east partition wall are fittings for harnesses and saddle-trees, some were broken off against the wall face. The common rafters attached to the wall plate and supported by a purlin, are modern.

*Plate 10 (shot 28): Tack room in the northwest extension. Looking southeast, 1m scale*

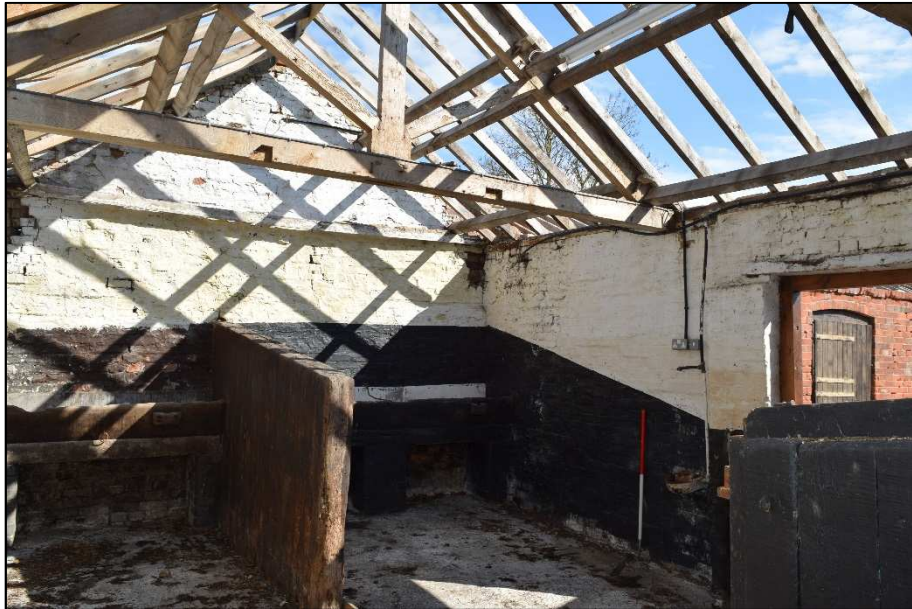
*Plate 11 (shot 30): View of the north stalls. Looking northeast, 1m scale*

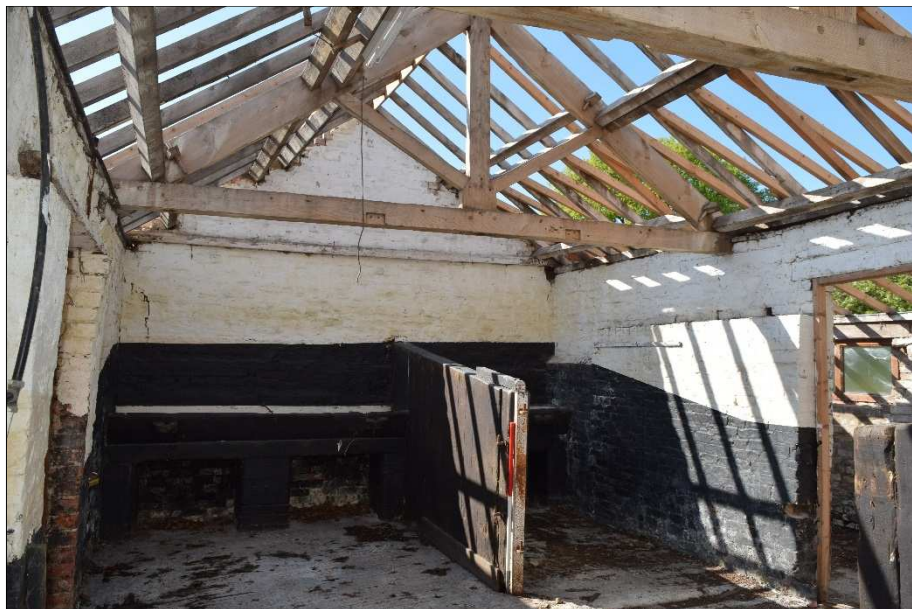
*Plate 12 (shot 31): View of south stalls. Looking southwest, 1m scale*

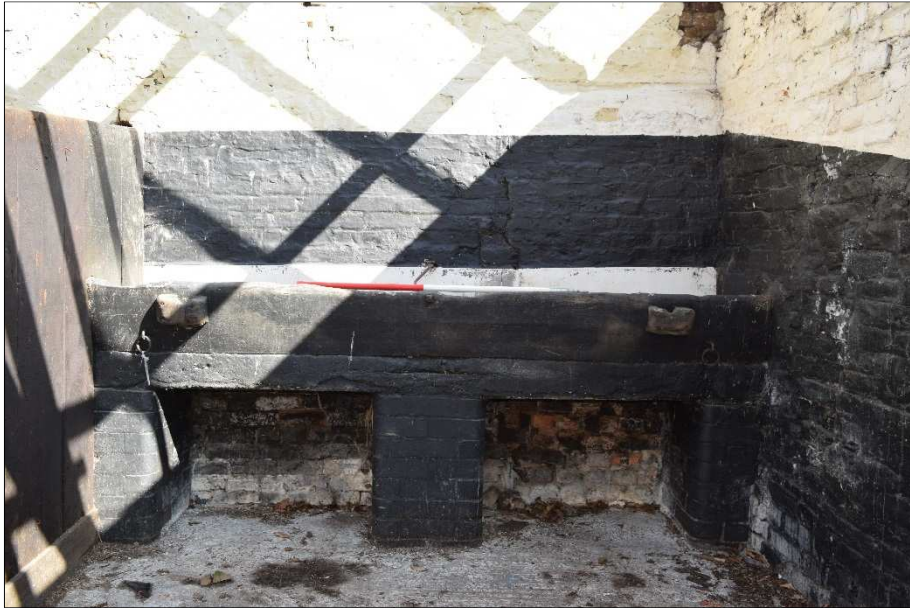
*Plate 13 (shot 32): Representative view of a feeding trough above which is a blocked up doorway to the north. Looking north, 1m scale*

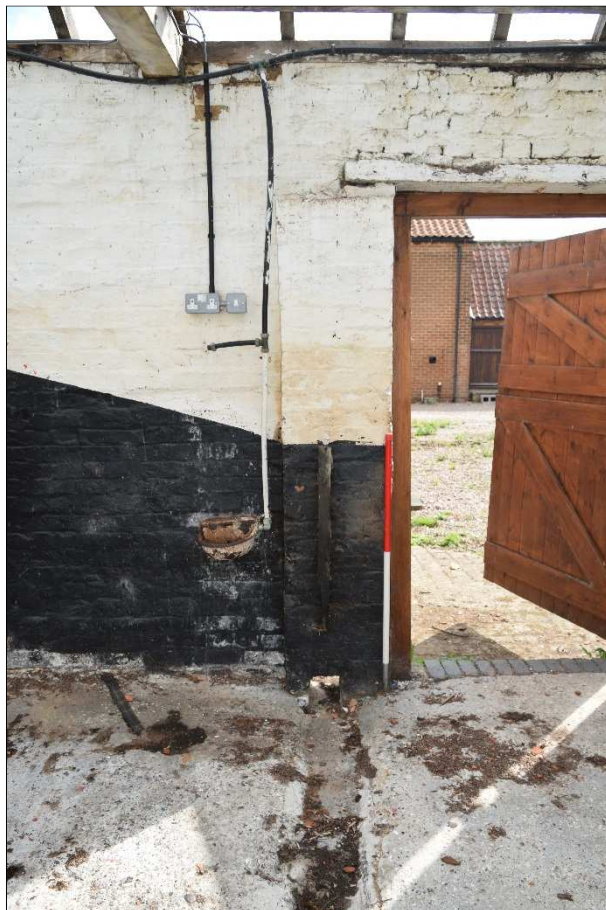
*Plate 14 (shot 38): Water drinker/drinking bowl on the east wall, notice the drainage channel below. Looking east, 1m scale*

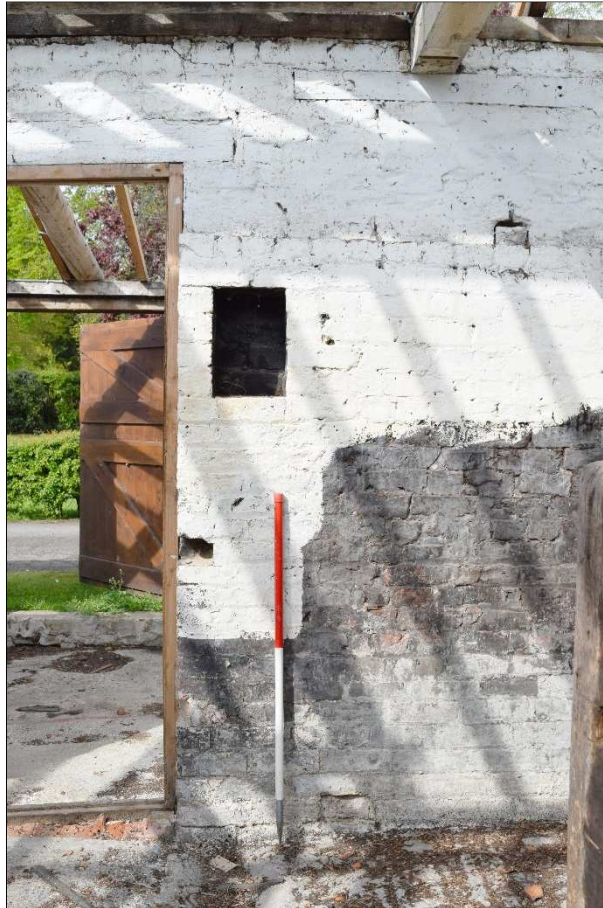
*Plate 15 (shot 37): Niche in the west wall of northwest stall. Looking west, 1m scale*

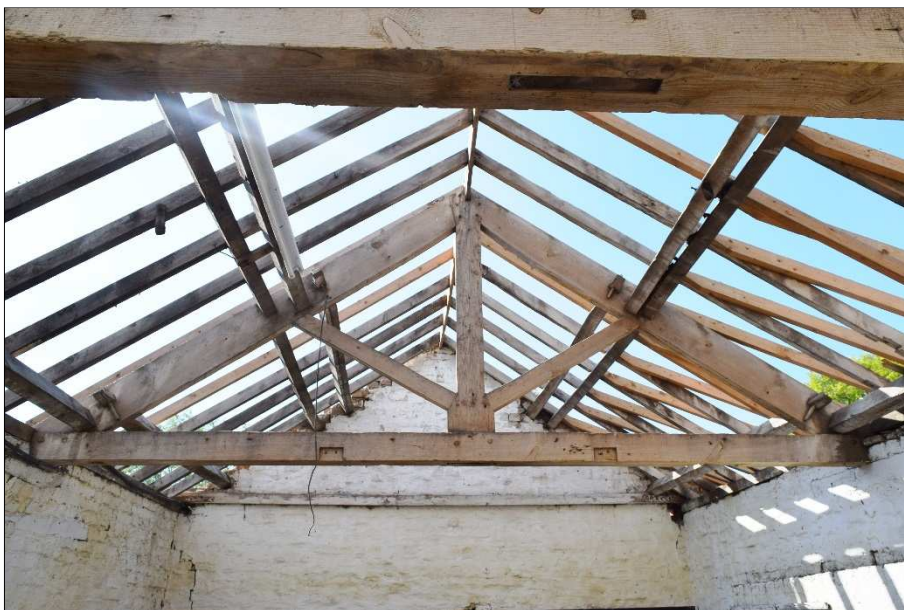
- 7.12 The roof structure within the northern bay consists of a morticed and tenon pegged king post truss with a ridge plank and a dovetail shaped tenon joint (Plate 16 and Plate 17). The purlins supporting the rafters are double rather than single at the centre of the truss. The tie beam is fixed to the wall plate, as are the rafters.

*Plate 16 (shot 33): King post roof truss in the northern bay. Looking south*

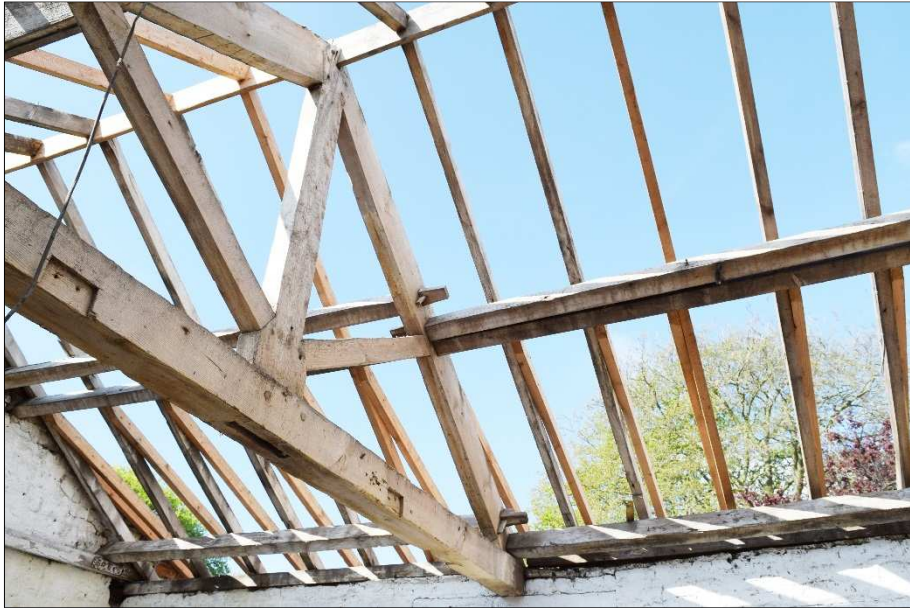
*Plate 17 (shot 35): King post structure with pegged purlins*

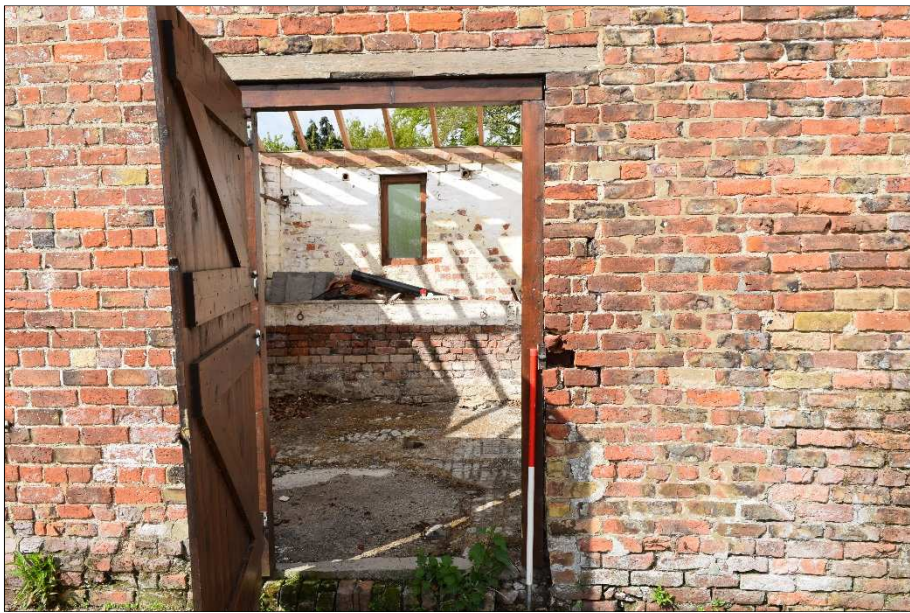
- 7.13 The stable box to the south was only rapidly surveyed due to bees. A cursory survey showed a trough against the west wall with two tethering rings (Plate 18 and Plate 19). This is the only place in the stable that hints towards an earlier floor surface, in this case comprising worn cobbles. This has been covered by a later concrete surface.

*Plate 18 (shot 39): Northern stable box. Looking west, 1m scale*

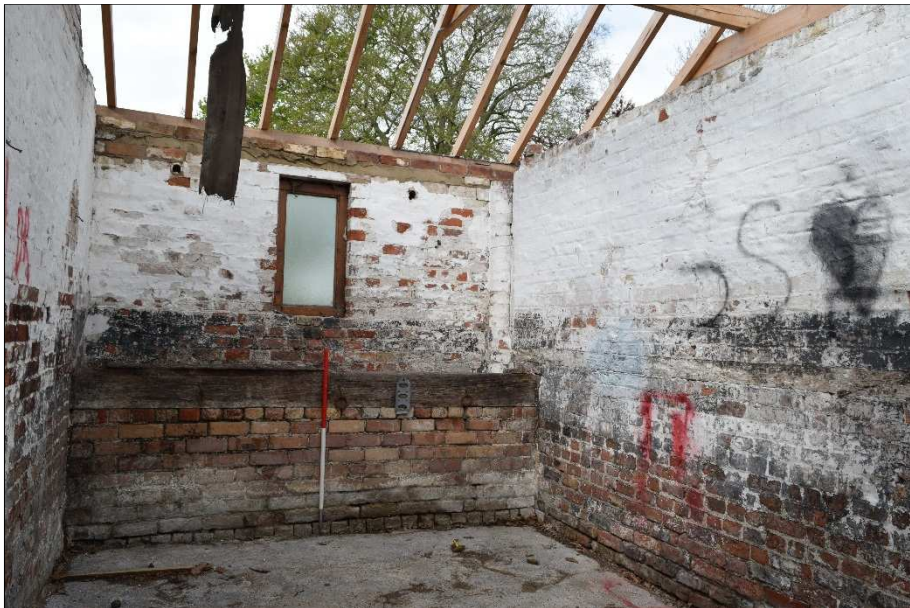
- 7.14 The box to the south of this had a similar layout to that to the north, with a brick trough to the west, with three tethering rings (Plate 20). The roof is modern and recently replaced, comprising rafters attached to the wall plate and supported by purlins and collars, with a ridge plank at the apex of the roof (Plate 21 and Plate 22).

*Plate 20 (shot 40): General view of southern stable box. Looking northeast, 1m scale*

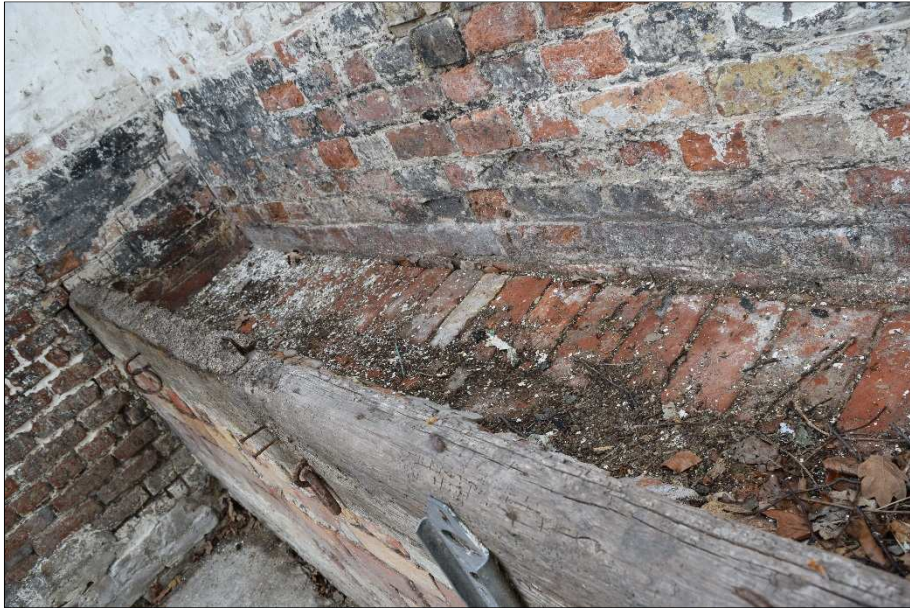
*Plate 21 (shot 42): Close up of brick trough. Looking southwest*

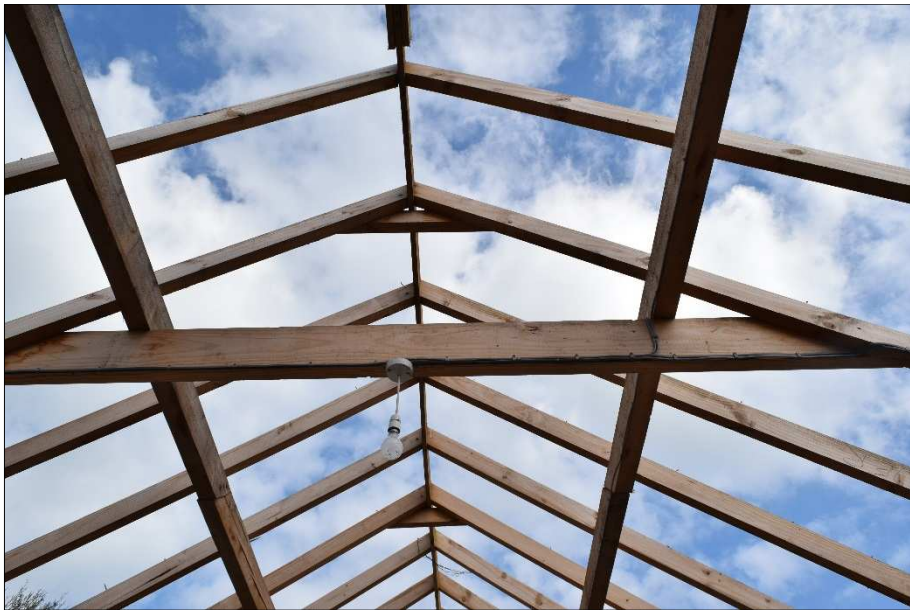
*Plate 22 (shot 41): Roof structure above the centre bays. Looking north*

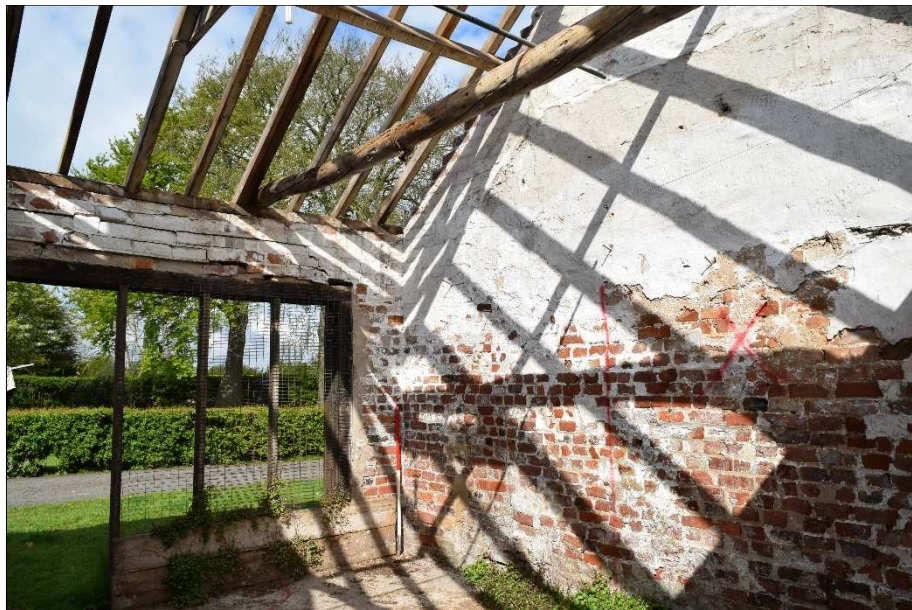
- 7.15 Within the second bay to the south is a room containing a partially demolished fireplace (Plate 23). The fireplace was a feature part of the harness room during the Victorian era, which suggests that was the original function of this room (English Heritage 2013, 36). Apart from a few nails fixed to the wall, there are no saddle-trees as in the tack room in the northwest extension. With the wall to the north being partially rendered it was impossible to judge whether there were traces of any removed fittings on this wall (Plate 24).

*Plate 24 (shot 45): Harness room and partition wall to centre bay. Looking northwest, 1m scale*

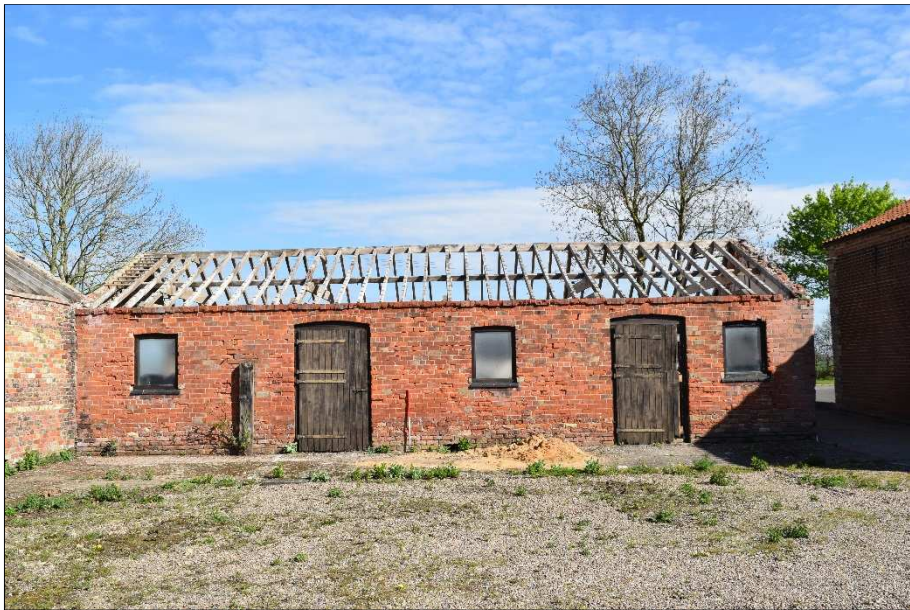
- 7.18 The south elevation has two stable doors with three evenly spaced windows, all in the same style as those on Building A and have retained their original segmental arches. A drainage hole/outlet can be found below the centre window, coming from an internal drainage channel (Plate 28).

*Plate 27 (shot 17): South elevation of Building B. Looking north, 1m scale*

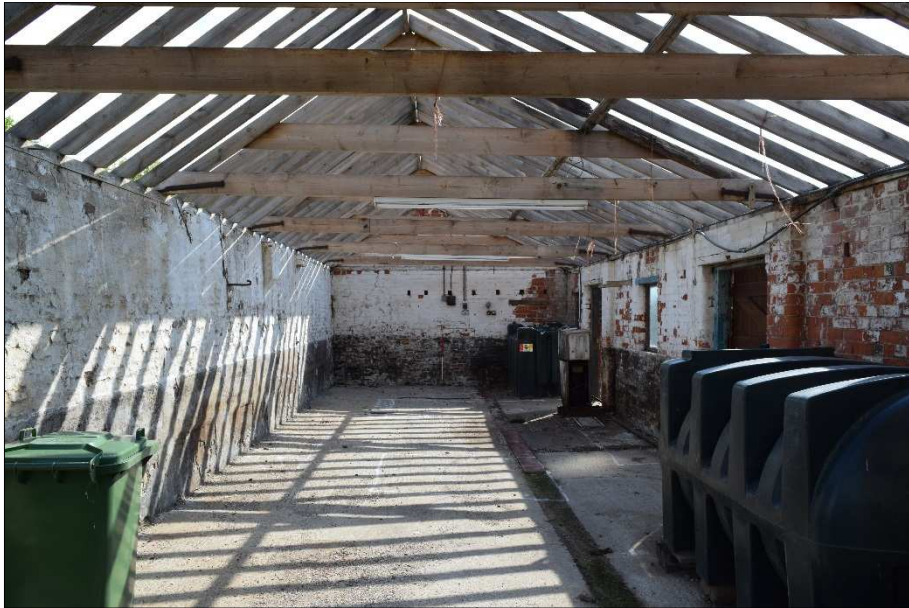
- 7.20 The interior of Building B is suggestive of a second stable, however no partitions have survived (Plate 30). There is a drainage channel to the south and saddle-trees on the south wall, with evidence of further fixtures having been removed from the south and east walls (Plate 31-Plate 33). The floor is of concrete and the walls have been whitewashed in the past. Each of the two doors have plain architraves with bullnose bricks surrounding the doorway. The roof structure consists of rafters attached to the wall plate and supported by

*Plate 30 (shot 23): General internal view of Building B. Looking east, 1m scale*
