1.0 Introduction

- 1.1 Allen Archaeological Associates was commissioned by Claystone Developments Limited to undertake a building survey of two ranges of barns that are being modified for residential use at Crossholme Farm on Well Street in Bishop Norton, Lincolnshire (Planning Reference M03/P/1003).
- 1.2 The methodology conforms to a specification prepared by this company (Allen 2007), and the English Heritage guidelines in *Understanding Historic Buildings: A Guide to Good Recording Practice* (English Heritage 2006).
- 1.3 A copy of the building survey report and the full project archive will be submitted to The Collection, Lincoln, for long-term storage, and will be stored under the Museum Accession Number 2007.245.

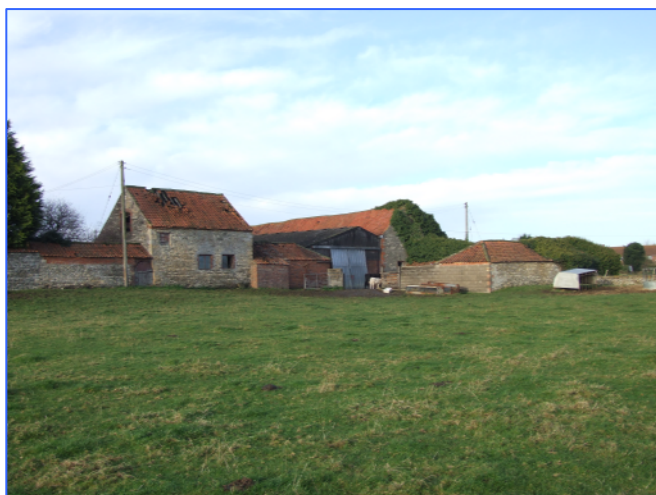
Plate 14: East range of the barn complex, with Buildings 4 and 5 in the middle distance and Building 3 in the background. Looking north-north-west.

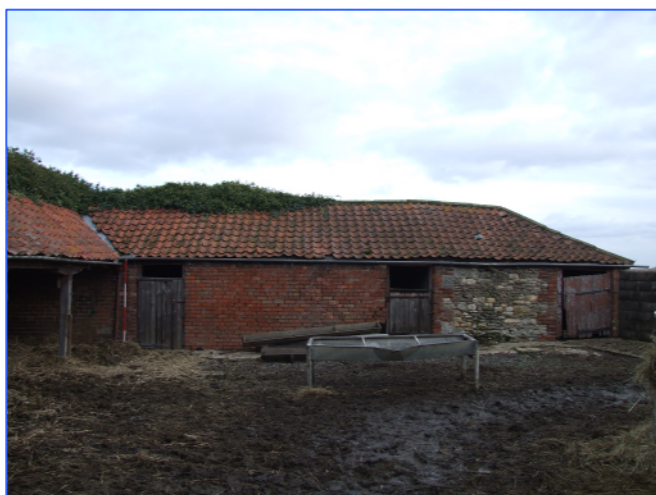
- 5.2.3 Building 4b - d measures 15.2m north – south and 4m east – west, and is constructed of a range of materials. The east elevation is of bonded limestone, the west elevation is part brick and part limestone, and the south elevation is tied into a low breeze block boundary wall that extends westwards to form the southern boundary of the crew yard. The brick and breeze block components represent later repairs or alterations to the building. The stone part of the west elevation exhibits the same saw tooth brickwork around the doorways evident elsewhere in the complex of barns, suggesting that all these elements are broadly contemporary. The stable block is covered by a hipped pan tile roof.

Plate 15: West elevation of stable block 4b, looking east.

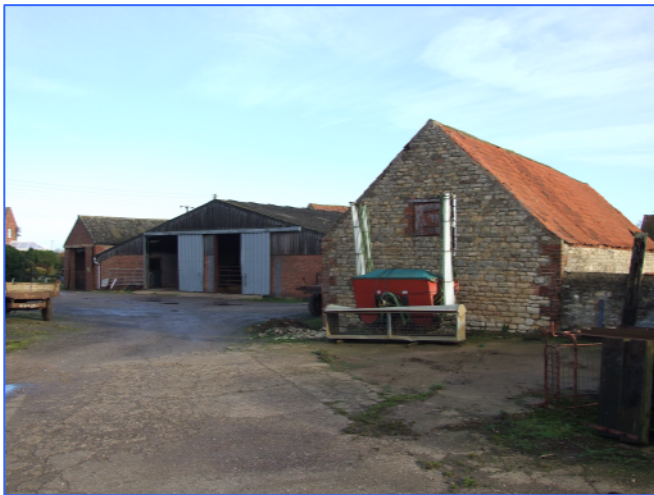
Plate 23: The barns from the west, showing building 6b in the foreground, with the covered crew yard and building 1 in the background.

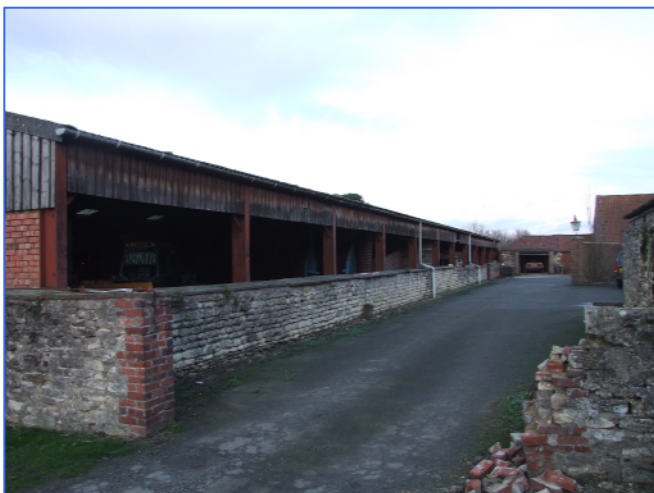
Plate 24: View along south boundary of covered crew yard, looking east-north-east.
