BUILDING SURVEY REPORT:
TOWNGATE HOUSE FARM, TOWNGATE WEST,
MARKET DEEPING, LINCOLNSHIRE

Planning Reference: N/A
NGR: TF 13258 10852
AAA Site Code: MADE 09
LCCM Accession Number: 2009.004
Oasis Reference: allenarc1_56812

Allen Archaeological Associates
Report Number 2009/011

March 2009

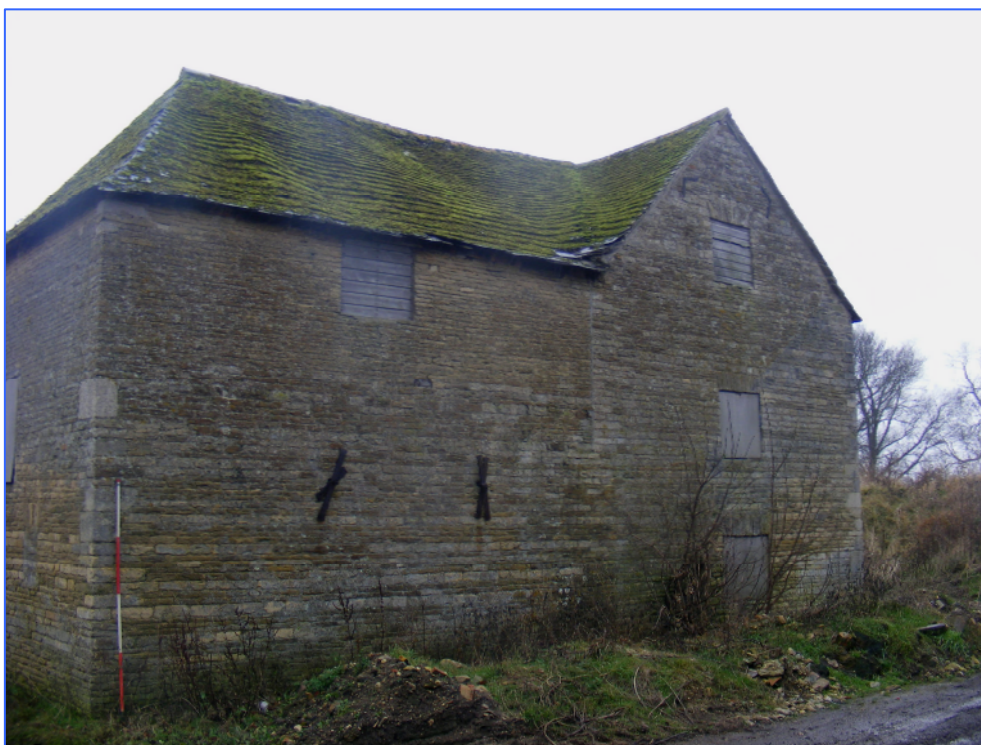
Plate 1 (Shot 91): North elevation of Building A, oast house and barn, looking south-west.

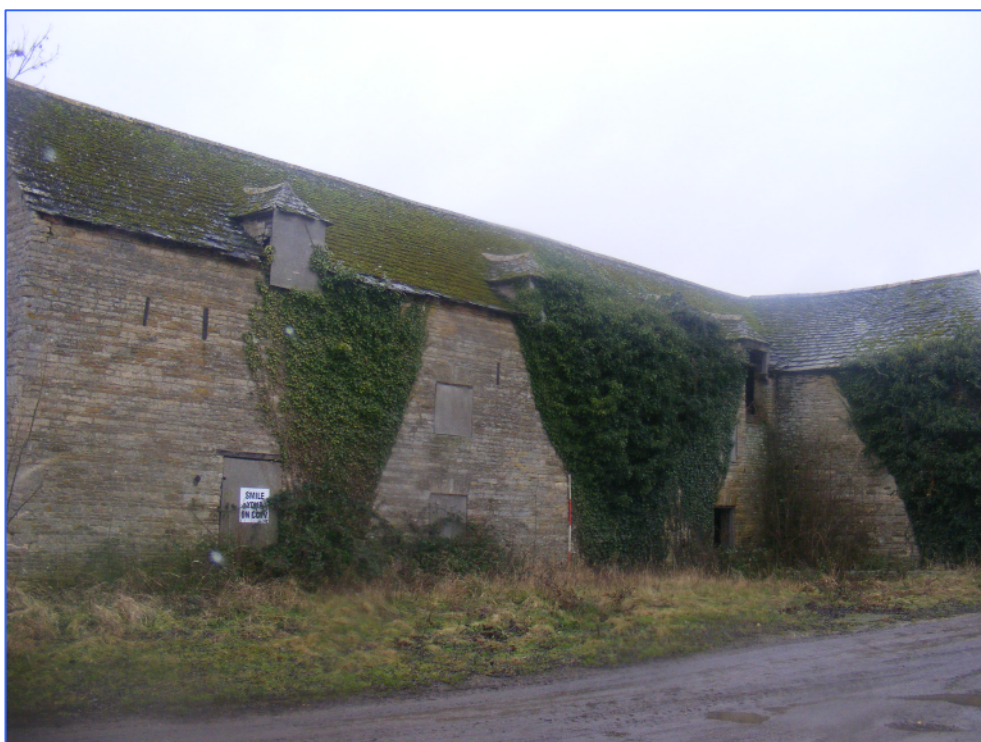
Plate 2 (Shot 88): South elevation of oast house and east elevation of attached barn, looking west-north-west.

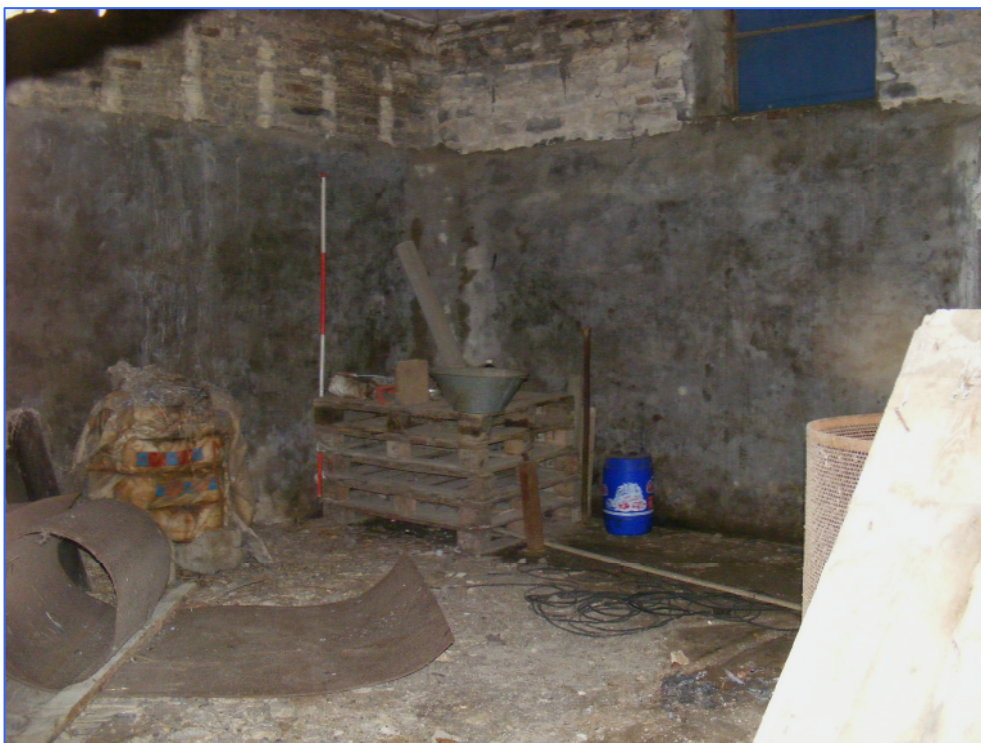
Plate 4 (Shot 86): Interior of the oast house, looking north. Note the scars defining the former joists of the first floor to the left of shot.

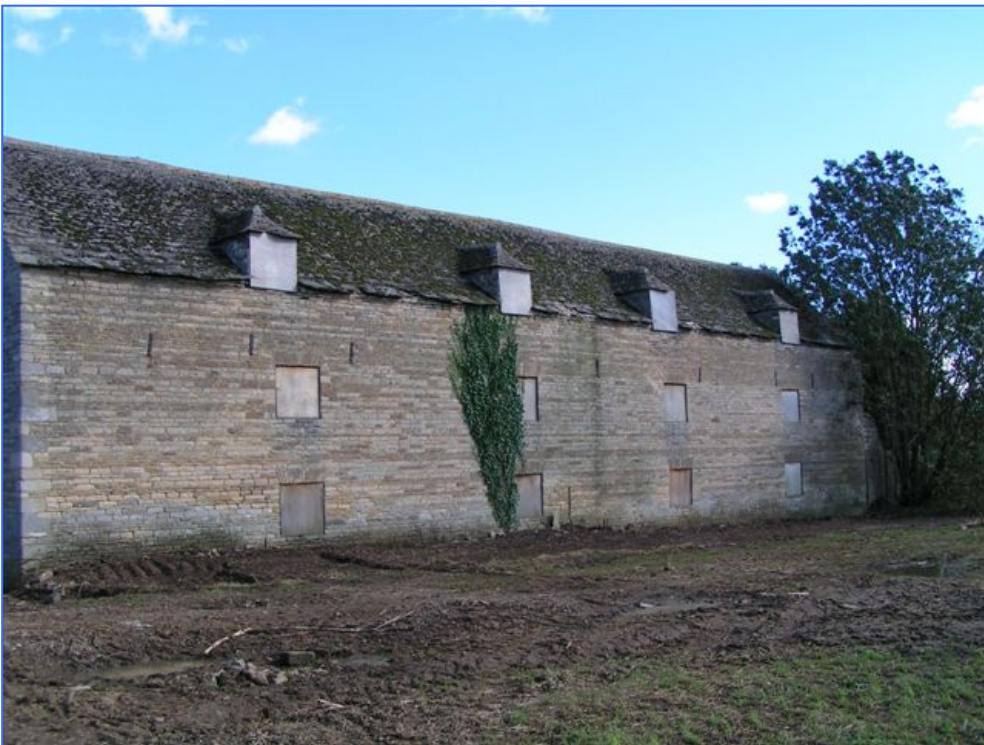
Plate 8 (Shot 119): West elevation of Building A barn, looking east-south-east.

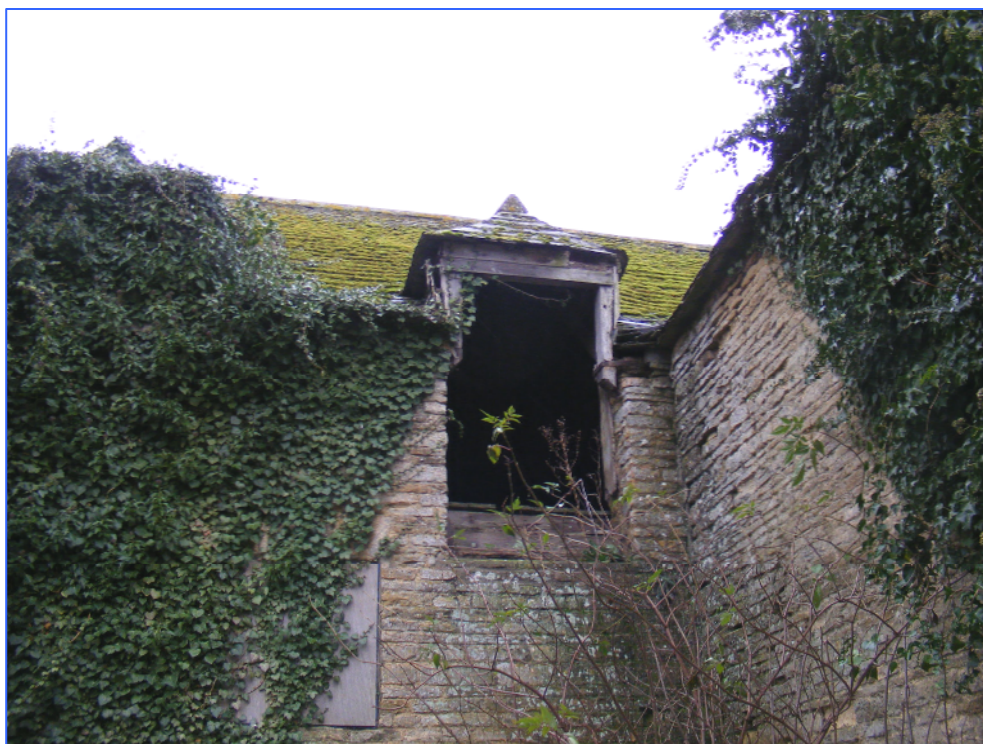
Plate 9 (Shot 95): Detail of doorway at north end of east elevation of Building A barn, looking west. The hipped roof reflects the design of the dormers on both this and the west elevation.

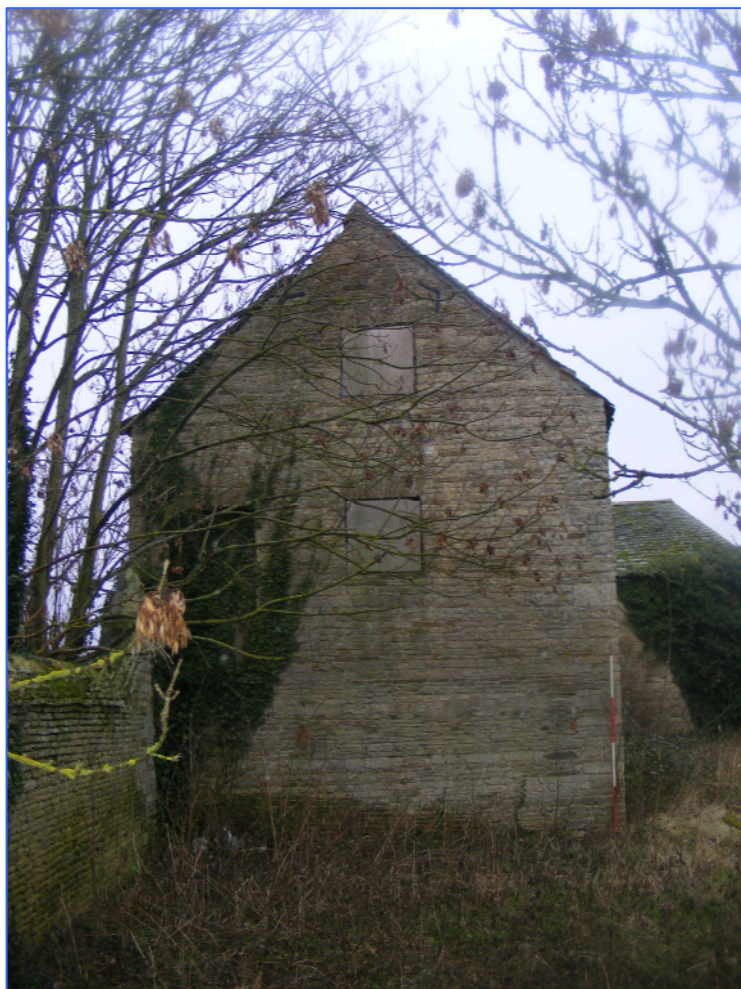
Plate 10 (Shot 89): South elevation of Building A barn looking north-north-west.

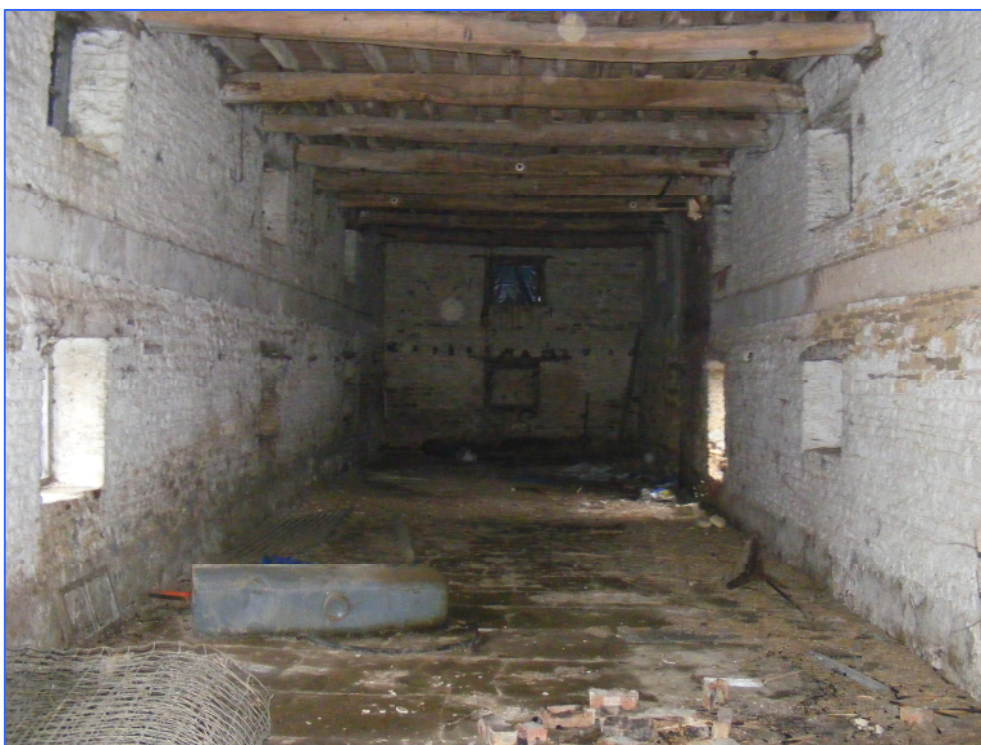
Plate 11 (Shot 74): Interior of Building A barn, looking north-north-west. Note the remnants of the former first floor joists at the far end of the building.

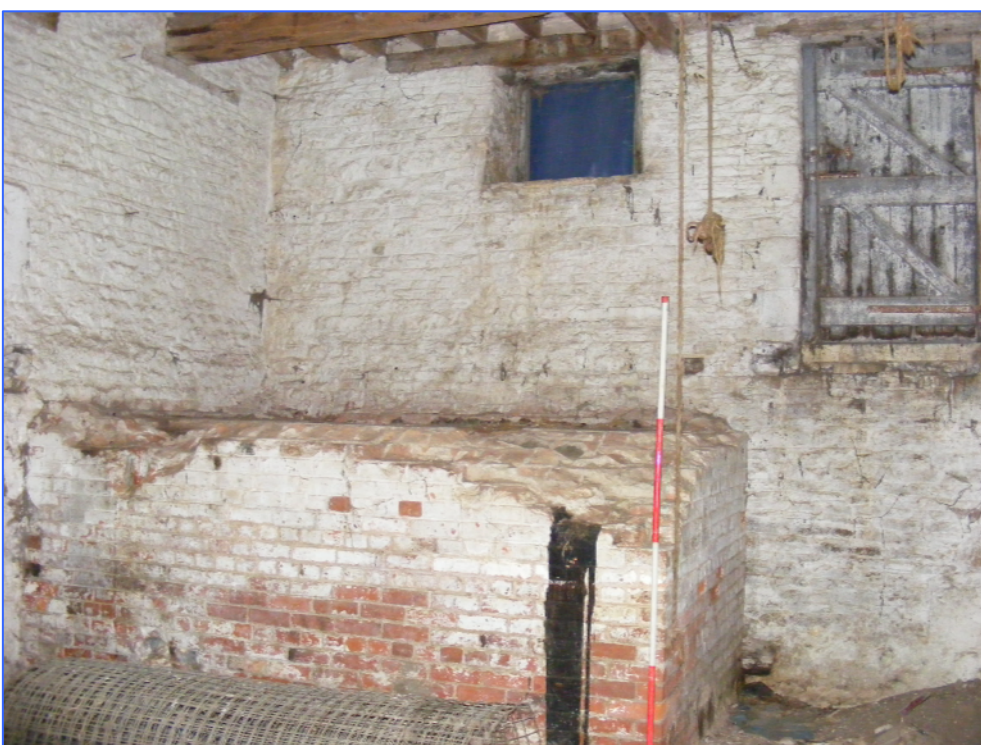
Plate 12 (Shot 73): Brick plinth, possible former machine stand at south end of Building A barn, looking south-south-east. Note also the doorway and pitching hole in the wall to the rear.

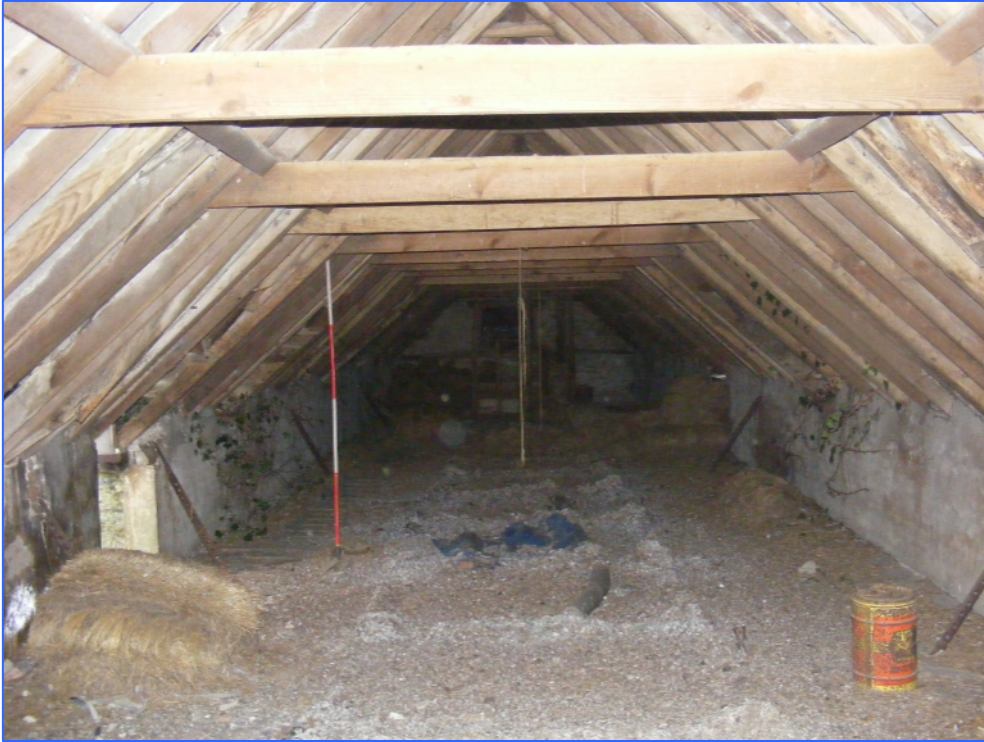
Plate 13 (Shot 47): First floor of Building A barn, looking south-south-east.

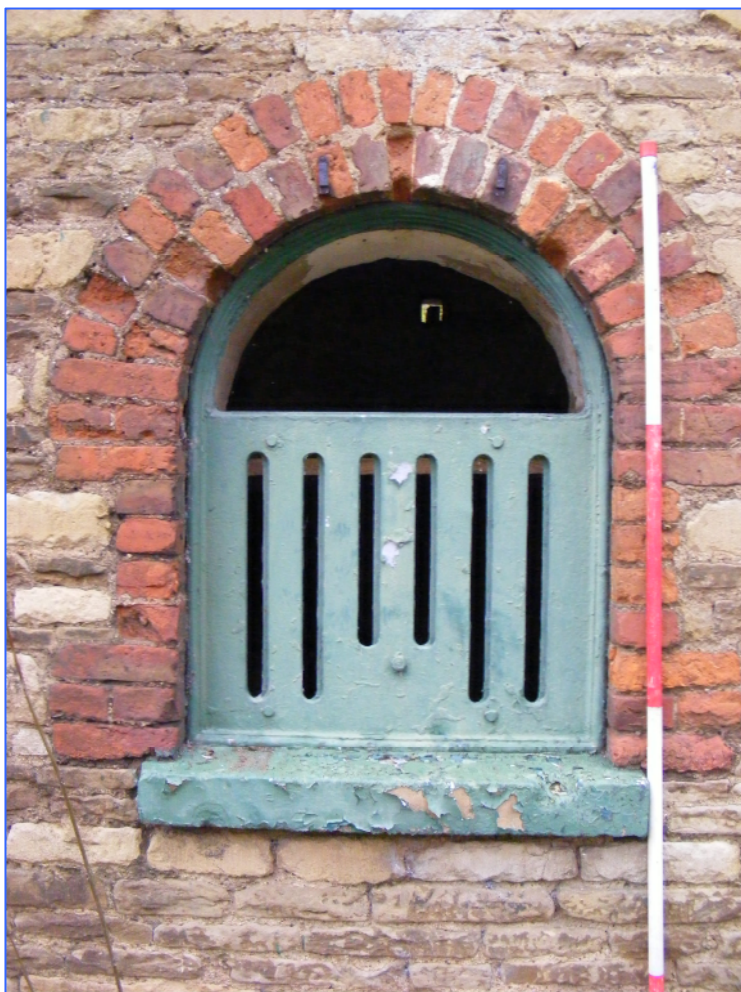
Plate 15 (Shot 43): Detail of ventilated opening in south elevation of Building B, looking north.

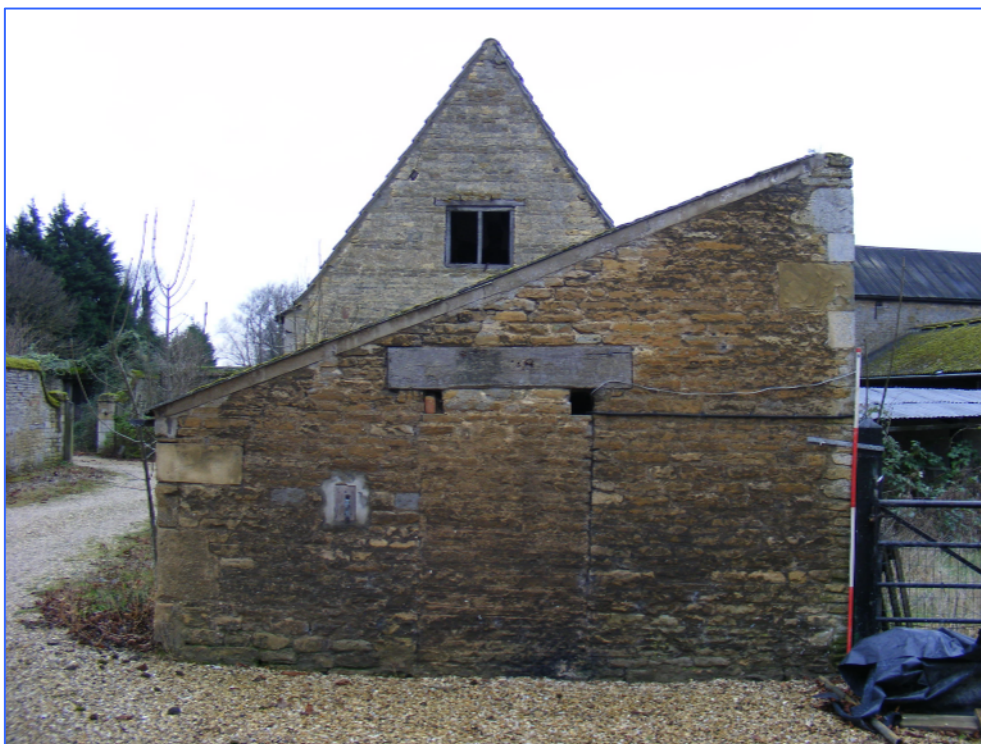
Plate 17 (Shot 36): East elevations of Buildings C (foreground) and B (background), looking west.

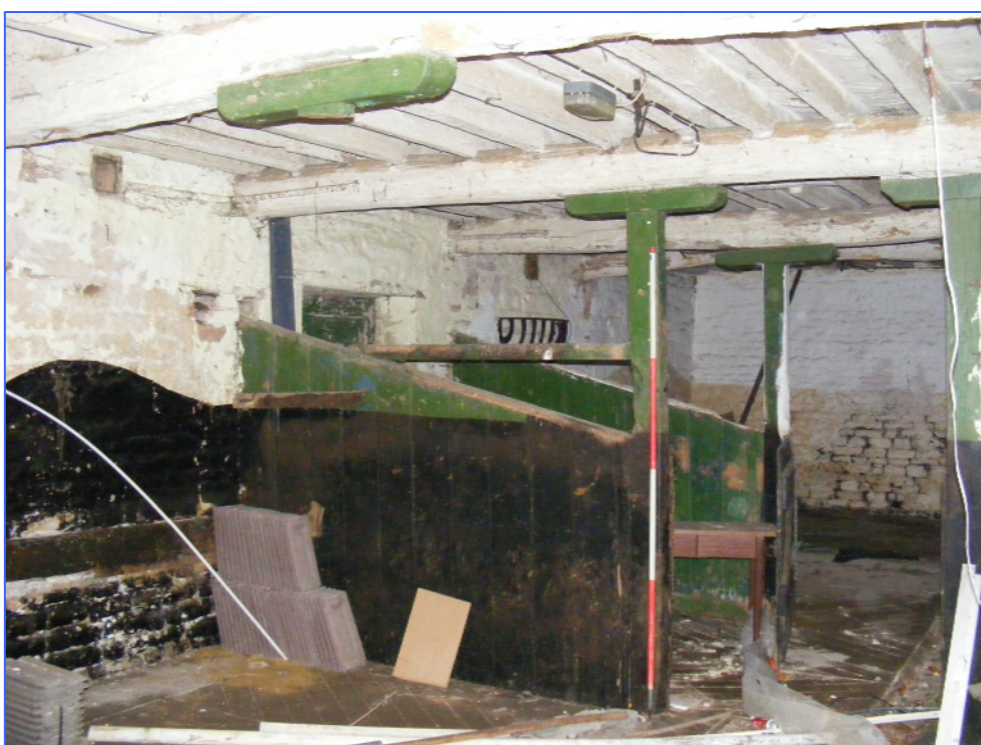
Plate 18 (Shot 48): Interior of stable block in Building B, looking east-north-east. Note the remnant of a former partition attached to the ceiling joist in the foreground.

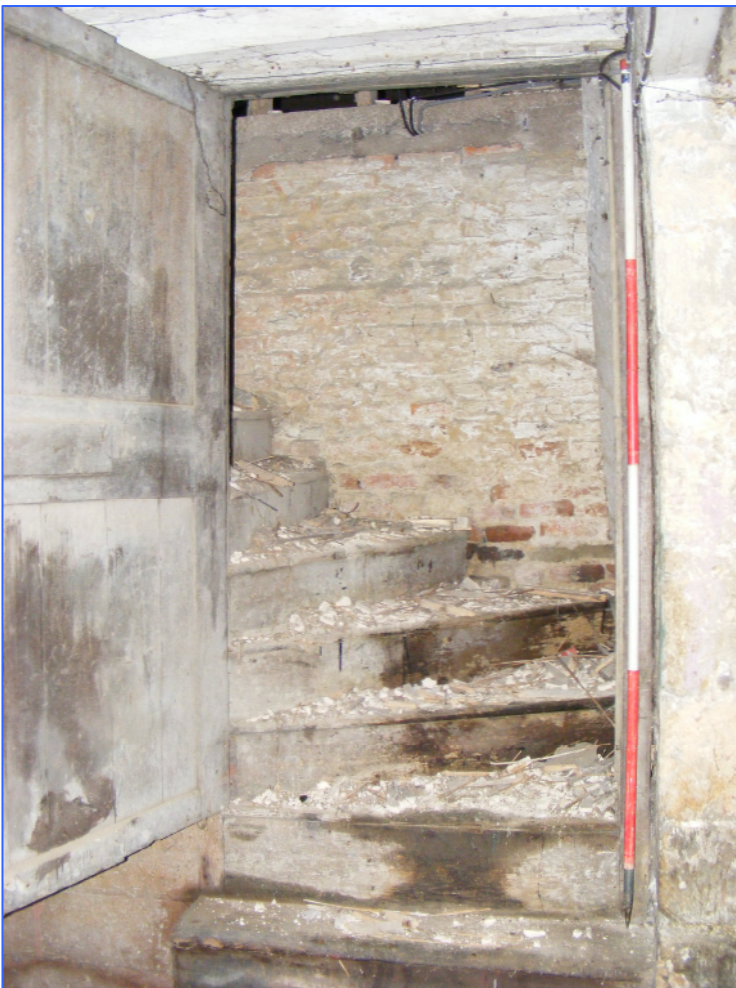
Plate 20 (Shot 47): Staircase in Building B, looking east.

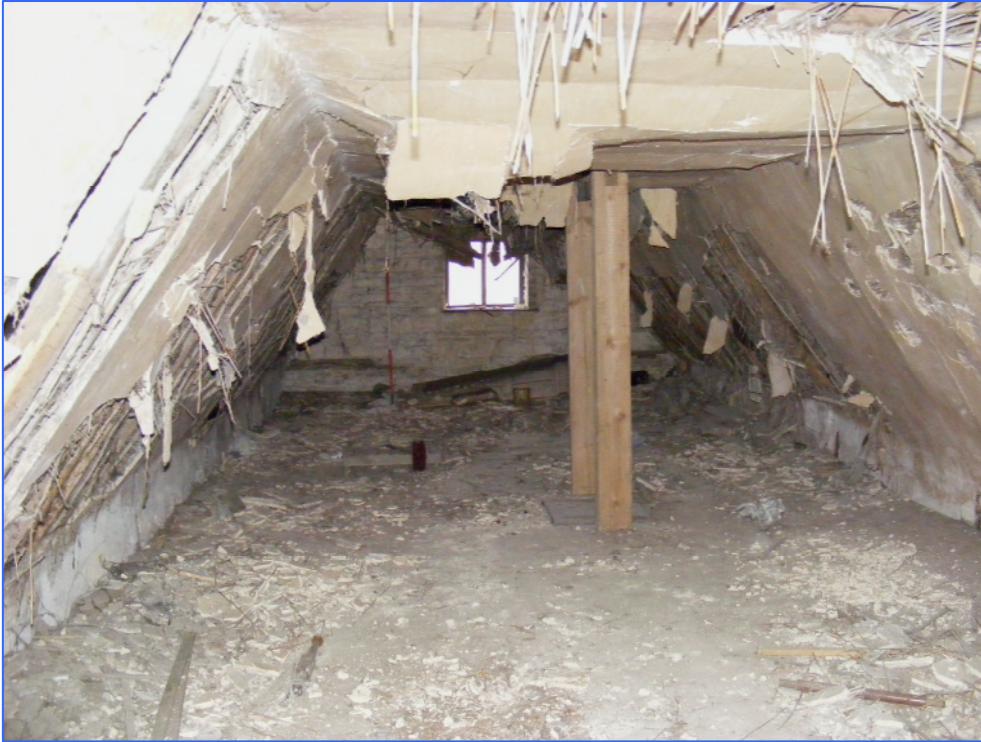
Plate 21 (Shot 52): Upper floor of Building B, looking east-north-east. In the centre of the shot is the hatch to the lower floor.

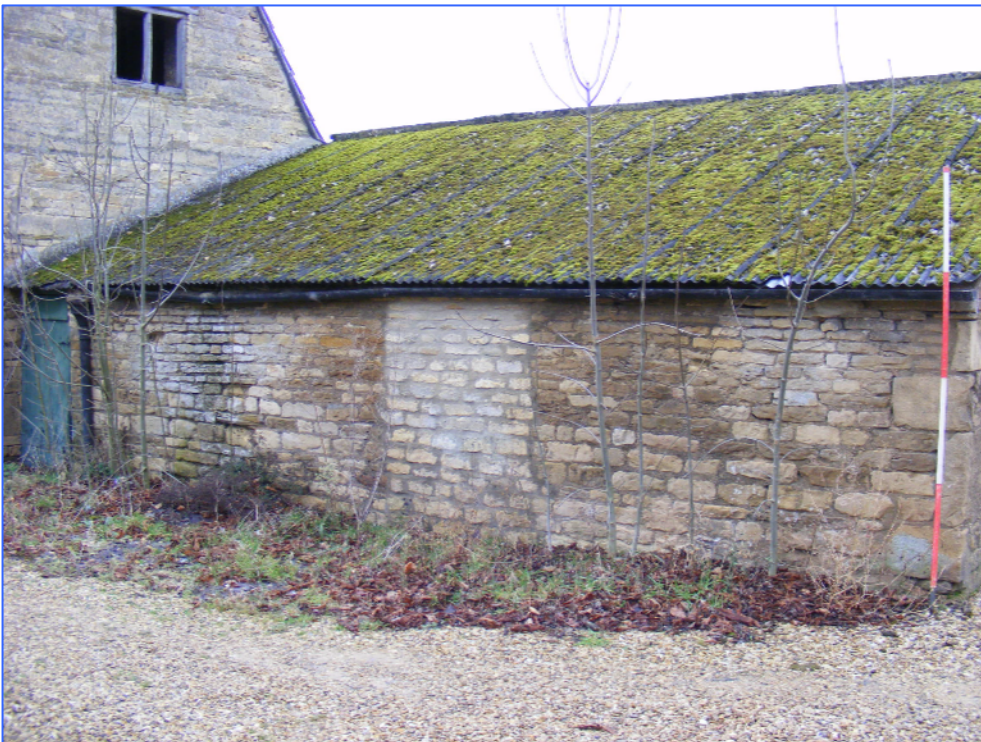
Plate 22 (Shot 37): South elevation of Building C, looking north-west.

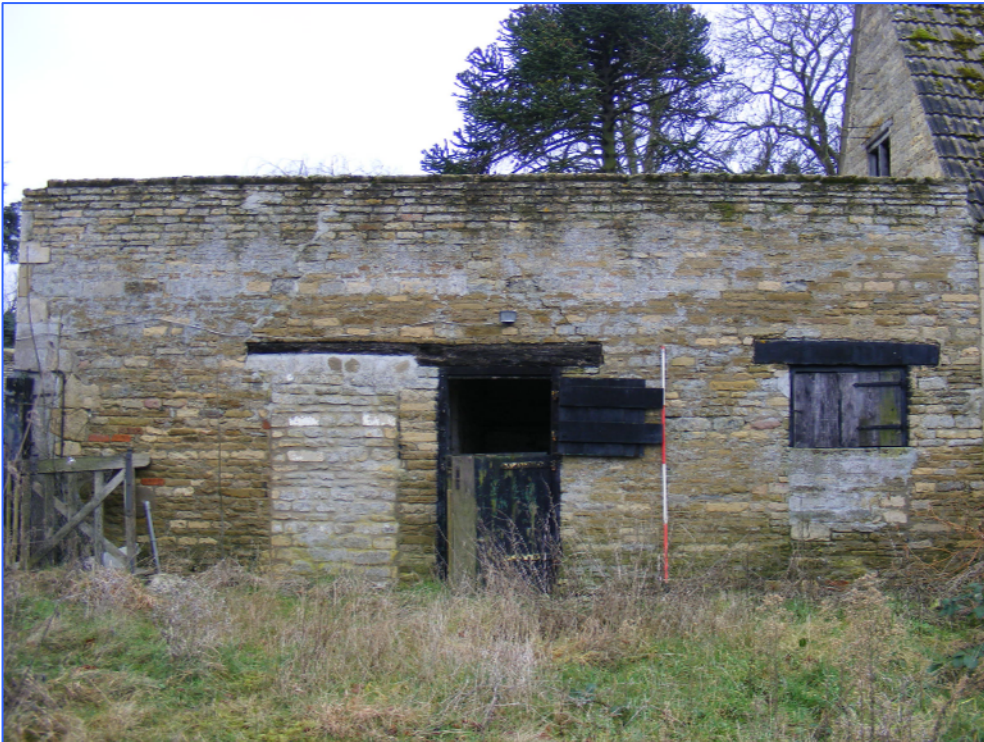
Plate 23 (Shot 38): North elevation of Building C, looking south.

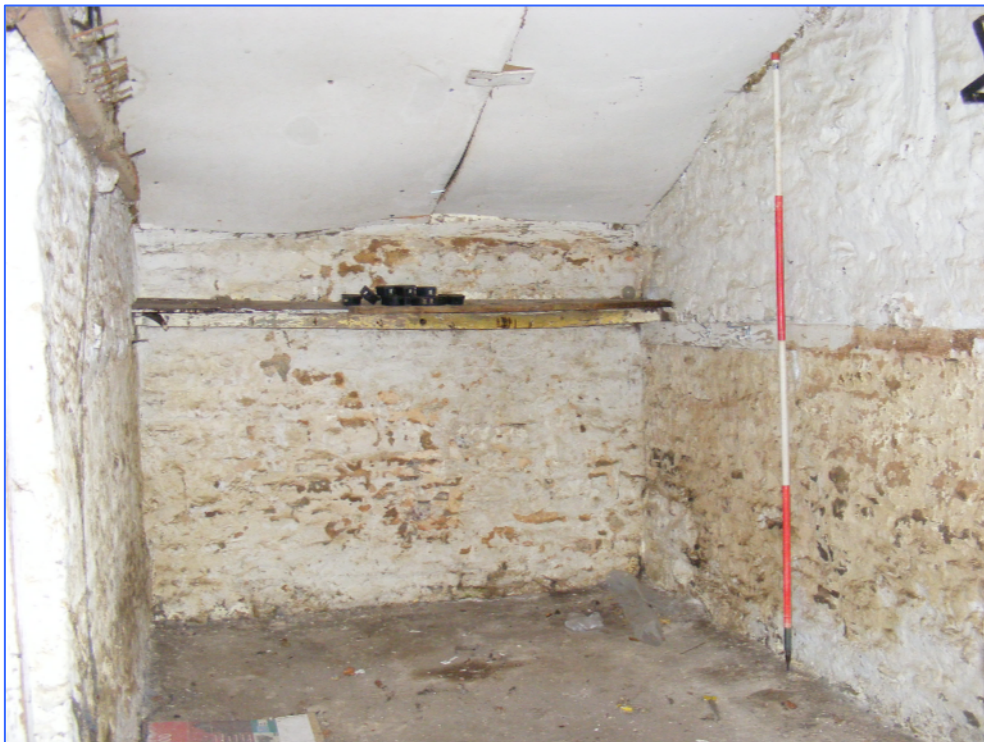
Plate 24: (Shot 39): Central room (C2), in Building C, looking south-south-east.

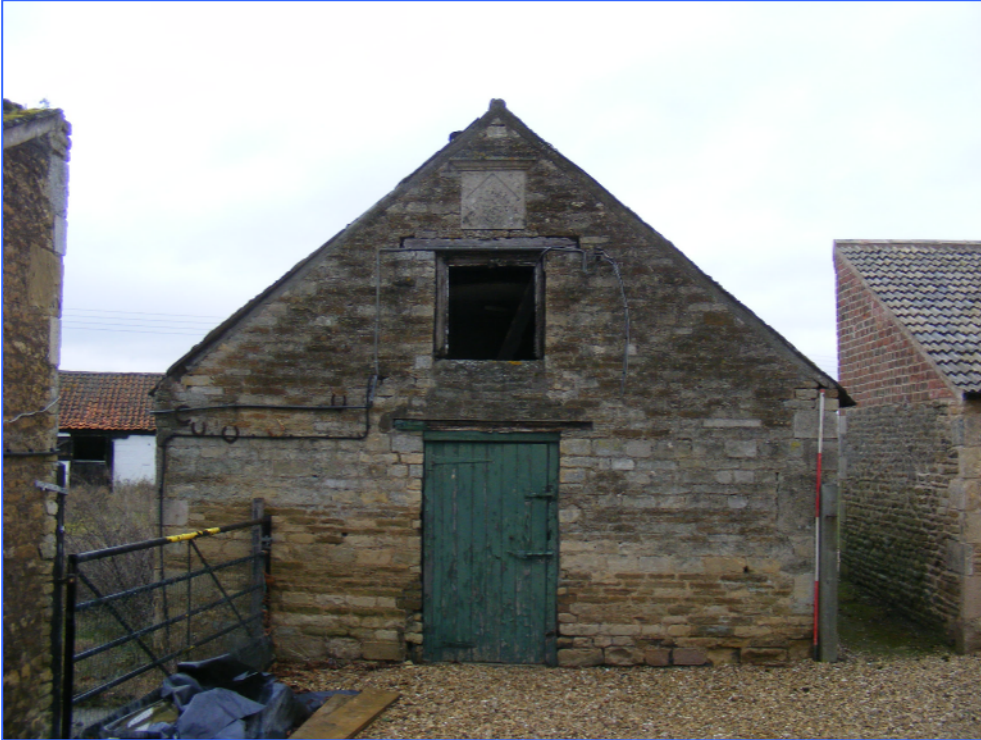
Plate 25 (Shot 1): South elevation of Building D, looking north.

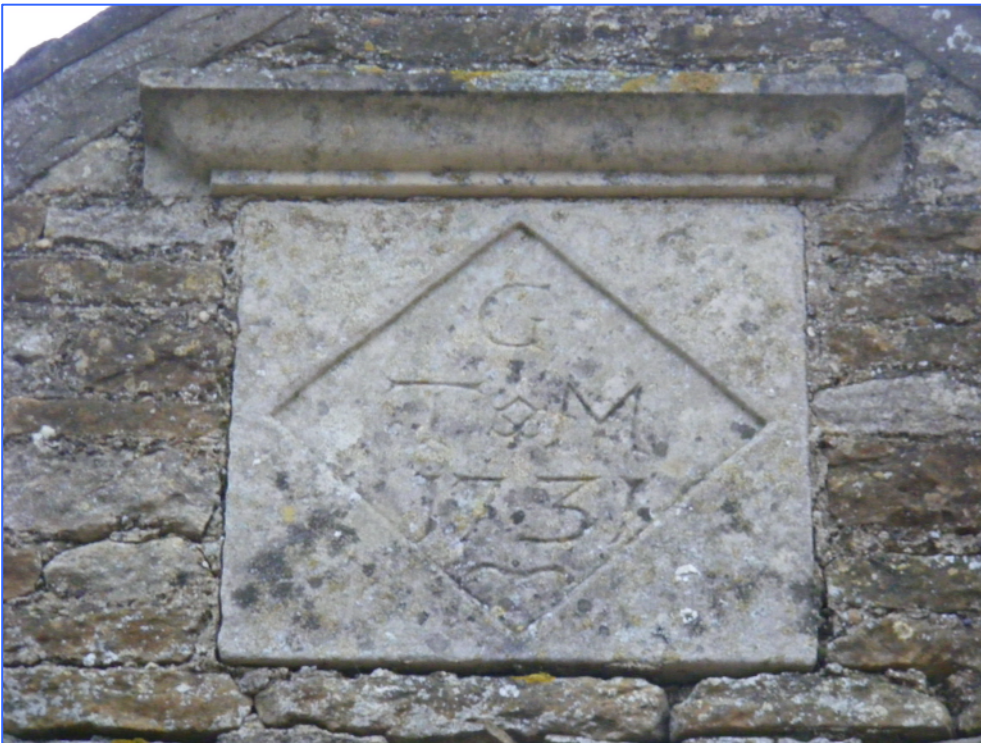
Plate 26 (Shot 2): Detail of datestone in south elevation of Building D, looking north.

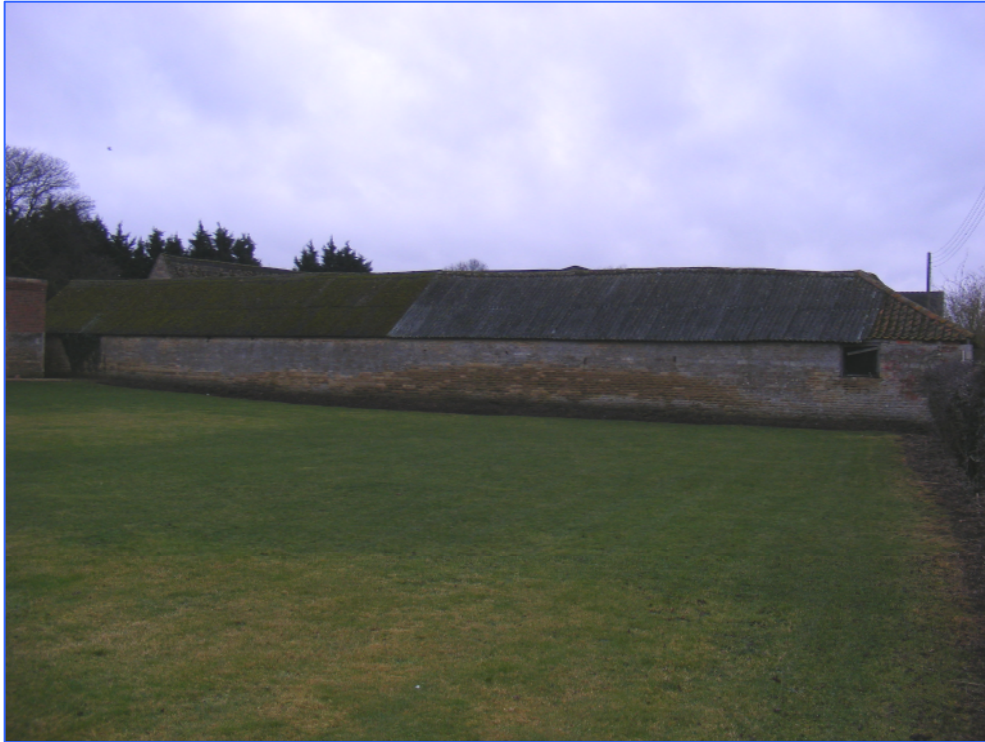
Plate 27 (Shot 3): East elevation of Building D, looking south-west.

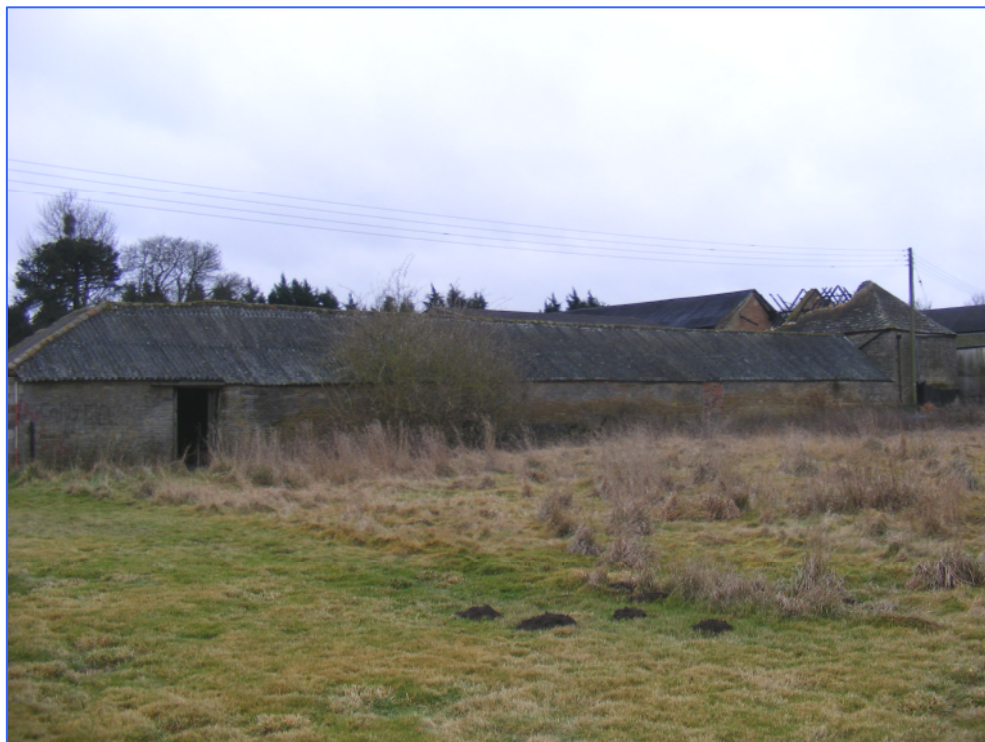
Plate 28 (Shot 4): North elevation of Buildings D (to left of shot) and E, looking west-north-west.

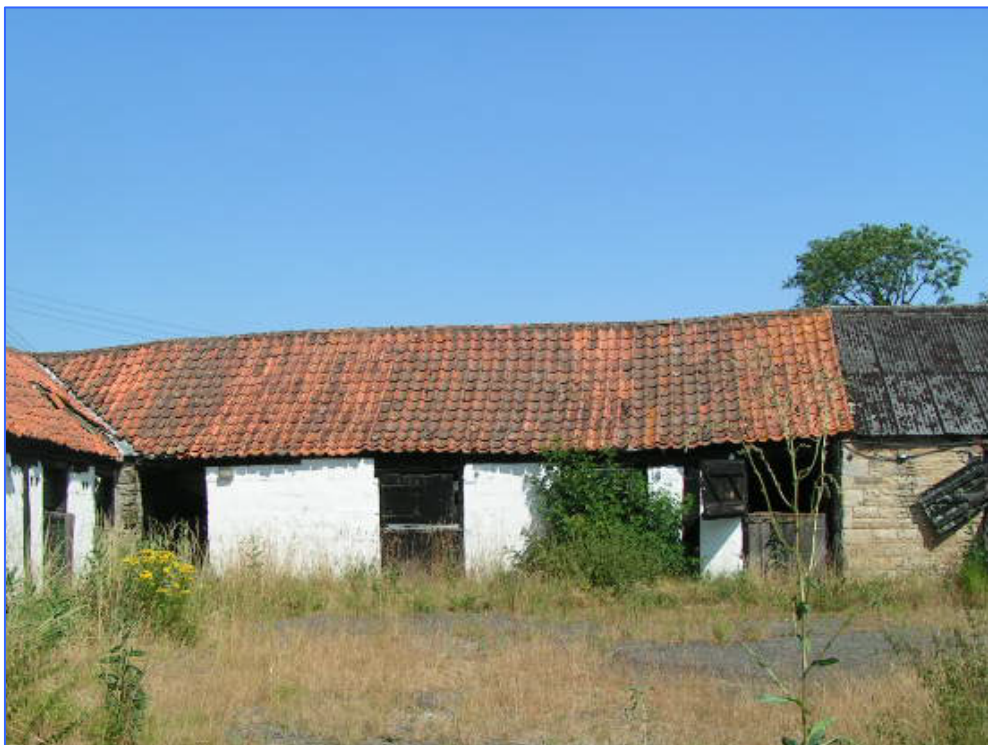
Plate 30 (Shot 155): West elevation of Building D, north end, looking east-north-east.

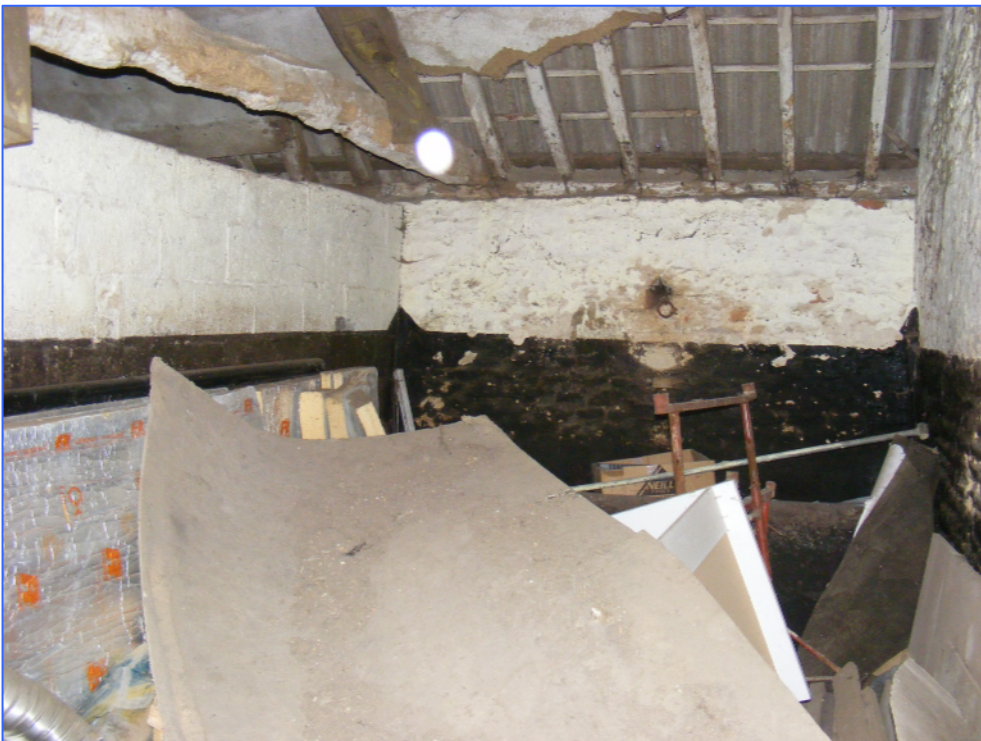
Plate 32 (Shot 11): Room D5, looking east-north-east, with brick partition to the left of the shot.

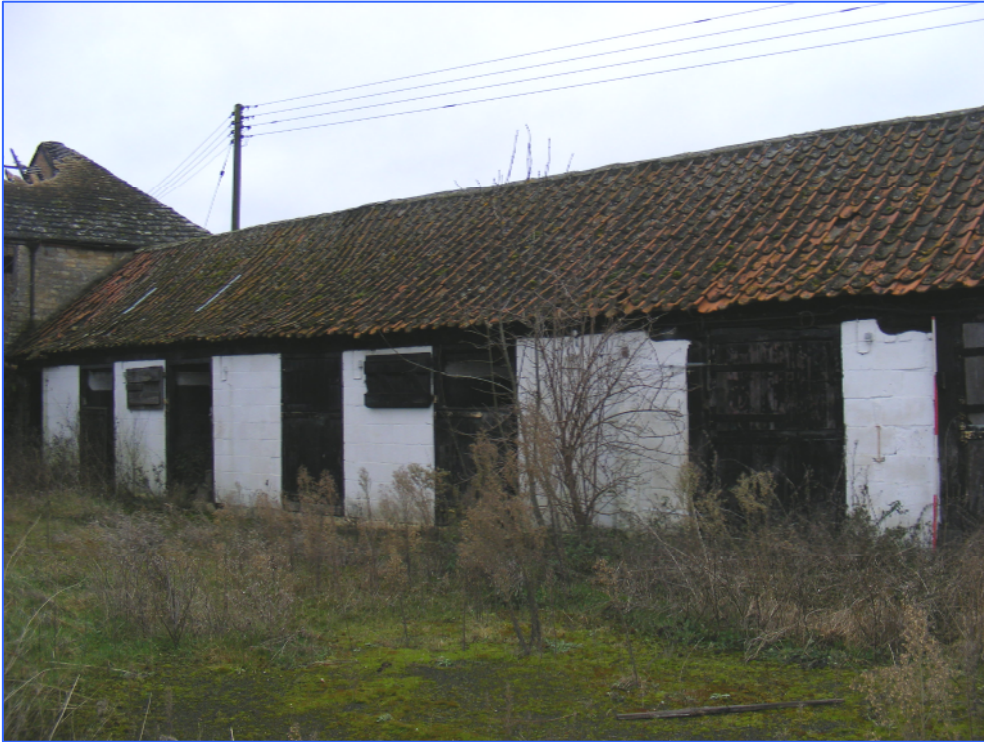
Plate 35 (Shot 20): South elevation of Building E, looking north-west. Building F is visible at the extreme left of the shot.

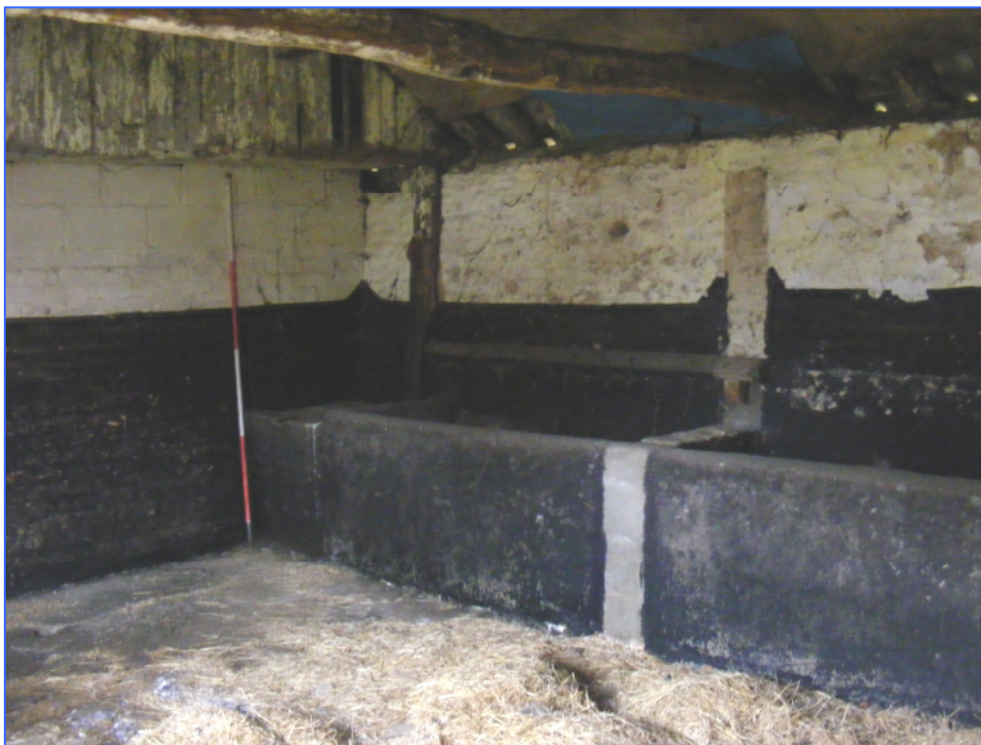
Plate 37 (Shot 25): Room E5, looking north-west. Note the scar in the middle of the shot indicating a probable former partition.

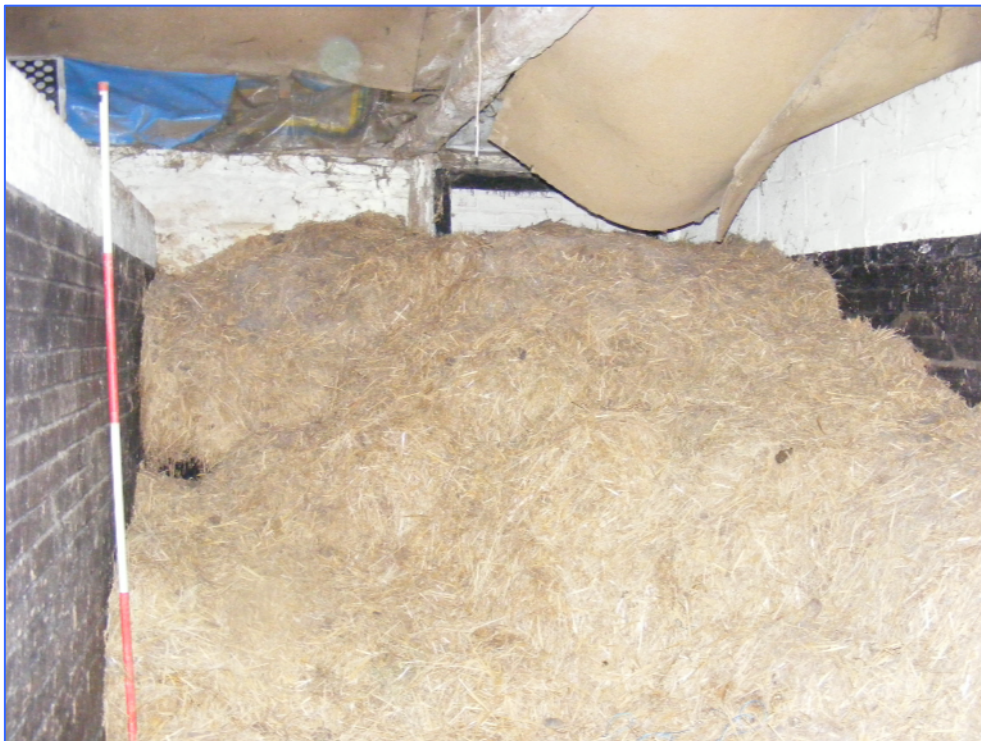
Plate 38 (Shot 27): Room E6, looking north-north-west. The top of the blocked doorway in the north elevation is visible in the background.

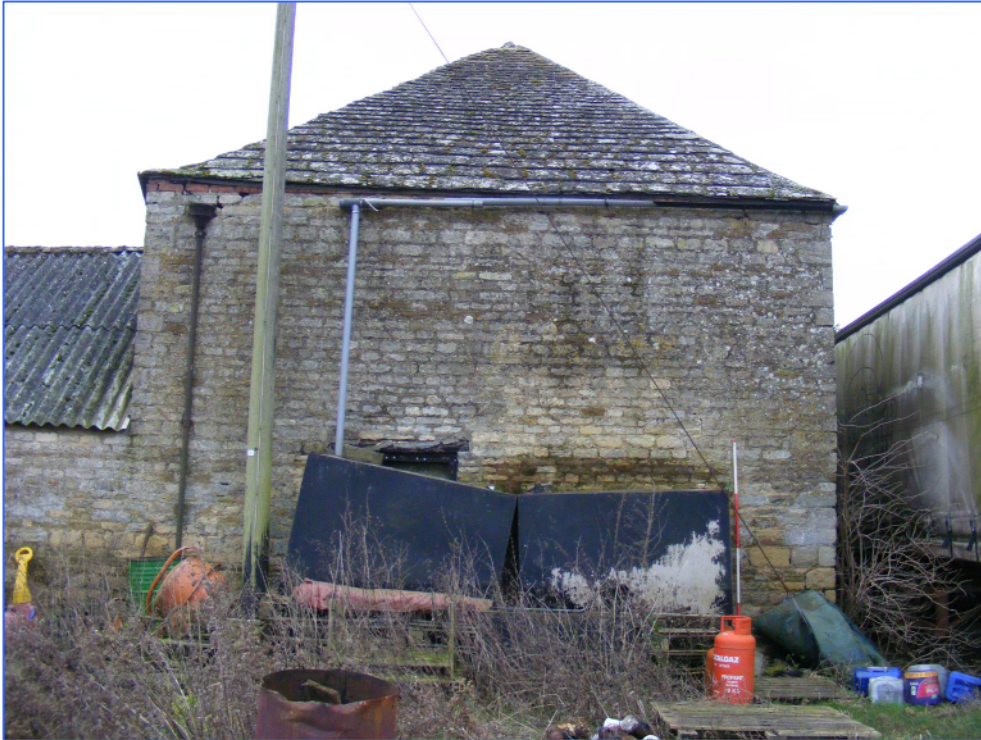
Plate 41 (Shot 66): North elevation of Building F, looking south-south-east.

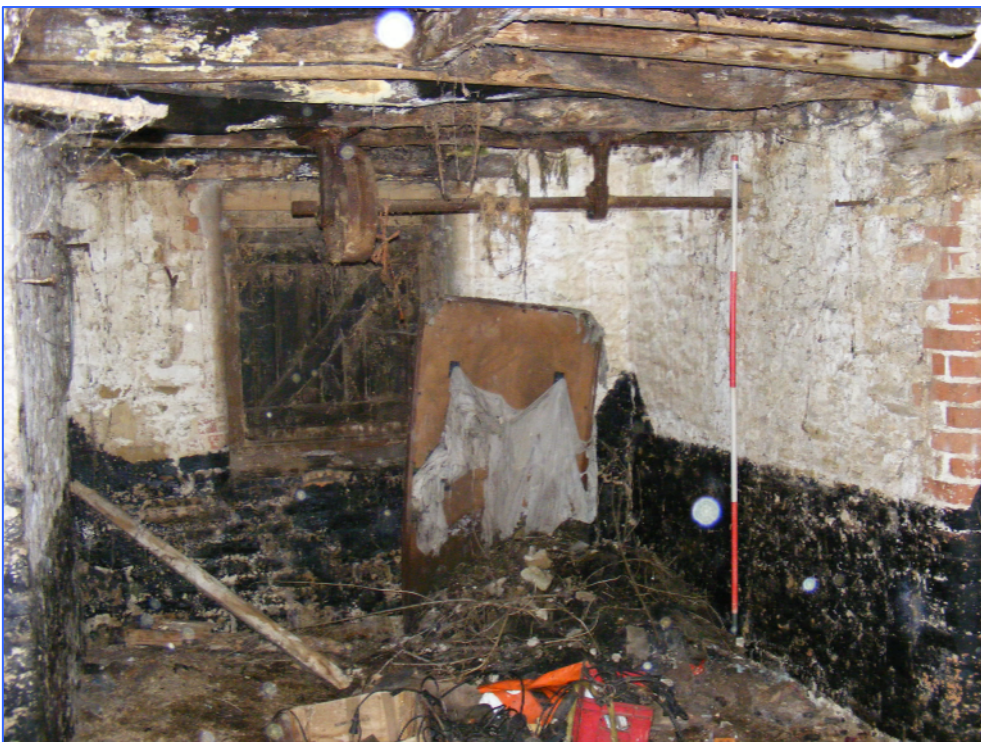
Plate 42 (Shot 69): Interior of Building F, ground floor, looking west.

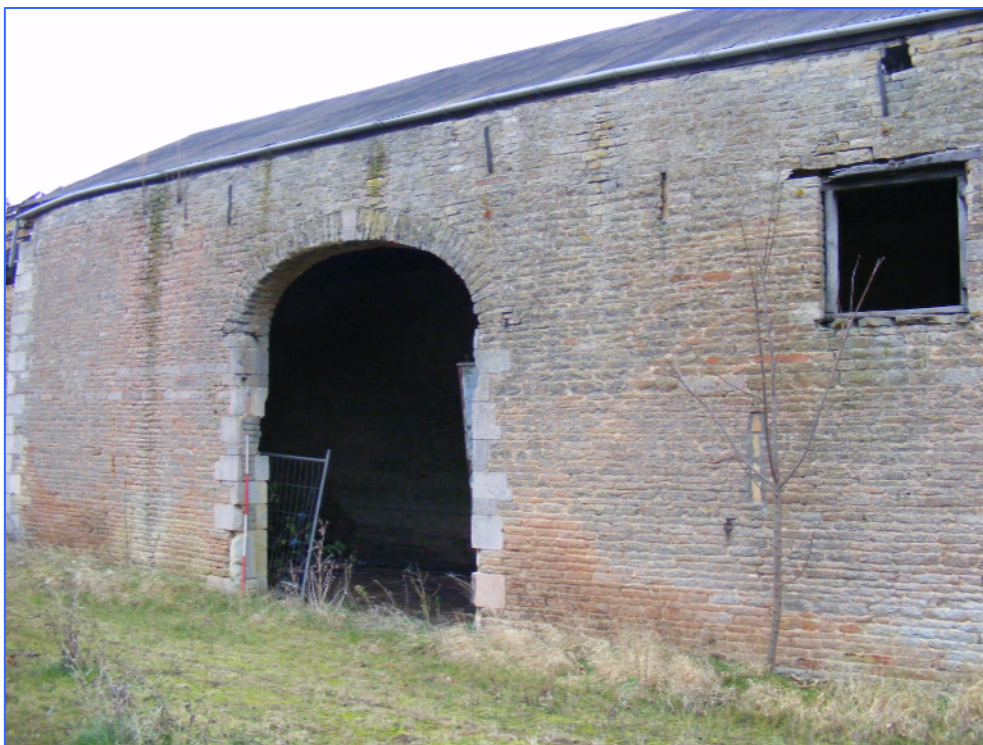
Plate 43 (Shot 65): West elevation of Building G, looking north-east, showing the large doorway typical of threshing barns.

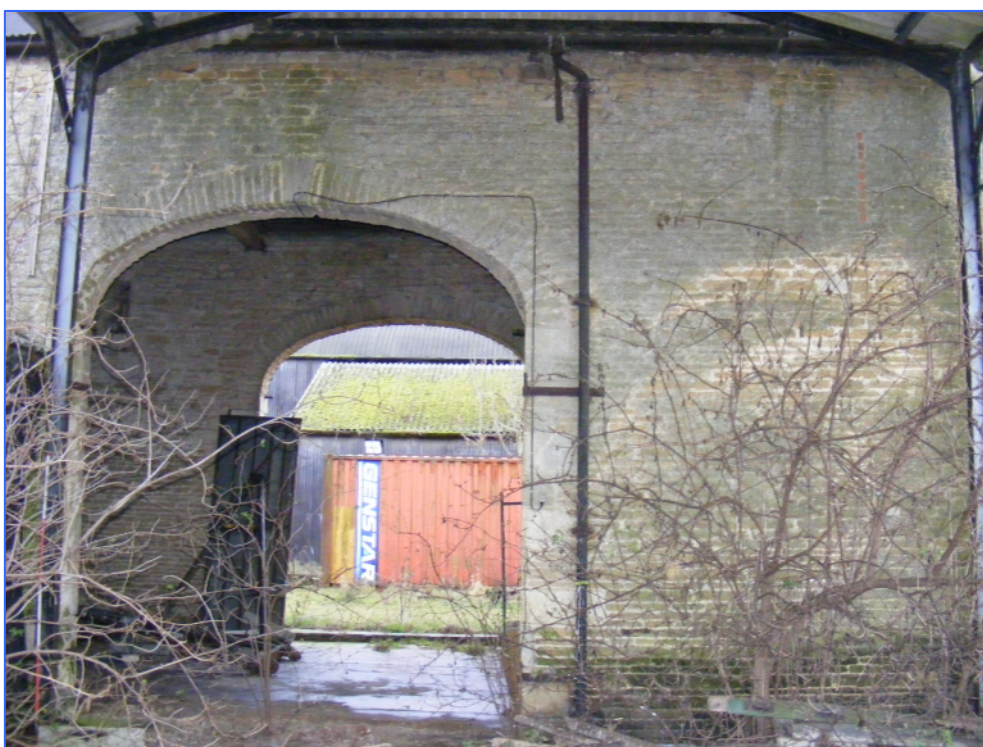
Plate 44 (Shot 61): Detail of doorway in east elevation of Building G, looking west-south-west, with the opposing door in the west elevation visible in the background.
