BUILDING SURVEY REPORT:
TOWNGATE HOUSE FARM, TOWNGATE WEST,
MARKET DEEPING, LINCOLNSHIRE

Planning Reference: N/A
NGR: TF 13258 10852
AAA Site Code: MADE 09
LCCM Accession Number: 2009.004
Oasis Reference: allenarc1_56812

Allen Archaeological Associates
Report Number 2009/011

March 2009

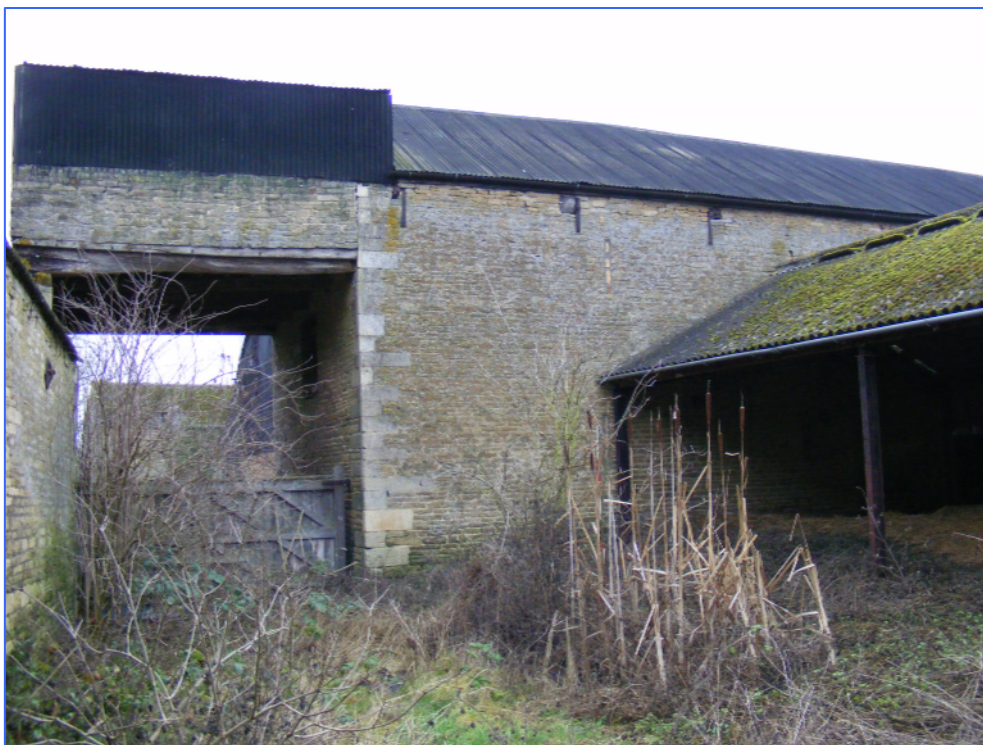
Plate 47 (Shot 58): East elevation of Building H and adjacent threshing barn, Building G, with modern barn J to the right of shot. Looking west.

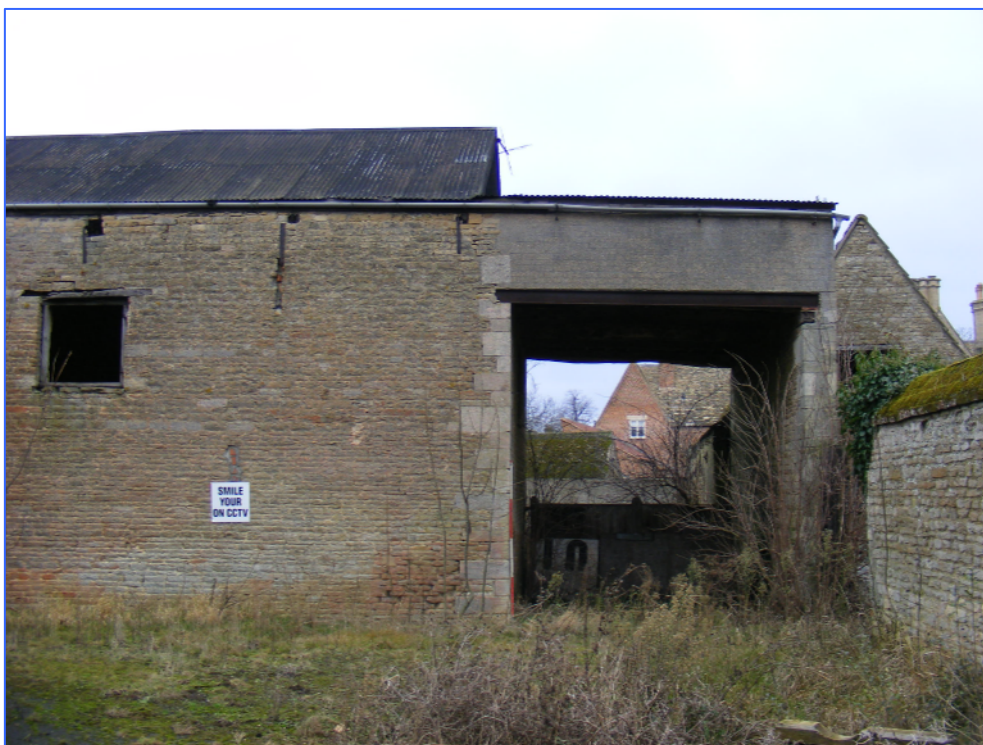
Plate 48 (Shot 64): West elevation of Building H, with threshing barn to the left and the boundary wall of the walled garden to the right. Looking east-north-east.

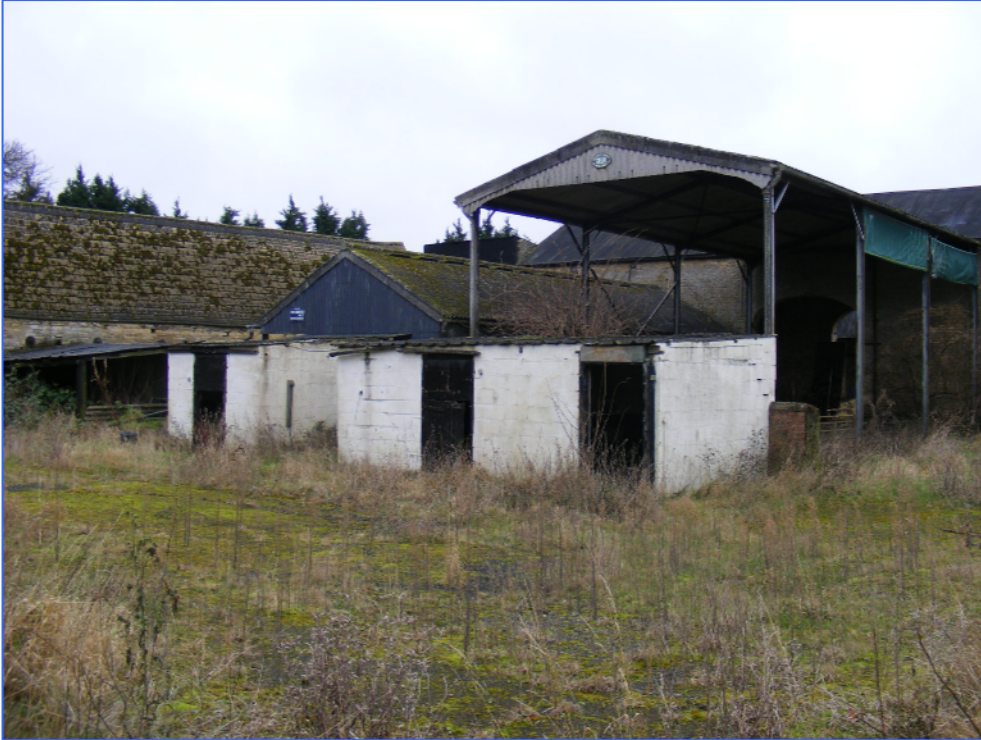
- 5.9.1 These two buildings represent modern steel framed structures extending eastwards from the east elevation of threshing barn G (Plate 49).
- 5.9.2 The northernmost building, H, is a steel framed structure with a corrugated steel double pitched roof, while Building I is also steel framed, with corrugated steel sheeting along its east side. There is a yard area to the south of Building I and two single storey brick and breeze block outbuildings are located against the east front of the two structures. There is a further wooden outbuilding to the south that is largely derelict.

Plate 49 (Shot 18): Modern steel framed barns I and J, with modern breeze block outbuildings to their front. Looking south-west.

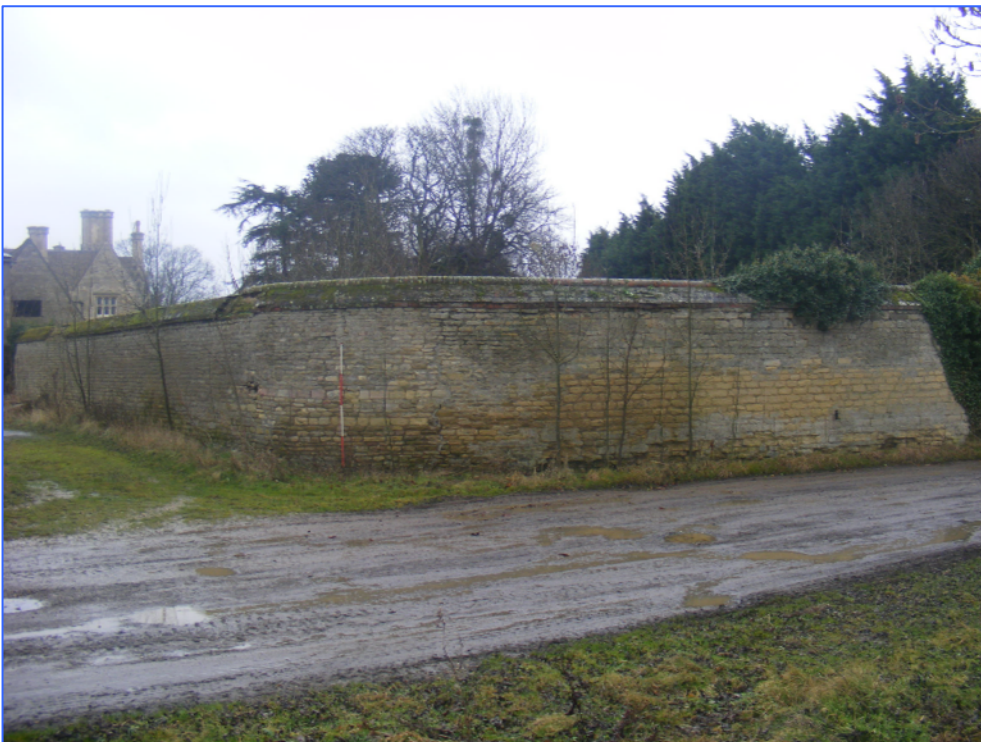
- 5.10.1 The walled garden is situated to the south of Building G and to the west of Building B. It is bounded by a coursed limestone wall that encloses a sub-rectangular area with maximum dimensions of 37m east to west and 27.8m north to south (Plate 50). It is accessed by an opening in its north wall, and by a doorway in the east wall. Much of the western part of the

Plate 50 (Shot 100): Exterior of walled garden, Area K, looking south-east. Towngate Farm House is in the background.

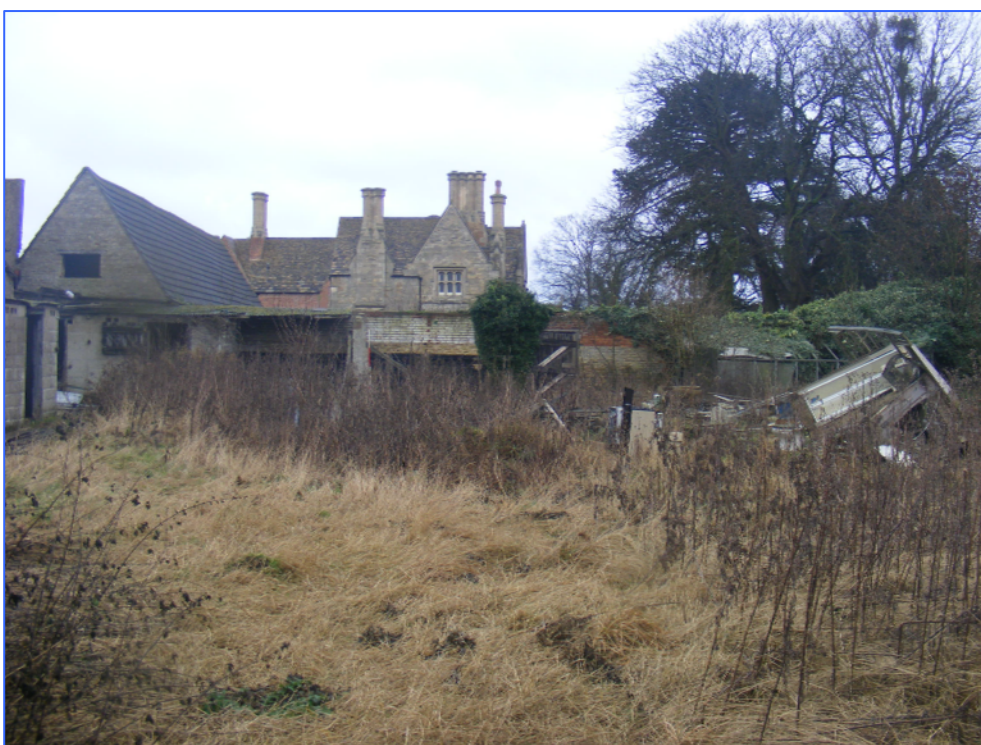
- 5.10.3 The remainder of the walled garden is very overgrown and contains large quantities of assorted debris, including a derelict modern greenhouse in the south-east corner. It is therefore not possible to comment on its original layout from the site visit (Plate 52).

Plate 52 (Shot 106): East end of walled garden, Area K, looking east-north-east. The breeze block outbuildings are to the left of the shot, with the black doorway to the farmhouse at the centre, and a derelict greenhouse to the right of the shot. In the background is Towngate Farm House, with the west elevation of Building B to the left of the shot.

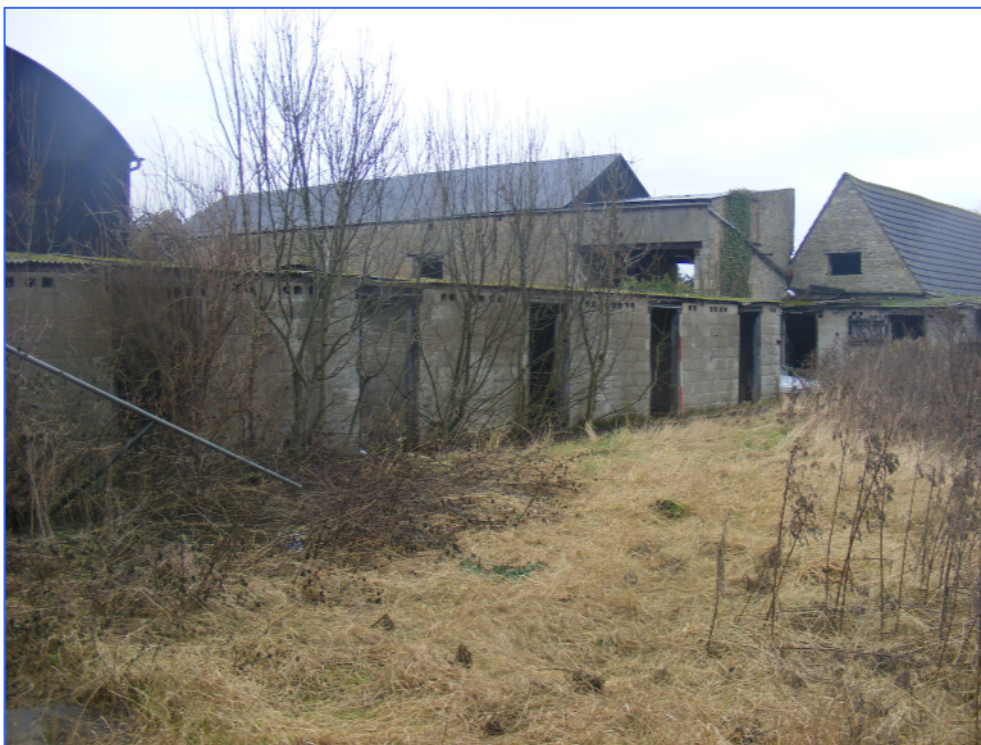
- 5.10.2 There is a range of single storey breeze block buildings against the north wall of the garden, and a further range against the east wall, all of which have small brick feeding troughs inside and are likely to have served as animal shelters (Plates 52 and 53).

Plate 53 (Shot 102): Breeze block outbuildings along north side of walled garden, looking north-east, with Buildings G, H and B in the background.
