Moss House Farm, Cockerham, Lancashire

Archaeological Building Investigation

Oxford Archaeology North

September 2009

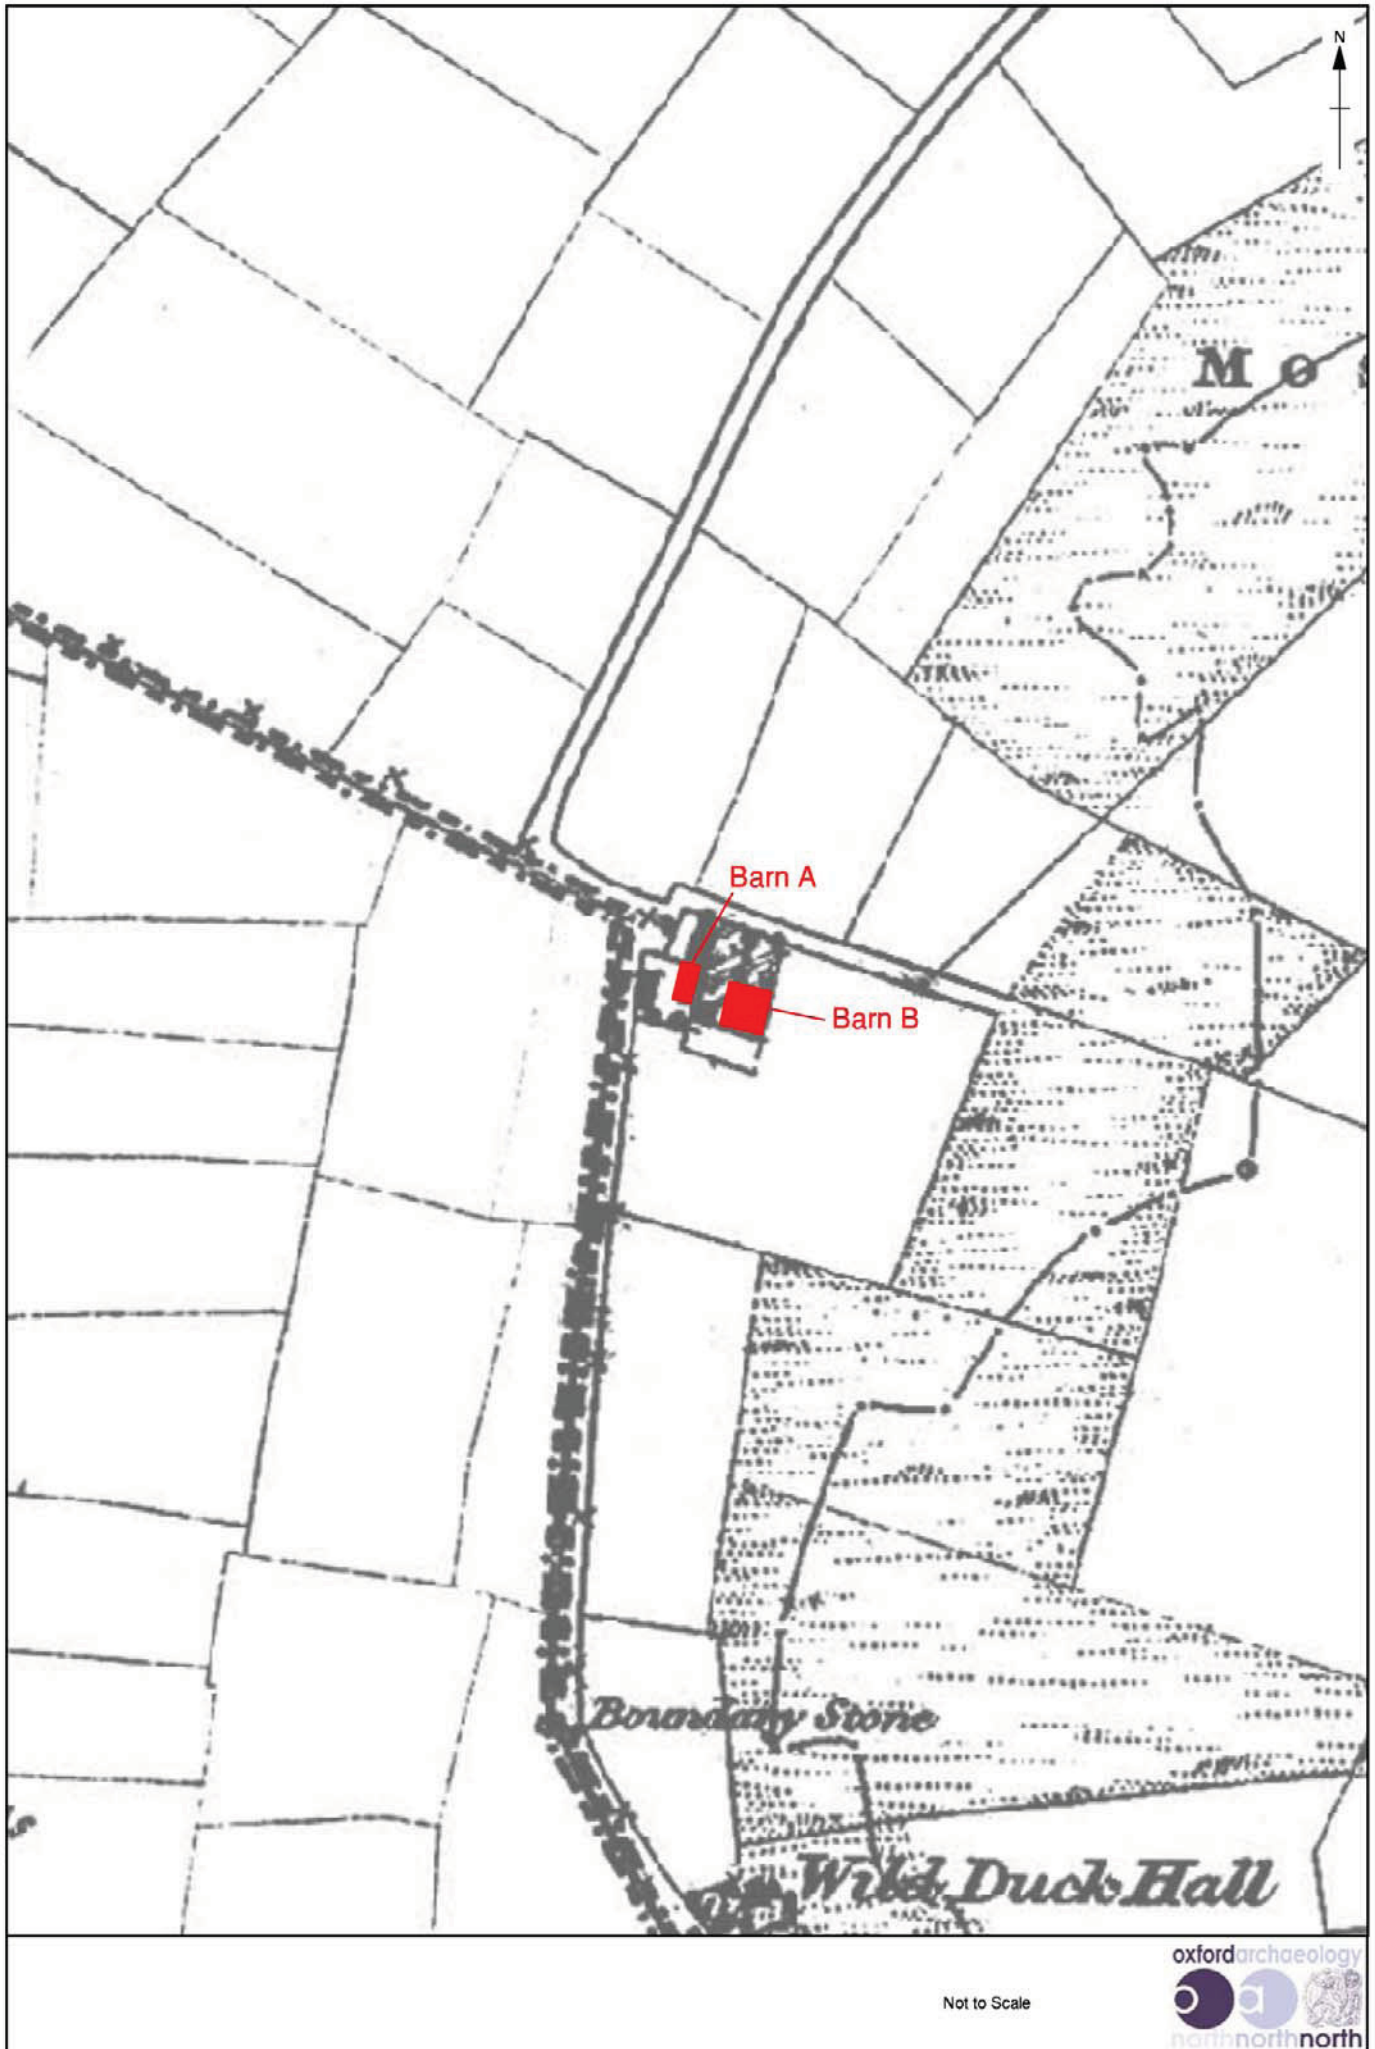
Figure 3: Extract from Ordnance Survey First Edition, 6 inch to 1 mile map, 1847

3.3.3 *Ordnance Survey, 6 inch to 1 Mile, 1847 (Fig 3)*: this is the earliest available detailed map of the area and clearly illustrates the road and field boundary pattern, which is very similar to the current appearance. To the right of the kink in the road first identified on Hennet's 1830 map, a collection of buildings is illustrated. One of these is a rectangular structure, which is of a similar footprint to the current Barn A (see *Section 4.1.1*). To the right of this, where the current barn B is situated, is a square wooded area. In common with both Yates' 1786 and Hennet's 1830 maps, there are other buildings labelled Moss House or Moss Houses located away to the south west.

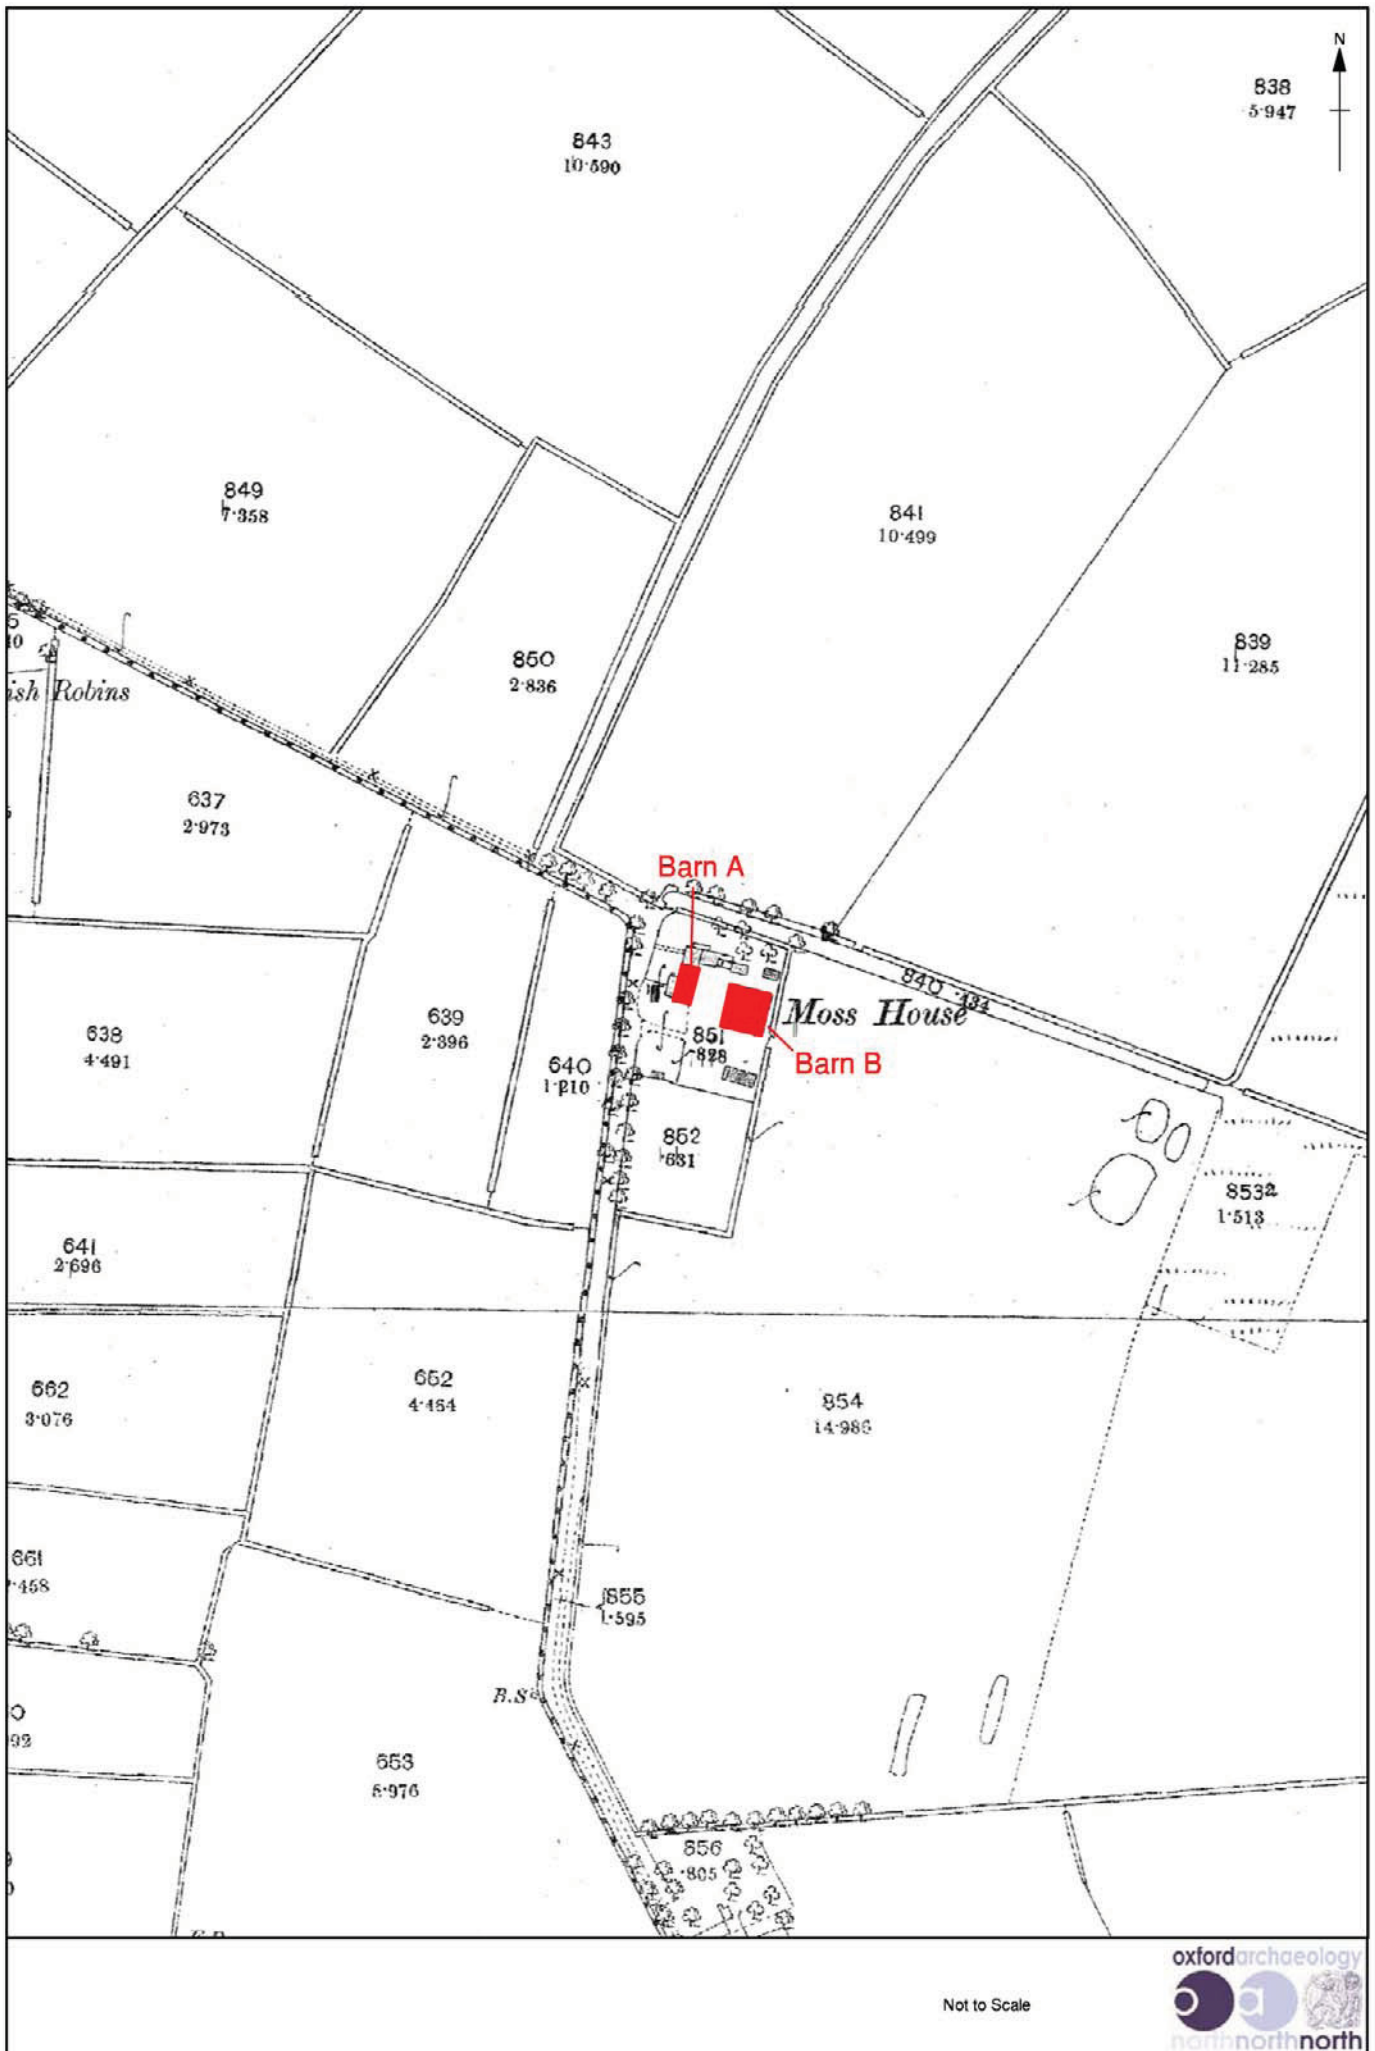
Figure 4: Extract from Ordnance Survey First Edition, 25 inch to 1 mile map, 1892

- 3.3.4 **Ordnance Survey, 25 inch to 1 Mile, 1892 (Fig 4):** this map is more detailed, and illustrates the nature of the layout of the buildings labelled Moss House. There are two ranges of buildings shown: one to the north and another to the west. The southern most of the buildings to the west is Barn A. On the opposite side of the farmyard are two detached buildings, the longer of these is (hard to see) Barn B. The remainder of the layout of the farmstead is clearly visible and paths and a dividing boundary are visible. The farmstead appears to be surrounded by a drainage ditch.

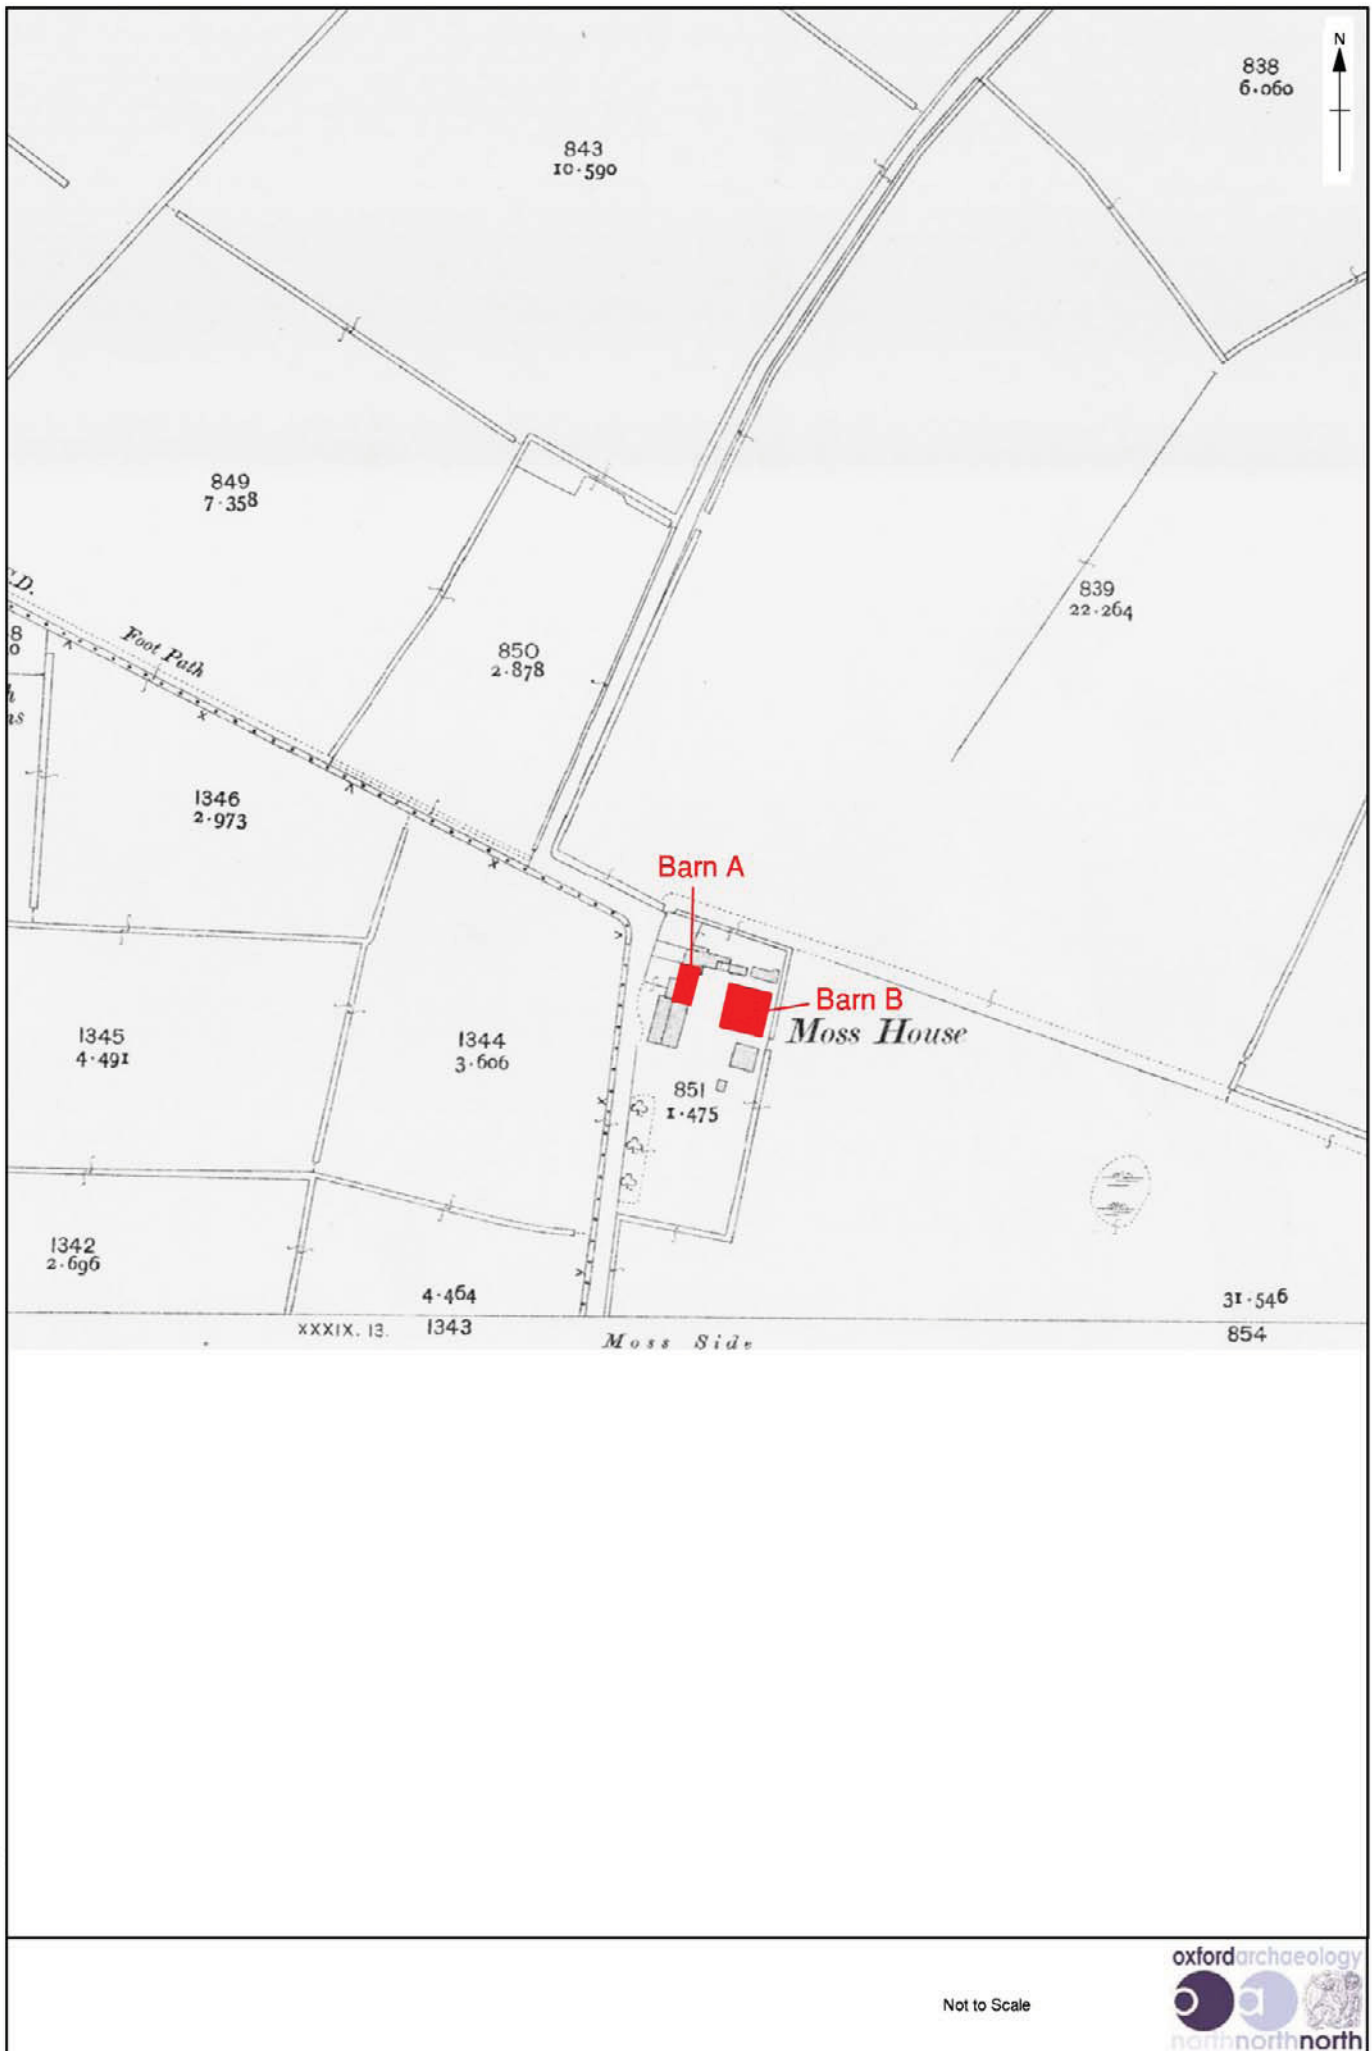
Figure 5: Extract from Ordnance Survey Second Edition, 25 inch to 1 mile map, 1912

- 3.3.5 **Ordnance Survey, 25 inch to 1 Mile, 1912 (Fig 5):** this map shows similar detail to the 1892 Ordnance Survey map, the most obvious difference being the addition of a large extension to the south end of the west building (Barn A). There are changes to the arrangement of the internal divisions within the layout of the farmstead and an additional structure located to the south of the current Barn B.

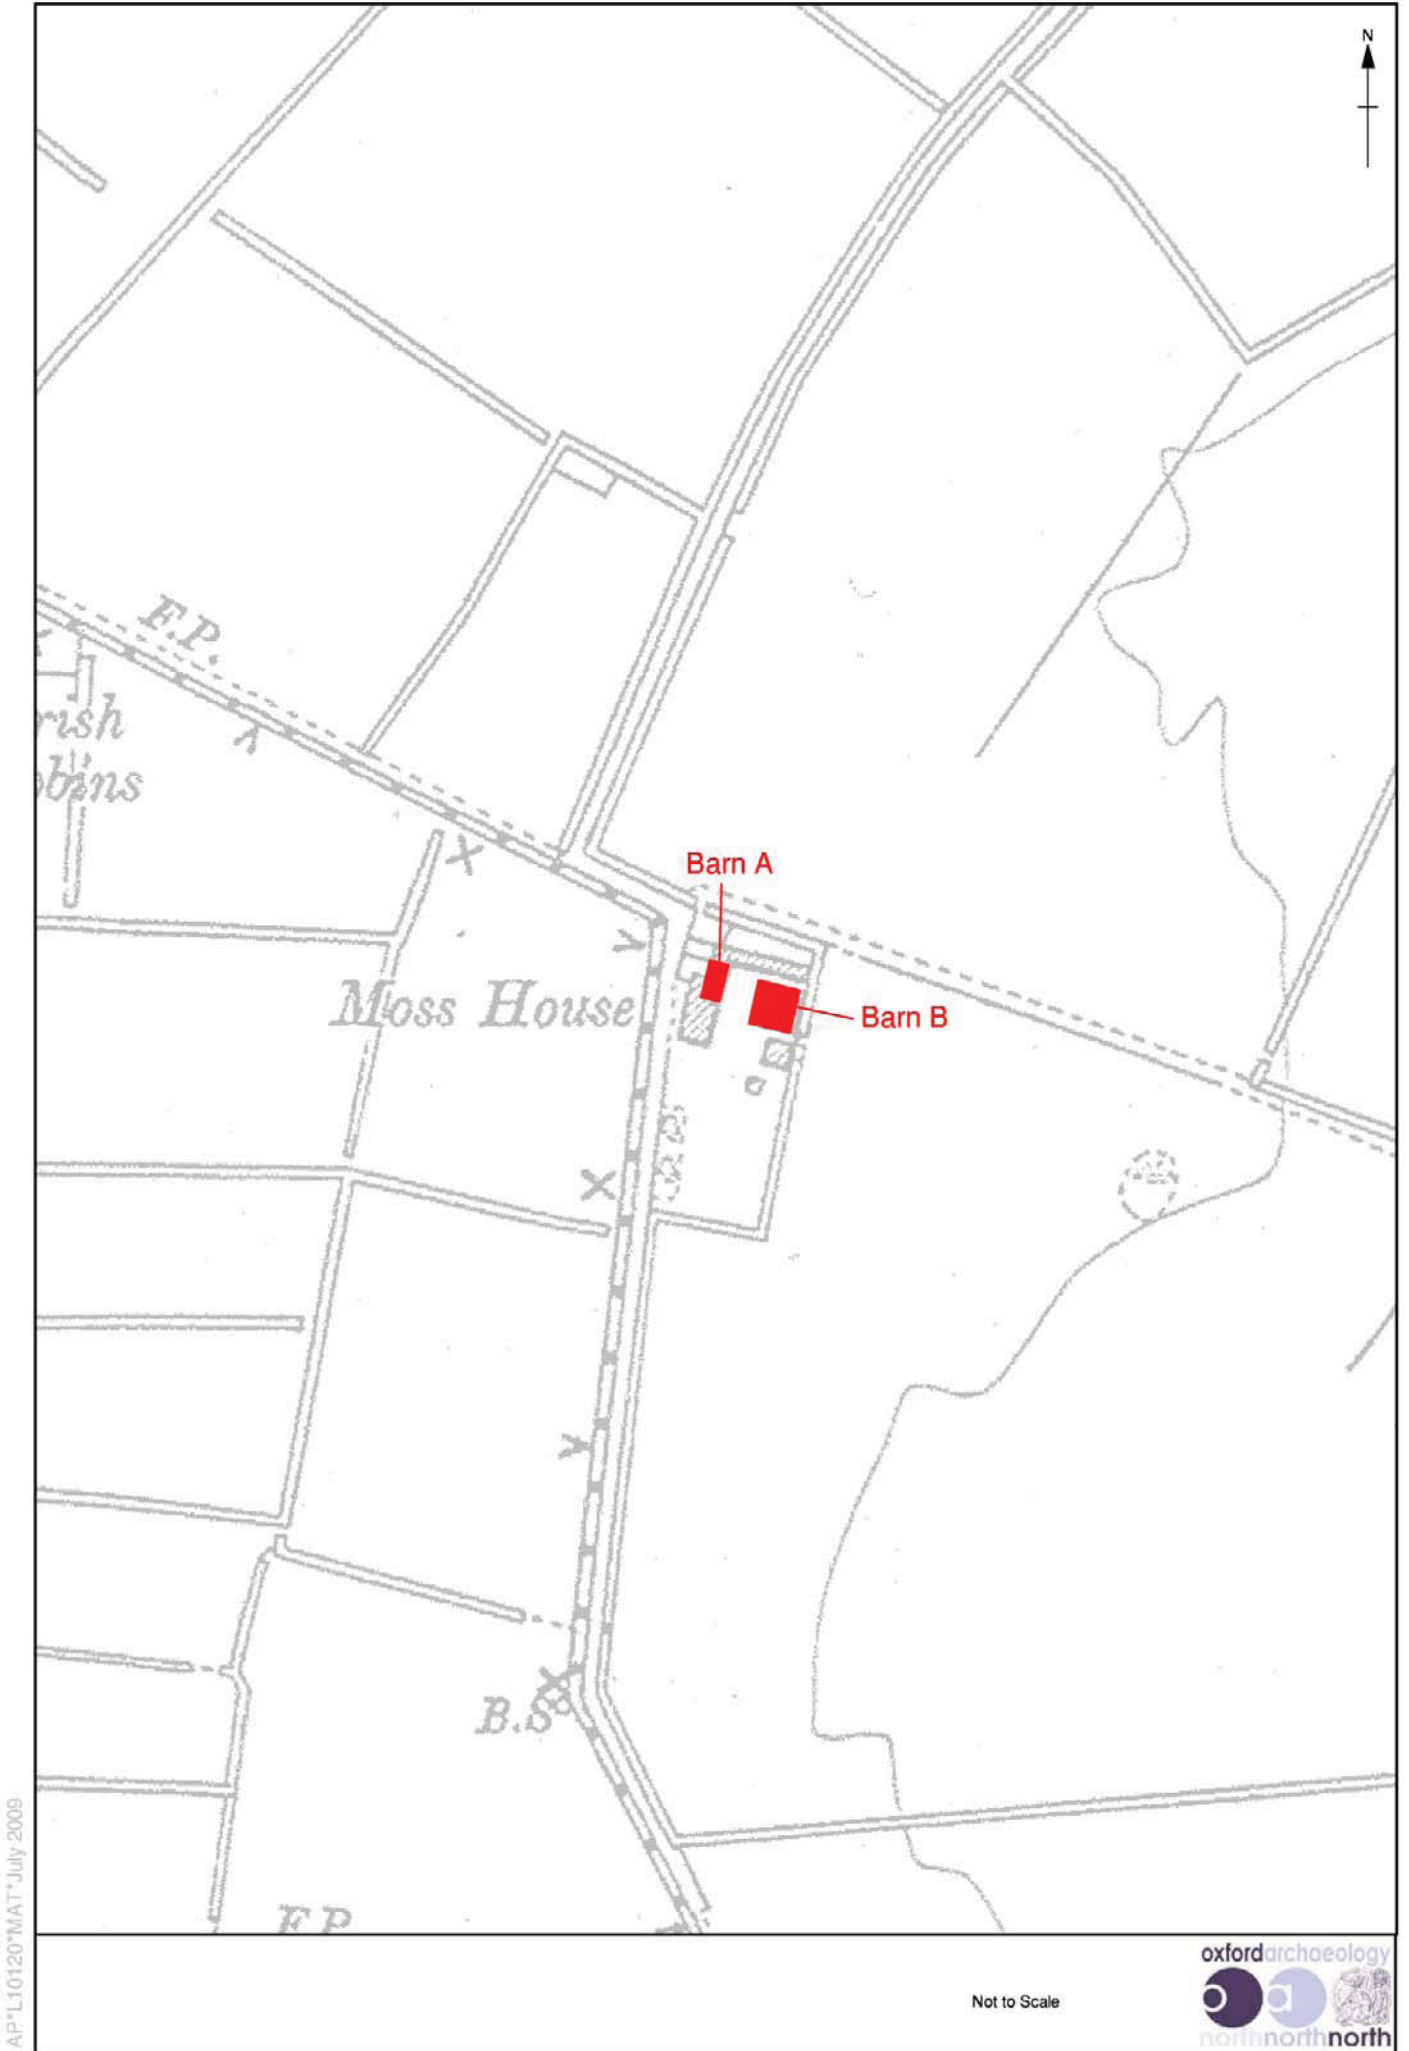
Figure 6: Extract from Ordnance Survey Third Edition, 6 inch to 1 mile map, 1914

- 3.3.6 **Ordnance Survey, 6 inch to 1 Mile, 1914 (Fig 6):** this map is not as detailed as the 1912 map but illustrates essentially the same layout. The north part western building has apparently been extended to the east.
