The Dye House, Hallthwaites, Millom, Cumbria

Archaeological Building Investigation

Oxford Archaeology North

November 2005

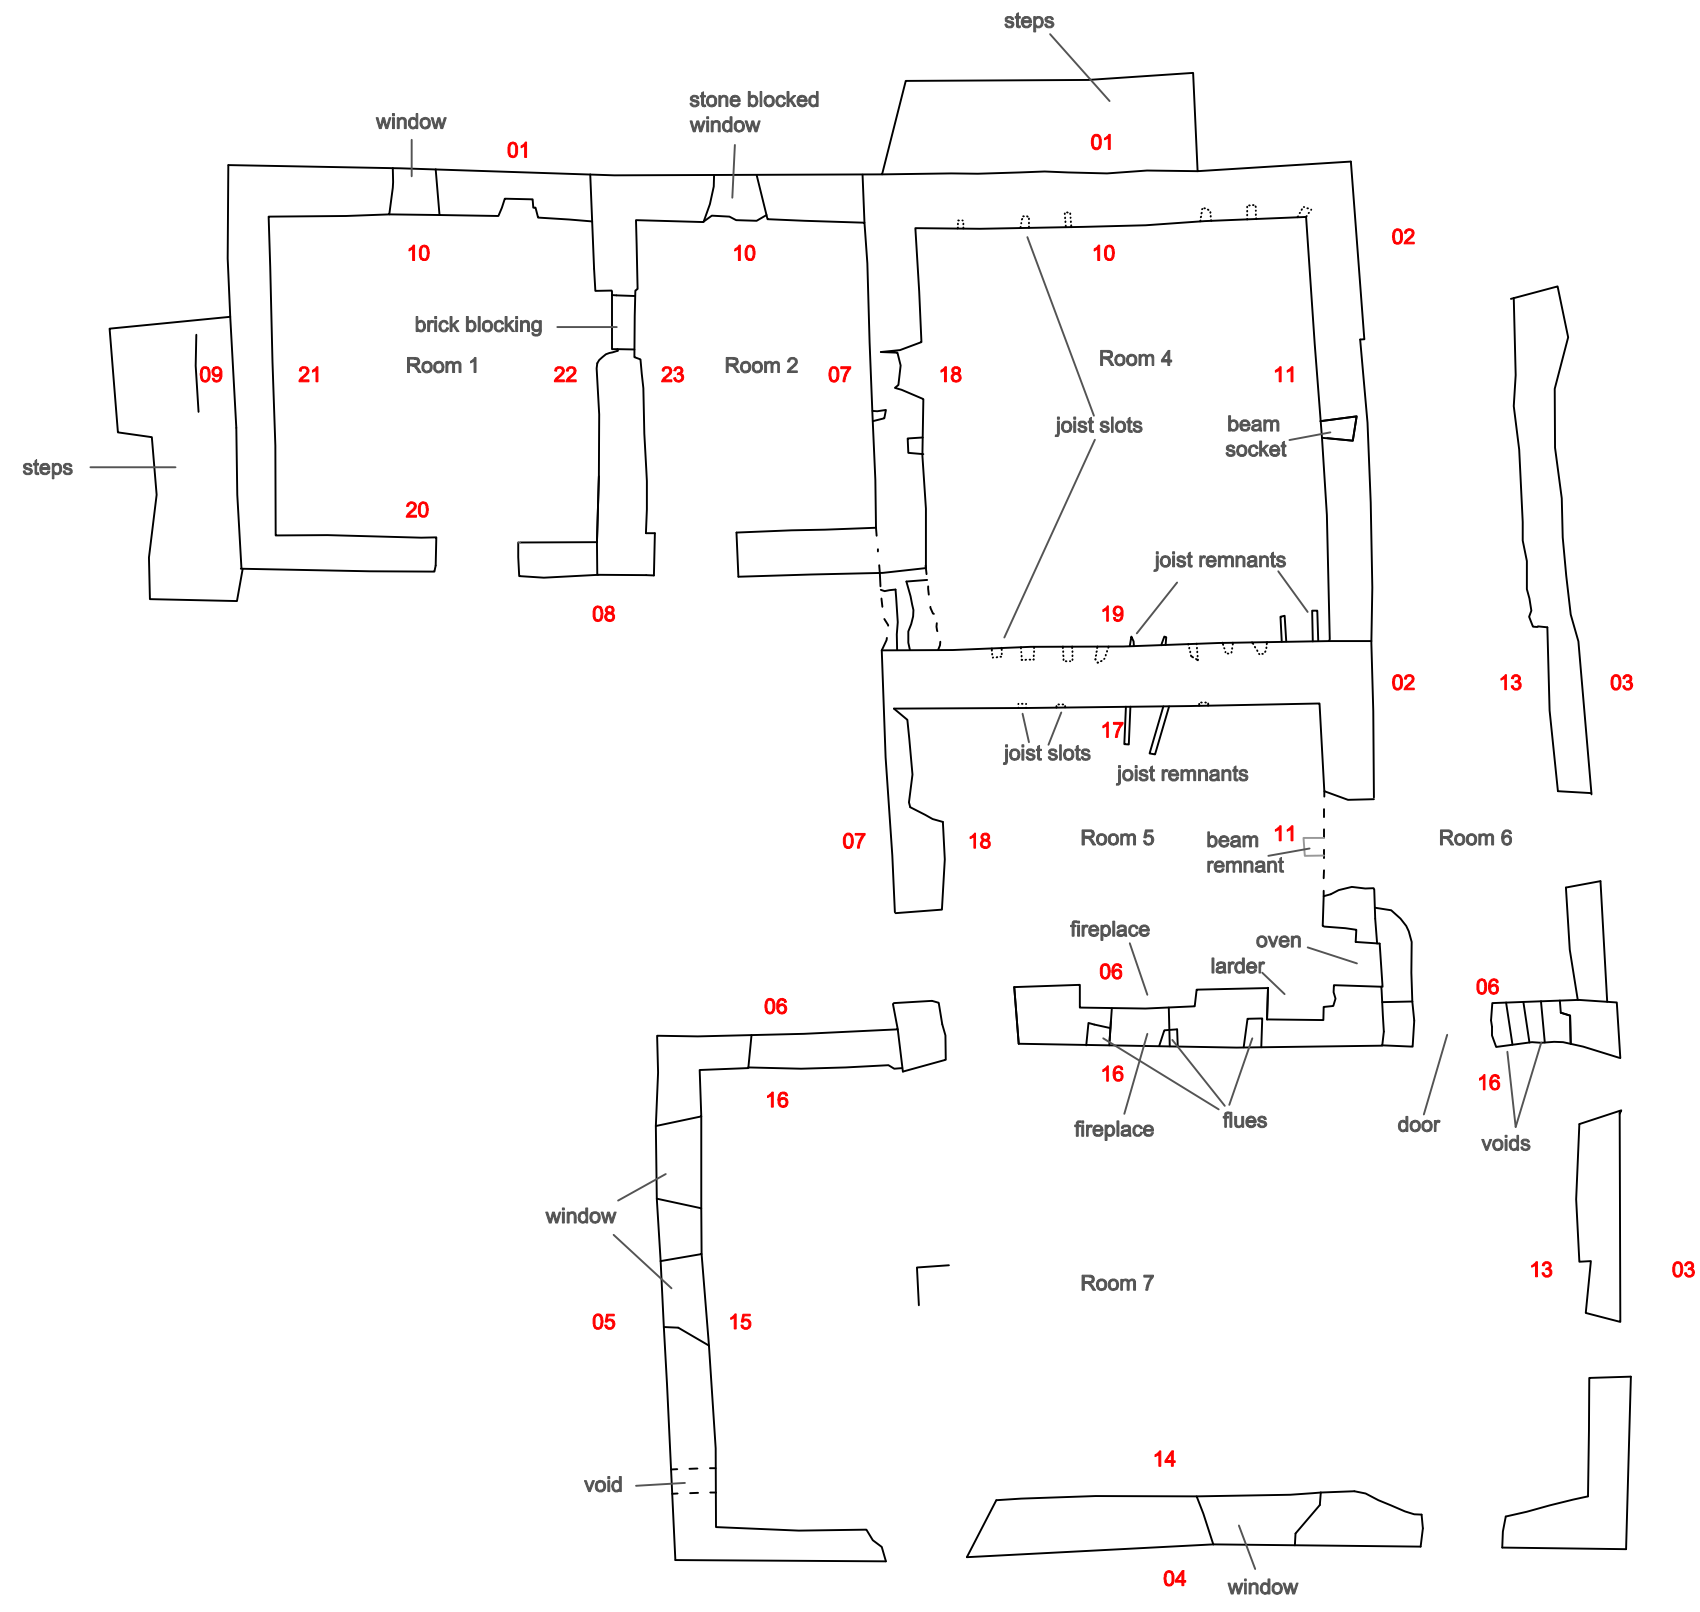
Figure 3: Ground floor plan

4.2.1 The whole complex comprises seven rooms and is set out in an asymmetrical 'C-shape' with the long axis of Rooms 1, 2, 3 and 4 aligned east/west (Fig 3). Rooms 1, 2, 3, 4 and 5 form an 'L-shape' and rooms 6 and 7 appear to have been built on to this. Most of the rooms are able to be accessed from a central area, which almost forms a small (grassed) courtyard. The Black Brook runs to the east of the building. Rooms 1 and 2 are situated below Room 3, while Rooms 4, 5 and 7 extend through both the ground and first floors.

4.3.2 The remaining roof (above Room 3) has a pitch of approximately 25 degrees, has slightly projecting eaves and comprises local slate laid in diminishing courses with a stone ridge. The remains of a brick-built chimney are present below the eaves of this roof on the north side (Fig 3). There are no rain water goods present. The rest of the complex is unroofed, but it reasonable to assume from the surviving evidence that it was roofed in a similar manner to the remaining roof. There is evidence to suggest (see *Section 4.4.1*) that the surviving roofed building (Rooms 1, 2 and 3) was constructed in more than

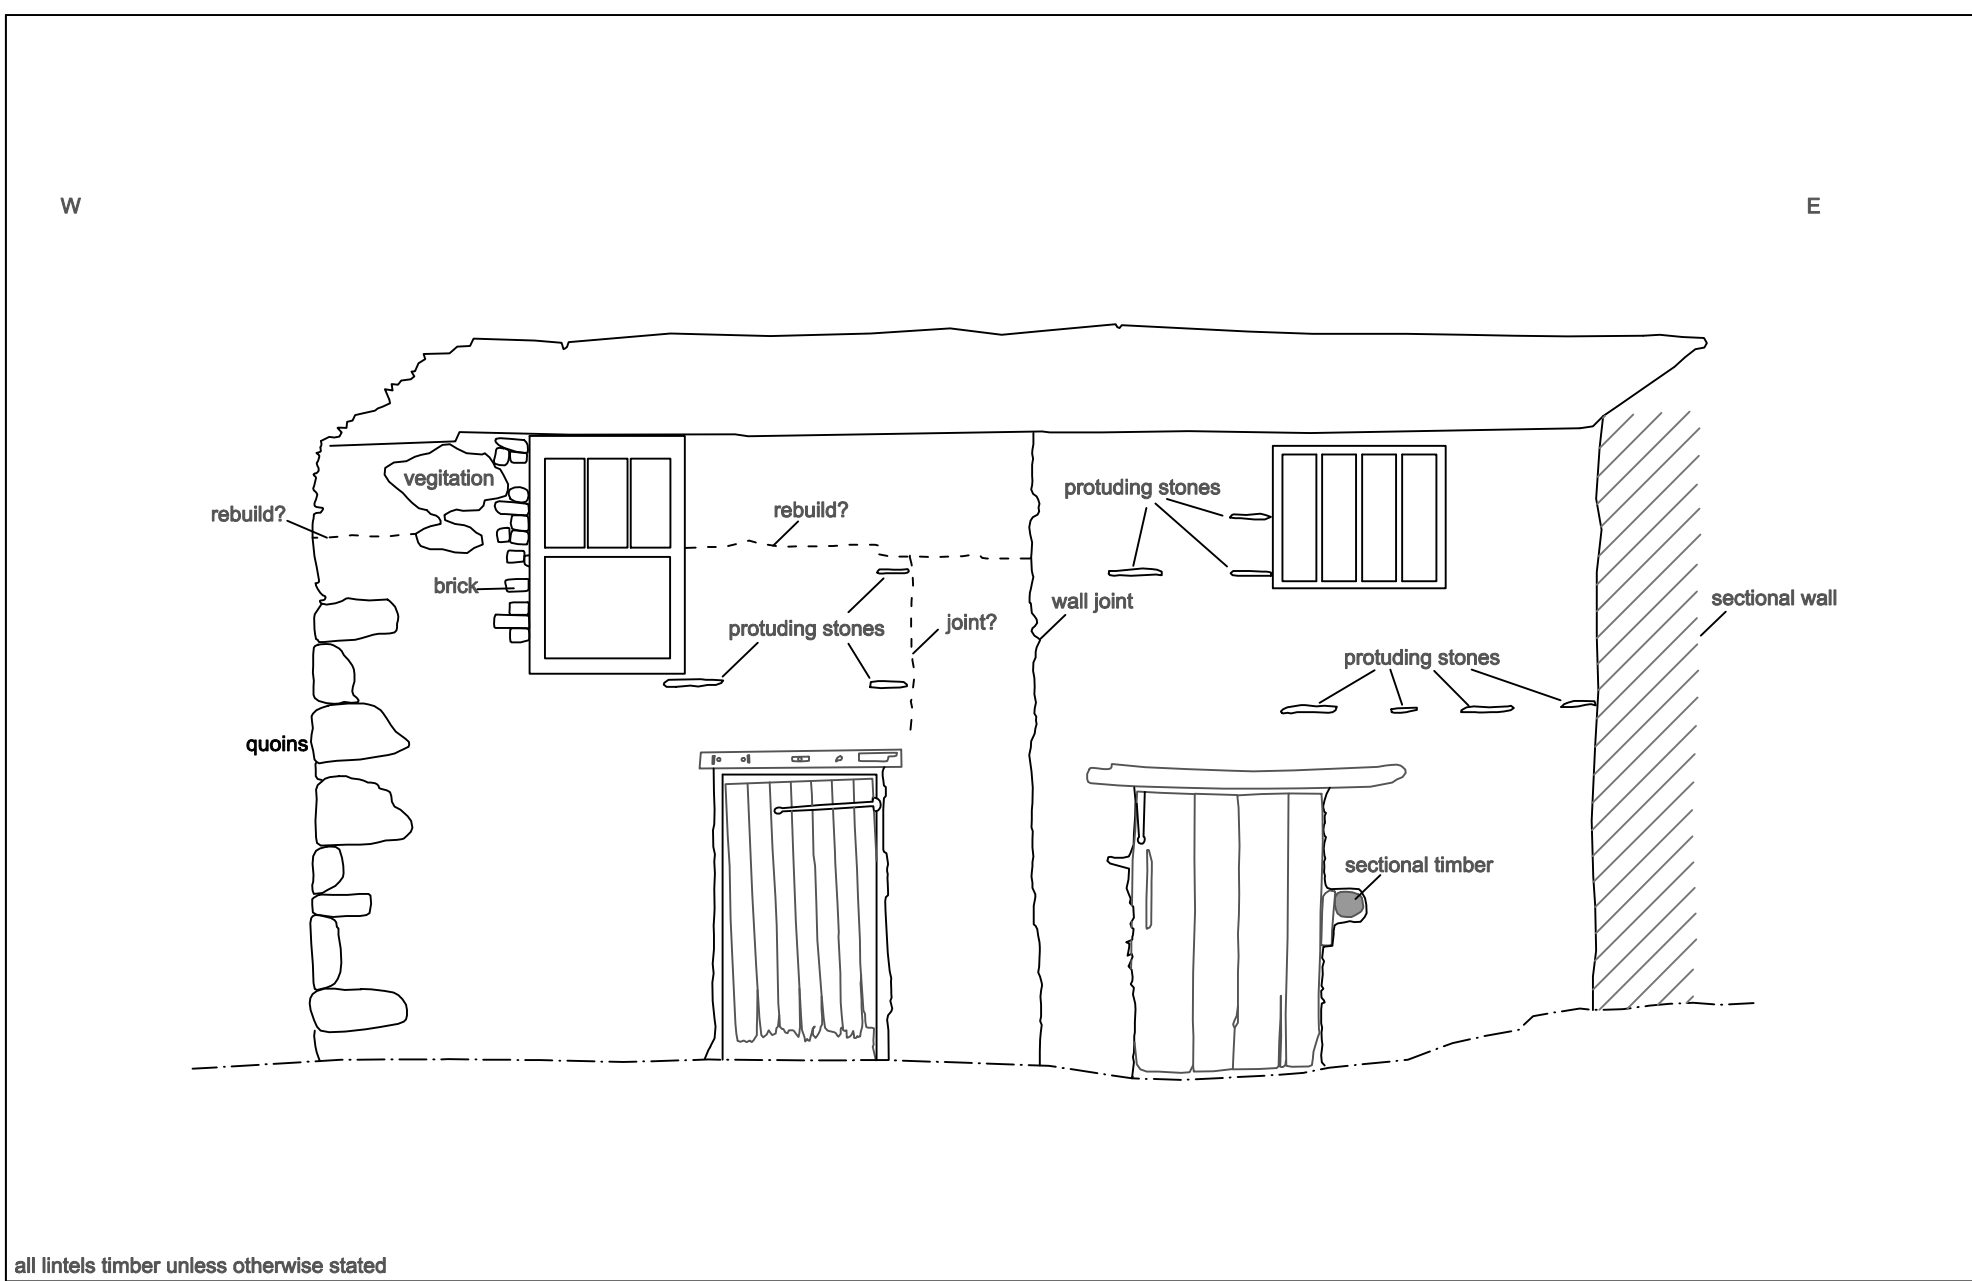
Figure 14: Elevation 8

- 4.4.9 **External Elevation 8:** (Fig 14; Plate 10) this is the south-facing exterior elevation of the main roofed building which contains Rooms 1, 2 and 3. It is

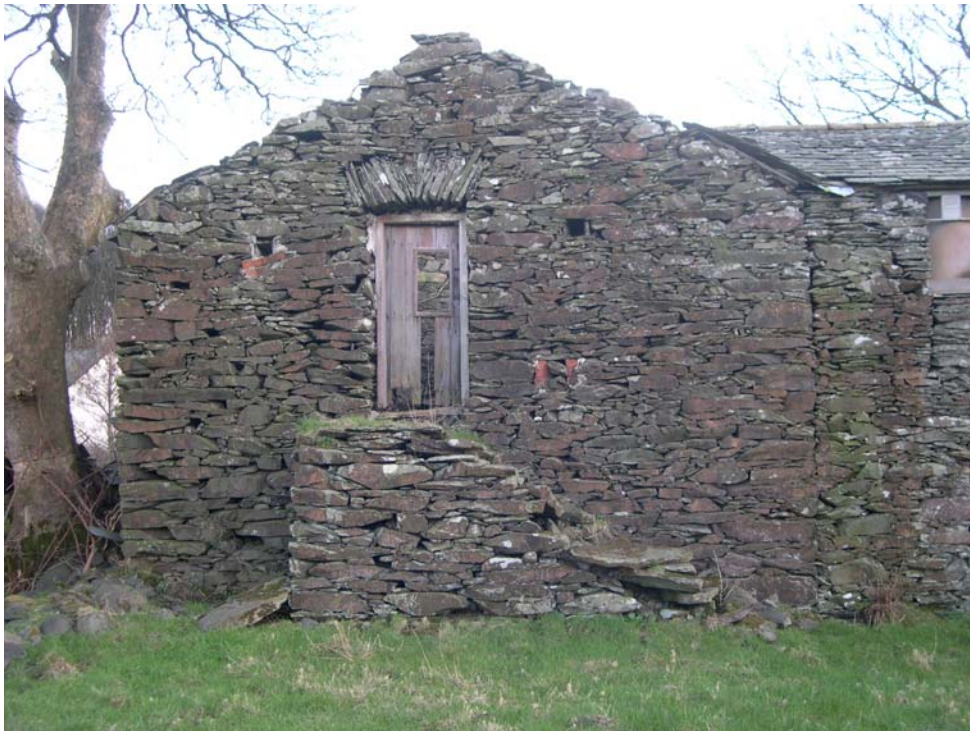
Plate 5: East end of Elevation 1

- 4.4.1 **External Elevation 1:** (Fig 7; Plates 4-5) this forms the long north external wall of Rooms 1, 2, 3, and the gable wall of Room 4, and is constructed from random uncoursed local stone, most of which is unworked. There are traces of lime mortar and lime render present particularly in the centre section of the wall (Room 2). There are four window openings, two providing light for the upper floor (Room 3) and one each for Rooms 1 and 2. All the windows differ in size and there is evident rebuilding corresponding to the remodelling of each opening, particularly the west windows. The first floor windows were glazed with simple multi-light frames (now much degraded). The east ground floor window is blocked, the west is boarded. All the openings have slate sills and the first floor windows have timber lintels (formed from the wall plate). A doorway with a distinctive arched head is present in the gable of Room 4 which once gave access to the (now gone) first floor. This is reached via a flight of degraded steps (possibly with eight steps originally) of the same construction as the rest of the building. A door with a single light is still present, as is the door surround (although both are much degraded). Either side of the door are two apertures (Fig 7) which may have supported a porch. A similar aperture (lined with brick) is located to the west of the door at low level. These are also visible internally.

- 4.4.2 It is evident that the wall was not constructed in a single phase, as shown by the two, very clear, vertical butt joins visible in the elevation (Fig 7). These correspond to the dividing walls between Rooms 1, 2 and 4. It would appear that Room 4 was the first to be built followed by Room 2 then Room 1 as Rooms 1 and 2 only have quoins on their western sides. The elevation of Room 1 is quite distinct in that it contains numerous large rounded boulders similar to those visible in the bed of the Black Brook. An inserted chimney (stack missing) constructed from hand-made brick is present just to the east of the western window on the first floor.

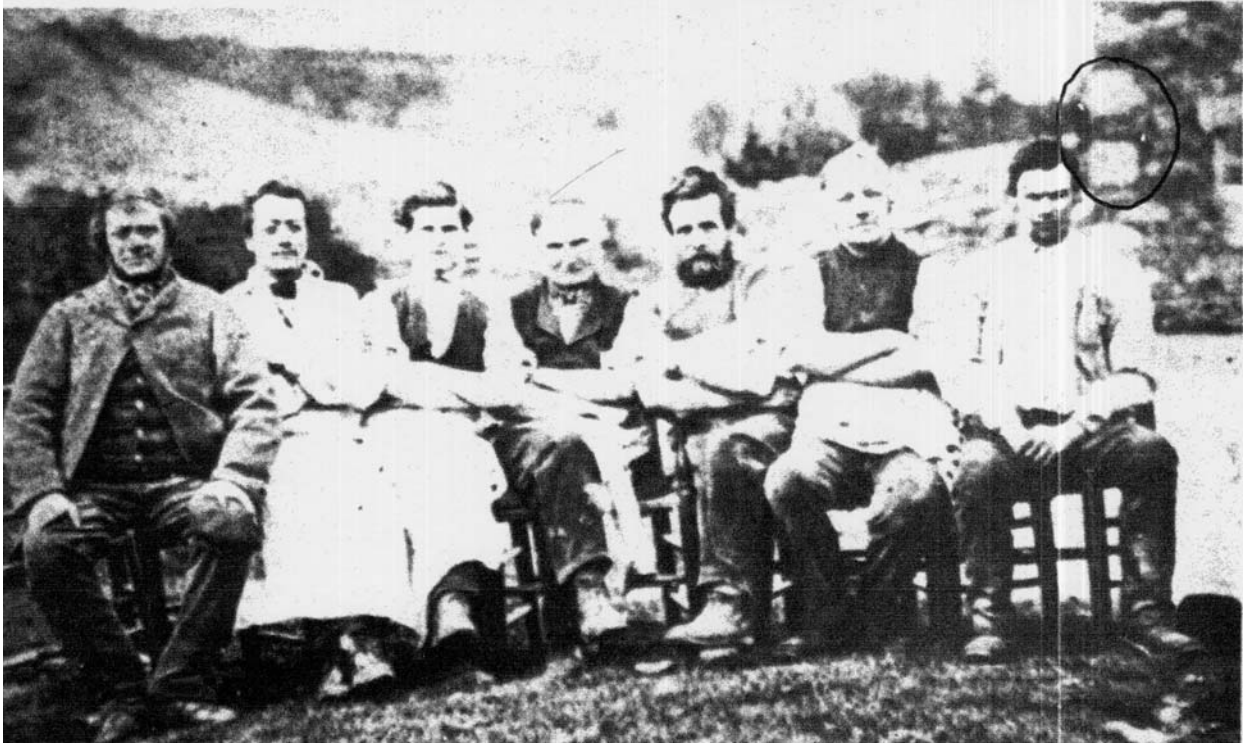
Plate 20: 1872 Photograph of JB Moore staff sitting outside the carding mill (Marshall & Davies-Shiel 1976) The possible matching quoins are highlighted.
