# 61 King Street, Blackburn, Lancashire

## Archaeological Building Recording

Issue No: 2013-14/1417

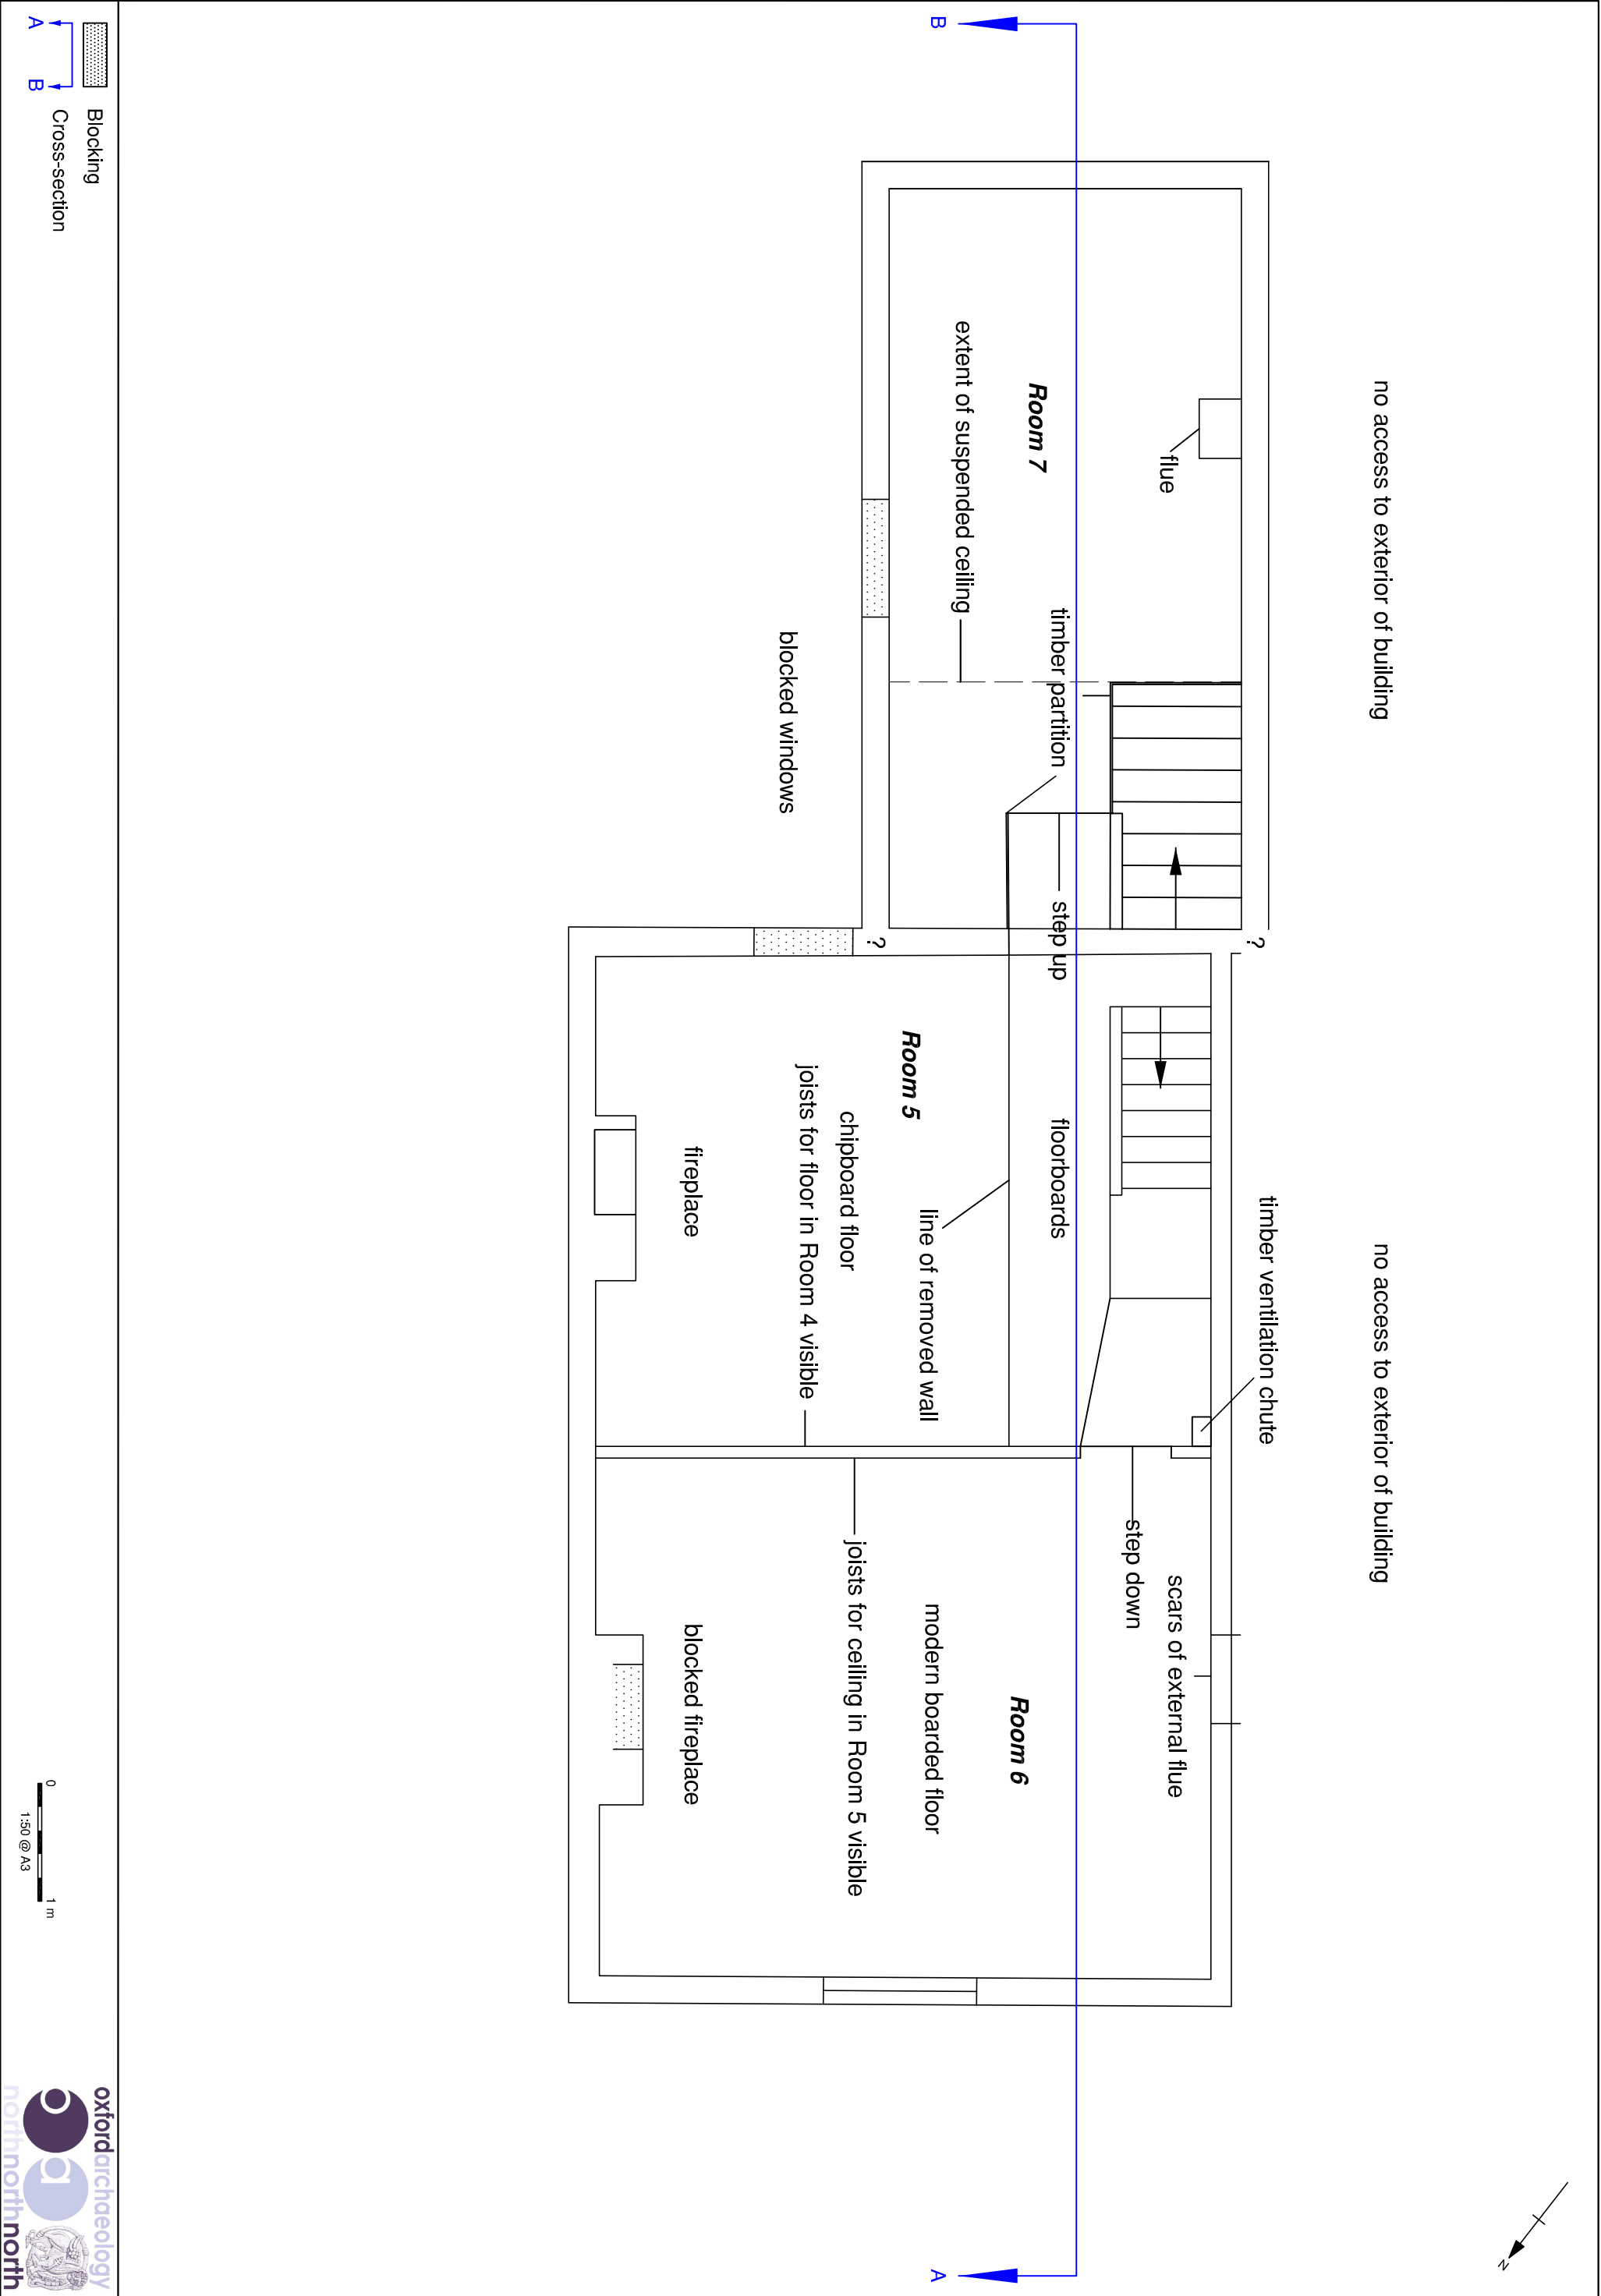
Figure 4: First floor plan of 61 King Street

3.2.21 **Room 5:** this room is immediately accessed upon climbing the stairs from Room 3 (Fig 4). It is via this room that Rooms 6, 7 and 8 are accessible (Fig 6). The room once probably formed a bedroom, and appears to have once been a room and corridor, as there is evidence for a dividing wall (possibly brick) in both the north and south walls and crossing the floor at the west side (Fig 4). There is a fireplace set within a chimney breast at the east side of the room, the remains of a grate being visible. The brick fabric is clearly visible here. A window is present in the south wall of the room, which is of sliding sash (with horns) construction the aperture is blocked from the outside with brick. This has subsequently been rendered over externally, only a projecting sandstone sill being visible (*Section 3.2.7*).

- 3.2.24 **Room 7:** this room is situated in the rear extension directly above Room 3 and is of a similar size (Fig 4). In common with Room 3, this room was being used for storage and was similarly cluttered. Much of the room was lined with fibreboard, obscuring the walls, and the room also had a plasterboard suspended ceiling of late twentieth century appearance. The suspended ceiling (2.37m high) covered approximately three quarters of the room (Figs 4 and 6) above which, was a further ceiling (2.7m high) that was of lath and plaster construction. This appears to be part of the original phase of the room. Above this, but unable to be inspected in detail, was the roof structure of the rear extension. This, from the limited inspection available, appeared to be a common rafter roof of softwood construction. The roof covering appeared to be lined with felt of late twentieth century appearance.

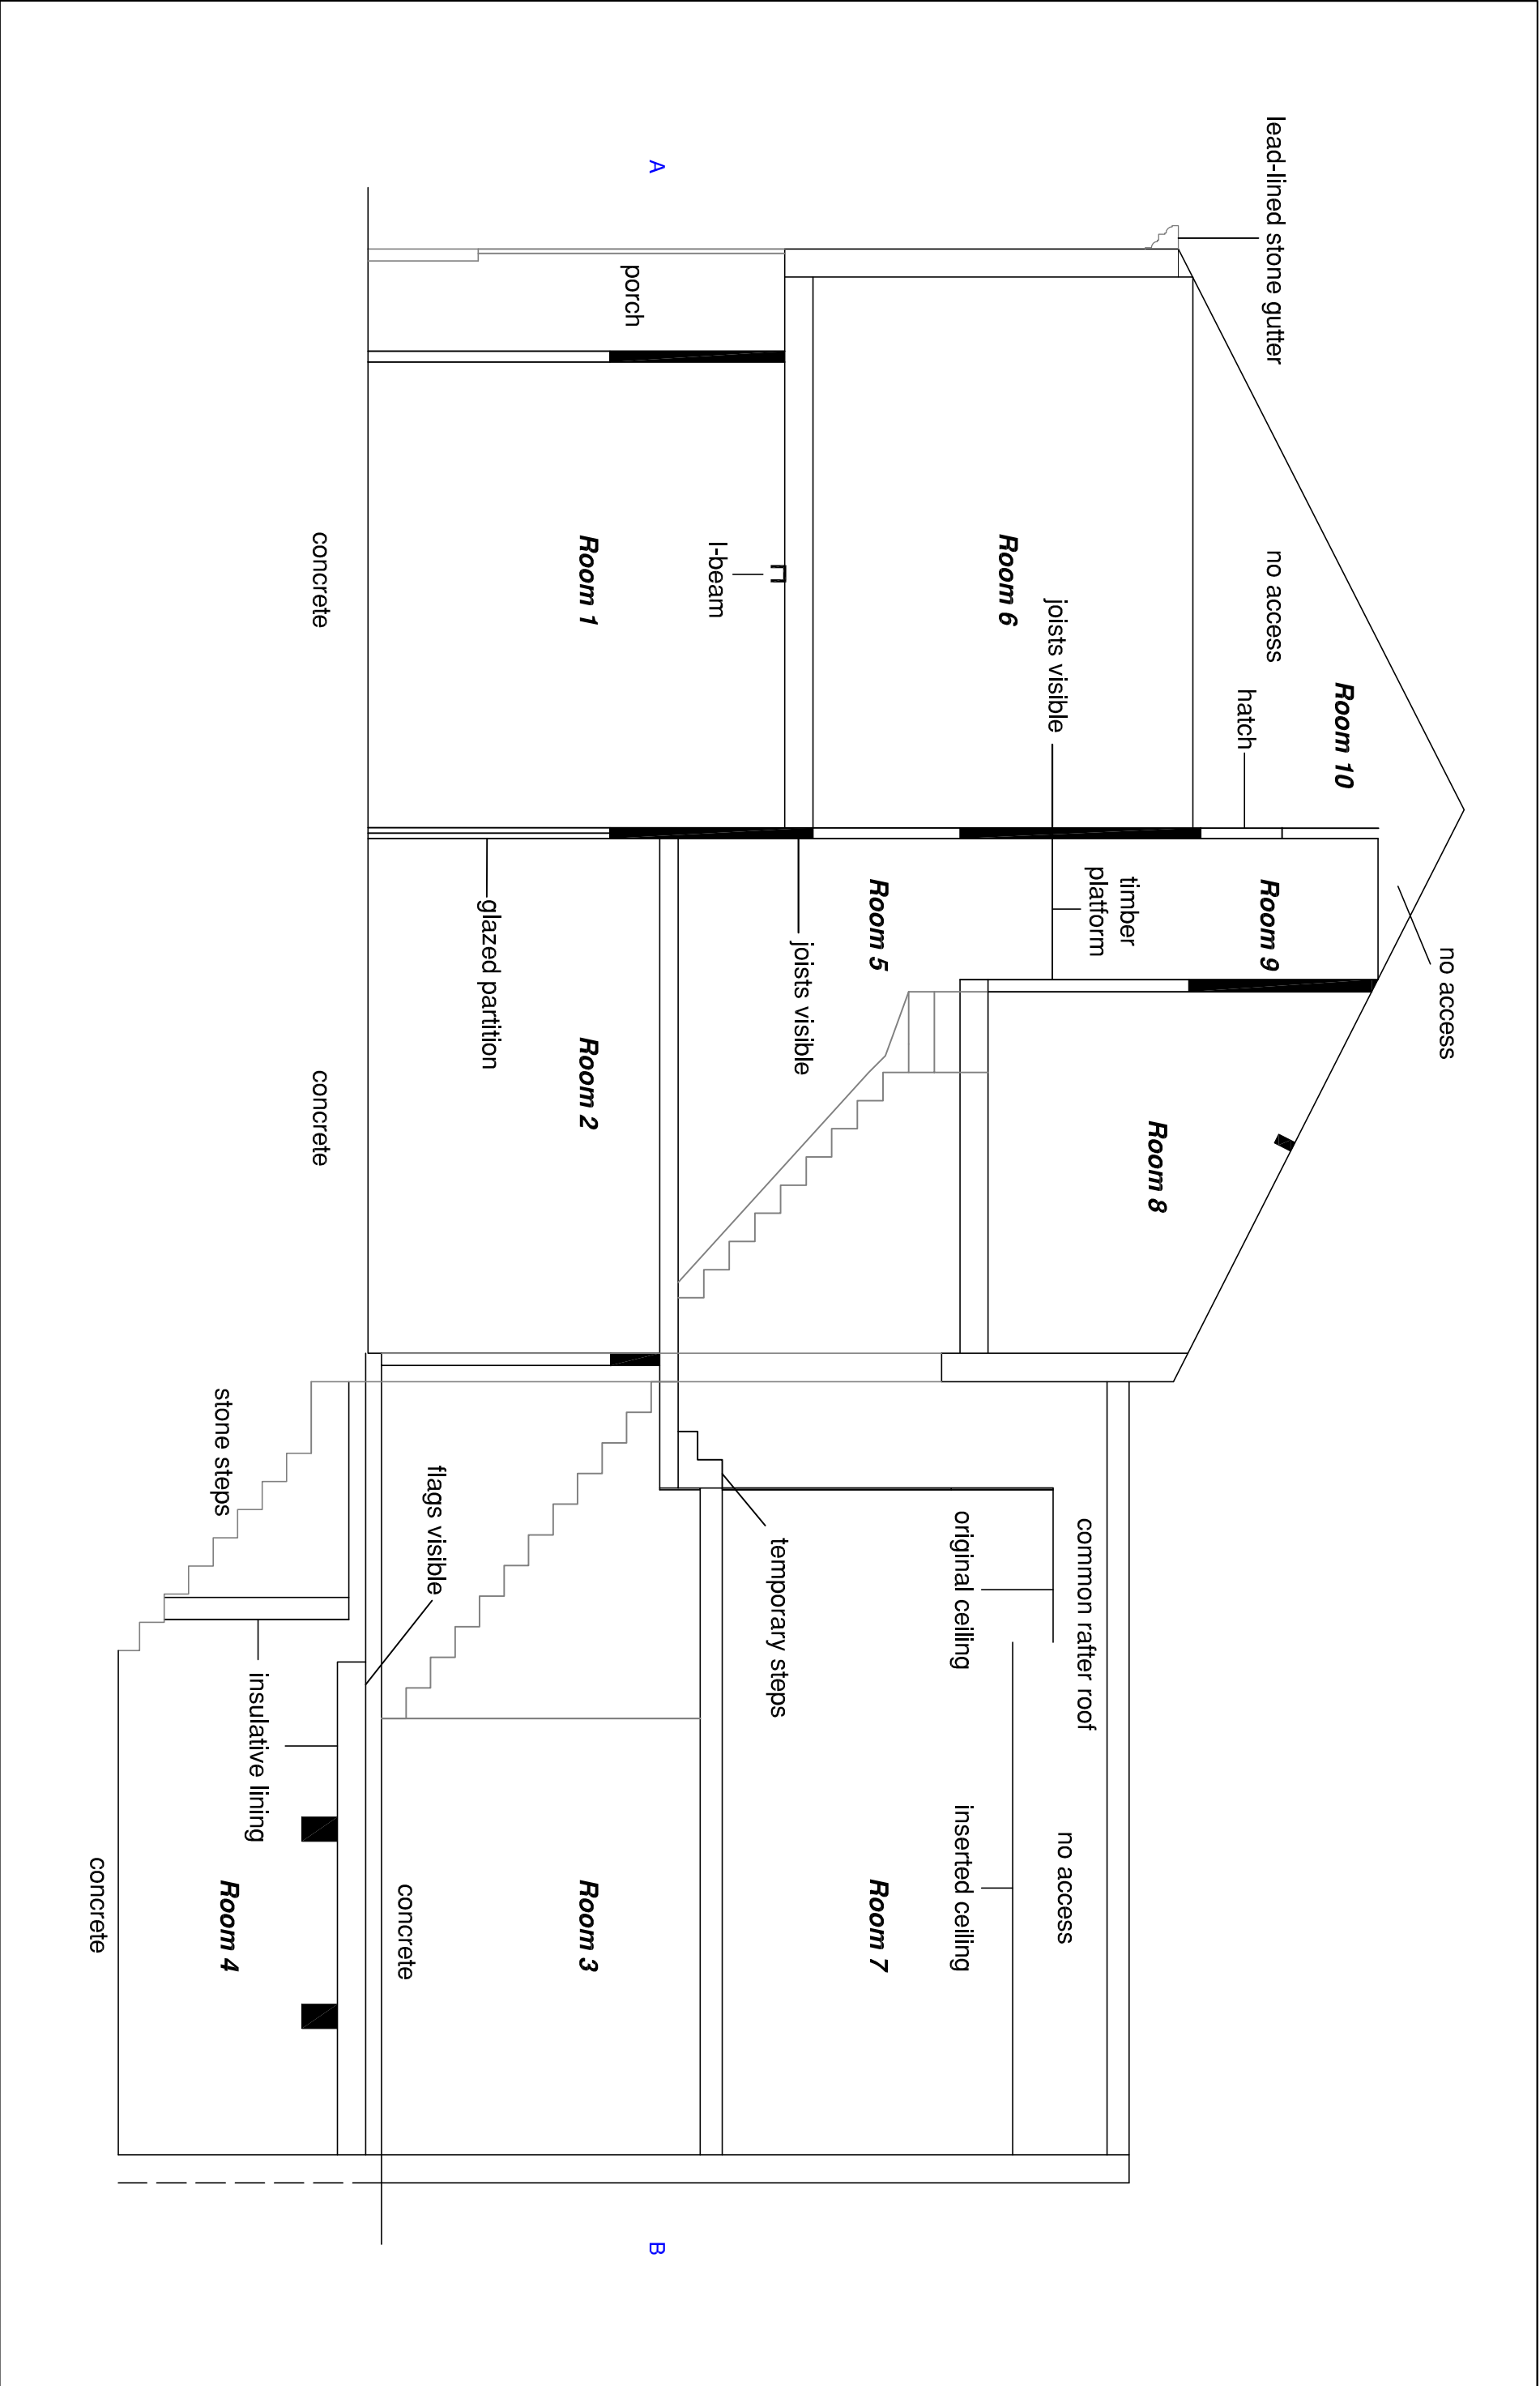
Figure 6: West-facing cross-section of 61 King Street

the level of the floor in this room (Plate 15). A flight of fibreboard (MDF) steps were once attached. To the left of the doorway is a vertical timber chute that extends to the second floor (Fig 4). The ends of the floor joists of Room 6 are visible at approximately 1m height in the north wall. Access to Room 7 is via a further short flight of steps, as the floor level in that room is slightly above the level of the floor in Room 5 (Fig 6).

- 3.2.23 **Room 6:** this room forms the principal room on this floor and was probably once the main bedroom. All of the plaster has been stripped from the walls of this room revealing the brickwork below together with some features of interest. There is a chimney breast situated on the east wall of the room which is a continuation of that from Room 1, within it is there being evidence of a blocked fireplace and some rebuilding to the flue. On the opposite wall are two vertical cracks that testify to the presence of the external flue described in *Section 3.2.9*. The ends of the joists comprising the ceiling of Room 5 and floor of Room 8 are visible in the south wall (Fig 6).

- 3.2.27 **Room 9:** this is the smallest room in the building and essentially forms a short corridor between Rooms 8 and 10. The door between Rooms 8 and 9 was of ledged-and-braced construction, probably dating to the nineteenth century. The east end of the room contained evidence for a former cupboard or shelving unit (Fig 5). Above this, in the ceiling, a former skylight was visible that had been sealed off at the time of the survey. At the west end of the room, access to the upper roof space and the adjacent Room 10, could be seen, but it was deemed unsafe at the time of the survey to try to access these spaces. The access into Room 10 consisted of a small hatch with timber door. Access to this hatch was via a timber platform. The walls of the room were, for the most part of lath and plaster construction, but the south wall was brick up to approximately 1.65m in height (Fig 6).
