# **Two Lions Public House, Great Dockray, Penrith, Cumbria**

## **Archaeological Building Investigation**

**Oxford Archaeology North**

March 2013

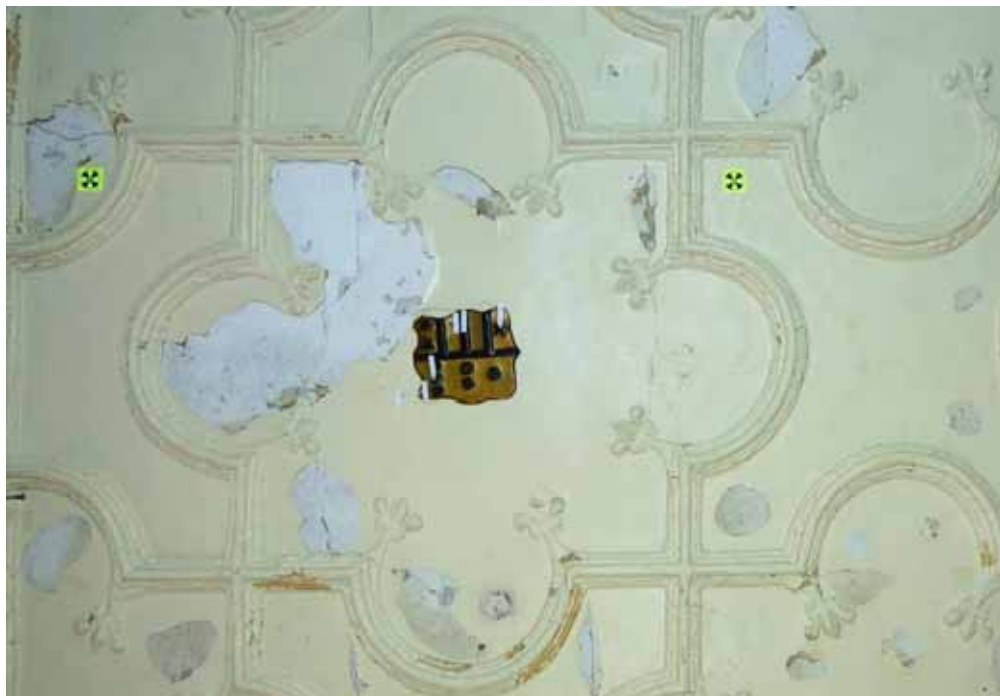
Plate 10: Example of a barbed quatrefoil panel showing fleur-de-lys and the shield

sections. The panels are full or parts of barbed quatrefoils, there being three full barbed quatrefoil panels. At each internal point between the barbs and petals of each quatrefoil, are moulded fleur-de-lys, there being eight within each full quatrefoil (Plate 10). Each full quatrefoil measures approximately 1.45m by 1.45m.

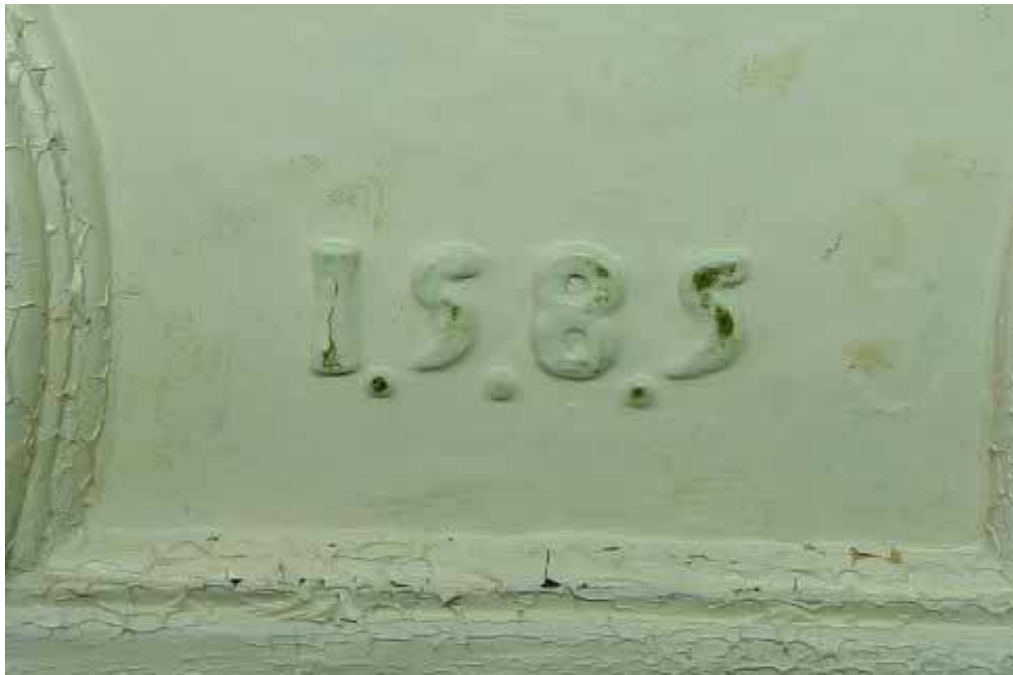
Plate 11: Date on the east section of the plaster ceiling

- 4.2.7 Along the long edges of each section of ceiling, are eight moulded palmette motifs that may represent anthemion leaves (Fig 3, Plate 10). There are three along the central long edges of both ceiling sections and two along the outer long edges (Fig 3). In addition to these, there are three fleur-de-lys motifs on the short edges that project inwards. There are two on the south section and one on the north section. In the middle of the north long side of the northern section of ceiling the date 1585 is moulded in relief (Plate 11). There are three full stops between the numerals (Plate 11).

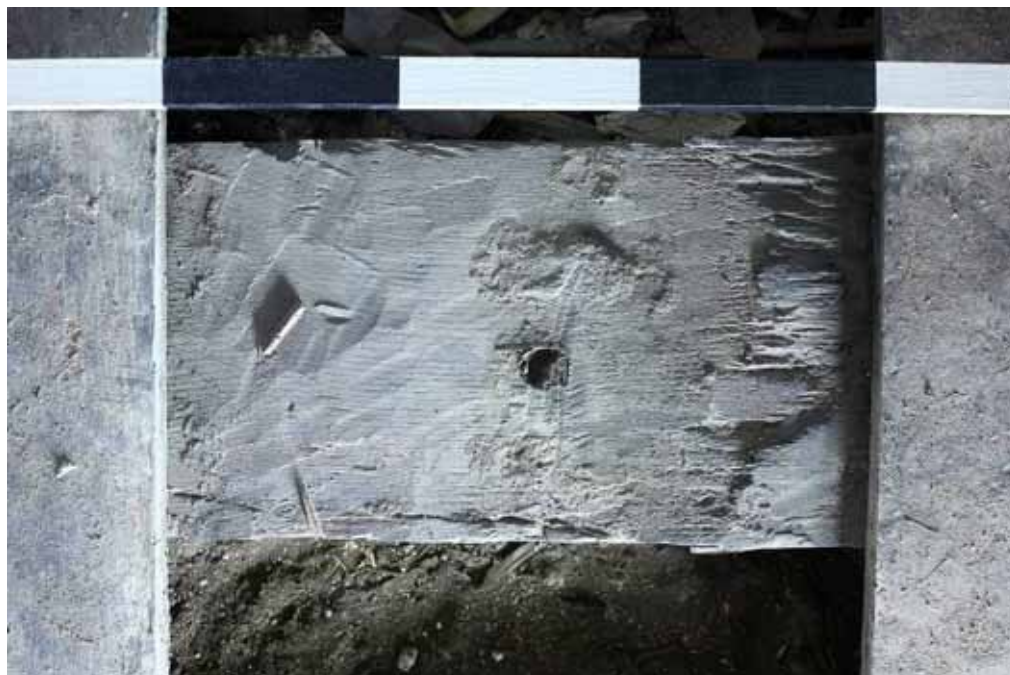
Plate 16: Example of adze marks on the upper face of Joist 11

4.3.3 The longest section of removed floorboard spanned the whole width of the room from the east and west walls, below which were 12 north/south-aligned joists. Each of the joists was numbered, commencing with Joist 1 at the west side (Fig 6), and each measured approximately 0.19m (7.5 inches) wide by 0.076m (3 inches) deep, except for Joists 10 and 12 that measured 0.139m (5.5 inches) by 0.09m (3.5 inches). Most of the joists were between 0.2m and 0.27m apart. There is some evidence of adze marks on the upper faces of some of the joists, Joist 11 being a particularly good example (Plate 16).

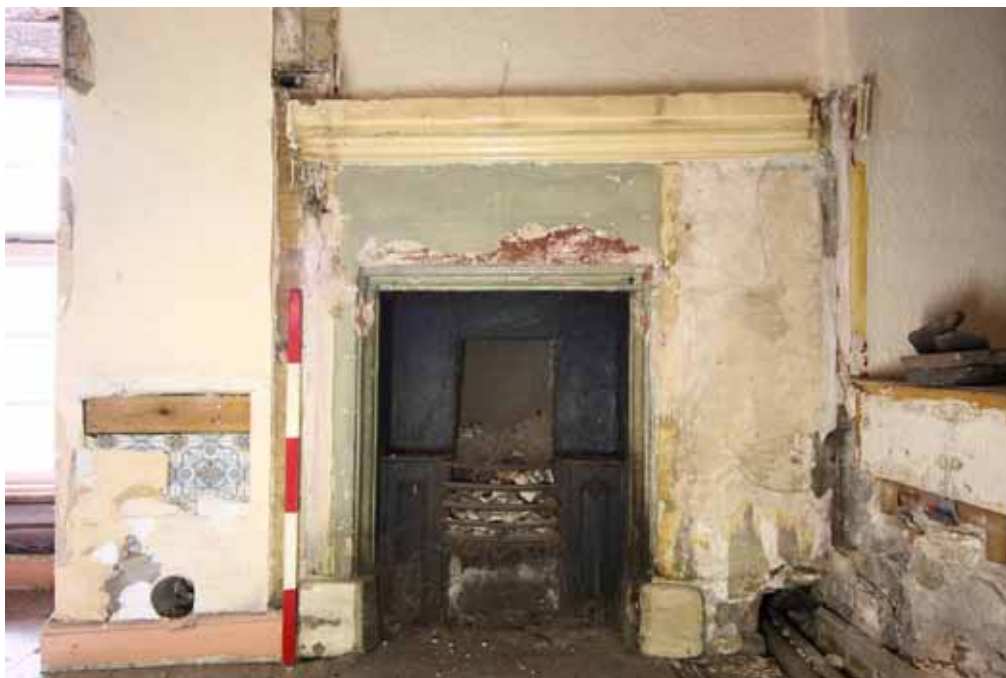
Plate 17: Fireplace revealed following stripping of Room 20

- 4.4.1 Other more general areas subject to internal stripping and removal of later material were also inspected during the recording fieldwork in order to complete the mitigation recording that commenced during the survey in 2006. Ultimately, during the site visits, very little fabric, other than internal partitions and false walls was removed. The only significant feature revealed following internal stripping in Rooms 20 and 21 was a previously unrecorded fireplace (Plate 17). The fireplace is situated in the west wall of Room 20 (Fig 5). The reveal is moulded, and is 1m high by 0.7m wide; the surround is of sandstone construction. Above the opening, at a height of 1.37m, is a substantial sandstone mantle shelf, possibly indicative of a former fireplace. The grate is cast-iron hob grate, probably of nineteenth century origin, with foliate designs on both the grate and the panels.

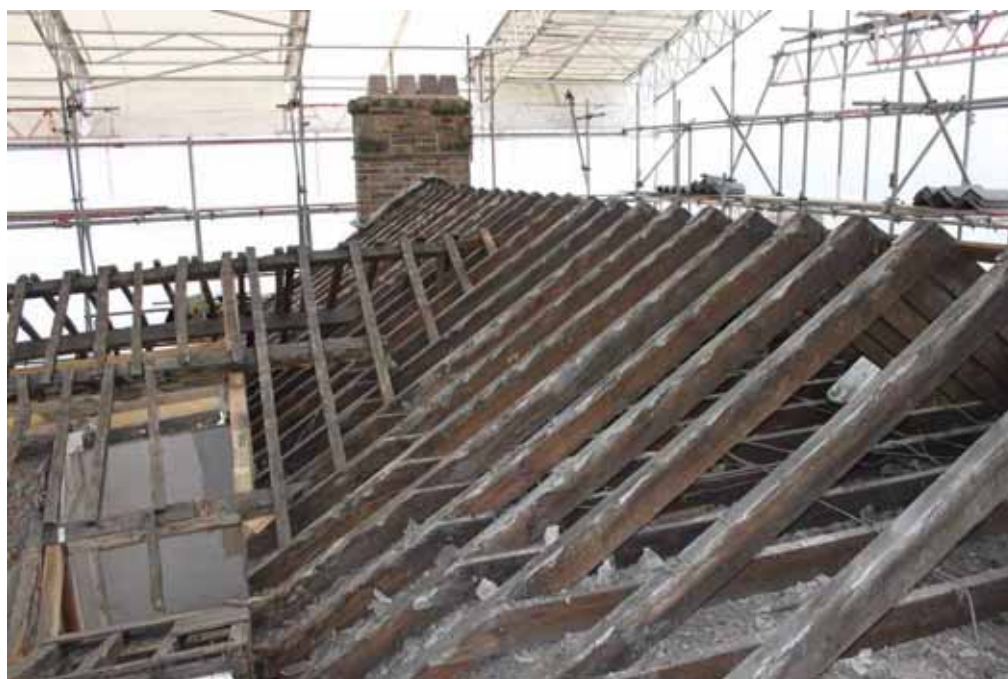
Plate 18: View of the western section of the roof, facing south

- 4.5.2 **The Western Section:** is a common rafter roof, with 25 pairs of rafters, each one with a collar. All the members are bolted together to form trusses and the whole roof is made of softwood (Plate 18). The rafters are joined at the ridge by a bolted lap joint. There is no ridge piece, nor are there any purlins, just a simple (modern) plank screwed to the rafters on the west side just below the ridge. Each of the members, including all the rafters and beams, measure 7 inches (0.18m) by 2.5 inches (0.063m). There is no access to the roof space due to the small dimensions of the available space.

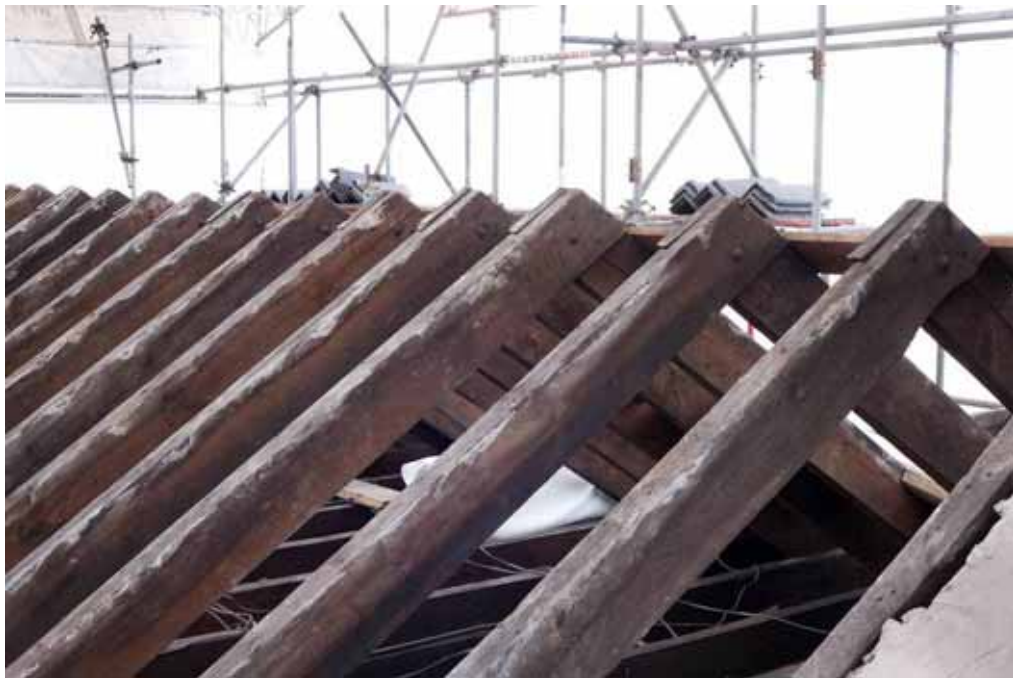
Plate 20: Detailed view of assembly marks on the trusses of the western roof

- 4.5.3 Detailed inspection of the members revealed the presence of several examples of inscribed, assembly, or ‘carpenter’s’ marks at the joins of the common rafters at the ridge and the collars lower down (Plate 20). Many of the joins are unmarked although some are just visible on the central trusses, but are impossible to inspect. Those joins with marks always exhibit a matching pair of Roman numerals, probably incised into the timber with the end of a chisel, the same number being present on both of the joined members. The numbering system on adjacent trusses is not sequential however, for example, the numbers on a row of adjacent trusses reads XXIII, IIVI, IXX and VIII. There is then a row of unmarked trusses before the next set of numbers.

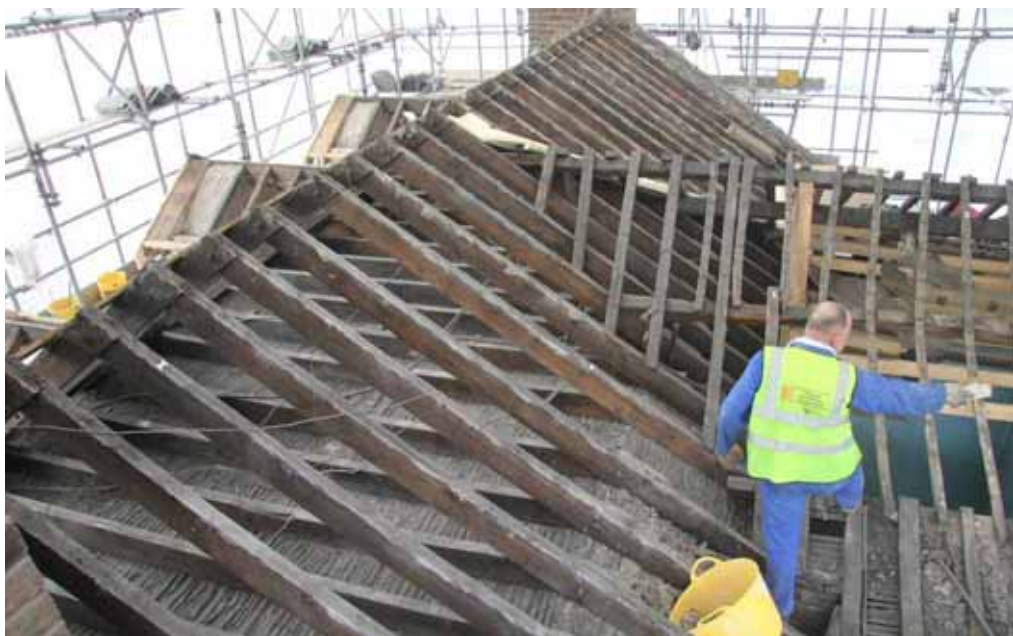
Plate 21: View of the join between the west and east roof sections

- 4.5.6 **The Central Section:** this section of roof lies on an east/west axis and simply butts against the east slope of the western roof section (Plate 21). The structure of the west roof does not appear to have been altered at all to accommodate the central roof section, the rafters of the central section simply rest on the rafters of the east slope of the west section. The purlins and ridge purlin extend to the

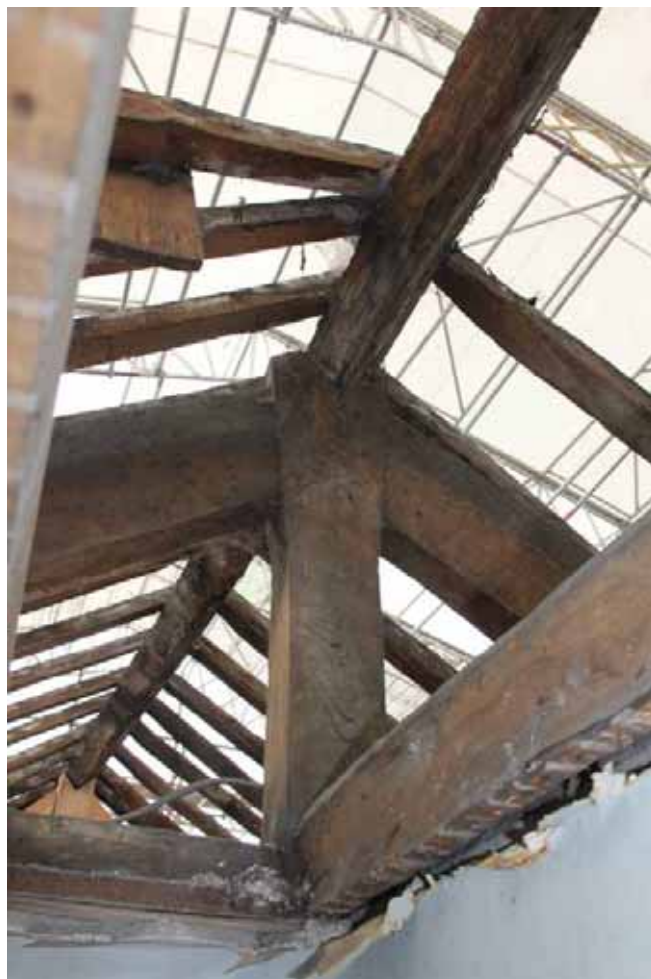
Plate 23: Visible king post above Rooms 30 and 31

- 4.5.7 There are two trusses, each with a king post (Plate 23). The tie beams form part of the ceilings of Rooms 17 and 18 but are not visible from within these rooms. The east truss has a strut close to the foot of the principal rafters, which is bolted to the rafter. The trusses are not clearly visible as much of the roof structure is occupied with garret rooms (Rooms 29, 30 and 31). Assembly marks are visible at the apex of each truss in both the king post and principal rafters. These are simple numerals punched in to the east face of the members with the blade of a chisel. The trusses are numbered with the west truss being truss number I. A further, smaller, truss is present close to the join with the east slope of the west roof section. This sits atop a section of the wall frame that forms the west wall of Room 30. Due to the inaccessible nature of the space, this was unable to be inspected. The feet of the trusses are set into the top of the walls on both sides, the common rafters rest upon sandstone tiles. There is a substantial step down to this roof space from the central roof section and there is no evidence present of any garret rooms within this area of the roof.

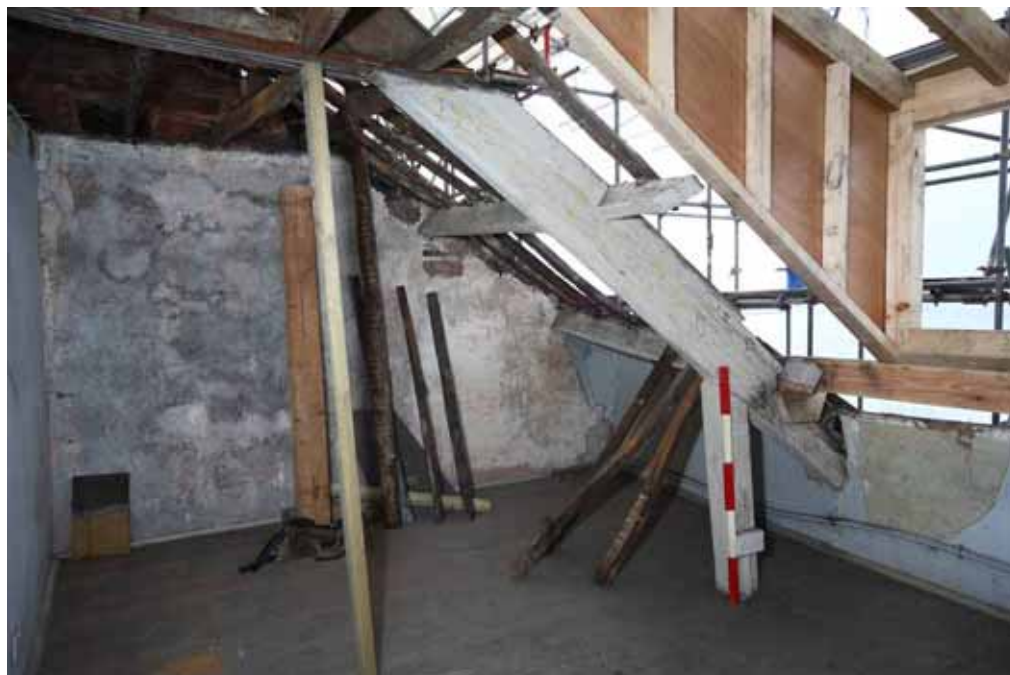
4.5.9 The garret rooms are accessed from the first floor via a flight of stairs and a short corridor. They are formed by partition walls of either lath and plaster or timber panelling (Plate 24), and are quite small. The rooms are lit by dormer windows which, at the time of the survey, were being replaced with new plywood and softwood constructions (Plates 21 and 23). The partition walls of these rooms are attached to a timber frame, the main members of which exhibit some tool marks such as axe and adze marks. Several beams have been inserted in between the trusses in order to form the frame. Most of the panelling of the partition walls that is visible appears to be reused, it having been cut to fit the frame.

Plate 24: Example of a garret room (Room 30) in the central section of roof

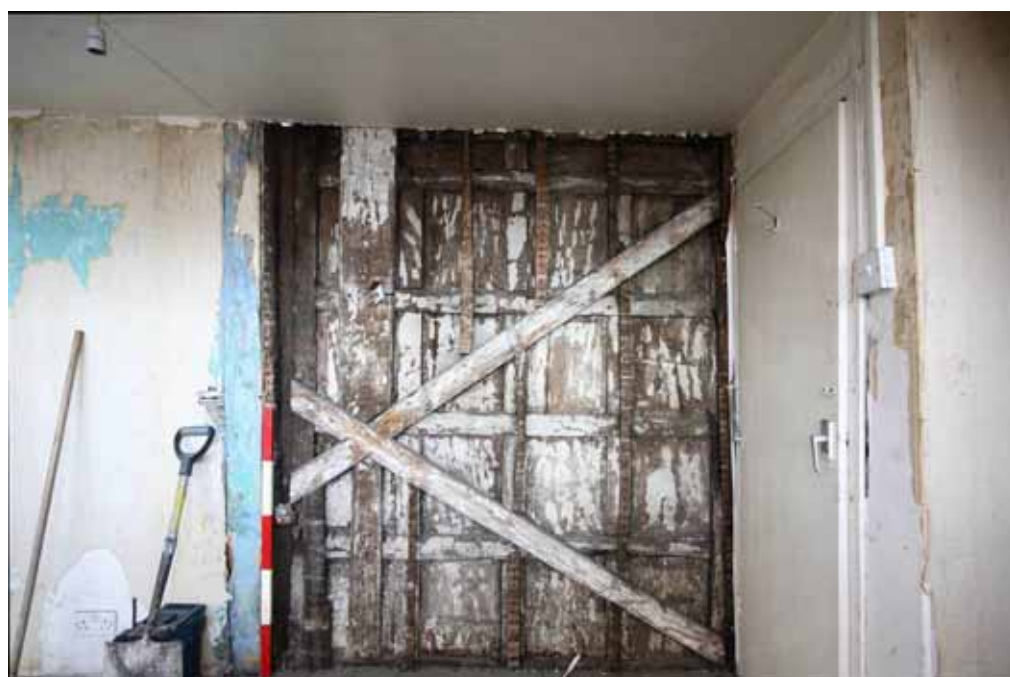
4.5.10 The timber panelling is quite plain in appearance (Plate 25) and is of rail and muntin construction, without any decoration whatsoever. The rails span the

Plate 25: Timber panelling revealed in the wall between Rooms 30 and 31

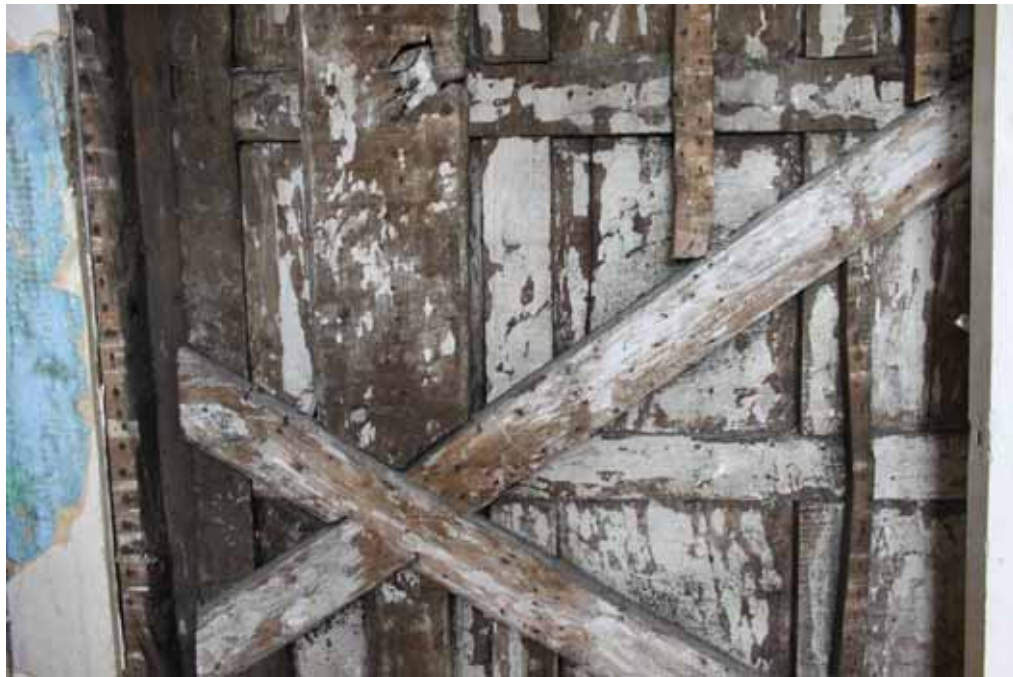
whole width of the panel, with the shorter muntins in between. Braces have been added, probably in order to provide more support for the wall covering and to support a vertical member that appears to support the ceiling joist. The braces are overlapping, the joint being a halved lap joint (Plate 27). The panelling was concealed beneath lath and plaster, the scars for the laths being immediately visible, that was fixed to vertical battens, in turn fixed to the panels.

Plate 26: Detail view of the braces and upright member in the panelled wall

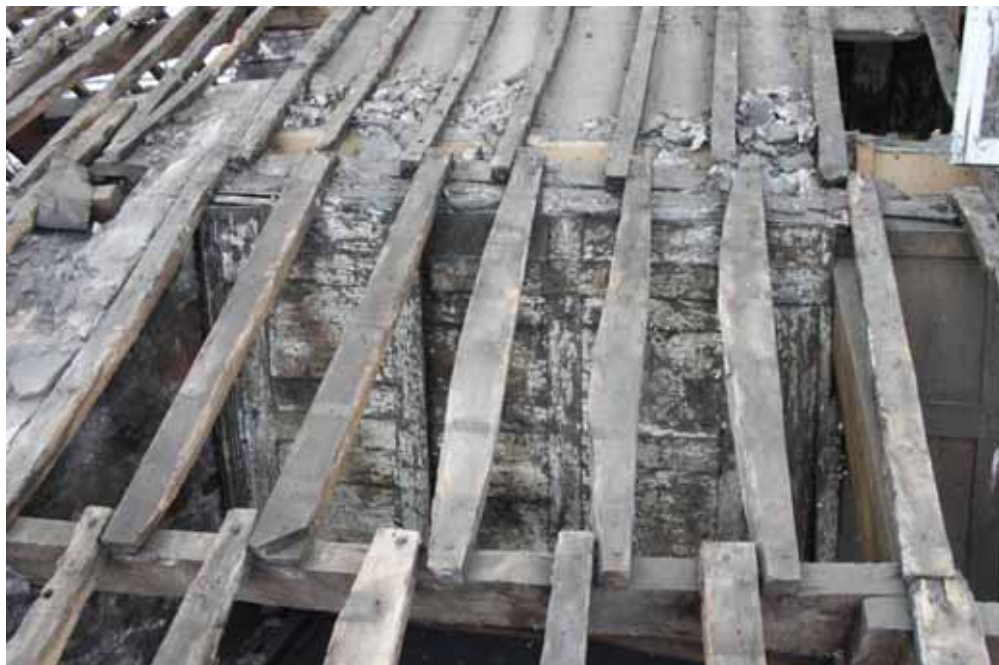
4.5.11 There are other timber panels of very similar appearance to those already described, that form lower walls set close to the eaves of the Rooms 30 and 31 on both sides (Plate 27). These too appear to have been reused the panelling on the south side of the roof (Room 31), exhibiting a moulding strip attached to one side (Plate 27).

Plate 27: Section of timber panelling situated on the south side of the roof forming the south wall of Room 30

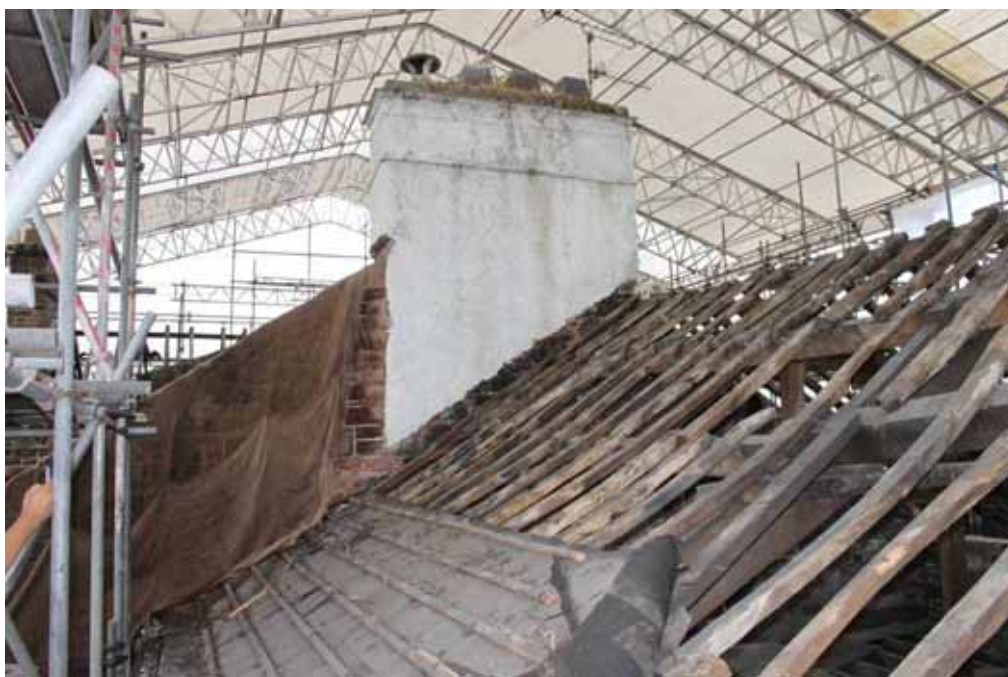
slope, the ridge and internal floor are stepped down from the central section (Plate 28). There is no evidence present for any garret rooms within this area of the roof.

Plate 28: View of the step down on between the central and east roof sections

- 4.5.13 Dividing the central and east roof sections, is a stone-built gable with projecting chimneystack at the apex (Plate 28). The chimneystack is covered with harling and differs slightly from those on the gables of the west roof section. There is a thin drip course and plain coping, the harling also carries on over to the flaunching. There are three plain square chimney pots and a concrete cowl. The gable wall is of similar appearance to the gables on the west roof section and is constructed of coursed, flat sandstone construction, with both cement and lime mortar. On the south side of the roof slope there is an exposed section of gable wall, at the base of which there is the inscribed date of 1838 (Plate 29). The inscription was made on a substantial stone block into which notches have been made.

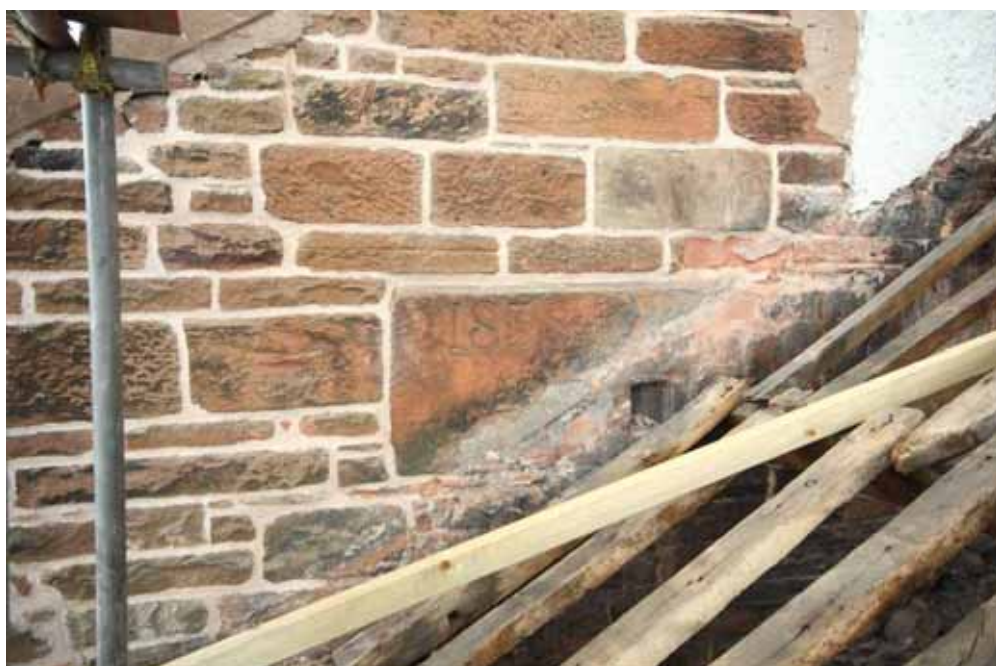
Plate 29: Inscribed date of 1838 in the east-facing gable of the central roof section

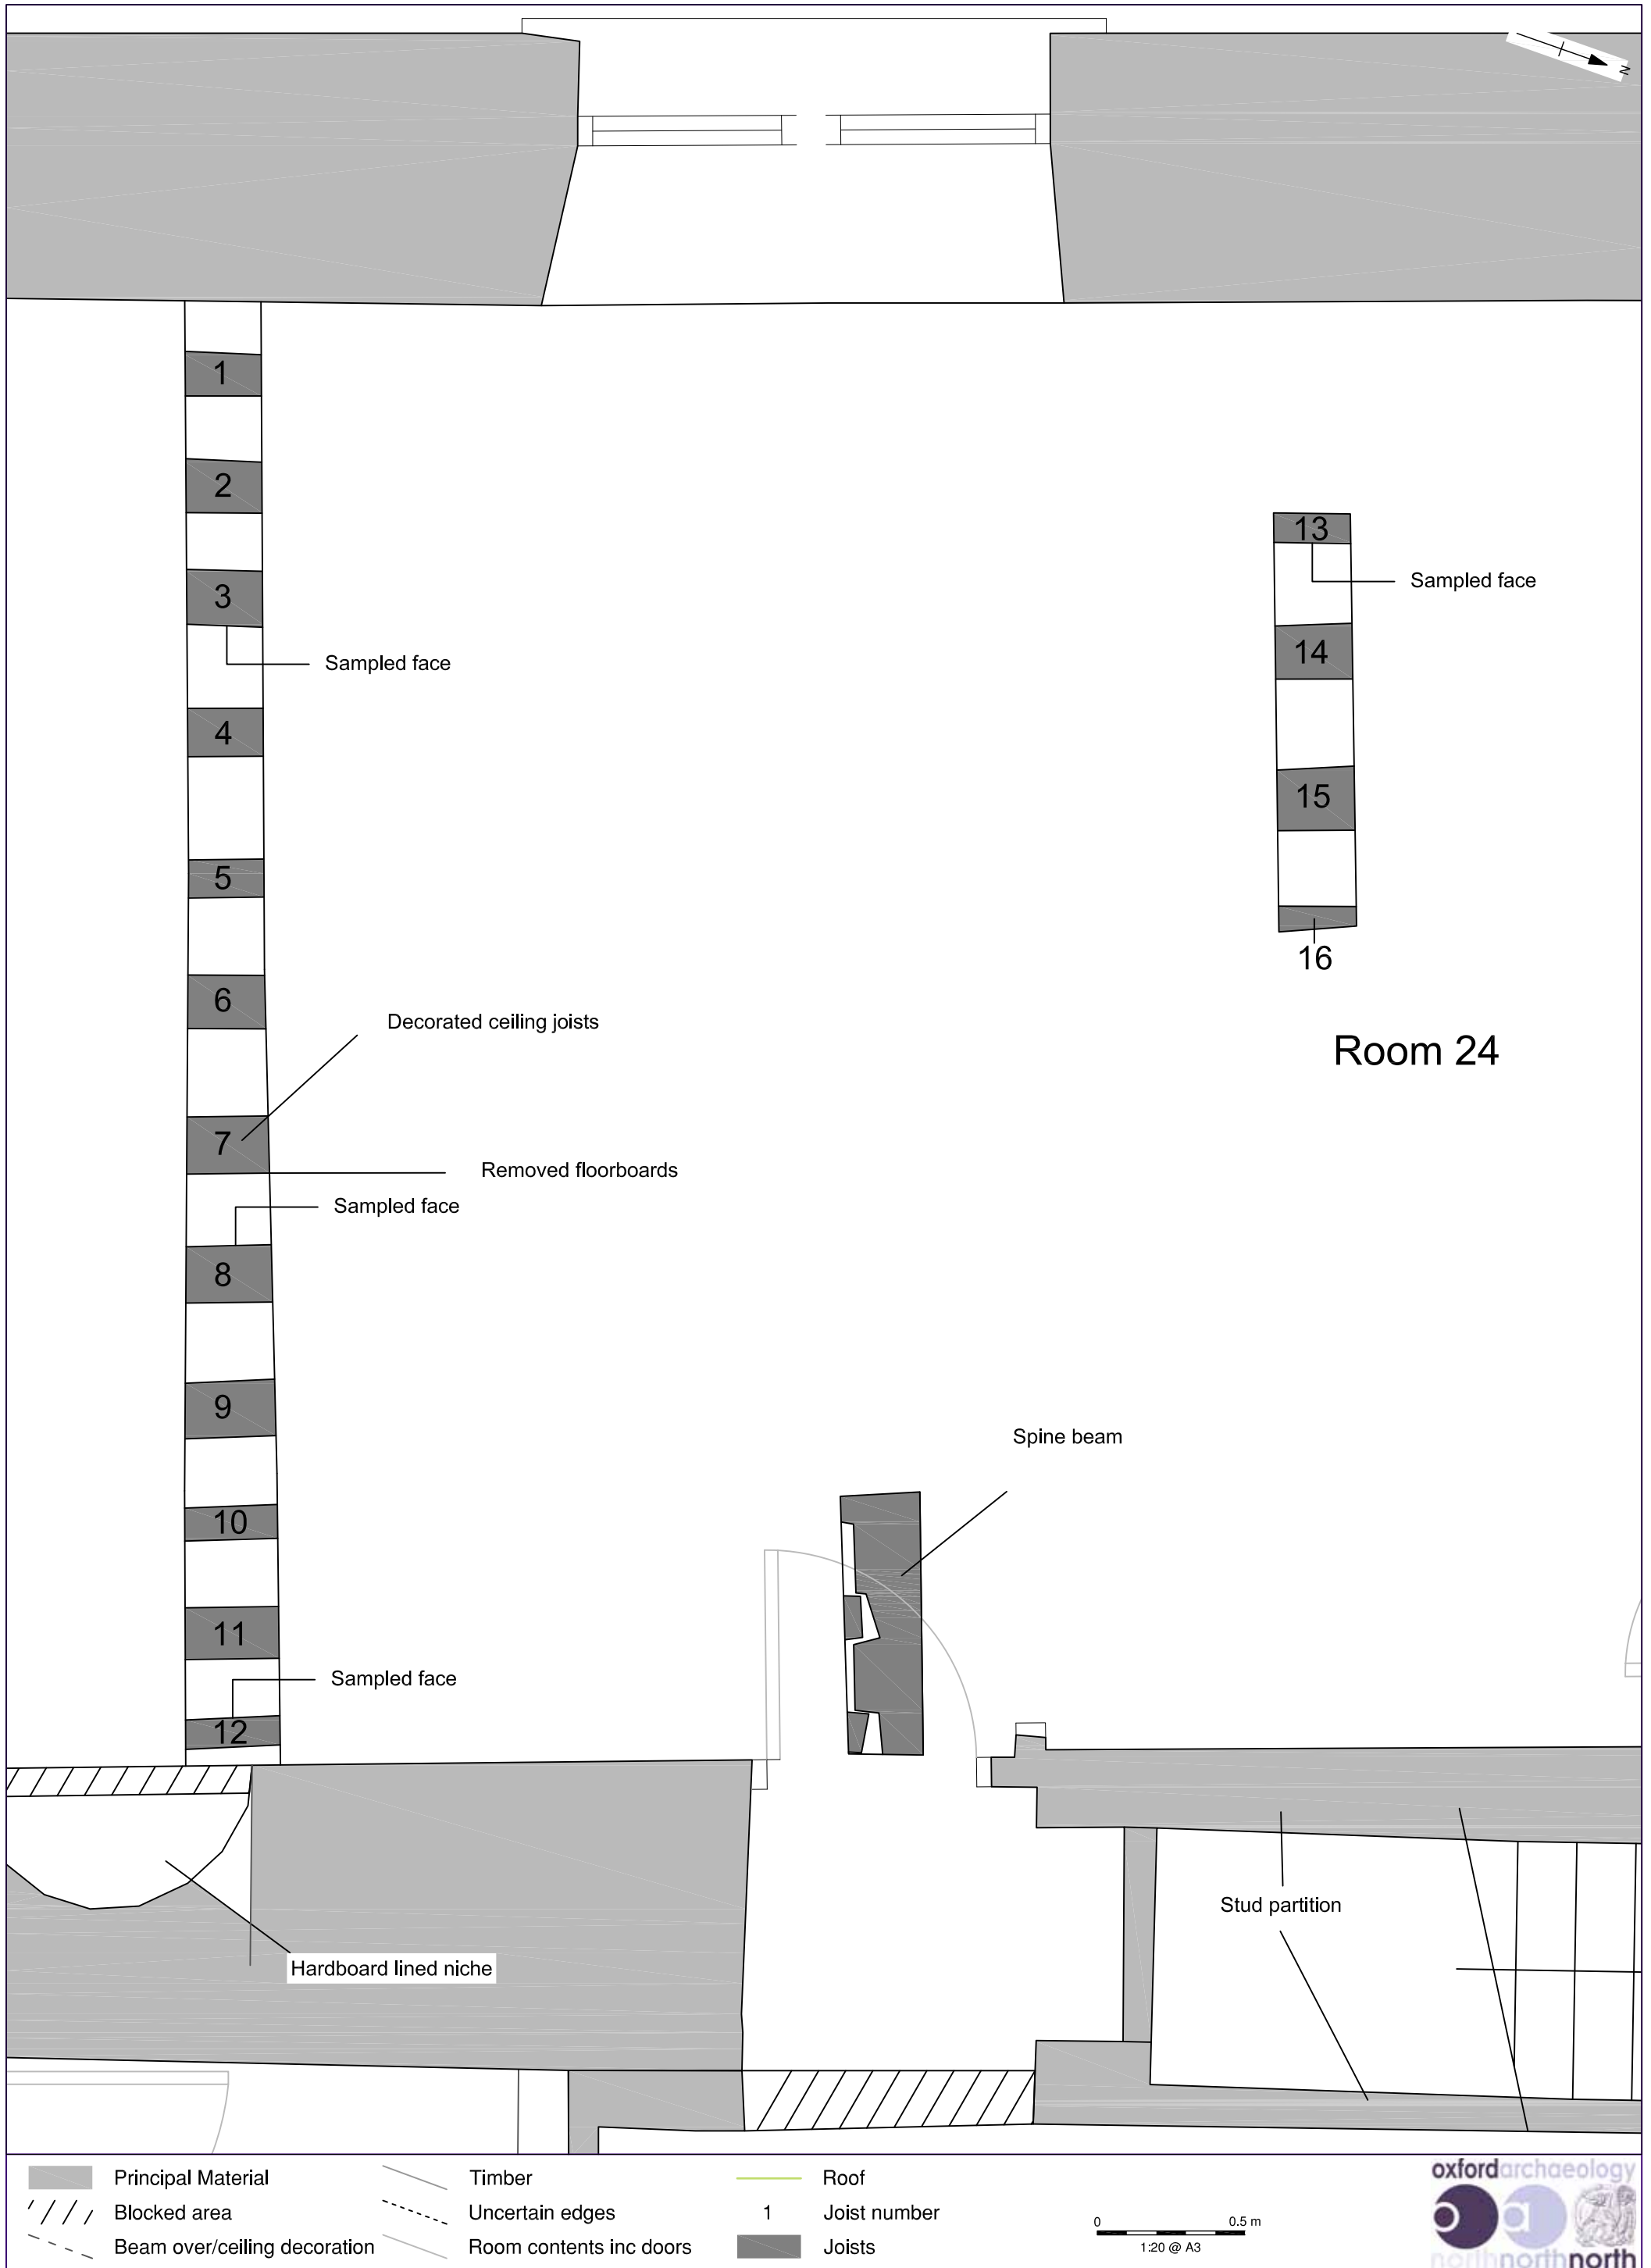
Figure 6: Locations of decorated ceiling joists

- 4.3.8 **Paint Analysis:** in order to determine the type of paint used for the decoration, a number of paint samples were taken from four joists, which were amongst those with the most visible and undamaged pattern; Each of the joists was numbered (see Fig 6) from 1 to 16. Samples of paint were taken from the east faces of Joists 3, 13, and the west faces of 8 and 12. A report outlining the results is in *Appendix 4*.
