ORDSALL HALL REFURBISHMENT, SALFORD

Archaeological Watching Brief and Excavation Report

Oxford Archaeology North

March 2012

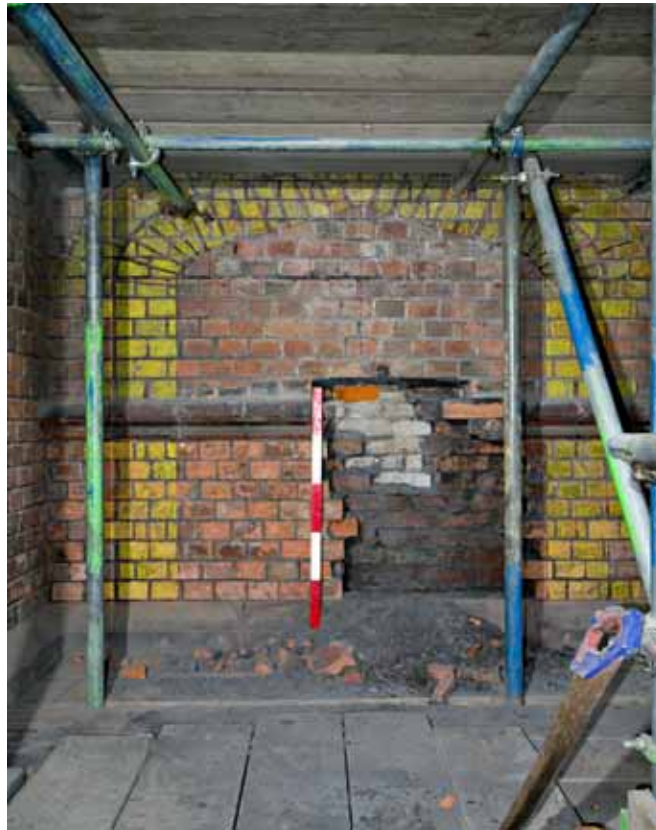
- 4.2.4 **New Door in the South Façade (G4)**: refurbishment works within the Great Hall included the insertion of a new doorway, at the western end of the south elevation, located to the west of the spere post (Fig 7; Plate 6). This allowed examination of the construction detail of the nineteenth century wall fabric.

Plate 6: South external wall of the Great Hall (G4), showing the position of the new doorway

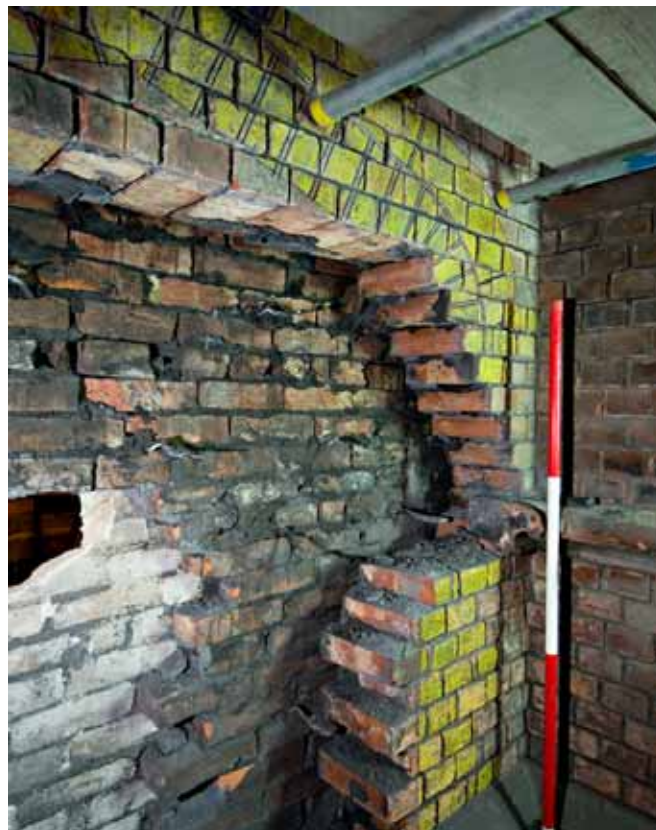
- 4.2.5 The south wall of the hall comprised brick cavity construction, the cavity being 2” (50mm) wide, and through which passed Y-shaped wrought-iron ties, at approximately every four or five courses (Plate 7). The external face was constructed using machine-made red brick, laid in header bond, and using a black sooty mortar, typical of the late-nineteenth and early-twentieth centuries (Plate 7). It was of full brick thickness – 9” deep (229mm). The inner wall was of a similar brick, but here the stretcher bond, typical of early cavity wall construction, restricted the width to 4” (108mm).

Plate 7: Detail of cavity wall construction

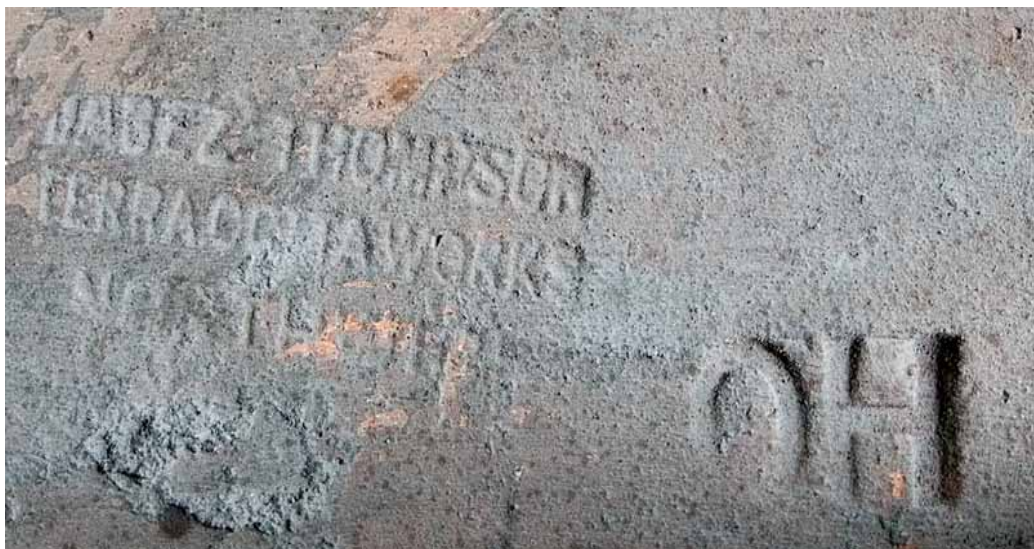
- 4.2.6 A terracotta string-course was incorporated into the external face of the wall. It was of *ogee cyma recta* style, being positioned at mid-floor level, and matching a similar string-course positioned between the ground and first floors. The individual sections of the string-course were jointed together with timber dowels and liberally bonded with a black sooty mortar (Plate 8). Each section was stamped on the reverse face with the makers mark “JABEZ THOMPSON TERRACOTTA WORKS MANCHESTER”, accompanied by the letters “OH”, suggesting that the mould was specifically made for Ordsall Hall (Plate 9).

Plate 9: Manufacturer's and batch stamps on string-course moulding

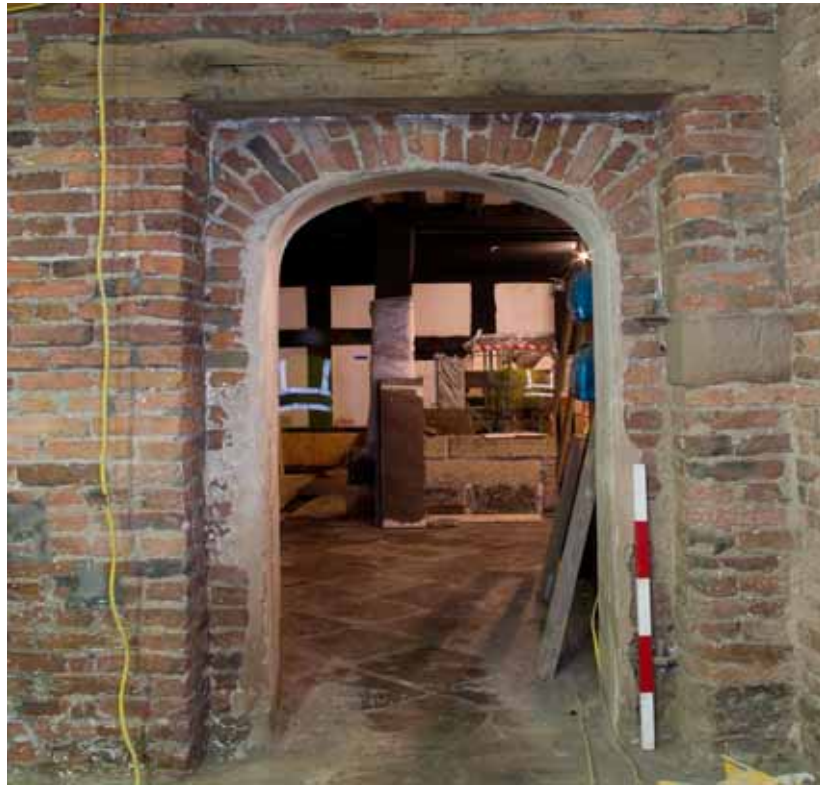
Plate 12: Internal doorway from the Kitchen(G10) through to the low end of the Great Hall(G11)

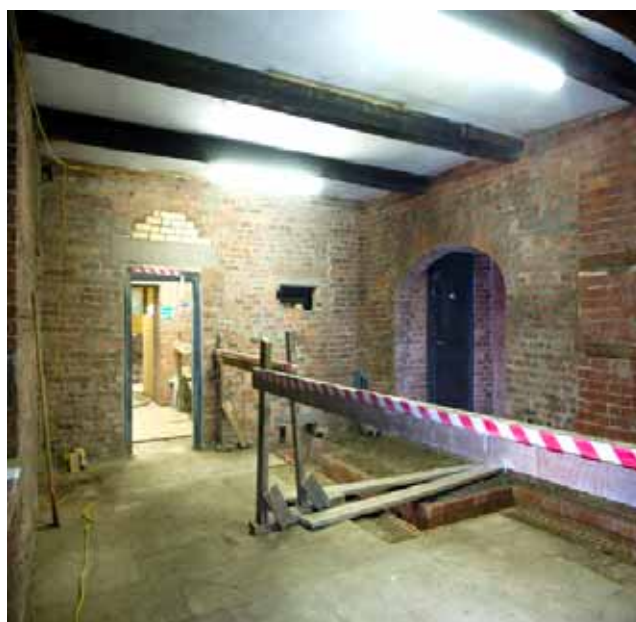
- 4.2.12 The southern wall of the kitchen appeared to form a contemporary return of the east wall, and was similarly constructed in English Garden Wall bond. An opening towards the western part of the wall had been blocked with machine-made brick, using a cement mortar, suggesting a twentieth century date, and its irregular shape would appear consistent with the blocking of a fireplace and rebuilding of the flue (Plate 13). A rectangular aperture at approximately door-head level, and with a concrete lintel, almost certainly represents access inserted into the flue. The full brick-thickness wall also appeared to retain a fireplace in the corresponding position on its southern face, within Room G9 (Fig 3). A wide doorway, towards the eastern end of the wall, may occupy an original position, but had certainly been remodelled, with the insertion of a concrete lintel, above a simple timber architrave (Plate 13).

Plate 13: View of the Kitchen (G10), showing flue aperture and re-modelled doorway

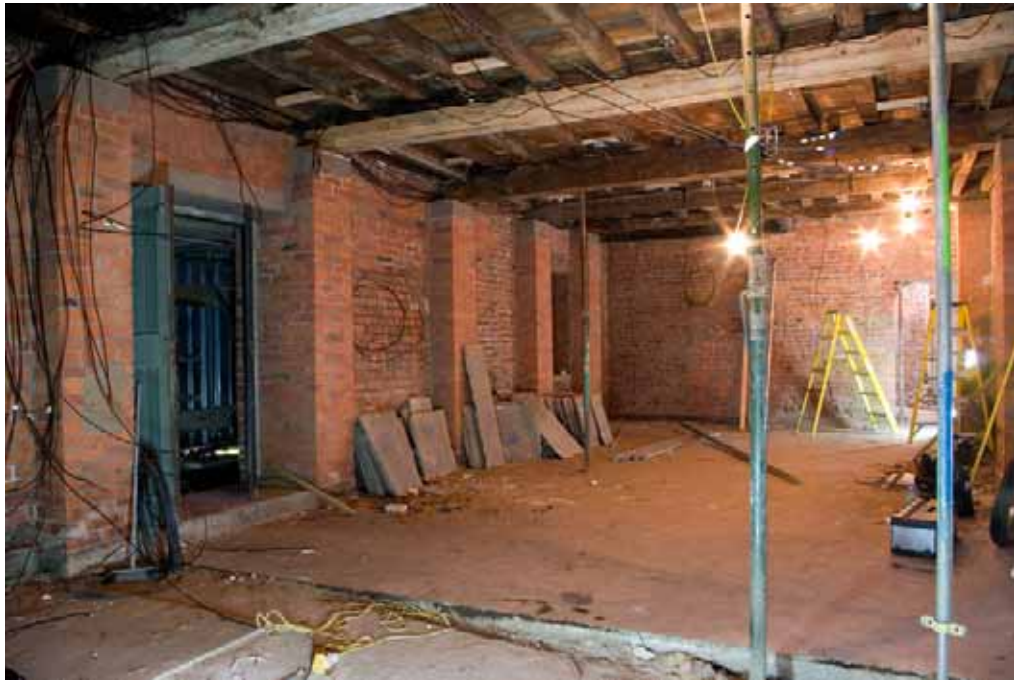
4.2.17 **Radclyffe Room, lift base and toilet works (G11A and G11B):** in order to improve access to the first and second floors of the building (the Egerton Lobby (**F8**) and the Roof Space (**S4** to **S9**) above), a lift was inserted into southern end of the Radclyffe Room (Fig 3). As in the kitchen to the south, the wall finishes were also removed (Plate 16) allowing for more detailed analysis of the room than had been previously possible.

Plate 16: General aspect of the Radclyffe Room (G11B), with inserted piers and doorway

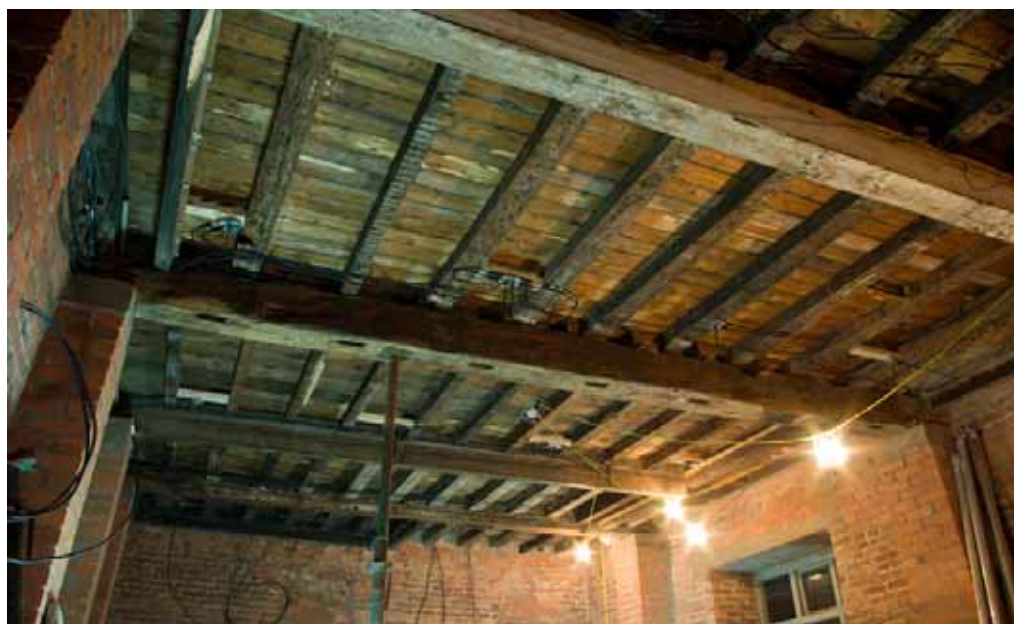
4.2.18 Where original fabric survived, the elevations were similar to those of the kitchen, comprising hand-made brick, laid in three-stretcher English Garden Wall bond, using a pale lime mortar. The two long elevations were heavily remodelled, with brick piers added to each elevation to support re-positioned ceiling beams above (Plate 16), the southern of which spanned to the east wall above an extant doorway, and had a run-out stop chamfer. The piers were concrete-capped, and almost certainly of twentieth-century date. The beams were all of relatively large scantling, and chamfered, with several retaining mortises and auger holes, being evidence of earlier use within timber framing (Plate 17).

Plate 17: Ceiling within the Radclyffe Room (G11B), showing re-used beams

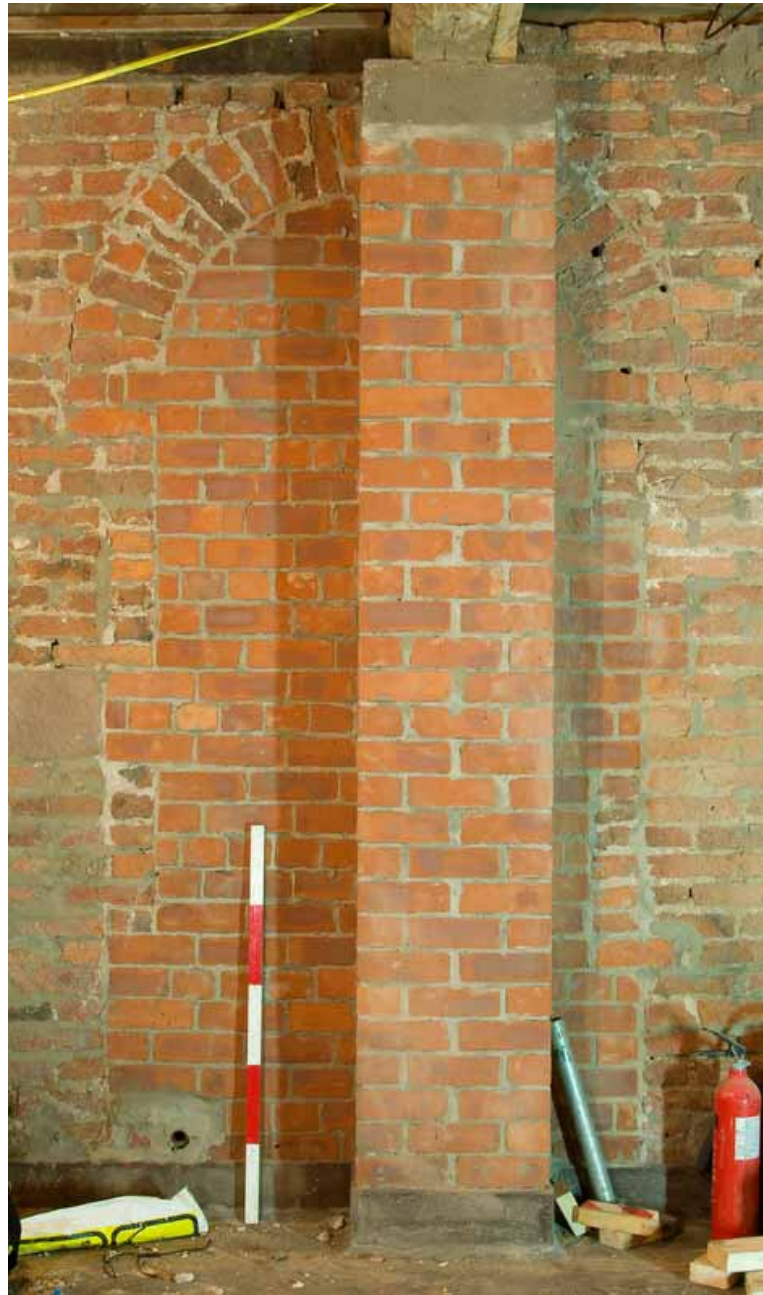
4.2.19 Large doorways were inserted into both east and west elevations, with associated late-nineteenth or early-twentieth century rebuilding, with that in the west elevation replacing an earlier doorway immediately to the north, which was possibly blocked at a slightly earlier date, the brick being bonded in a black sooty mortar. A tall, segmental-arched doorway into the Stair Tower (G13) in the eastern elevation, was blocked for the construction of one of the adjacent brick piers (Plate 18), demonstrating that access was not required from the stairs to the ground floor by this time. A padstone for a pintel, as that seen within the kitchen (Section 4.2.11, above), was present to the left side of the blocking.

Plate 18: Blocked doorway into Stair Tower (G13)

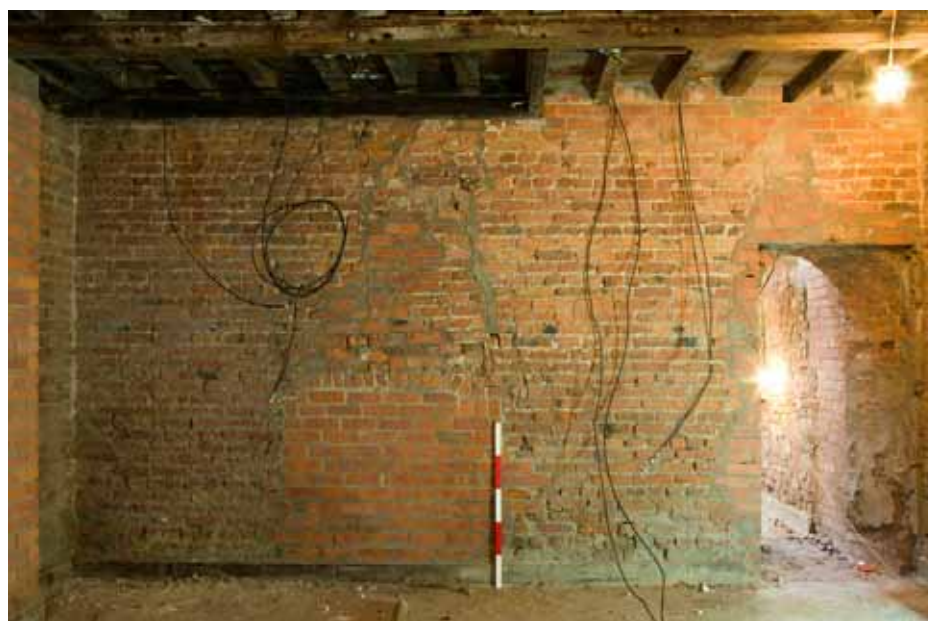
4.2.20 The north and south elevations both contained blocked fireplaces. That in the north wall was offset to the left of centre, giving symmetry to the elevation, which had a doorway at its right-hand side into the annexe to the north (Fig 3). The fireplace was approximately 4' (1.22m) wide, and had a very shallow basket-handle arch, and was blocked with twentieth-century machine-made brick, bonded in a cement mortar similar to that used in the construction of the brick piers (Plate 19). The flue above had also been rebuilt on at least one occasion. The doorway within the north wall also had been remodelled in the twentieth century, with the round-headed arch being removed on the facing skin of the two brick-thickness wall, and replaced with a flat lintel, presumably in order to house a standard timber door frame (Plate 19). The fireplace in the southern elevation was placed on the right side of a projecting chimney-breast (Plate 20), which shared a flue with the large inglenook fireplace to the rear in the kitchen. The hearth appears to originally have been positioned centrally within the chimney-breast, and was approximately 4' (1.22m) wide. It was subsequently narrowed on its left side, whilst being extended to the right. The new aperture had a two-row segmental arch, incorporating machine-made and refractory brick, bonded in black sooty mortar (Plate 20), both suggesting a late-nineteenth or early-twentieth century date for the remodelling. The fireplace was blocked with similar brickwork to that in the north elevation, almost certainly in the twentieth century.

Plate 19: Blocked fireplace and remodelled doorway, the Radcylffe Room

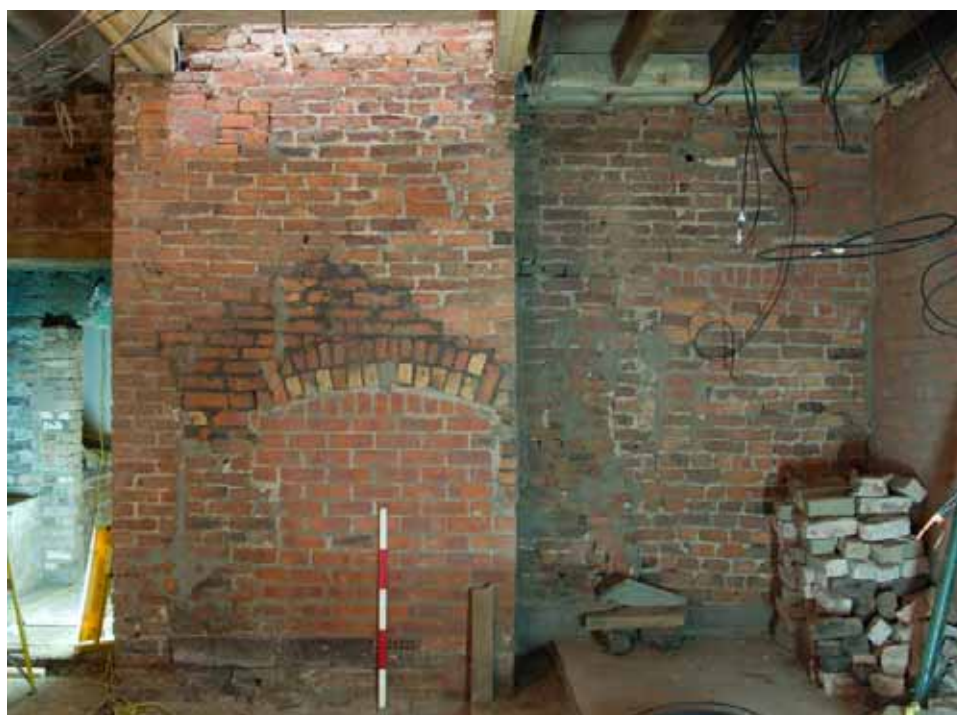
Plate 20: Blocked and remodelled fireplace, south wall, the Radclyffe Room

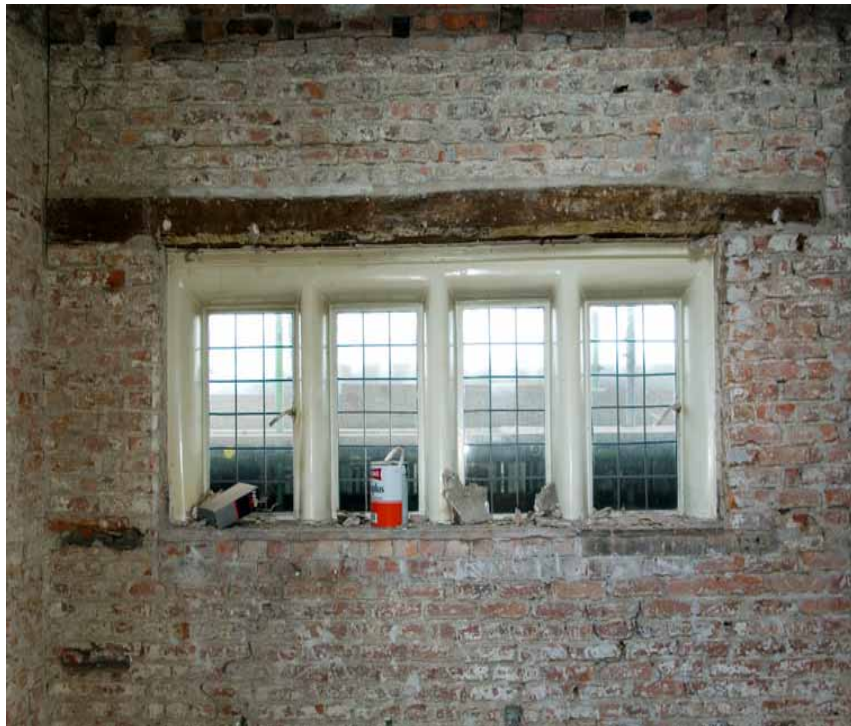
Plate 21: Remodelled first-floor window in Stair Tower

4.2.25 The first floor (Room **F12**) had only a single window, which was placed in the main façade, and comprised a large horizontal four-light, mullioned window, similar to those on the ground floor, but retaining a timber lintel, although it too had been reduced in height at sill level (Plate 21). At second-floor level (Room **S9**) a further three-light mullioned window had a central light extending into the gable above. The mullions and transom were of bare brick,

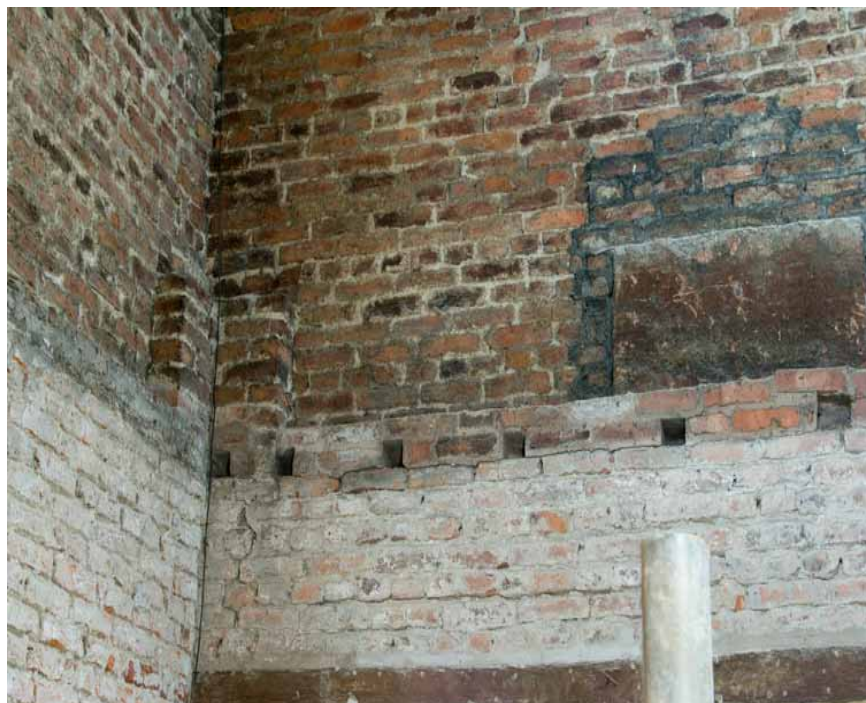
4.2.21 **Stair Tower (G13):** partitions and wall finishes within the tower were removed in order to insert a new staircase. The three-storey tower comprised Rooms **G13**, **F12**, and **S9** (Figs 3, 4 and 5), and appeared to have been an addition to the west wing, with a straight joint visible internally between the north wall of the stair tower and the east wall of the west wing. The walls were of hand-made brick construction, laid in three-stretcher English Garden Wall bond, using a pale lime mortar (Plate 21). The bricks were of typical eighteenth or nineteenth-century dimensions, measuring 9 x 4 ½ x 2 ½” (228 x 114 x 63mm). Several patches of machine-made brick repairs were observed, as were similar rebuilds around remodelled window apertures (Plate 21). The walls were of 1½ brick-thickness, except for at second-floor level, where the thickness was reduced to a single brick; this being tied into each corner of the wider wall below by brick piers six-courses high and one brick wide (Plate 22).

Plate 22: Reduced wall thickness at second-floor level of the stair tower

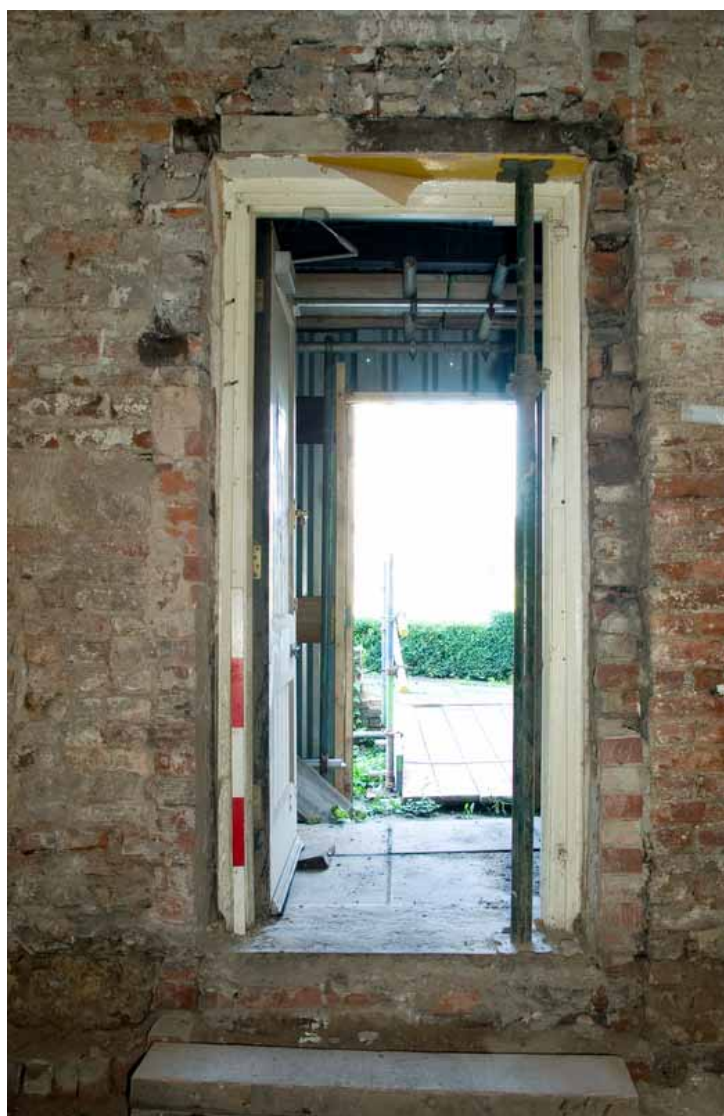
4.2.22 A doorway in the east wall afforded access through the main façade of the tower. This had been narrowed slightly, and the remodelled lintel, may originally have been arched. The original north jamb contained two sandstone blocks, similar to those in the kitchen and the Radclyffe Room (*Sections 4.2.11 and 4.2.19* above), supporting the hinge pintels (Plate 23). Original access into the ground floor of the west wing was via a large doorway at the north end of the west wall, described on its opposite face in the Radclyffe Room (*Section 4.2.19*, above; Plates 18 and 24). This was latterly replaced by a door at the southern end of the elevation, which had itself been removed prior to commencement of the watching brief. A similar, but smaller doorway at first floor level (Plate 24) was also blocked, and had been replaced by a centrally-placed doorway, with concrete lintel, and of twentieth century date. The third floor was accessed via a pair of arched doors set within timber framing (Plate 25).

Plate 23: Remodelled entrance in Stair Tower

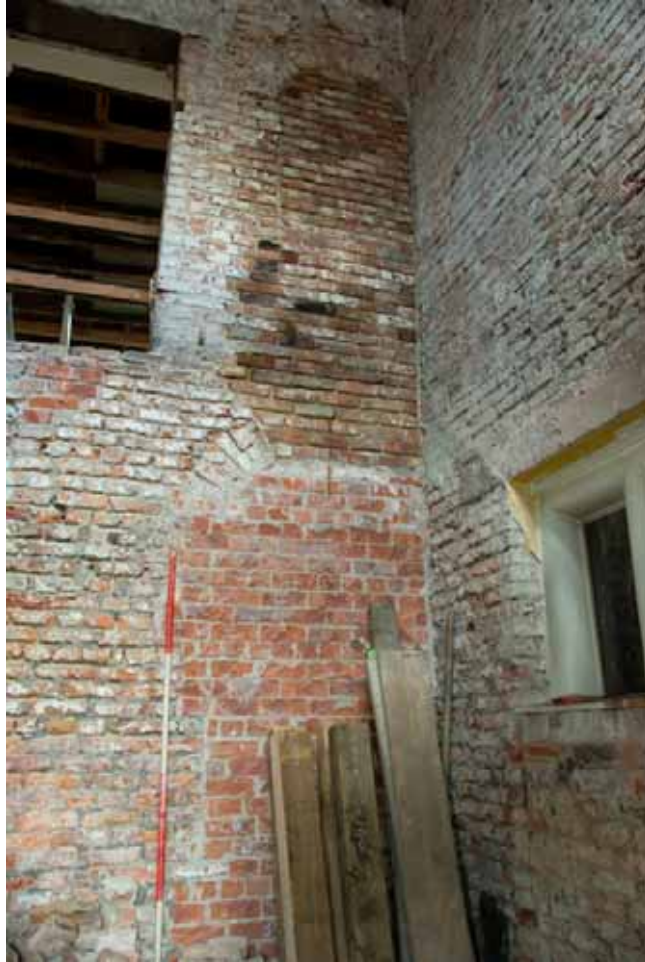
Plate 24: Blocked doorways in the Stair Tower, at ground and first floor level

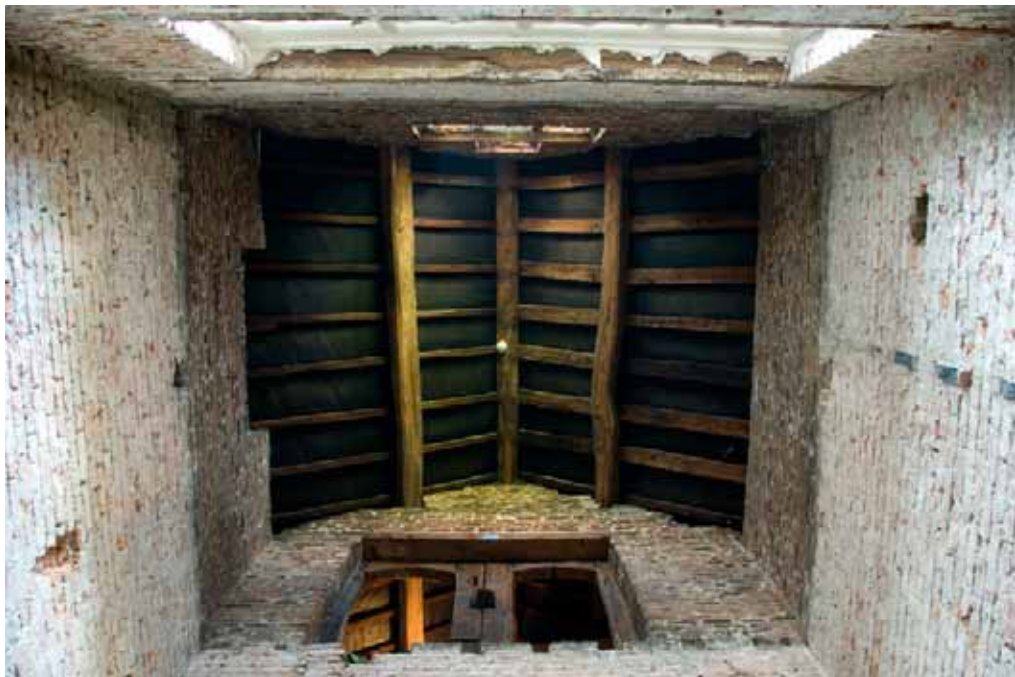
Plate 25: Timber-framed doorway to second floor, with roof detail above

- 4.2.26 The pitched roof of the stair tower was visible from the ground floor (Room **G13**), and was of common rafter construction, carried on a single purlin to each pitch (Plate 25). It was of oak construction with the rafters on the southern pitch being of significantly lower scantling, and probably representing a late-nineteenth century replacement.

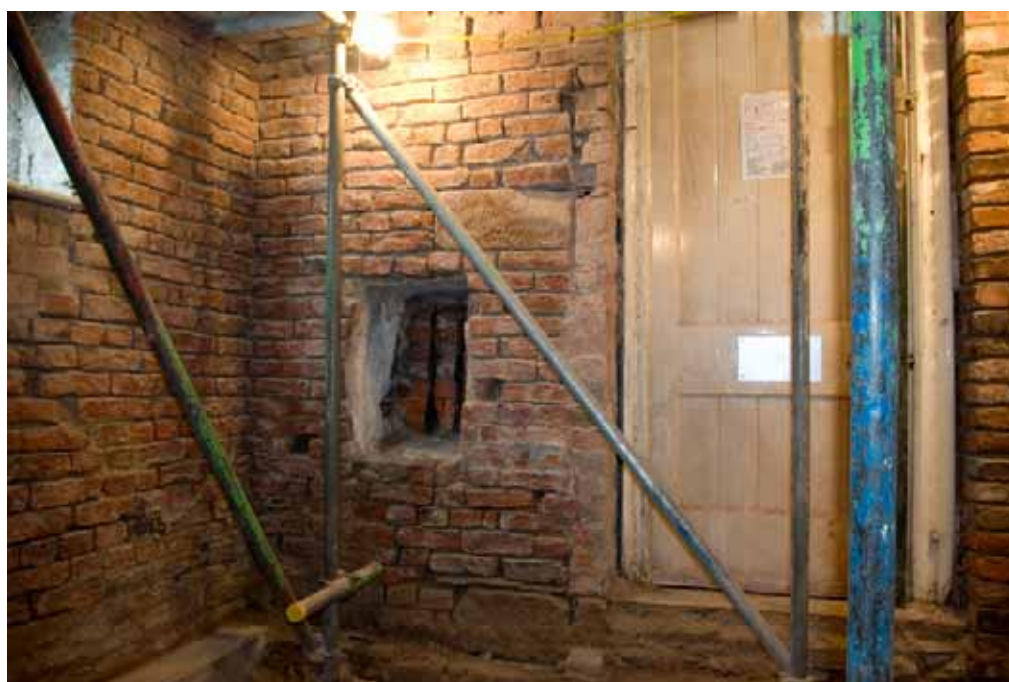
4.2.23 The ground floor (Room **G13**) had windows in all of the external elevations (Fig 3). A large horizontal three-light window in the north elevation, with plaster-rolled brick mullions similar to those of the larger first-floor window (Plate 21), had been reduced in height, the base having been infilled with modern brickwork. A smaller, two-light mullioned window in the south elevation, was of similar style, although this appeared to have been inserted into an earlier aperture. A small, single-light window located to the left of the doorway in the east elevation, retained vertical wrought-iron bars (Plate 26). This had been blocked externally with a single skin of brickwork, and covered by panelling on the internal face. It appears to have been cut into the brickwork (Plate 26).

Plate 26: Small window with wrought-iron bars revealed at ground-floor level

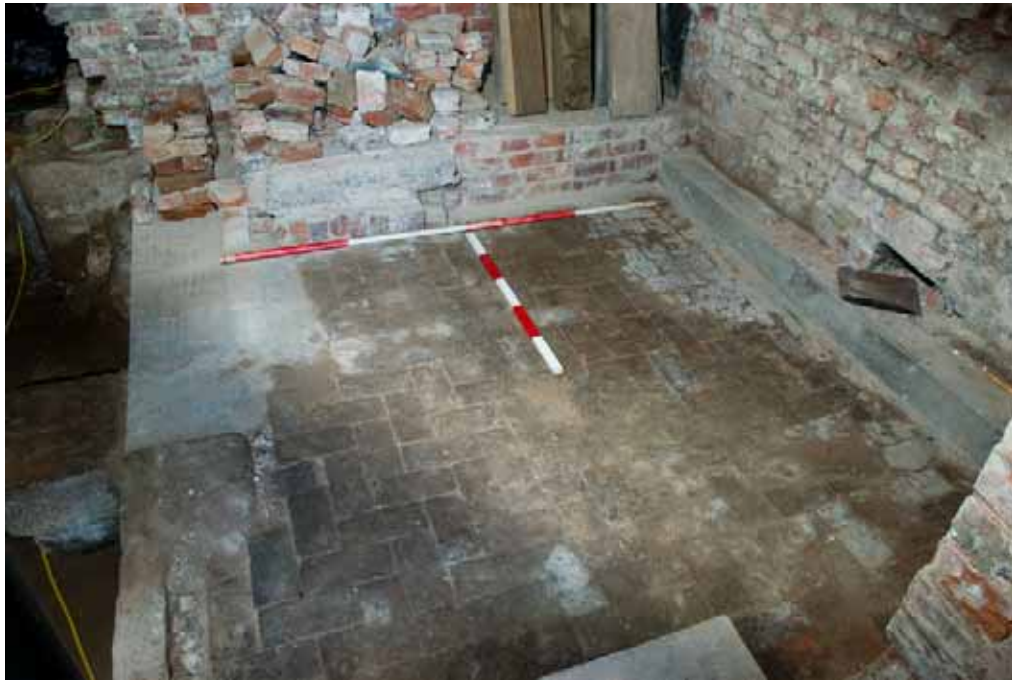
4.2.24 The northern part of the stair tower had a herringbone brick floor (Plate 27) positioned at doorstep level, whilst although the southern part of the floor comprised a further brick floor, it was laid 15" (0.38m) below the level of that to the north. The square bases for both the main newel (offset slightly to the south), and the curtail newel post, were *in-situ*, with slightly raised brick forming the riser of the foot of the staircase beyond (Plate 28). Whilst the staircase was possibly a late-nineteenth century insertion, the stone newel pads were almost certainly original, and the arrangement of windows and original door apertures suggests the original stair was an open-string, quarter-turn staircase. The lower level of the southern part of the floor was probably designed to allow for increased access under the staircase.

Plate 27: Herring-bone brick floor of Stair Tower

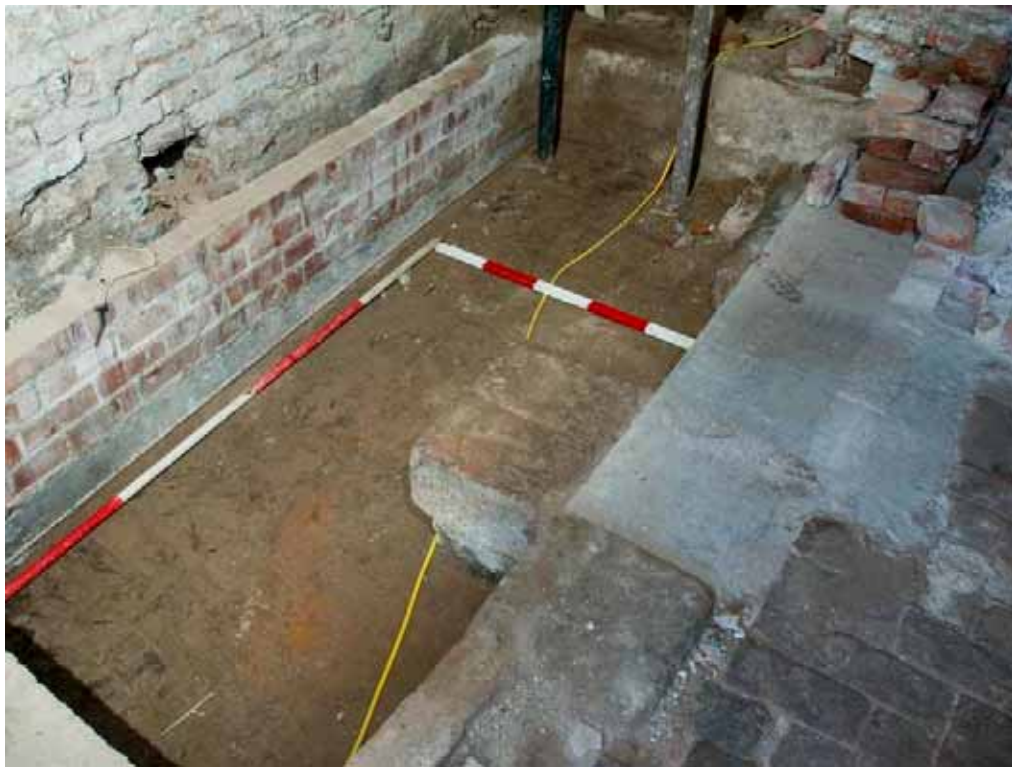
Plate 28: Footings of staircase and newel

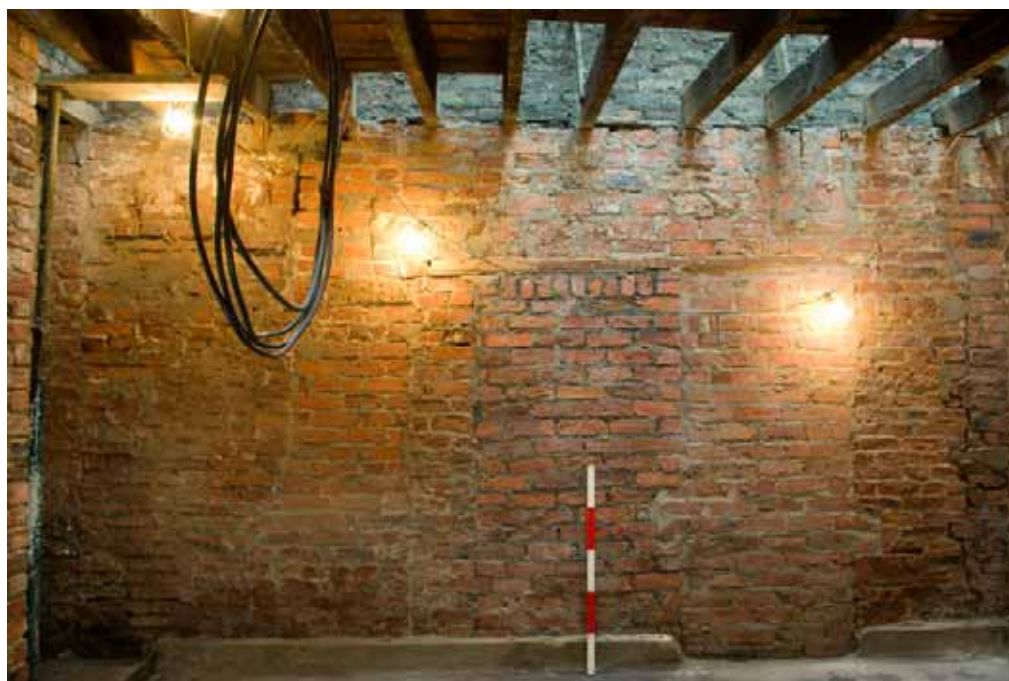
4.2.30 The relatively short west wall contained four apertures, all having been blocked subsequently (Plate 31). At its southern end, it originally appeared to have housed a large full height doorway, being approximately 6' (1.83m) wide. A further doorway of similar width was inserted to the north of a narrow brick pier, providing access into a small lean-to extension which it is clearly depicted on a painting dated to 1830 (Plate 2). The southern aperture was then remodelled to form a 2' (0.61m) wide vertical window, which was also blocked subsequently. The doorway into the extension at the north end of the west wall was narrowed, almost certainly at the turn of the twentieth century, at which time the lean-to was removed, leaving an external door towards the north end of the west wall. Finally, this aperture was also blocked, with the door in the east wall becoming the only external access.

Plate 31: Blocked apertures in west wall of the annexe

- 4.2.32 The floor within the annexe comprised late-nineteenth century 6" (0.15m) ceramic quarry tiles, laid in a diamond pattern of red and black tiles. The raised brick hearth was bounded by edge-set refractory brick, and the alcove to the right of the chimney-breast appeared to have a concrete step of similar height, although this was obscured by the footing of a structural prop (Plate 31).

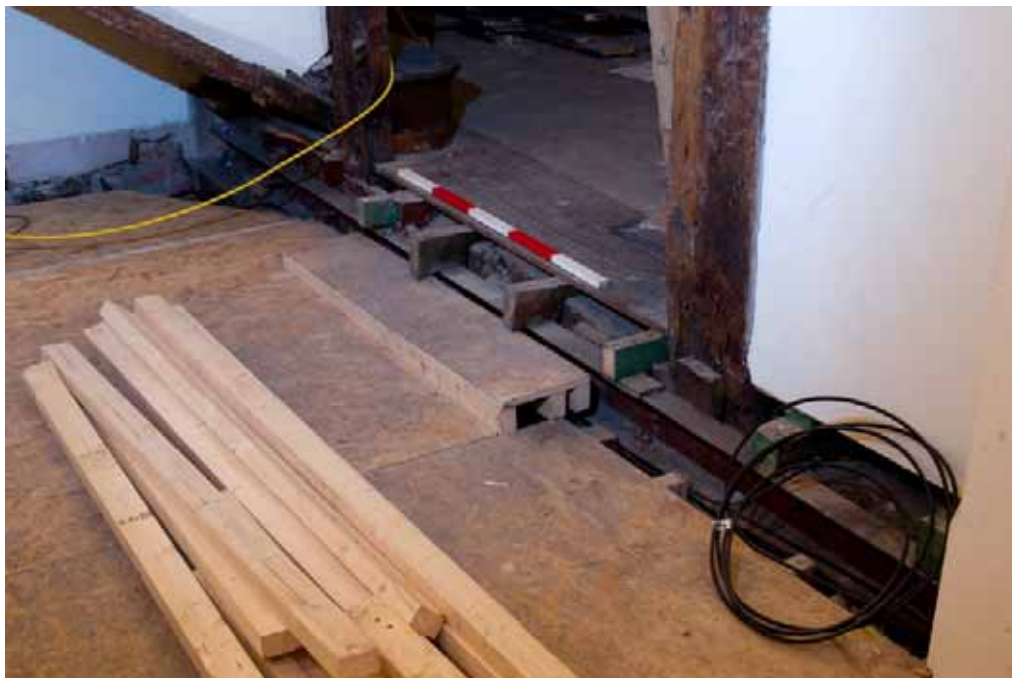
4.2.38 An I-section rolled-steel joist situated below the threshold between Room **F3** and Room **F1** (Plate 35), bore no makers stamp, and appears to be of mid/late twentieth century date. Whilst the timber rail of the wall-frame survived *in situ* behind it, the steel joist appears to have been inserted to carry the structural load of the floor of Room **F1**, which was placed at a higher level than that to the west (Plate 35).

Plate 35: Steel beam inserted to support wall frame and floor

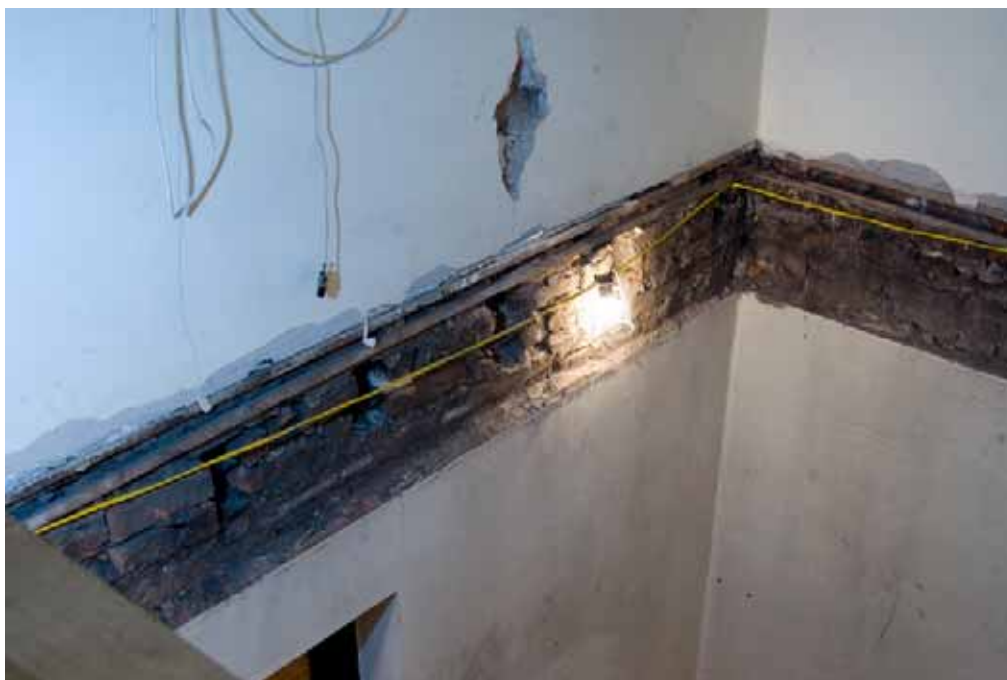
- 4.2.40 The removal of the existing floor left a wide scar, approximately 7½” (0.19m) wide (Plate 36), around the base of the north, south and east walls (the west side of the floor remained intact at the time of the inspection). The walls were of hand-made brick construction, typically measuring 9 x 4 x 2¼” (0.23 x 0.10 x 0.06m), bonded with pale with lime mortar. The evenly-spaced, vertical-section joist slots for the recently removed floor were visible in both the north and south walls (Plate 36).

Plate 36: Extent of wall-strip for watching brief, Room F1

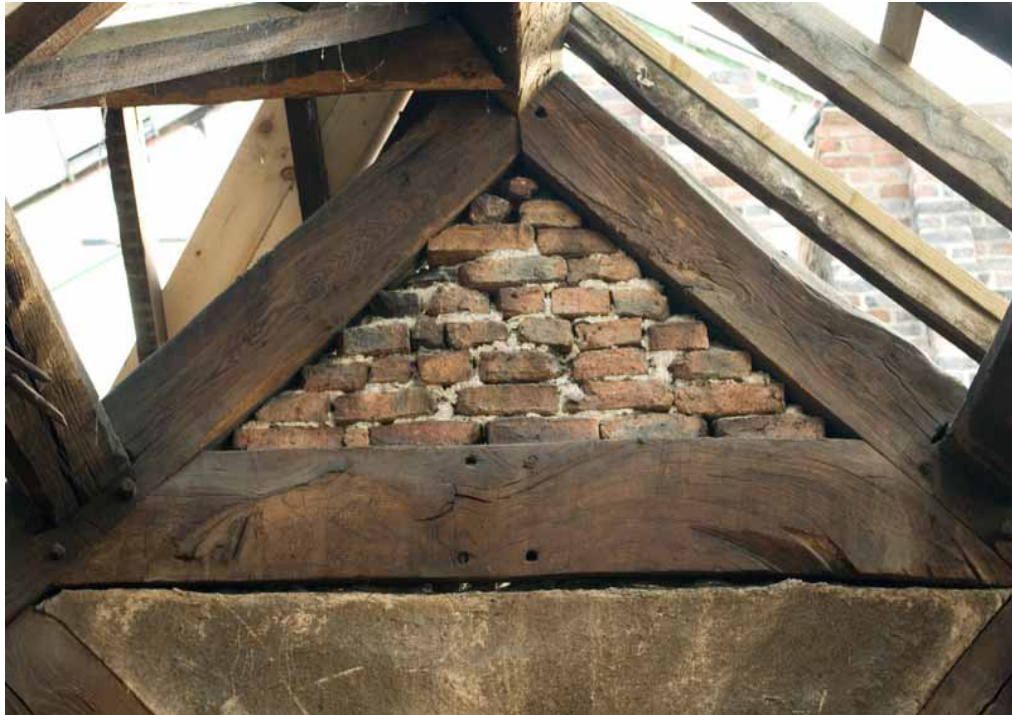
- 4.3.3 Above the tie-beams, large scantling principal rafters were quadruple-pegged into mortices, and formed a birdsmouth at their apex, clasping a more slender square-section ridge purlin (Plate 38). Two angled-braces above a collar were also incorporated into the truss, all having double-pegged mortices. However, all of the collars had two empty central mortices (Plate 38), and the joint forming the birdsmouth for the ridge appeared very untidy carpentry in comparison to other elements of the timber-framing. A peg-hole near the apex of each of the western pitch principal rafters appears to represent the remains of a mortice (Plate 38), with the rafter originally oversailing that to the east. The empty mortices in the collar were matched by a similarly positioned mortice in the tie-beam (Plate 39), and by mortices on the soffit of each of the upper principal rafters. This represents an unusual arrangement, whereby two vertical struts gave the impression of a king-post, but lacked its structural role, being broken by the collar, which provided the support.

- 4.3.4 The timber-framing within the trusses was infilled with daub, or wattle and daub panels, supported by staves (Plates 37, 38, and 39). Several of the panels were empty (Plate 40), whilst the upper panel of the central truss had been infilled with brick nogging (Plate 38), quite possibly during the construction of the present west wing.

Plate 38: Detail of truss apex, showing ridge assembly, and brick noggin

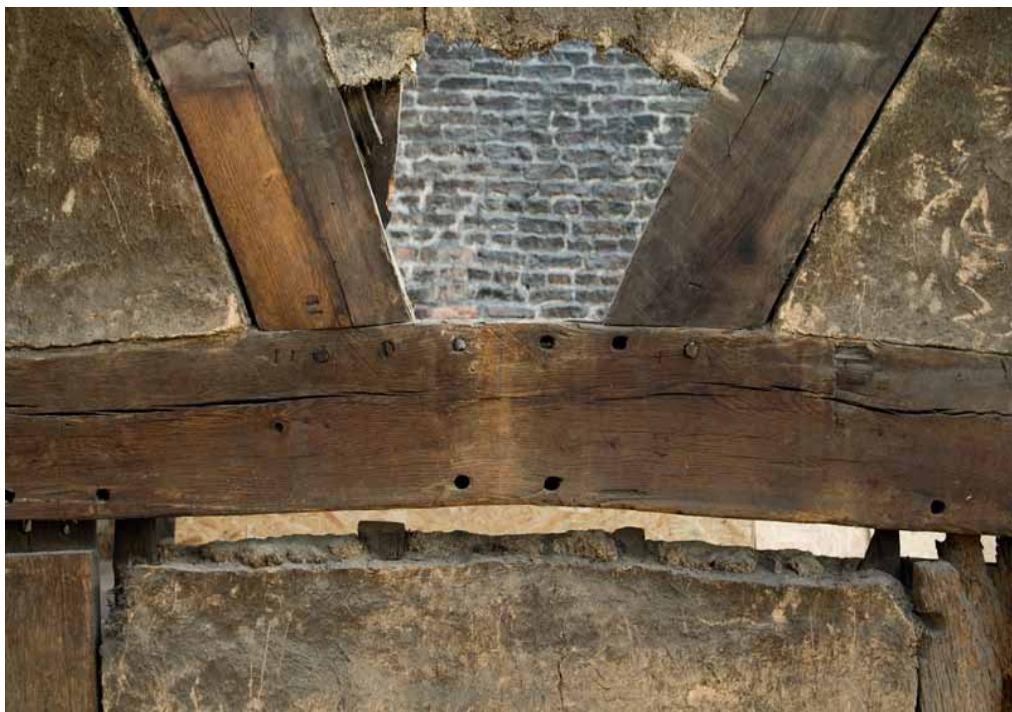
Plate 39: Assembly marks and redundant mortices, with wattle and daub panelling

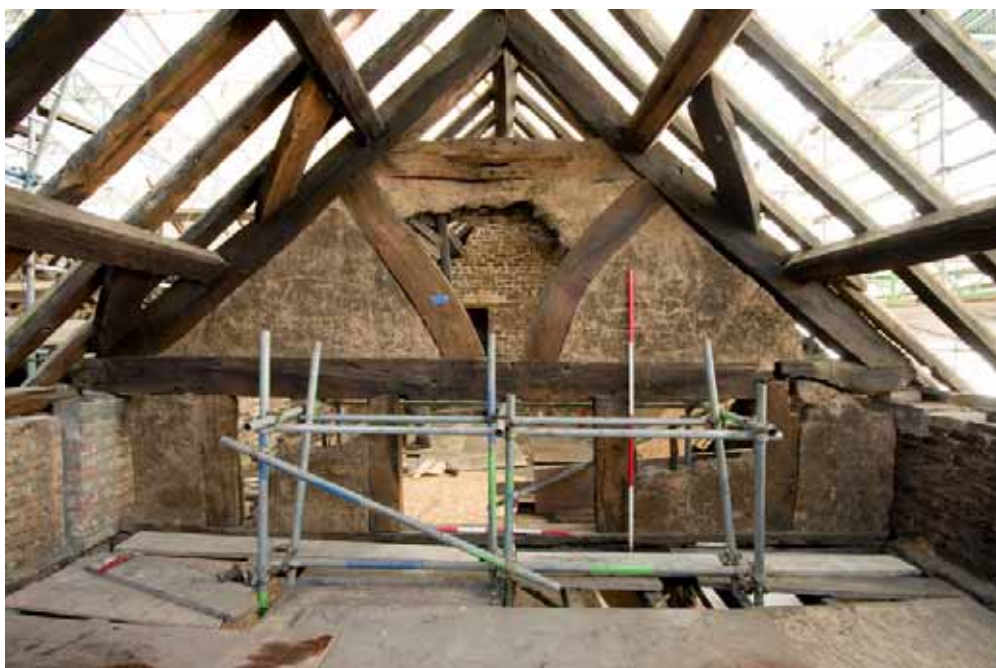
Plate 40: Southern truss of the west wing, with original wind braces

- 4.3.5 Each of the trusses had inscribed assembly marks on their northern faces, although not fully discernible, the numerals IIII and V were present with some additional tags. Chiselled I and II marks were observed on the tie-beams of each of the trusses, with corresponding marks on the arched braces from the tie-beams (Plate 39). The two purlins to each pitch were butt-ended into the trusses, and had arched wind braces from the principal rafters on both north and south sides (Plate 40).

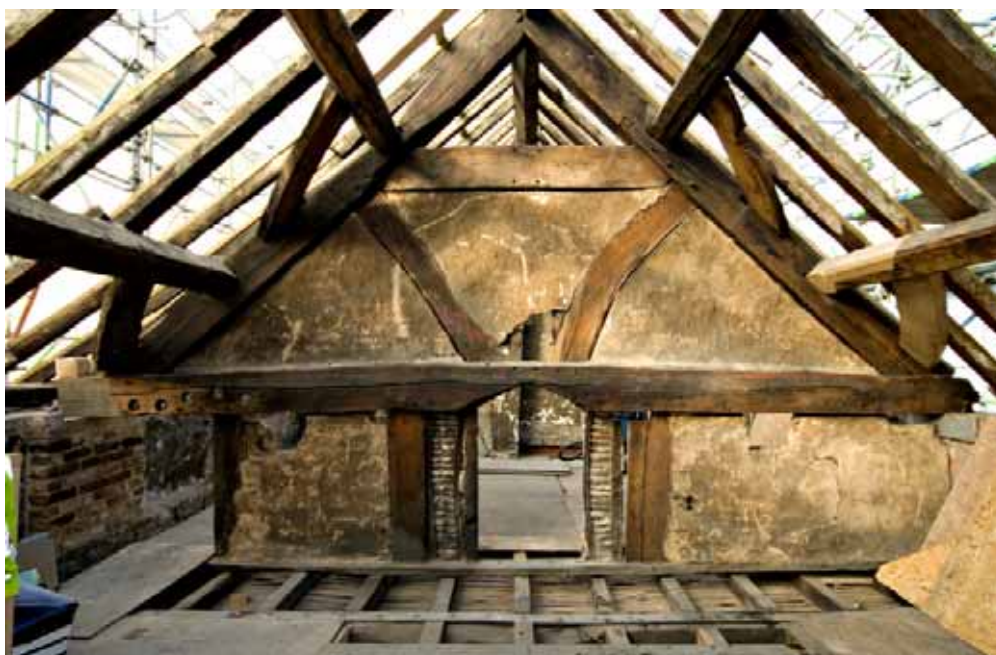
- 4.3.6 The northern truss, forming a partition between Rooms **S9** and **S8** (Fig 6), differs from those to the south, in that it has a central doorway, with a carved four-pointed arched head, being cut from the tie-beam (Plate 37). This represents a secondary feature, cut through the truss, with auger holes for the earlier staves visible in the bottom rail. The upper, northern, face of the truss was refaced either side of the door with lath and plaster panelling, containing horse-hair. This had also been applied to the other panels of the upper face (Plate 37). The lower face appears to have been left exposed, showing the post inserted to form the western door jamb, which was hung by pintels on this face (Plate 41).

Plate 41: Lower face of northern truss of west wing, with remodelled doorway

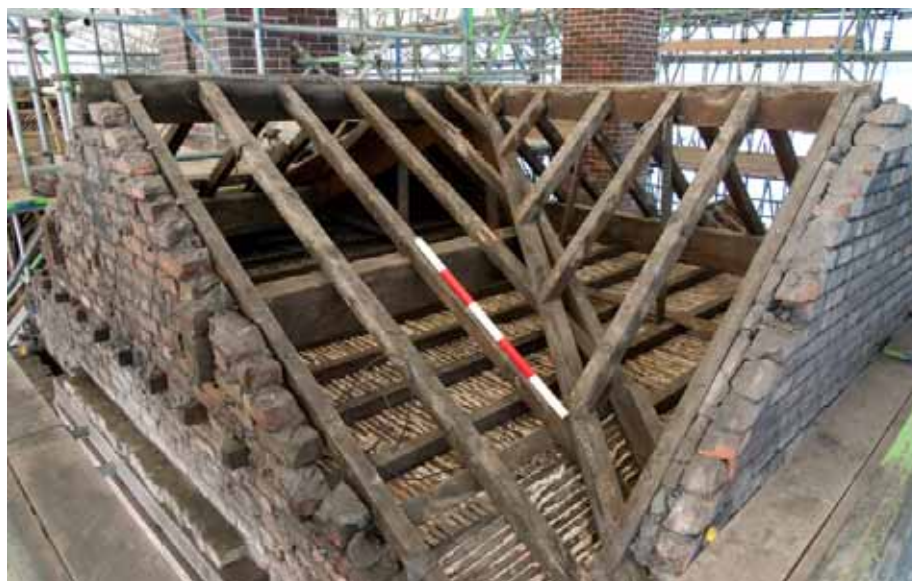
- 4.4.2 **Roof A:** this represents the roof above Room S2, in the south-eastern corner of the east wing (Fig 5). For the main part the roof was east/west aligned, with gables to the south and east. Both gables were of brick construction, with the ridge and single side purlins housed within the eastern gable, and passing through the smaller southern gable, which was of single-skin thickness (Plate 42). Each valley of the southern gable had two valley rafters: a full-length valley rafter, onto which the rafters of the gable were nailed; and a shorter rafter, with a splayed scarf onto the valley rafter, which in turn housed the feet of the rafters of the steeper eastern gable (Plate 42).

Plate 42: Roof A, with timbers projecting through single-skin southern gable (left)
