ORDSALL HALL REFURBISHMENT, SALFORD

Archaeological Watching Brief and Excavation Report

Oxford Archaeology North

March 2012

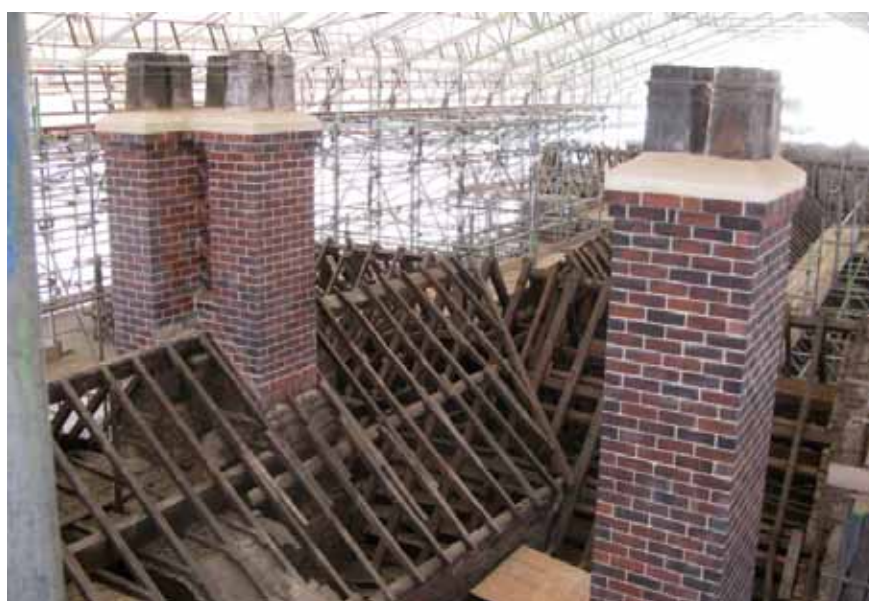
- 4.4.3 The roof contained a large rectangular chimney-breast, with a triple-pillared chimney-stack rising through the ridge, in a T-shape plan arrangement (Plate 39). Each contained two flues within stretcher bond stacks, and was tied into the adjacent pillar at both the crown and the mantel (Plate 43). The internal faces between the stacks were infilled with decorative brickwork arranged in a zigzag pattern (Plate 43). The pots were squared, with diamond panels, above a chamfered crown cap (Plate 43). The ridge purlins of the roof were socketed into the chimney stack. To the west the ridge was supported purely by the attached rafters, the western end resting only partially on the lower scantling northern valley rafter, which overlay Roof C (Plate 43). The southern valley rafter terminated prior to the ridge, where it butted an adjacent rafter.

Plate 43: Roof A, with triple-pillared chimney-stack and remodelled purlins and rafters

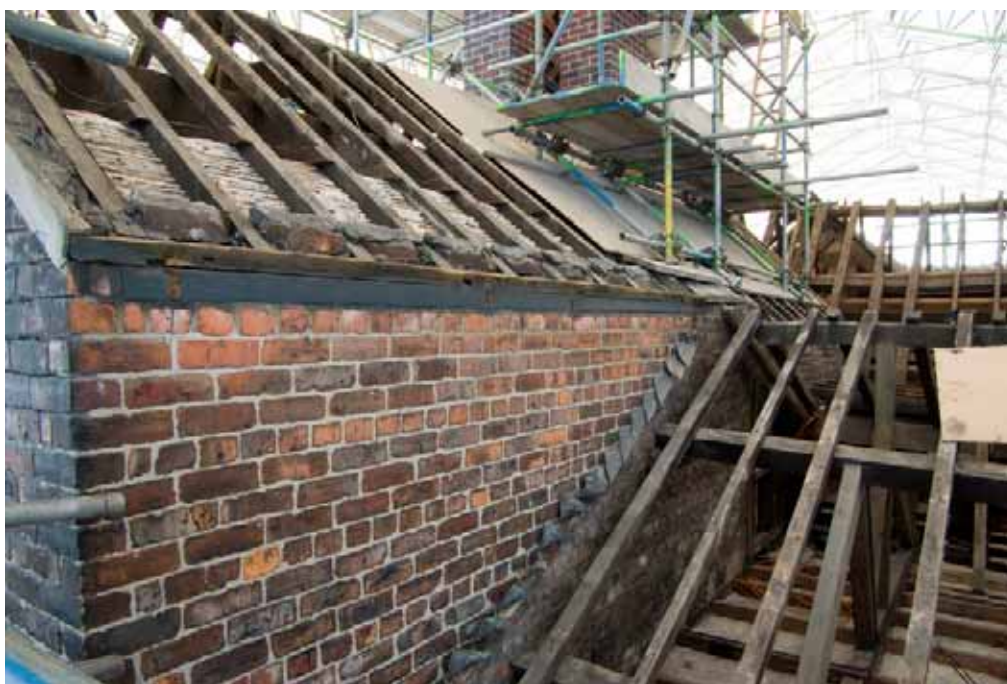
Plate 44: Relationship between Roofs A (left) and B (right)

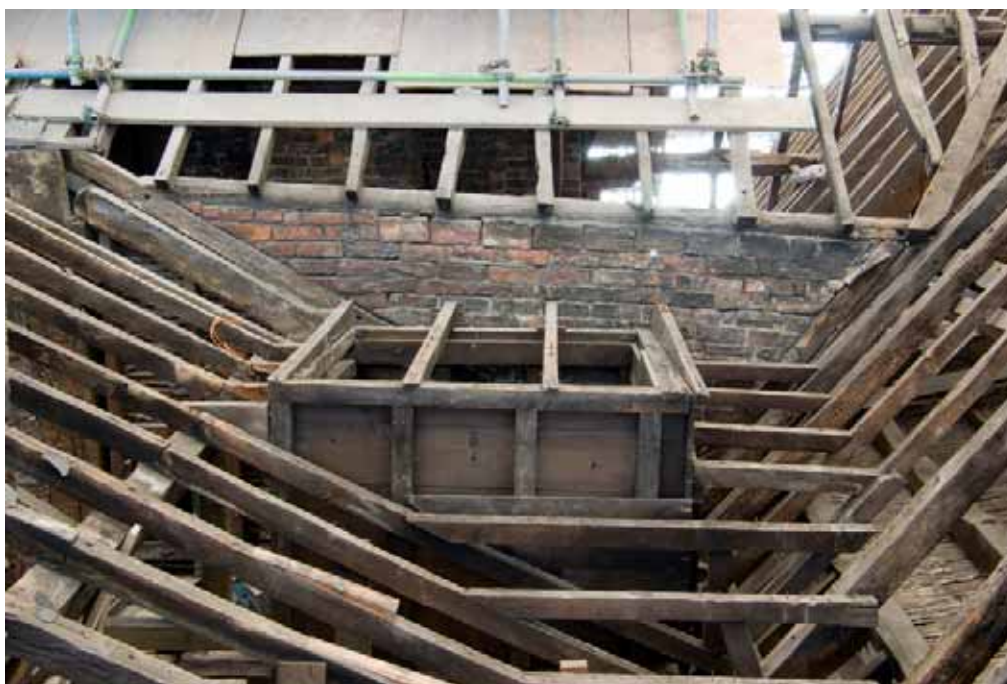
tank, which was housed in the valley between Roofs **B** and **C** (Plate 45). At their base, the rafters on this pitch were also strengthened, being sprocketed onto the wall plates at the northern end, and onto the lower purlin of Roof **C**, further to the south (Plate 45).

*Plate 45: Timber water tank between Roofs **B** (left) and **C** (right)*

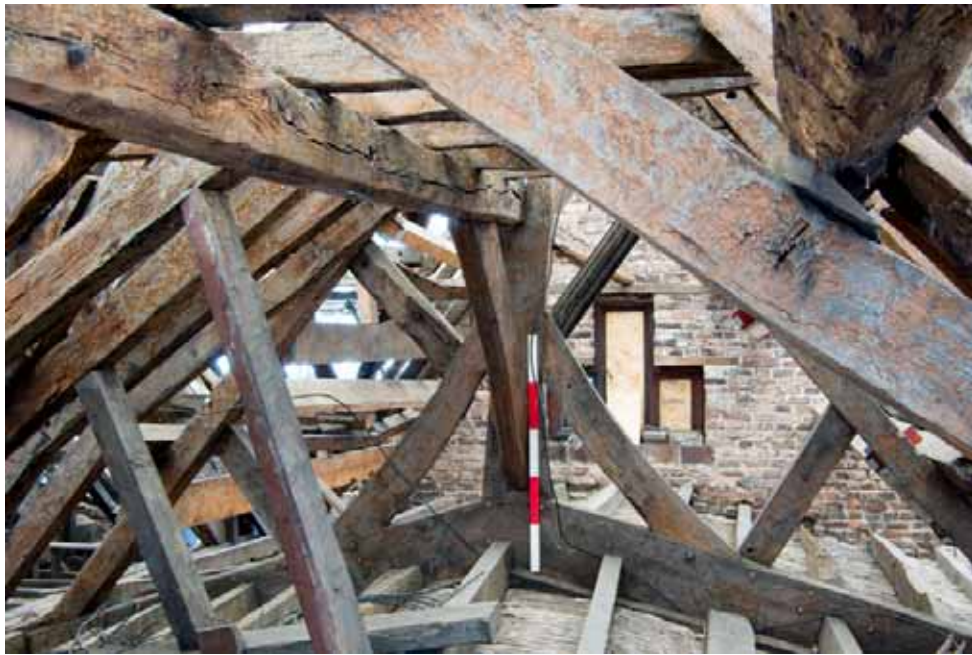
4.4.9 The roof retains two cranked tie-beams, each carrying a central crown-post, held in position by down-braces. Those on the southern truss are convex, whilst to the north they are concave (Plate 46). The foot of each crown-post is splayed to accommodate a straight longitudinal brace to a collar purlin, which is clasped by the jowled head of the crown-post (Plate 46). Both crown-posts retained evidence for tenons at their heads, for jointing to a collar above. At the northern end of the roof the collar purlin is socketted into the brick gable. However, it retains a notched lap joint adjacent to the wall (Smith 1995, Fig 12), denoting the position for a further arched brace, which would have been attached to a crown-post in the position of the present brick gable.

Plate 46: Northern truss, clasp crown post, Roof C

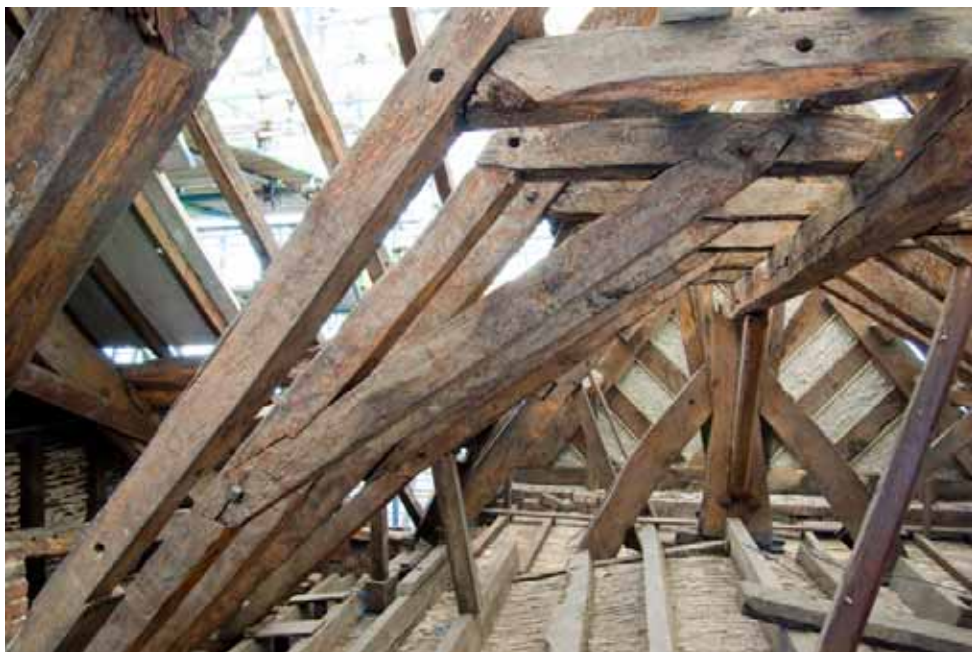
4.4.10 Between the two trusses the roof retains its original form, comprising seven lower scantling common rafter trusses, the collars of which were carried on the collar purlin (Plates 46 and 47), but were also braced to each rafter by straight 'soulaces' (Plate 47). These are joined with notched oblique lap joints, on differing faces (Plate 47), with the collars having similar joints to the rafters, whilst the rafters of each pitch have a simple halved lap joint at the apex of the roof (Plate 48), all joints being single-pegged (Plates 47 and 48). It is noteworthy that this original form of the roof had neither a ridge nor side purlins, with the longitudinal stability being provided solely by the collar purlin.

Plate 47: South truss, with detail of rafter, collar, and soulace construction, Roof C

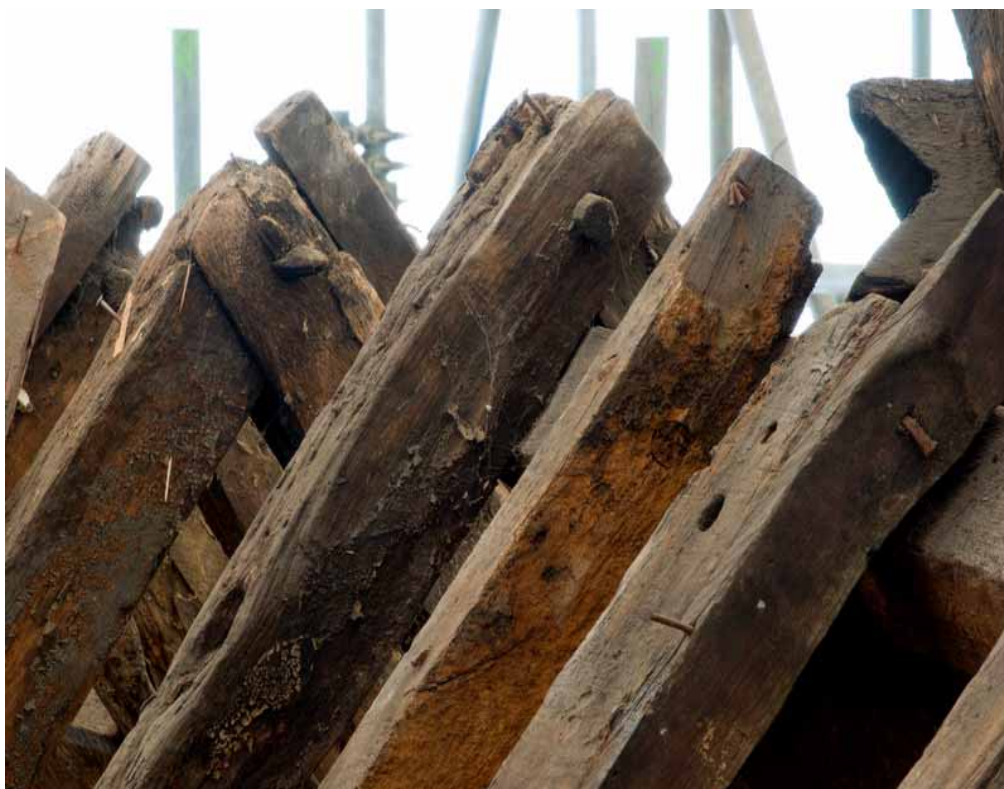
Plate 48: Halved and pegged common rafters, Roof C

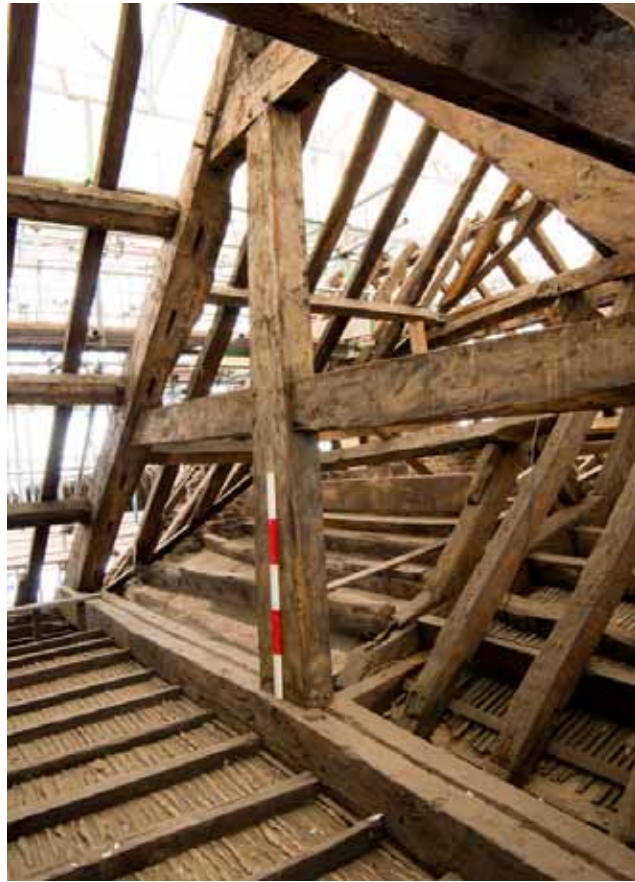
- 4.4.11 The northern two rafters appear to have been cut too short for their intended role, and had small extensions added, presumably prior to the erection of the frame, using stop-splayed scarf joints (Plate 49). Many of the timbers of the common trusses bear carpenter's assembly marks. It would appear that the series was numbered from the southern end, with the trusses having their upper faces on the northern side. However, the trusses appear not to have been arranged in the order that they were numbered, with the sequence apparently being I, II, VII, VIII, V, X, and VIII. These trusses could easily have been positioned once the wall frame below had been erected, and it is therefore likely that their final position was unimportant. The wall plate was jointed immediately beneath the northern extant crown-post truss, using a splayed scarf, with over-squinted abutments (*ibid*).

Plate 49: Eastern truss, Roof D, with scarfed common rafters of Roof C behind (bottom right)

- 4.4.18 Unfortunately, no access was possible to examine the detail of the joint between this truss, and the perpendicular truss of the earlier Roof **C** to the immediate east (Plate 49). However, it appears to comprise a relatively large-scantling trimmer to a ceiling joist of Roof **C** (Plate 49).

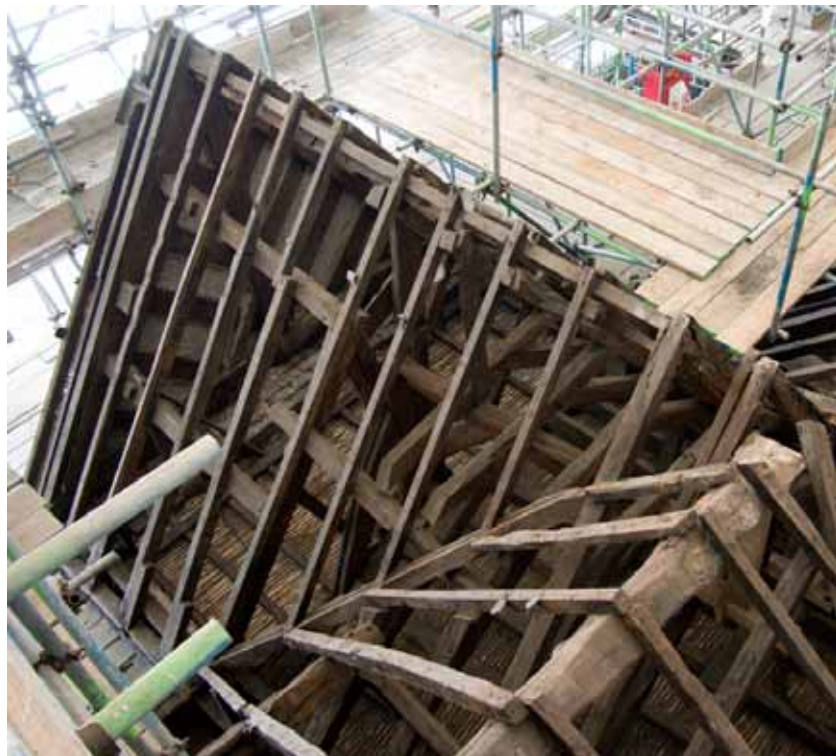
- 4.4.12 The southern three rafters between the trusses have been remodelled with late jack rafters replacing the upper elements, and forming part of a southward extension of the roof, which had a low-scantling ridge and two side purlins added to the earlier structure (Plate 50). These were trenched into short principal rafters which were added to the crown-post truss (Plate 51), rising to only the height of the upper purlin. Additional braces to the upper purlin and ridge were also bolted with an iron plate to horizontal timber pads below (Plate 51). The northern part of the roof also had been heavily remodelled, again with two side purlins and a re-used ridge purlin being inserted. The replaced square-section rafters were attached to the ridge with large round-headed nails (Plate 52).

Plate 50: Remodelled southern part of Roof C

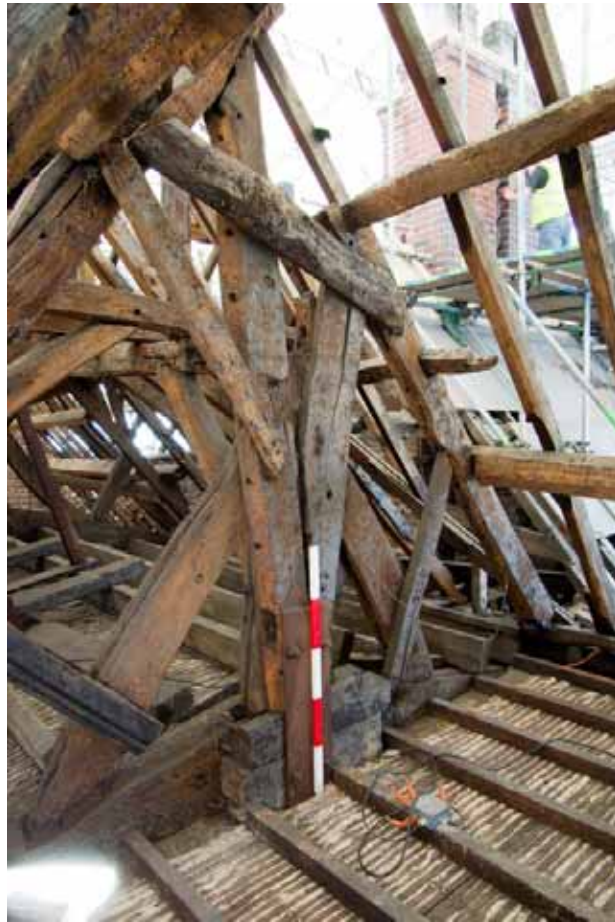
Plate 51: Remodelling of southern truss, Roof C, with inserted short principal rafters

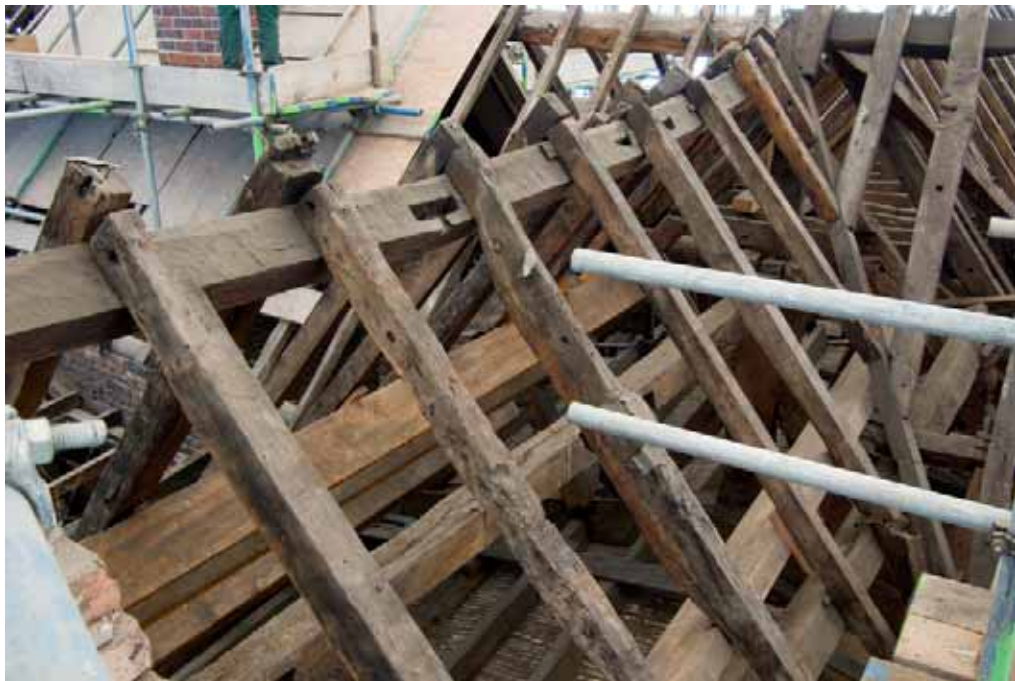
Plate 52: Re-used ridge purlin and common rafters, northern part of Roof C

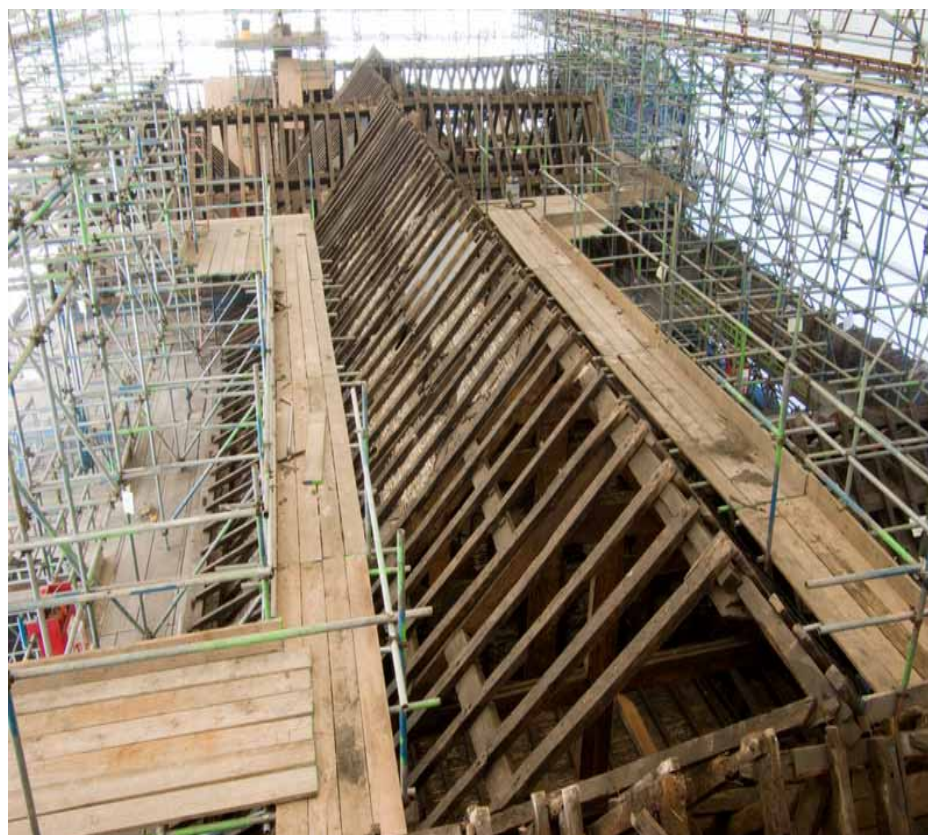
Plate 53: General view of stripped Roof D, with sprocketing to southern parapet

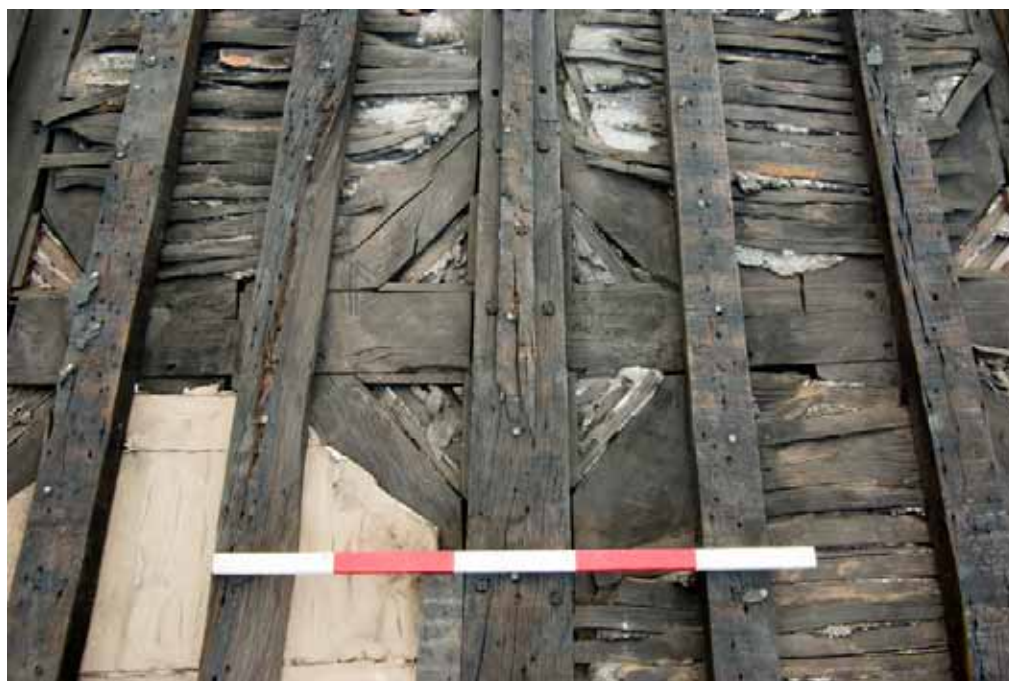
- 4.4.15 The carpentry of the purlins and panels comprised single-pegged mortice and tenon joints (Plate 54), with the exception of the longitudinal joints between purlins. That observed on the ridge purlin had a splayed scarf joint with bridled and squared abutments, the evidence for the bridle comprising a peg below the splay, which would have been redundant without the internal bridling (Plate 55).

Plate 54: Pegged jointing of decorative timber panels on Roof D

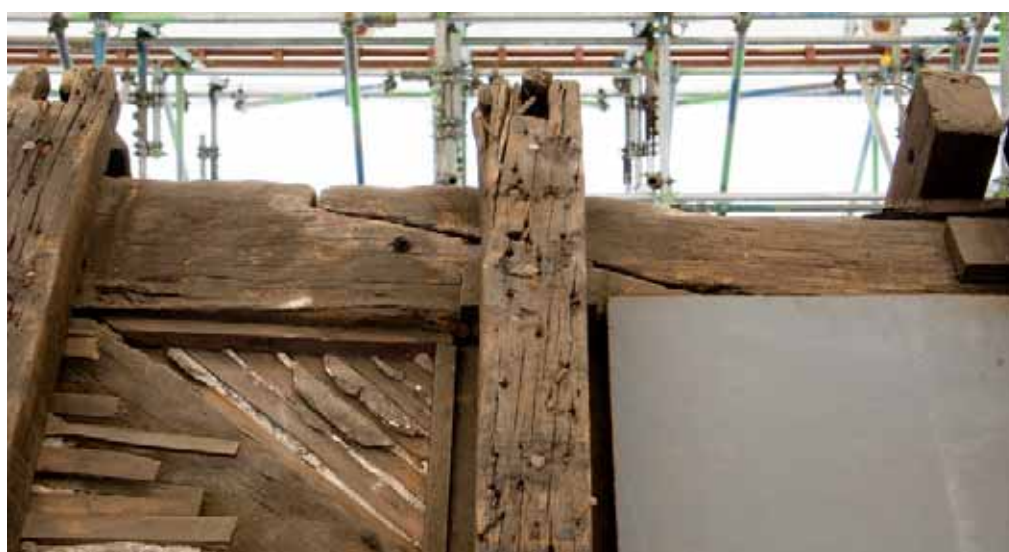
Plate 55: Bridled scarf joint in ridge purlin (Roof D)

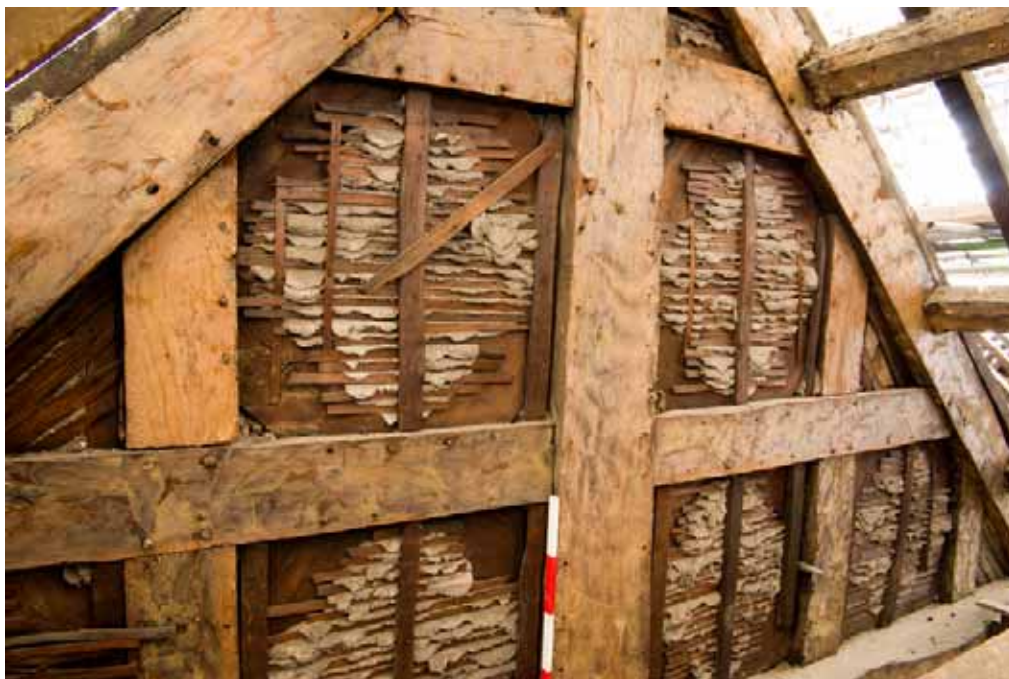
Plate 57: Lower face of truss forming Dais in Great Hall (Roof D)

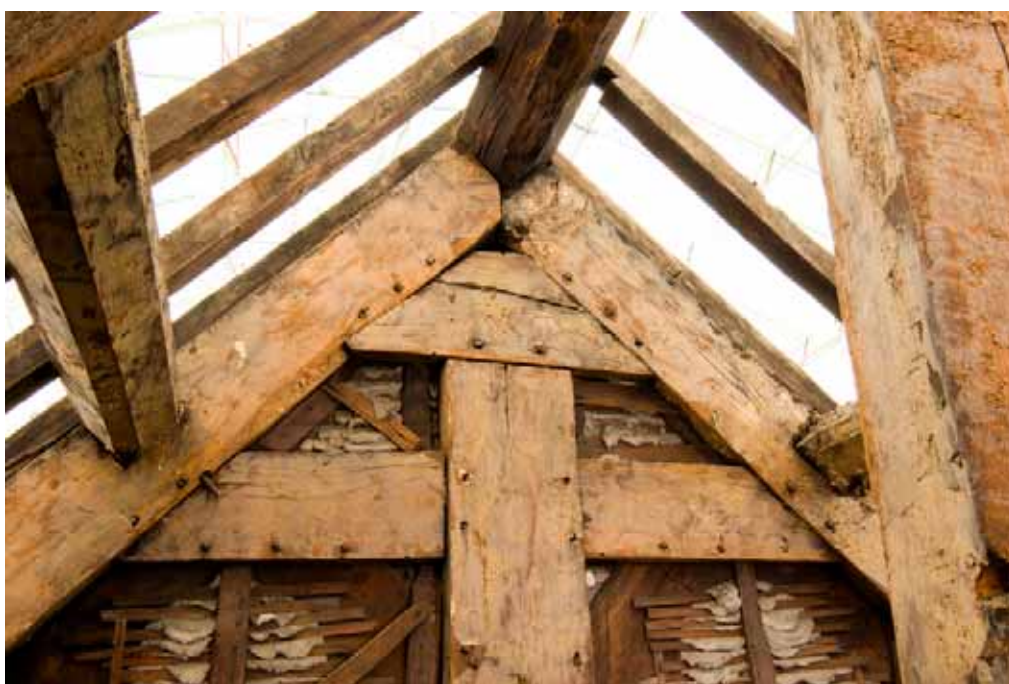
Plate 58: Saddle within truss construction, and pegging of decorative panelling (Roof D)

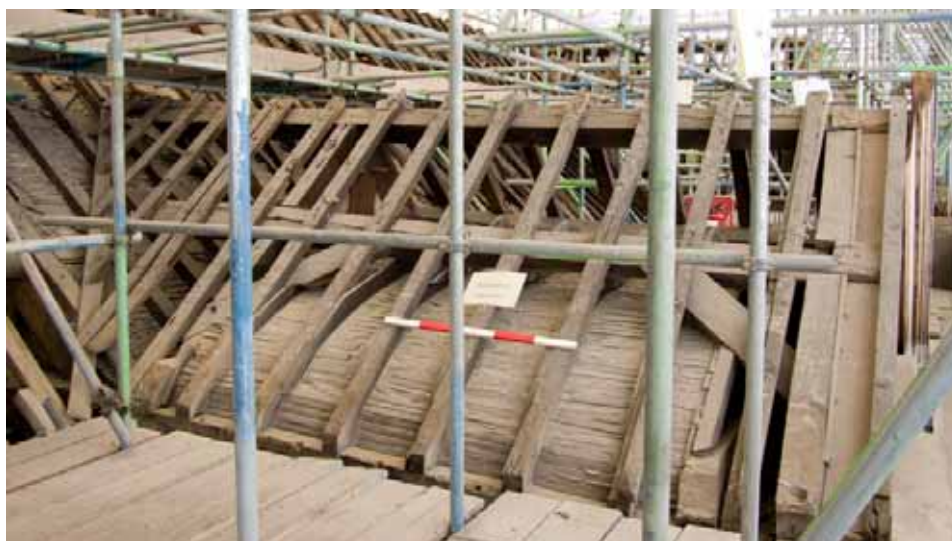
large nails (Plate 59), with those on the eastern side oversailing those to the west.

Plate 59: Roof E, with king-post truss either end, and vaulted ceiling

4.4.21 The ceiling below was barrel-vaulted, and formed of lath and plaster, the runners for which were three-pieced, and essentially comprising slender arch-braces to the rafters (Plate 59). Either end of the ceiling met the tie-beams of the roof above (Plate 60).
