HOLLIES FARM, SCHOOL LANE, HARTFORD,

**CHESHIRE WEST AND
CHESTER**

Archaeological Building Investigation

June 2010

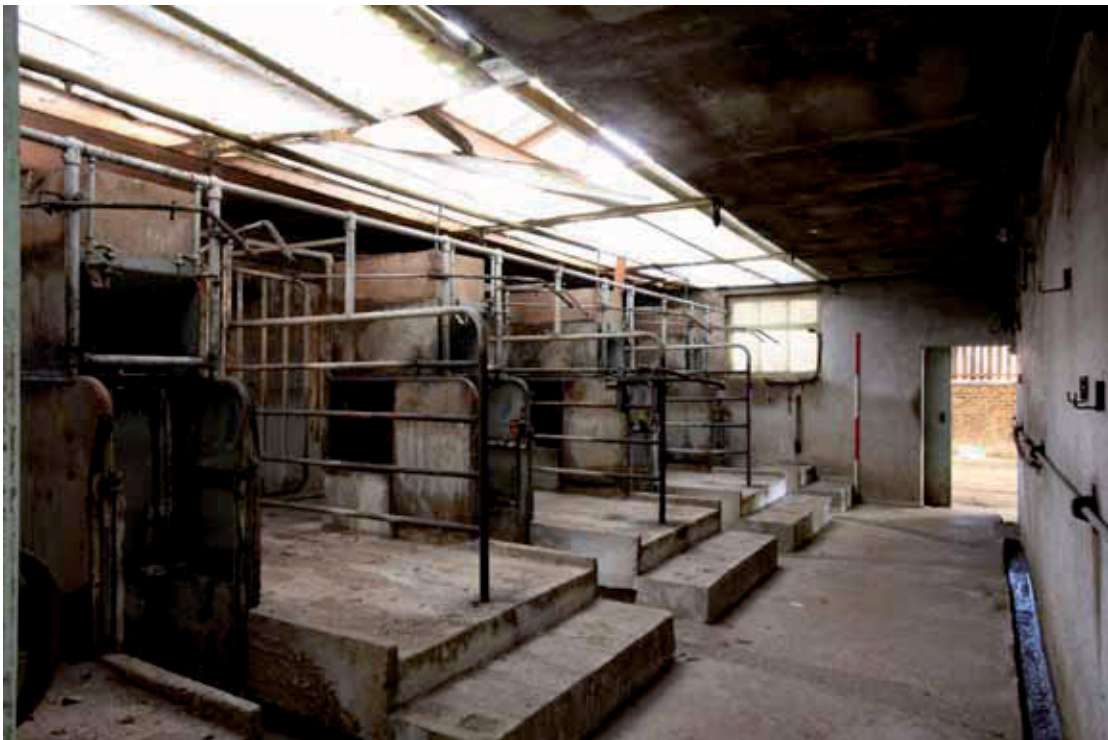
- 4.5.14 The double doors lead into a preparation room. It has rendered walls and a concrete floor, and metalwork in the floor suggests that a large table or piece of machinery has been removed. A sliding door in the right corner of the room leads through into a milking shed (Plate 33). A walkway and open drain are to the right of the room, with seven milking bays to the left. The far elevation contains a cattle entrance into the milking bays, with a further entrance at the end of the walkway, a covered window is present between these. At the far end of the building is an entrance into Building 1 with a sliding door; this appears to be a modern insertion. A window and a door in the dividing wall between this building and Building 4 have been covered, although not totally blocked.

Plate 33: Milking apparatus within the rear room of Building 3

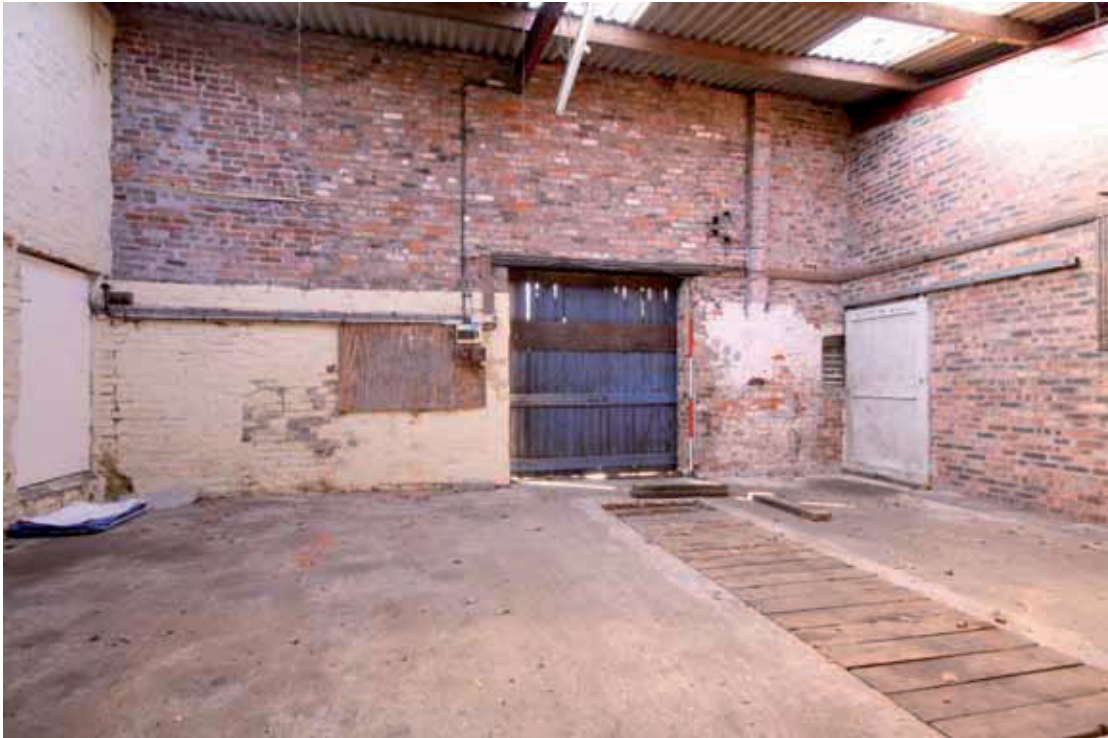
- 4.5.15 **Building 4:** is a maintenance room with a covered inspection pit in the floor, presumably for the maintenance of vehicles (Plate 34). It has an access door to every wall, with the only external face having a large timber sliding door. The majority of this building is made up from the re-used structure of Building 2. Building 2 is incorporated into the external wall, the dividing wall between Buildings 3 and 4, and also part of the rear wall of the building (Figure 11). There is a single blocked doorway on the right of the external elevation and the large sliding door has removed another. There is evidence of a door jamb in the rear elevation, although this has been abutted by modern brickwork and is only evident as a singular sandstone block in the lower door jamb.

Plate 34: Interior of Building 4 with inspection pit in floor

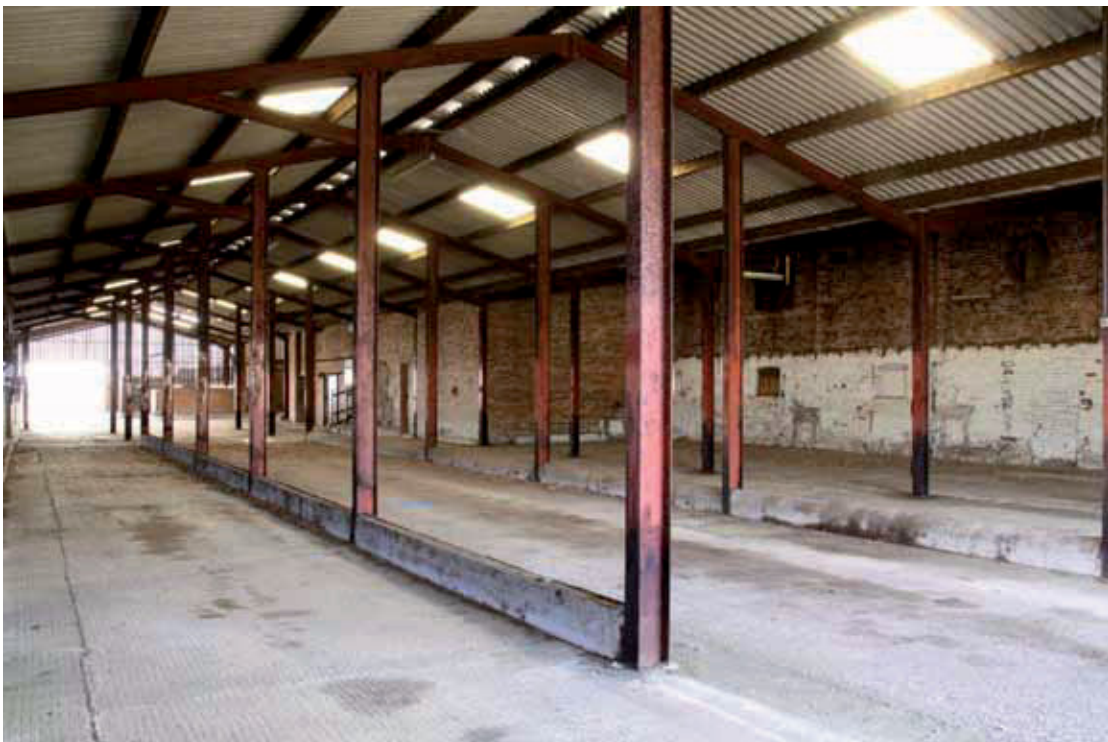
- 4.5.17 **Building 6:** the large, long, modern high-roofed cattle shed with several bays, incorporates parts of the earlier structures on site. It is supported on an I-sectioned beam frame, with an asbestos and plastic corrugated roof throughout (Plate 35). Where modern walls have been added, they are mostly of brick to half-height with wooden shuttering above. Large sliding timber doors are present to each gable end and the floors are of impressed concrete. The remnants of a row of I-section beams evident within the floor suggests that even this modern building has undergone alterations in form or function. Buildings 1, 3 and 4 all have entrances in to this building. To the south-east end are two large concrete block storage areas for either haylage or silage.

Plate 35: Interior of Building 6, a modern high-roofed cattle shed

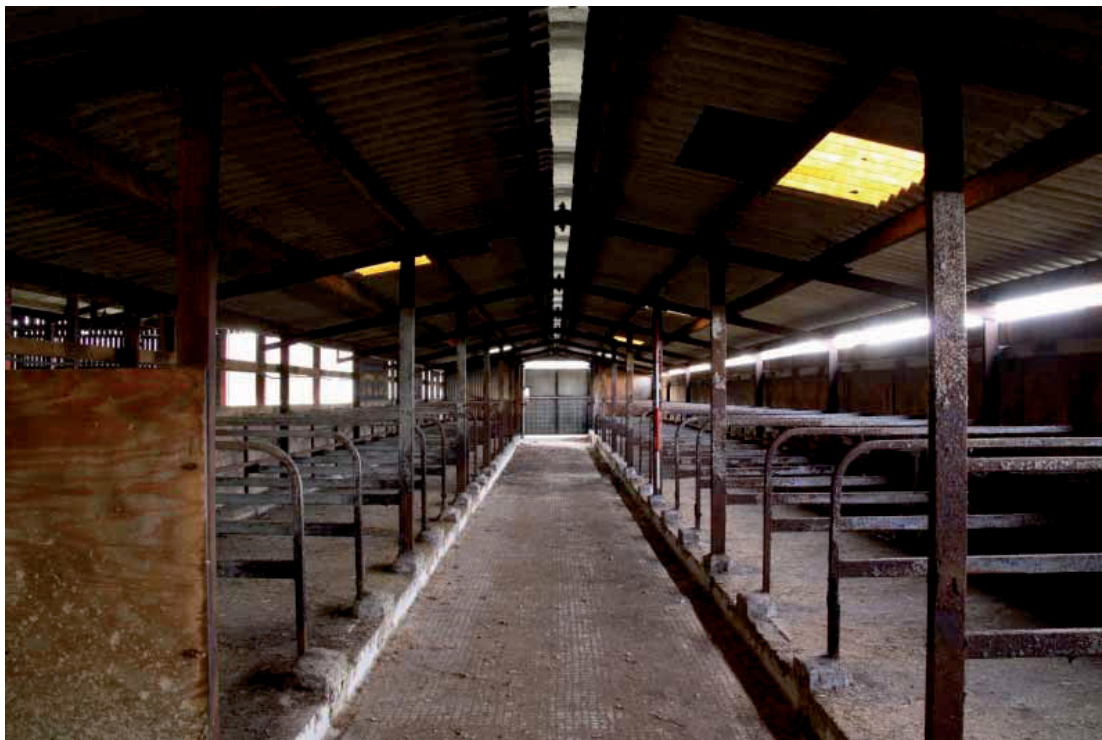
- 4.5.19 **Room 6.2:** this is a small cattle shed, an almost scaled down version of the larger cattle shed that is the majority structure of Building 6 (Plate 36). It has a metal frame with timber/woodchip panelled sides. It is divided into cattle stalls using tubular metal stall partitions.

Plate 36: Smaller cattle shed, Room 6.2
