**Steer Bank Farm
Harworth
Nottinghamshire**

Historic Building Record (Level 3)

CA Project: MK0926

CA Report: MK0926_1

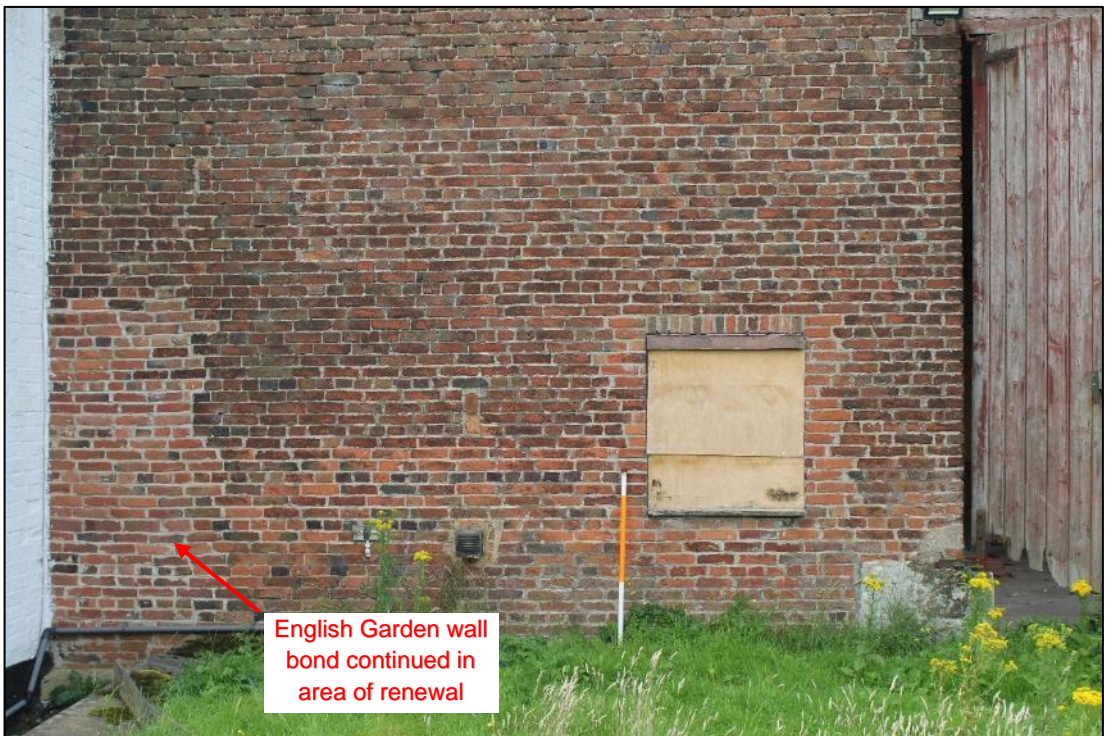
Photo 3: Detail of brickwork, Building A, northern elevation

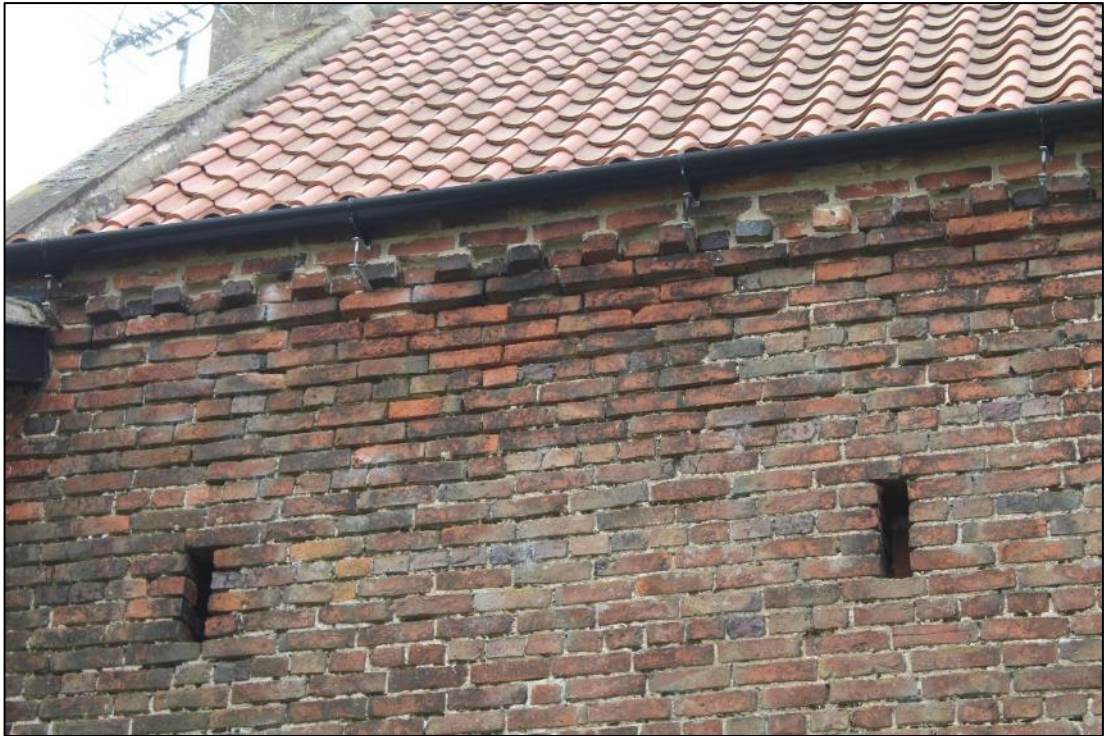
Photo 4: Dentils beneath roof eaves, Building A, northern elevation

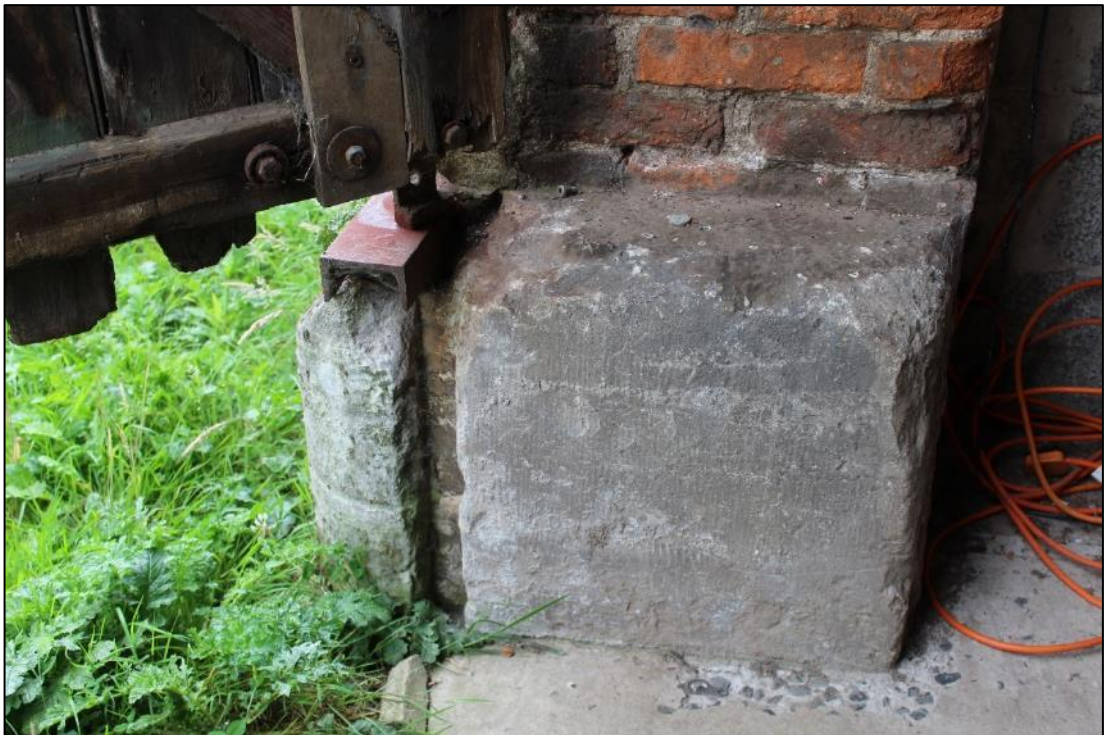
Photo 6: Plank groove within stone base, northern threshing doors of Building A

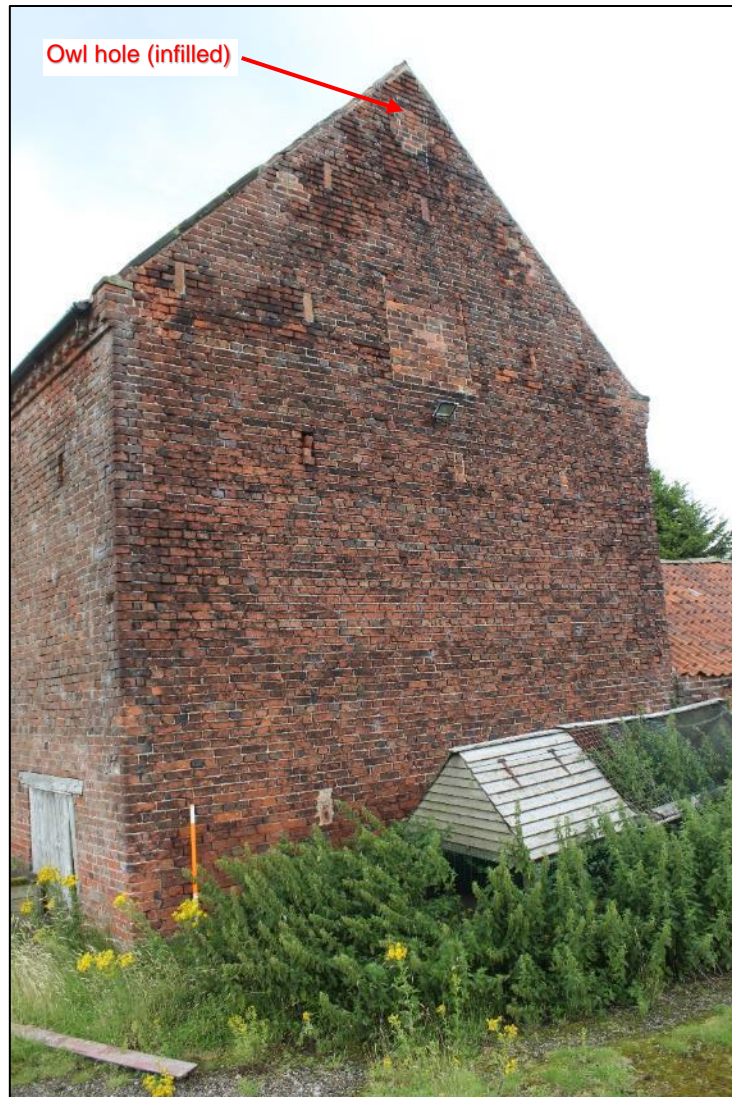
Photo 8: Building A, western elevation

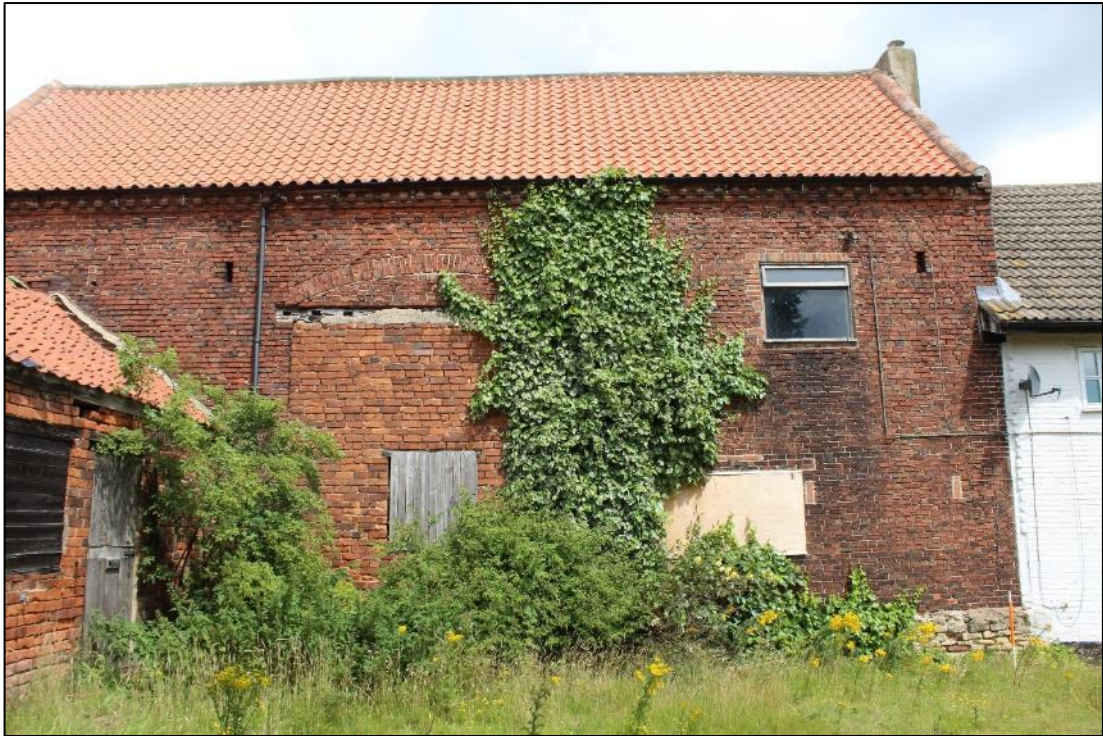
- 4.8. The southern elevation of the building (Photo 9) exhibits a considerable degree of alteration, the principal instance of which is the infilling of the southern threshing doors with red brick. The size of the infilled brick is larger than the prevailing brickwork of the barn and appears to have been installed in the 19th or early 20th century, likely signalling the cessation of the threshing function of the building. Above the infill is a large timber lintel that incorporates three visible mortices that indicate that the timber was likely repurposed from an earlier building (Photo 10).

Photo 9: Building A, southern elevation

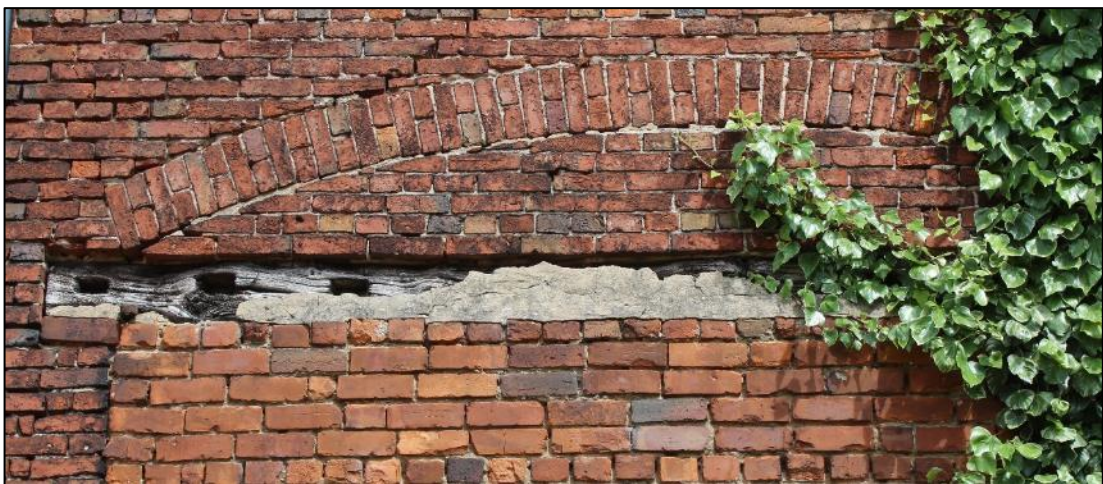
Photo 10: Detail of timber lintel above southern threshing door infill

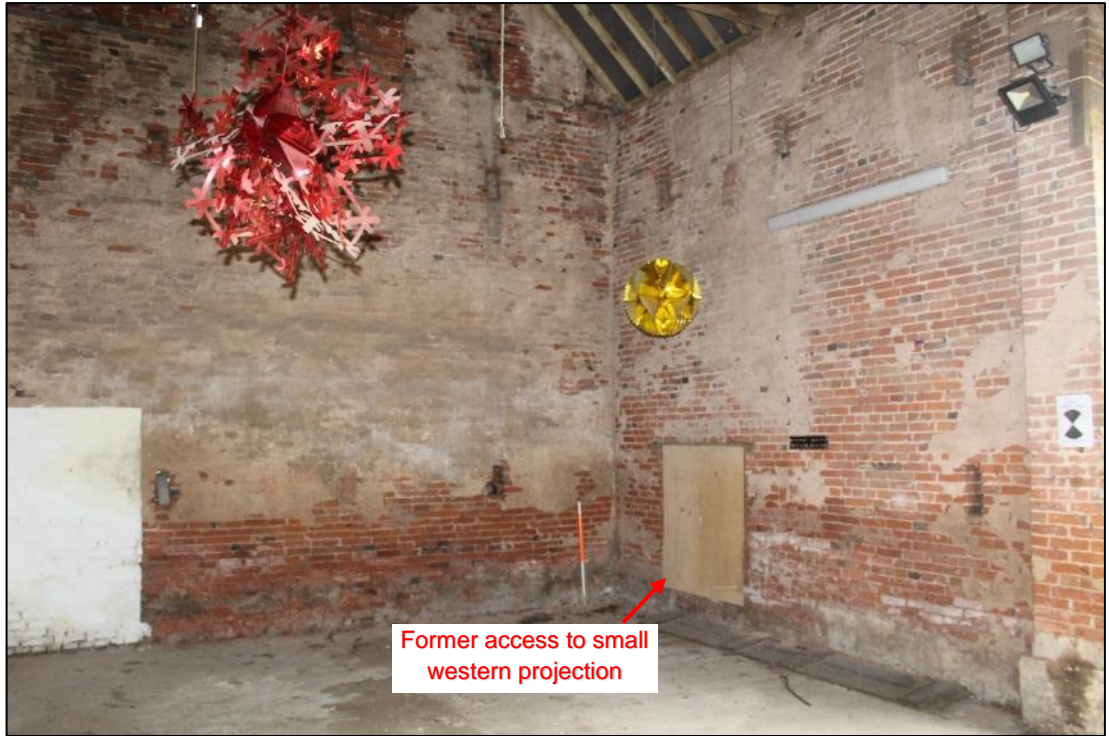
- 4.11. The interior of the building comprises a single, large open space, representative of a threshing barn of its type (Photo 11). The symmetrical proportions of the room are, however, interrupted by the insertion of an extension to Building B, which has breached the ground floor portion of the eastern two bays of Building A, and comprises an enclosed concrete block element with no access between buildings (Photo 12). This was presumably constructed as a cheap alternative to extending the existing Building B outwards through the erection of new external walls, and a possible reflection of the declining fortunes and lack of functional importance of Building A at the time. The appearance of the concrete blocks suggests that the breach into Building A occurred during the mid to late 20th century.

Photo 11: Overview of western extent of Building A interior

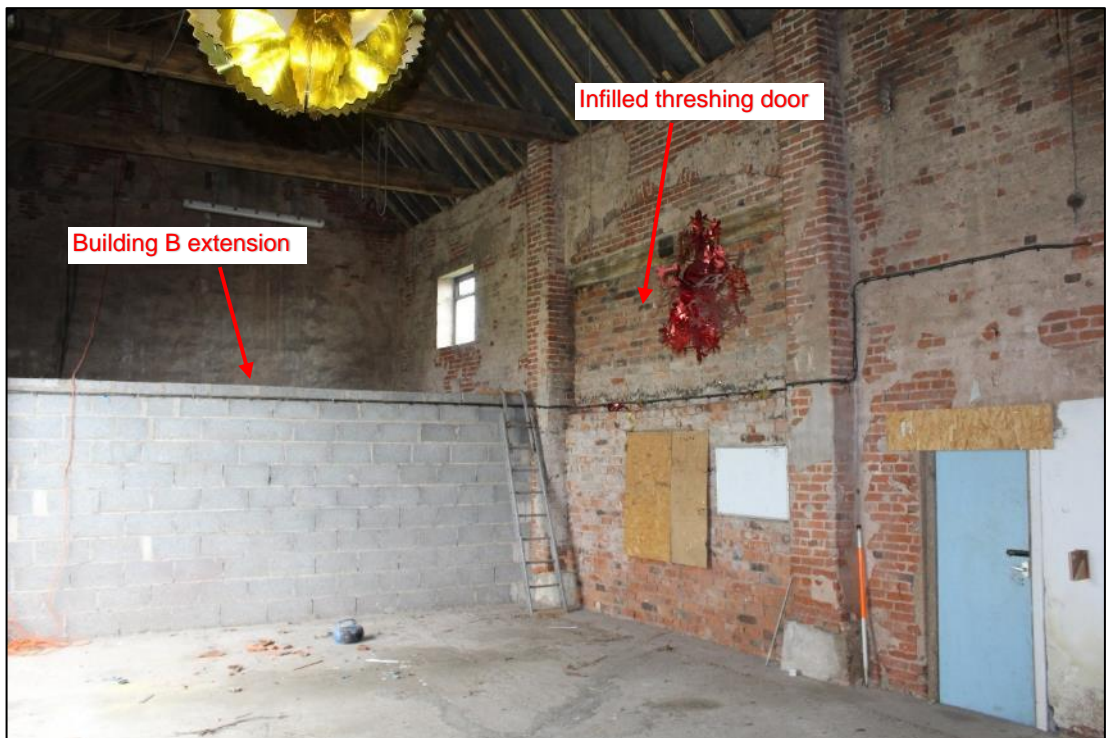
Photo 12: Overview of eastern extent of Building A interior

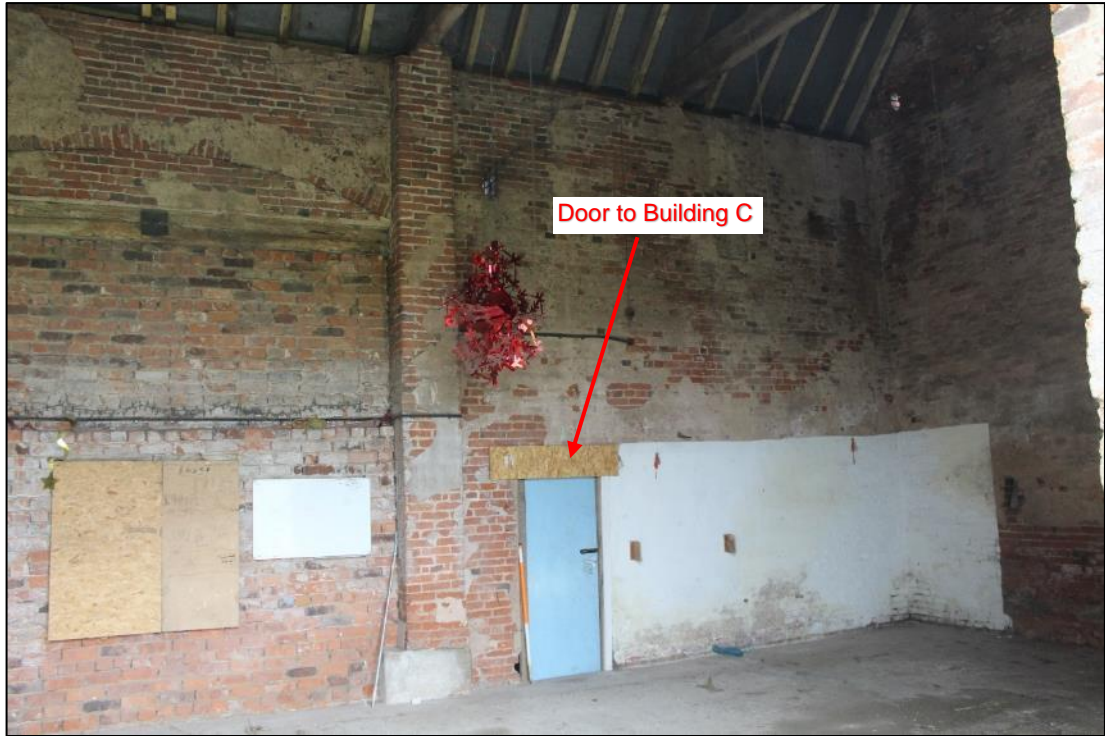
- 4.13. The visible brickwork within the building evidences much variation, partially due to deteriorating render covering portions of the wall alignments and also alterations to the brickwork itself. This is clearest in the portion of the southern elevation where the former threshing door has been infilled (Photo 14). The brickwork of the infill is clearly different in tone and size to the original materials and, despite the attempt to conform to the prevailing English Garden Wall bond, the brickwork identifies itself as a later addition.

Photo 13: View towards the southern wall within Building A

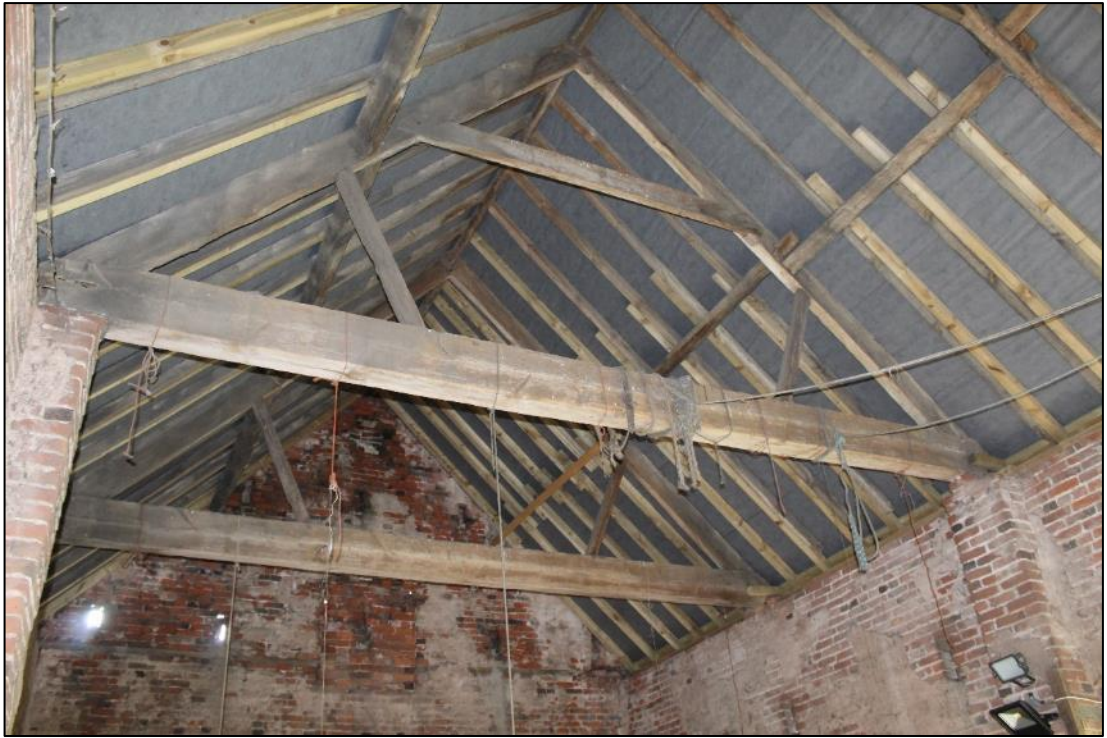
- 4.14. The roof of the building comprises a dual pitch structure of timber construction featuring a comparatively standard configuration of rafters, purlins, ridge beam and principal rafter trusses (Photo 15). The roof incorporates four timber trusses, each

Photo 15: Overview of roof structure, Building A

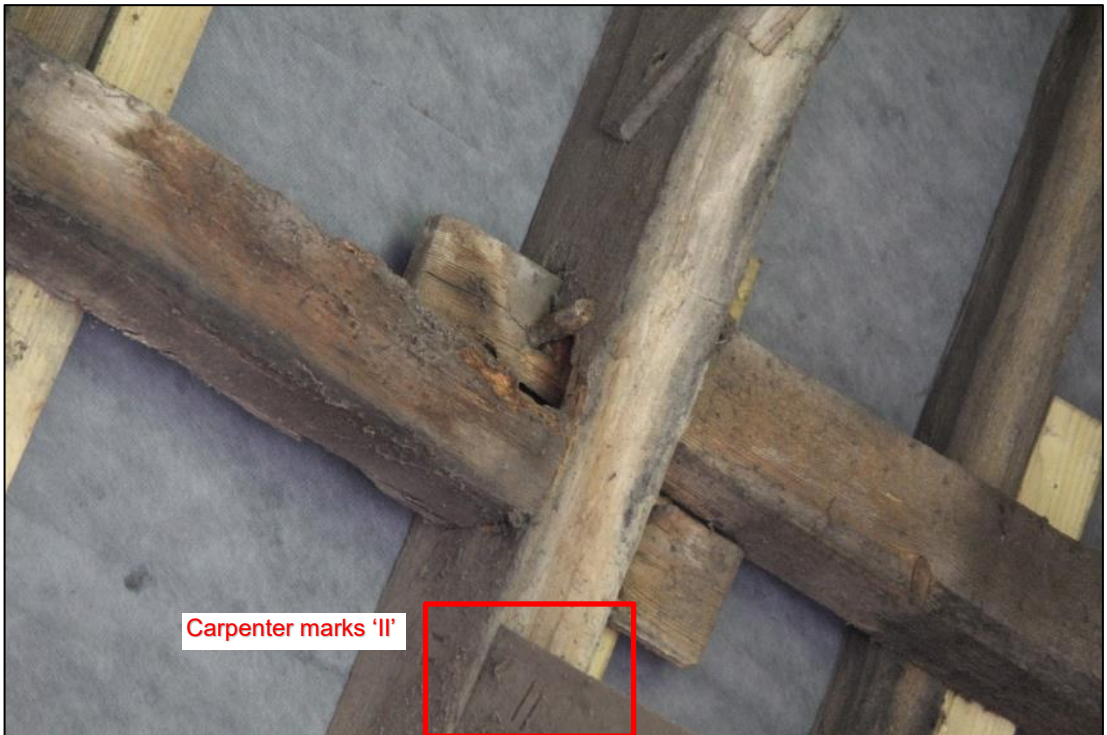
one featuring raking struts, tie beam, collar, principal rafters. The purlins are threaded rather than trenched and overlap, secured by a timber peg (Photo 16), with each truss separated by an individual purlin piece. The configuration of roof trusses signals a five bay building, with a central threshing floor (Fig. 12).

Photo 16: Threaded purlins on southern principal rafter of truss II

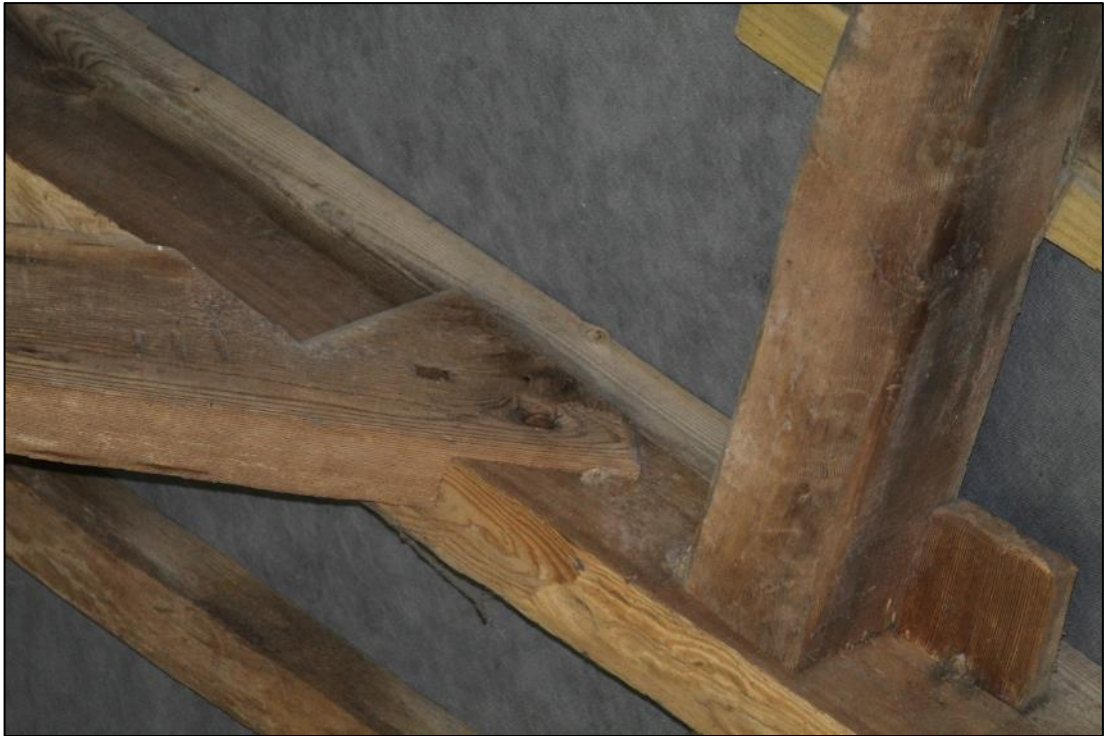
- 4.15. Each truss is jointed and pegged; most joints are not visible in their construction, however, the jointing of the collars to the rafters incorporates half-dovetail lap joints to secure the two members together (Photo 17). This method of jointing is stronger than a simple angled half-lap joint and likely required more skill to produce. There is clear evidence for replacement members, particularly of the rafters and purlins (i.e. the more slender elements of the roof structure). The exterior appearance of the roof tiles also suggests a comprehensive programme of repair or replacement. As such, the trusses may be the only original elements of the roof structure remaining.

Photo 17: Detail of half-dovetail lap joint between collar and rafter of truss II

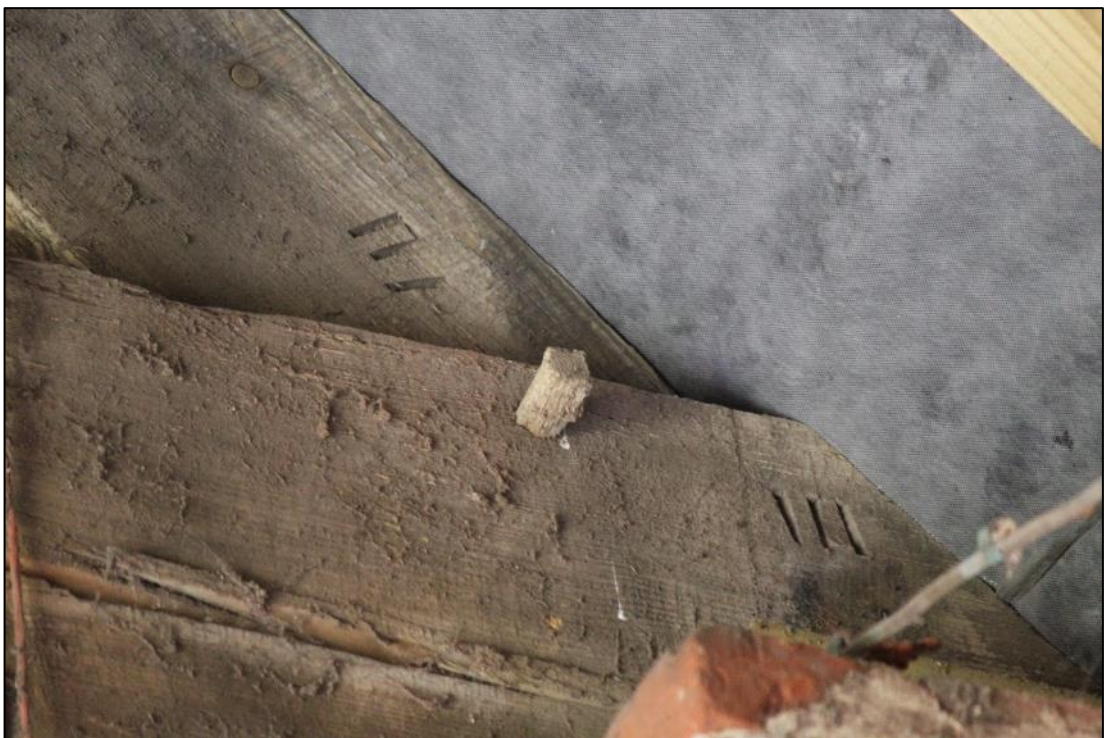
Photo 18: Detail of carpenter marks 'III' on truss III

- 4.16. Carpenters marks were observed on two of the trusses. Closer inspection may reveal further marks, however, visibility from the ground only allowed for a view of two areas of marks. A marking of 'II' was observed at the joint between the southern angled brace and rafter, on the second truss from the western end of the barn (Photo 16). A second set of mark was observed on the third truss from the western end of the barn, which depicts markings of 'III' on both the tie beam and rafter (Photo 18). The observable sequence of carpenter marks makes it possible to extrapolate the likely sequence of trusses, even in the apparent absence of any other visible carpenters marks. The westernmost truss was likely marked as 'I' whilst the easternmost truss was likely marked 'IIII' (see Fig. 10).

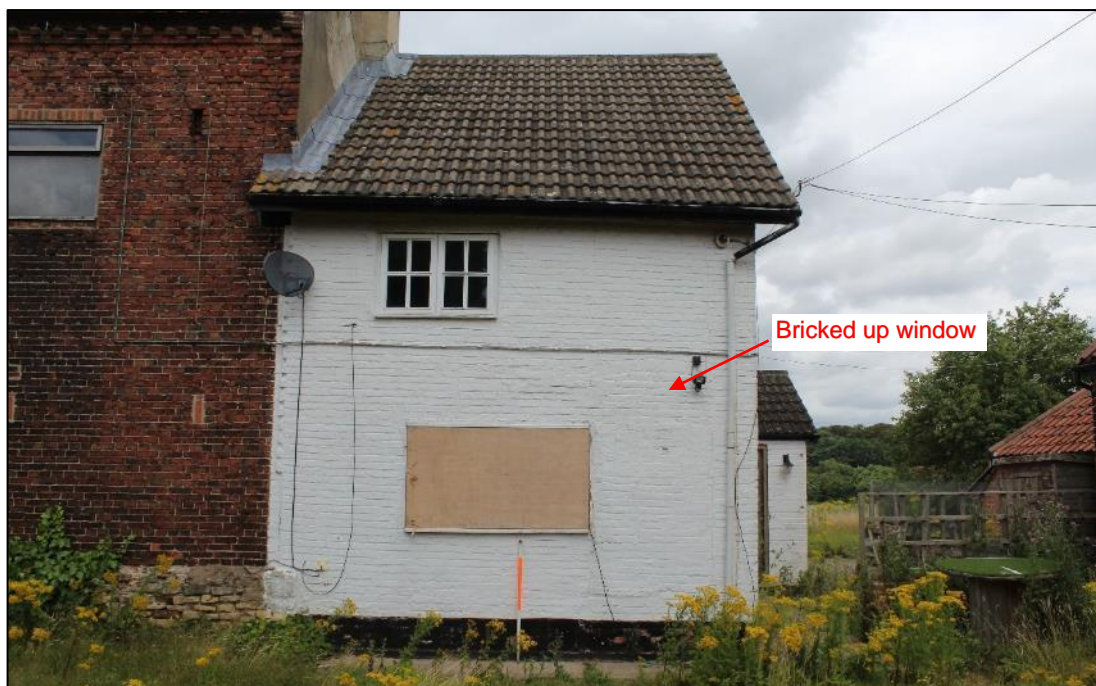
Photo 19: Building B, southern elevation

- 4.17. Building B is abutted to the eastern gable of Building A. The farmhouse comprises a two storey configuration and incorporates three main elevations (north, east and south) with a further, small western elevation within the projecting portion. The southern elevation (Photo 19) aligns with the southern elevation of Building A and is crudely butted against the barn, as evidenced by the lack of skilful knitting in of the brickwork (Photo 20). The brick bond of the southern elevation is also inconsistent, where varying configurations of English Garden Wall bond are employed. The brickwork of Building B generally lacks the quality of Building A.

- 4.19. The southern elevation incorporates two window apertures and further, bricked up aperture, none of which suggest any degree of symmetry or regularity in their placement, suggesting a degree of alteration over time.

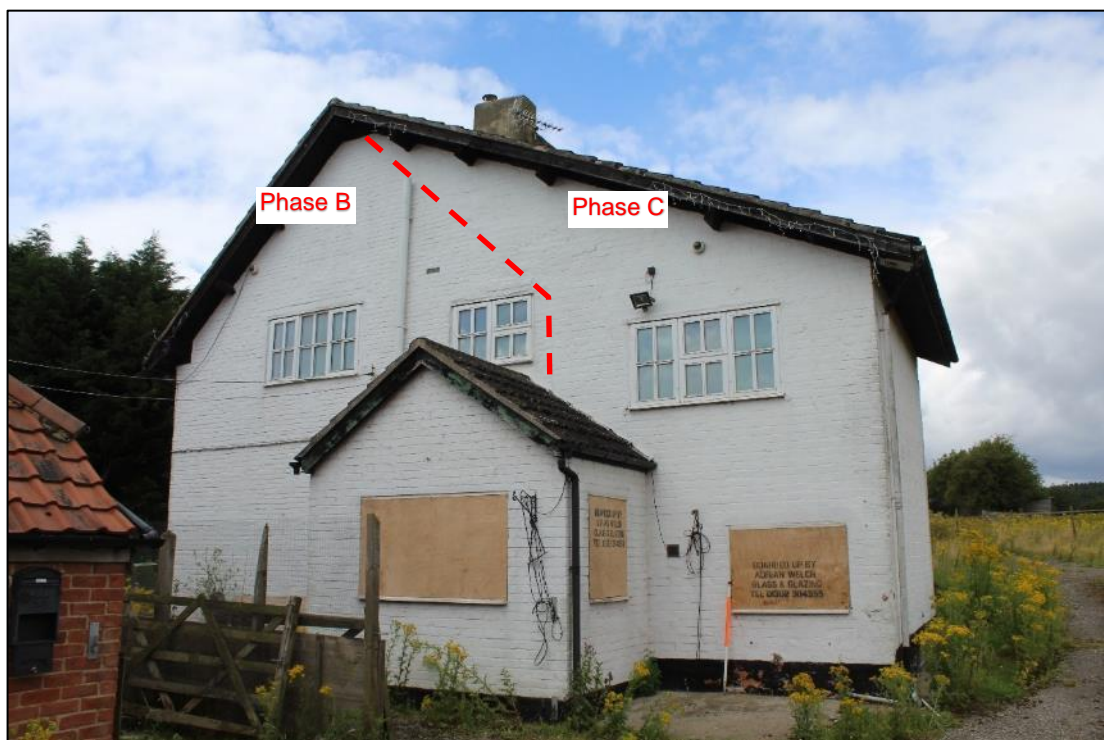
Photo 22: Building B, eastern elevation

4.20. The eastern elevation incorporates the building's wide gable end, with unequal roof pitch (Photo 22). The brickwork exhibits a clear difference in phasing where the earlier form of the farmhouse has been extended through constructing upon the former

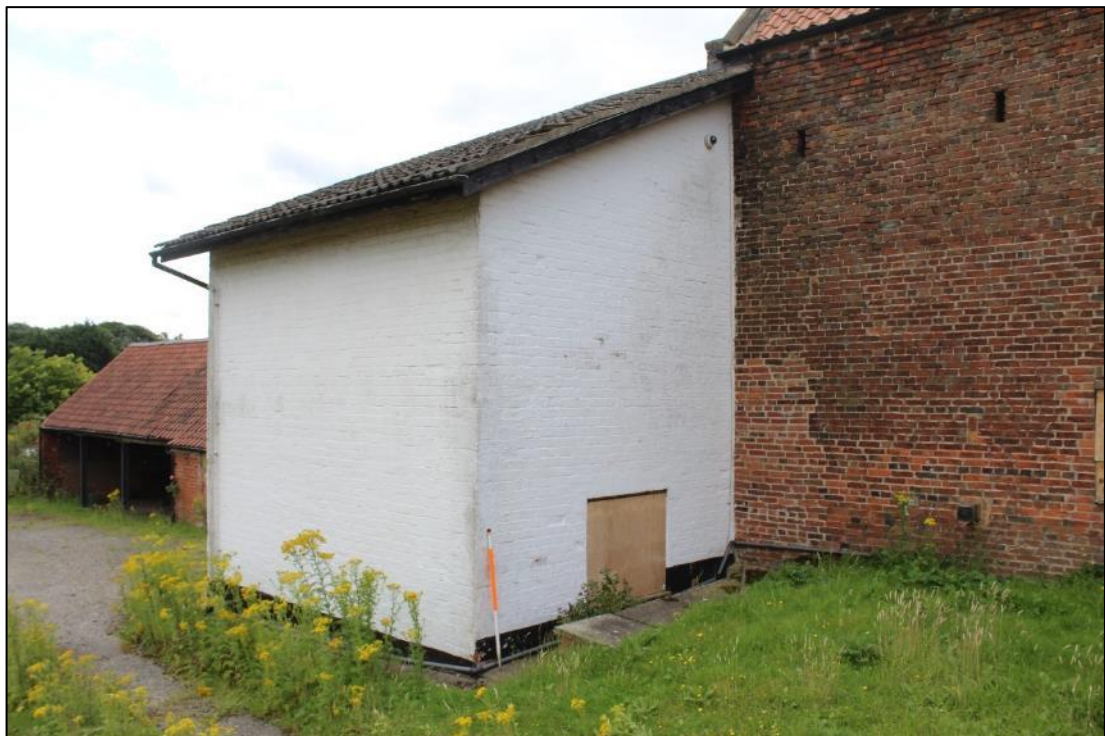
Photo 24: Building B, northern and western elevations

4.22. The northern and western elevations of the building comprise the later extension to the farmhouse. The projection is slightly lower than the earlier phase of the building and incorporates only one aperture on the western elevation but none on the northern

elevation (Photo 24). The projection first appears on the 1899 map (Fig. 5) and its appearance generally accords to this period.

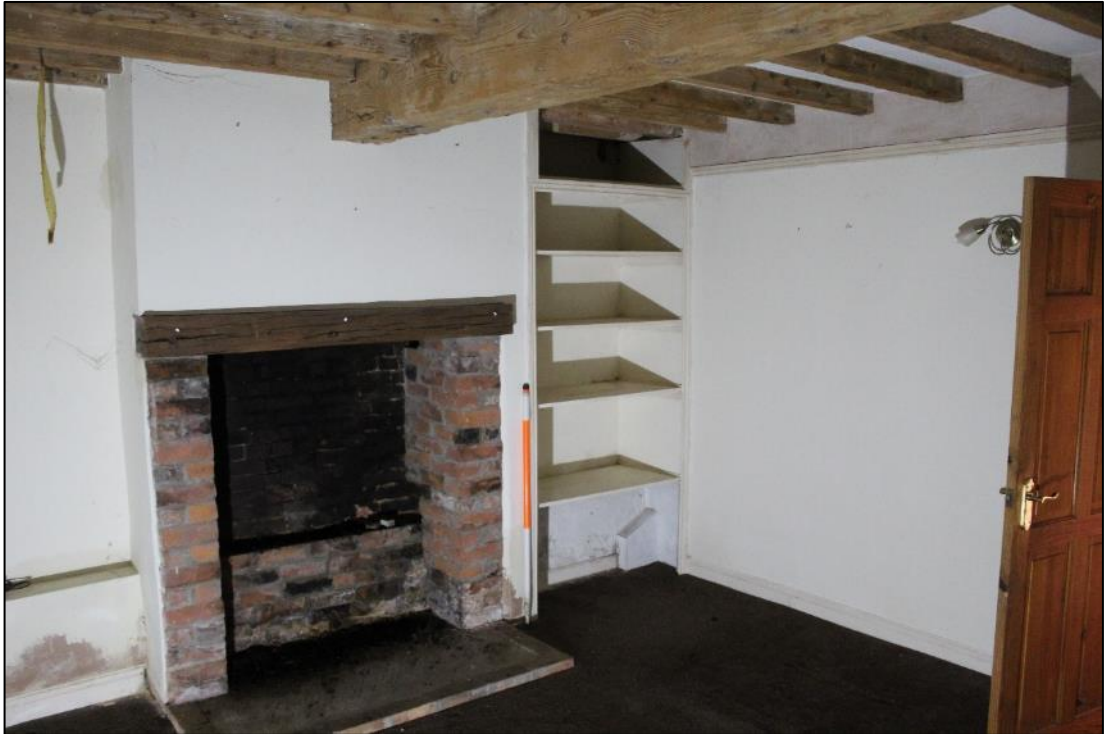
Photo 26: Overview of Room B3, looking north-west

- 4.24. Room B3 comprises the principal living room of the building (Photo 26). A brick fireplace is located centrally within a chimney breast on the western wall of the room whilst the ceiling incorporates a central bridging beam with joists extending to the north and south. The bridging beam appears to be historical in appearance and incorporates a visible carpenter's mark at its western extent (Photo 27). The mark is either a 'II' or else incorporates an additional angled mark (akin to a reverse 'lambda') that has also been documented as a possible mark representing '2' (Fig. 13). This suggests that the beam may have been repurposed from an earlier building, however, it is unclear whether it came from the neighbouring threshing barn, an earlier incarnation of Building B, or elsewhere entirely. The large size of the beam would

have made it difficult and expensive to transport large distances so it is likely to have originated within the locality somewhere. Certainly, the accompanying joists and their association with the bridging beam appear modern.

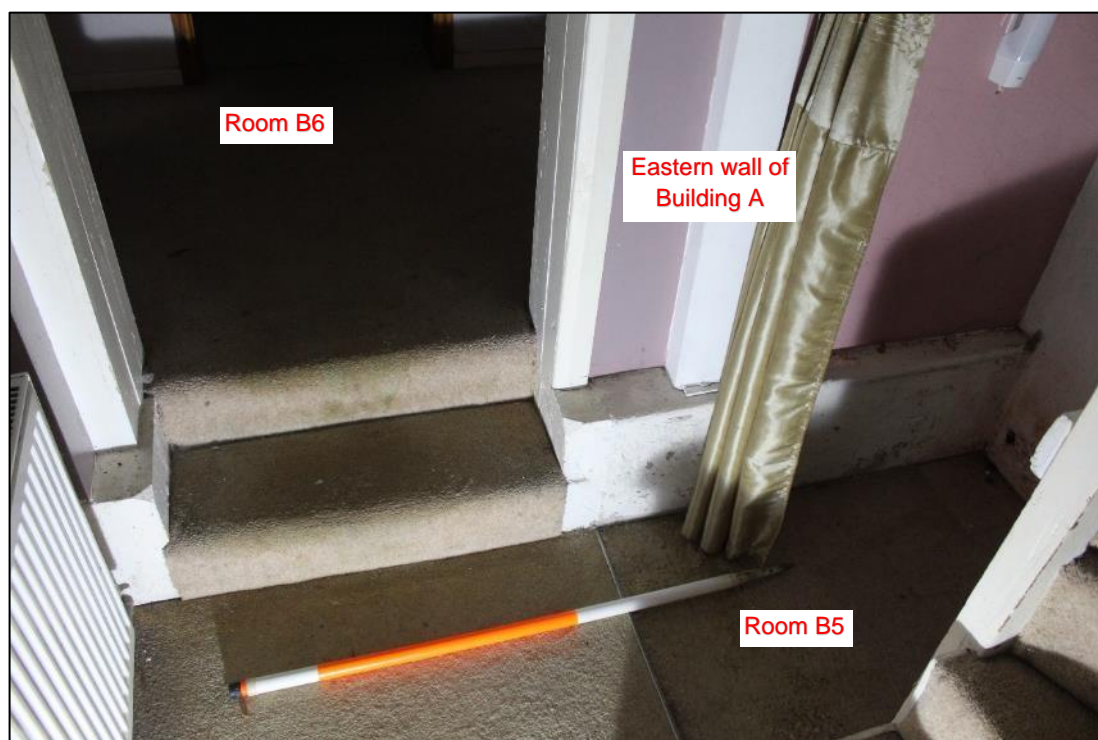
Photo 28: Detail of threshold between Rooms B5 and B6

- 4.25. To the north of Room B2 is Room B4 which represents a modern kitchen. The room incorporates no features of historical note. A beam is aligned north to south across the room and is a machine cut example, according with the late 19th-century date of the projection, within which the room is contained.
- 4.26. Room B5 functions as a stair lobby and provides access to Rooms B6, B7 and B8. The position of Room B5 is such that it incorporates an opening through the former eastern wall of Building A. This is evidenced by its relative position, the difference in floor level, and the comparative thickness of the wall fabric at this threshold (Photo 28).

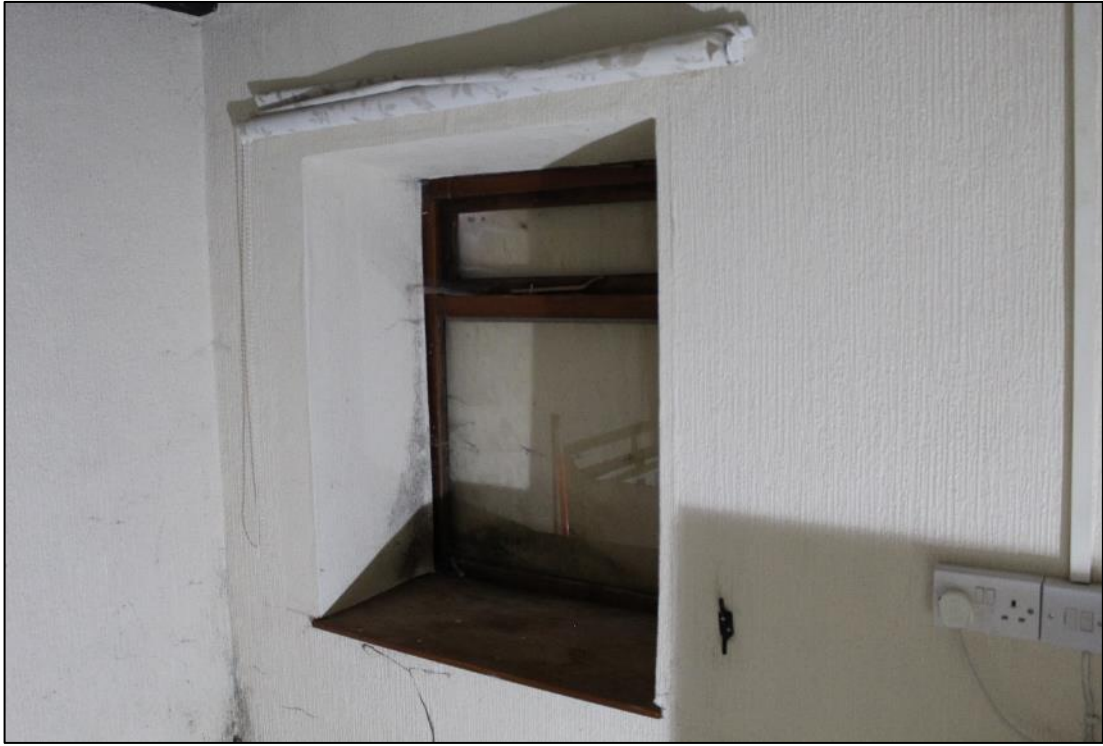
Photo 29: Window within northern wall of Room B7

- 4.27. Rooms B6 to B8 are contained within the 'cell' in the eastern two bays of Building A (Photo 12) and, consequently, contain no historical features of interest. Given the concrete block construction of the cell and lack of historical features, the rooms are likely to have been constructed during the mid to late 20th century as a means to

extending the farmhouse. Notably, the window reveals within these rooms are comparatively thick (Photo 29), evidencing their position within the walls of Building A.

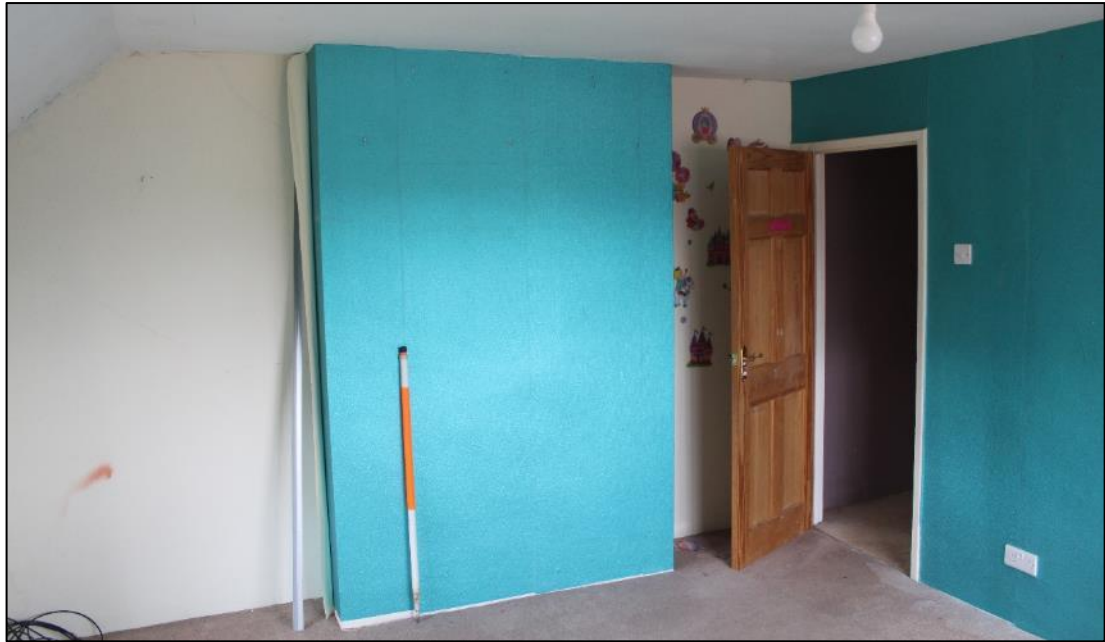
Photo 30: Room B10, looking north-west

- 4.28. The upper floor is accessed via a single dogleg staircase within Room B5, which provides access to Rooms B9 to B11. The three rooms are decorated in a modern style, with no visible historical features of note. Room B10 (Photo 30) incorporates a redundant chimney breast, positioned above that within Room B3 and visible externally, on the eastern side of Building A (Photo 21).

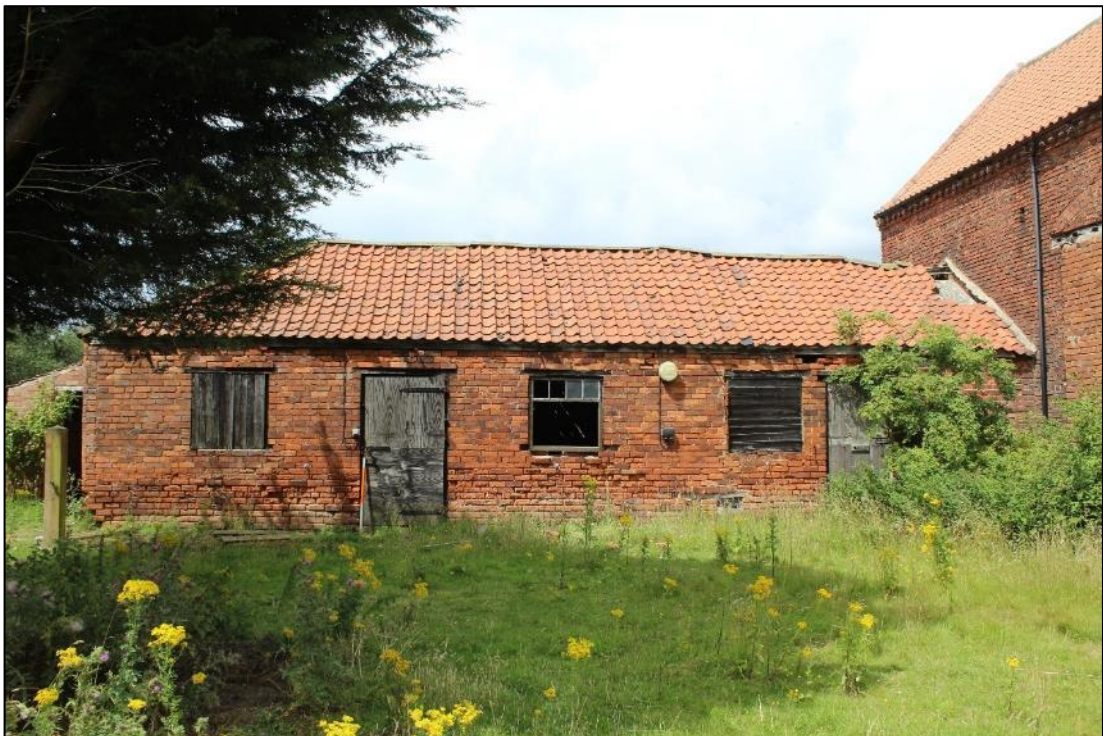
Photo 31: Building C, eastern elevation

- 4.30. Building C is located to the western extent of the farmyard and is abutted to the south-western extent of Building A. The building extends for five bays and is single-storey. The roof is covered in clay pantiles whilst the elevations are constructed of red brick, laid in a variety of brick bonds in combination of stretcher and Flemish wall bond (including five stretcher courses to each Flemish course for the eastern elevation), implying a considerable programme of repair and/or rebuilding at some point.
- 4.31. The building is accessed via the eastern elevation (Photo 31) which incorporates two doorways to the northern and southern extents of the building. There are also three window apertures, two of which serve the southern extent. Whilst the northern and

southern windows are boarded up, the central window is clear (but damaged) and comprises a row of four small lights along the top portion of the unit. The lower portion may have incorporated further glazing bars but these are now missing. The most recent function of the building was evidently that of a stable block for recreational horse riding.

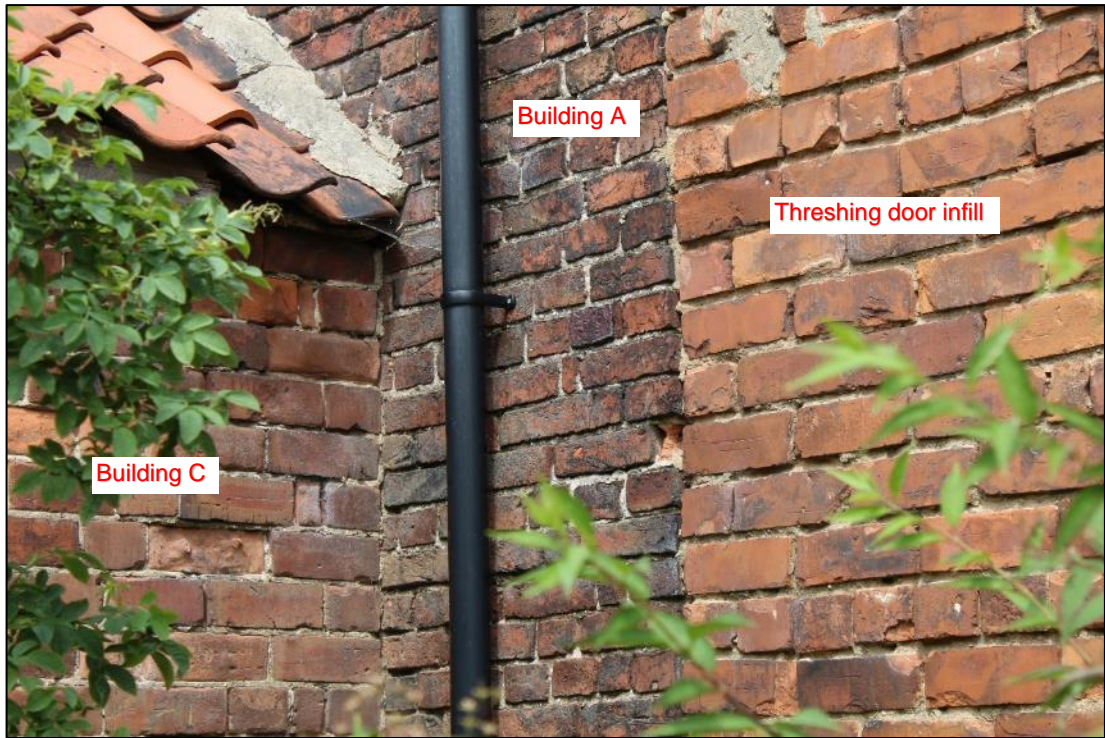
- 4.32. The junction between Buildings A and C illustrates the difference in phasing. The brickwork of Building C is abutted to the southern elevation of Building A and clearly does not match the brickwork in either appearance or size (Photo 32). Notably, the brickwork of Building C shares a similar appearance with that of the threshing door infill, suggesting a possible contemporaneous intervention, however, this is unlikely as it would have resulted in a comparatively short lived configuration of Building A with two opposing threshing doors.

Photo 32: Detail of junction between eastern elevation of Building C and southern elevation of Building A

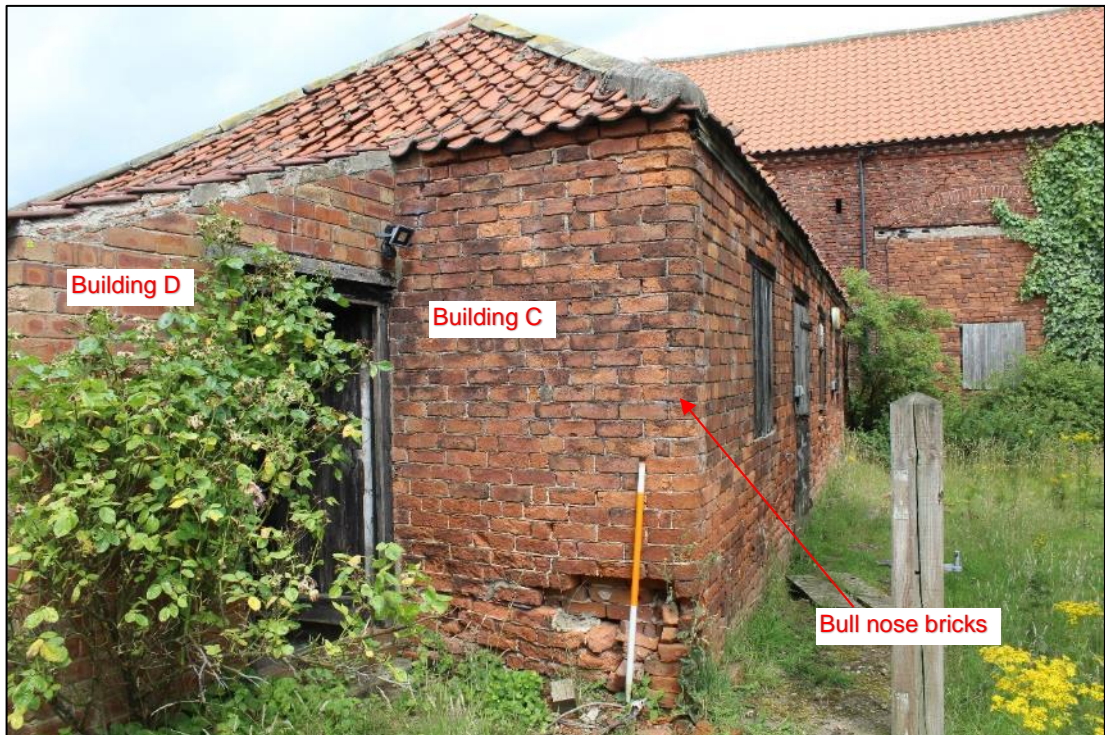
Photo 33: Building C, southern elevation

- 4.33. The southern elevation is plain and accommodates Building D (Photo 33). The corners of the southern elevation incorporate bull nose bricks, typically used for the easement of animals and/or carts around corners without harm. The western elevation was substantially obscured by vegetation and could only be partially viewed, however, the elevation appeared to contain only a single doorway (Photo 34), probably for access by the farmer to access the internal manger troughs.

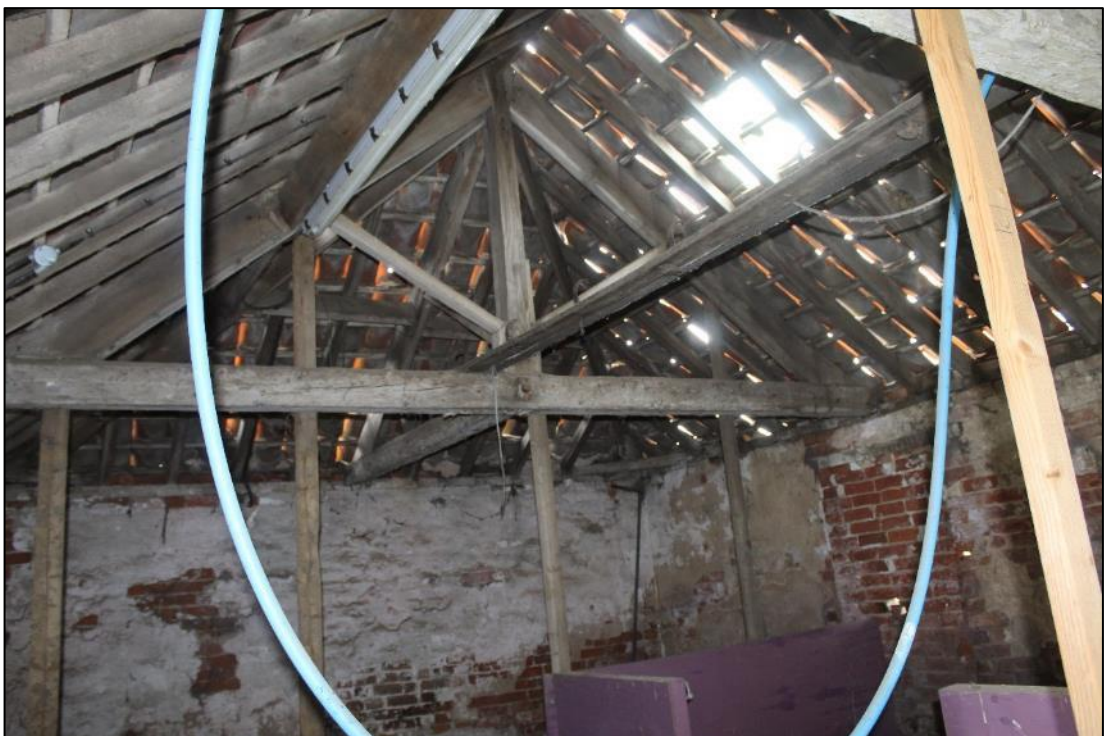
Photo 36: Overview of roof structure within Room C1, looking south

- 4.34. Internally, the southern extent of the building (Room C1) is presently configured to house horses, incorporating modern stall partitions (Photo 35). However, the former cow house configuration can still be identified. A clay tile manger routes along the western wall of the interior whilst a drainage channel is still present along the centre of the room, aligned north to south. The roof comprises a simple construction of two king-post trusses, rafters and purlins, characteristic of the building's early 19th-century construction date (Photo 36).
