**Steer Bank Farm
Harworth
Nottinghamshire**

Historic Building Record (Level 3)

CA Project: MK0926

CA Report: MK0926_1

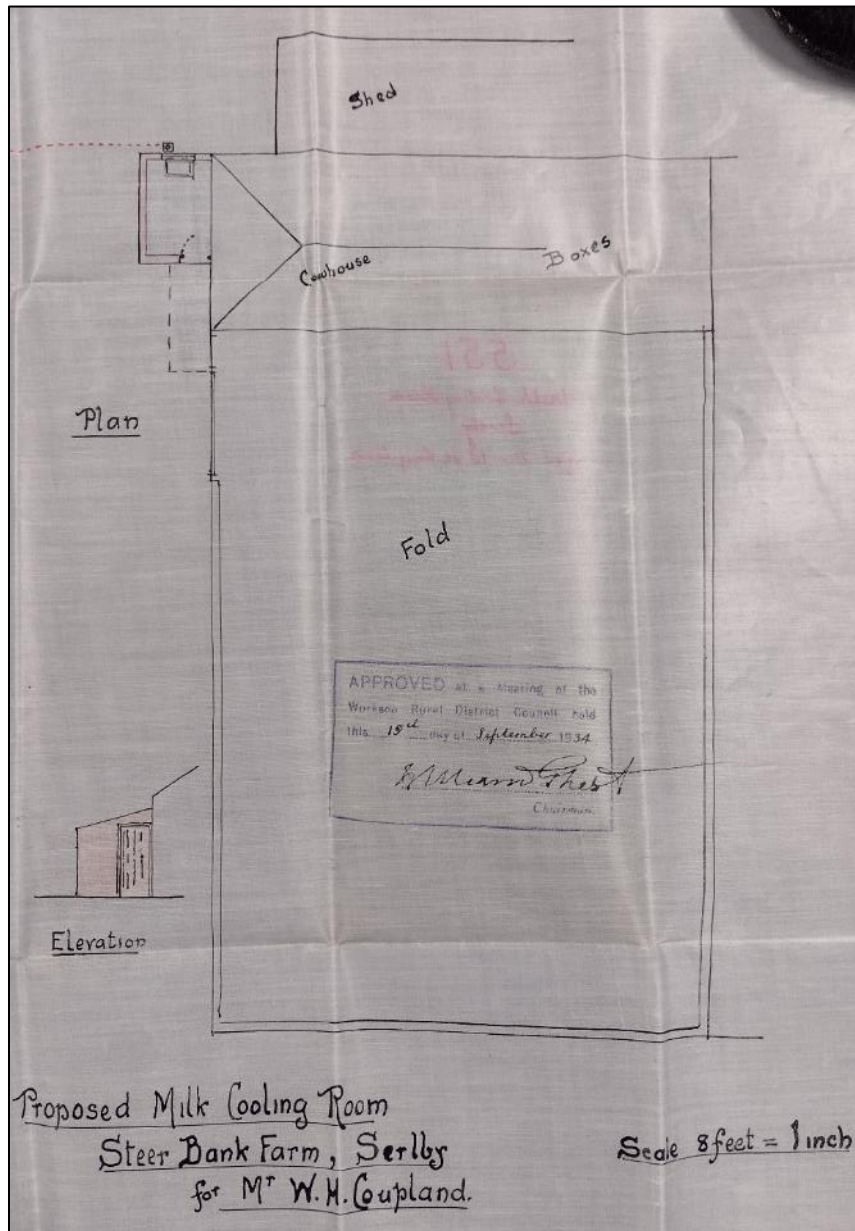
Fig. 14: 1934 plan of milk cooling room at the farm (NA ref: DC/WR/2/1/1/WR551)

- 4.38. It is clear that the presence of the manger and drainage channel, combined with relatively low levels of light and ventilation, are suggestive of the building functioning as a former cow house. This description is reinforced by a building plan for Building D, dated 1934 (Fig. 14; NA ref: DC/WR/2/1/1/WR551) which described Building C as a 'Cowhouse' and 'Boxes'.

- 4.39. Building D (Photos 39 and 40) is a small red brick structure with pantile roof, abutted to the southern elevation of Building C. The building is described in plans dated 1934 as a milk cooling room (Fig. 14), and incorporates a single door within the eastern elevation and a blocked up window within the western elevation. Internally, a small shelf is supported on two brick stands, which appear to be depicted on the original plans (Fig. 14), otherwise the Building is empty of any features or equipment that may relate to the cold storage of milk.
- 4.40. The size of the building suggests a very small scale of milk production and possibly functioned for the benefit of the estate (Serlby Hall) only, with no wider distribution of the product.

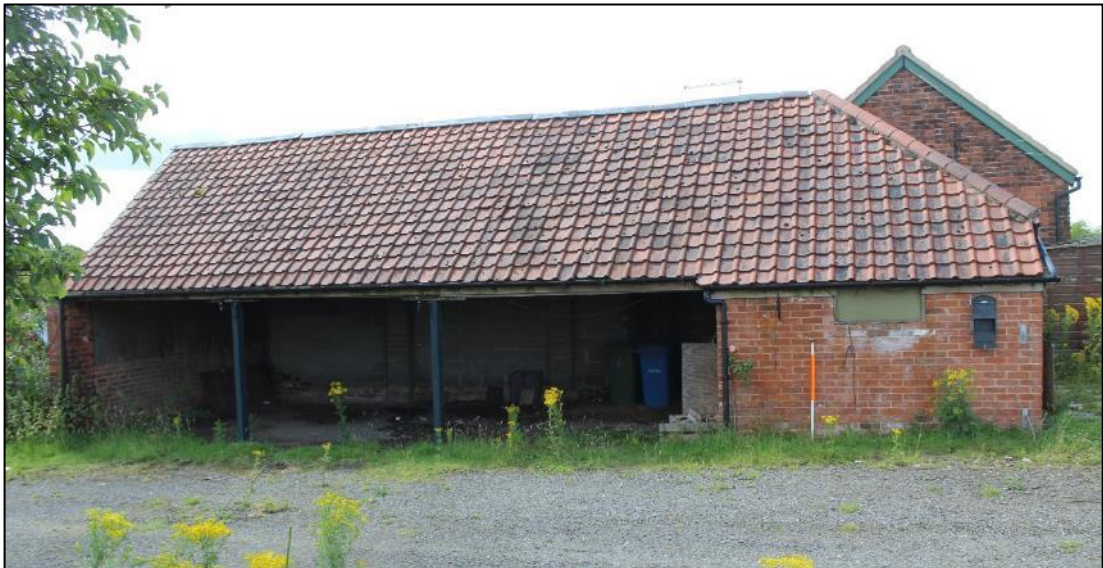
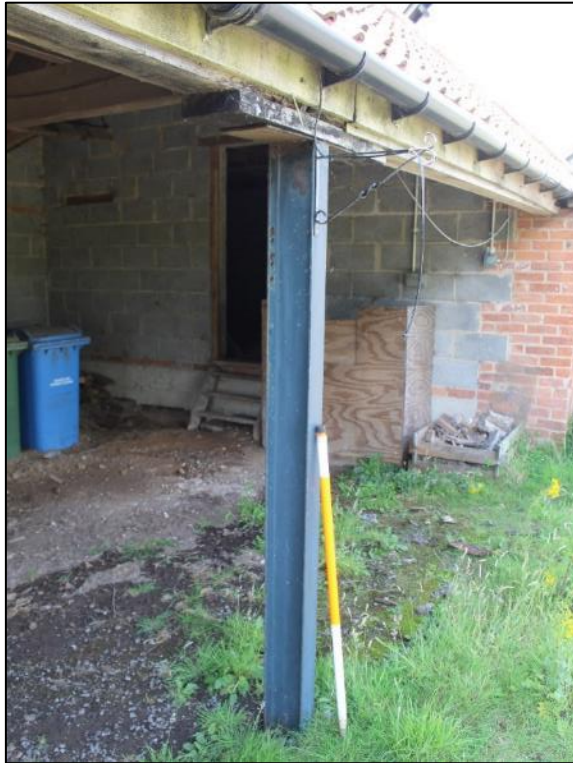
- 4.42. The eastern three bays of the northern elevation area open and incorporate steel I-beams as posts to support the roof structure, forming Room E1 (Photos 41 and 42). The western bay and western elevation of the building is faced in red brick and encloses room E2, beneath the hipped portion of the roof; this portion appears to be contemporary with the southern elevation and was likely constructed during the mid to late 20th century. The northern elevation fronts onto the current access drive to the rear of the farmstead. The orientation of the openings and access to the driveway therefore suggest a former cart shed function.

4.47. Upon initial appraisal, the appearance of the building is consistent with the characteristics of a cart shed. The northern elevation (Photo 41) is mostly open and incorporates I-beam steel posts to support the roof structure above the principal opening (Photo 42), creating the configuration of a typical cart shed, albeit using non-traditional post materials. However, the historic maps (Table 4.1) record a sequence of alterations to the building, which suggest that the present configuration is not historical.

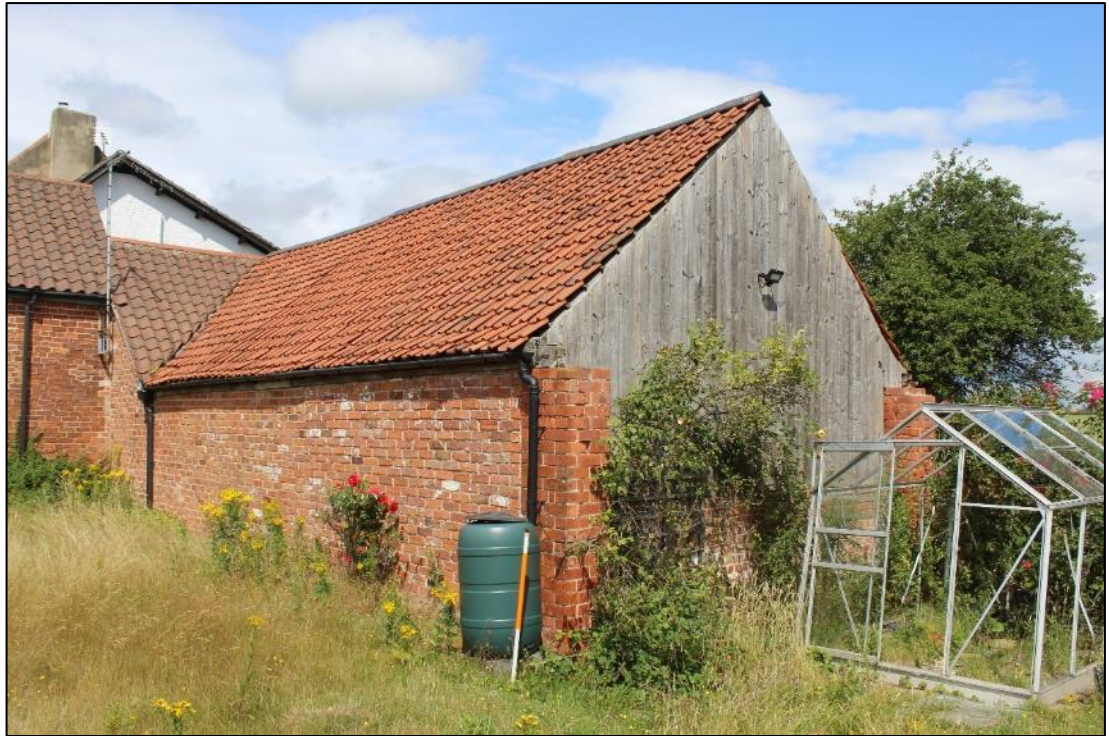
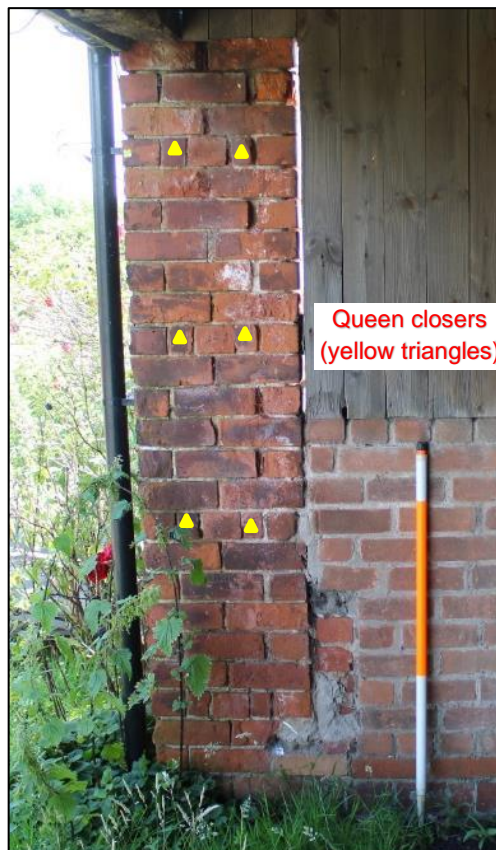
- 4.43. The eastern elevation of the building principally comprises timber planks to the upper portions with a base of red brick, laid in stretcher bond (Photo 43). The northern and southern extents of the elevation are bookended by a pair of brick pilasters of earlier appearance to the surrounding fabric, suggesting that they may have formed free standing pillars, independent of adjacent walling, that possibly suggested an open ended structure. This is also evidenced through the incorporation of 'pairs' of queen closers in each side of the pilasters, indicating the extent of the brick face (Photo 44).

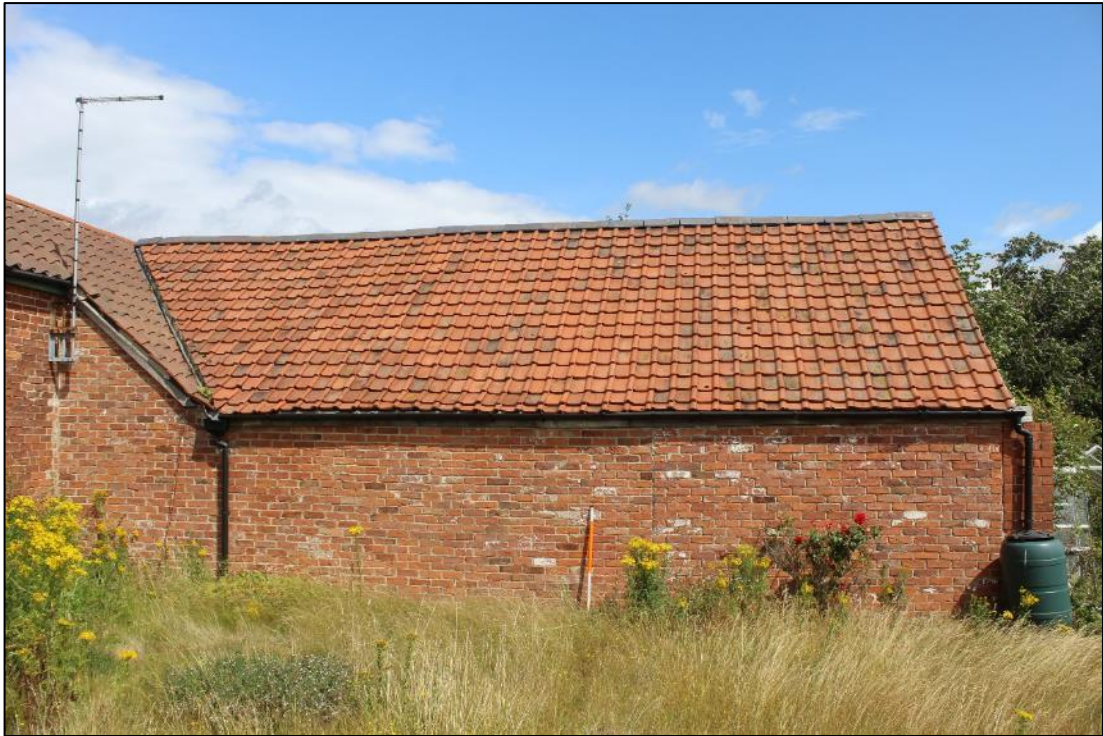
Photo 45: Building E, southern elevation

- 4.44. The southern elevation comprises a red brick external wall, laid in a stretcher bond and featuring an apparent expansion joint approximately two thirds along the elevation (Photo 45). The construction of the wall appears comparatively recent, likely dating to the mid to late 20th century (Phase E). This date accords with the method of construction where a red brick external skin is presented whilst, internally, the wall consists of concrete block. Given the degree of change to the building over time, the southern elevation was likely rebuilt following the extensive changes to the south where Building E was apparently open fronted to the south, historically (Figs. 5 and 6).

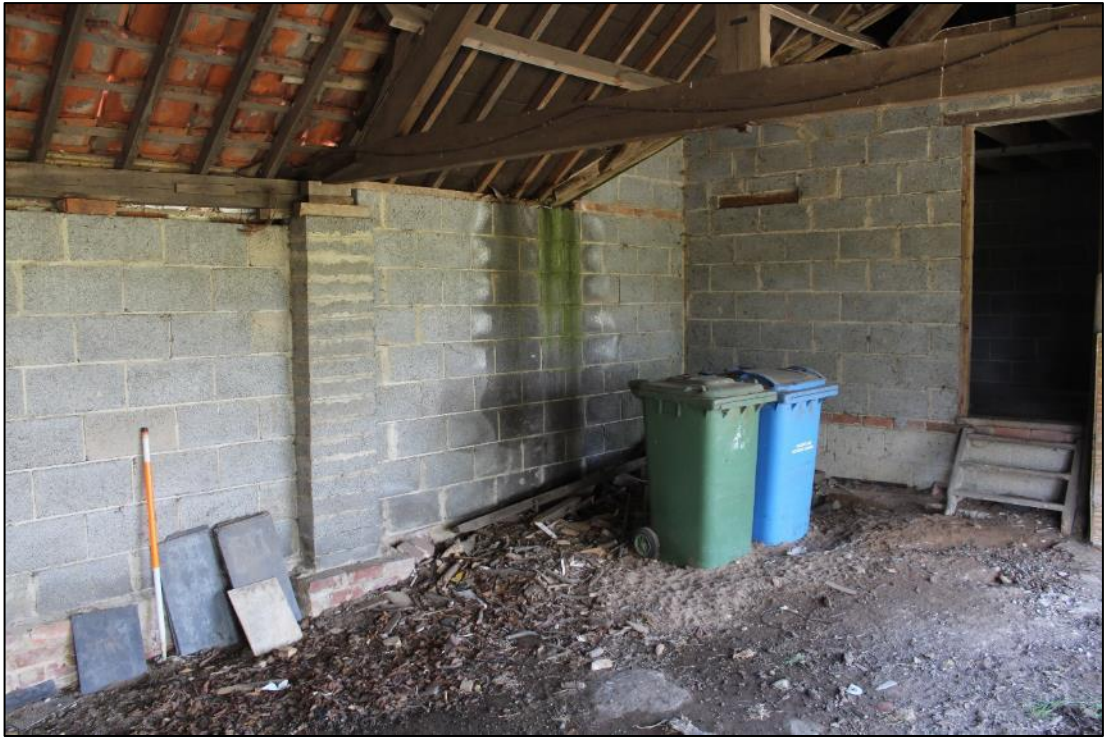
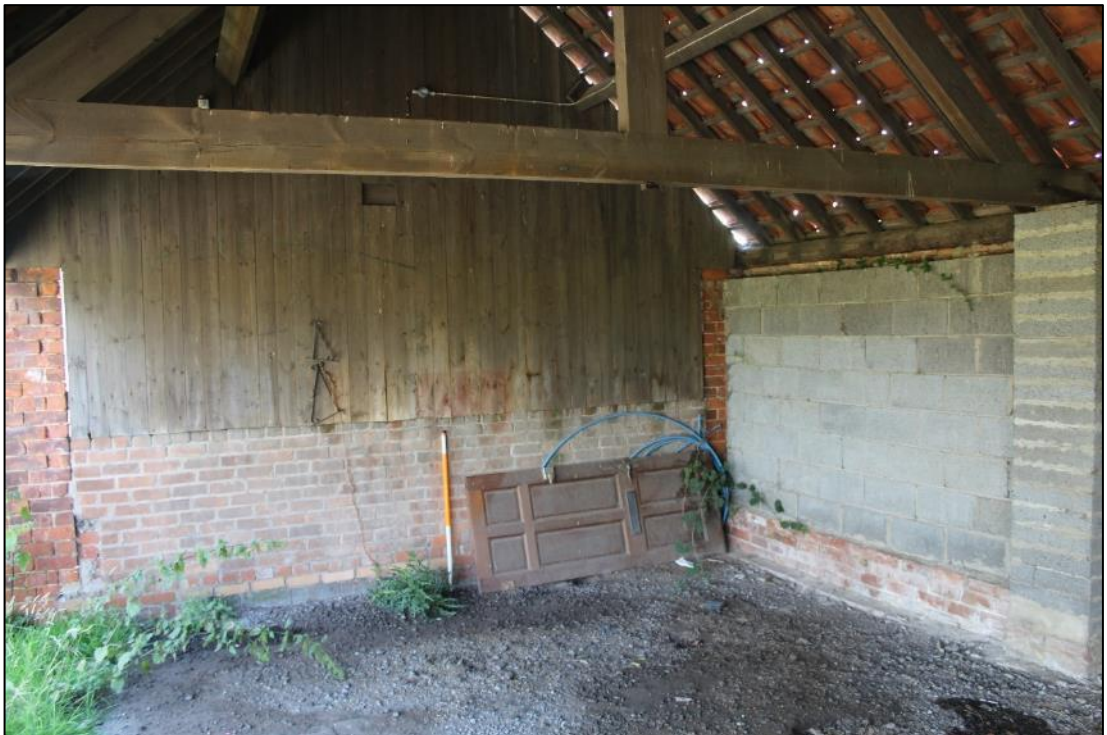
- 4.45. Room E1 comprises the principal, open fronted portion of the building and was likely used to house carts or farm machinery (Photos 46 and 47). The present configuration of the room is substantially modern. Concrete block wall alignments evidence considerable alterations and imply a substantial programme of rebuilding, leaving little of the earlier building surviving beyond the pair of brick pillars at the eastern extent (Photo 44). The roof trusses comprise ubiquitous machine cut king post examples of modern (i.e. mid to late 20th century) appearance.
- 4.46. Room E2 (Photo 48) comprises a small, enclosed room at the western extent of the building that incorporates a small animal enclosure, with external access hatch. The room appears contemporary with the principal brick and concrete block body of the building and therefore dates to the mid to late 20th century (Phase E).

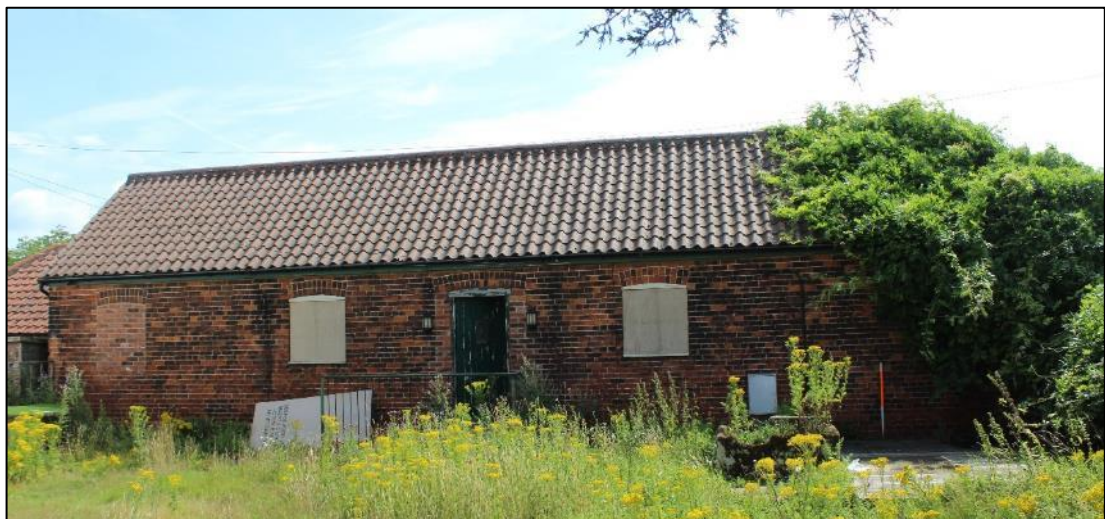
Photo 49: Building F, western elevation

- 4.48. Building F forms the eastern range of the principal courtyard and comprises a red brick building, laid in English garden wall bond, with clay pantile gabled roof. The Building is a linear configuration that incorporates three windows (one infilled) and one doorway within the western elevation (Photo 49). The doorway exhibits alteration to the surrounding brickwork that suggests that the present door represents a narrowing of the aperture from a previously wider door (Photo 50). The width of the associated brick arch lintel also evidences the previous door width and implies a possible access for cattle, suggesting a possible former use as a loose box. A bricked up window is positioned at the northern end of the building (Photo 49), possibly as a result of the building's conversion to a residential use.

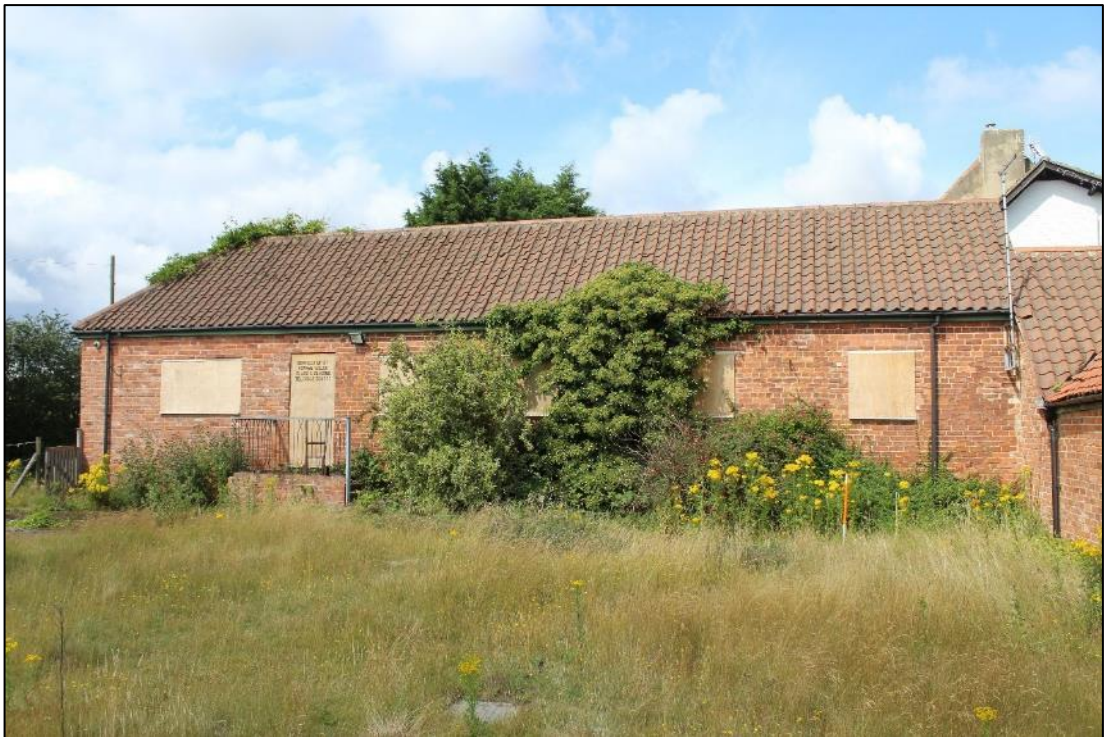
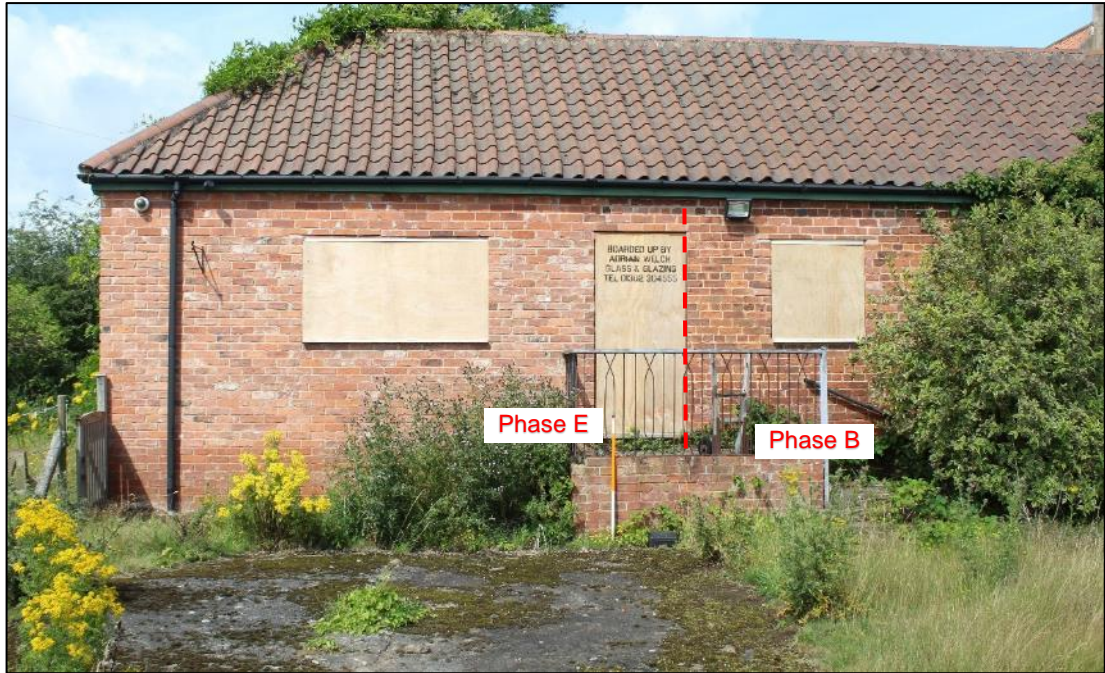
- 4.49. The southern elevation is partially obscured by vegetation but incorporates a modern window unit and modern (i.e. Phase E) brickwork, laid in stretcher bond, at the eastern extent (Photo 51). This modern brickwork extends around the southern extent of the eastern elevation (Photo 52), suggesting a considerable instance of repair and rebuilding of this part of the building. A clear change in the brickwork illustrates the junction between Phases B and E (Photo 53). The clay pantile roof is straight and consistent in its appearance, implying that it was renewed during the mid to late 20th century (Phase E) or later still.

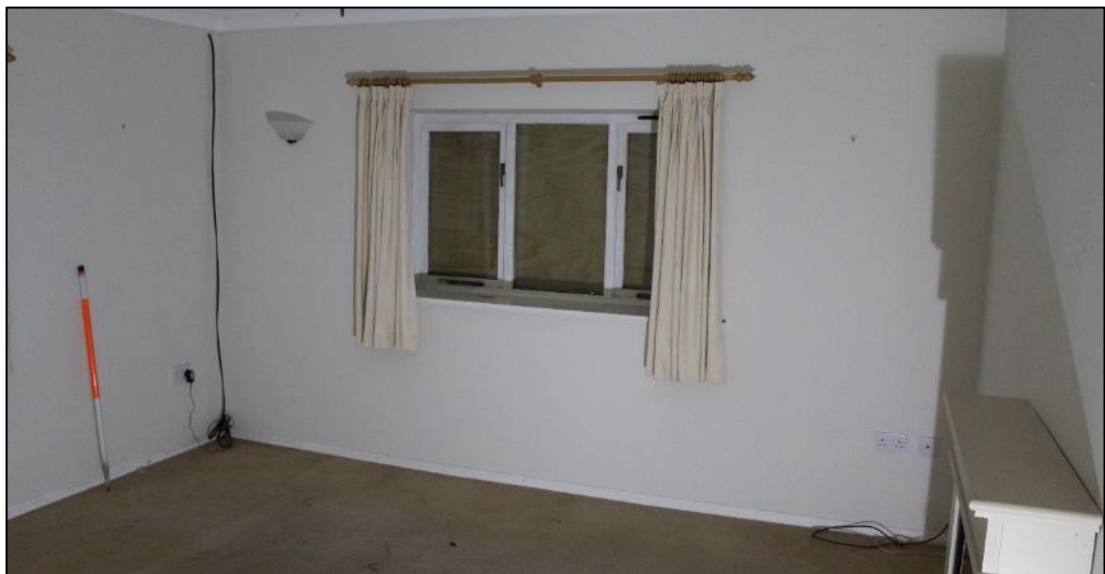
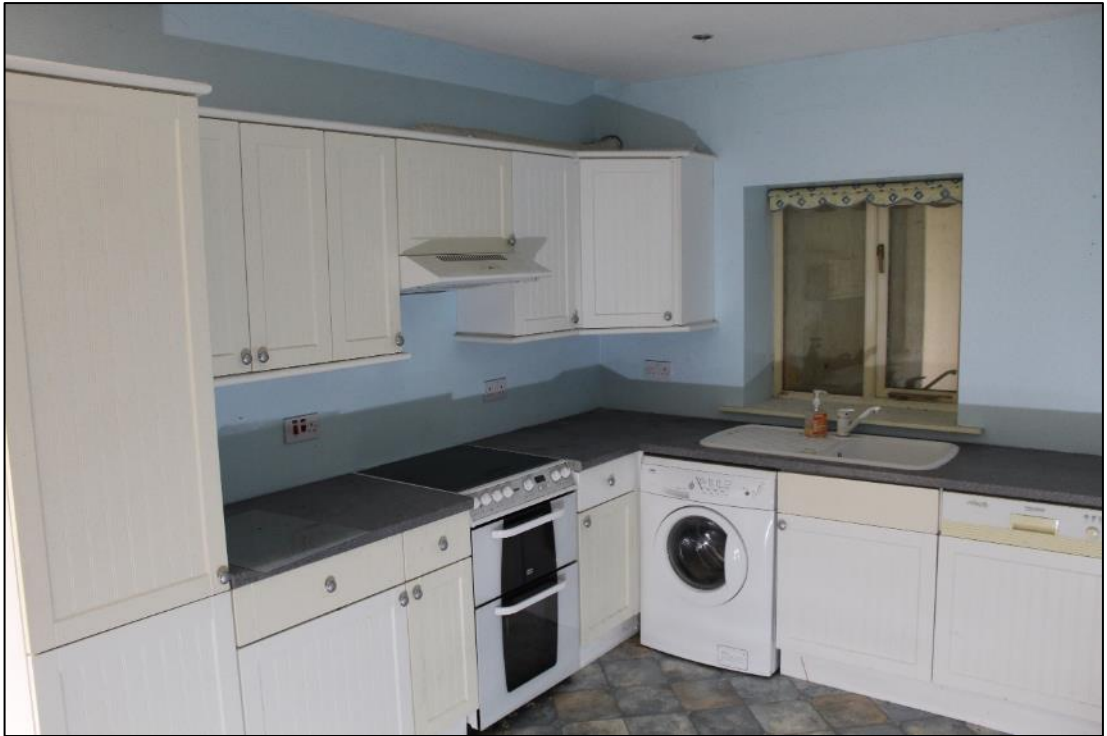
- 4.50. Internally, the building most recently functioned as a residence. This is evidenced by the comprehensive partitioning of the building and character of its rooms. Rooms F1 to F5 comprise a series of standard living room (F1), kitchen (F2), bathroom (F3) and bedrooms (Rooms F4 and F5) (Photos 54 and 55), incorporating no historical features. The roof structure was visible through a loft hatch and incorporates entirely modern machine cut timbers (Photo 56).

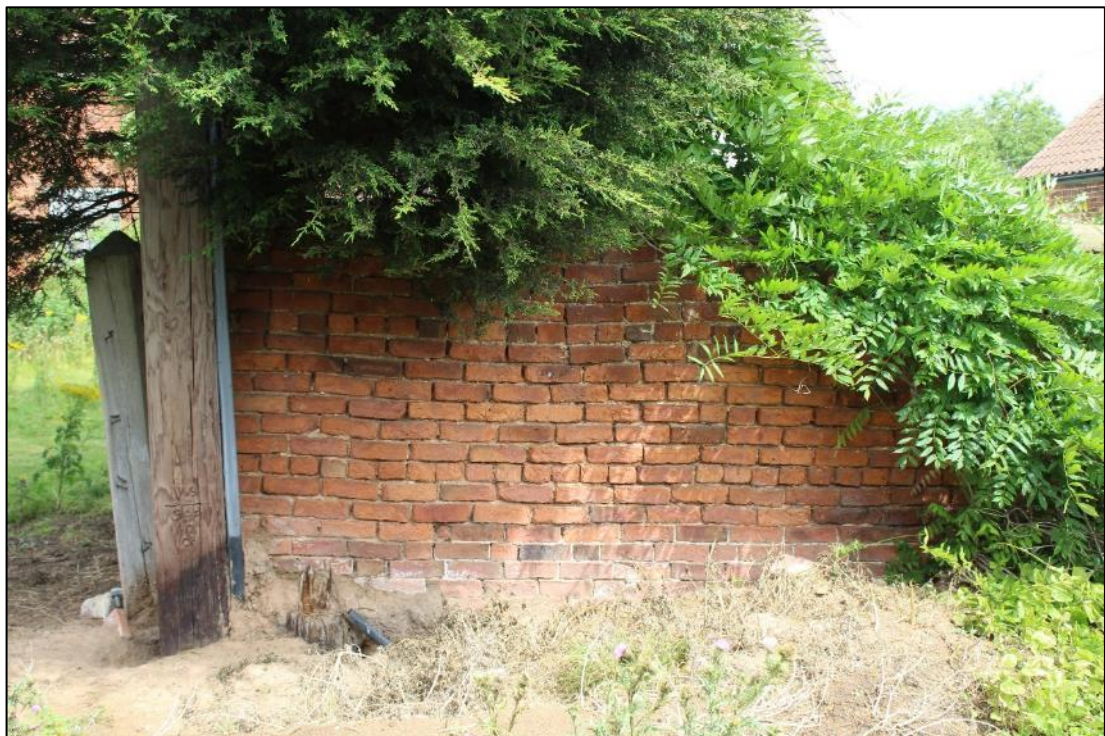
Photo 57: Detail of southern boundary wall, looking north

- 4.52. The principal farm buildings are arranged in a regular U-plan courtyard configuration, supplemented by a further boundary wall along the southern alignment of the courtyard (Photo 57). The wall comprises red brick, broadly laid in English garden wall bond with curved stone coping. A gap is present between the western extent of the wall and the southern extent of Building C, allowing for access to the yard for animals and carts.
- 4.53. The eastern portion of the farm once accommodated a collection of buildings that have now been demolished, returning this part of the farm to an L-shape configuration (Photo 58). An area of hardstanding remains visible adjacent to Building F that likely formed the base of the former open fronted structure. To the north of Building A is a small propane store (Photo 59), likely constructed as part of Phase E during the mid to late 20th century.

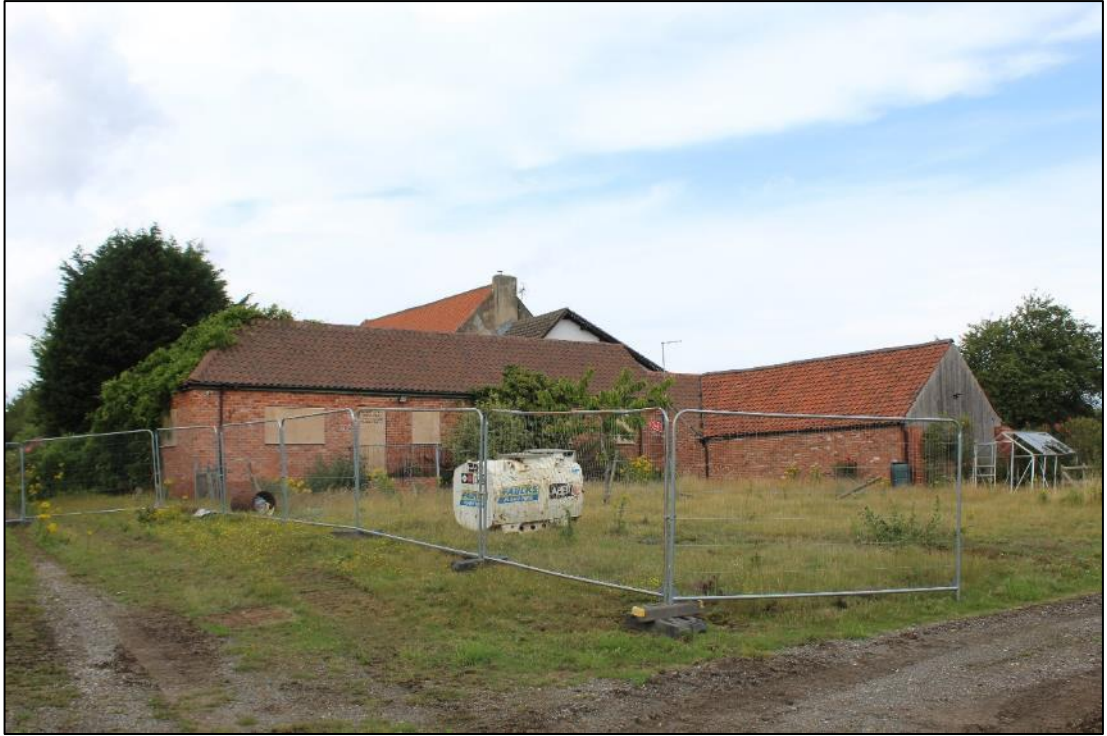
Photo 58: View of farm from the south-east

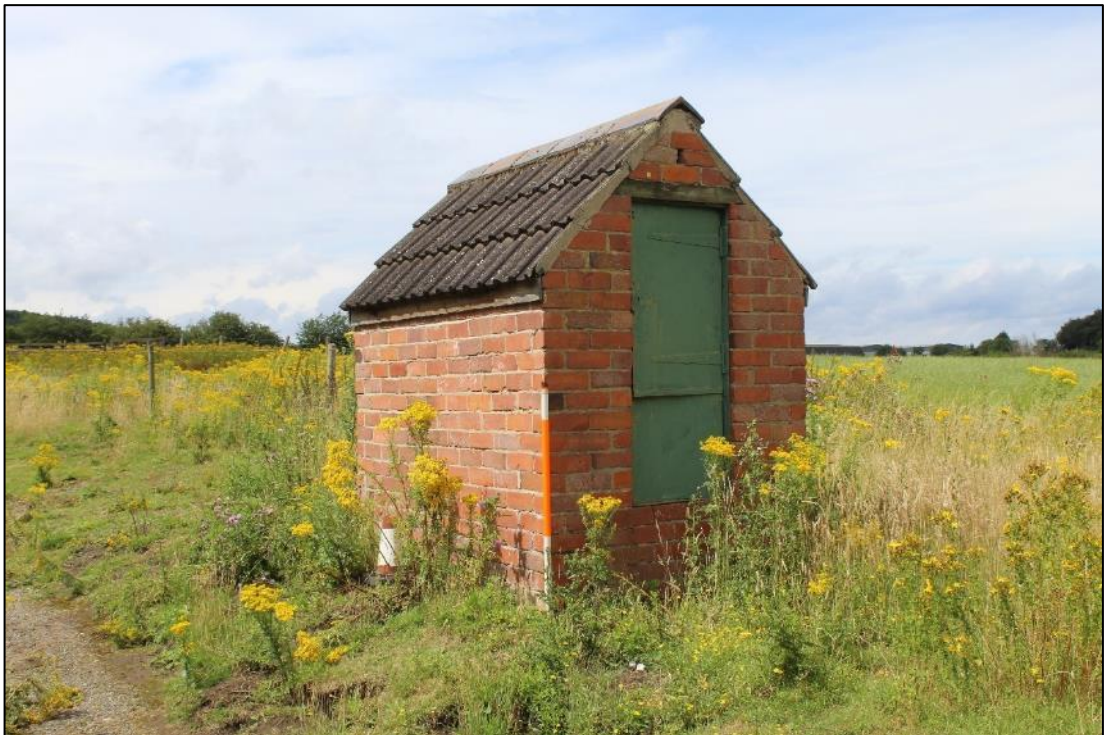
Photo 59: Propane store, looking north-west
