The Grand Western Canal Halberton Devon

Interpretative earthwork survey, photographic
survey and watching brief

CA Project: 4408
CA Report: 13481

January 2014

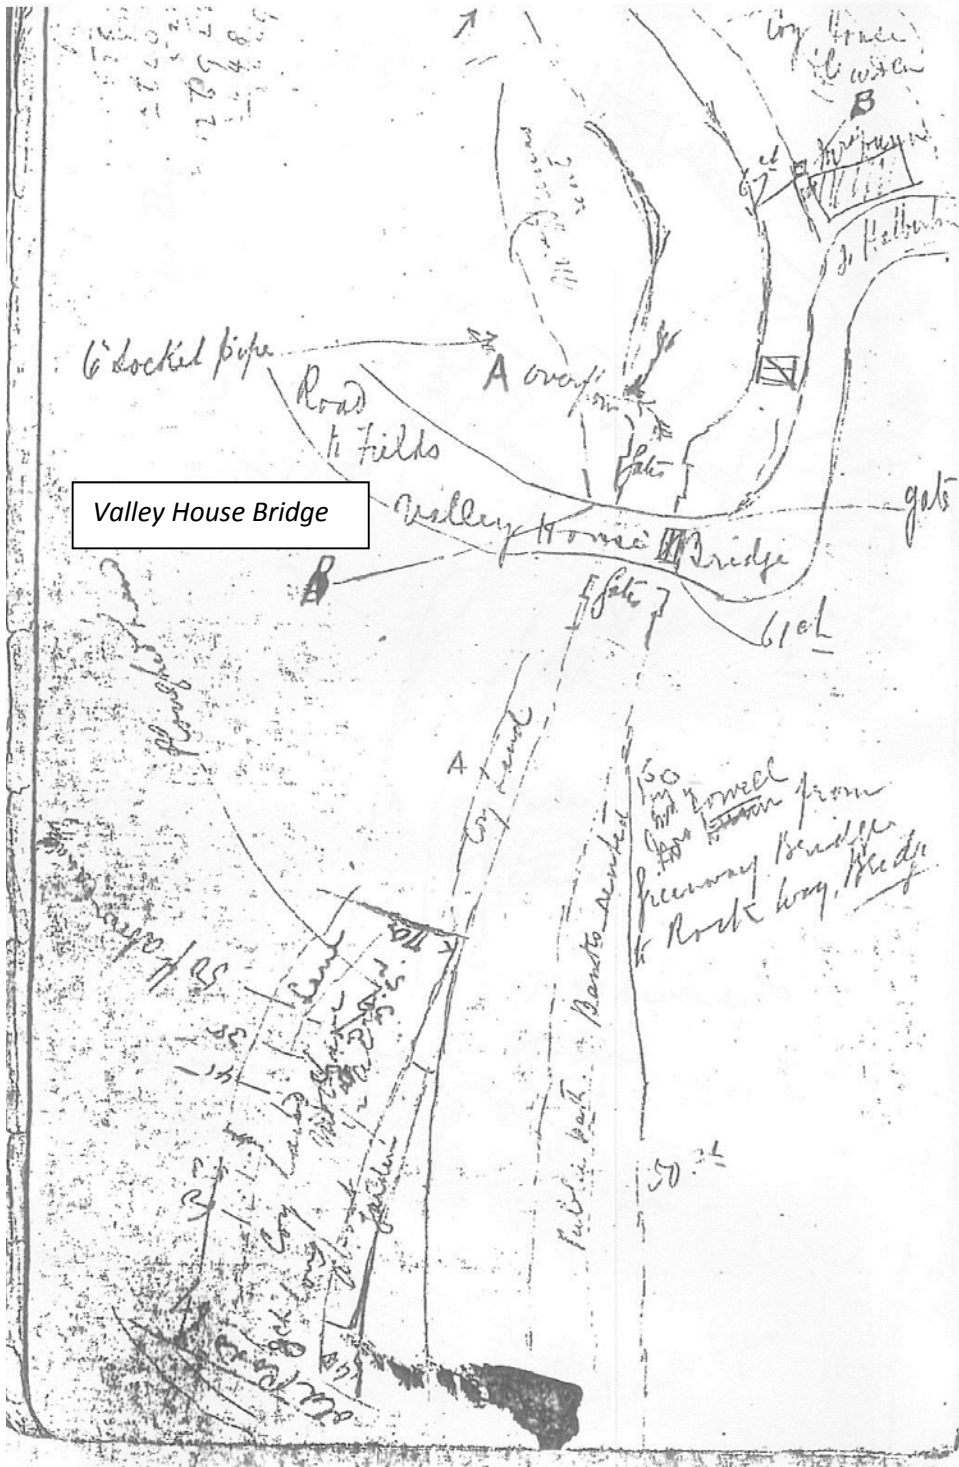
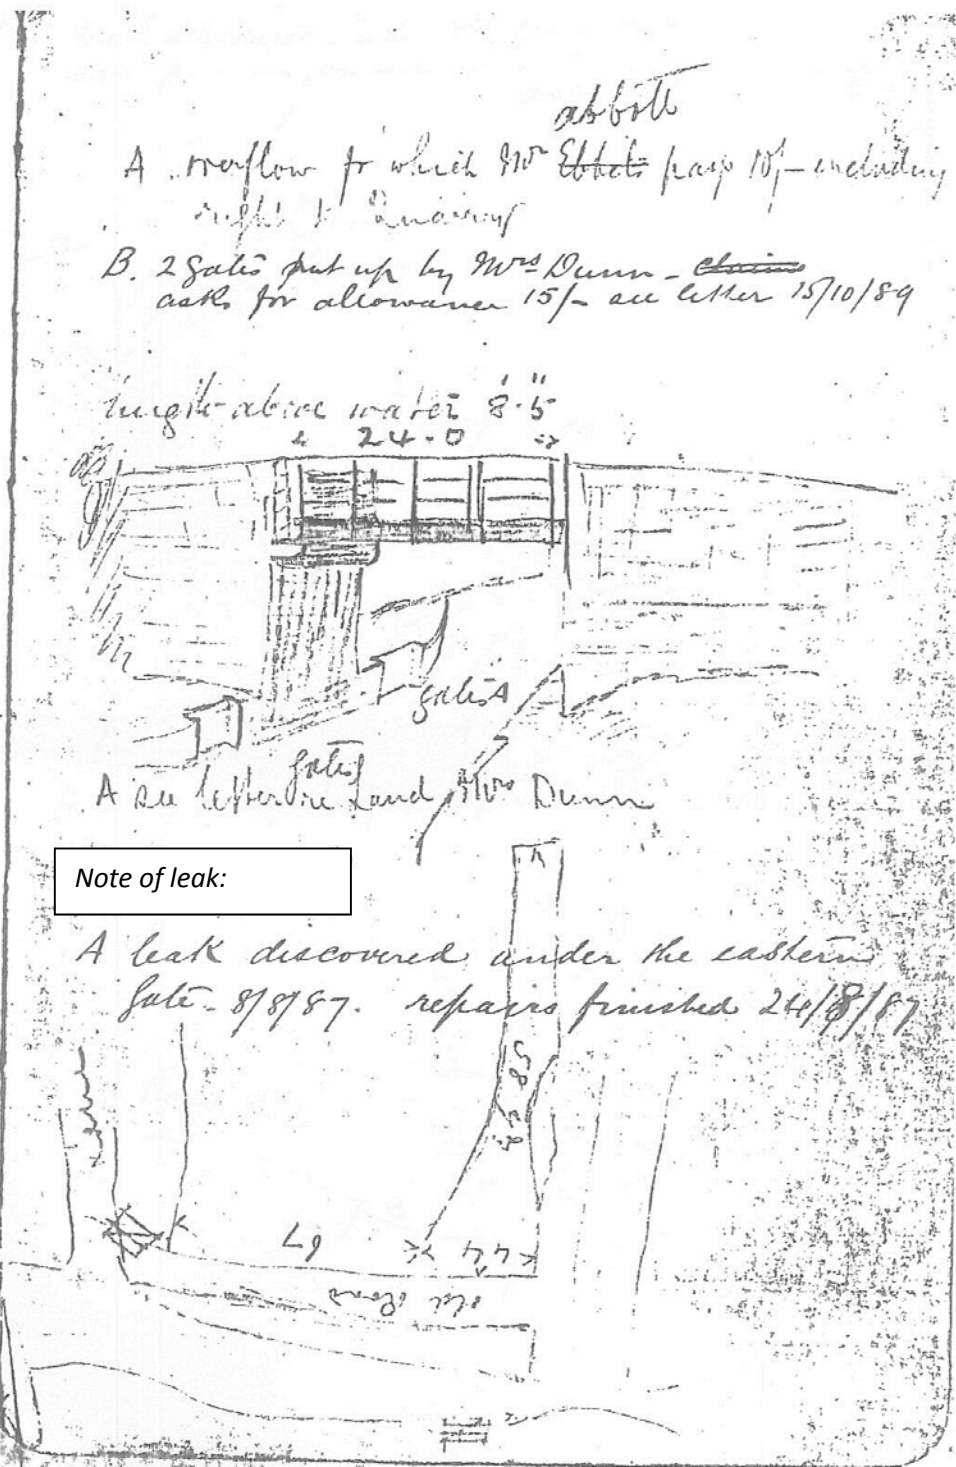
- C The notes appear to be a functional description of the on-going maintenance of the canal and associated infrastructure. Whilst the date of the notes overall is 1889, many of the notes appear to relate to events prior to this.
- D Two key points of interest are noted on the included excerpt: firstly the Swing Bridge was at that time referred to as Valley House Bridge, and secondly the note of a period of repairs on the eastern stop gate which occurred between the 8th and 24th August 1887.
- E Given the limited exposure of the stop gates themselves, no evidence of the repairs was noted during the course of these observations.

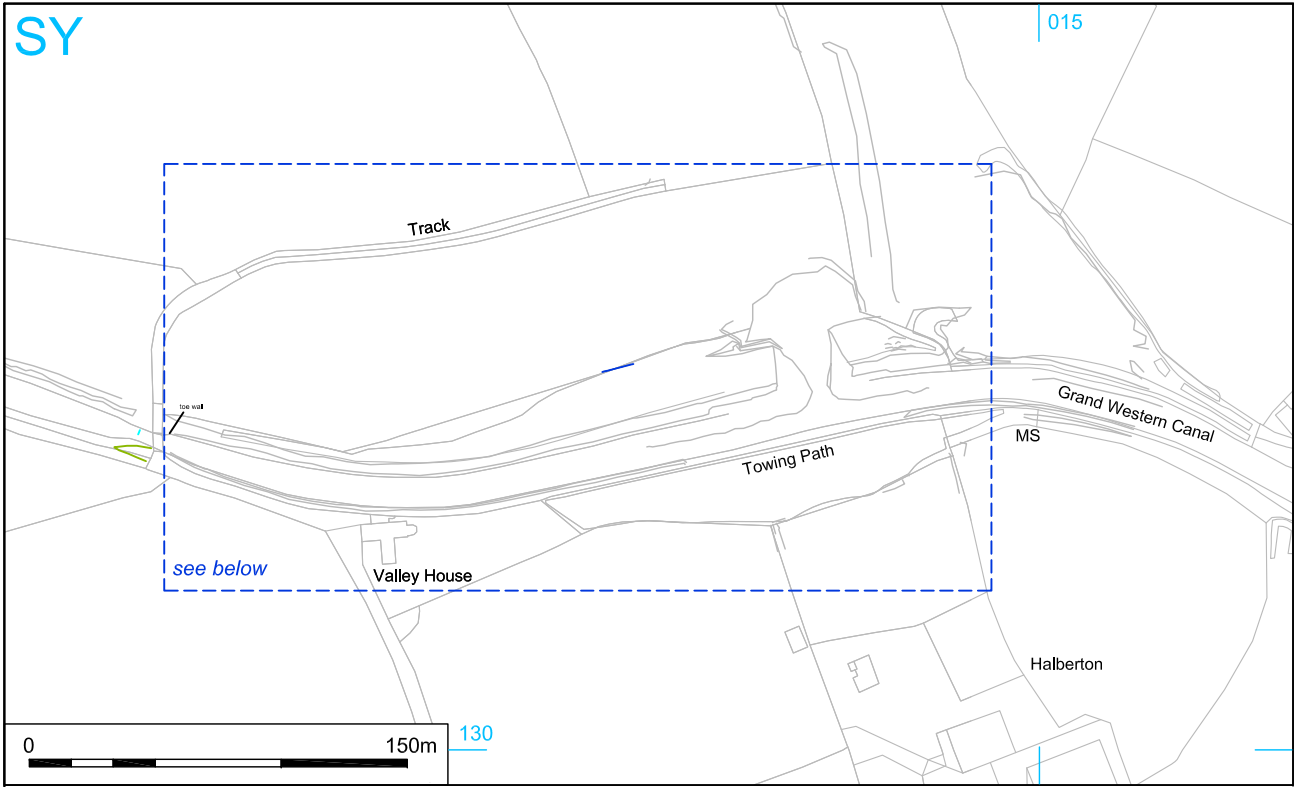
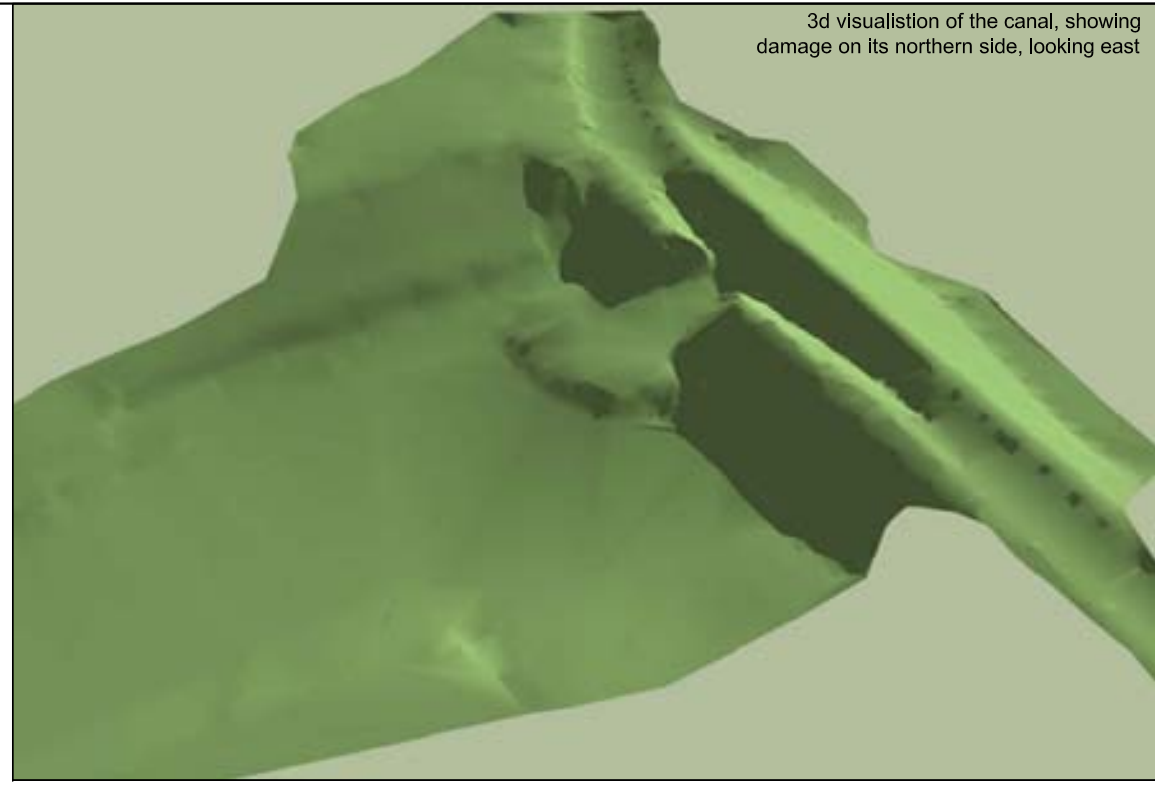
19

- 4.23 The south toe wall was more carefully built and mortared where it passes over the culvert which took the stream in the bottom of the valley under the embankment (Fig. 2 and 19). The depth of the culvert was estimated to be between 3m and 4m.
