Barn at Church Farm Besford Worcestershire

Historic Building Recording

CA Project: 5452

CA Report: 15537

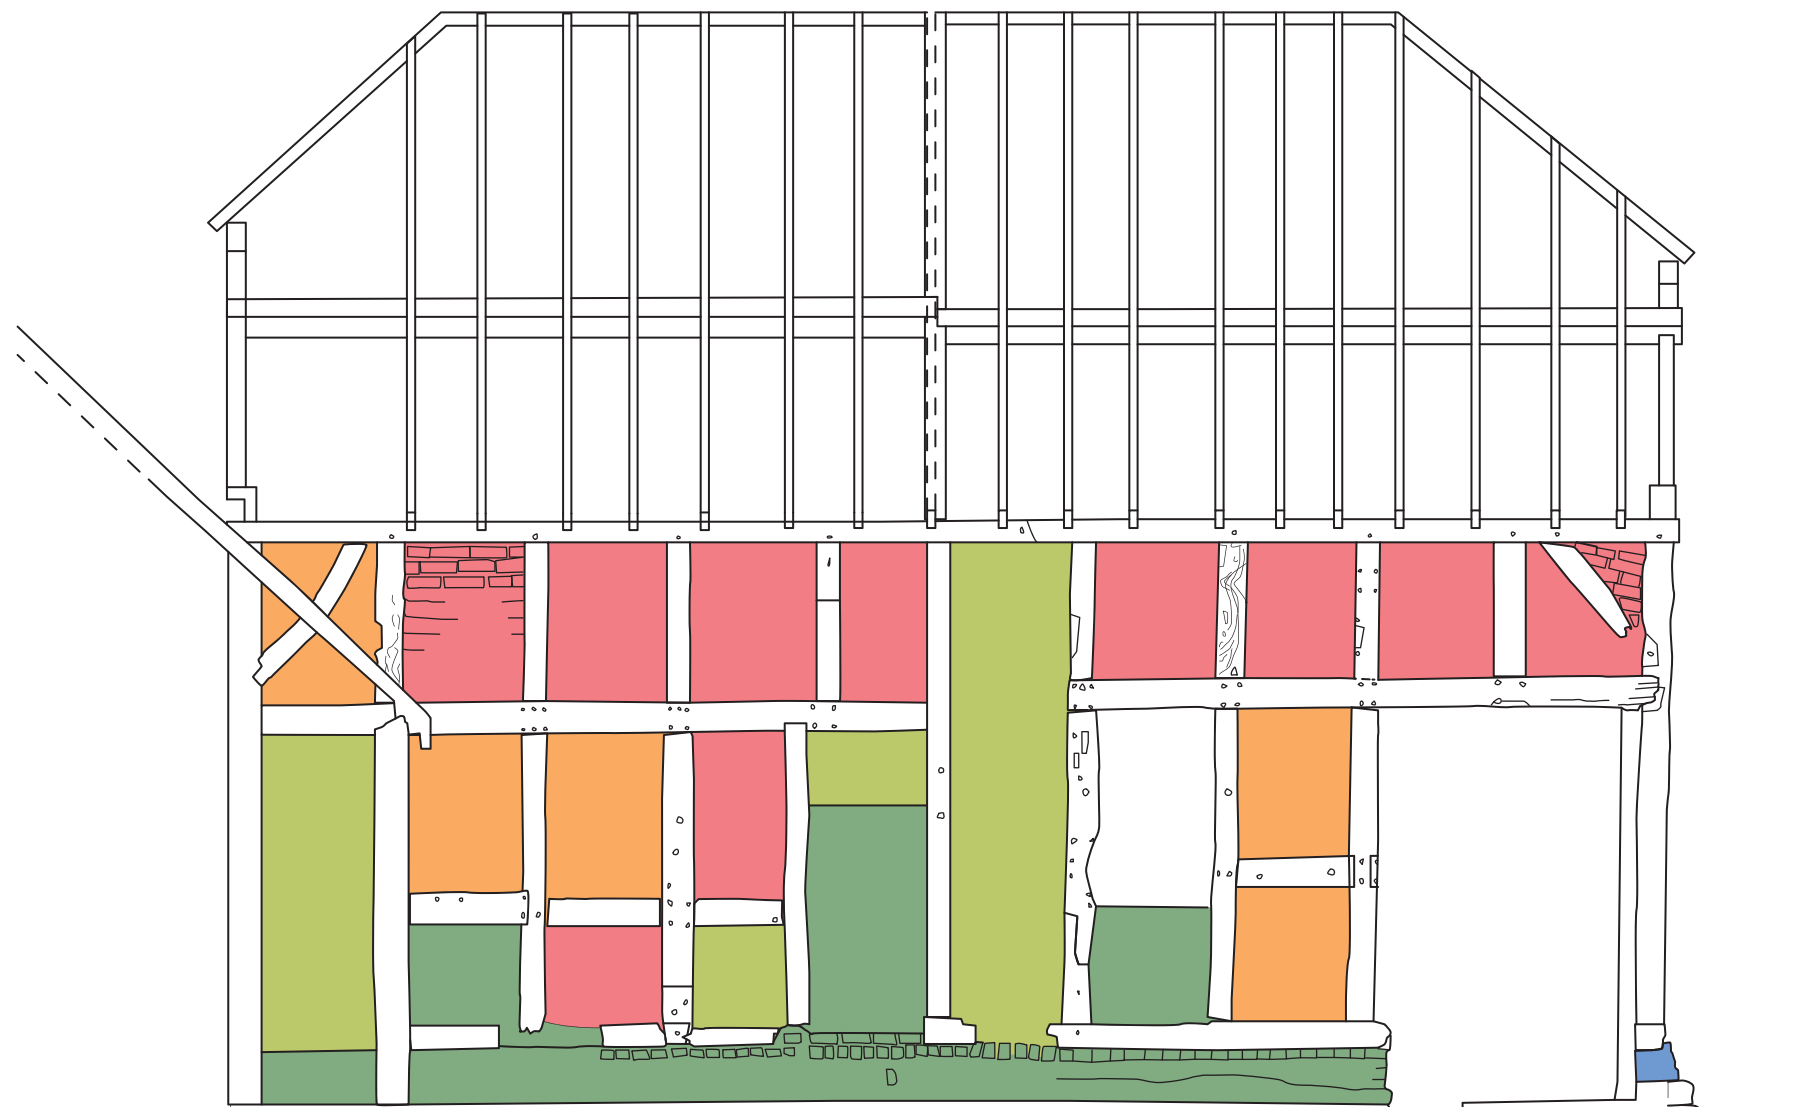
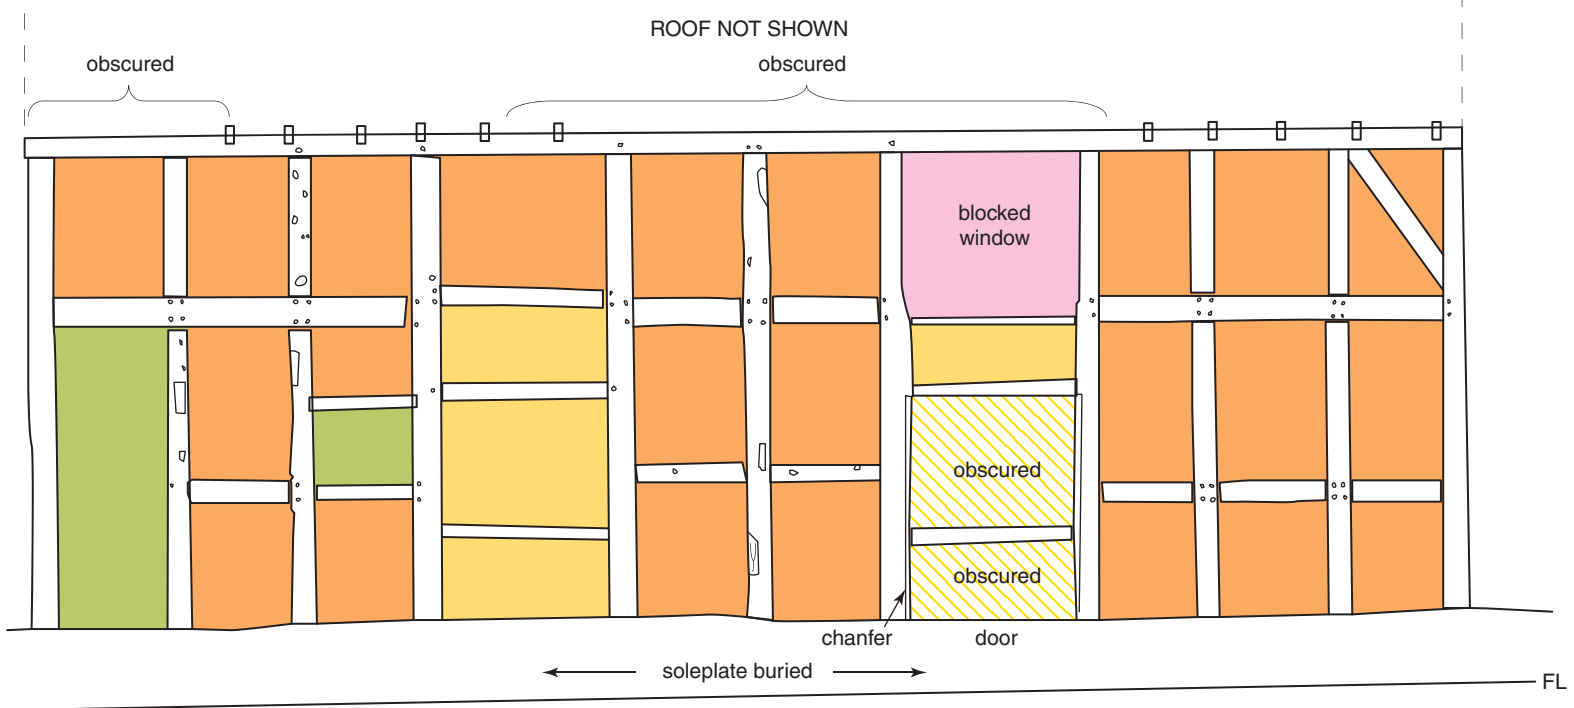
FIGURE TITLE
East and west elevations of the barn

- 4.10 The west elevation is different in detail. As it has no large built-in doorways, the storey posts are spaced more regularly. The north-west corner post has been replaced in brick. The post immediately north of the central truss has been removed below the upper rail and replaced a few inches northwards (Figs. 4 and 7). The replaced post, as with many other inserted timbers, is not pegged and properly jointed but a crude chamfered lap is contrived and the new timber nailed in place. The moving of this post seems to have been to create a door into the northern room,

as the soleplate is also missing here and the bricks in the plinth are arranged as if to provide a threshold (Figs. 4 and 7).

- 4.11 South of the central truss the next bay has lost both its rails. The lower section of the next bay is open from below half height and the timber between it and the previous bay has been replaced with a slightly over-sized timber jointed to the stub of the original with a face-halved scarf (Figs. 4 and 8).
