Chevithorne Barton Tiverton Devon

Historic Building Watching Brief

CA Project: 880169 CA Report: 17091

March 2017

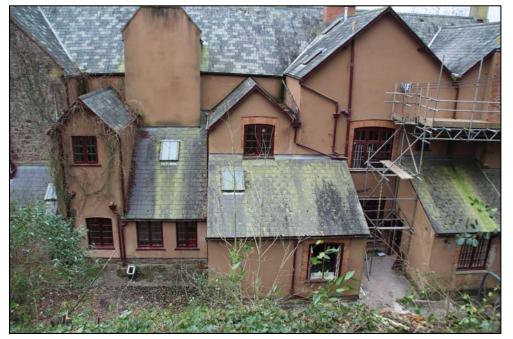
- 5.67 The northern section was covered by two parallel north/south roofs slightly lower than the main roof and joining it on valley rafters (Fig. 13). They also had kingpost trusses and similar purlins. The trusses ran along the line of the base of the north slope of the main roof and supported the north end of those trusses in wrought-iron, bolted brackets (Fig. 39).

Figure 13: The north elevation of the house showing the rear ranges before demolition

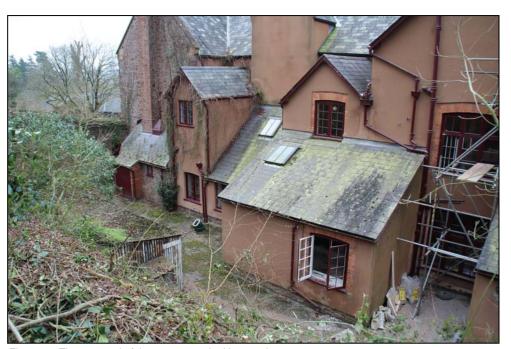
Figure 19: The east end of the rear range, looking south-east

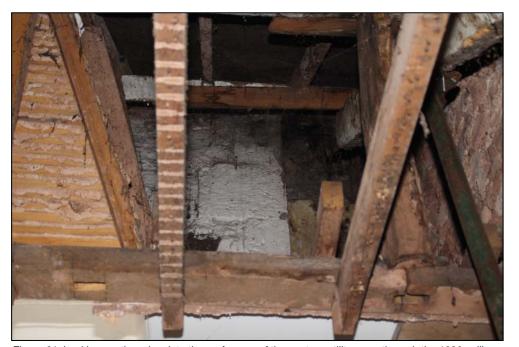
Figure 21: Looking south and up into the roof space of the eastern utility room through the 1930 ceiling joists to the skylight shaft, white painted timbers and hall stack

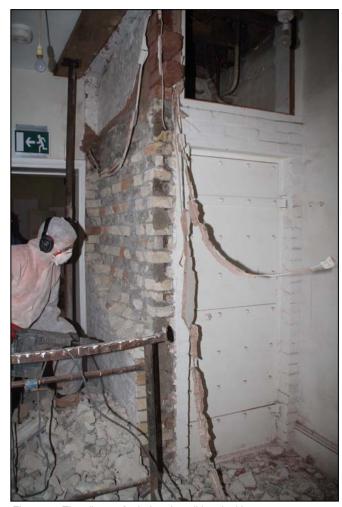
Figure 22: The silver safe during demolition, looking west

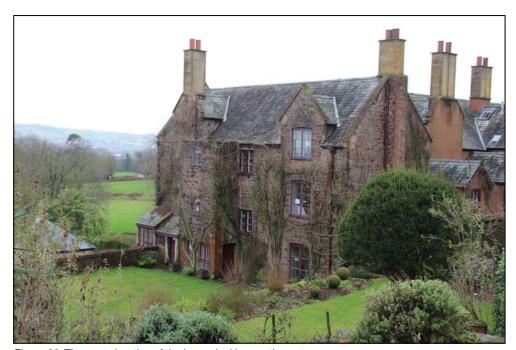
Figure 26: The east elevation of the house looking south-west

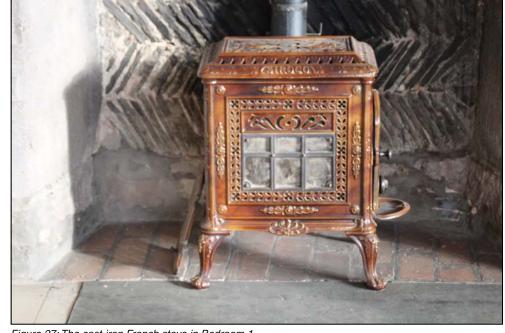
- 5.47 Bedroom 1 has a wonderful cast-iron stove of later 19th-century style, glazed to look like polished hard wood. It is the Siroco (sic) model named after the hot Mediterranean wind, a well-known type manufactured by the Faure Revin Foundry in the Champagne-Ardennes region of Northern France around 1910 (Fig. 27).

Figure 27: The cast-iron French stove in Bedroom 1

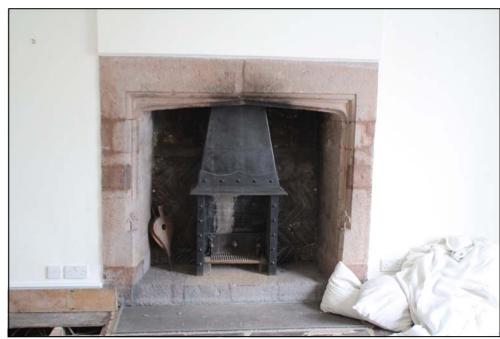
- 5.48 This would be an appropriate date for the wrought and cast-iron hearth in Bedroom 2, of Arts and Crafts style (Fig. 28).
- 5.49 In the western wing the interior was re-ordered in 1930 (Fig. 4). Stripping out and removal of most of the internal walls in the current programme has allowed some observations and interpretations to be made.

Figure 28: The hearth in Bedroom 2

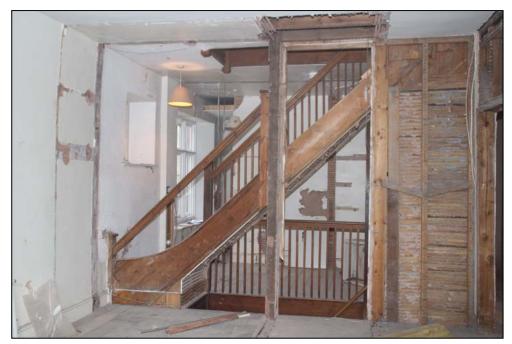
Figure 30: The stair inserted in 1930, first floor looking east

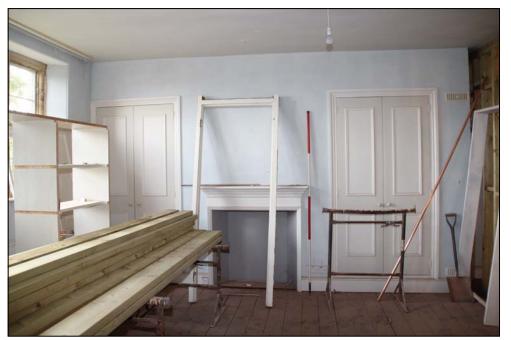
- pre-1880 stair in this wing. The south end would avoid the problems met with by the present stair (see below).
- 5.54 The fitting out and fireplace of Bedroom 5 appears to be 1930 work (Fig. 31).

Figure 31: The west wall of Bedroom 5

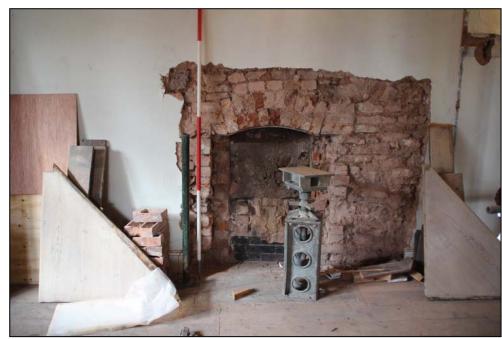
- 5.55 The brick-lined fireplace recess revealed in the north wall of Bedroom 6 is similar to the middle phase of that in the Office and is integral with the 19th-century walling. It cuts into the earlier masonry on its eastern side which is visible in a small area on the right hand side of the brickwork (Fig. 32).

Figure 32: The fireplace recess in the north wall of Bedroom 6 (scale in 0.5m divisions)

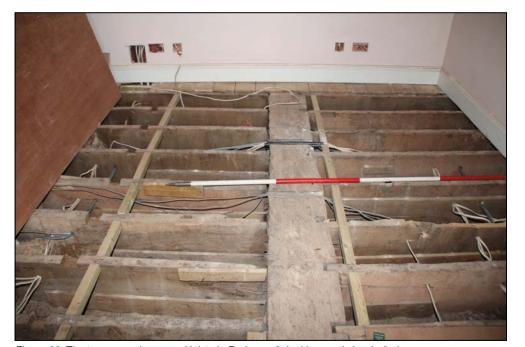
- 5.58 The removal of nearly all the floorboards in Bedroom 8 showed the basic structure of the floors at this level (Fig. 33). This survived on the western side of the transverse central beam where the upright and quite narrow joists were fitted into the beam via a complex joint that can perhaps be described as a central tenon with an undersquinted or spurred tusk and a diminished shoulder. The joists in Bedroom 7 were similarly jointed.

- 5.59 On the east of the beam in Bedroom 8 the mortises had been cut out into simple cogs and new joists fitted. These had to be new as the originals, when cut to fit, would be too short (Fig. 33).

Figure 33: The transverse beam and joists in Bedroom 8, looking north (scale 2m)

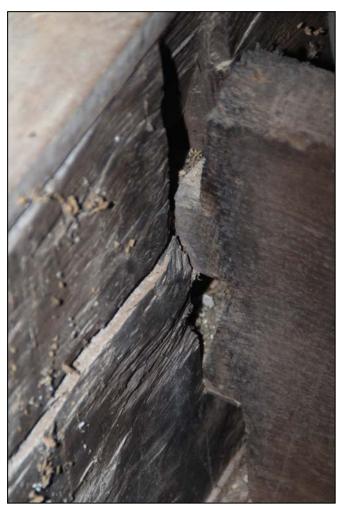
Figure 34: The mortise and tenon joint of the joists and beam in Bedroom 8

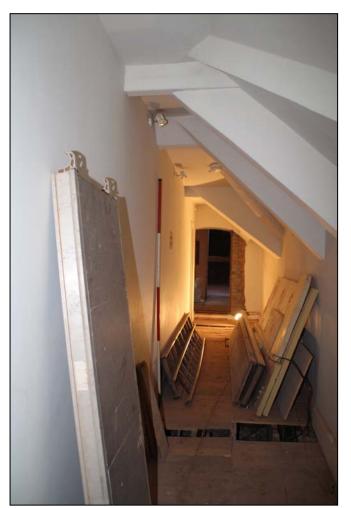
Figure 35: The second-floor corridor of 1930 looking west (scale 2m)

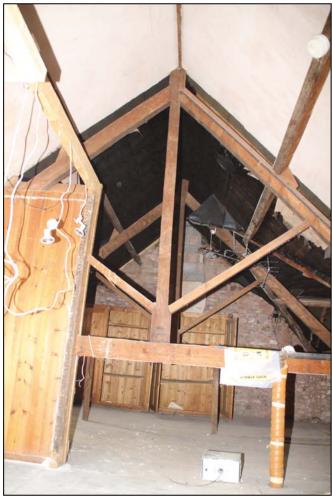
- 5.66 As first built the roof ran east/west supported on three kingpost trusses linked to each other and the gables by heavy purlins resting on the back of the principals and supported by cleats. It was the same width and height as the central 17th-century range (Fig. 38).

Figure 38: The central and western trusses of the west wing, looking west

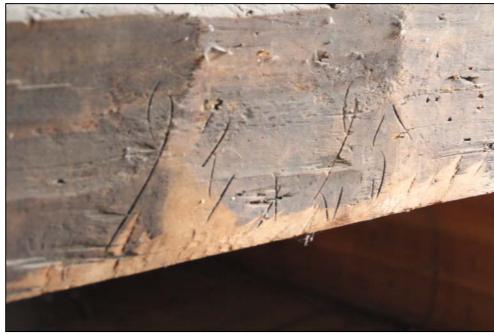
- 5.68 Two of the timbers retain Baltic timber marks on the axe-hewn faces, the timbers having been sawn down from larger timbers imported as roughly squared baulks. The wood is "deal", fir from one of the Baltic suppliers. These are the western truss tiebeam on its western side (Fig. 40) and the eastern lower purlin in the kitchen,

Figure 40: The Baltic timber merchant's mark on the tiebeam of the western truss (beam is 200mm deep)

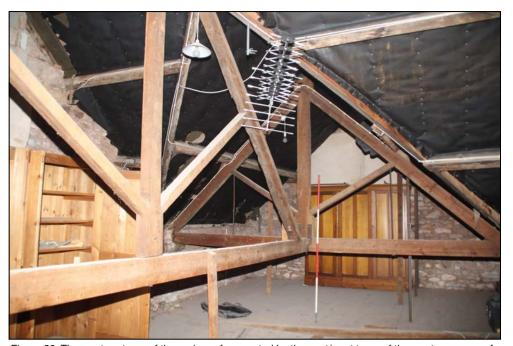
Figure 39: The western truss of the main roof supported by the east/west truss of the western rear roof, looking north-north-west (scale 2m)

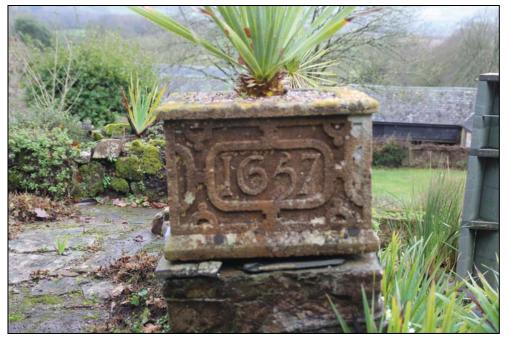
Figure 44: One of the two stone planters in the eastern terraced garden, dated 1657
