Plot C2 Millbay Plymouth

Archaeological Watching Brief

CA Project: 880071
CA Report: 17355

June 2017

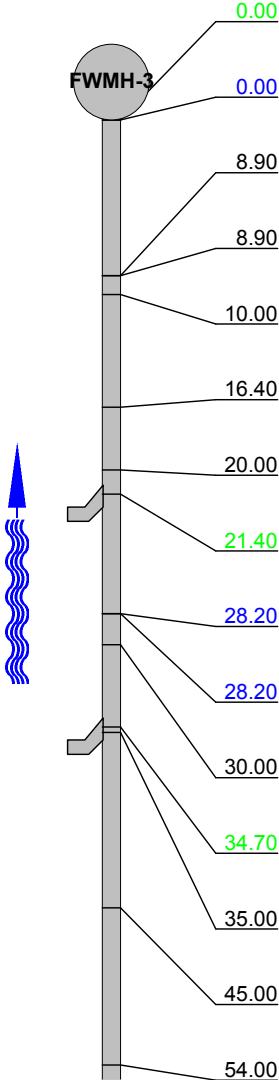
MH	Start node type, manhole, reference number : FWMH-3	00:00:06		(Constr) 0
0.00	WL	Water level, 10% of the vertical dimension	00:00:07		(Serv) 0

8.90	REM	General remark Remarks: CONCRETE REPAIR TO THE TOP OF THE PIPE	00:01:08	5_3A	(Misc) 0
8.90	SC	Dimension changes, 900mm high, 900mm wide	00:01:17		0
