# Catherine Dalley House Scalford Road Melton Mowbray Leicestershire

Historic Building Recording

CA Project: MK0090 CA Report: MK0090\_1

August 2019

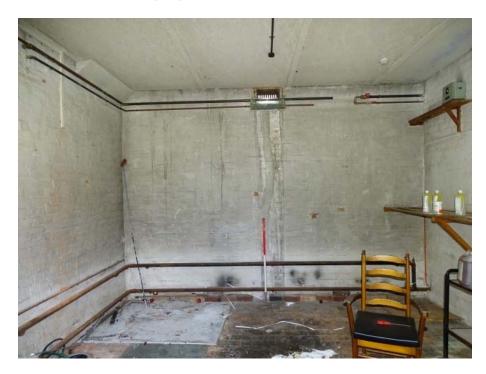
Photo 94: Cottages ground floor room 4 looking north

4.40. Room 4 forms the second bay from the west, fronted by a set of double garage doors at the ground floor (Photo 75), and has at its entrance a blue brick border with a cobbled floor surface (Photo 91). The doors are held with thick steel brackets and hinges (Photo 92) set against chamfered brick edging (Photo 93). The interior space is a painted brick rectangle (Photo 94), the historic cartographic sources suggest that the rear wall and door arrangement (Photo 95), were inserted in the early 20th century when the separate buildings were joined.

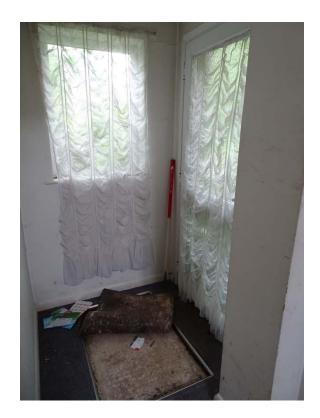
Photo 96: Cottages ground floor porch arrangement

4.41. The east aspect of the Cottages is accessed via a 20th-century porch arrangement that was locked on the day of the survey (Photo 96). The porch provides an entrance into room 5. Room 5 has a modern screed floor and a uPVC window arrangement looking north (Photo 97). The room also contains a chimney breast (Photo 98), that reflects the stack arrangement in the roof structure (Photo 75).

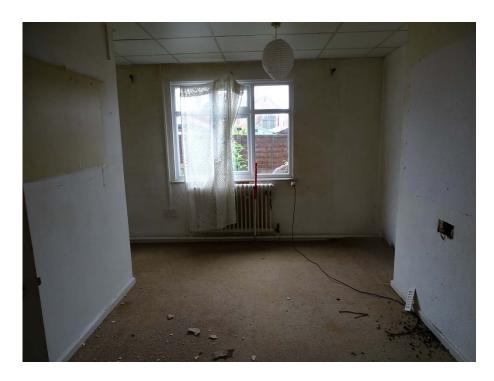
Photo 99: Cottages ground floor room 6 looking north

4.42. Room 6 at the ground floor of the Cottages is accessed to the right of the porch entrance and has a modern uPVC window arrangement facing north (Photo 99), and is carpeted over a screed floor. The room contains an under stairs cupboard arrangement (Photo 100). The modern looking timbers used in the staircase construction and differences in the brickwork revealed, suggest that the staircase and brick partition is a modern intrusion that is potentially commensurate with the modern porch arrangement. The room contains the reverse of the chimney breast in room 5 (Photo 101), the chimney breast contains a ventilation slot suggesting a fireplace behind.

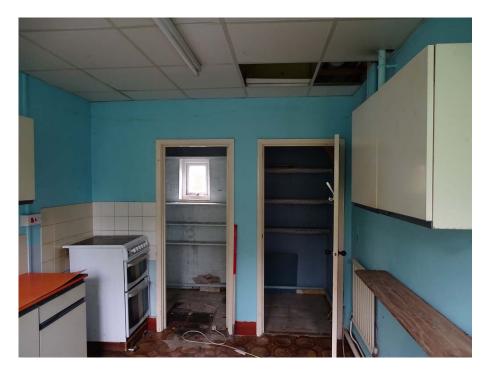
Photo 102: Cottages ground floor room 7 looking north

4.43. Room 7 of the ground floor of the Cottages is accessed via an internal door from room 6. The room is a kitchen space with two cupboards at its north aspect (Photo 102), below a modern suspended ceiling. The south aspect of the room has a modern uPVC door and window arrangement (Photo 103), the door being locked on the day of the survey.

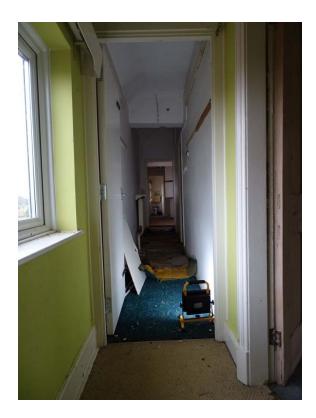
Photo 104: Cottages first floor east/west corridor looking east

4.44. The first floor of the Cottages has an east/west orientated corridor (Photo 104) that allows access to rooms 8-14. Rooms 8 and 9 represent the first floor of the original west aspect cottage of the range. Room 8 has been converted to a modern small bathroom and toilet space (Photo 105). Room 9 (Photo 106) has been used as a bedroom and contains a chimney breast with a ventilation slot (Photo 107) that reflects the chimney stack arrangement in evidence at the exterior of the Cottages (Photo 75).

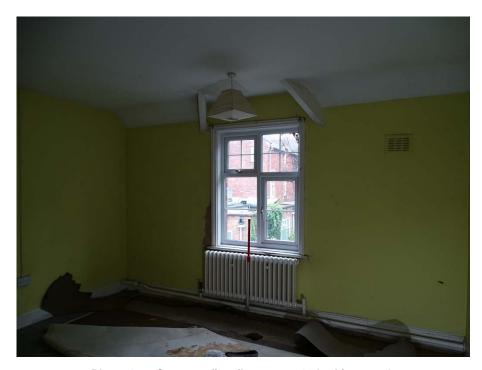
Photo 108: Cottages first floor room 10 looking south

4.45. Room 10 has been created above the void space represented by room 4, potentially during the early 20th century remodelling of the range. The room contains a south-facing modern uPVC window (Photo 108), and has been used as

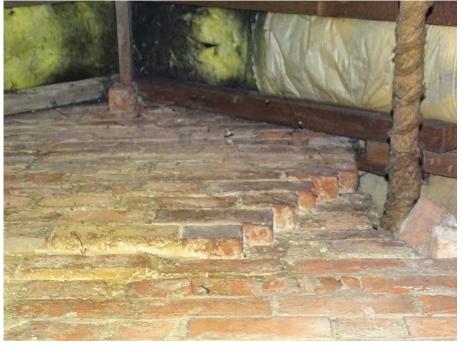
Photo 109: View into loft hatch in room 10

a bedroom. The room has an open loft hatch that allows a view of the brick corbelling (Photo 109), to what would have been the external chimney stack at the east elevation of the once separate dwelling. The room also contains a chimney breast at its east aspect (Photo 110). The intrusive asbestos survey has revealed the lath and plaster composition of the north aspect partition wall, the ceiling is similarly revealed as modern gypsum boarding.

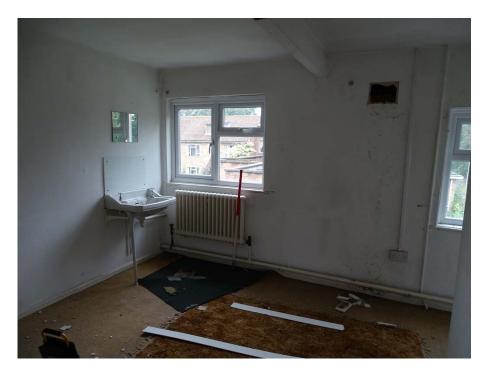
Photo 112: Cottages first floor room 12 looking south

4.47. Room 12, with the exception of its north and south external walls has been created using modern partition walls. It appears to have been used as a self-contained living space (Photo 112). There is a full span timber roof beam that has a bolt at centre span that would suggest a steel King Rod above (Photo 113).

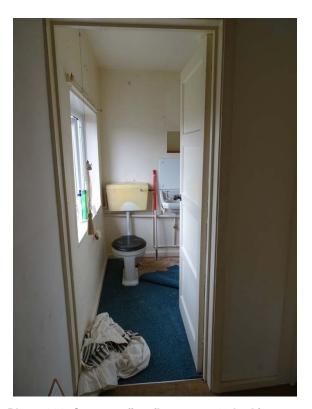
Photo 114: Cottages first floor room 13 looking east

4.48. The east/west orientated corridor of the Cottages first floor terminates at its west aspect in a bathroom, room 13 (Photo 114), and an access into room 14. Room 14 contains modern uPVC window units (Photo 115), and a second full span timber roof beam with a bolt at centre span (Photo 116).

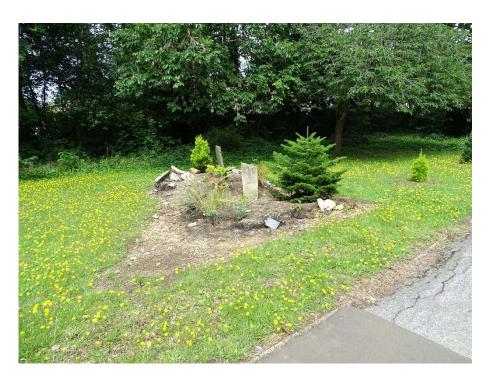
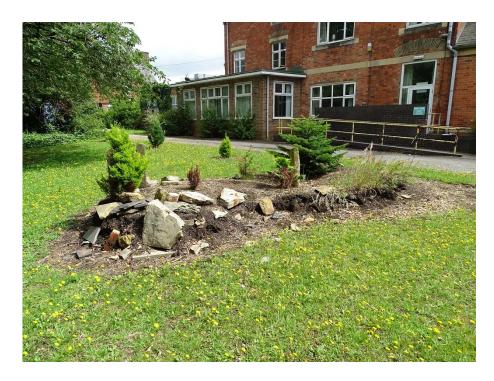
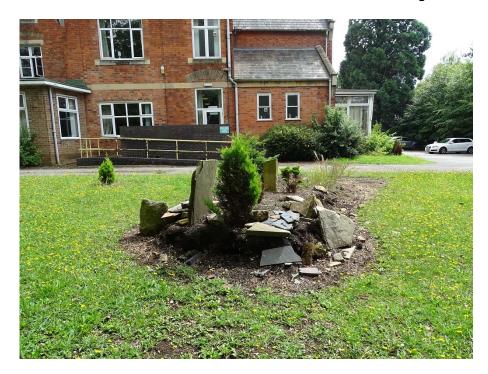
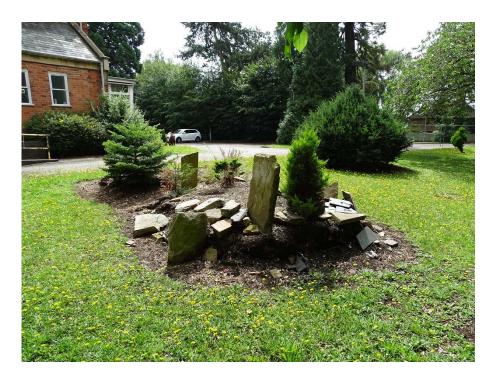
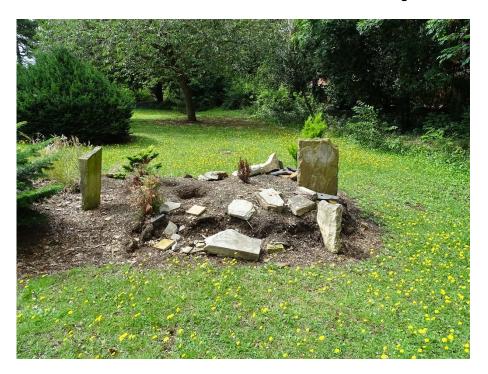
- 5.14. The grounds at the west aspect of the House contain an interesting mound feature (Fig. 5). Anecdotal evidence suggests that the mound feature may represent a burial site of a favoured horse, associated with the fox hunting tradition of the House. The arrangement of stones and trees on the mound is intriguing (Photo 118 – 122).

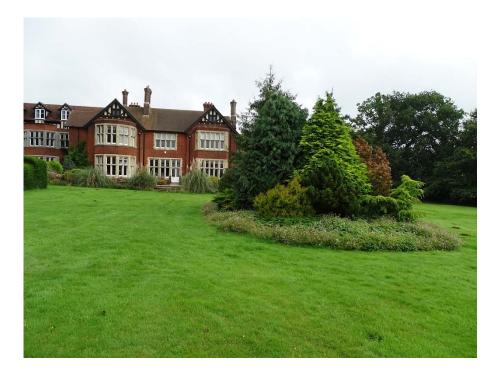
Photo 123: Burial mound in the grounds of the Scalford House Hotel

5.15. The practice of burying a favoured horse in the grounds of hunting lodges is not without precedent. The nearby Scalford Country House Hotel, built at the beginning of the 20th century was used as a weekend hunting lodge. The house was purchased in the 1930s by Colonel Colman of the Colman's mustard family, Colonel Colman is reputed to have buried his favourite horse in the grounds of the house, a burial plot that remains today (Photo 123).
