# The Garages, Temple Guiting Manor

*Level 2 Historic Building Recording*

CA Project:CR0132

August 2019

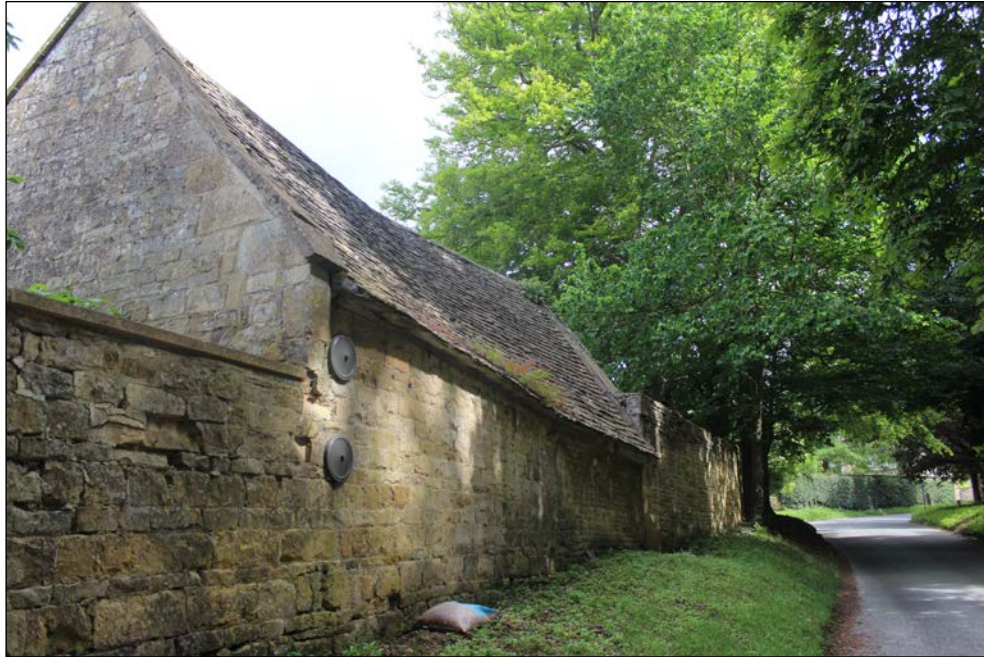
**Fig. 9** East, roadside elevation of the garages, view to the north

- 3.8. The buildings (Fig. 2) comprise of two structures known as the north and south garage located on the east side of the main drive to the house accessed from the north via Manor Lane. Their east elevations abut an earth bank bordering the main road through the village of Temple Guiting (Figs 9 & 10).

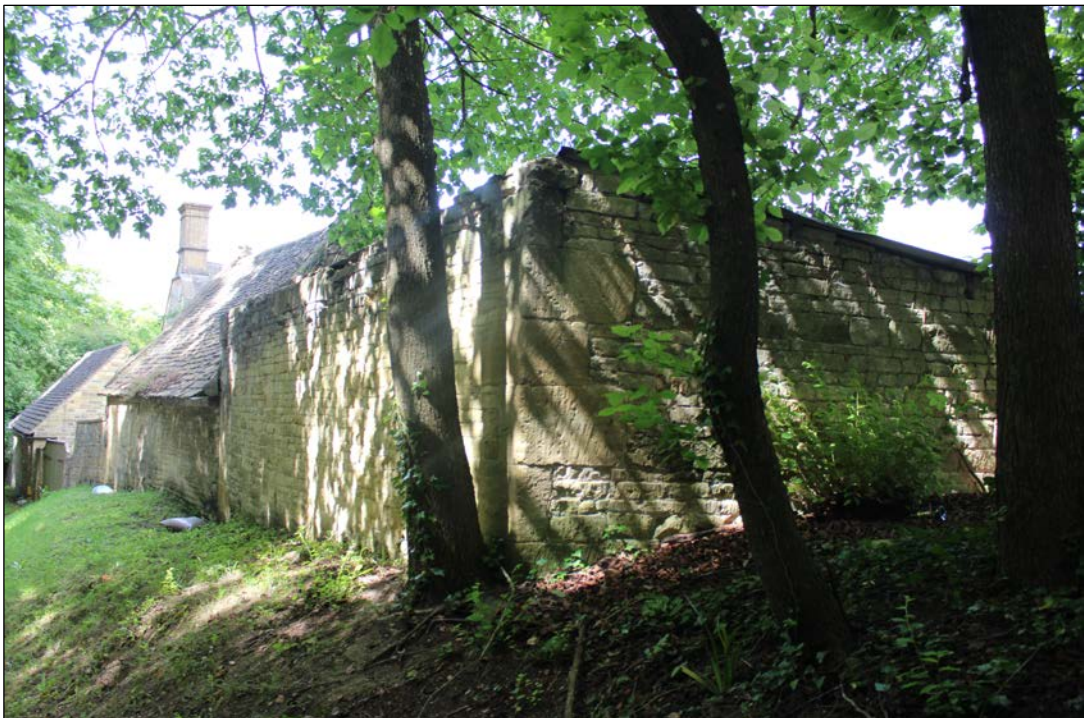
**Fig.16** View of north and east walls of north garage, view to the south

3.11. The north wall abutting the lane bank shows part of a blocked-up doorway evidenced by large ashlar quoins and inset rubble infill (Fig. 14) and the east wall viewed from the lane has what looks to be an ashlar stone cill which is clearly a truncated window (Fig. 15). Both of these features are entirely consistent with the theory that this building is formed from the truncated eastern range of the large barn.

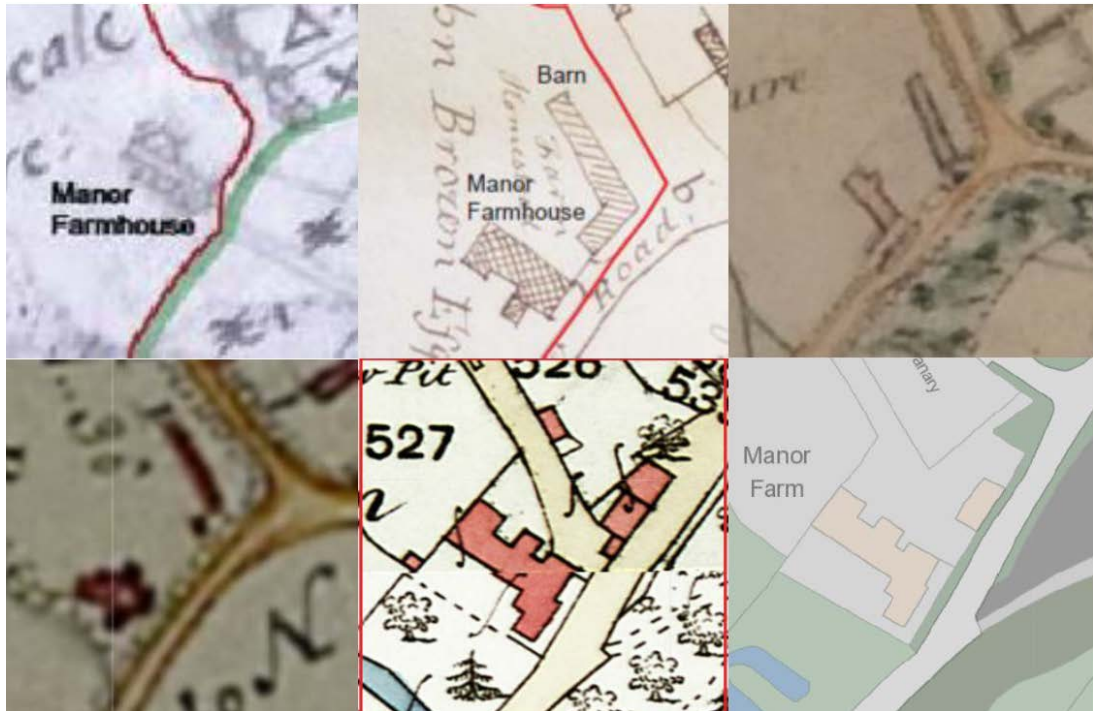
Fig. 39 Tiled map detail, from top left clockwise: 1603, 1804, 1818, 1840, 1881, 2017

- In the 1st Edition OS map of 1881 the barn has gone and the two garage buildings appear to be in their current form (though the 'kink' in the plan form is not evident). A small building sits attached to the south. The main farm buildings now appear to form a group c.60m to the west of the garages, away from the manor.

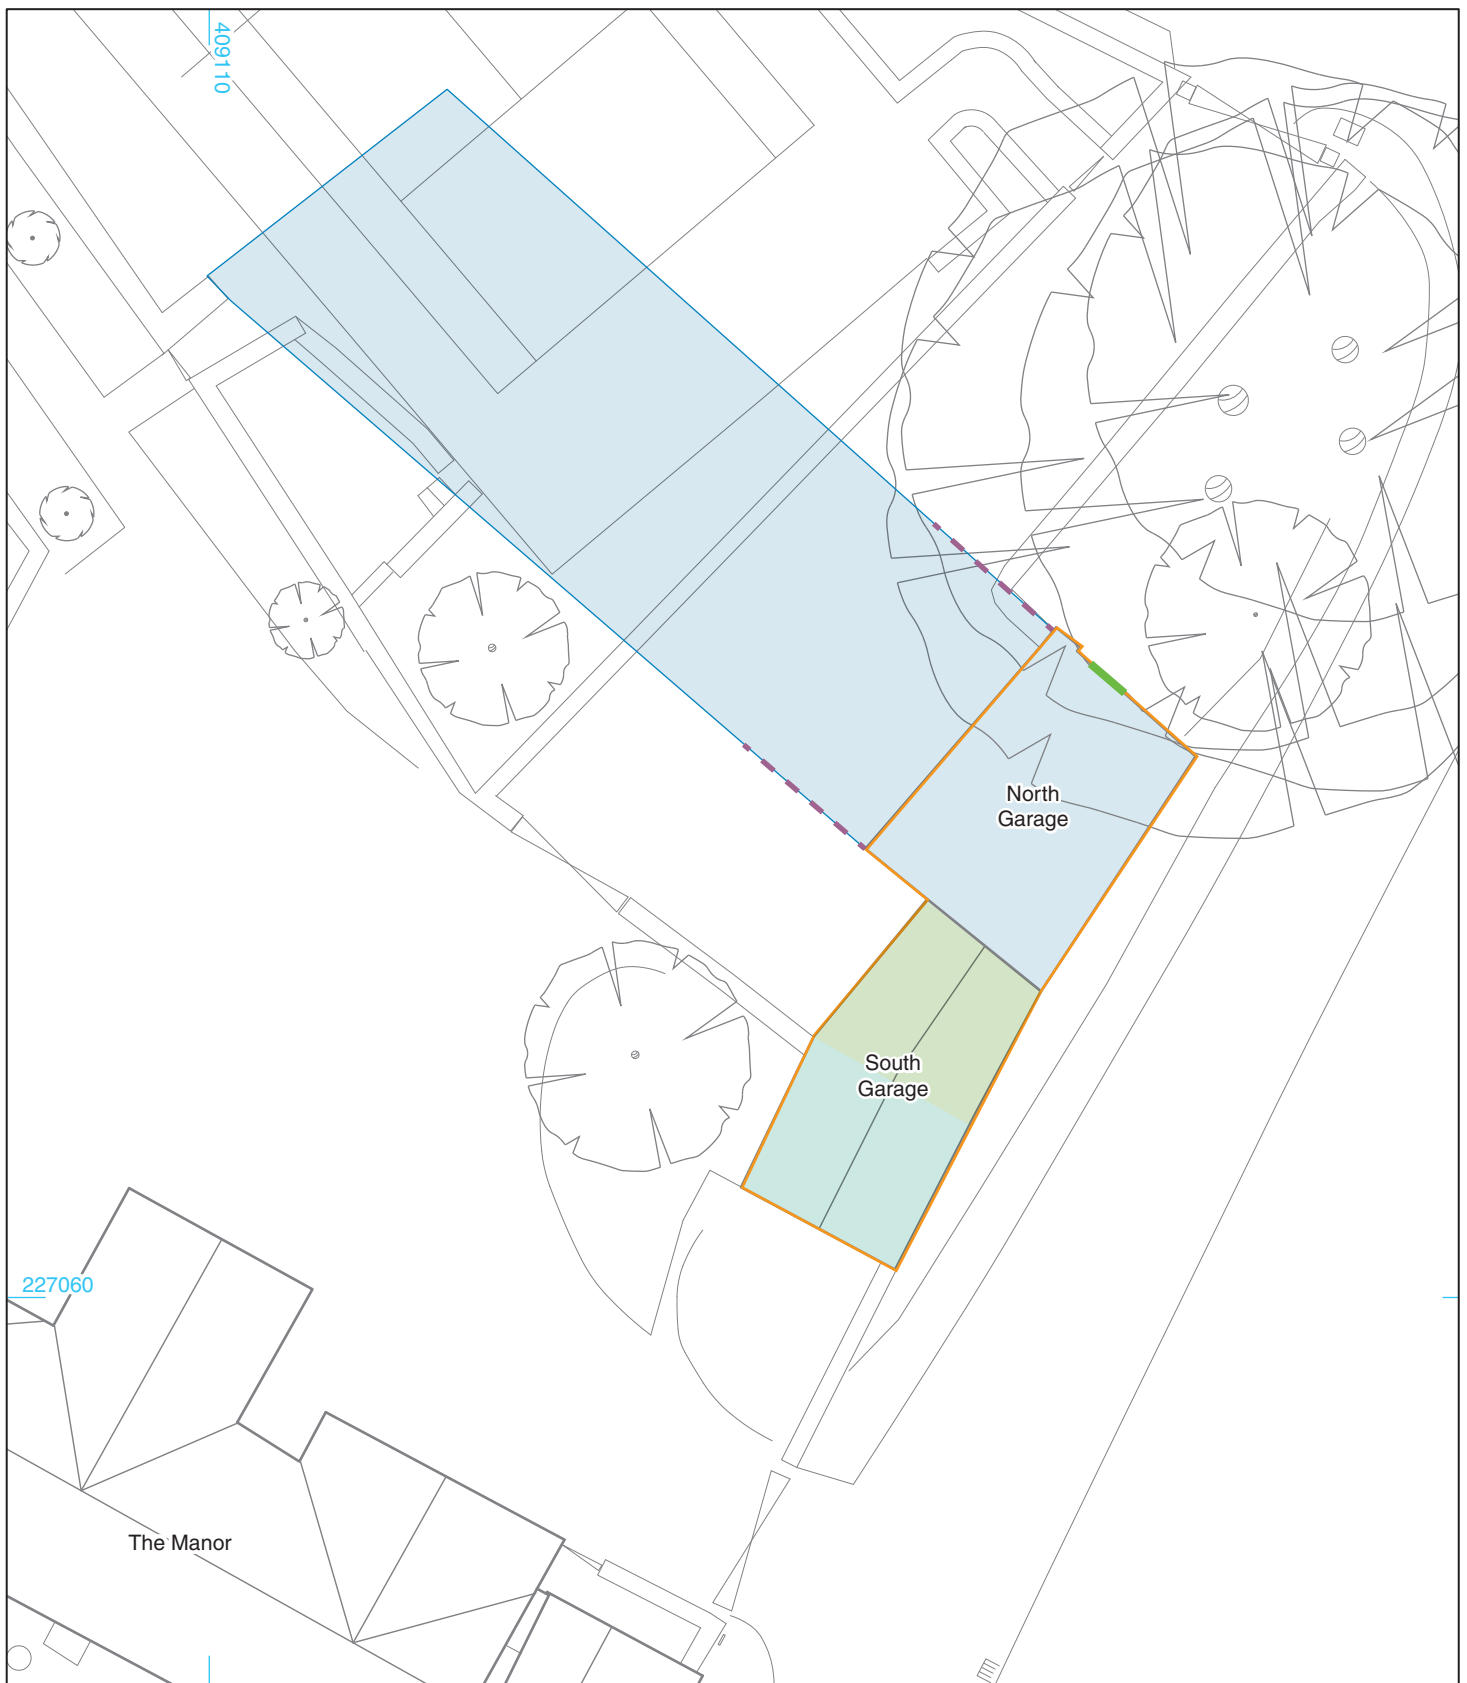
3.27. Of course, the cartographic evidence of plan form may be incorrect or inaccurate, but given that some of the evidence is supported by visual clues within the fabric of the buildings, the above is an 'educated guess', as shown on Fig. 38.

- The Garages
- Original south building, built between 1818 - 1840
- 'Infill' building, built post-1840
- Possible plan form of barn
- Possible location of threshing door
- Site of infilled doorway
