# The Old George, High Street Stony Stratford Milton Keynes

*Historic Building Recording*

CA Project: MK0097

October 2019

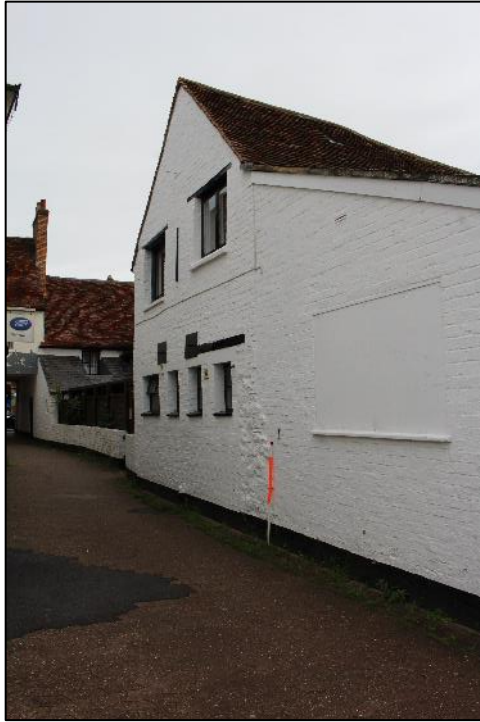
**Photo 8: The re-built brick gable end of the late 18th/early 19th century range.**

- 4.5. The Staff WC, Boiler Room and the en-suite bathrooms associated with Rooms 6 and 7 are situated within the L-shaped, gable ended range of late 18th/19th century date (Photos 2 to 5). The range is of rubblestone construction and is slightly narrower and with a shallower pitched roof than the earlier late 17th/18th century range. The range has been remodelled with the reconstruction of the western gable end in brick, no earlier than the 19th century (Photos 7 to 10).

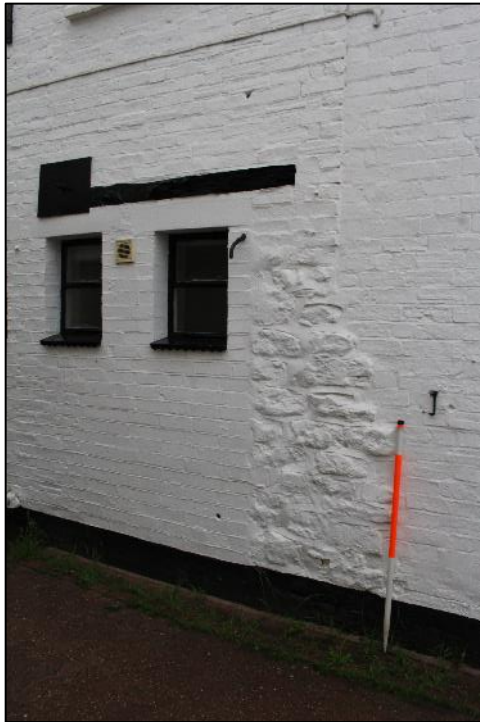
**Photo 10: An area of rubblestone within the re-built western gable end.**

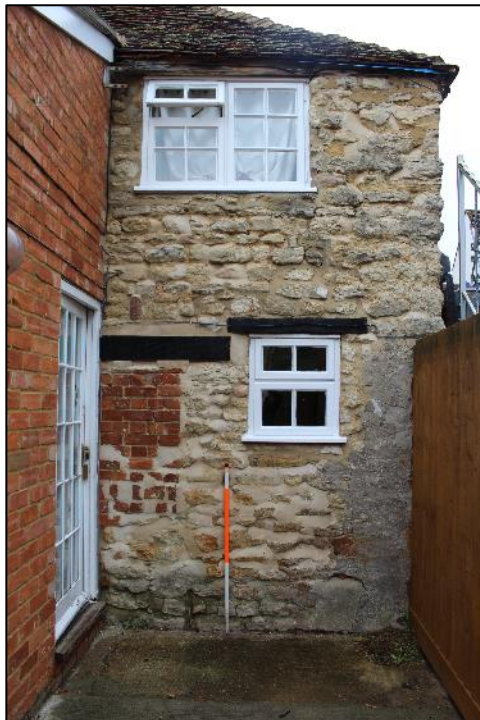
**Photo 11: Detail of the southern elevation of the late 18th/early 19th century range.**

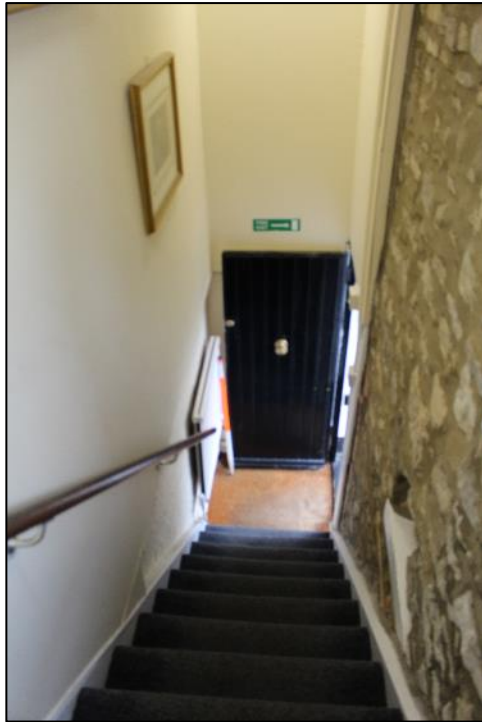
**Photo 22: An overview of the stairwell.**

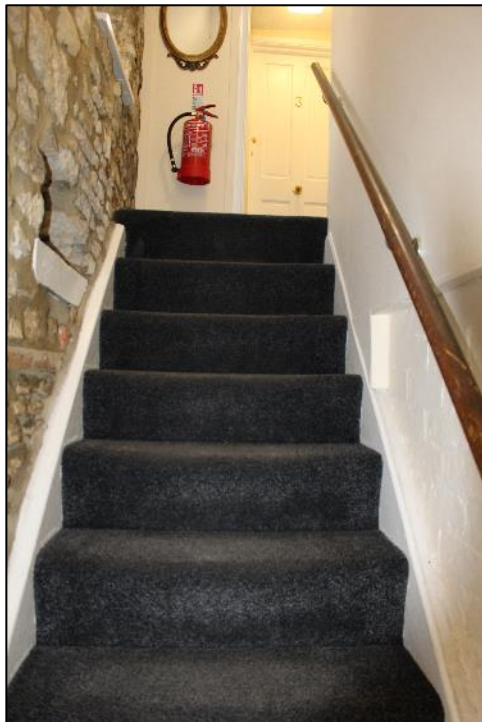
**Photo 23: An overview of the stairwell.**

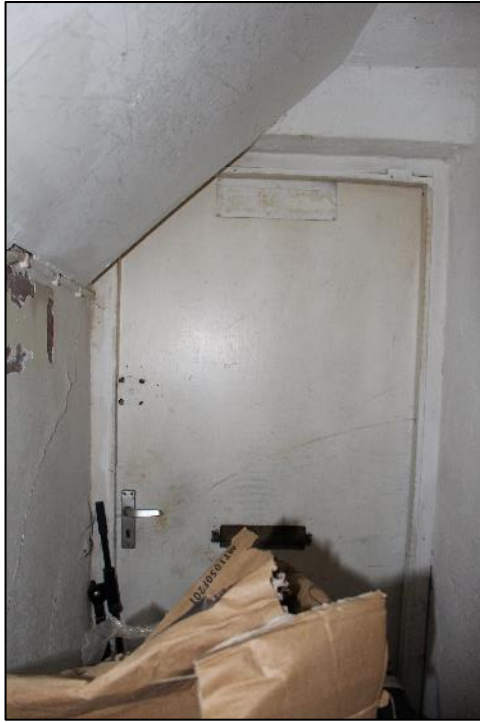
- 4.8. The doorway at the eastern extent of the northern elevation is un-used but the doorway has not been blocked (Photo 4 and Photo 26). The door would have provided access from the courtyard in to the eastern extent of the gable ended range which has been subdivided in to three small rooms (the Staff WC/store and the en-suite bathrooms for Rooms 6 and 7). The partition rooms forming the en-suite bathrooms are of brick construction with some breeze block repairs. The use of brick suggests that the partitions were added either after or at the same time as the rebuilding of the gable end of the late 18th/ early 19th century range (Photos 27 to 30). The underside of the staircase is visible within the lobby area to the Staff WC and crudely cuts across the door opening within the northern elevation further suggesting that these rooms formed part of the conversion of the Building (Photo 26).

**Photo 26: Door opening within the northern elevation of the late 18th/early 19th century range.**

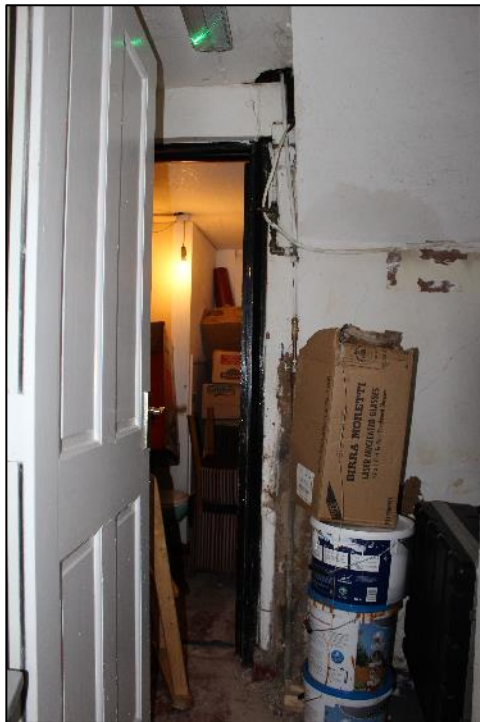
**Photo 27: The Staff WC/store from the east.**

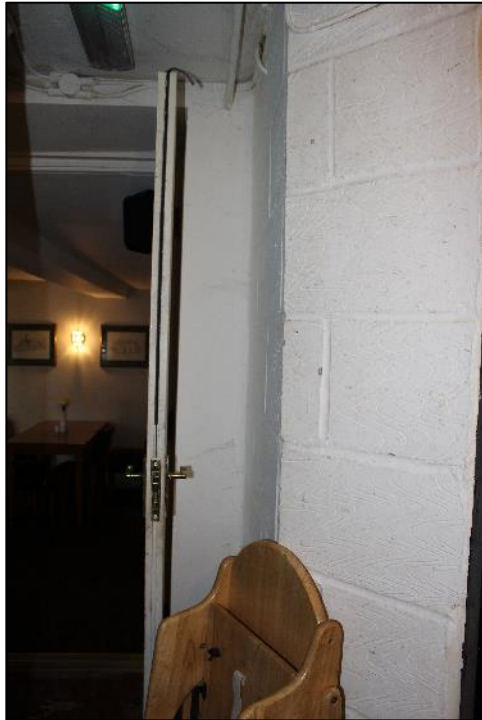
**Photo 28: Breeze block wall construction to the southern wall of the Staff WC/Store.**

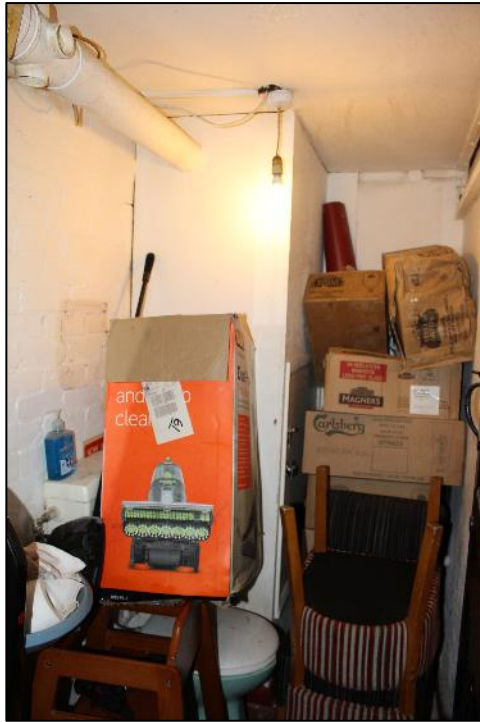
**Photo 30: The western extent of the Staff WC/ store.**

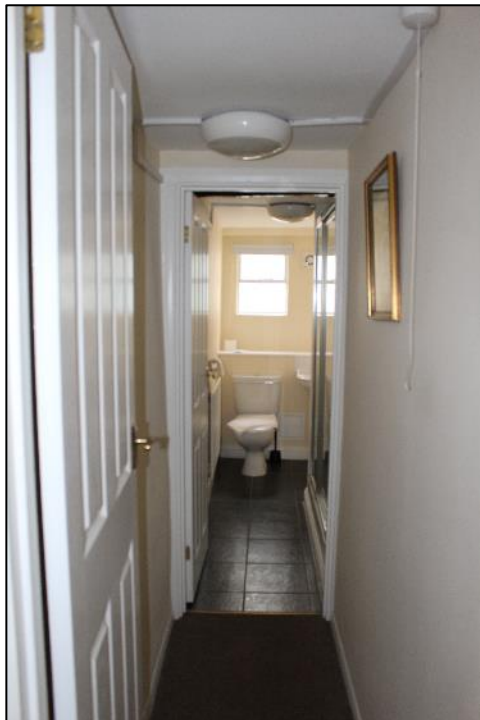
- 4.9. The en-suite bathrooms of Rooms 6 (Photos 31 to 33) and Room 7 (Photos 34 to 37) contain a number of substantial timbers aligned on a broadly north to south axis. The timber within Room 7 (Photos 34 and 36) appears to have been boxed in and the brick walls constructed around the timber, whilst the timber within Room 6 has been left un-boxed (Photo 32). These timbers are not apparent within the Boiler Room and the Staff WC but it is possible that they form part of the ceiling/floor structure associated with the rebuilding of the gable end of the late 18th/ early 19th

**Photo 31: The corridor to the en-suite bathroom of Room 6.**

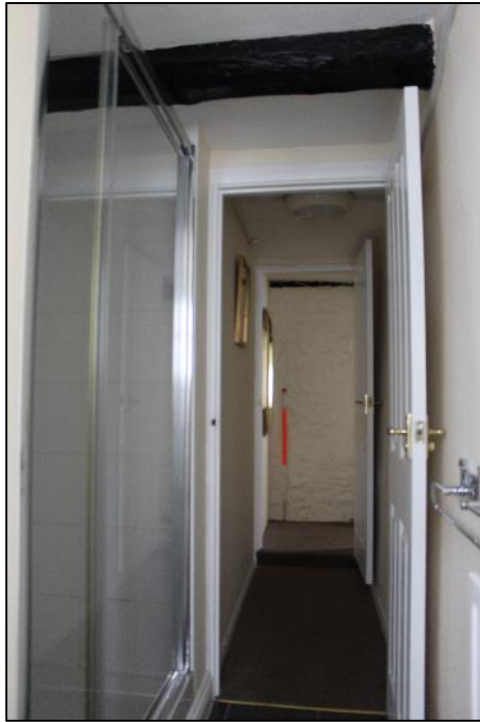
**Photo 32: Timber beam within the en-suite bathroom of Room 6.**

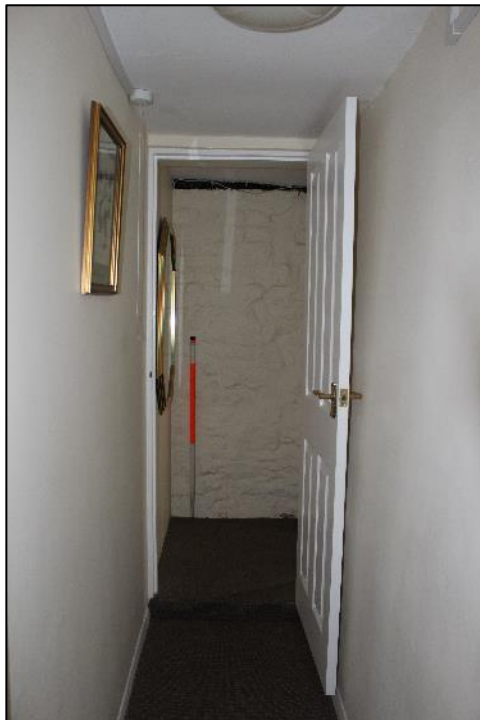
**Photo 33: The corridor within Room 6 looking towards the rubblestone western elevation of the late 18th/ early 19th century Building.**

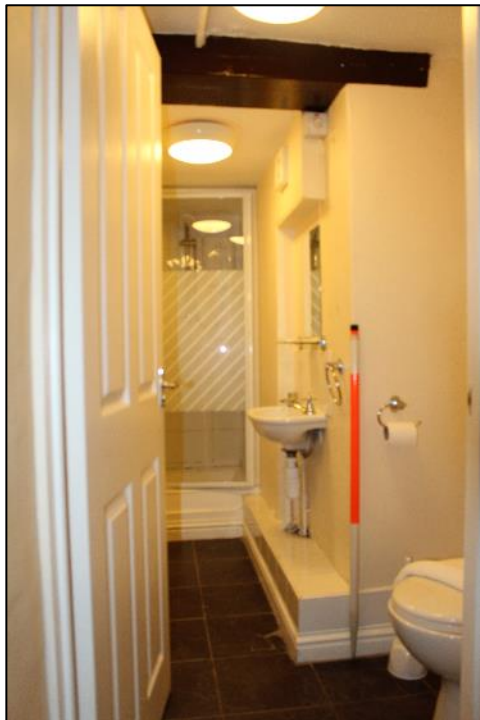
**Photo 35: The en-suite bathroom of Room 7 from the east.**

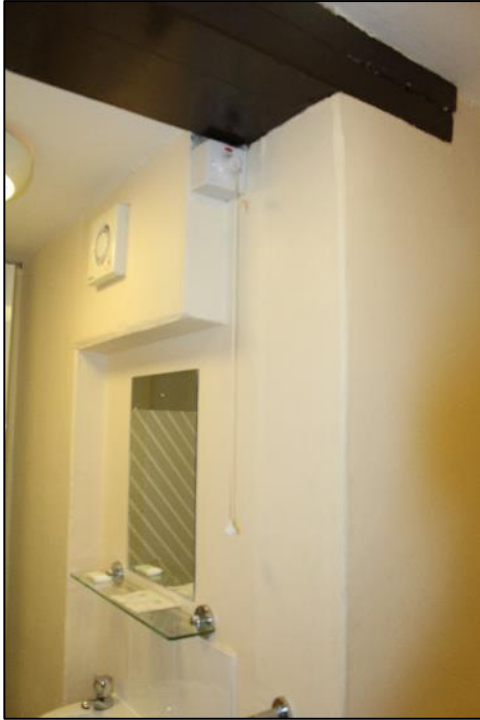
**Photo 36: Detail of boxed timber within the en-suite bathroom of Room 7.**

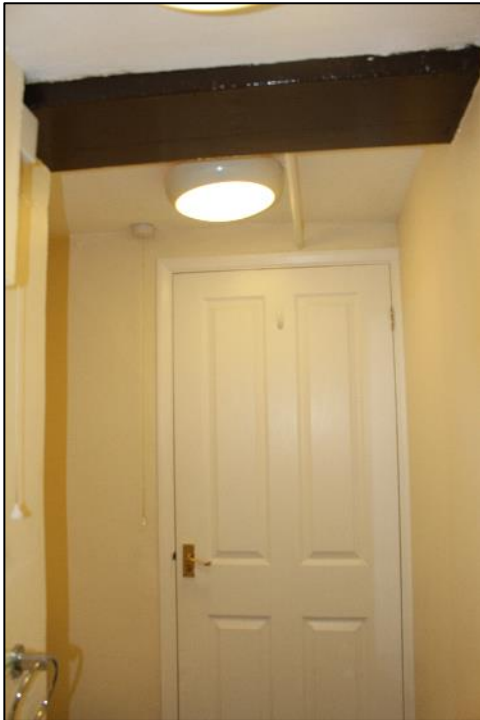
**Photo 37: Detail of boxed timber and door opening within the en-suite bathroom of Room 7.**
