# Greendale Farm Clyst St. Mary, Devon

*Historic Building Recording (Demolition)*

CA Project: EX0074

April 2020

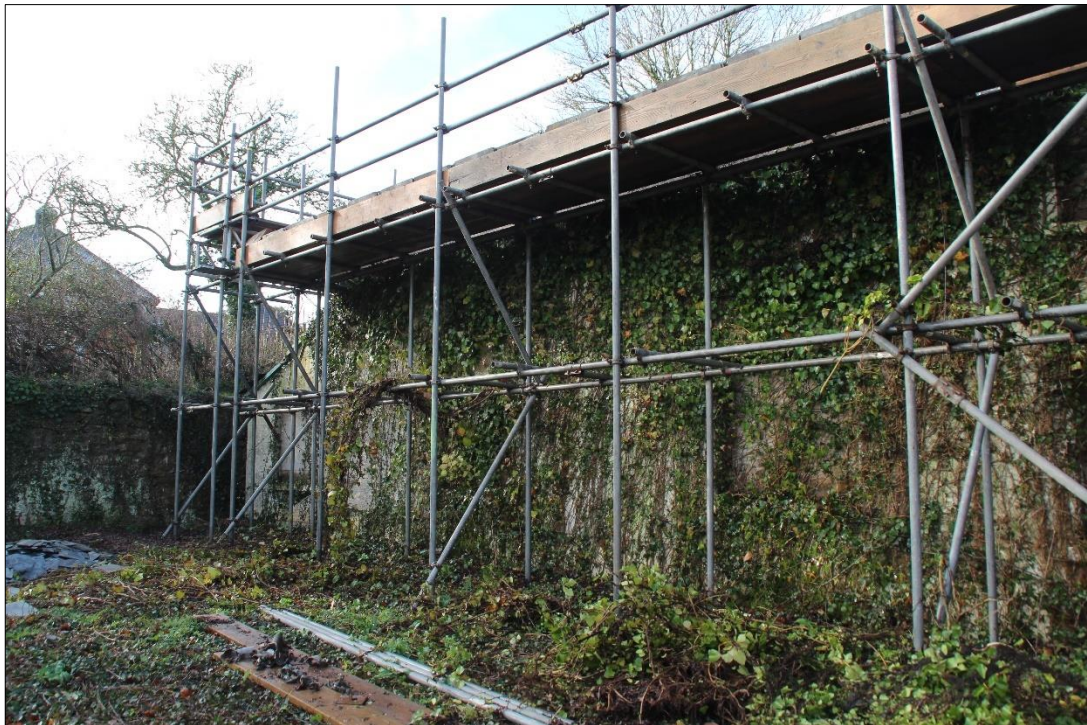
**Fig.6 Eastern elevation of the Building, image taken looking south-west**

- 4.1. During this site visit, the early stages of stripping out of the Building had occurred; the slate roof tiles had been removed and access to the roof was possible via the scaffolding. Internal inspection was limited to ground floor areas only as water ingress had made the upper floor unsafe to access.
- 4.2. Figs. 6 and 7 give an overview of the eastern elevation of the property from ground floor level. The windows are boarded, and there is nothing of note to record here.

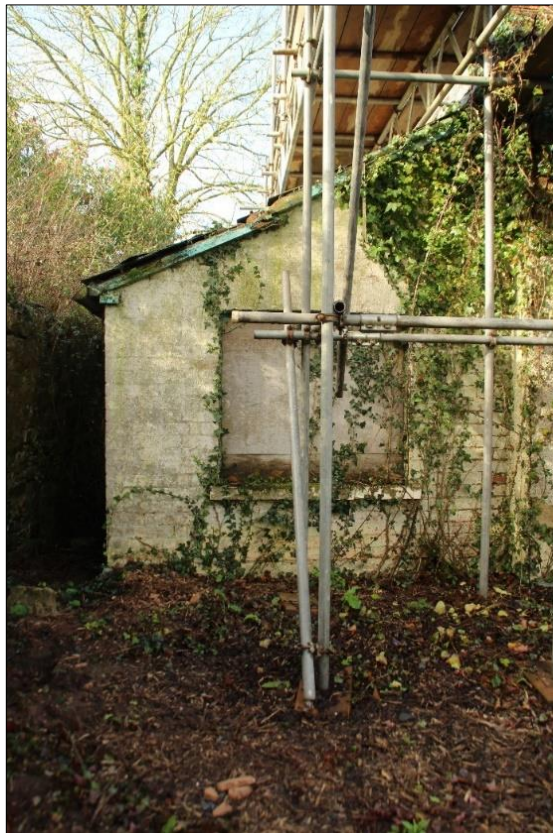
**Fig.8 Dairy extension, image taken looking west**

- 4.3. It was not possible to move around the southern part of the Building due to safety concerns, but a view of the dairy extension was seen (Fig.8).

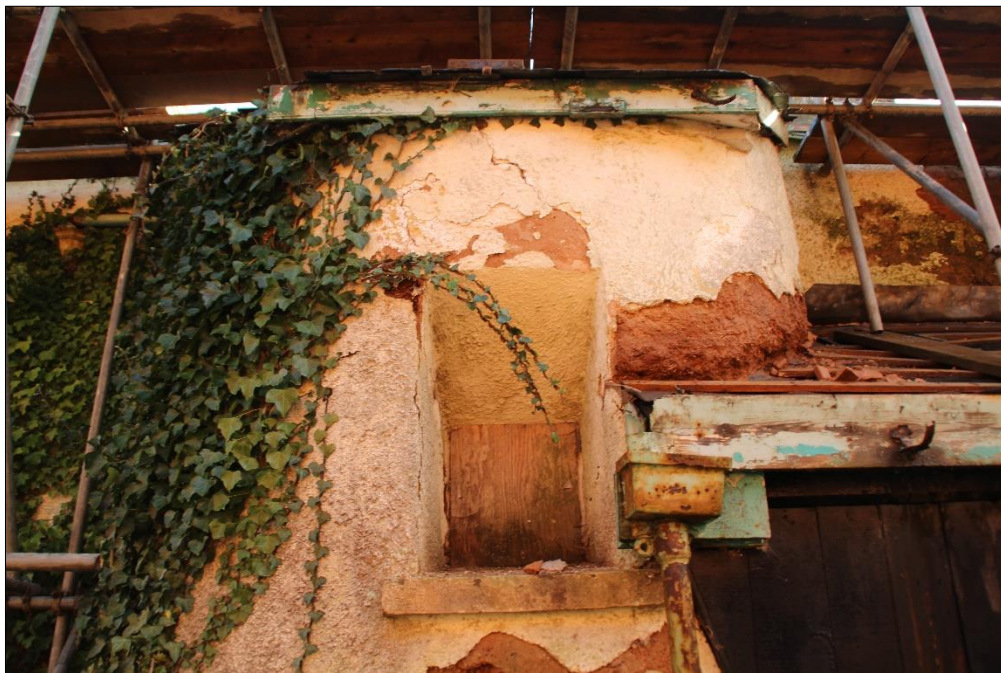
- 4.6. The west elevation is the most complex, as it has both the circular turret and the kitchen and lean-to extensions. The turret (Fig.11) had lost some of its render at this site visit, and it was observed that the structure has been heavily repaired over the years, a hotchpotch mix of cob, brick and local stone, thought to be Heavitree, was observed within the walling. A low brick string course was observed, presumably inserted for structural reasons. The small window top lighting the modern lavatory now within the interior of the turret, with its thick splayed reveals, was observed, and the slate lean-to roof was at this point still in-situ.

**Fig.12 View of the turret window and joint with the lean-to roof**

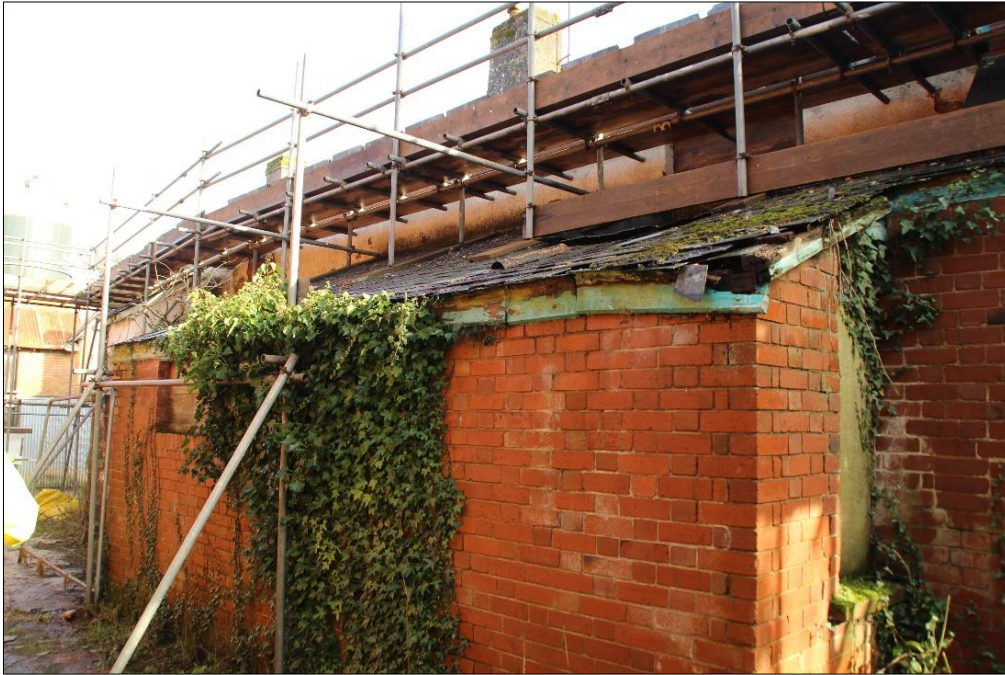
- 4.7. Moving further south along the west elevation, the lean-to porch abuts the stair turret, nothing of interest was noted with this structure. Adjacent and just south is the kitchen lean-to extension, which Morriss suggests is an early-mid 20th century addition to the Building. It is built of brick (Fig.13), but a cob wall was observed as being the walling structure between the kitchen and the interior of the Building as

**Fig.13** View of the kitchen extension on the western elevation, view taken looking north-east

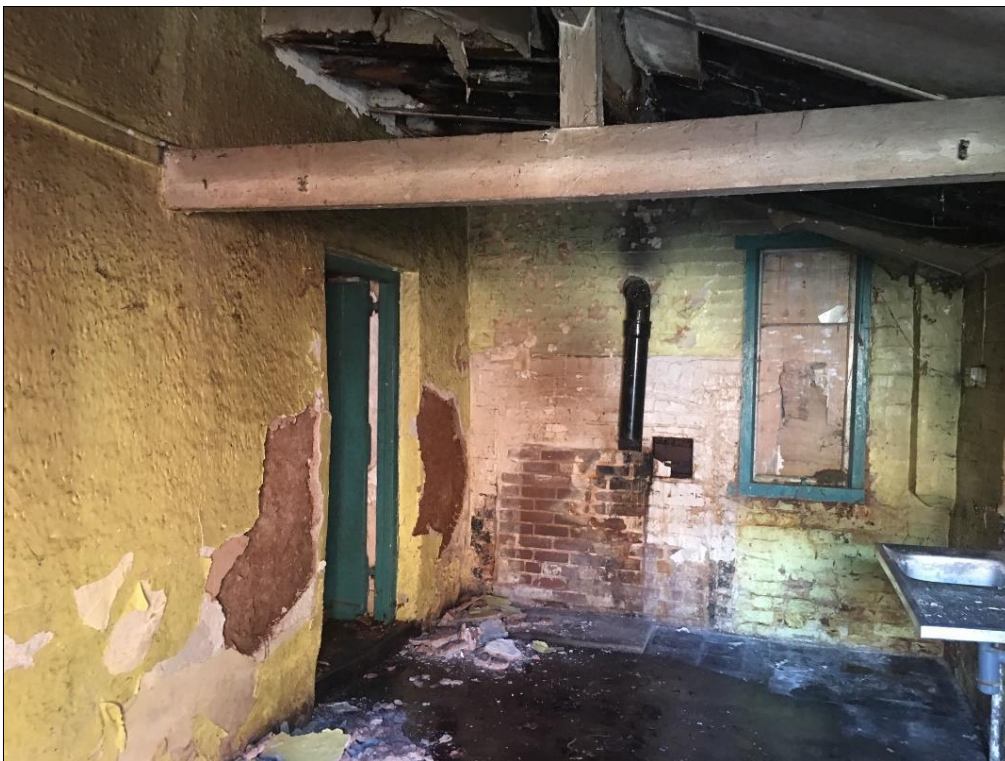
seen on Fig.14 where areas of plaster have been removed. This wall is part of the extended part of the Building (the southern section).

**Fig.14** View of the interior of the kitchen looking towards the entrance to the rear hall

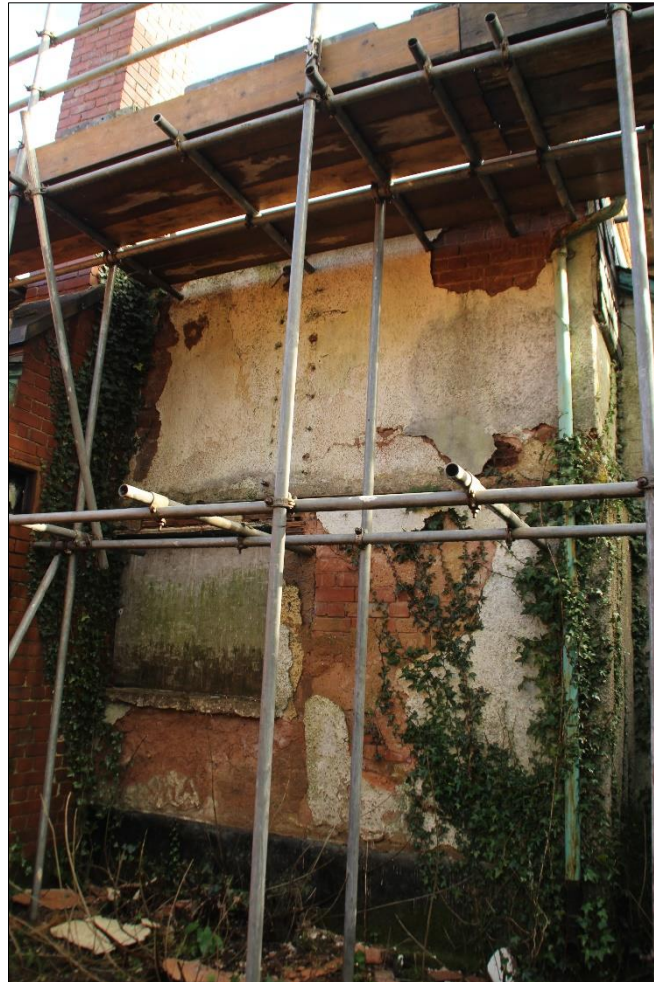
- 
- 4.8. At the southernmost end of the west elevation of the Building more mixed type walling was seen, with brick infilling between areas of cob, and a slate string course below just above ground floor level (Fig.15). Again, this is part of the Building that was extant before 1839, but is the later addition to the original northern dwelling. A blocked-in window has a stone or concrete sill with timber lintel above.

**Fig.15 The northern section of the eastern elevation**

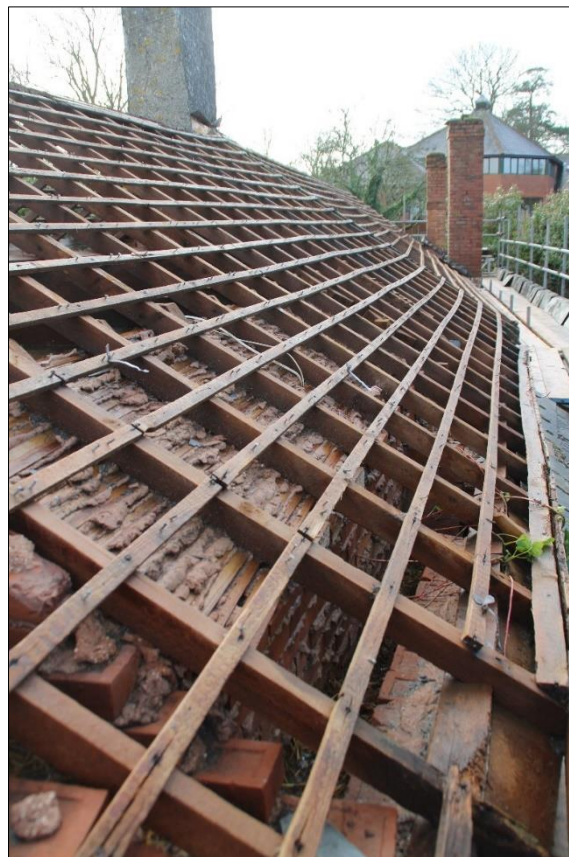
**Fig.17 View of the western roofscape, looking south**

- 4.9. The roof structure has been uncovered and it is was possible to view the roof timbers and general structure from the vantage point of the scaffolding. The roof itself appears to have been replaced as the timber battens, purlins and rafters were all machine cut in relatively good condition. This may be a result of the c.1900 refurbishment. A general view of the east and west elevation of the roof structure is seen in Fig.16 and 17 showing the overall arrangement. Note the kink in the roofline adjacent to the central chimney stack which delineates the older northern section of the Building from the later (pre-1839) southern section.

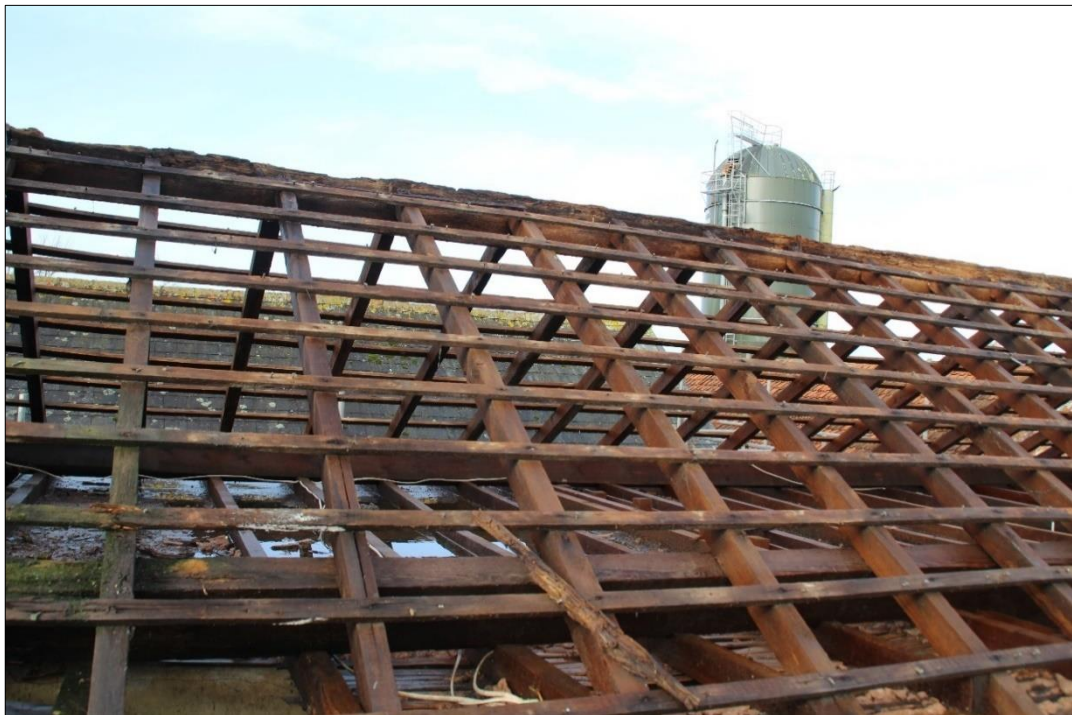
- 4.12. Moving around the east elevation, this shows a simple ridged roof arrangement, with machine cut coupled rafters and battens in good condition. The ridge piece is an older piece of wood, as looks to be hand cut, though water ingress may have caused it to rot and thus appear rougher. Given however that this is the older part of the Building, it is possible the ridge piece is original or part of an earlier roof structure than the extant version. A large purlin type member is seen in Fig.19 resting on the regularly spaced collars that act as joists of the ceiling below. No substantial tie beams were noted in this part of the Building, suggesting the collar performed the structural tying-in function within a simple collared roof truss.

**Fig.19 View of the eastern roofscape, looking internally within purlin resting on rafters**

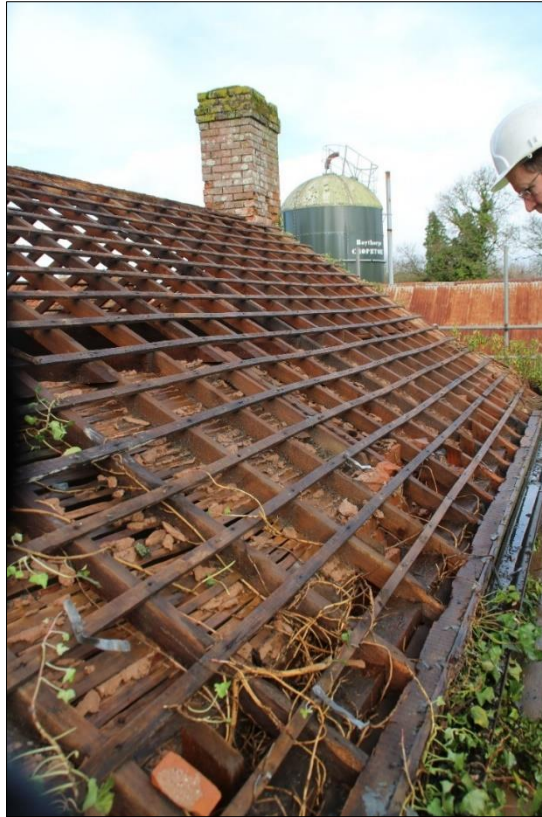
remaining roof space (Fig.20). The central chimney stack forms the link between the northern and southern sections of the Building. Some of its render has been removed to reveal crude buff or pale bricks (Fig.21). It is not possible to date these bricks, but it is clear they are a different earlier phase of the Building to the other chimneys. Buff bricks are a known import from the Netherlands during the 17th century but the deterioration on these bricks makes dating difficult. A curious stepped arrangement is seen within an internal roof void; Fig.22 gives a view from above. To the left of the void is the lathe and plaster of the upper room of the southern building and to the right, modern bricks which probably form part of the new brick spine wall located in this part of the Building. This may indicate the chimney was at one point on an external wall of the northern Building, though the chimney void may also have been created when the Building was extended pre-1839, with the chimney structure being uncovered and incorporated within the new structural arrangement.

**Fig.20** View of lathes and torching, eastern roofslope

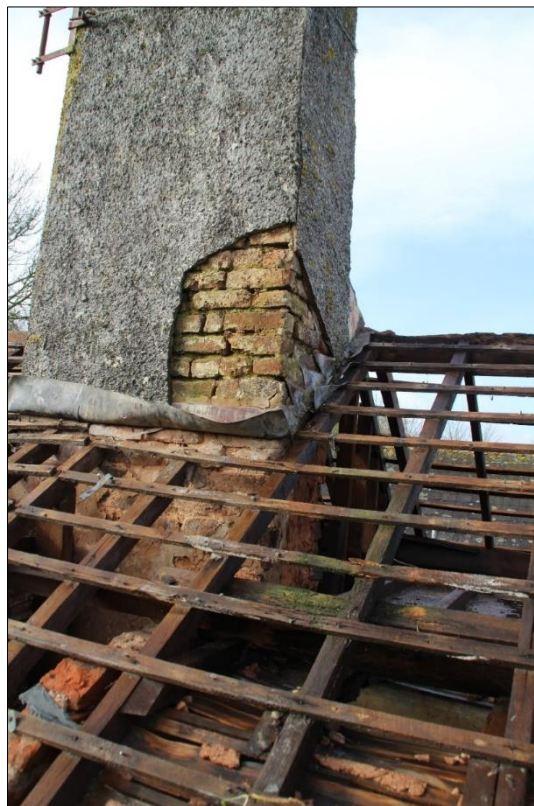
**Fig.21** View of large central chimney stack with pale bricks

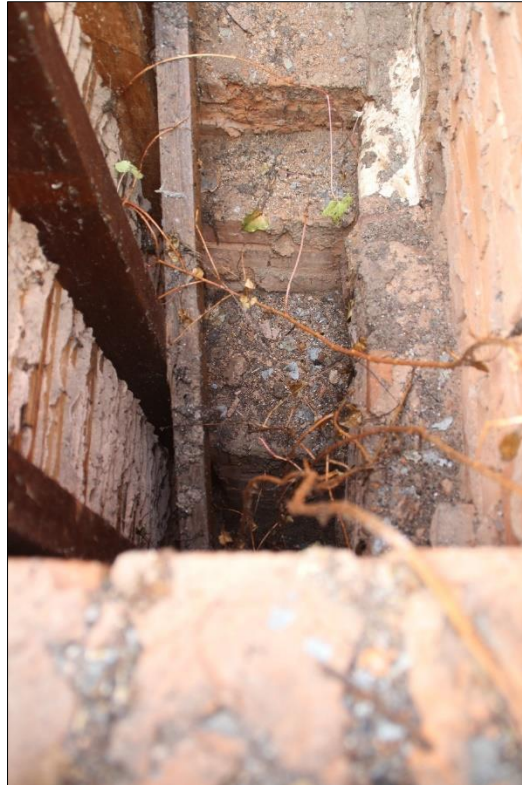
**Fig.22 Void within the roofspace next to older chimney**

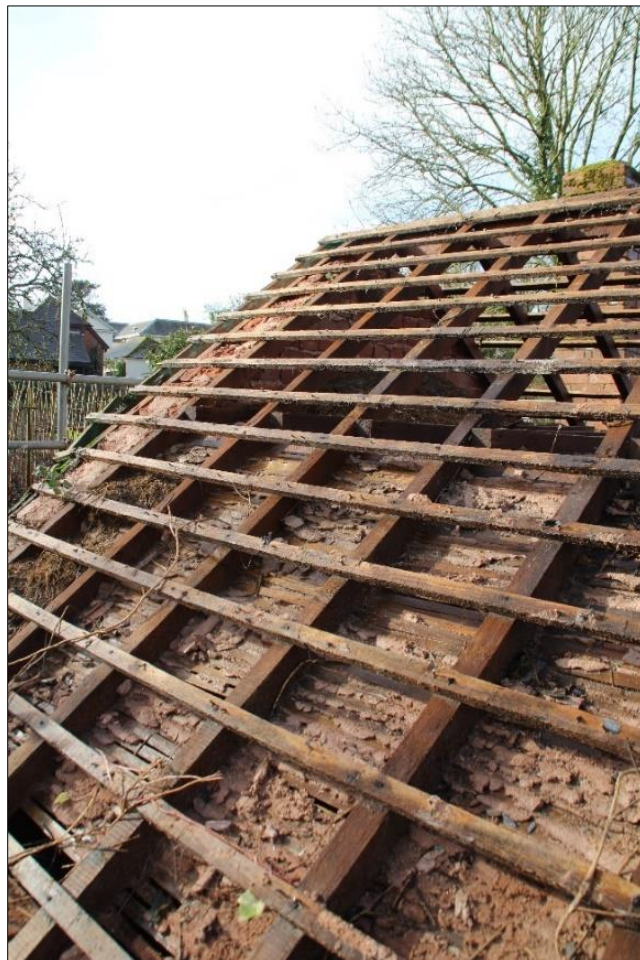
- 4.14. Moving further south on the east elevation, a similar coupled rafter roof structure was observed in the southern portion of the Building, though the ridge piece is in good condition and machine cut, indicating it is a newer piece (Fig.23). Of note here is that there are more substantial and less regular collar tie beams in this part of the Building. They are machined and rest on substantial purlins against up to which there is lathes and torching forming the eaves in the rooms below. This difference between the north and south portions further corroborates the theory that they are of different construction dates.

**Fig.24 Lathe and torching on eastern roof slope**

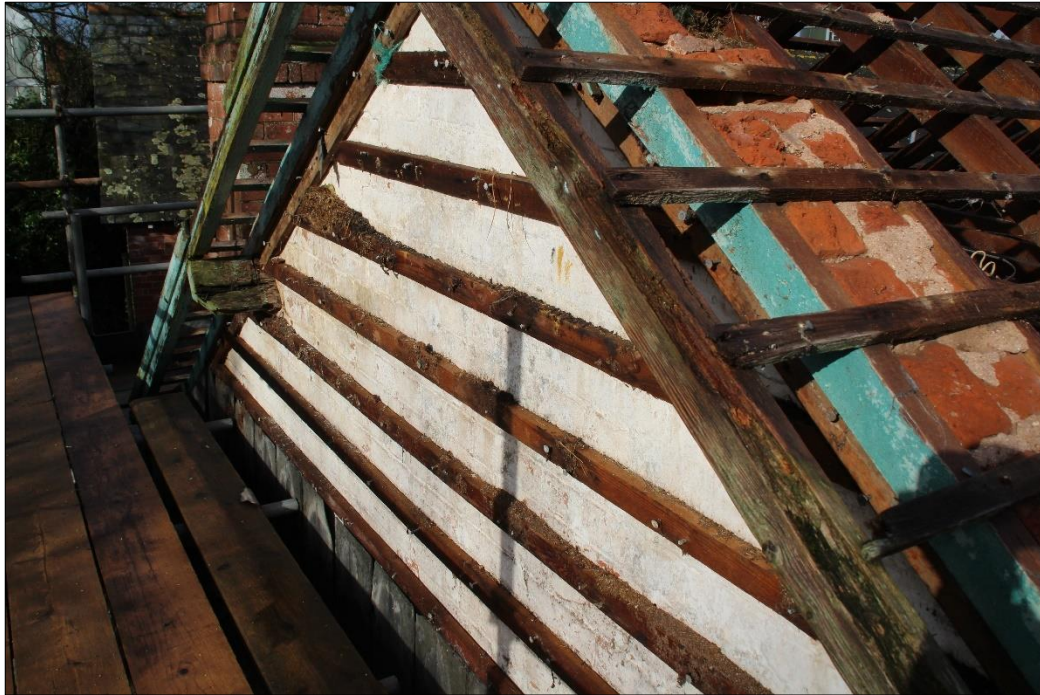
- 
- 4.15. The southern gable wall is formed of brick, with slates hung over the upper part of the gable. At the site visit the slates had been removed to reveal the brick wall below it, punctuated with timber battens on which to nail the slates (Fig.25). The overhang of the eaves was clearly substantial, as seen on the northern gable end.

**Fig.25 Southern gable end showing brick wall with battens for hanging slate tiles (removed)**

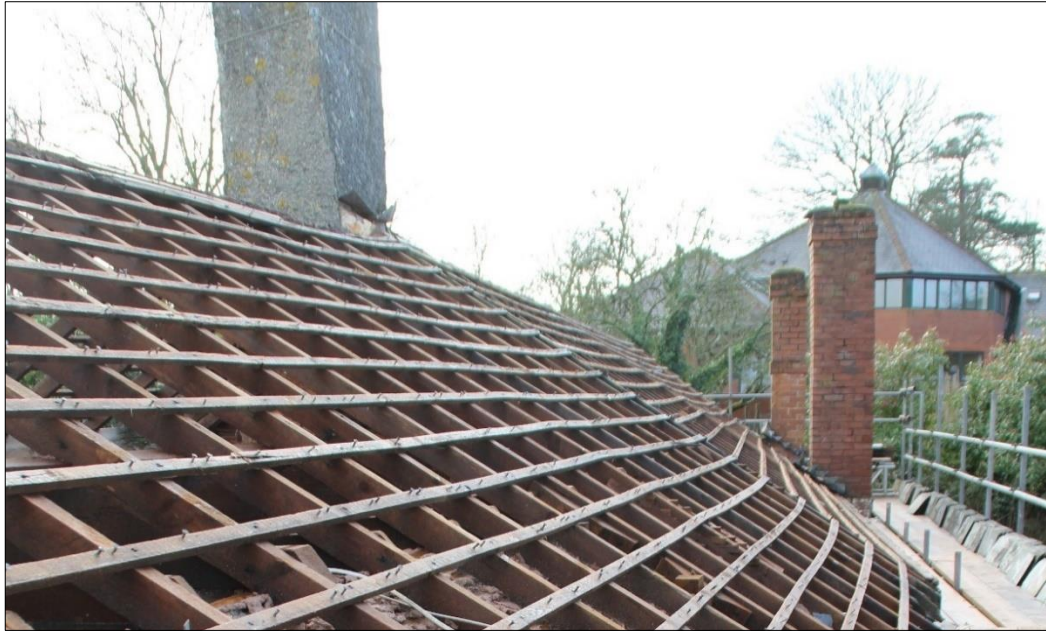
- 4.16. On turning to the west elevation, there are two chimney stacks located in the southern portion of this elevation (Fig.26). One, the southernmost, is located part way up the roof slope and appears to have some age; it is probably original to the construction of this part of the Building. The other is a more modern version with neat machine cut bricks. Their proximity is something of a mystery, though the more modern chimney served the kitchen below it, so its construction was probably born of necessity. The older chimney sits nearly at the southernmost end of this elevation, serving the ground and first floor rooms at this end of the Building. Interestingly, the ground floor room is now a dairy (see Morriss p.27) with slate shelving on brick piers, therefore the fireplace must have been obsolete. This suggests either only the upper room had a fireplace, or the ground floor room was repurposed into a dairy at some point in the 19th century as the room now does not have an infilled corner.

**Fig.26 View of two chimney stacks on western roof slope**

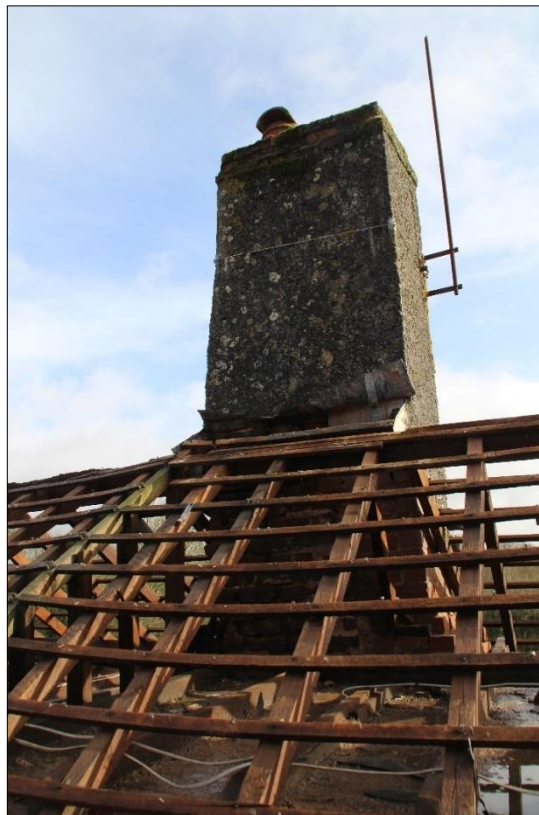
**Fig.27 Central large chimney stack seen from the west**

- 4.17. The large stack in the centre of the Building is seen taking up the eastern half of the roof space (Fig.27)

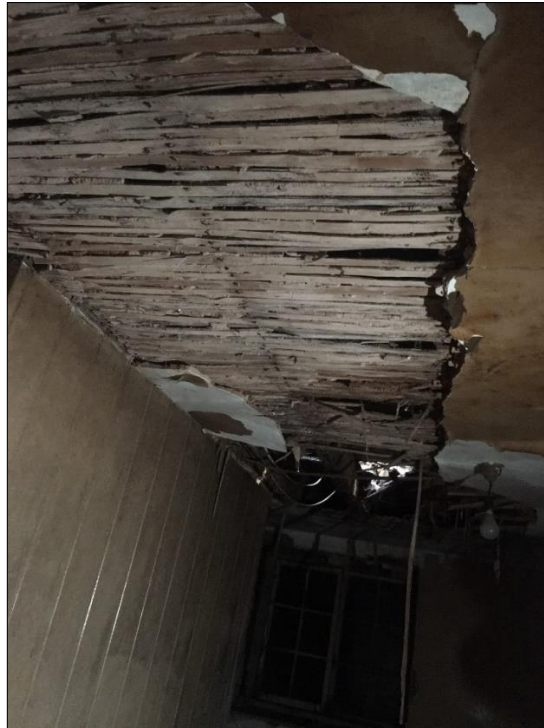
- 
- 4.18. Moving internally, only parts of the Building were safe to access. Entering via the kitchen extension, the ceiling of the rear hall was exposed, showing lathes. The tongue and groove boarding of the staircase is seen on the left (Fig.28).

**Fig.28 The rear hallway with lathes in the ceiling**

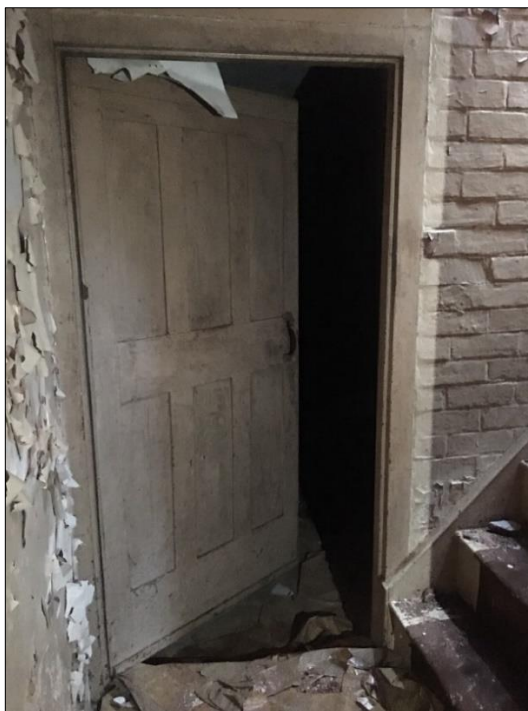
- 4.19. The wide three panelled door mentioned by Morriss is seen accessing the living room, with the brick cross wall of this part of the house visible on the side of the staircase.

**Fig.29 Doorway to living room showing brick spine wall**

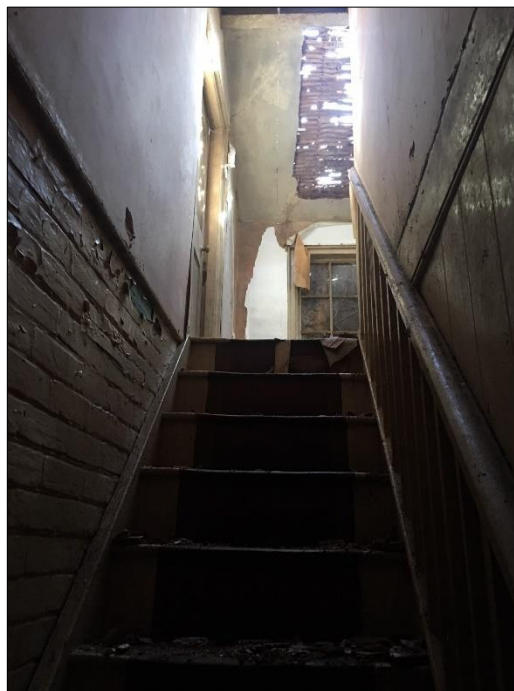
**Fig.30 View up southern stairs**

- 4.20. Looking up the southern stairs, it was possible to observe the landing with ceiling lathes, the simple handrail with bannister boarded with the tongue and groove, suggesting a later date for the addition of a partition. A timber casement window was seen at the top of the stairs.

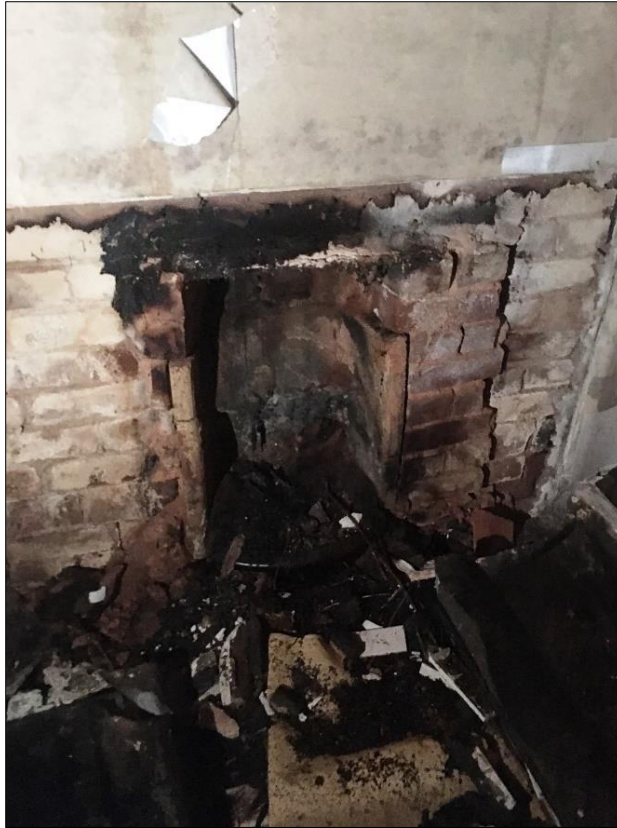
- 4.22. On entering the living room, a casement window with window seat below was seen in the east wall. The modern fireplace had been removed revealing a small brick opening in the chimney stack (Fig.32).
- 4.23. Wallpaper had been removed to reveal smooth plastered walls, though areas of plaster had been removed in the northern part of the Building to reveal cob underneath. Also in the living room a substantial beam running north-south was noted with iron strapping, which may suggest re-use or some stabilisation work to laterally pin the two cross walls in this part of the Building (Fig.33). The beam enters into a plain rectangular cornice or similar covering which runs around the room at the junction of ceiling and wall. This feature is unlikely to be decorative but perhaps structural or to cover cob/brick jointing.

**Fig.32 Brick fireplace in living room**

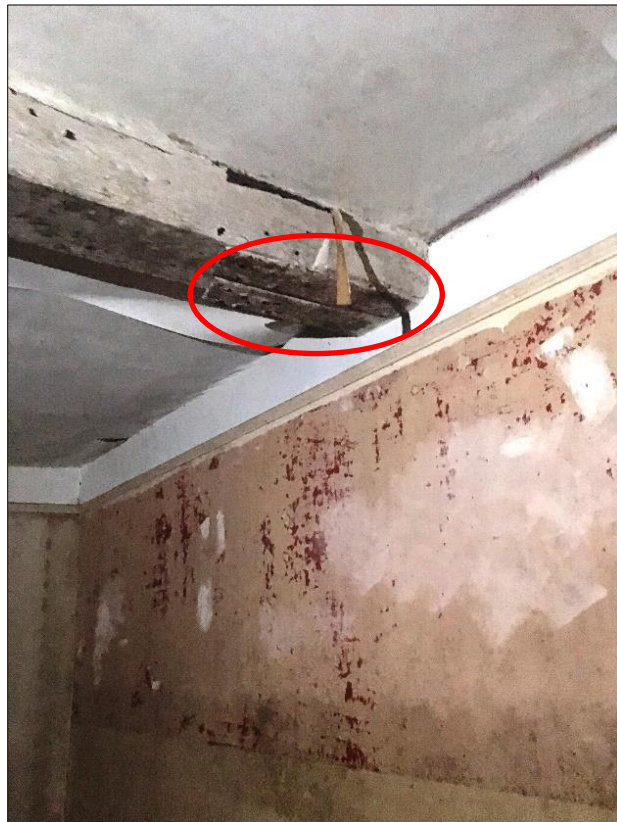
**Fig.33 Beam in the living room with iron work**

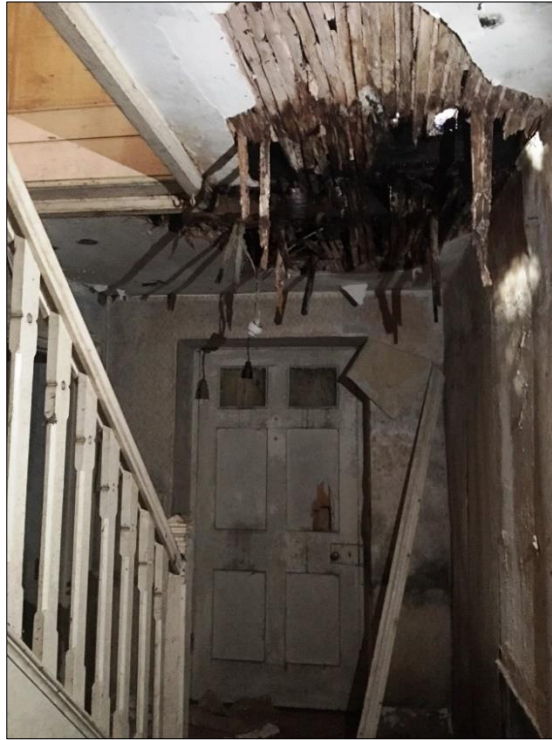
- 
- 4.24. A lathe ceiling was also uncovered in the main entrance hall. A plain brick lined fireplace was also seen in the sitting (north) room (Fig 34).

**Fig.34 Lathe ceiling in the main entrance hall**

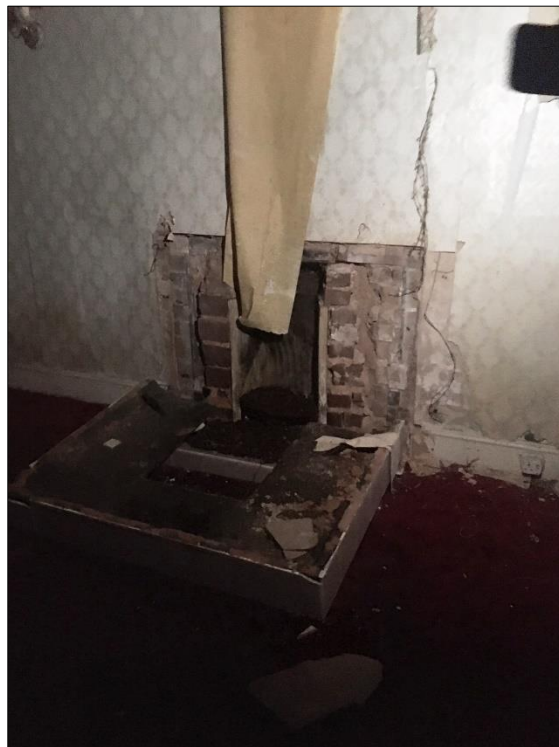
**Fig.35 Brick fireplace in the sitting room (northern elevation)**

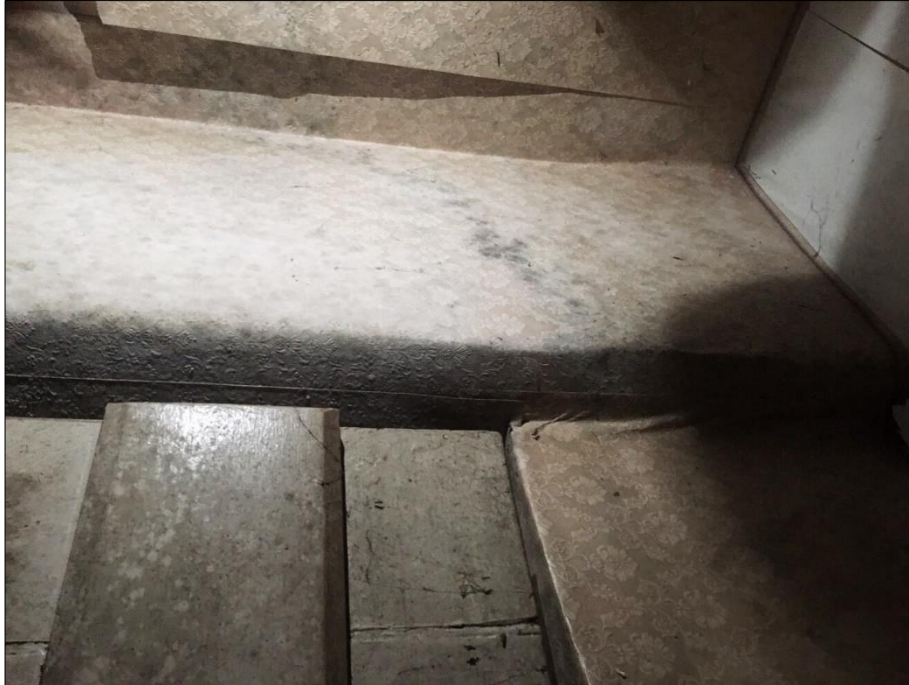
4.25. The doorway to the external east lean-too loggia is a plank door with moulded cob reveals (Fig.36). The stair turret itself has been altered to form plain box room with lavatory, no demolition occurred in this area yet (Fig.37).

**Fig.36** View of plank door out to west elevation showing cob curved reveals

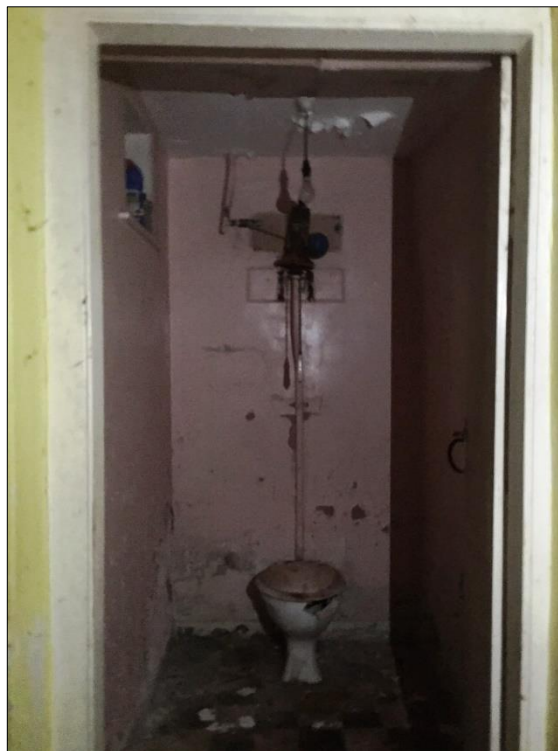
**Fig.37** Lavatory inside the curved turret

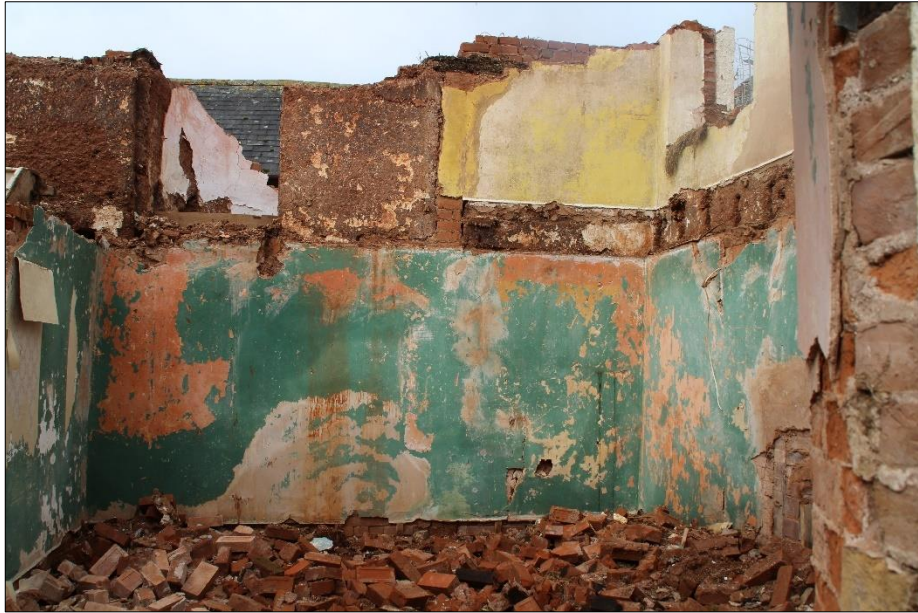
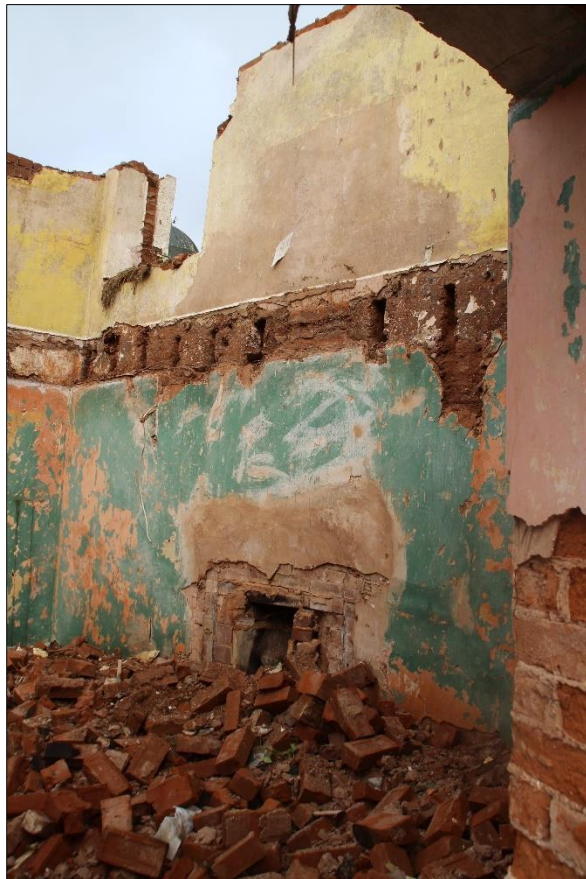
- 4.31. Figs.41 and 42 shows a view of the sitting room taken looking west and north (as per plan) showing the extent of the use of cob on the west and north elevations. Brick patching is seen as is some cob repairs which have a different darker colour and some straw visible. The mortices of floor joists are visible in the northern wall. The brick fireplace is visible with what looks to be a concrete lintel.

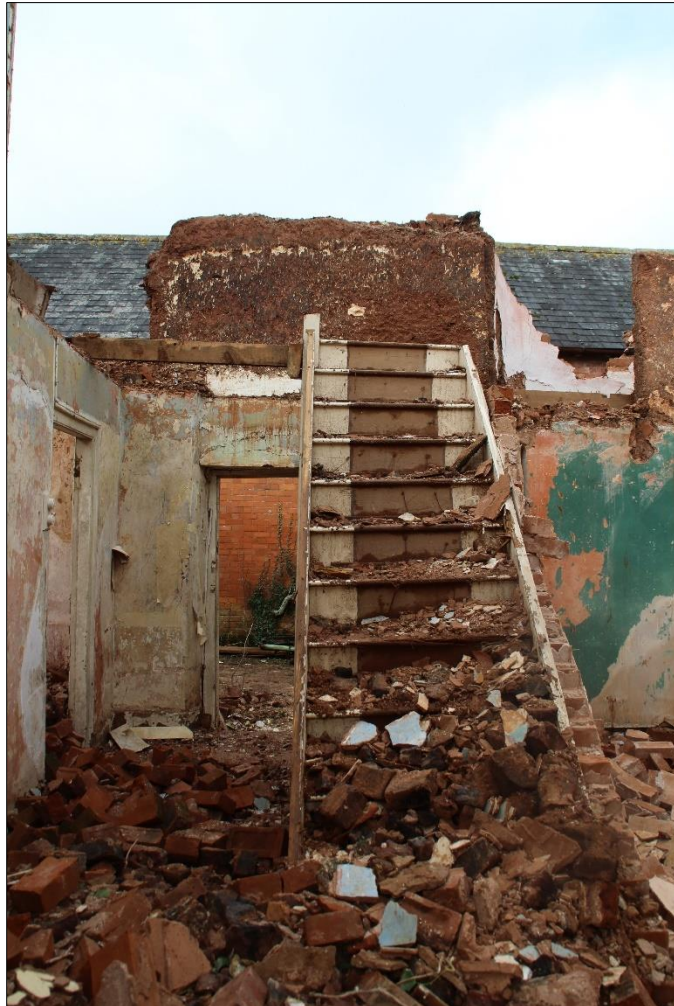
- 
- 4.32. The main entrance hall with remnants of staircase is seen in Fig.43, again showing the extent of cob walling to the western elevation. Insertions of timber act as wall plates at first floor level.

**Fig.43 View of the main entrance hall, looking west**

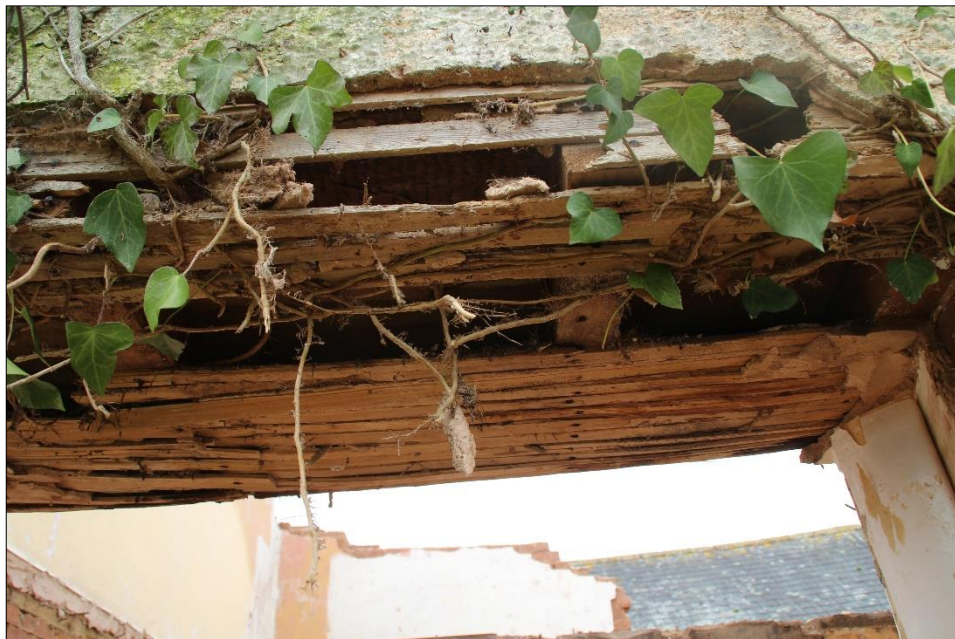
- 4.34. A combination of timber framing, lathes and bricks formed the lintel of the east elevation window to the living room as seen in Fig.45.

**Fig.45 View of lintel over window in eastern elevation**

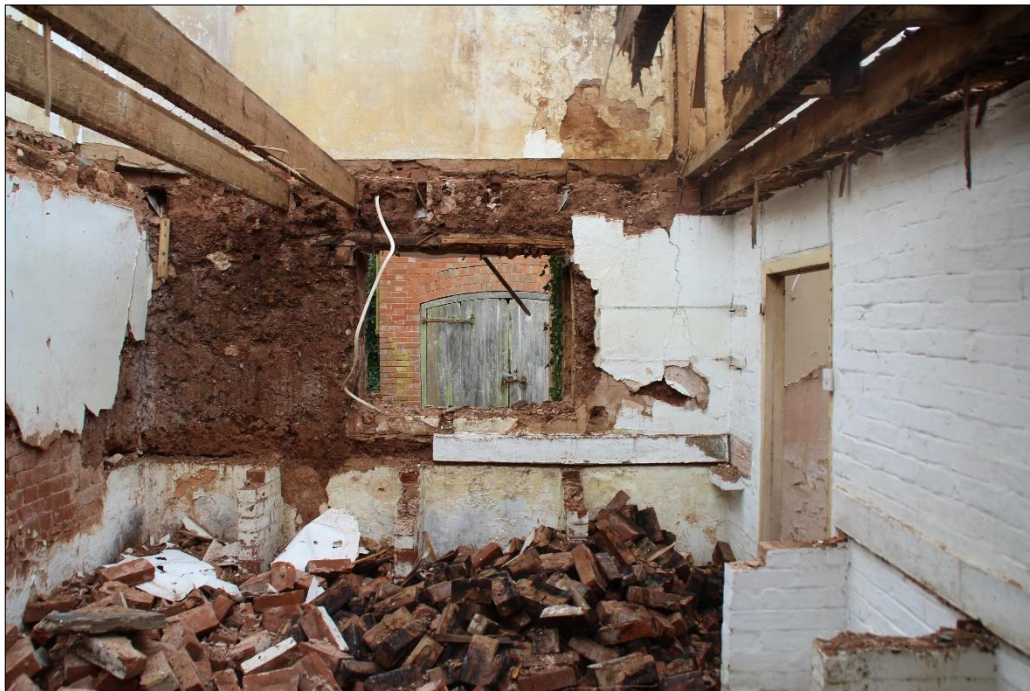
- 4.35. An image of the dairy room shows the southernmost brick internal spine wall. The western elevation is cob with brick to the southern elevation. The corner fireplace is visible in the room above (as per Fig.46) but there is no evidence that the extended

**Fig.46 View of the dairy, looking west**

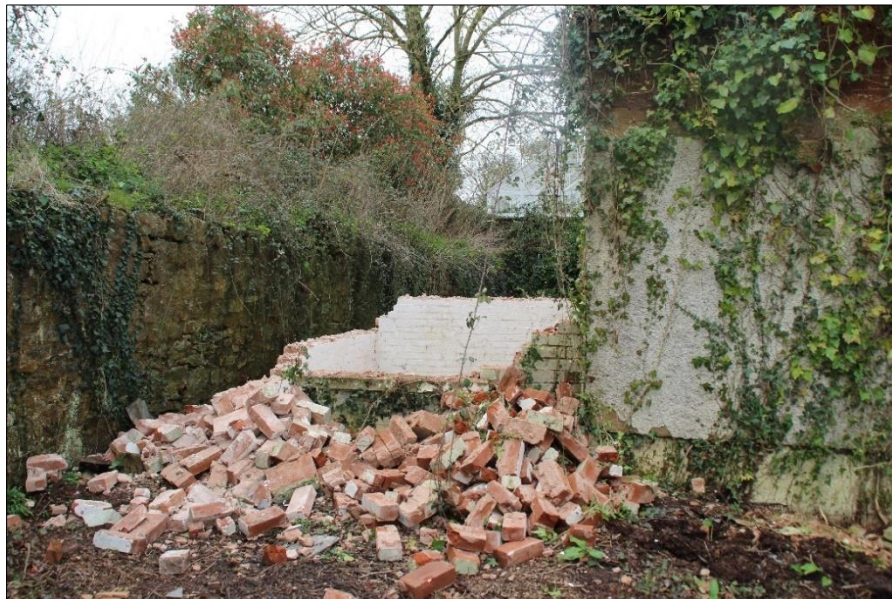
- 
- 4.37. The brick 20th century dairy extension was observed partially demolished with nothing of note to record (Fig.48)

**Fig.48 View of brick dairy extension, looking west**

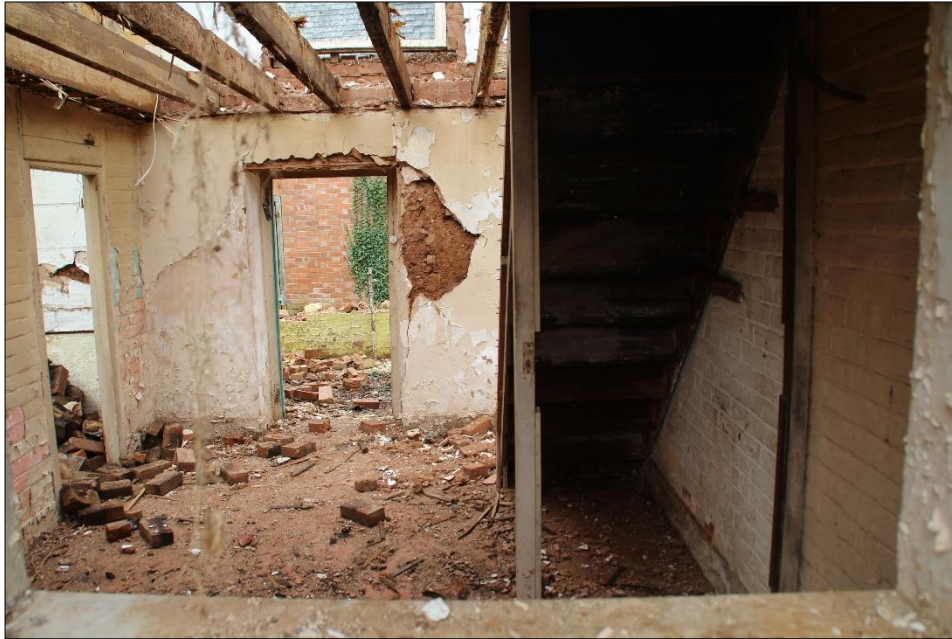
- 
- 4.39. The interior of the rear hall was observed, showing the cob western wall with brick patching above and remains of staircase and floor joists.

**Fig. 50** View of the rear entrance hall with staircase to right

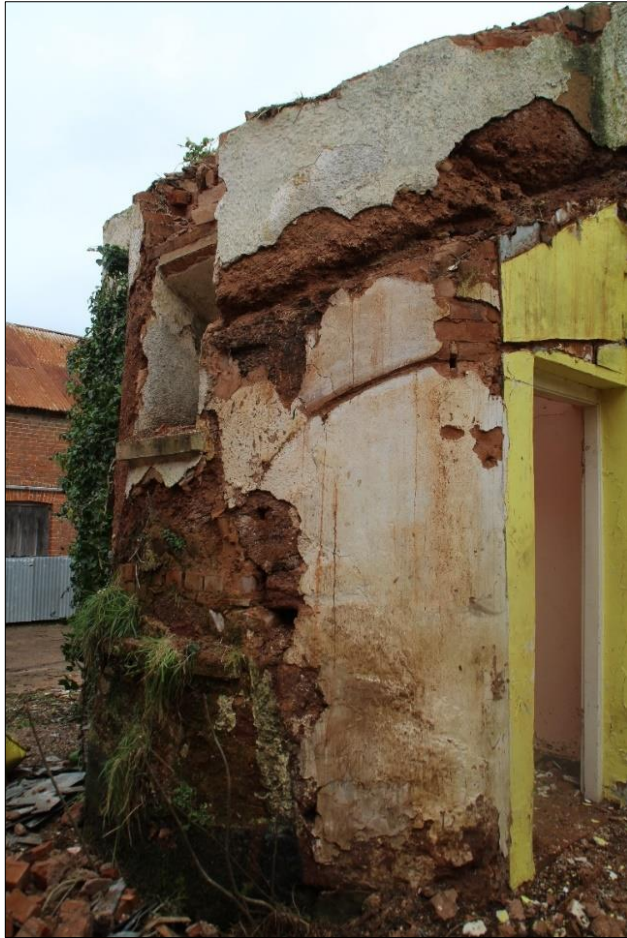
- 4.40. Externally on the western elevation, render had been removed from the circular turret, showing the upper parts of it to be of mostly cob construction with the patching in Heavitree stone and brick seen in earlier images of this structure (Fig.51). Internally the ceiling of the lavatory had been removed and it was possible to see the curved upper part of the turret (Fig.52).

**Fig.51 View of turret looking north**

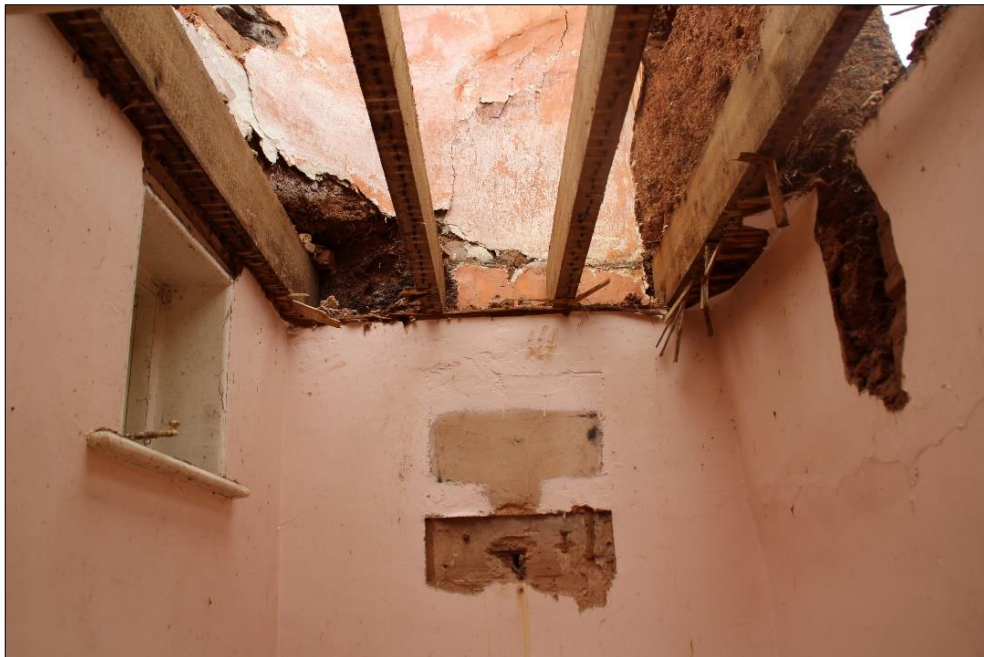
**Fig.52 View of interior of turret looking up**

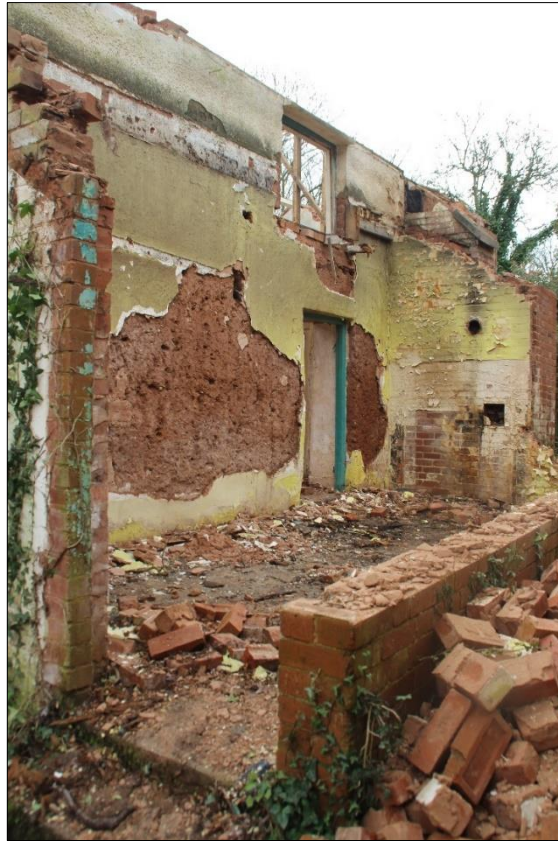
- 
- 4.41. The kitchen extension had been demolished, revealing the original section of western elevation, predominantly in cob (Figs. 53 and 54). As usual brick patching is seen in the cob walling, particularly near windows and other insertions.

**Fig.53 View of the demolished kitchen extension**
