# Greendale Farm Clyst St. Mary, Devon

*Historic Building Recording (Demolition)*

CA Project: EX0074

April 2020

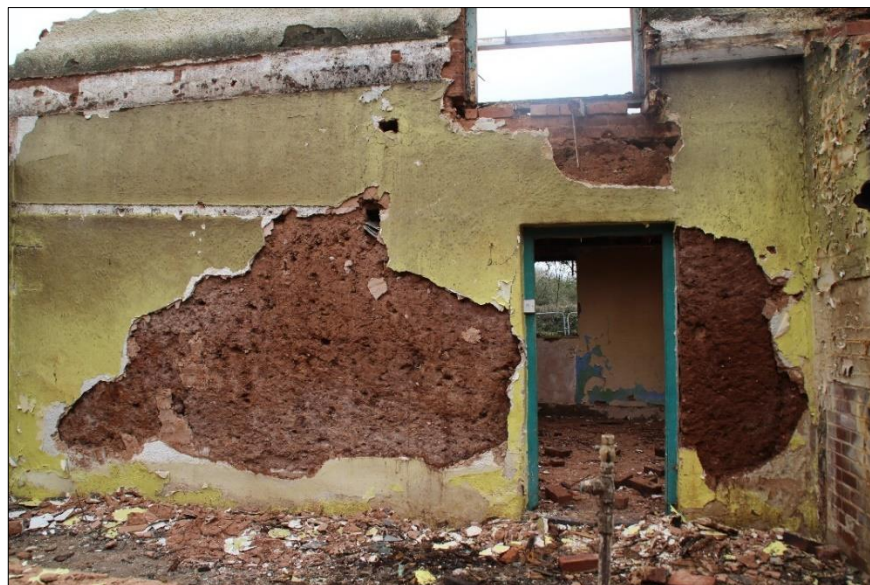
- 
- 4.41. The kitchen extension had been demolished, revealing the original section of western elevation, predominantly in cob (Figs. 53 and 54). As usual brick patching is seen in the cob walling, particularly near windows and other insertions.

**Fig.54 View of the western wall of the building within the former kitchen extension**

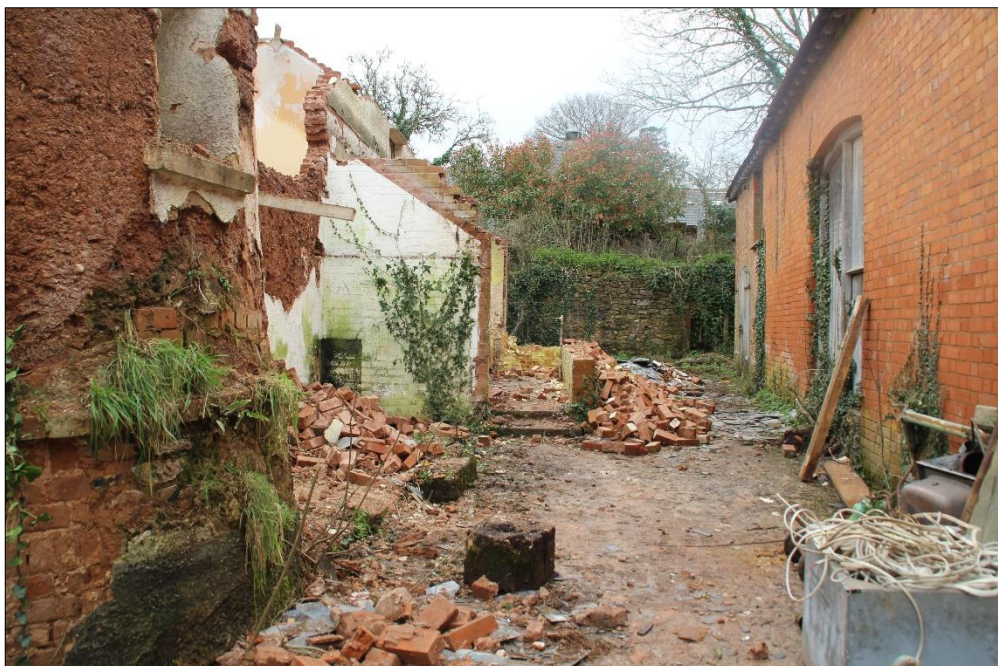
- 4.43. Fig.56 gives a general view of the western elevation, showing the mix of cob and brick which comprises this elevation of the Building.

**Fig.56 A general view of the western elevation, looking south**

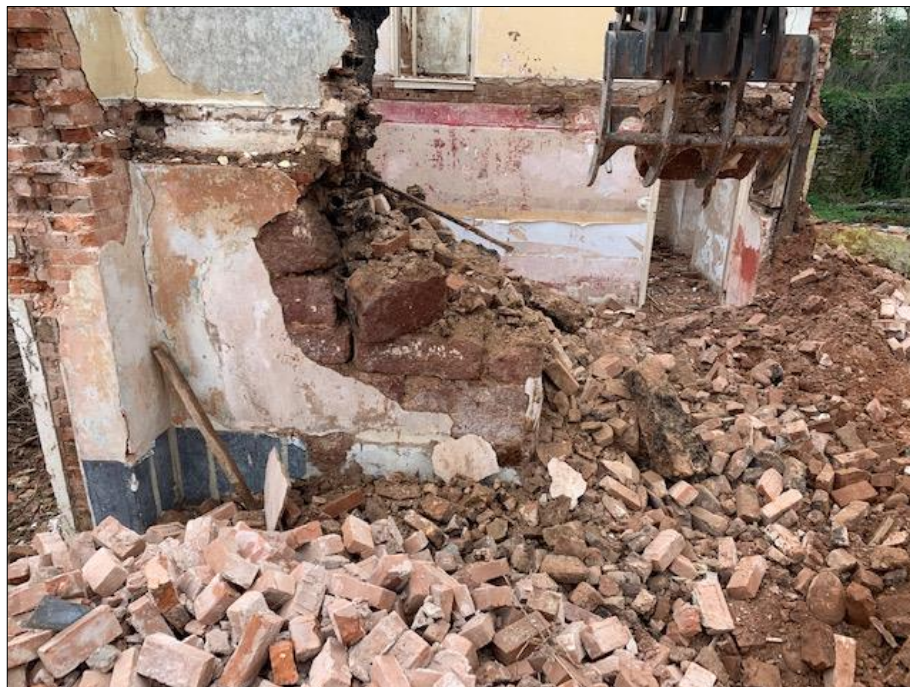
- 
- 4.44. Further demolition of the northern gable elevation revealed that a good proportion of this elevation was formed cob, as seen in Fig.57. A section of wall at low level was also found to be local stone blocks, possibly Heavitree stone (Fig.58)

**Fig.58 View of stone walling within fabric**

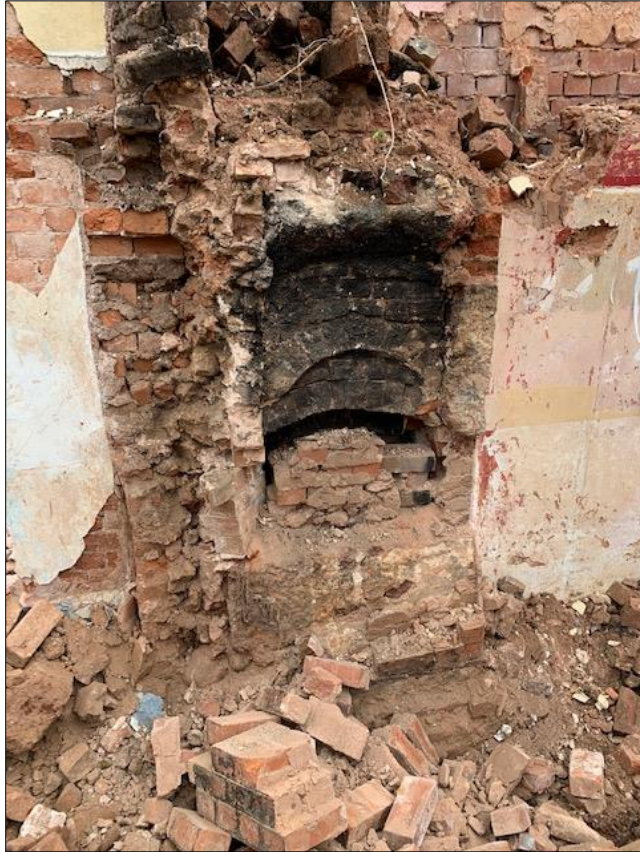
4.45. Further demolition of the central, oldest chimney stack revealed the remains of part of a bread oven (Fig.59 and 60) with some smoke blackening to bricks above. Ovens and chimneys were traditionally built in brick for their heat resistance properties. The presence of this oven and its associated chimney may well explain why bricks were used to build the eastern elevation.

**Fig.59 Bread oven discovered in large chimney stack**

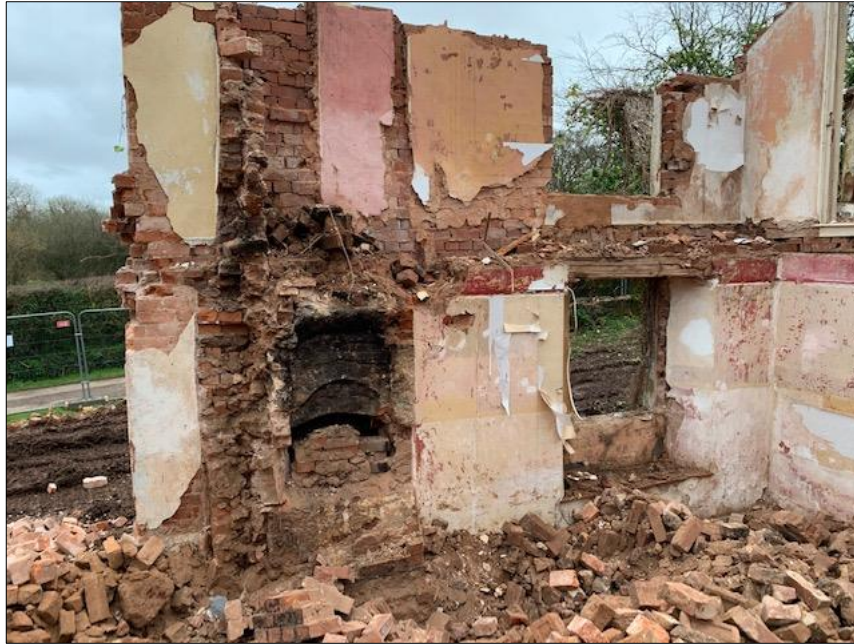
**Fig.60 View of bread oven within eastern elevation and large chimney stack**

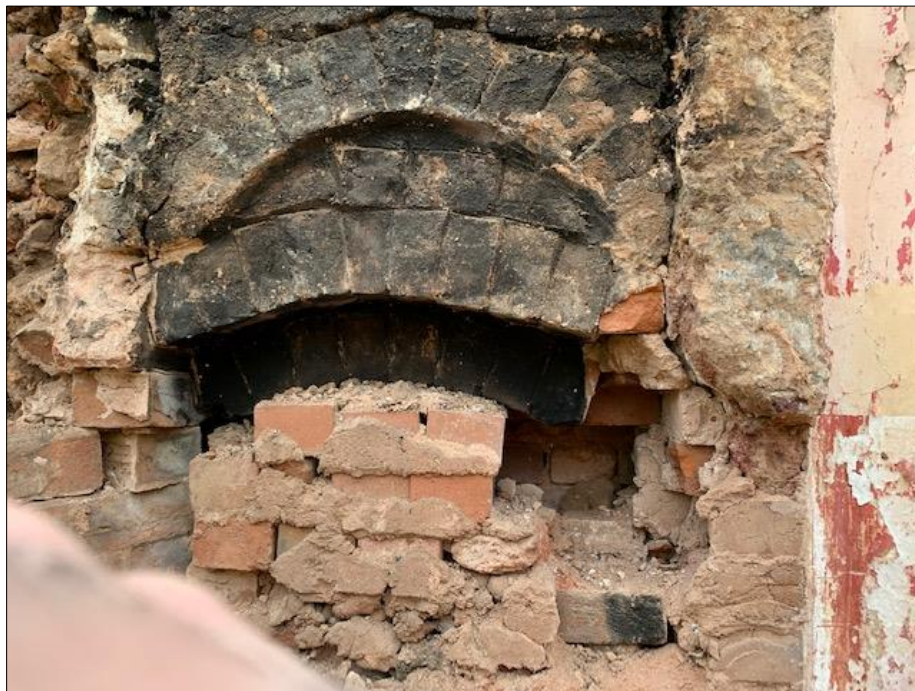
- 4.46. The oven was formed of relieving arches in handmade brick, various propping has occurred as the fireplace was altered to the polite one seen in the earlier images of the demolition (Fig.61). It is not possible to accurately date this feature, though it is likely to date to the earlier iterations of this dwelling.

**Fig.61 Detail of bread oven**

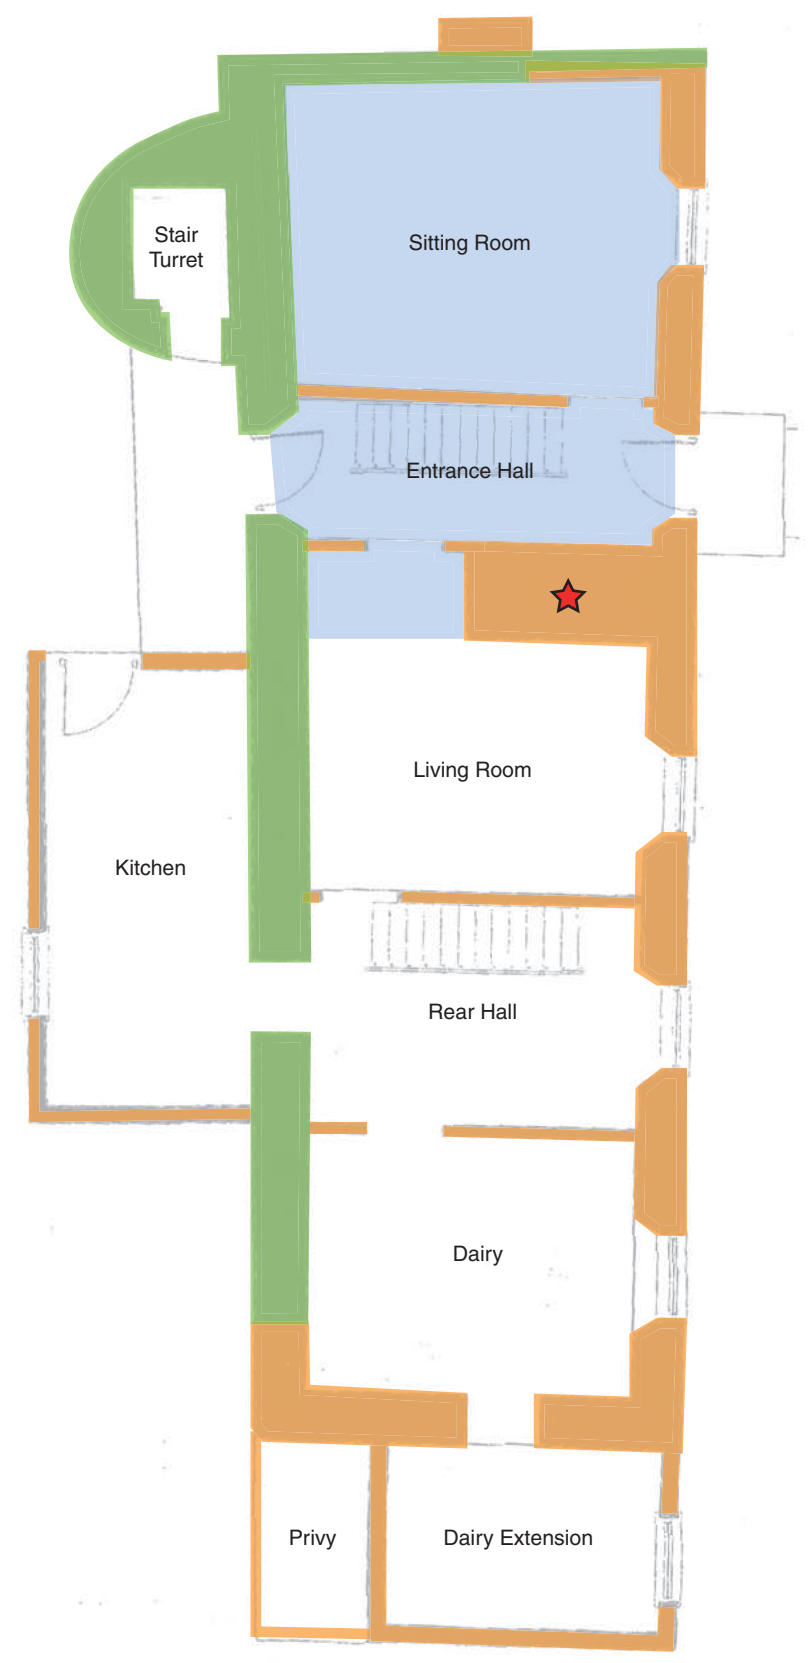
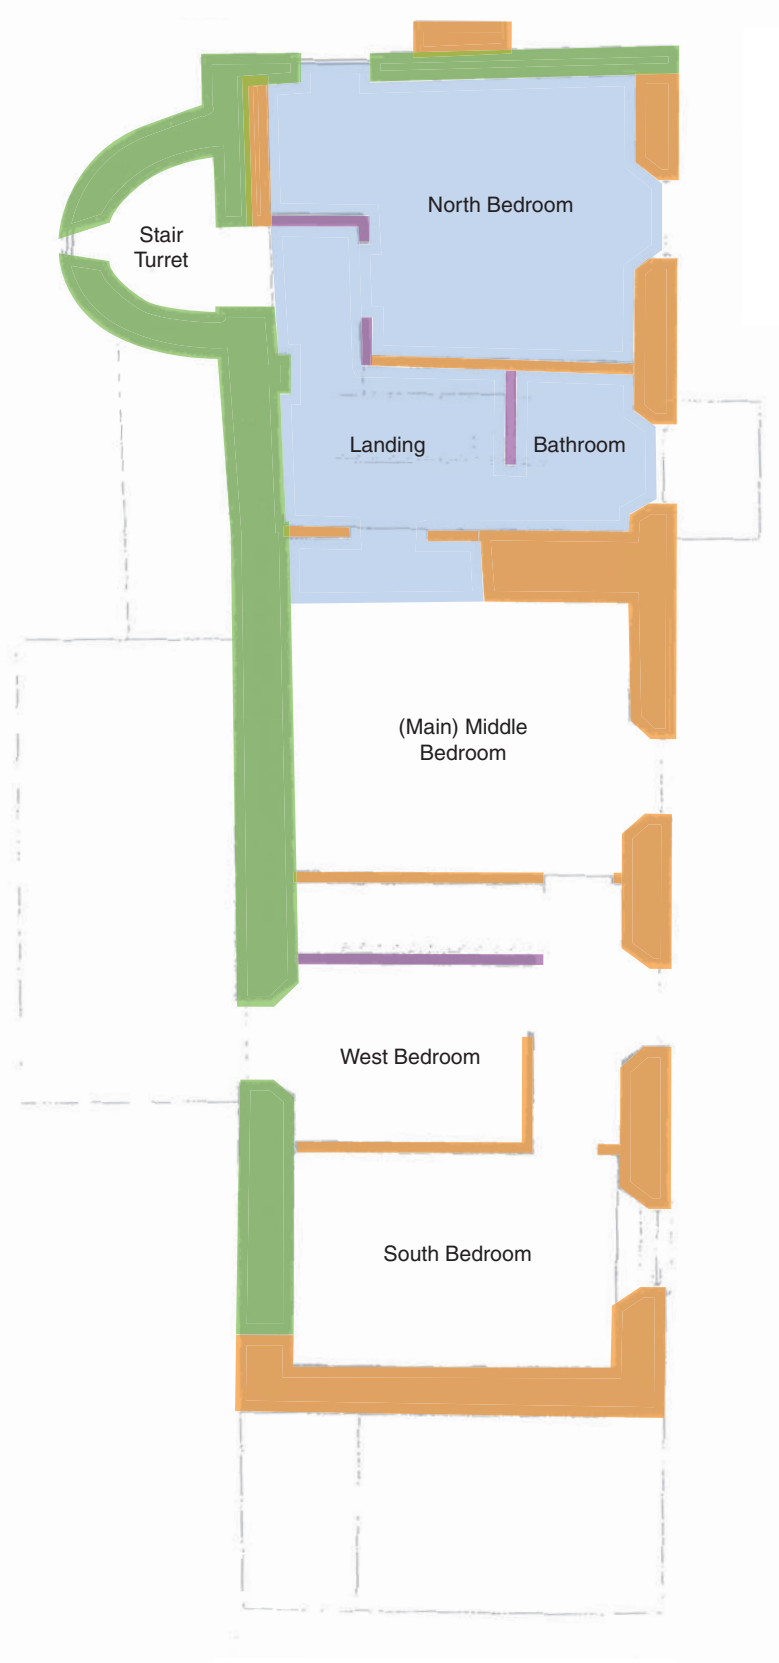
- 4.48. Fig.62 is a floor plan of the Building illustrating features, fabric and phasing.
- 4.49. One anomaly which is difficult to explain but which was observed is the fact that the west elevation is built of cob (with some brick patching in and other interventions) but the eastern elevation is built of brick, with clearly different phases of brick work. The presence of the probable stair turret on the western elevation does point to an earlier building, which may be formed of the northern section of the Building. The kink in the Building line at roof level also illustrates this (Fig.58 illustrates the possible early building on the plan). The brick work around the main eastern door appears to be handmade, this may indicate that this part of the elevation was built in the 18th or early 19th century, when the Building was extended as shown in plan in the 1839 Tithe Map. The use of cob for the 'lesser' elevation, and brick for the 'front' may have been a desire for status, or a pragmatic decision based on the supply of materials/skilled labour at the time or for structural reasons related to the incorporation of the older chimney stack with bread oven in the 'newer' building. The latter may be the more likely option given there is no evidence that 'status' was a significant factor in the ownership of the farm and that practical remodelling of an older cob building was the main activity.

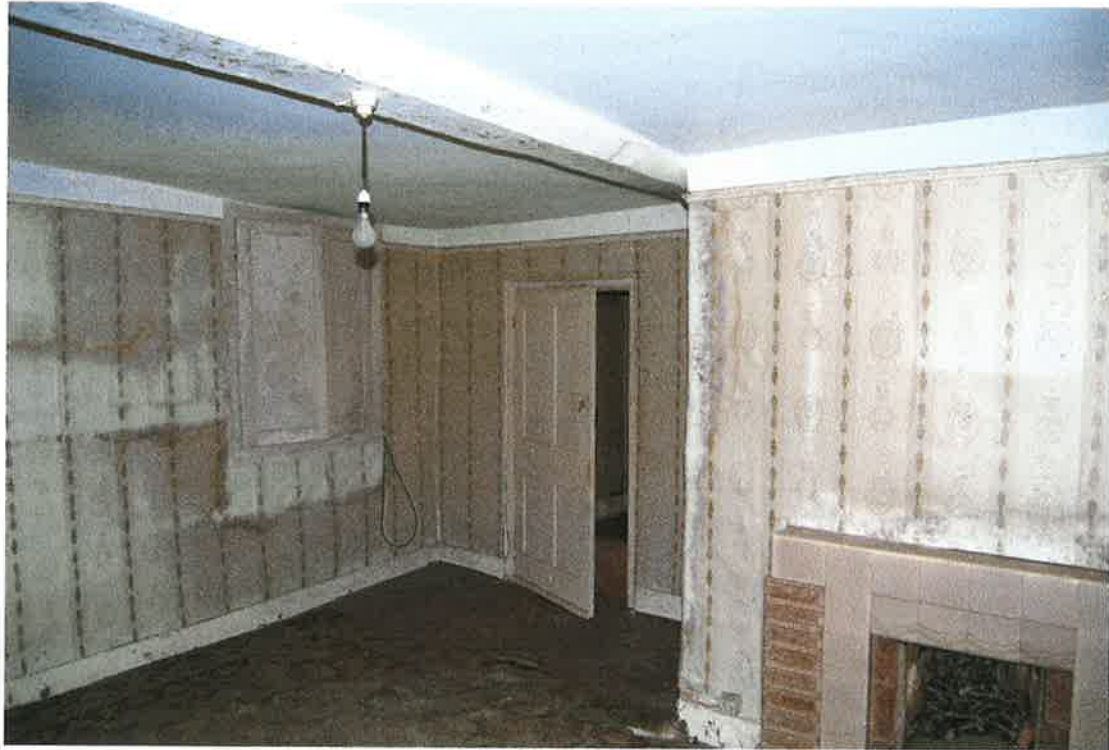
Pl.16: The living room, looking north; the mid-20<sup>th</sup> century fireplace is in the large stack to the right and the cupboard on the left could be the site of an original window.

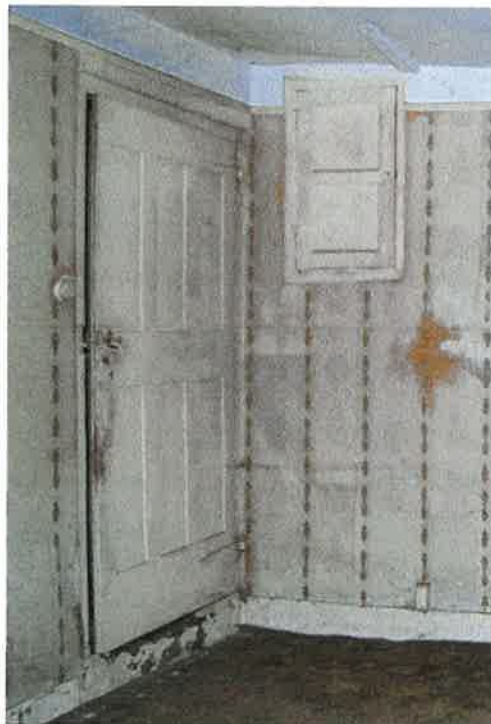
Pl.17: The south door of the living room and the small 'spice cupboard' type feature in the north wall next to it.

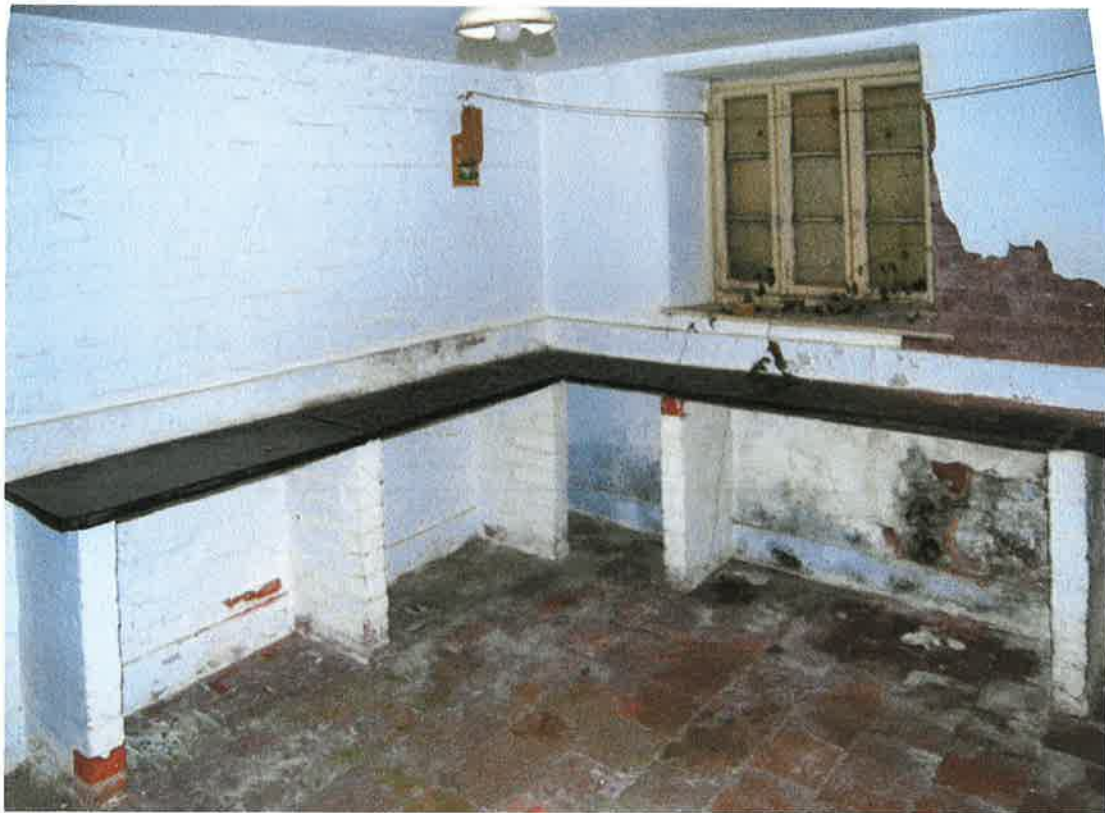
Pl.18: The slate shelves on brick piers in the presumed dairy at the south end of the farmhouse. Note the three-light window in the rear wall and the quarry tile floor.

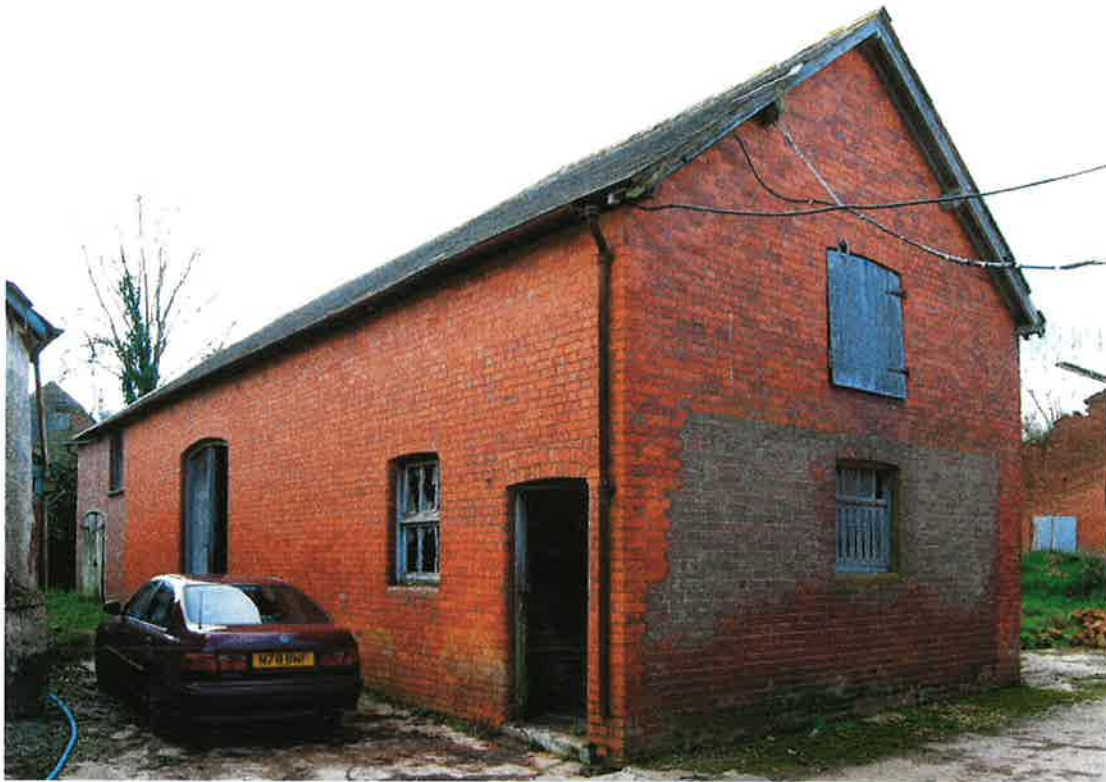
Pl.23: The Barn from the north-east; note the different brickwork in the lower part of the gable wall, probably part of an earlier building.

The general character of the brickwork and the machine-sawn timbers of the roof structure suggest a late-19<sup>th</sup> century date for the construction of this building. However, its north gable clearly contains the remnants of the ground floor of a slightly earlier brick building on much of the same footprint. That building is probably the one indicated on the 1839 tithe map.

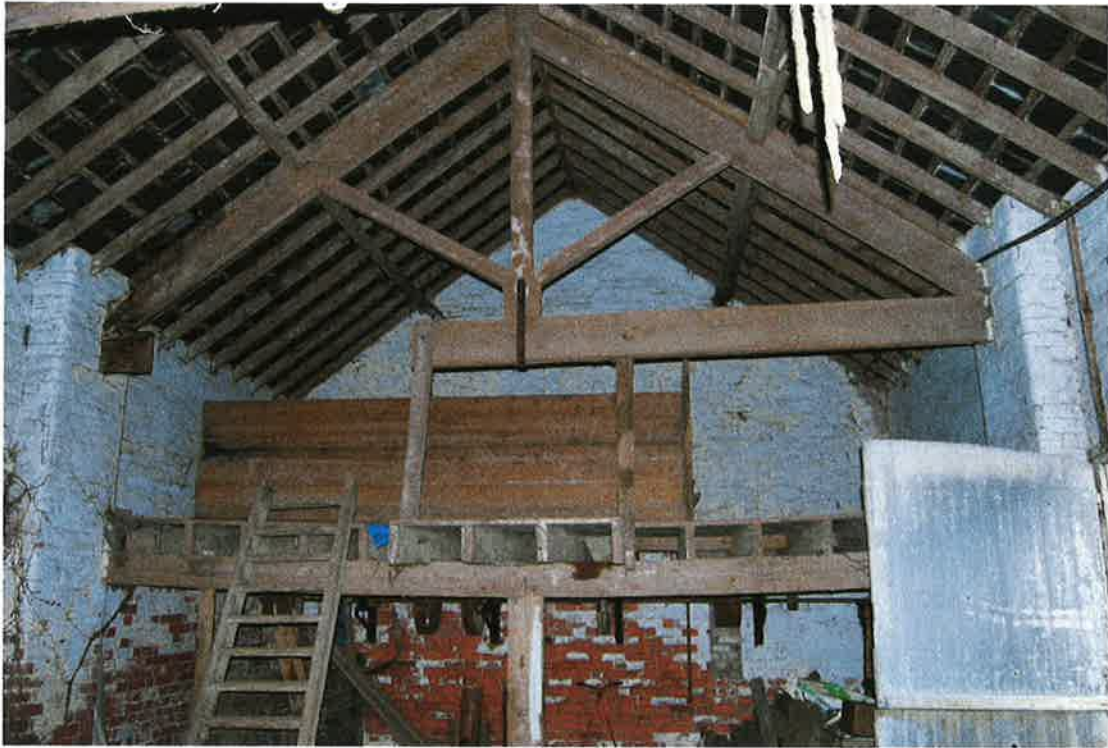
The feet and heads of the king-post are swollen and from the top of the swelling rise a pair of angled struts, of quite thin scantling, to the principal rafters. A large section of the tie-beam of the northern truss was removed to allow access to an inserted gallery at this end of the Barn.

Pl.25: The inside of the Barn Range, looking north; note the cut tie-beam of the truss, the inserted gallery, and beneath, the line of belt shafting against the cross-wall.

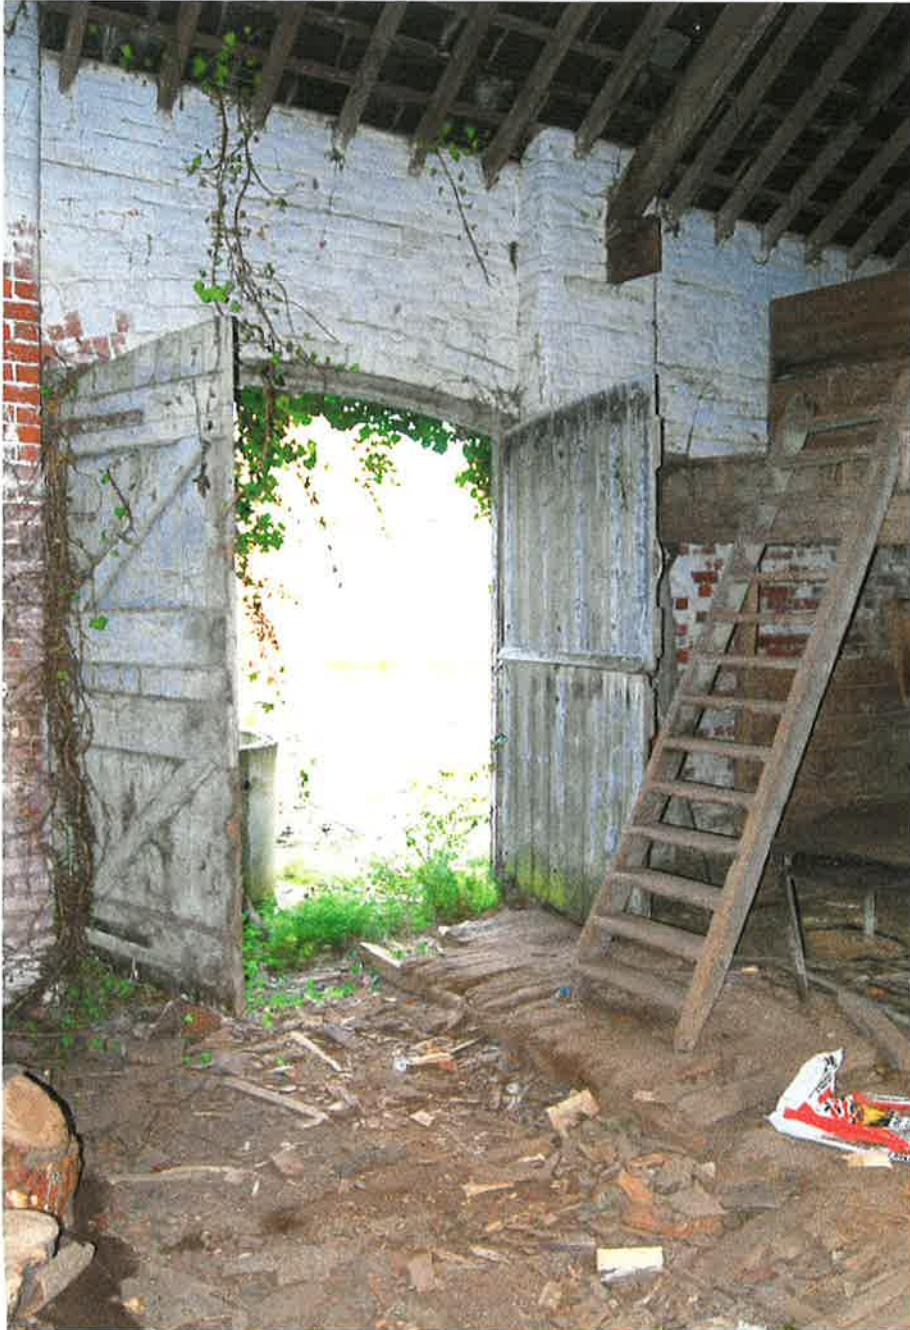
Curiously the floor throughout this section is of boarding on joists, the boards probably of oak and now in quite poor condition.

Pl.27: The inside of the Barn Range, looking towards the west threshing floor doorway. Note the remains of the original timber floor.

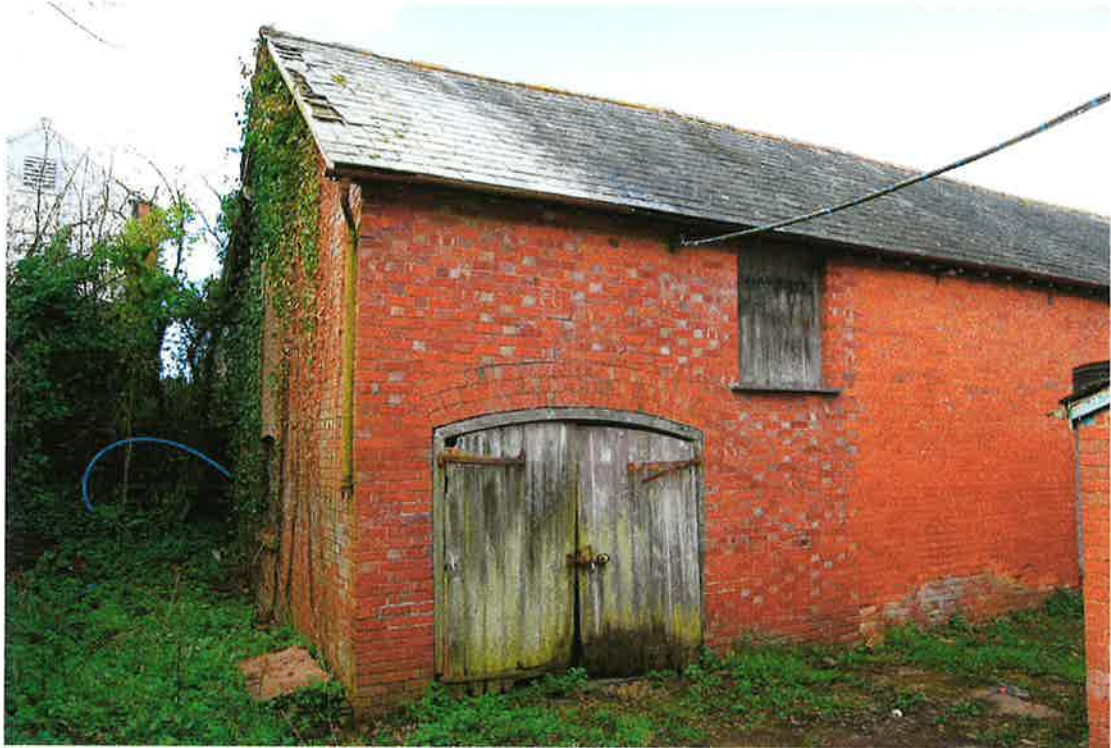
Pl.28: The Cart Shed from the south-east; note the vertical break between it and the adjacent Barn (Building B) to the right.

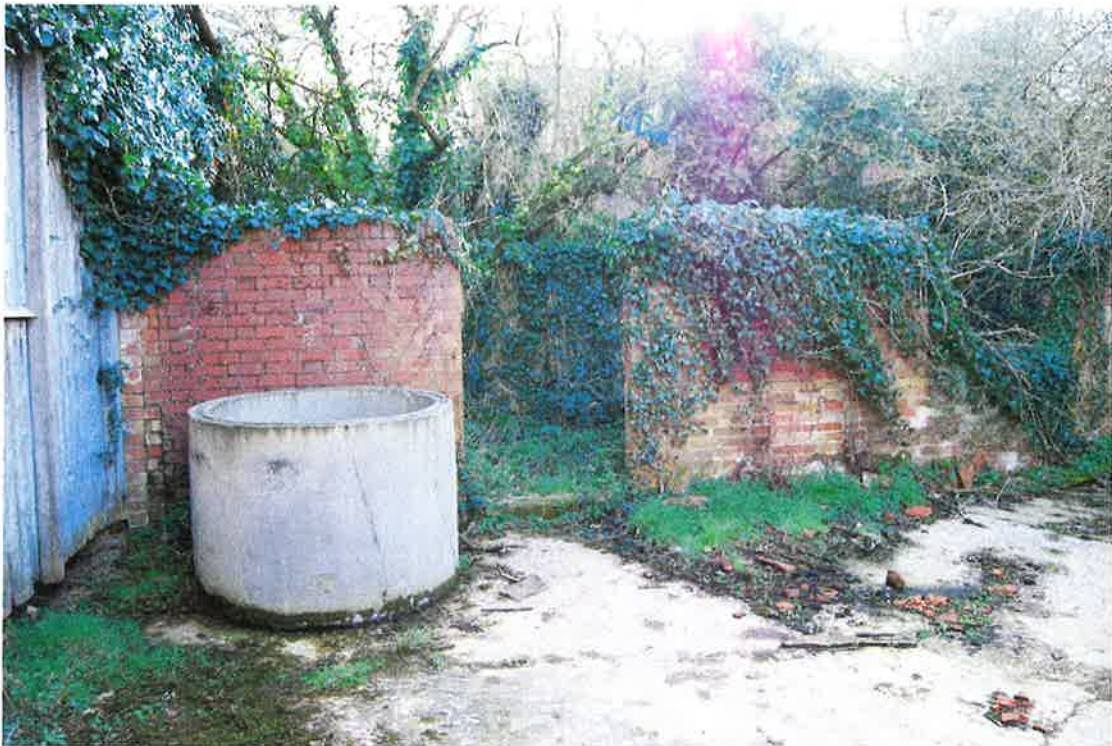
Pl.31: The ruined West Linhay (Building D) from the north.

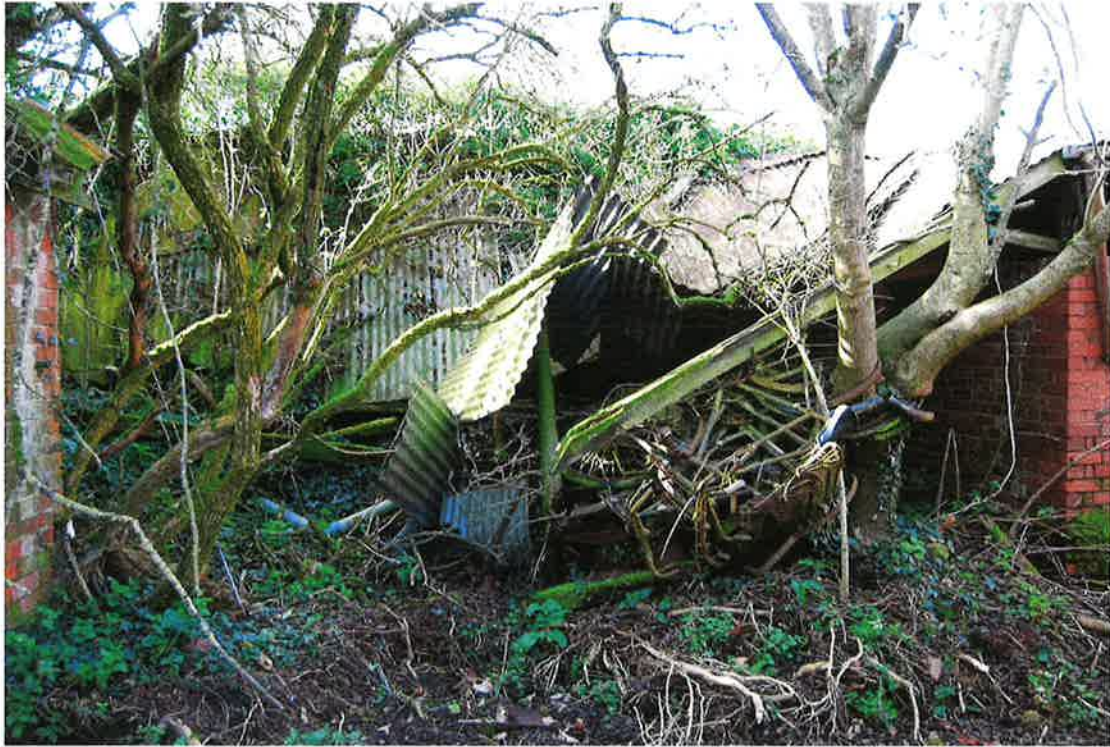
At the western end of the main farmyard is a collection of derelict or ruinous shelters, including a brick-built one probably of early-20<sup>th</sup> century date and a roofed open-fronted shelter, now collapsed, built against a brick revetment wall. Access to these buildings was precarious and they are of little or no historical significance.

Pl.34: One of the collapsed shelters at the western end of the farmyard.

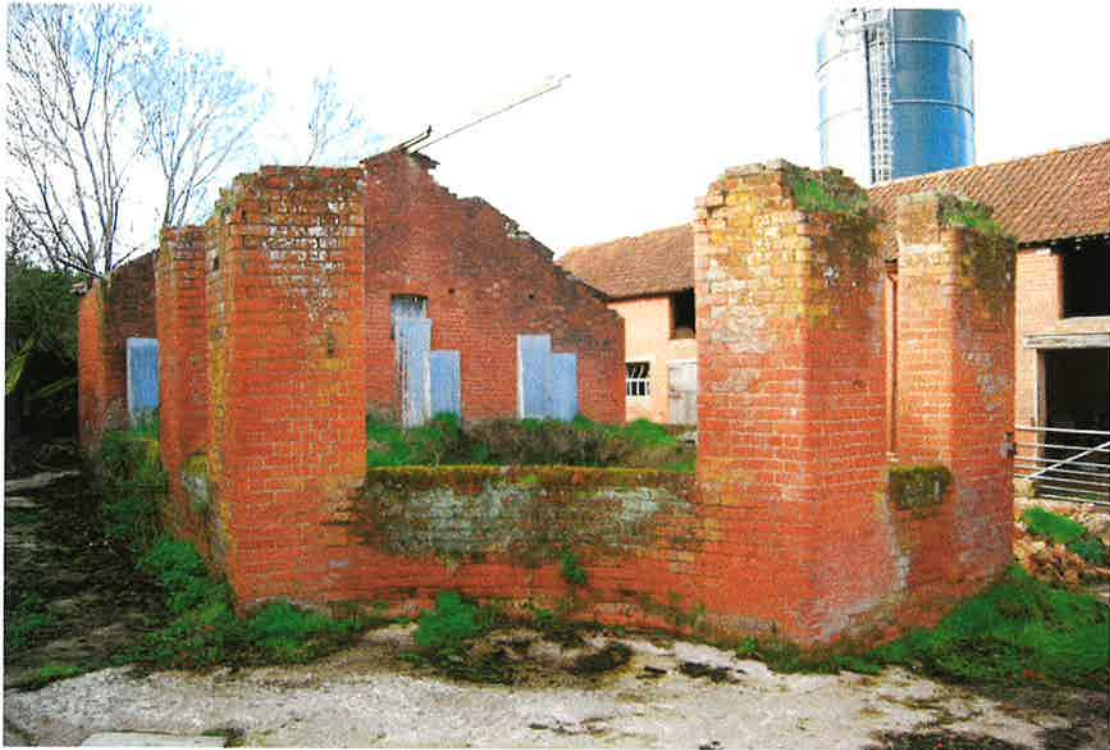
The only unusual feature is the primary circular cut-out at the south-eastern corner. This is close to the adjacent Barn Range (Building B) which has surviving belt shafting that includes an external belt wheel on the outside wall facing the cut-out. It is just possible that the cut out is associated with a horse gin, but the space seems rather constricted.

Pl.37: The circular 'cut-out' at the south-eastern corner of the range.

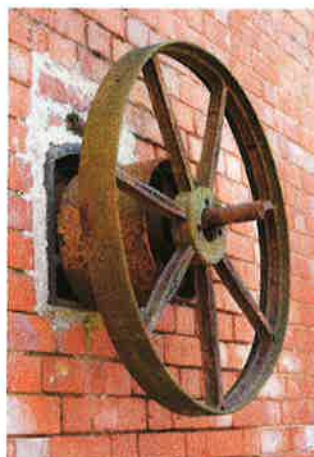
Pl.38: The belt wheel attached to the shafting in the Barn close to the 'cut-out'.

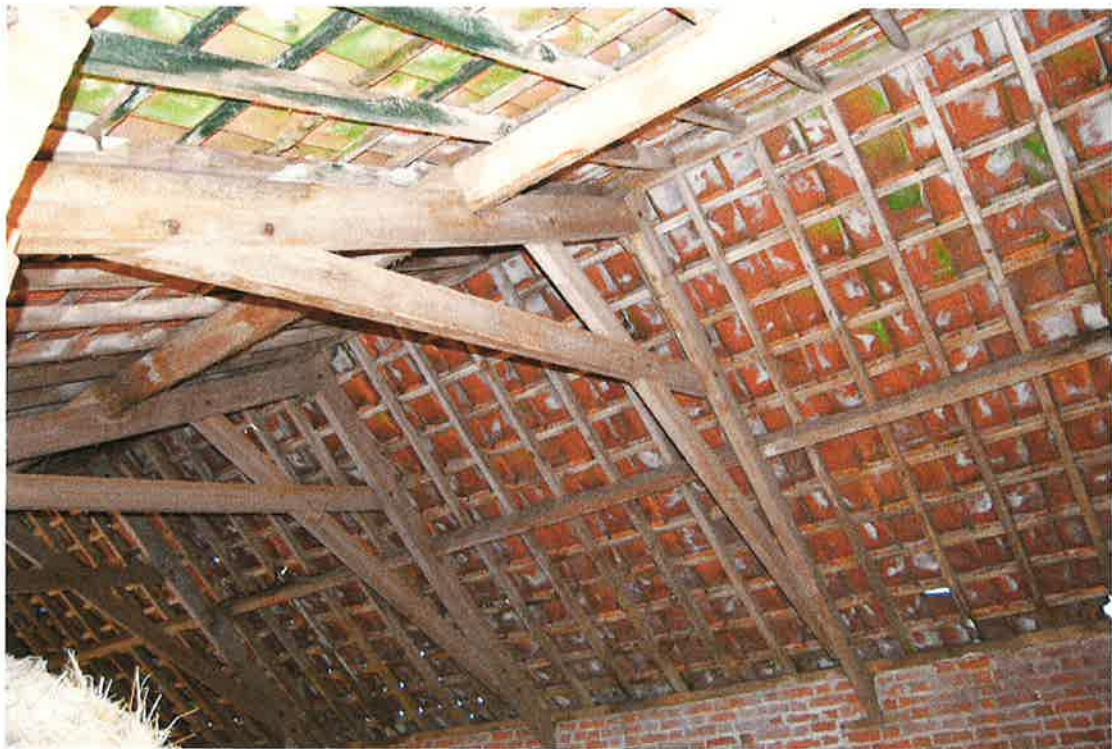
Pl.42: The unusual scissor-braced roof trusses in the North-West Range (Building H).
