# The Maltings, Tetbury Lane Nailsworth

*Historic Building Recording (Level 2)*

CA Project: CR0178

December 2019

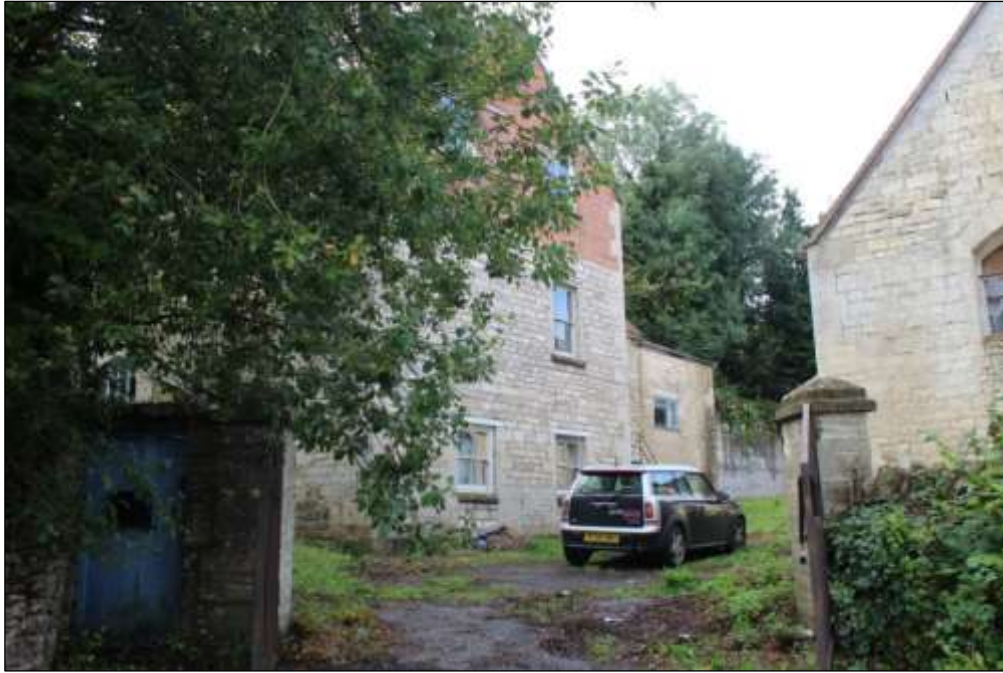
- 3.12. The Site is entered through a set of gates with stone piers topped with cornice and flat pyramid finial. A pedestrian gate is located to the left of the gateway when entered from the road. Maltings 1 is located to the right of the gateway, and Maltings 2 is located to the left (Fig 7).

**Fig.7 View of the entrance of the Maltings from Tetbury Lane, Maltings 1 on the right**

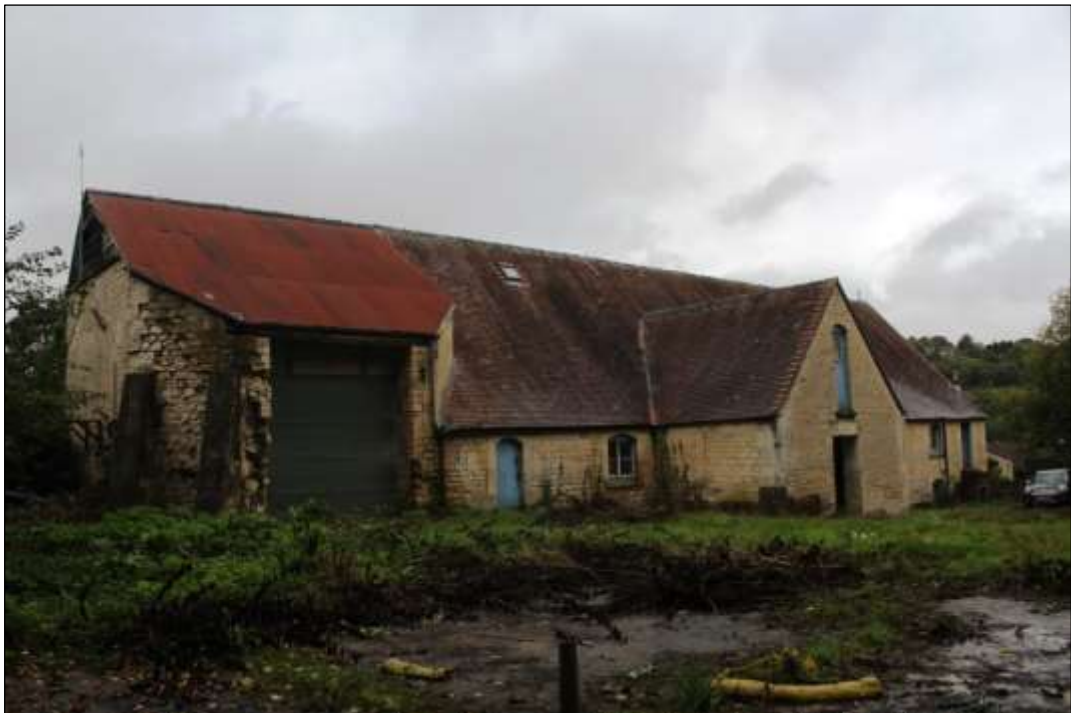
- 3.14. Maltings 1 is the northernmost building of the two, located on the right as the yard is entered (Fig.9). It is believed to be purpose built c.1880-1. It is a nine bay building with two storeys and attic space, though the kiln at the western end occupies a tenth bay, but is essentially a separate structure in form and appearance. The western (kiln) end disappears slightly into the hillside. There is a gabled cross wing placed centrally in the composition. The building is c.70m long by c.30m wide (wider in the cross wing) and is built in coursed stone blocks with stone quoins and window dressings. The main building has a gabled roof with plain tiles. The main building has a gabled roof with plain tiles.

**Fig.9 View, taken towards the north, of Maltings 1**

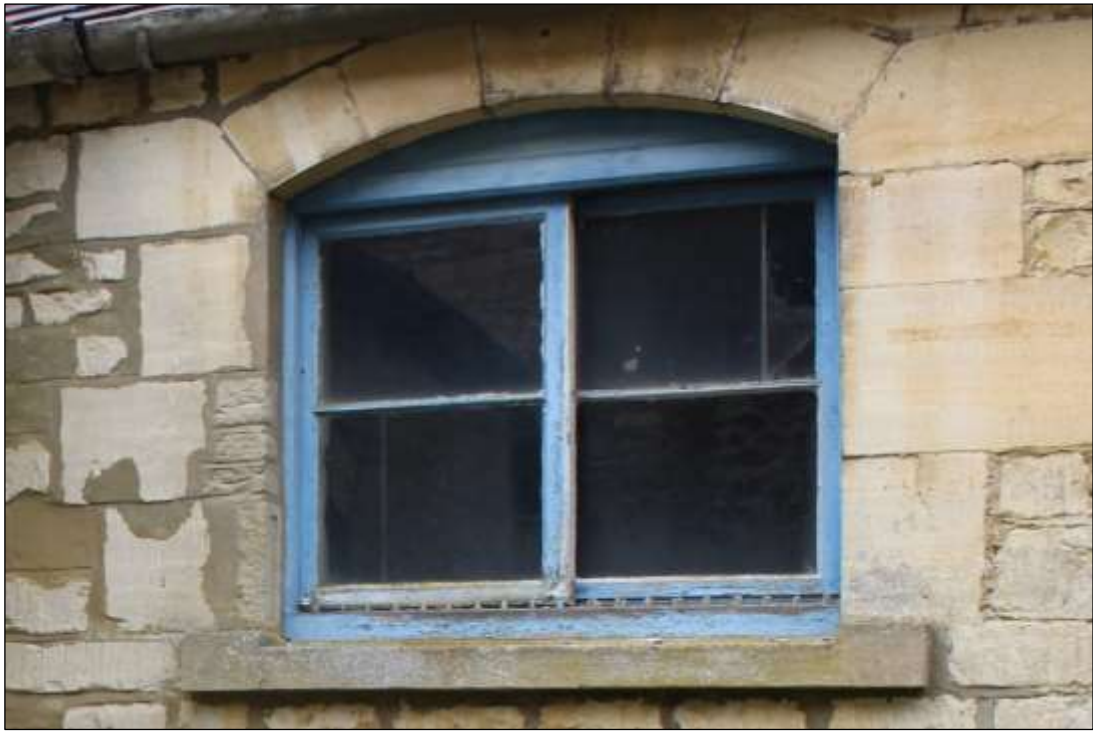
- 3.15. The windows, which feature stone segmental arch lintels, dressings and cills, are four light with side sliding sashes, this is evidenced by one sash overlapping the other, and a row of pins which appear to be guiders for the sash as it slides sideways (Fig.10). Several of the windows are more modern replacements, but the majority are original side sliding sashes as shown in Fig.10. The doorway and window configurations are shown in Figs.11 to 15.
- 3.16. The kiln structure to the west of the building has lost its conical roof and is now roofed diagonally in corrugated metal. It is formed in a hexagon shape in coursed stone with two large buttresses to the south facing wall. There has been extensive alteration to this structure and some of the stonework is in poor repair. Externally

**Fig.10 View of a typical window, Maltings 1**

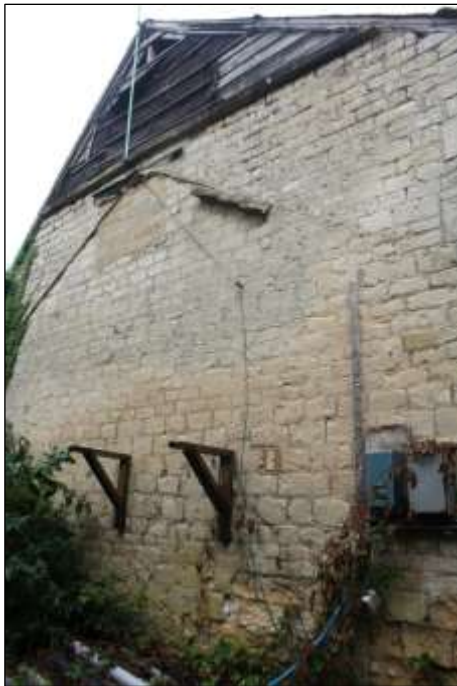
this is seen in the loss of one of the sides of its hexagon shape which is now a large metal roller door as per Fig.11. The western elevation has two bracket fixtures and a blocked-in window, with a timber section to the top of the gable end. A building scar shows evidence of a gable end roof abutting this elevation; this is no doubt the structure shown in the 1882 and 1901 OS maps but absent in the 1936-37 map, and possibly in use as a stable or storage.

**Fig.12 View towards the west elevation of Maltings 1 showing scar of attached building and other accretions**

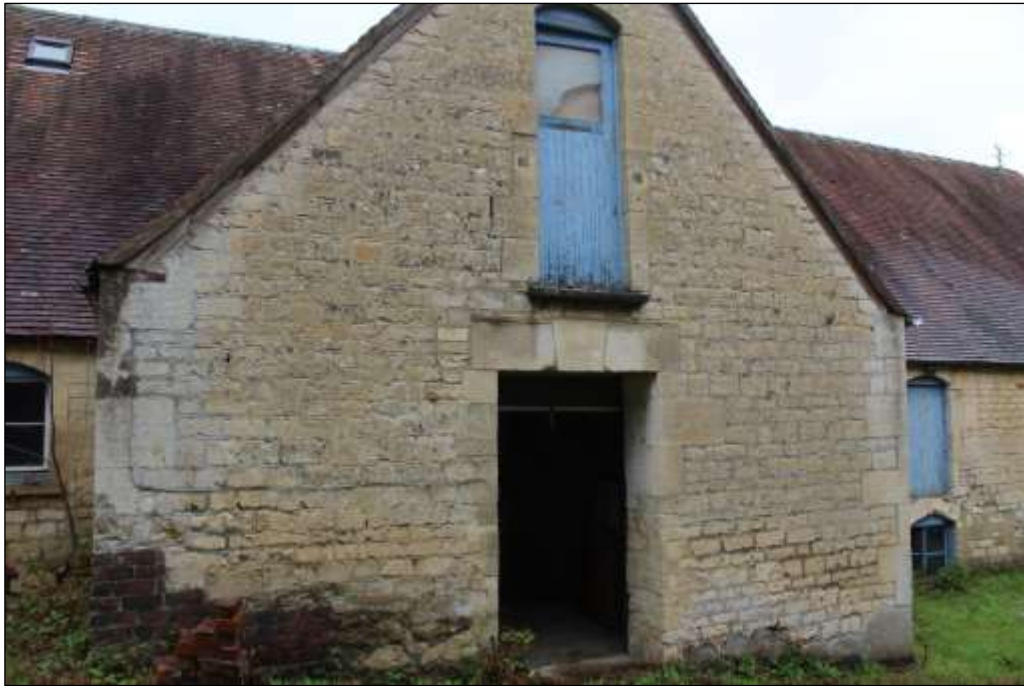
**Fig.13** View of the cross-wing of Maltings 1, image taken looking north

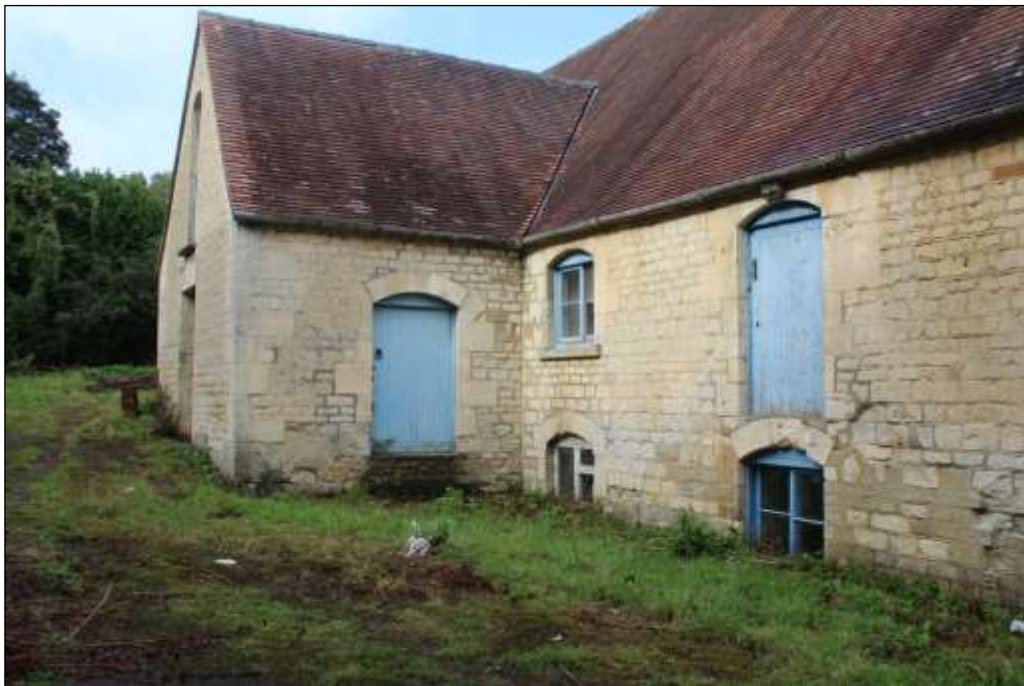
**Fig.14** View to west of the cross-wing and eastern section of Maltings 1

- 3.17. The central cross-wing features a doorway with stone lintel and keystone at ground floor level, and a narrower door with arch lintel at first floor level. A wooden bridge linking this doorway to Malthouse No.2 kiln is shown in an historic illustration of the buildings as shown in Fig. 16 and the southern side is blank. The east side of the crosswing features a further doorway as shown in Fig.14.

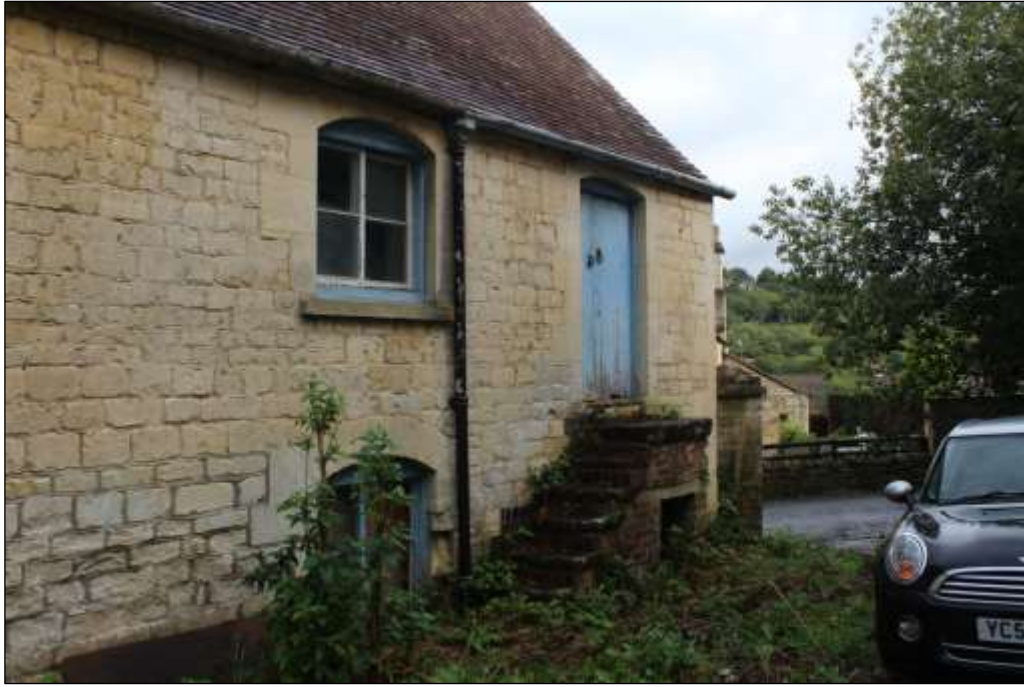
**Fig.15 View to the east of the eastern section of Maltings 1**

- 3.18. The main access to the Malthouse is located at the eastern end, via a brick staircase as shown in Fig.15 and double doors into the upper growing floor. The eastern (roadside) elevation has two wide segmental arch windows at first floor level, with a smaller window within the gable apex (Fig.17). The two first floor windows are partially bricked internally and have lost their timber frames to a temporary Perspex covering. A short door at ground floor level leads into three brick arched vaults.

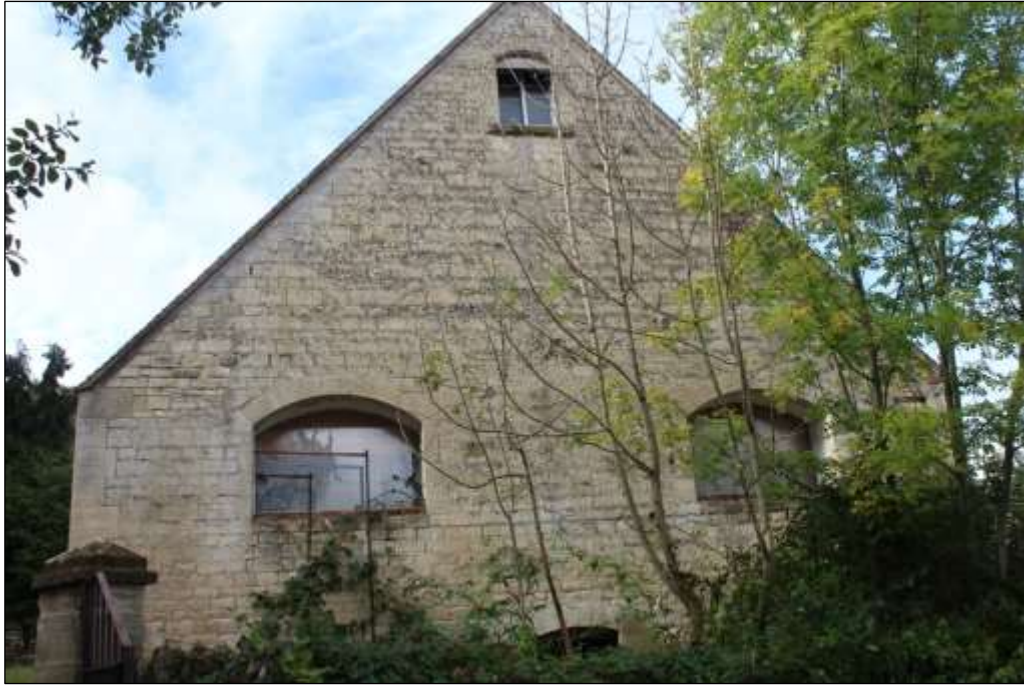
**Fig.17 Eastern elevation of the Maltings 1**

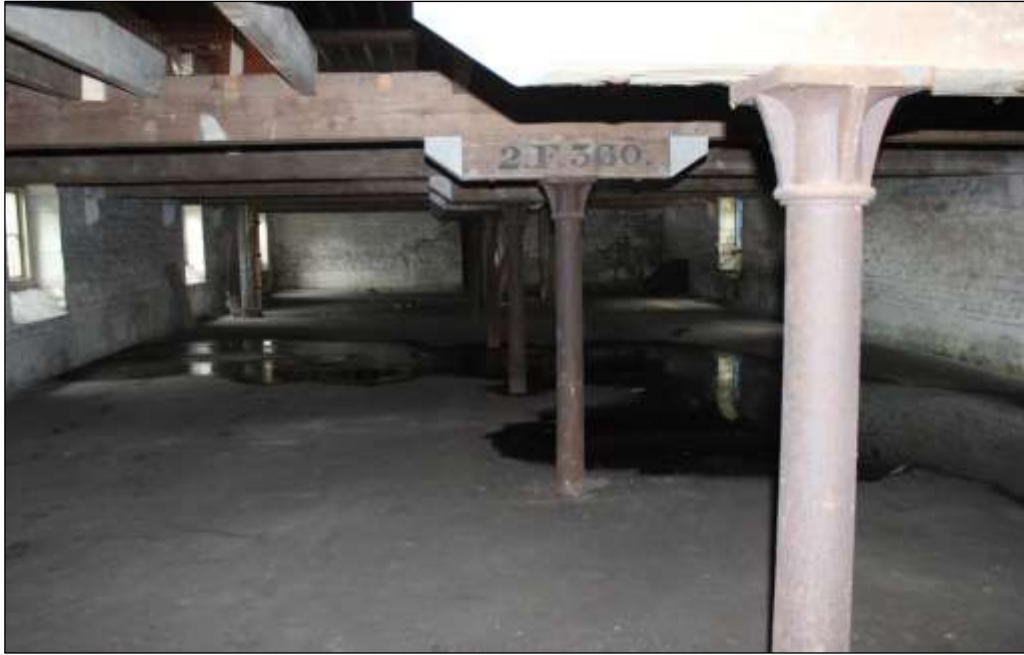
- 3.20. This floor is accessed from a staircase located at the kiln of the upper growing floor (where external access is afforded) and a staircase by the central hoist (Fig.18). This floor spans the length of the building (not including the kiln) at lower ground level, and is lit and ventilated by four light sliding sash windows, to the south side these address the ground level outside though there is a lightwell ditch. The windows have sloping cills which appear to be formed of concrete; surfaces were no doubt never horizontal in such spaces to prevent the accumulation of wayward grain.

**Fig.18 Lower growing floor of Maltings 1**

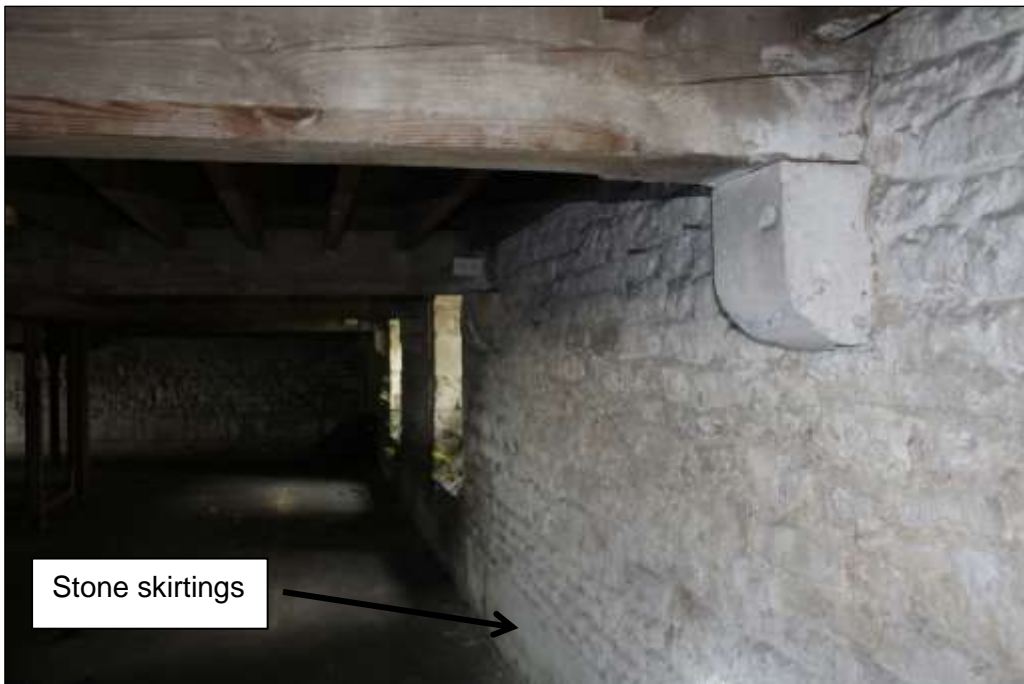
- 3.21. The first floor is supported on substantial cast iron columns spaced at even intervals along the space. These are topped with a shaped chamfered pad or pillow, in turn supporting very thick beam members spanning the width of the building. These rest on stone corbels in the side walls and from these beams run joists and boards. This arrangement is illustrated in Fig.19. The floor to ceiling height is quite low though it is adequate for access and inspection.

**Fig.19 Main span beams resting on stone corbels, lower growing floor of Maltings 1**

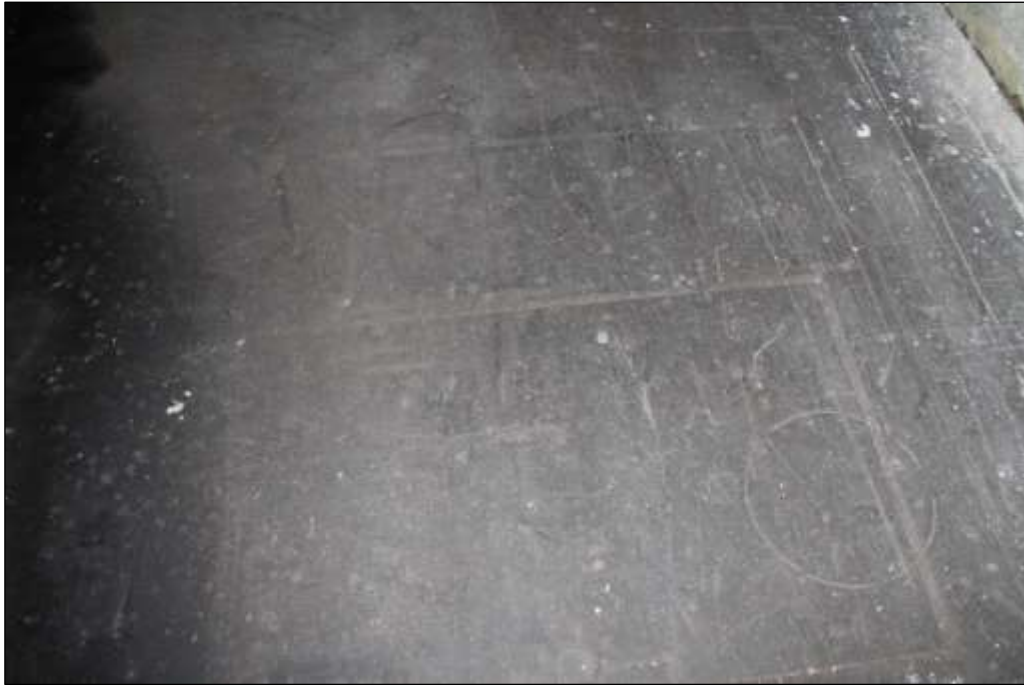
3.22. The floor surface is asphalt and there is good survival; much of the asphalt retains a patina of grooves and marks as it is a slightly malleable surface (Fig 20). There are stone skirtings to the floor to help retain the moisture of the germinating grain laid out on the floor, and limewash has clearly rubbed away (Fig 19). The external walls are formed of coursed rubble stone with what appears to be a limewash (Fig 20). A

**Fig.20 Patina of use on the asphalt surface, Maltings 1**

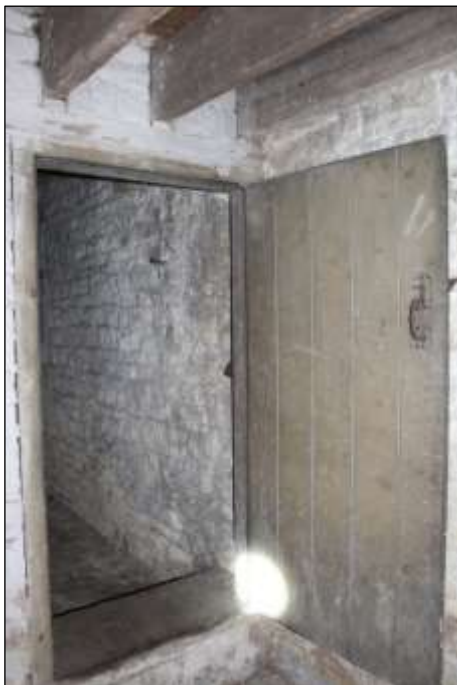
timber door (Fig 21) at the kiln end of the space accessed the ground floor of the kiln area. The doorway features a high step to prevent loss or seepage of grain from the growing floors.

**Fig.21 Timber door and step from lower growing floor to kiln area, Maltings 1**

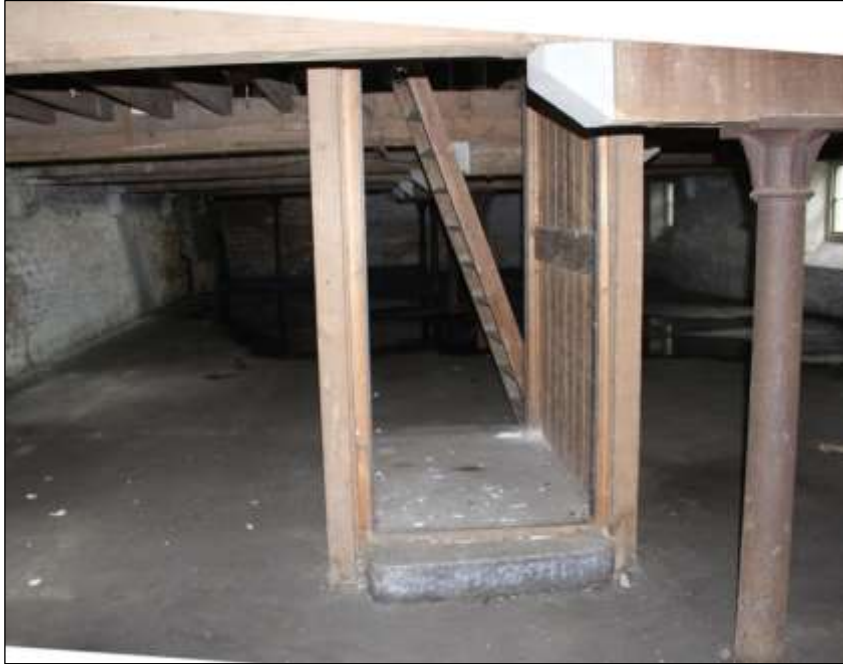
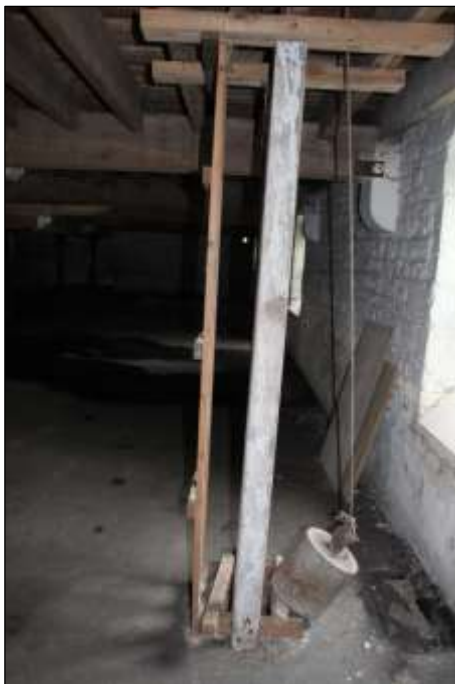
3.23. A hoist with associated counter balance weight is seen in the fourth bay along (from the north-eastern end); these also feature on the upper growing floor. They are not thought to be original and are later additions (Figs.22 and 23). A floor hatch over a rectangular brick lined hole is found at the kiln end of the space; it is not known what the purpose of this features is (Fig.24).

Fig.22 image of hoist equipment and hatch on lower growing floor of Maltings 1

Fig.23 Detail of hoist counterweight, lower growing floor, Maltings 1

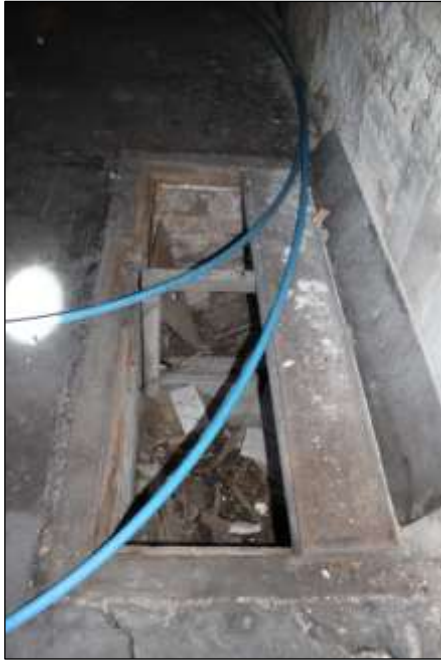
**Fig.24 Floor hatch with bricked out hole, lower growing floor Maltings 1**

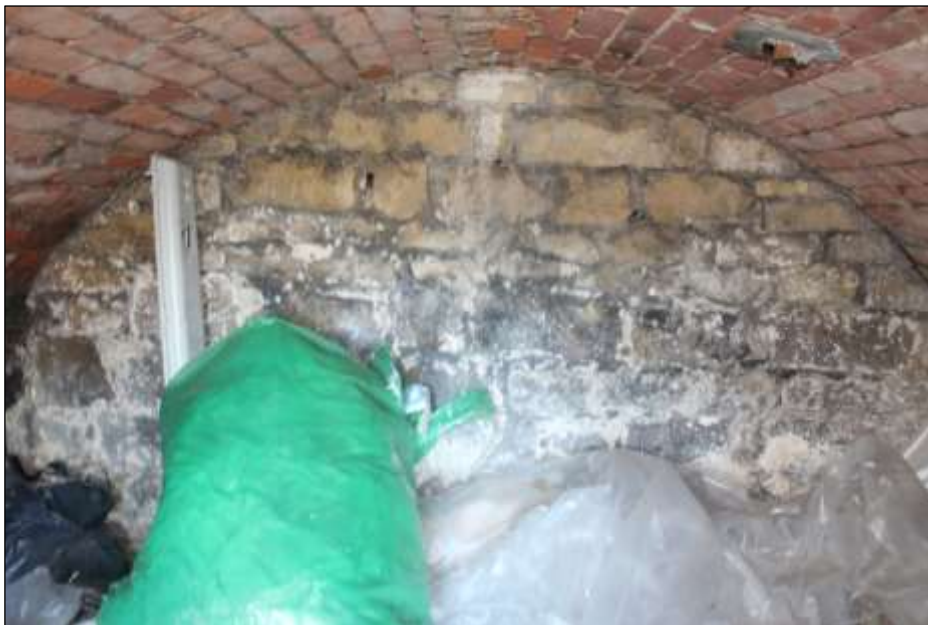
- 3.24. Three small rooms are located under the steep, and are not accessible from the lower growing floor, only from the outside (north-west facing elevation). Only the middle room could be accessed but they appear to be half height brick vaulted structures, currently used as a rubbish area (Fig.25). The rooms to either side are accessed via small hatch doorways and inspection suggests they are nearly full of unwanted building rubbish and melted piles of asphalt.

**Fig.25 Interior of small vault under the steep, Maltings 1**

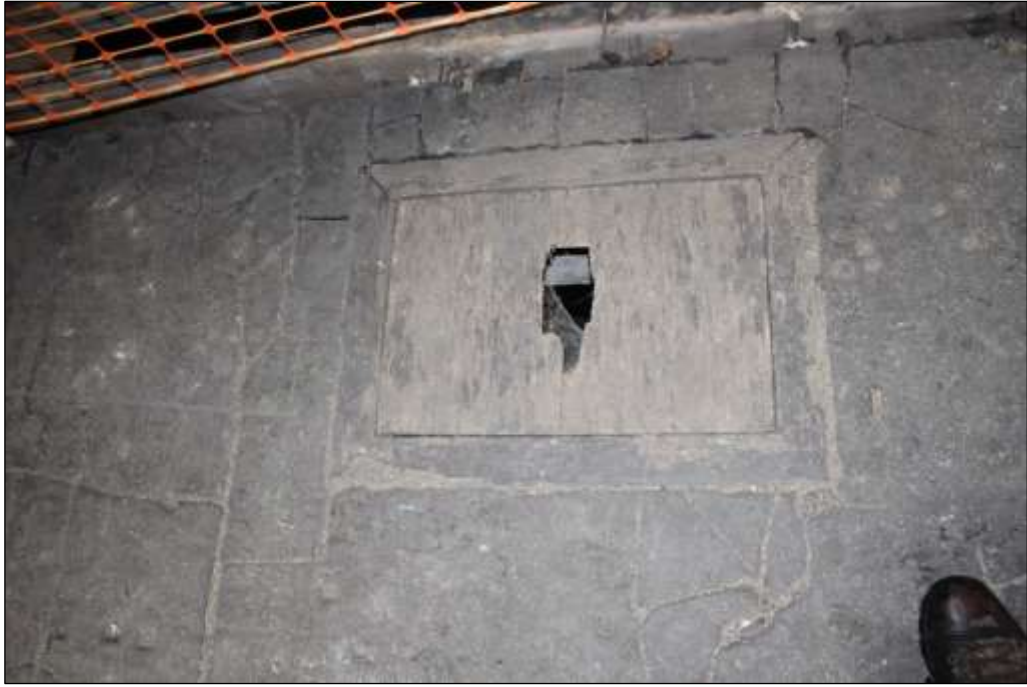
**Fig.29 Hatches in upper growing floor**

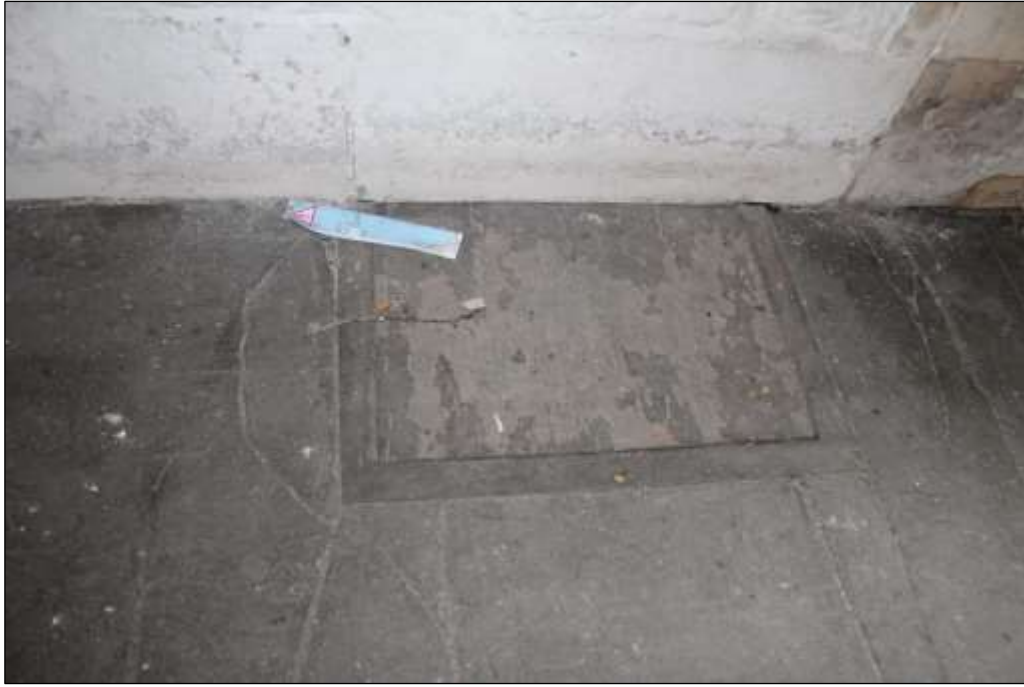
- 3.25. The upper growing floor (or ground floor on plan) is accessed via the external steps at the north-eastern end of the building, and internally via the two staircases from the lower growing floor (one at kiln end and one in bay four). The remains of the steep is found to the right hand (north facing) wall of the space. Two of the sides of the steep, built in brick and finished in concrete, remain *in situ*, as does the footprint of the concrete floor. This is shown in Figs 26 and 27 with the hacked ends of the two sides of the rectangle being shown. A scar located halfway along the long side indicates the steep was formed of two vats. The floor plans found in Appendix 2 feature a shaded area delineating the area of the steep on the ground floor plan. Four hatched traps, or chutes are seen in the main floor just outside of where the walls of the steep would have been located, this would have been to shovel grain to the lower growing floor (Fig.30. A hatch is also located adjacent to the north-western wall, with a ladder found below in the lower growing floor, this would have been an historic access to the lower floor. These are shown in Figs 30 and 31.

**Fig.31 Hatch onto lower ground floor ladder, located in upper growing floor**

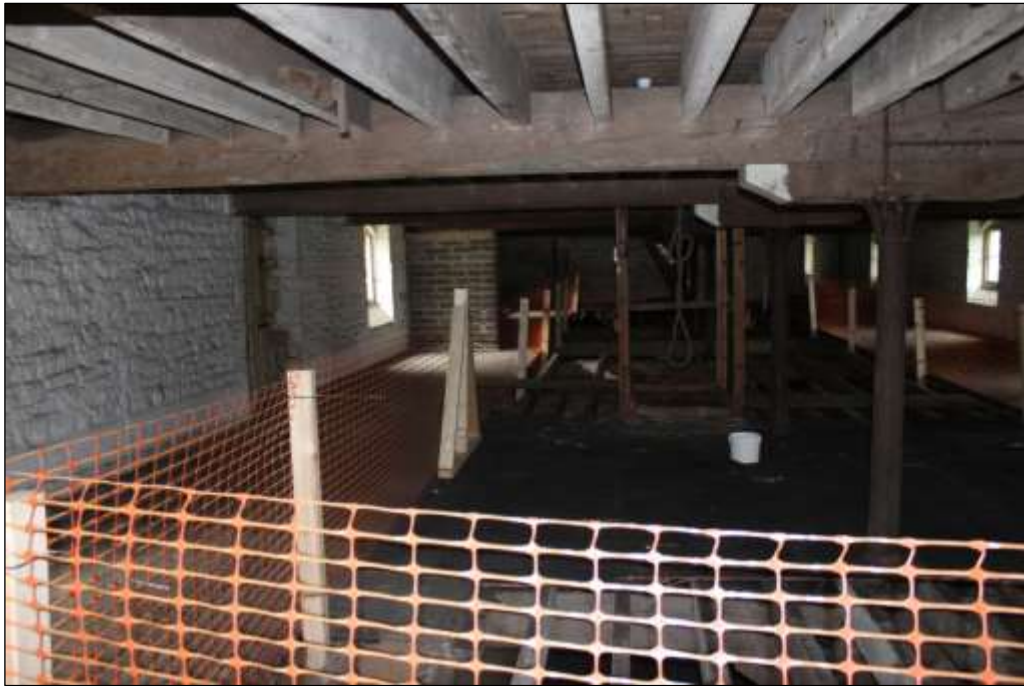
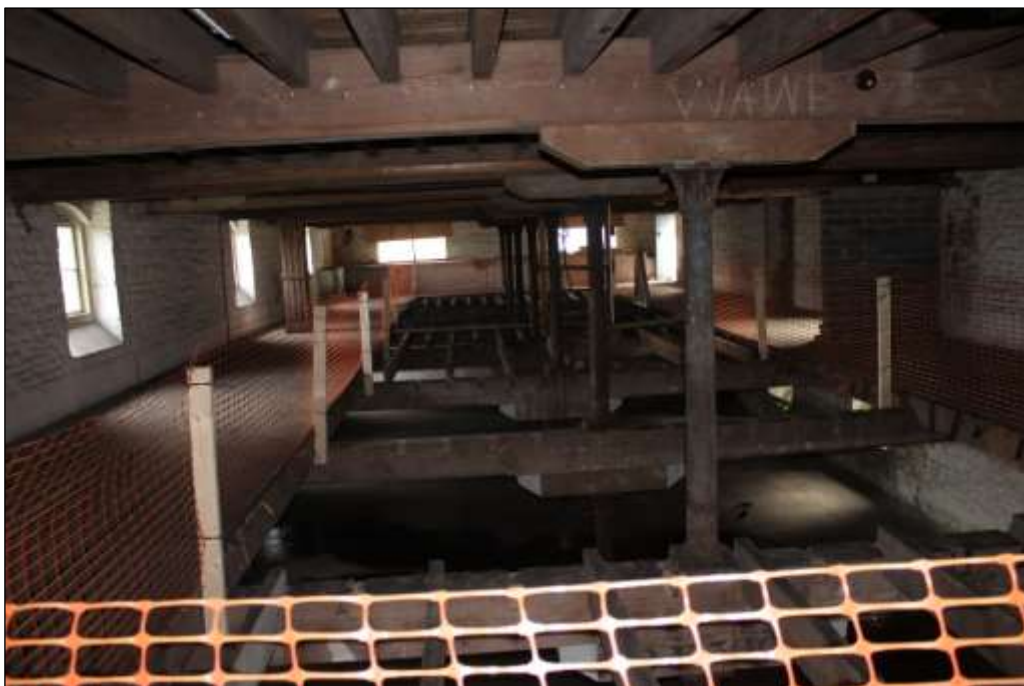
- 3.26. To the right of the steep located immediately in front of access to this space is the expanse of the upper growing floor (Figs.32 and 33). This space spans the full length of the building bar the kiln to the far west end. In form, materiality and appearance it is similar to the lower growing floor, with central cast iron columns with thick pads, supporting substantial chamfered and stopped beams resting on stone corbels at the wall ends. The floorboards are again lined with asphalt with stone skirtings. At the time of the site inspection an area of timber flooring had been removed by previous owner leaving a void running along the centre of the upper growing floor looking down to the lower growing floor, though this does show the structural members in good detail.

**Fig.32 Upper growing floor viewed from east end**

**Fig. 33 Upper growing floor viewed from west end**

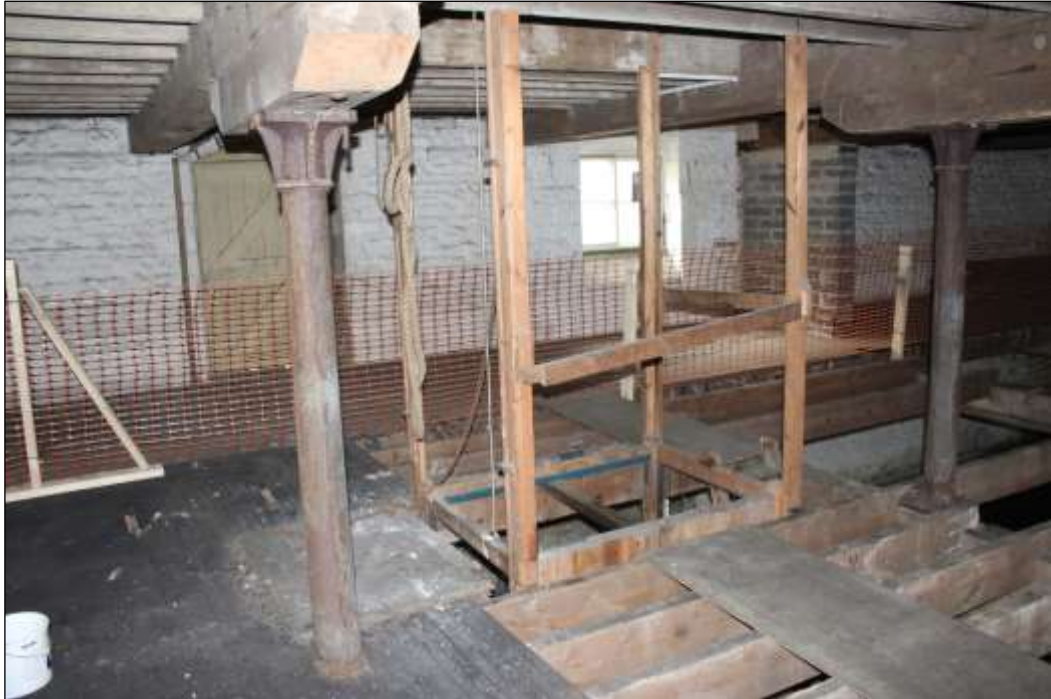
3.27. As with the lower growing floor the hoist structure and pulley are visible within the space as seen in Fig. 34. A ladder staircase at the kiln end of the building leads to the first floor Fig. 35. An external timber door is located at the south-western end of

**Fig.34** View of hoist structure, upper growing floor

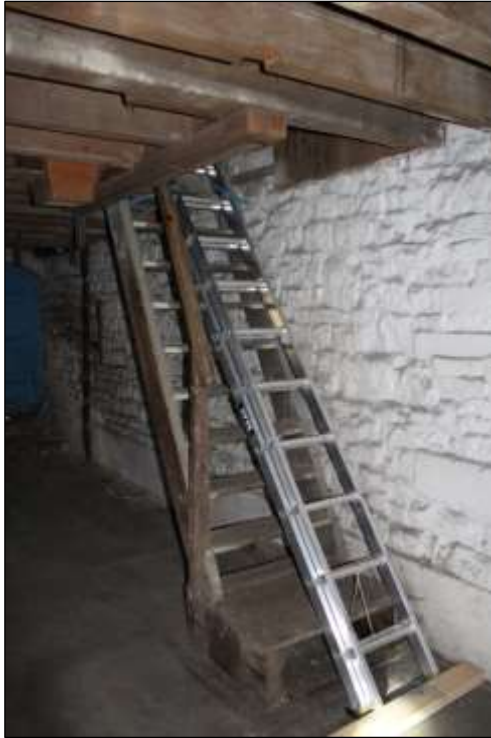
**Fig.35 Ladder to lower storage floor (first floor)**

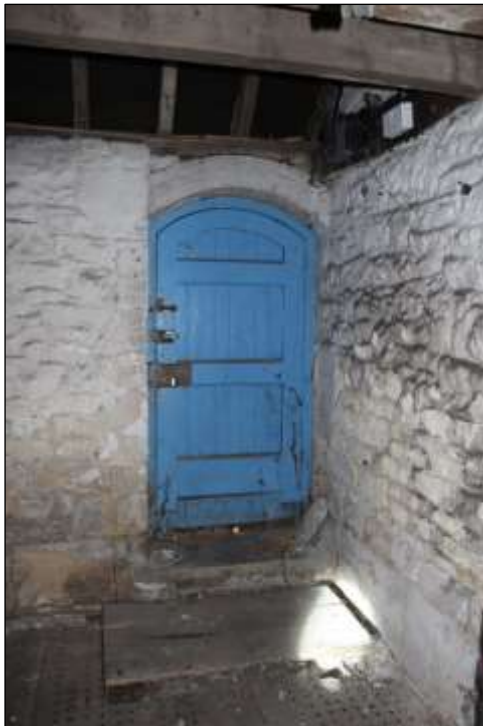
the growing floor, with a perforated metal threshold plate extending into the room (Fig. 36).

**Fig.36 Doorway to southern (courtyard) elevation**

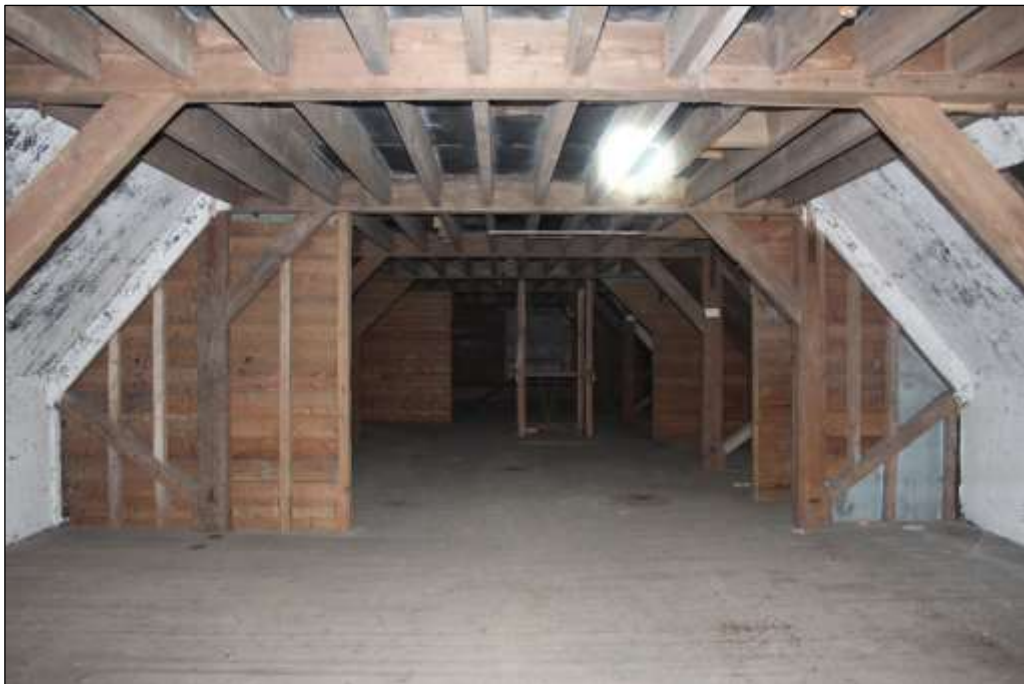
- 3.28. This floor is accessed via the ladder from the kiln end of the upper growing floor. It is a timber lined space as seen in Fig. 37 without any external windows. Timber stud/tongue and groove walls create bays within the overall braced timber truss which extends up to the upper floor. This truss is braced in some corners with metal strapping. There is some what appears to be lead lining within some bays. The pulley hoist cage is extant though it clearly finishes at this level as no opening is seen to the upper floors, though the ropes that form part of the operation are fed into the upper floor above (Fig. 38).

**Fig.37 View of lower storage floor (first floor) of Maltings 1, view to the west**

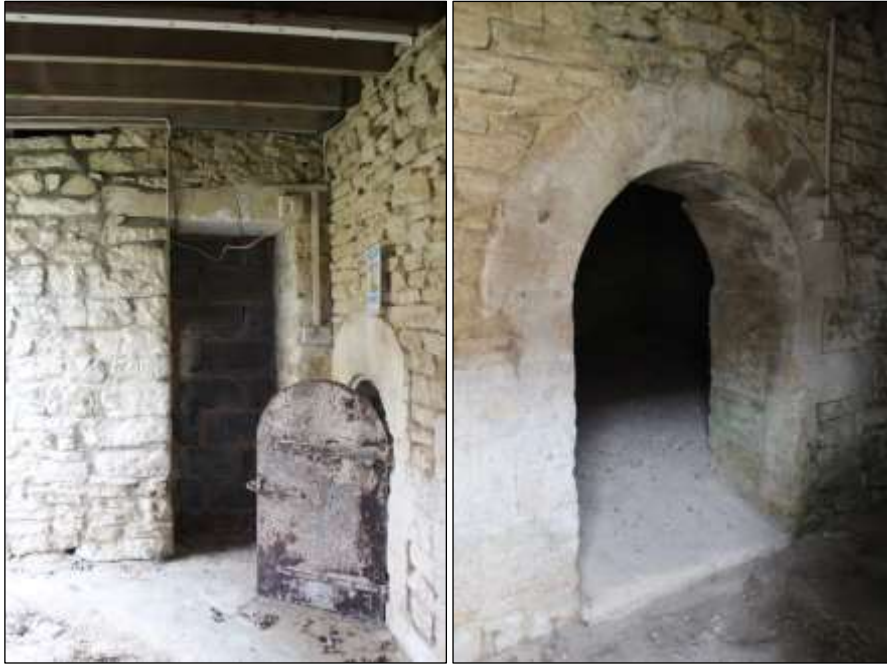
- 3.62. On the ground floor, in the room adjacent to the kiln chamber, there are two ashlar arched openings into the kiln chamber, the left hand smaller one with original metal door appears to have housed the furnace or one of them, whilst the right hand one is bigger, showing hinge ironmongery which also suggests it had a door and a role as part of the furnace (Fig. 84). It is possible the left hand door provided some ventilation. No internal furnace fittings survive. It is possible to access the chamber through the larger doorway. The metal and mesh drying floors are revealed when looking up into the kiln space with the hatches already described shown above the metal floor, Fig. 85 illustrates this. The floor of the chamber appears to have been recently concreted, and the furnace/s have been cleared of any fittings and detritus (Fig. 86).

**Fig.84 details of openings to the kiln to Maltings 2, doorway from the north elevation providing light from the left (note blocked doorway)**

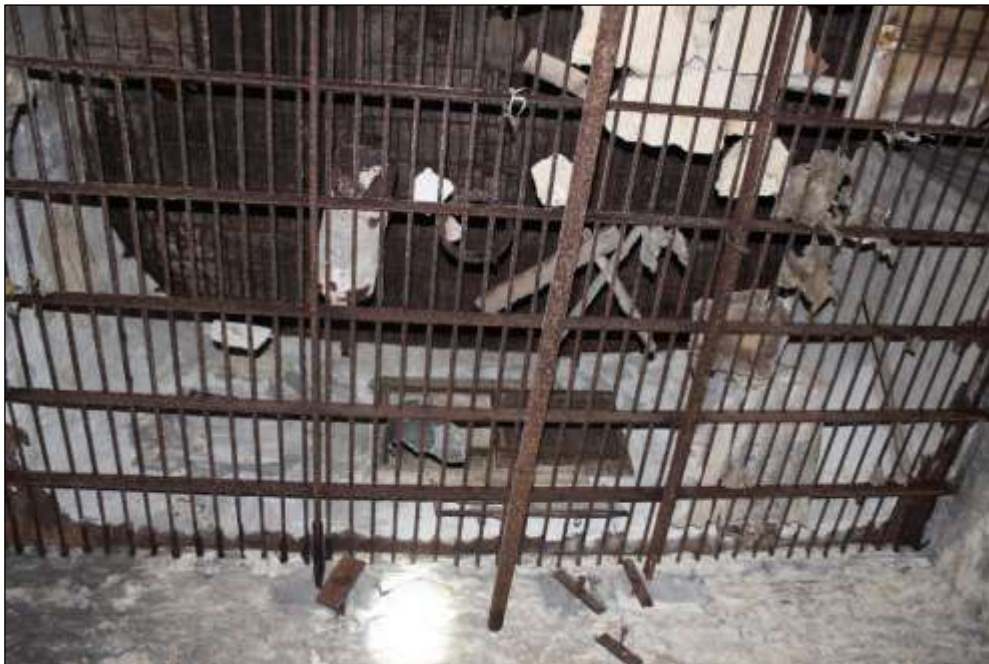
**Fig.85 Looking upwards into the body of the kiln, showing the metal floor and wire mesh floor above**

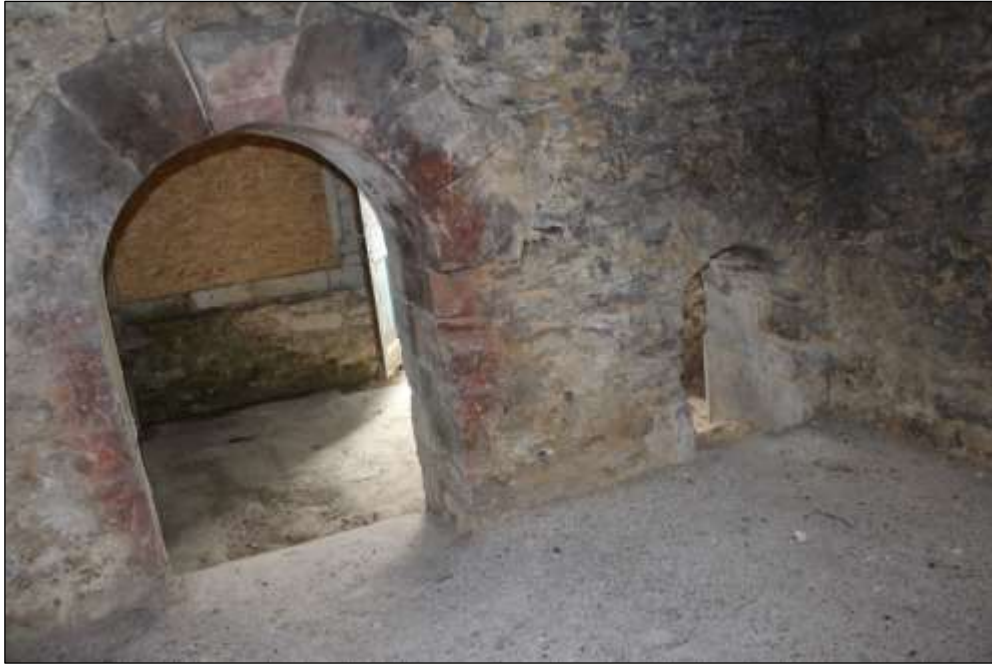
**Fig.86 Internal view of the kiln looking out towards the north**
