# No.6 Motor Transport Site RAF Quedgeley (now Quedgeley East Business Park)

*Historic Building Recording (Level 2)*

CA Project: CR0694

CA Report: CR0694\_1

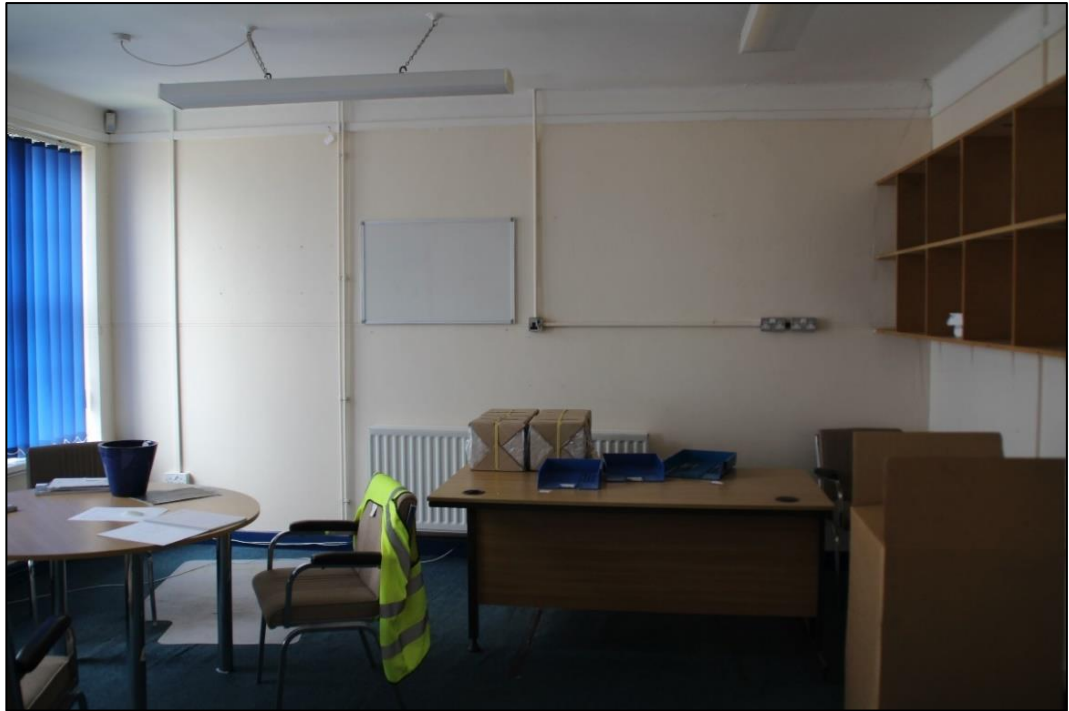
- 4.49. It is not clear where the original canteen would have been located, but likely in the rear room, with the kitchens/pantry etc found in two small rooms flanking the rear corridor. At the HQ site there was also an officers/supervisor's canteen in the same building, therefore one of the front elevation (west) rooms flanking the entrance corridor could have been a separate dining room for higher ranking personnel. Of

**Photo 79** View of a former canteen room now office room, located at the front (west) of the building

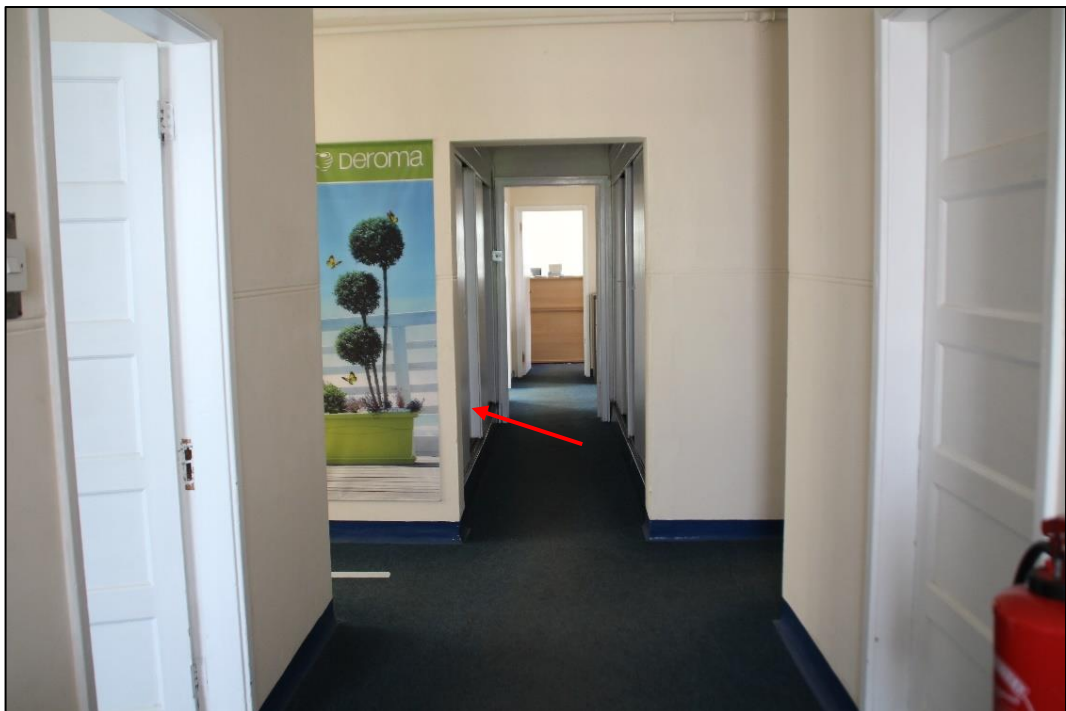
**Photo 80** View from the main door to the rear of the building where the canteen may have been located with possible kitchen arrowed

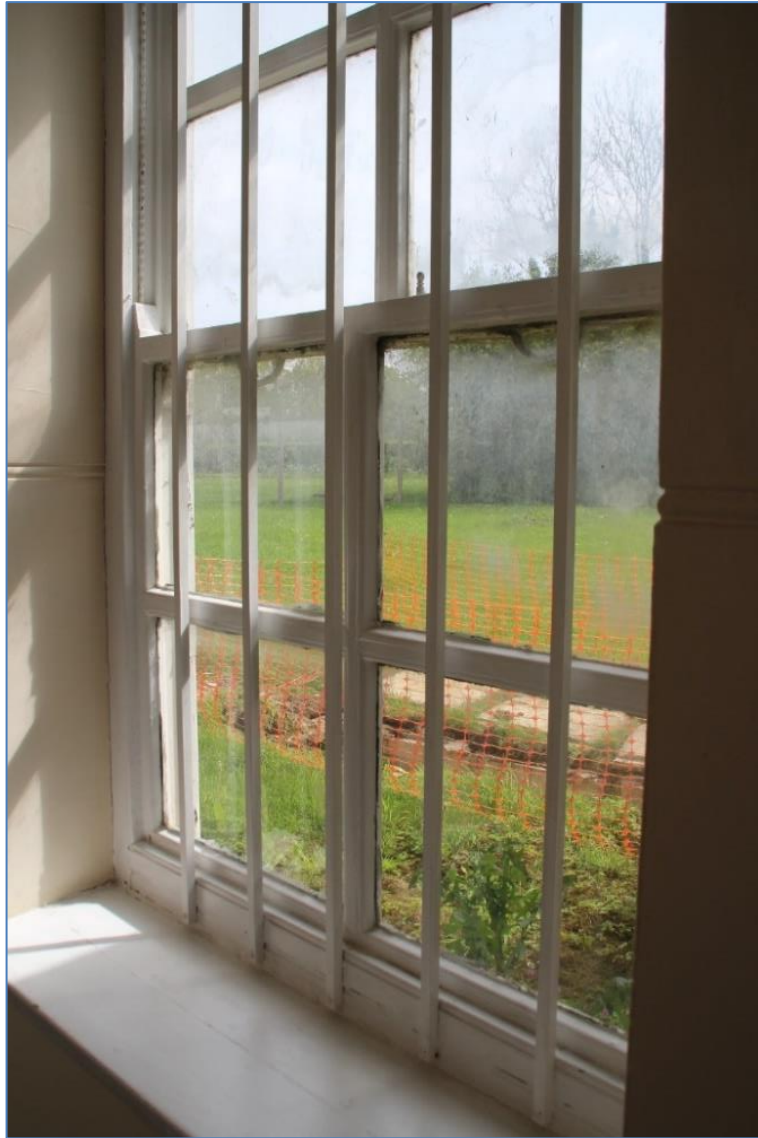
- 4.50. The Building has been converted to offices, so there are no remnants of its earlier use, however the same attention to detailing as seen in the other non-storage buildings is seen here, such as the good quality timber four panelled doors with timber architrave, and the multi-pane timber sash windows with horns (Photo 81), some barred, presumably to keep the contents of the room – probably a dry food storage - secure.

**Photo 81**      **Detail of original timber window with bars on the canteen kitchen**

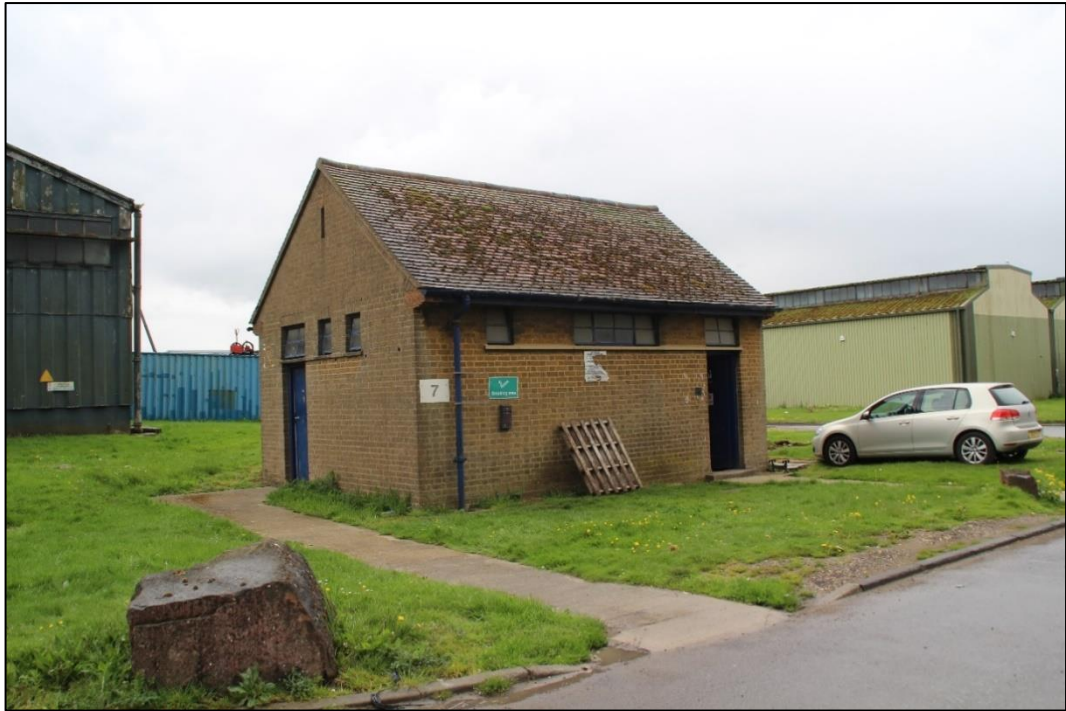
- 4.51. The toilet blocks, of which there are two on the site, are small brick-built buildings with pitched tiled roofs and high small high-level windows as seen in Photo 82. There is a Ladies and Gents door located on opposing corners of the Building accessing the divided sections. Internally the doors (Photo 83) are identical to those seen in the Warden's office and canteen, whilst the high-level windows are frosted Critall style (Photo 84). Sanitary ware appears to be original with high level cisterns and typical 1930's detailing (Photo 85).

**Photo 82** View of Building 9, toilet block, image taken looking south-west

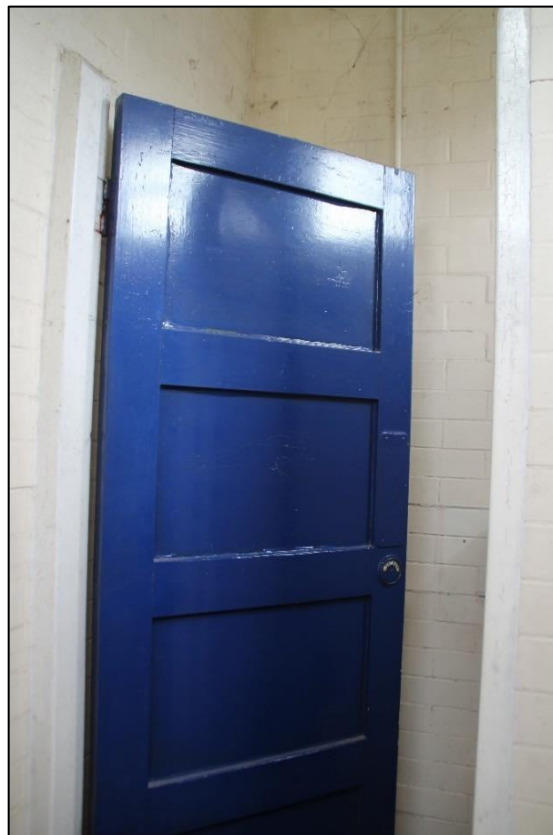
**Photo 83** Detail of panelled door to cubicle in Ladies toilet

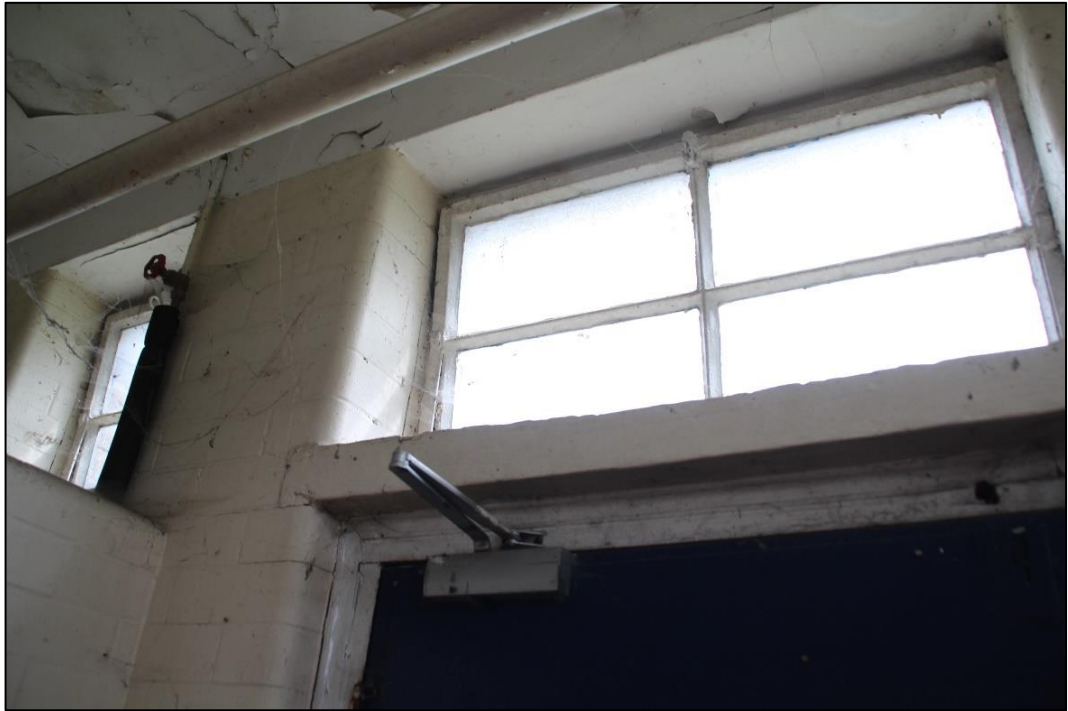
**Photo 84**      **Detail of high-level metal windows in Ladies toilet**

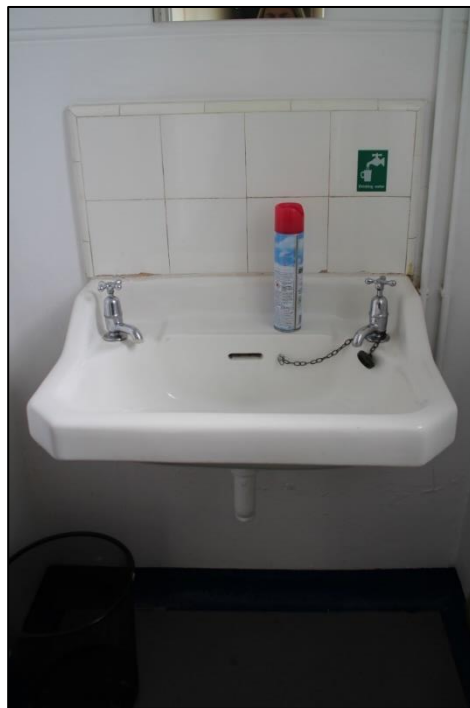
**Photo 85**      **Detail of sink in Ladies toilet**

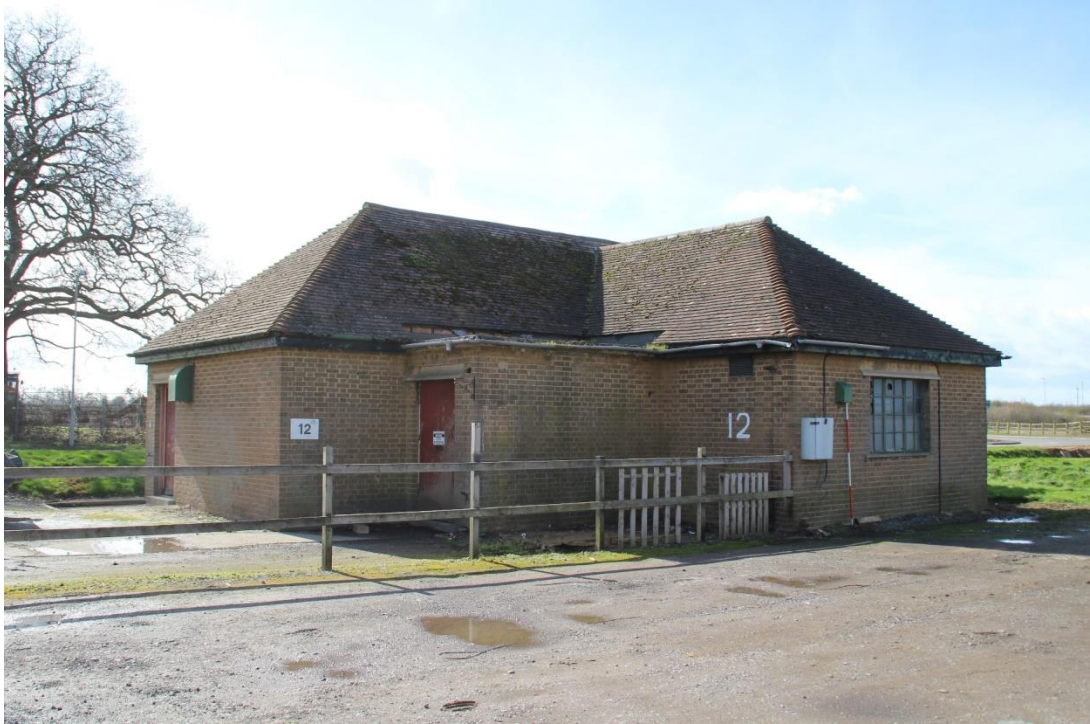
- 4.1. This is a single-storey brick building on a T plan (Figs 3, 4 and 5). The brick (8¾" x 4¾" x 2¾" , 222mm x 111mm x 70mm) is laid in a regular Flemish Bond. The roof is hipped and covered with plain tiles. The hips and ridge are covered with half-round tiles. The valleys have shaped soakers. The valleys have shaped soakers.

**Figure 3** *Building 1 looking south-west (scale 2m)*

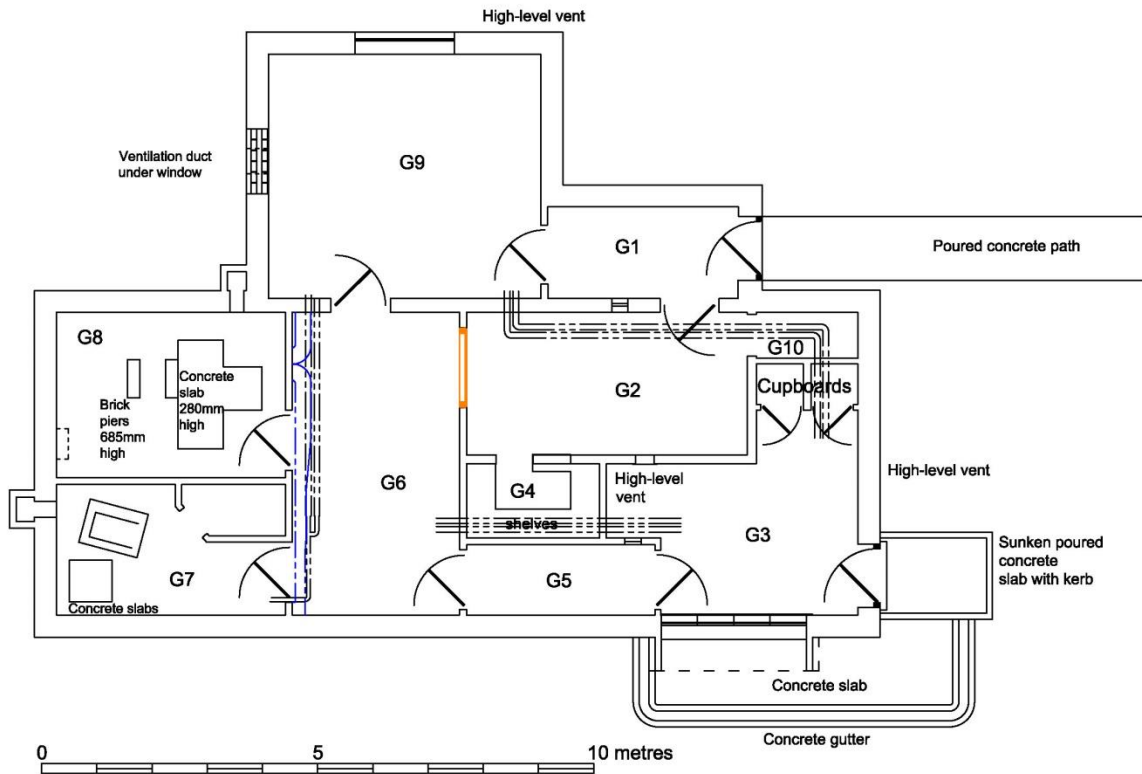
- 4.8. The interior is divided into several rooms all of which are part of the 1939 build (Fig. 5). The original finish varies. In Rooms G3 and G9 the walls are plastered up to the ceiling (Figs 8 and 15). In all the other rooms except for G7 and G8 the plaster only extends to the top of the doors (Fig. 10). In these exceptions it only reaches up to c. 1.22 m (Fig. 11); where not plastered the walls are painted brick. The ceilings are all plain plaster. The roof structure was not seen (but see Building 2 below).

**Figure 5** Floor plan of Building 1. Later changes are in orange. The chain lines show overhead pipes or clear evidence for them; blue indicates ceiling-level ventilation ducting in G6

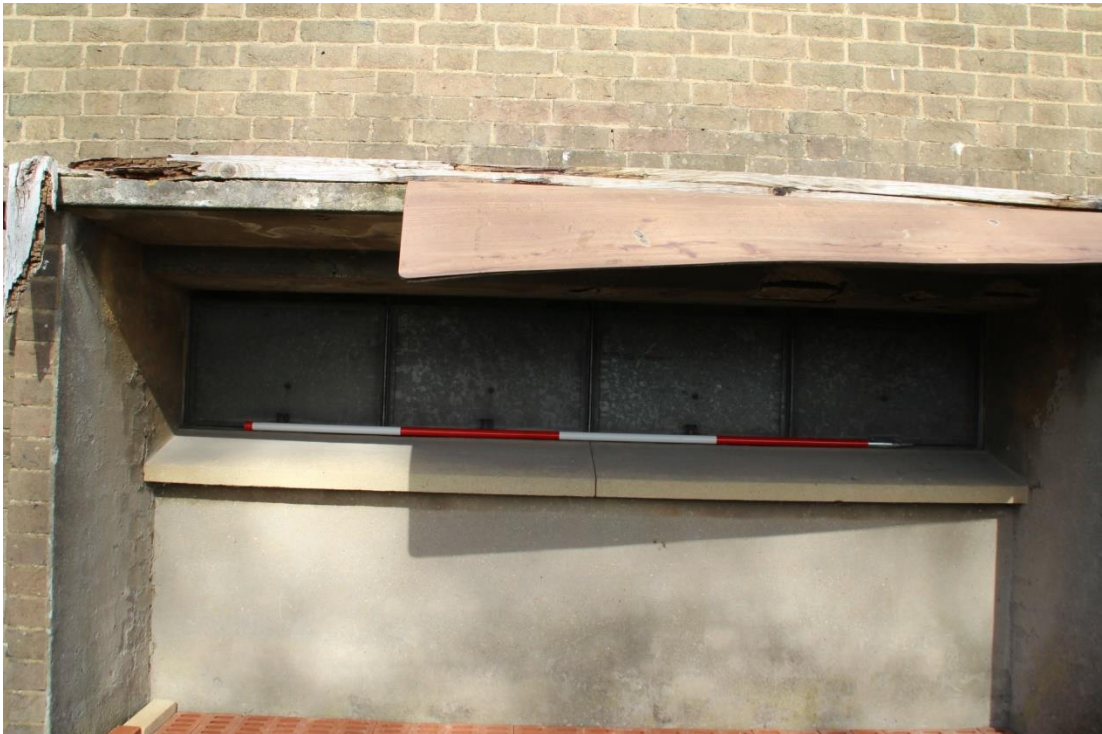
protected by short cheek walls and a concrete canopy (Figs 5 and 7). The shutters could not be opened but appeared, from the measurements taken, to be in two layers, one flush with the interior (Fig. 8), the other some 130 or 140mm away (Fig. 5).

**Figure 7** *The steel shutters of the “delivery bay” in the south side of Building 1, cf Fig. 8 (scale 2m)*

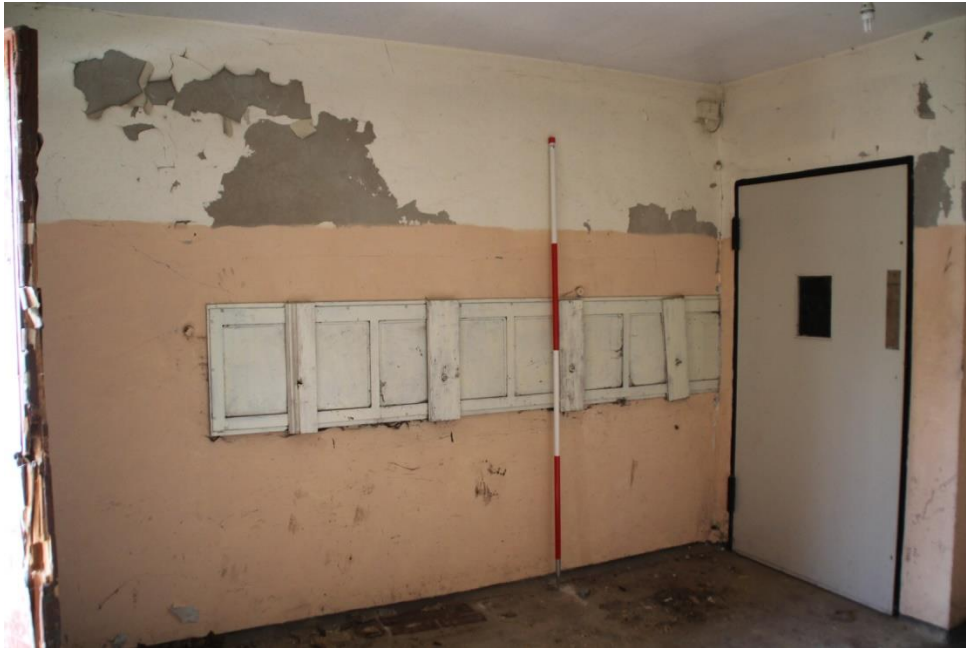
**Figure 8** The steel shutters of the “delivery bay” seen within G3, looking south-west, cf Fig. 7. The wooden planks are later fixings (scale 2m)

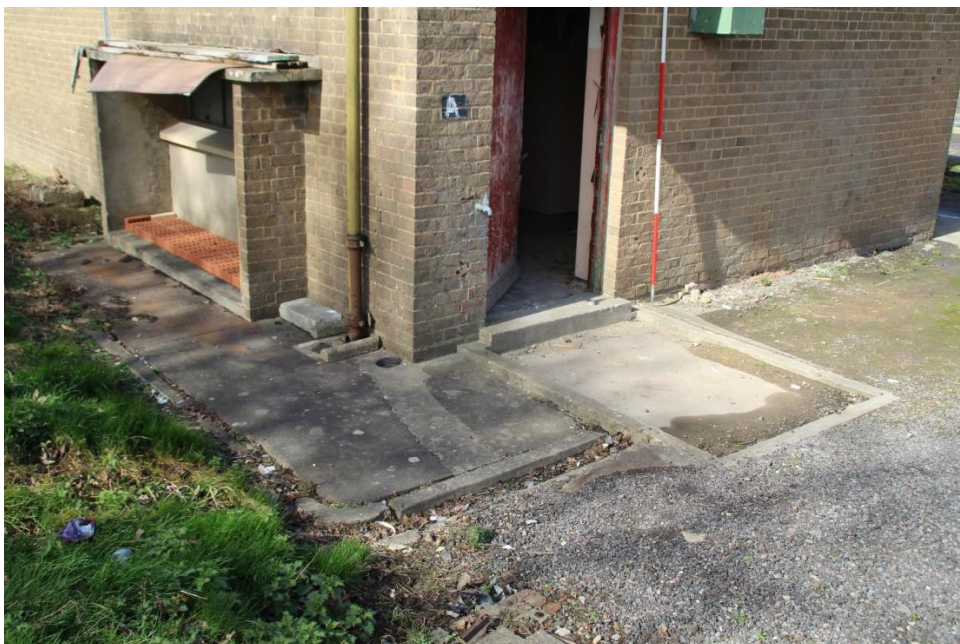
- 4.6. Below the shutters is a concrete apron with a gutter all around (Figs 5 and 9).
- 4.7. This appears to be for the delivery (or disposal) of some kind of liquid, but this cannot be confirmed. There is no obvious standing for a vehicle near this point.

**Figure 9** The concrete apron around the “delivery bay” in the south side of Building 1 and the slab outside the door to G3, looking north-west (scale 2m)

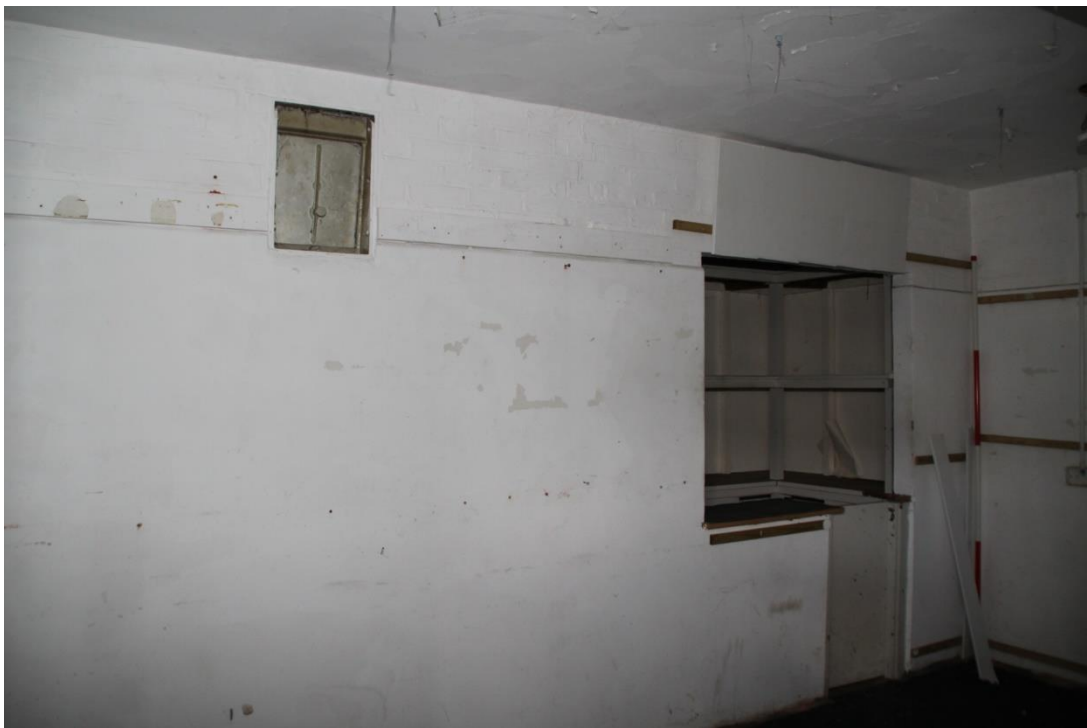
- 
- 4.15. There were several vents in the outside walls and one in the wall between G2 and G3. The ones in G3 and G9 have externally hoods and face downwards (Fig. 3). That in the west wall of G9, which is certainly an original feature, has horizontal louvres externally (Fig. 6) but is closed on the inside by a substantial steel cover that could only be opened after removing several bolts and which semi-permanently sealed the vent (Fig. 14).
- 4.16. The one in the north wall of G3 had a heavy steel frame and a top hinged flap. The frame has 11 threaded holes indicating the former existence of a duct, hood or cover (Fig. 15). On the other side, in Room G2, the flap had a knob suggesting it was accessible here, not in a duct, and there is no sign of the fittings for one (Fig. 10).

**Figure 10** Room G2 in Building 1, the recess G4 and the steel lined duct from G3, looking south-east (scale 2m)

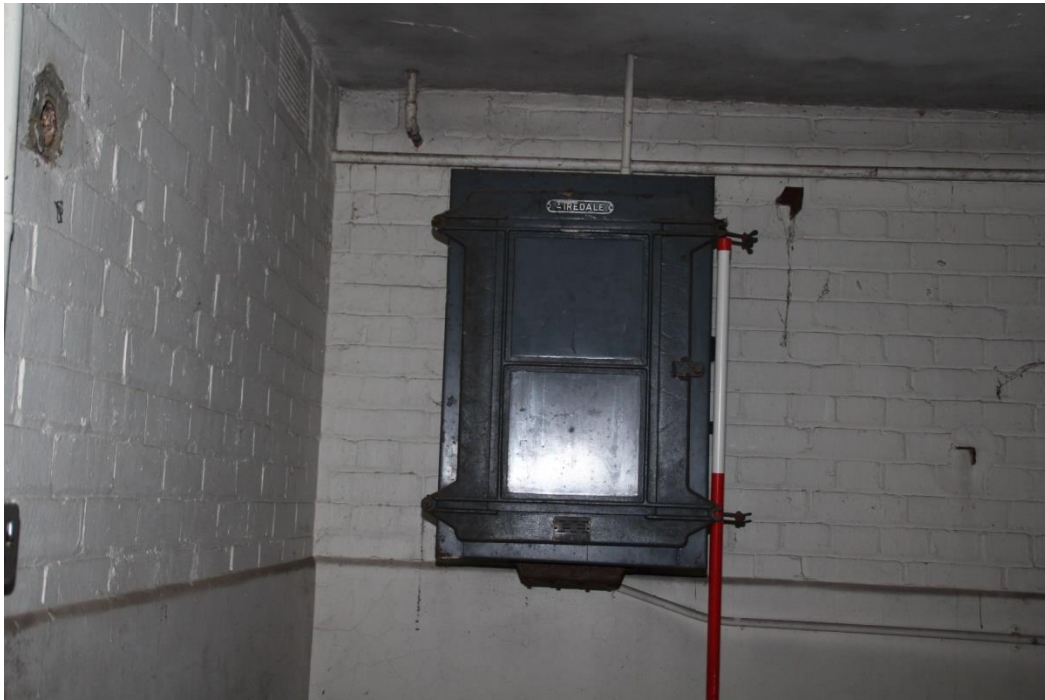
- 
- 4.10. Room G8 clearly had some kind of heavy electrical equipment as a 400v control box is still *in situ* on the west wall (dashed line on Fig. 5 and unopened in Fig. 11) and there is a heavy-duty junction box on the north wall (just visible in Fig. 19). The control box has a potentiometer to control the speed of three electric motors in unison, a mercury switch and other electrical components beyond my technical knowledge to interpret, but which appear to be in triplicate (Fig. 13). As the ventilation ducts seem to begin in this room, it is assumed that that the motors drove ventilation fans. The ducting only seems to have served rooms G6 and G9 (Fig. 5).

**Figure 11** Room G8 in Building 1, the electric motor control box and half height plastering (scale in 0.5m divisions)

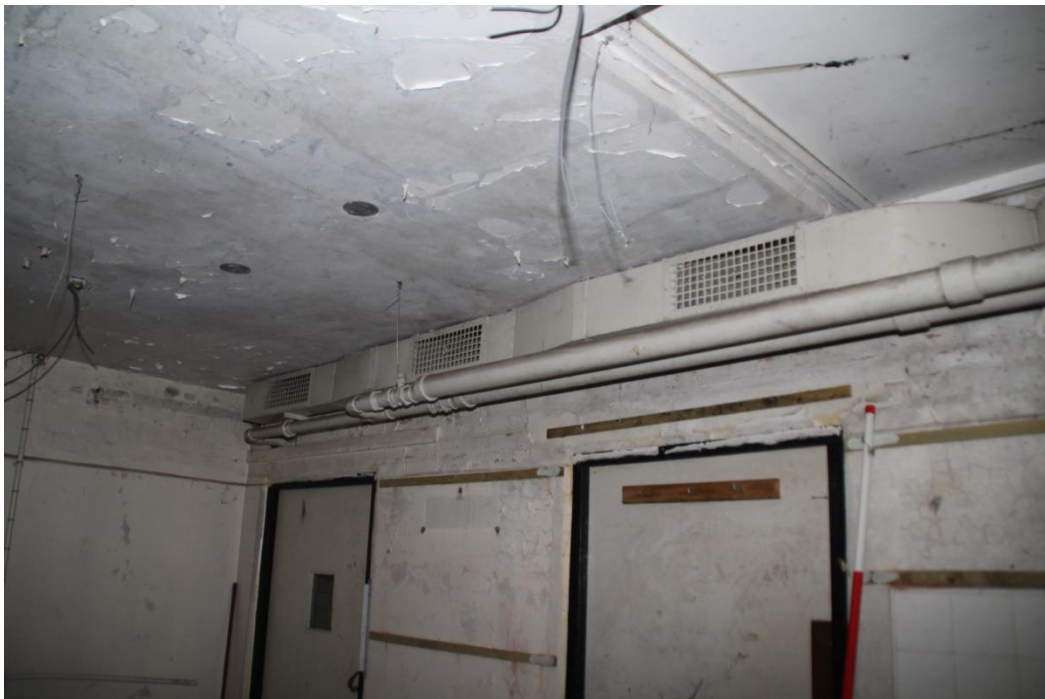
- 4.14. The overhead pipework appear to be for heating, but it is only partly in place. The layout suggests that the origin of the pipework was in Room G7. The splitting of one smaller bore pipe into two large bore pipes by the door to G7 (Fig. 12) suggests that this is the origin of a high pressure fluid feeding a lower pressure system that then ran around G9, G3 and G2 before returning to G6. What happened at the end of the system, if this interpretation is correct is unclear.

**Figure 12** The pipes and ductwork in Room G6 in Building 1, looking south-west

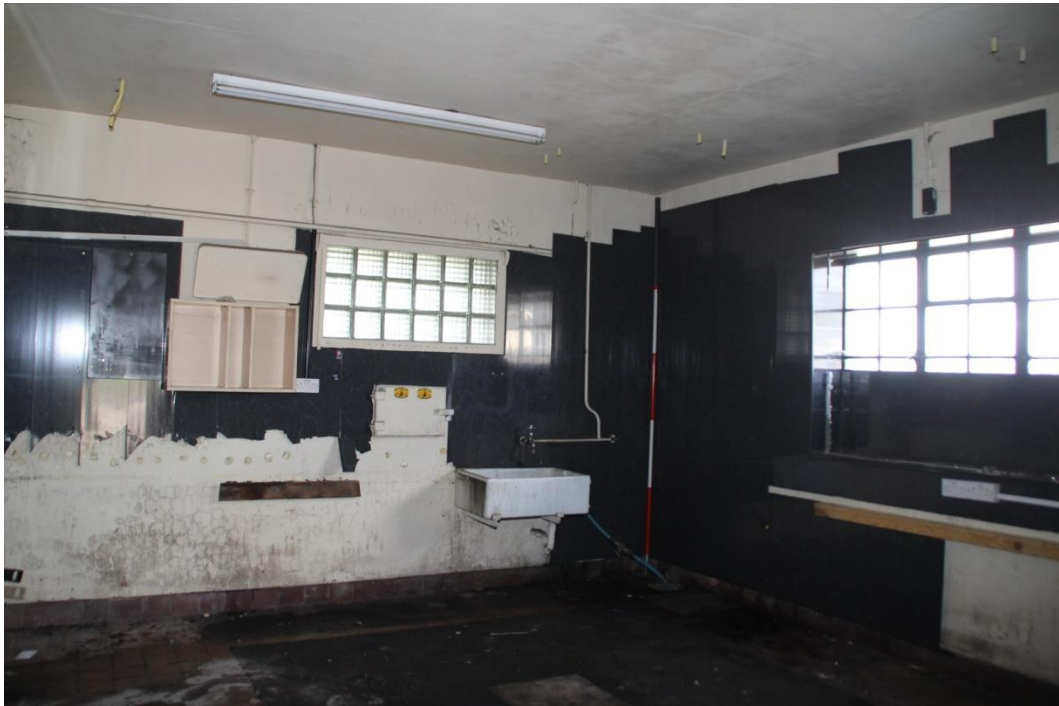
**Figure 14** Room G in Building 1, showing the glass block window in the east wall and the heavy hatch closing the louvre under it, cf Fig. 6. Also visible is the black plastic cladding (scale 2m)

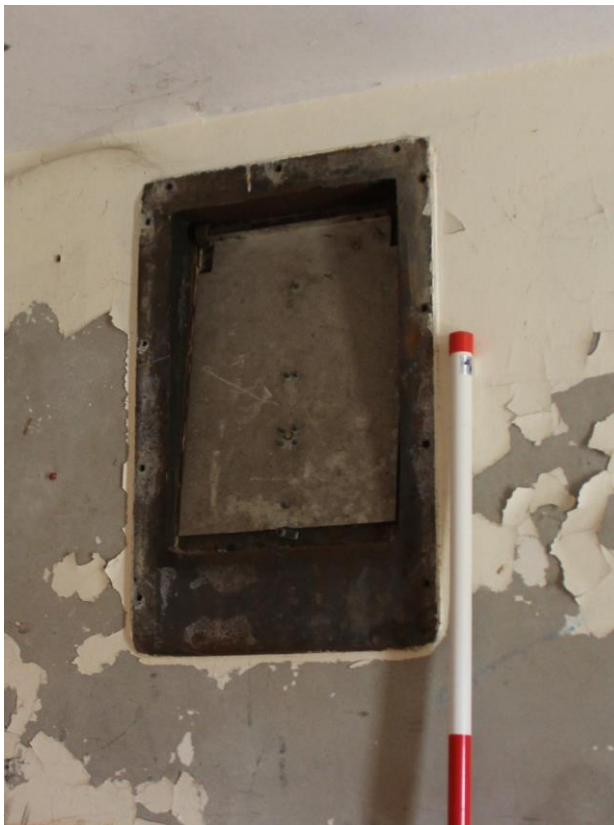
**Figure 15** The heavy steel-framed vent in the north wall of G3 (scale in 0.5m divisions)

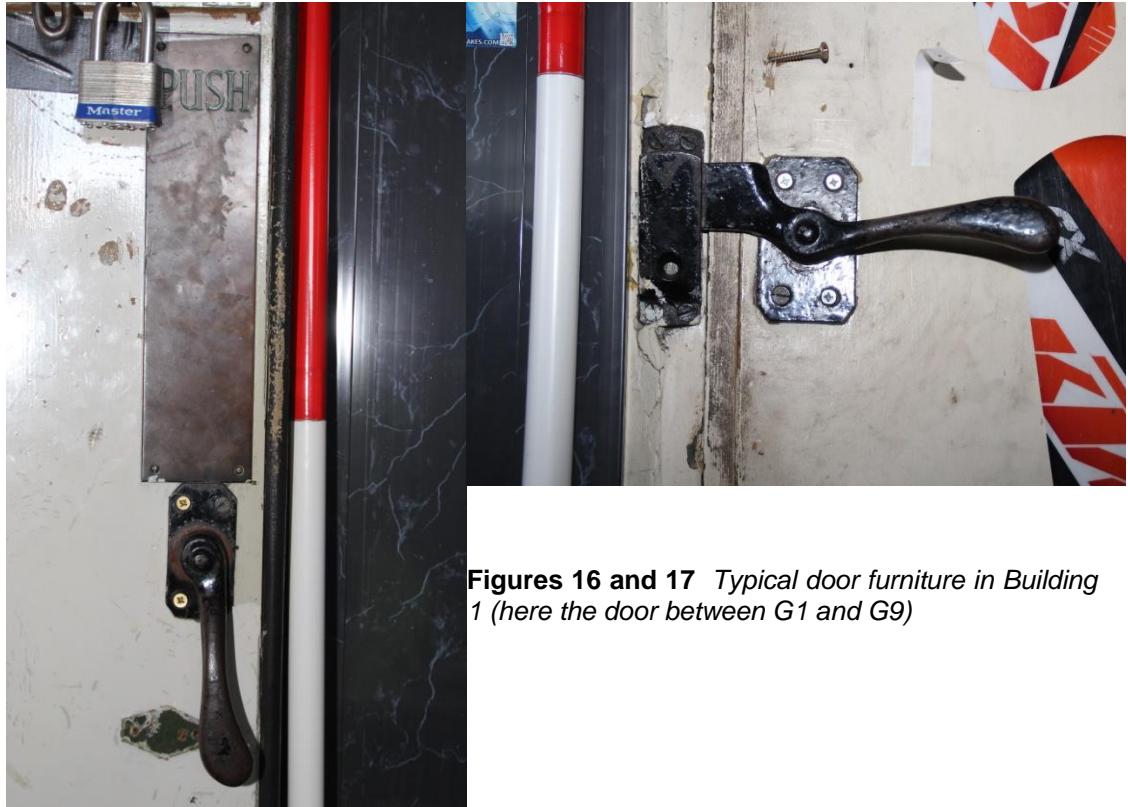
- 4.17. The rooms all retained their original doors and door furniture (Figs 16 and 17). Room G2 had a wide opening into G6 without a door and another into the small room G4 (Figs 5, 10 and 18). The former has been blocked to half its height with a chipboard and studwork wall. The opening into G4 seems always to have been half closed by a low brick wall which supports a wooden counter with an opening section and wicket door. The room is lined with cupboards under a similar counter around the other three sides. Above the counter are shelves supported on wooden strips on

**Figures 16 and 17** Typical door furniture in Building 1 (here the door between G1 and G9)

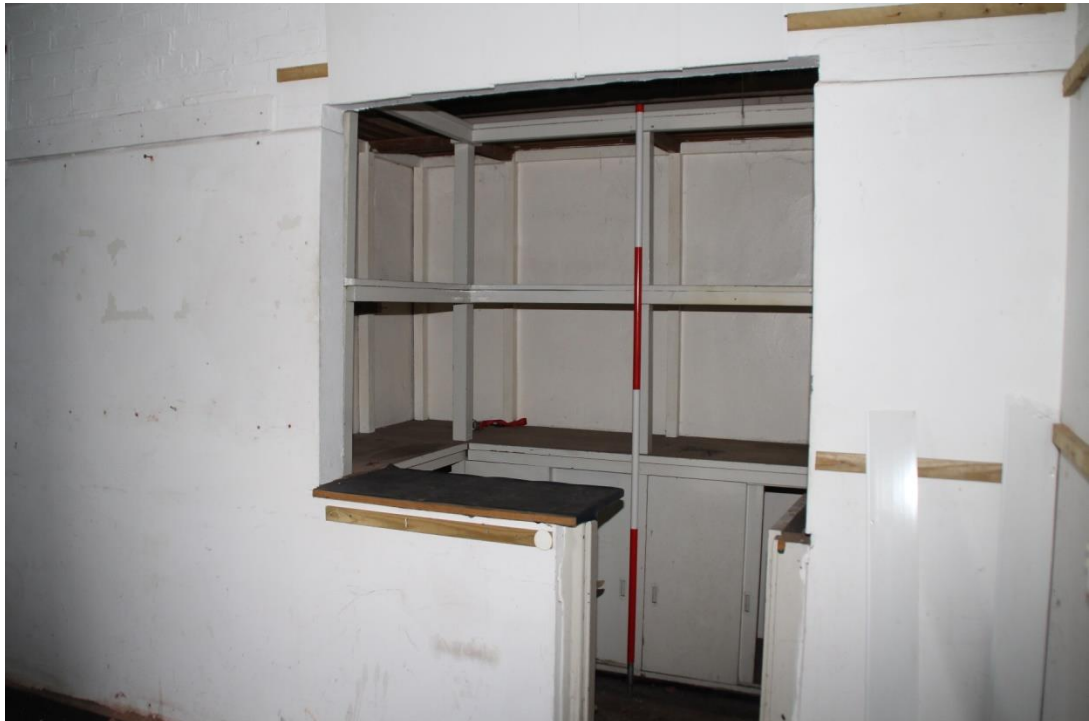
the walls and vertical studs rising from the counter top. These may well be later additions, but the cupboards and counter are thought to be original (Fig. 18).

**Figure 18** G4 seen from G2 looking south-east (scale 2m)

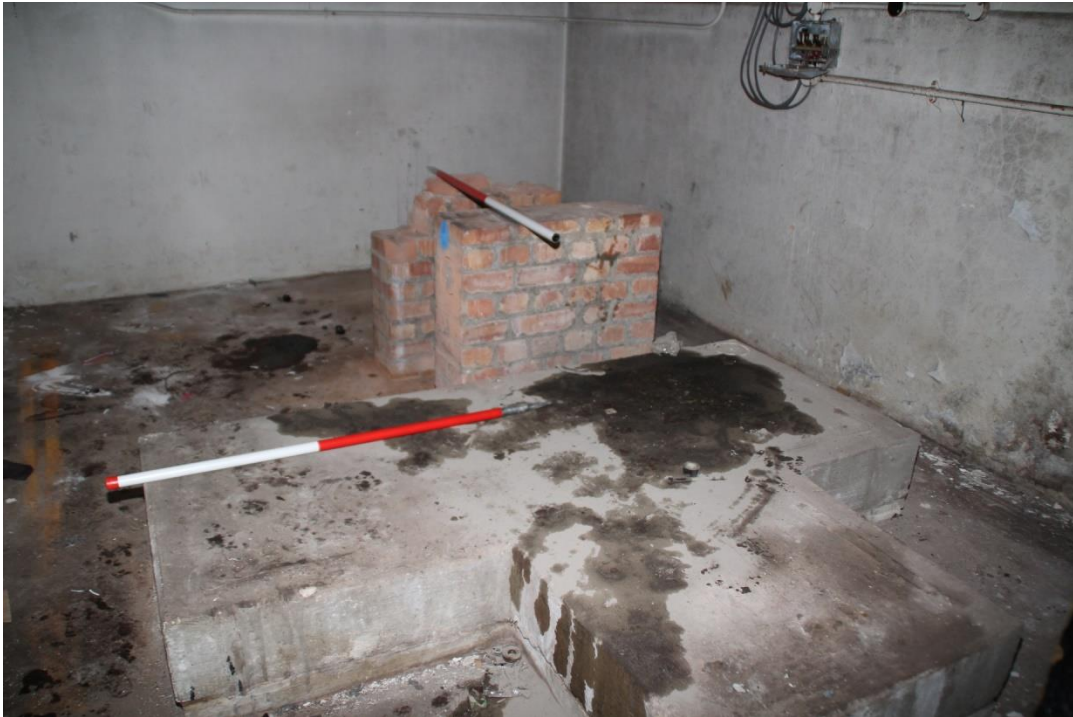
- 4.11. This machinery would have been mounted on the brick and concrete bases on the floor of this room (Fig. 19).
- 4.12. Room G7 also has concrete machinery bases on the floor (Fig.5) but the purpose of these is not clear. The north-west base is next to the base of the external flue.
- 4.13. The need to ventilate these small rooms might be the result of their also housing generating equipment such as a diesel or petrol generator. There is a significant spill of engine oil in G8 (Fig. 19).

**Figure 19** *The machinery bases in G8 looking north-west (scale 2m)*

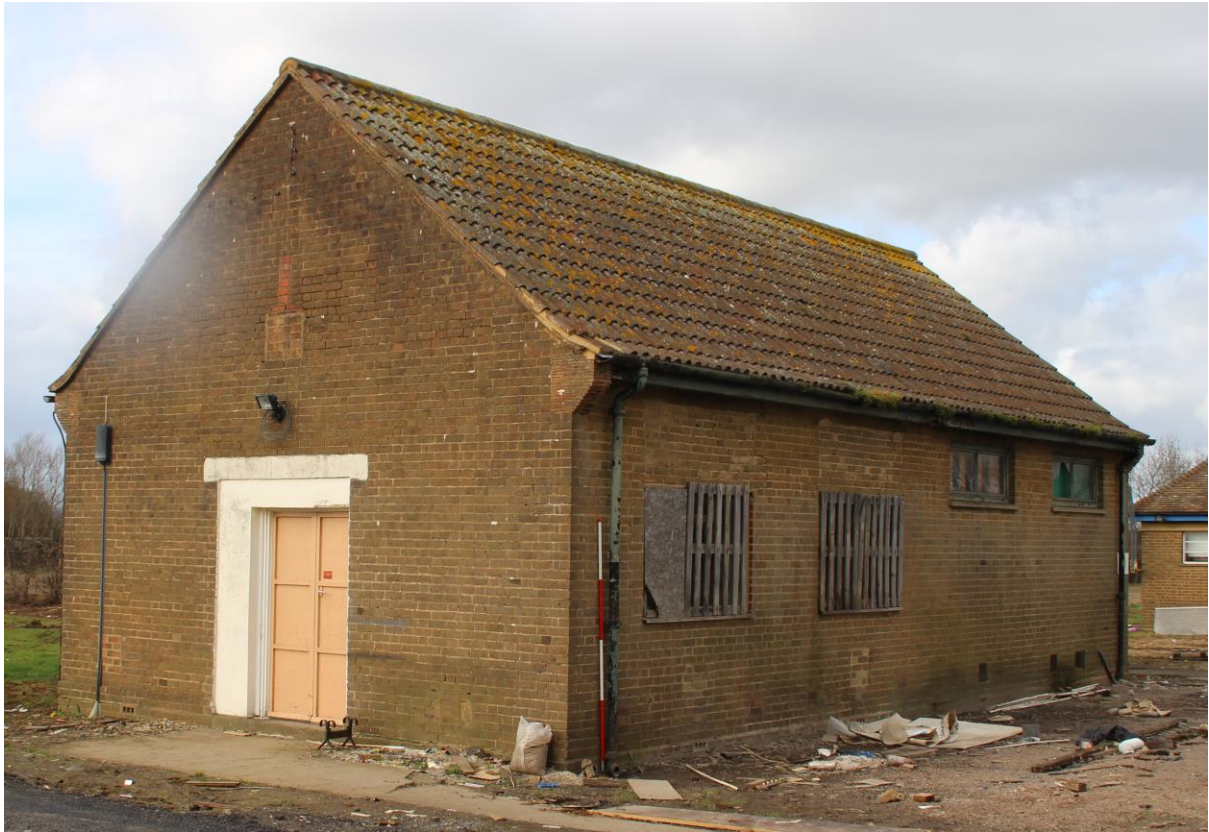
- 4.25. There is a door centrally in each end (Fig. 22). The northern one has been reduced in width and a door inserted centrally (Fig. 21). The southern one is also reduced in width but the inserted double door is set to the east (Fig. 20). The concrete lintels are not shaped.

**Figure 20** *Building 2 looking north-west (scale 2m)*

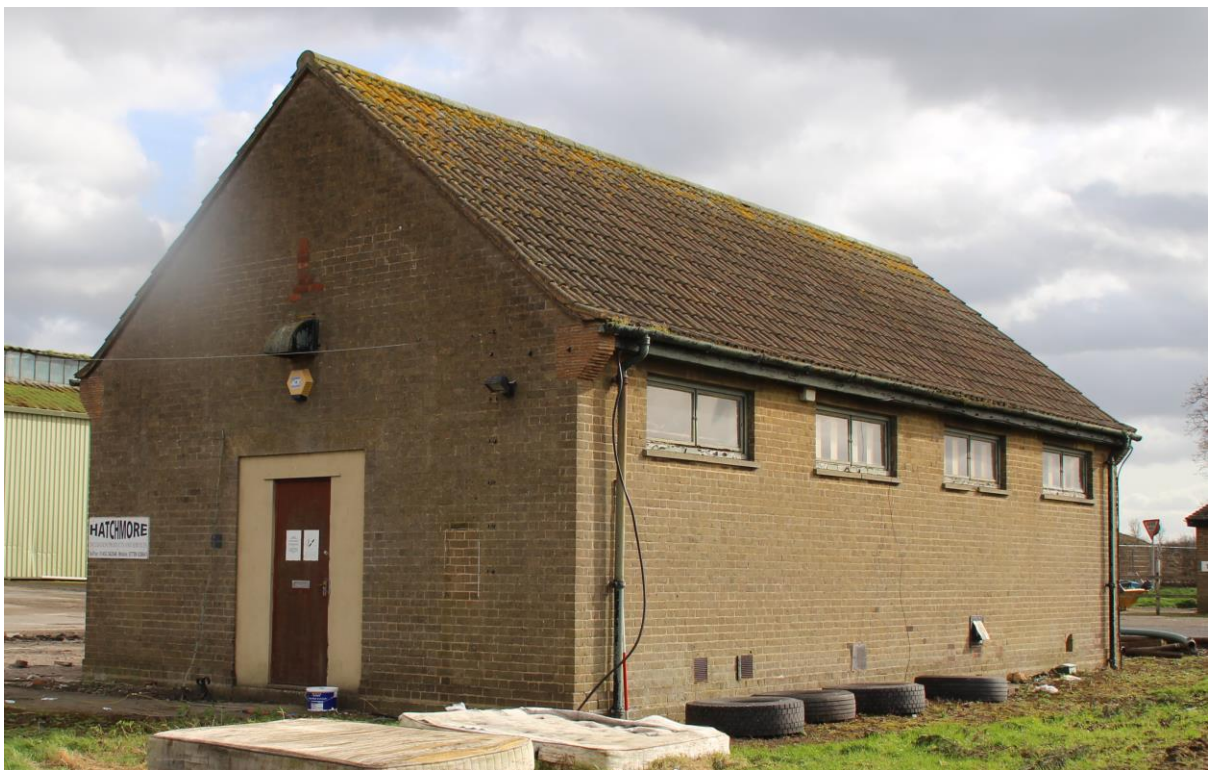
- 4.24. This is a plain rectangle in plan in similar brickwork to Building 1 (Figs 20, 21 and 22). The roof is covered in ceramic double Romans. Unlike Building 2, its ends are gabled and the eaves extend beyond the side walls to be supported on corbels made of multiple courses of thin tiles (Fig. 21).

**Figure 21** *Building 2 looking south-east (scale 2m)*

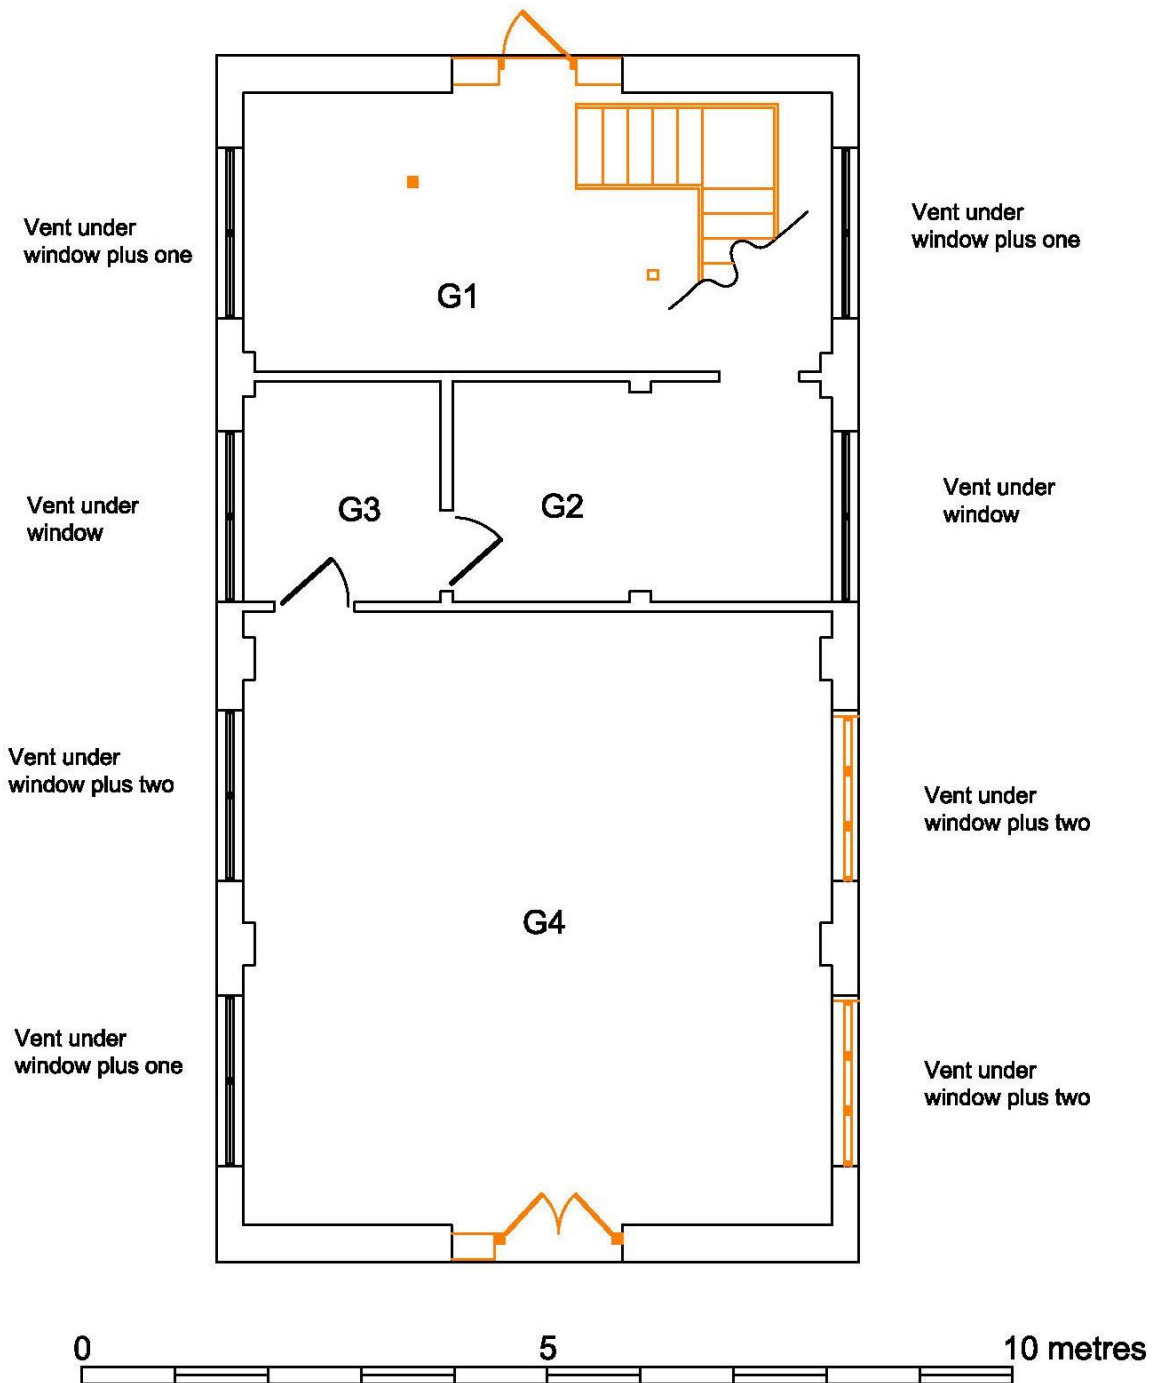
- 4.27. The interior is divided into four rooms (Fig. 22). G4 occupies just over half the length on the southern end. G1 occupies the north end bay, and the remaining space between them, just less than a quarter of the plan is divided between G2 and G3, the later roughly a third of the width of the building.

**Figure 22** Floor plan of Building 2. Later changes in orange (north to top)

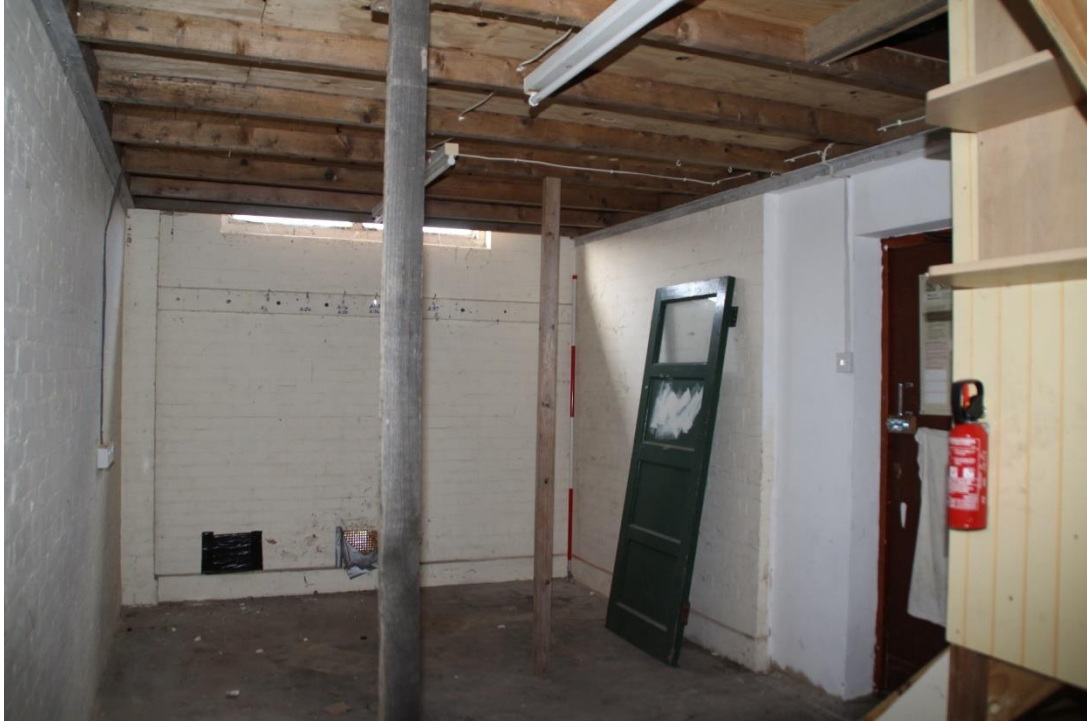
- 4.28. G2-G4 have a plaster ceiling as in Building 1. G1 however, has had the ceiling removed and an upper floor inserted at a lower level. It is reached by a crude wooden stair (Fig. 23).
- 4.29. The walls are all unplastered and painted. The internal doors are typical 1930s-50s wooden doors of four full-width panels, the top one glazed. Three still remain but one between G1 and G2 has been taken off its hinges.

**Figure 23** Room G1 in Building 2 showing the inserted first floor. The stair is just visible on the right (scale 2m)

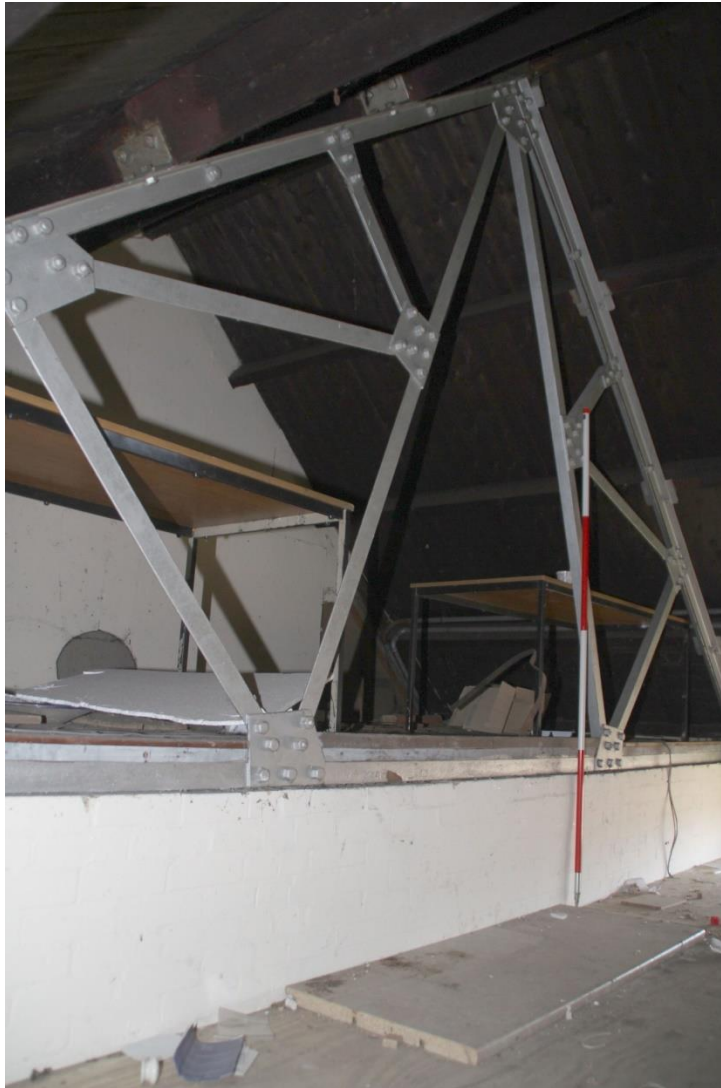
- 
- 4.30. This upper floor has revealed the roof structure. This is as expected: a bolted light-weight steel, W-braced truss supporting timber purlins, three on each slope. The roof is sarked (Fig. 24).

**Figure 24** The northern roof truss in Building 2, looking south-west (scale 2m)
