# No.6 Motor Transport Site RAF Quedgeley (now Quedgeley East Business Park)

*Historic Building Recording (Level 2)*

CA Project: CR0694

CA Report: CR0694\_1

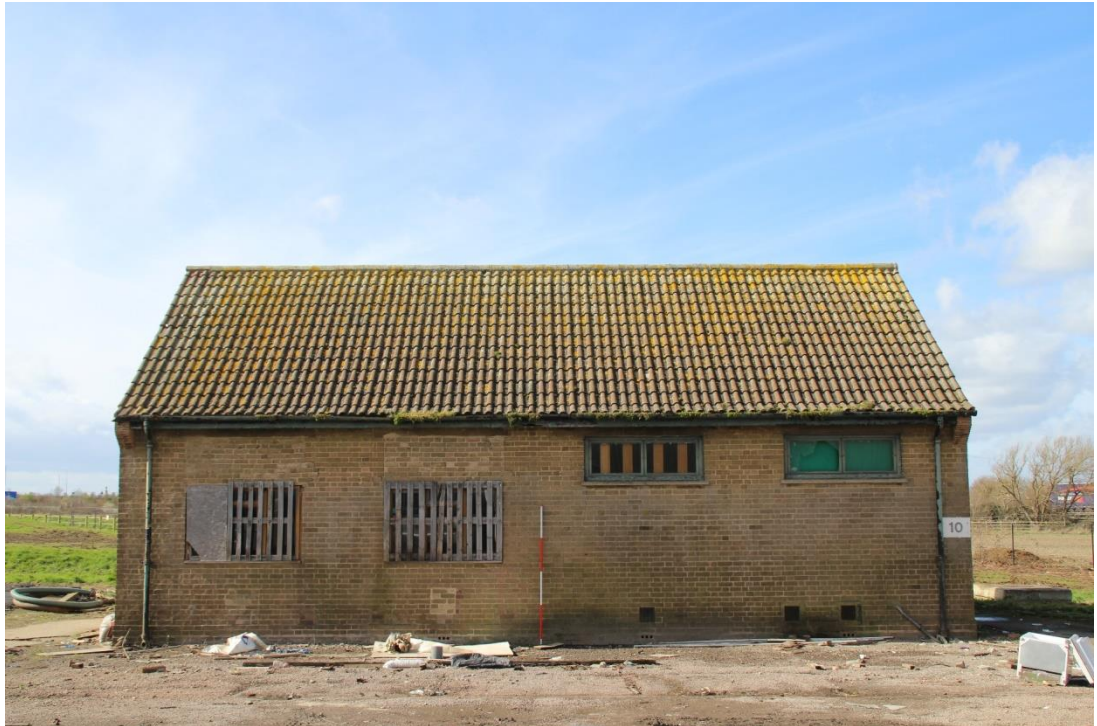
- 4.35. There are roughly foot-square (0.3m) ventilators near ground level on the west elevation (Fig. 25). Each window has one centrally below it, but others (four of them now blocked up) supplement these, one at the north end and two flanking the central one under the second window from the south. The brickwork shows these are original. Another has been inserted later, just above the set of three.
- 4.36. There is a blocked opening in the north end, east of the door, perhaps for a larger duct (Fig. 21). There is also a hooded duct like those in Building 1 in the gable over the northern door (Fig. 21). Internally a short length of ducting remains in place containing a heat exchanger like a car radiator, suggesting that this is some kind of air-conditioning system (Fig. 27). There is evidence for a similar fitting at the south end (Fig. 20).

**Figure 25** *The east elevation of Building 2 (scale 2m)*

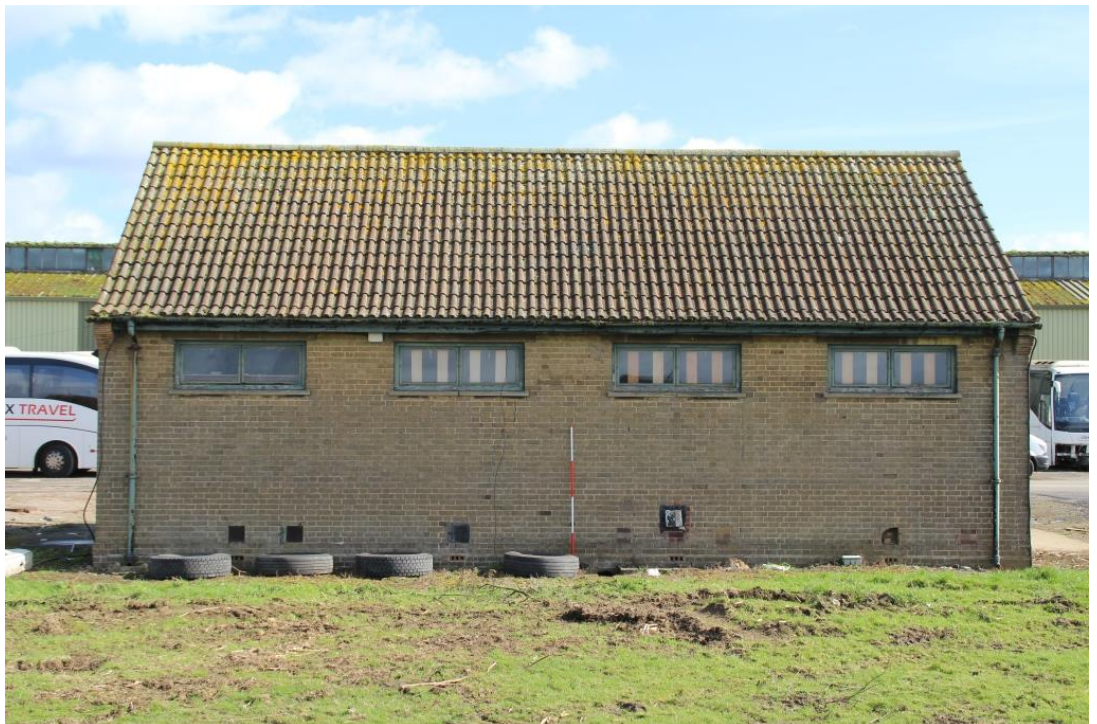
**Figure 26** *The west elevation of Building 2 (scale 2m)*

- 4.37. There is also provision for ventilation ducts in the ground level on the western side with almost the same distribution: the southern window has three rather than two. The northern three remain unblocked (Fig. 26).

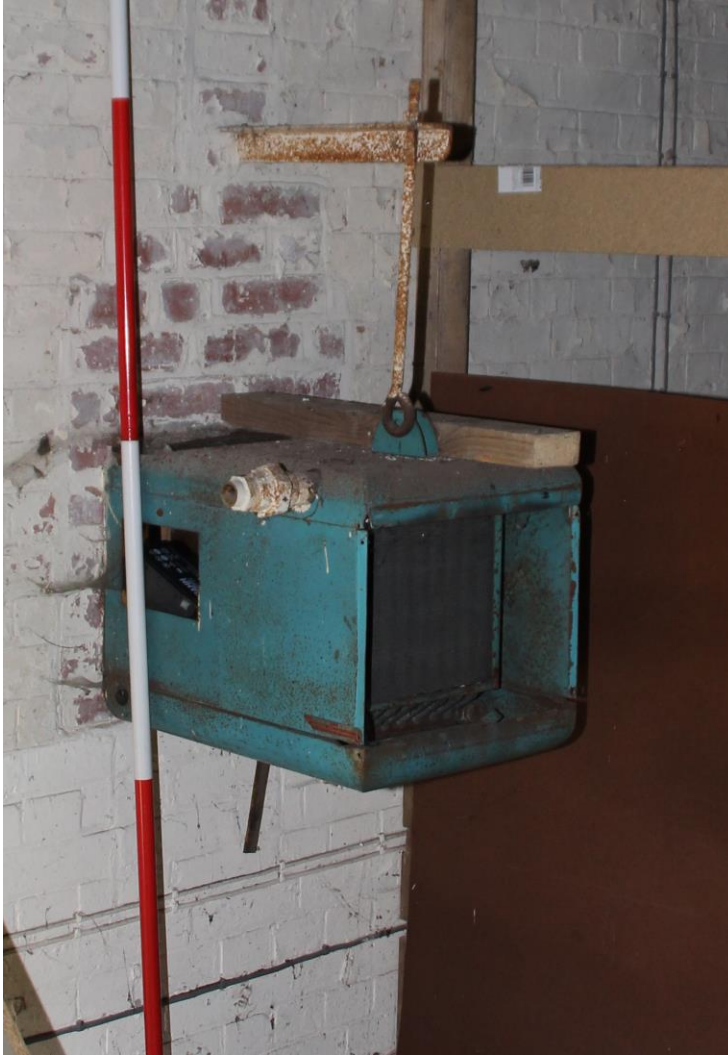
**Figure 27** *The interior of the ducting on the north gable of Building 2 (cf fig. 21) Scale in 0.5m divisions*

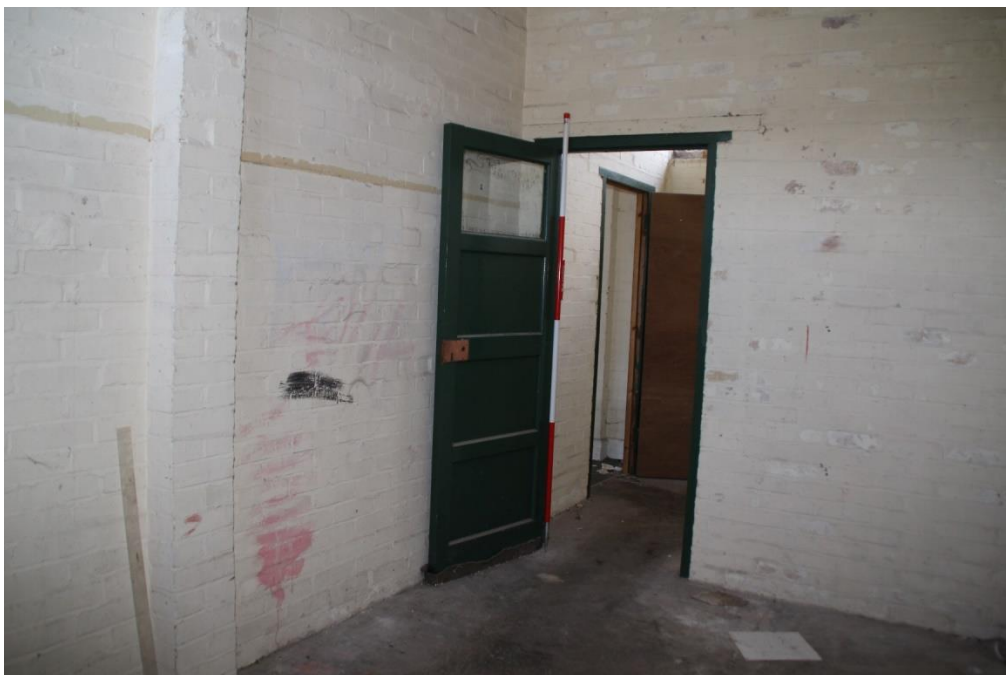
**Figure 28** *Building 2: Room G2 looking into G3 (scale 2m)*

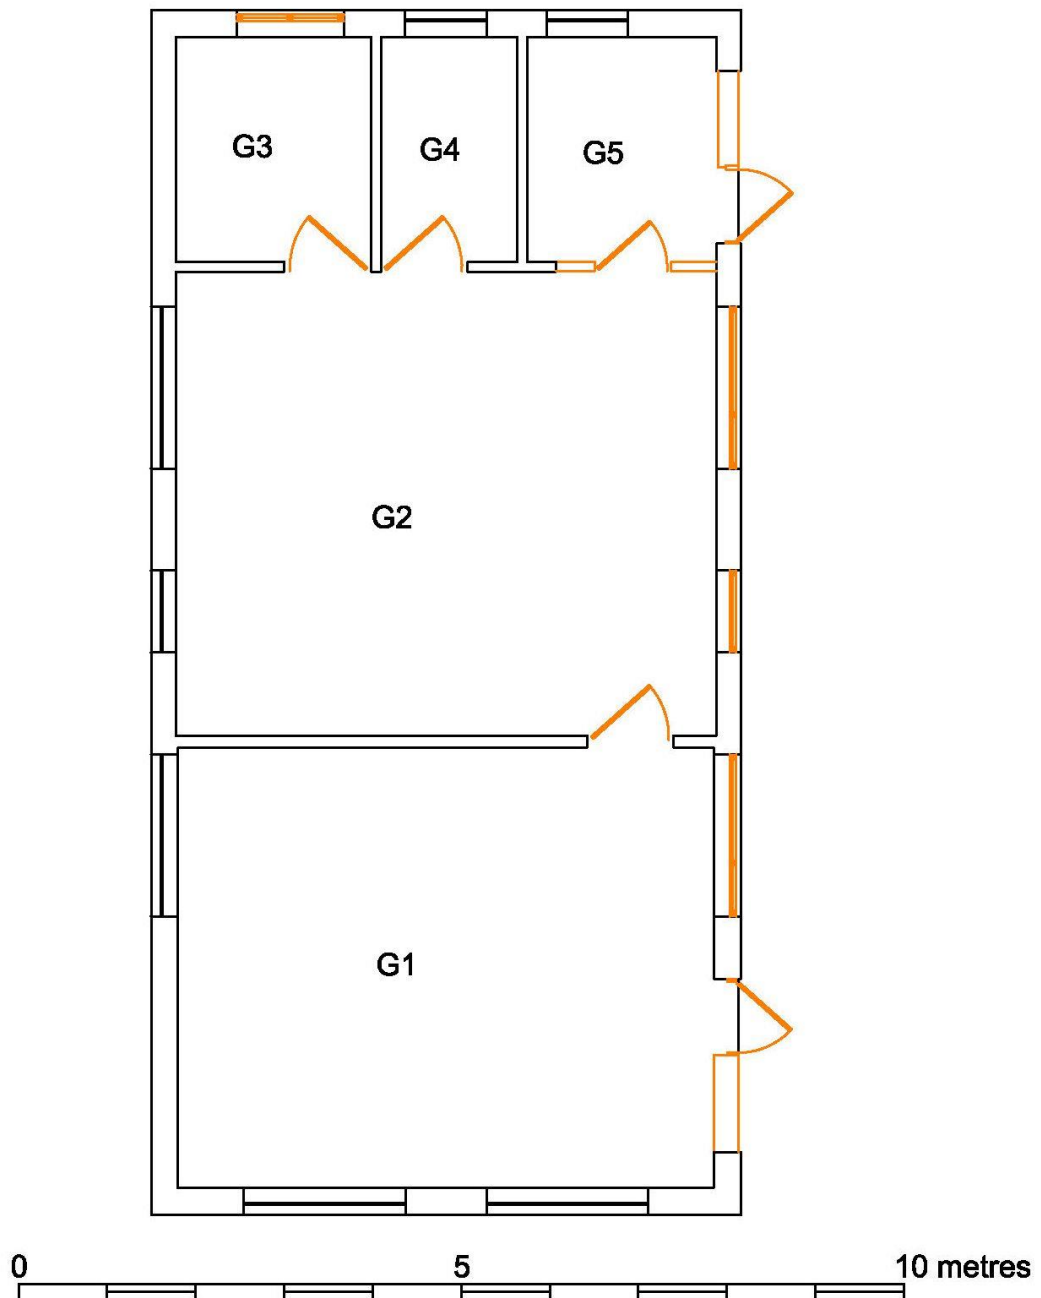
**Figure 30** *Floor plan of Building 3; later changes in orange (north to top)*

- 4.40. This is also similar to Building 1 in roof and walls, but again is a simple rectangle in plan (Fig. 30).
- 4.41. It has a shaped lintel over the windows but here this is one continuous strip along the entire elevation and indeed around the entire building as a kind of cornice.
- 4.42. There is a double-width door opening at each end of the east elevation (Fig. 31). They have each been reduced to single doors on one side of the opening. The windows occupy the positions of three high level windows like those on the west side, but have been extended to their present depth and fitted with wooden casements.
- 4.43. There are two similar windows on the south elevation and three on the north. The windows on the west and south side retain their steel, Crittall-type frames as do two

4.44. The interior arrangements do not reflect the exterior symmetry. The walls are, nonetheless, the original build. The north end is divided into three small rooms (Fig. 30, G3-5). The eastern one (Fig. 30, G5) was originally an internal porch or lobby with a wide opening into G2, to match its wide external doorway. Both openings have been narrowed and fitted with doors (Fig. 31).

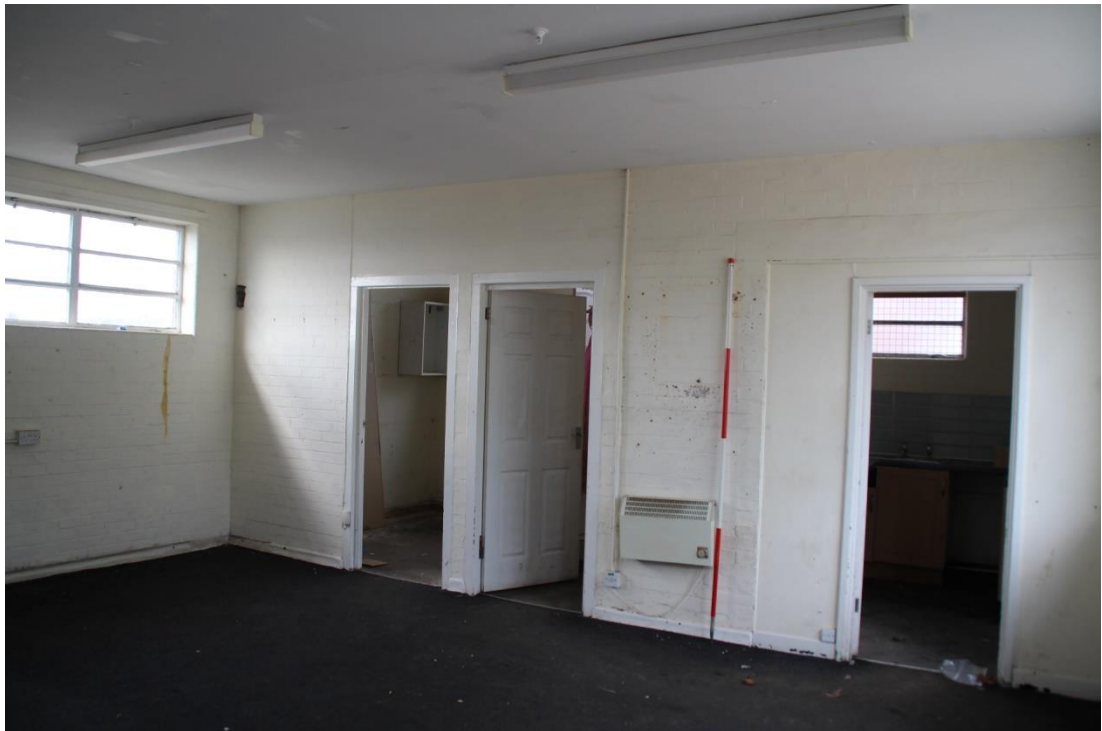
**Figure 32** Building 3, Room G2, looking north-west and doors to G1-G3 (scale 2m)

- 
- 4.46. The rest of the building is given over to two approximately equal-sized rooms (Fig. 30, G1 and 2 and Figs 32 and 33). The doorway between them is original, but again the door is modern.
- 4.47. The interiors are painted brick, except for G1, which is plastered (Figs 32 and 33). This seems to be secondary, as it is contemporary with the blocking of the wider doorway and the insertion of the present narrow one.

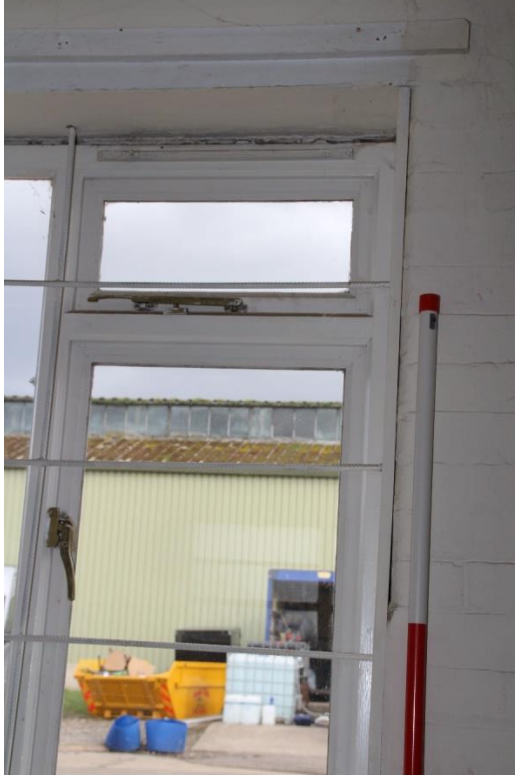
**Figure 34** *Building 3, detail of extended windows in Room G2, looking west (scale 0.5m divisions)*

- 4.48. The original window jambs were rounded internally, but the lengthened ones were left sharp (Fig. 34).
- 4.49. The lack of heating, wide doors and high windows again suggests a utilitarian function for the building (to be expected in the context, after all), probably storage. However, its detailed use remains unknown in the absence of documentation (which will exist somewhere).
