Holmbush Mine Engine House Windsor Lane, Kelly Bray Cornwall

*Costed and Prioritised Proposals for Capital Works
to support Conservation and Management of the
Scheduled Monument
(Costs redacted version)*

CA Report: CR1008_2

December 2022

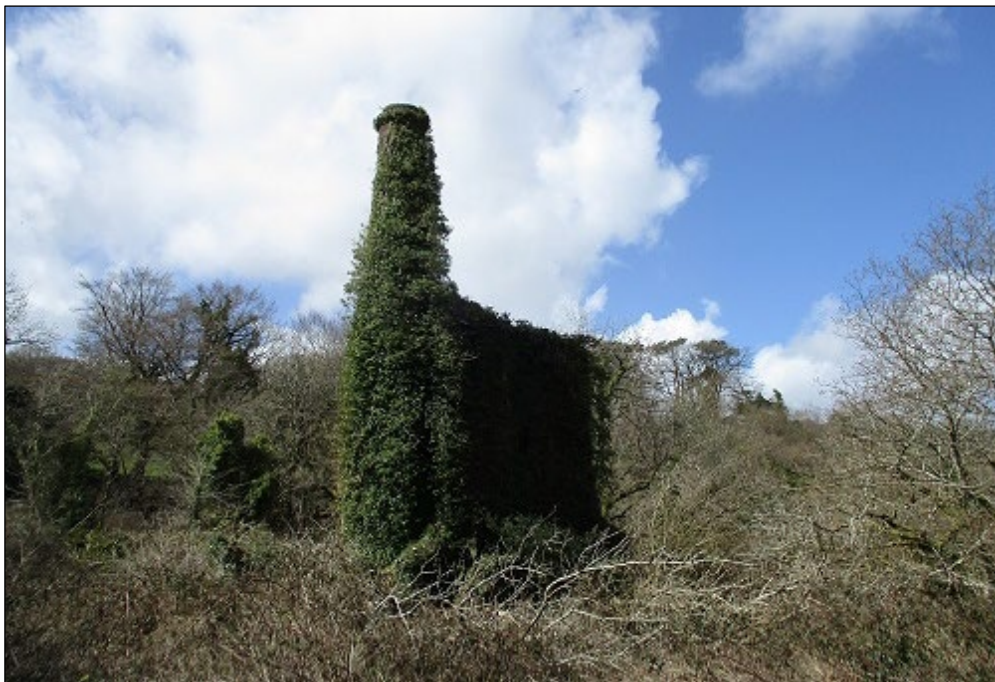
- 3.3. At the time of the Site visit, the Site was generally overgrown with hardy perennial scrub, such as gorse and brambles, and a variety of self-seed trees (Photograph 1). However, recent vegetation clearance and felling of diseased ash trees provided adequate access to the structures for specialist survey work.

Photograph 1. Holmbush Engine House looking north-west

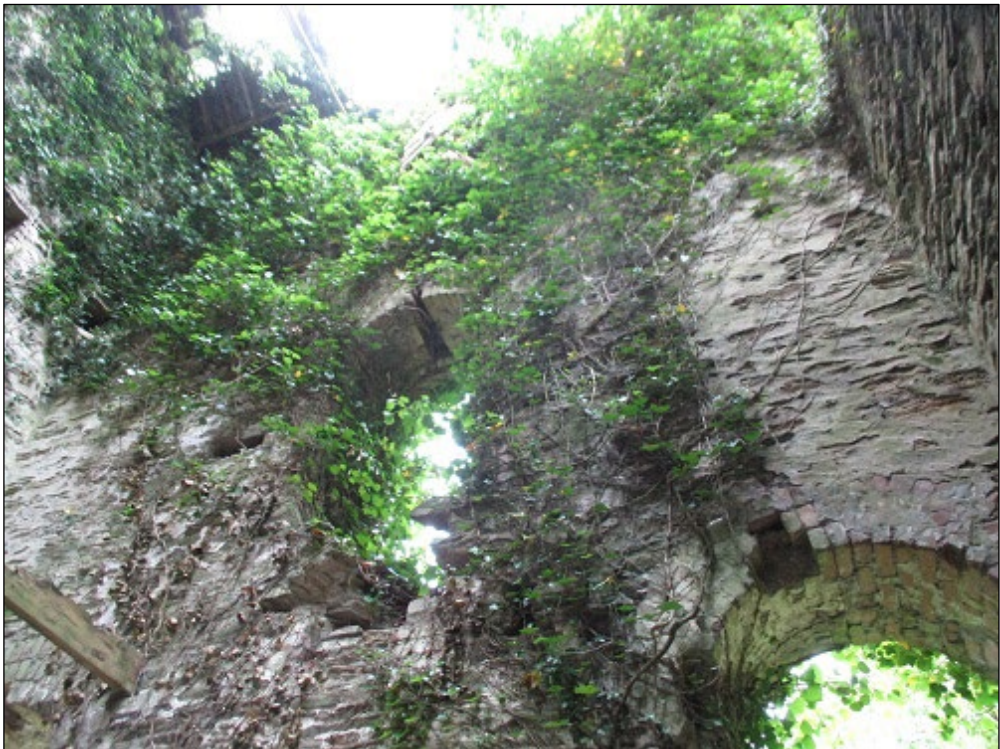
5.22. On the west wing wall, externally, both ground level openings were partly visible (Photograph 4), although all features above their brick arched headers were concealed beneath dense ivy. There were loose or missing bricks in the internal reveals to most openings (Photograph 5). However, the crack identified in 1998, running from the brick arch to the first floor window to the cill of the second floor window above could not be seen due to ivy. Indeed, a relatively thick covering of ivy on the internal side of the west wing wall, above the level of the first floor window arch, precluded a meaningful assessment of condition, or identification of other features recoded in 1998. Rotted timber lintels were also noted to the northern door opening, and to the blocked opening located just above and to the south of the first floor opening. Externally, the masonry appeared to be relatively stable, but several original roof timbers were noted hanging down from the top of the wall, which are potentially unsafe, and there were also loose slates.

Photograph 5. West wing wall interior elevation first and second floors

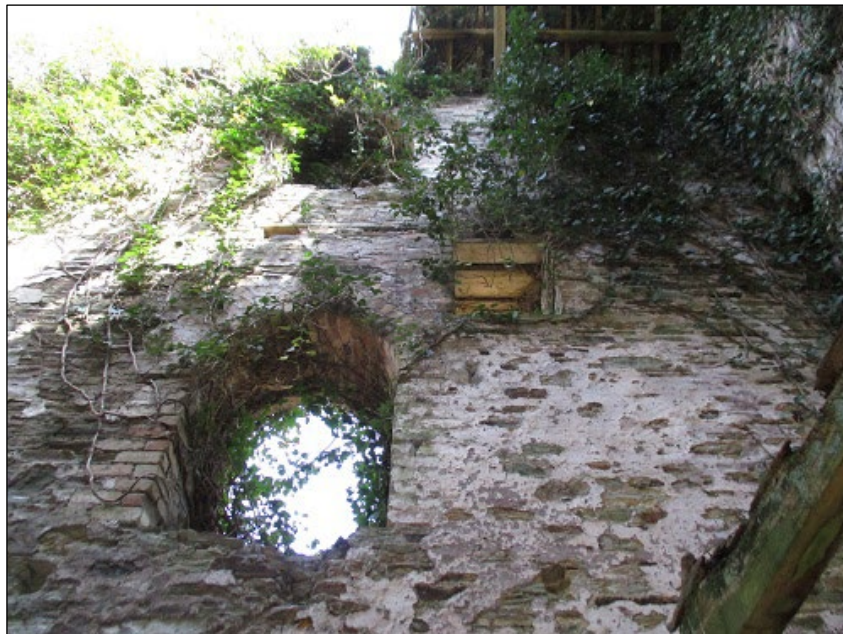
Photograph 7. Internal elevation of west wing wall first and second floors

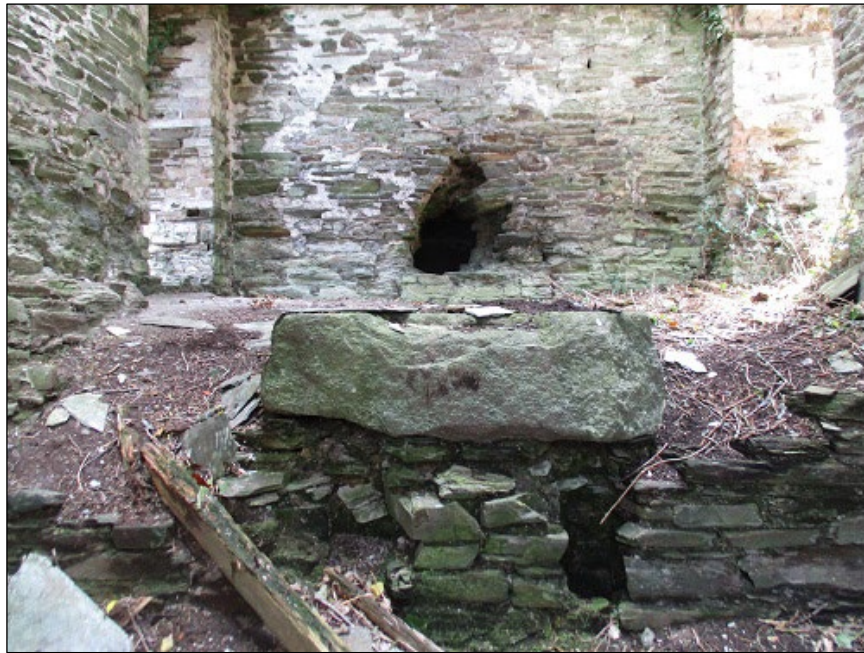
5.25. For the larger extent, those internal feature described in 1998 were identified. The cylinder bedstone remained *in-situ*, although the surface was covered in detritus so that the four bolt holes were not visible. The retaining wall to the bedstone level, which forms the southern wall to the cataract pit was in generally poor condition, with some masonry failures (Photograph 9). That said, two rectangular access bolts holes were visible, with the one on the eastern side surviving in better condition. First and second floor joist holes were still readily visible and generally in good condition. However, of the three floor joists recorded in 1998, only two complete lengths survive and the most northerly of these was well rotted. Two partial floorboards were also noted, resting on the first floor joists, against the east wing wall. Areas of lime-washed plaster survived in places across the interior walls.

Photograph 9. Access bolt holes beneath the cylinder bedstone

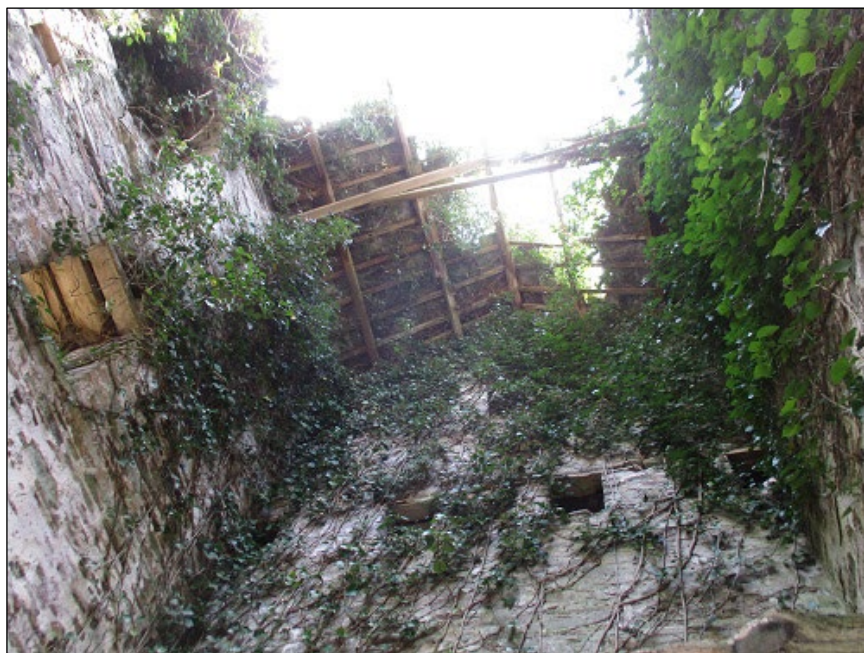
5.26. Also, in 1998 two A-frame trusses were recorded as surviving across the southern half of the structure, supporting the remnants of the original slate roof. Only one of these survived, but with rafters still supporting some of the original slate covering (Photograph 10). Presumably though, since 1998 a large number of the formerly surviving roof slates have fallen into the interior, as attested by the slate fragments strewn across the floor level of the cataract pit and bedstone cylinder.

Photograph 10. A-frame roof truss and surviving covering

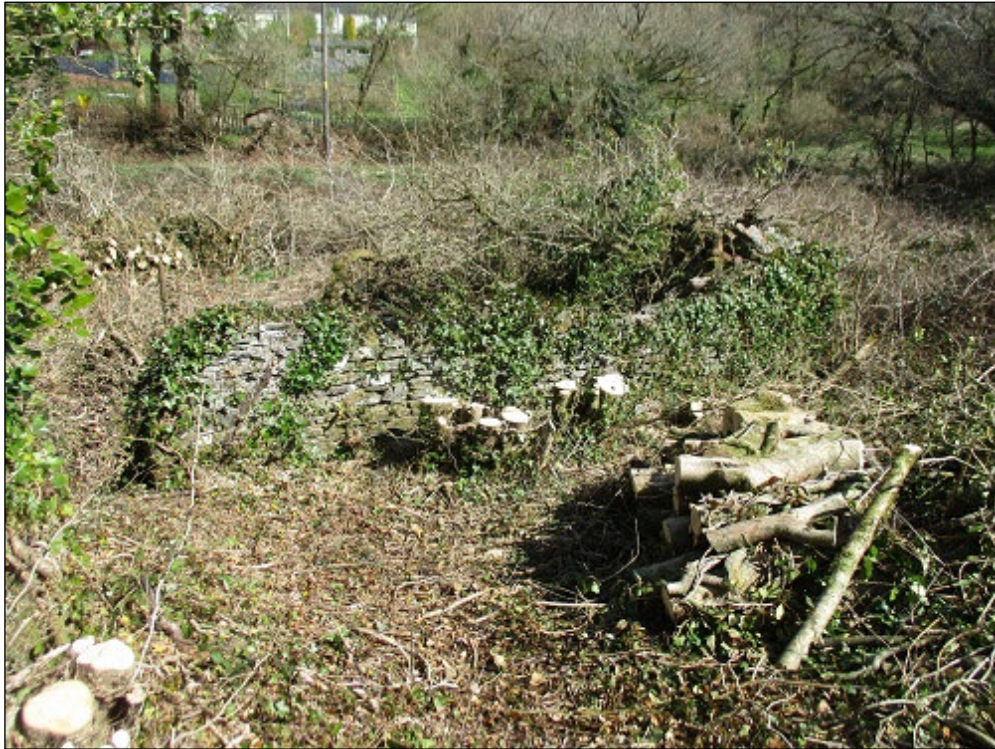
5.40. The west wall continued south beyond the extent of the Engine House's east wing wall to complete and enclose the long rectangular footprint of the Boiler House (Photograph 16). The external surface of the platform on the west side of the wall was approximately 1.2m higher than the ground level within the Boiler House. In addition, the top of the west wall was approximately 1.2m higher than the external ground surface and hence 2.4m above the ground level within the boiler house. Where this wall adjoined the south-east corner of the Engine House adjacent to the Boiler House Chimney, there was an opening measuring approximately 0.75m wide and 1.2m high comprising the full height of the wall from the external ground level (Photograph 17). Ivy covered brick jambs were recorded on either side of the opening, although only remnants survived on the south side. Given the proximity of this opening to the chimney, it may have been related to the linking flue, although

Photograph 16. West wall of Boiler House looking south-east from atop platform

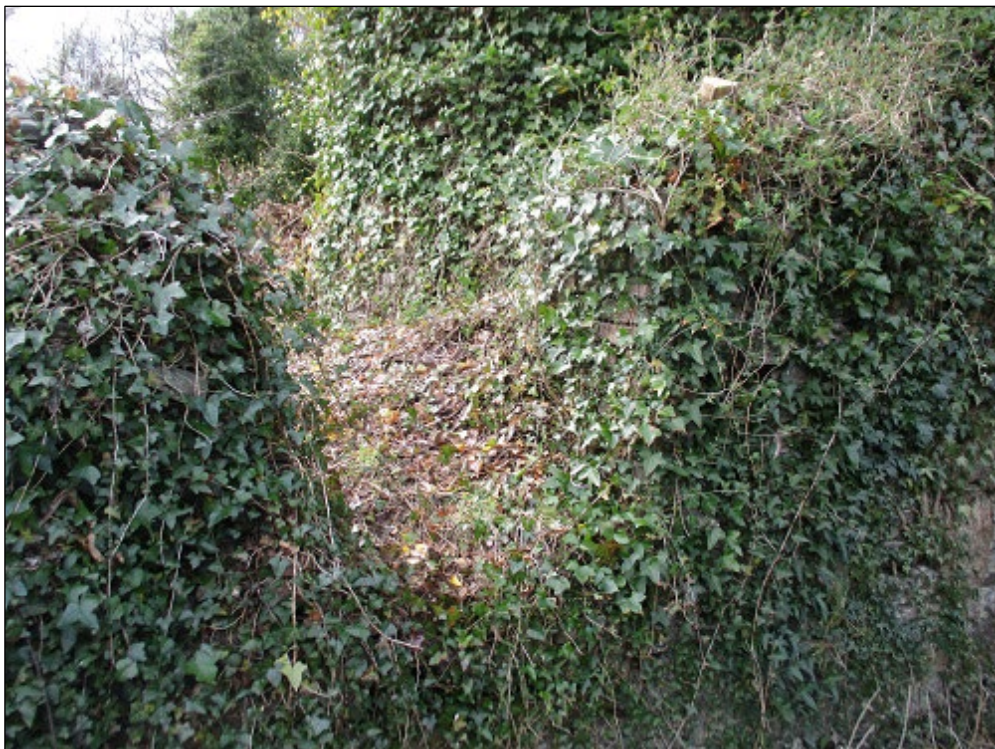
Photograph 17. Boiler House opening in west wall (ivy covered chimney base in background)

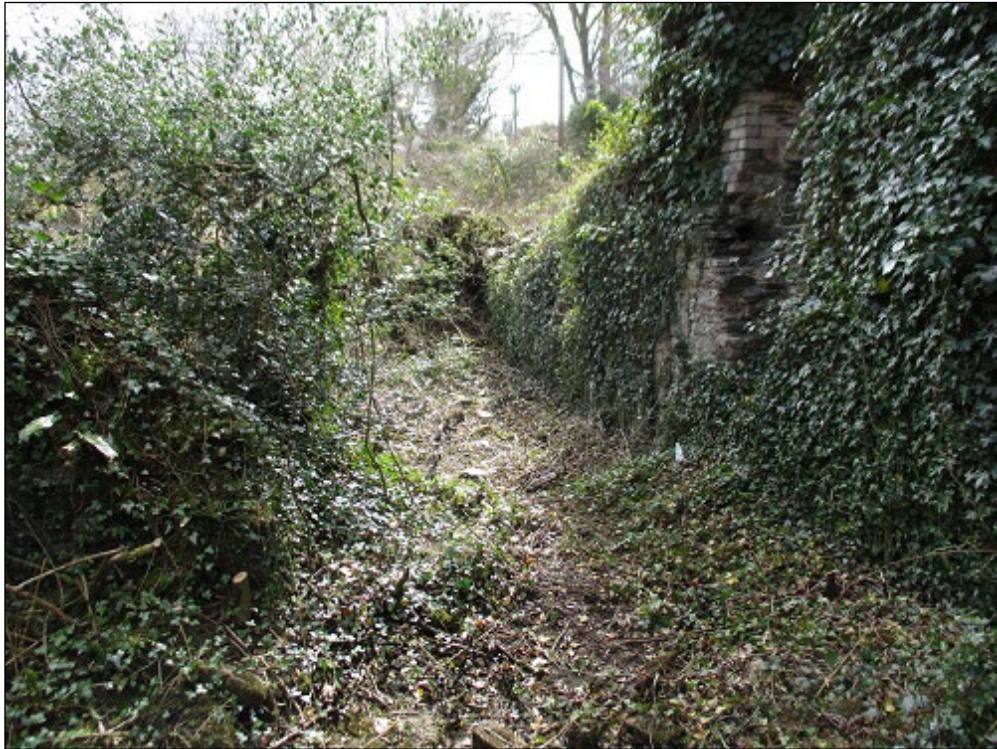
5.41. As in 1998, the floor of the Boiler House was covered in vegetation, ivy and rubble, obscuring any obvious structural features, although an uneven, but nonetheless slight change in ground level between the interior footprint length running alongside the Engine House and that projecting further to the south, would seem to demarcate the space on functional grounds.

Photograph 18. Boiler House floor looking south-west

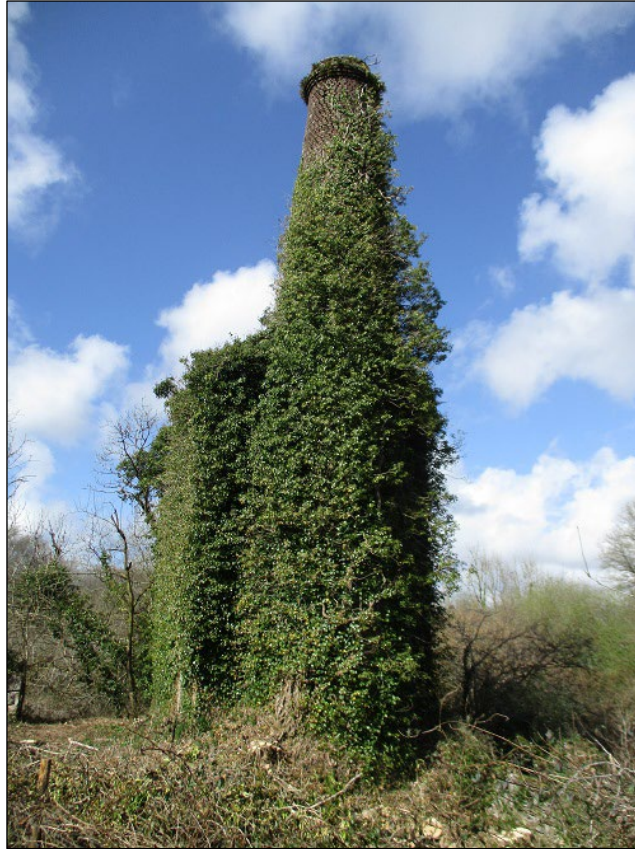
- 5.46. As in 1998 assessing the structural condition of the Boiler House Chimney was all but impossible, given the very thick carpeting of ivy that adheres to it (Photograph 19). Only of the upper brickwork capping courses were visible on the south and west sides of the chimney. Here bricks were clearly missing, and the brickwork open jointed (Photograph 20). From below, in places, it was possible to see daylight through gaps in the brick's mortar bonding. At the base of the chimney, the dense ivy covering still prevented identification of the flue, although what appeared to be a pile of ivy covered masonry, on the east side, most likely represented its position. However, despite the thick covering of ivy, there were no obvious structural failures to the chimney's structure since 1998, and externally the structure appeared to be true to line and reasonably stable.

- 5.48. On balance, the Boiler House Chimney was assessed to be in **medium condition**.

Photograph 19. Boiler House Chimney looking north-east

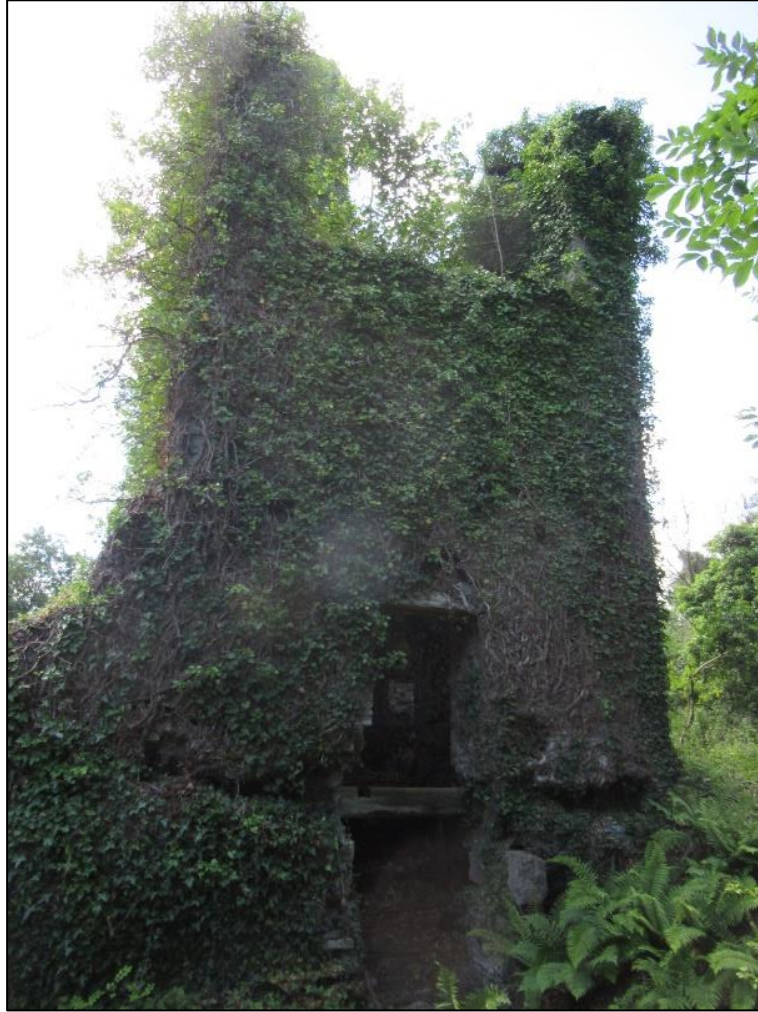
Figure 23.01 – North elevation of Engine House.

- 23a.01 1998 Recommendations:
Ivy and rubble removal followed by further structural surveys. Consolidation and repair works. Lintels replaced and collapsed stonework above rebuilt. Complete repointing likely not necessary. Wall capping required to weatherproof them. Re-timber and re-slate entire building.
It is apparent that no repair works have been undertaken since the 1998 survey.
- 23a.02 Current condition:
The Engine House measures approximately 8.25m x 6.00m. This building is Grade II Listed and was likely constructed in the 1850s, but may have been extended afterwards to accommodate new machinery.
It is heavily covered in ivy, making a proper assessment of its structural condition difficult. The engine house has been classed as in poor

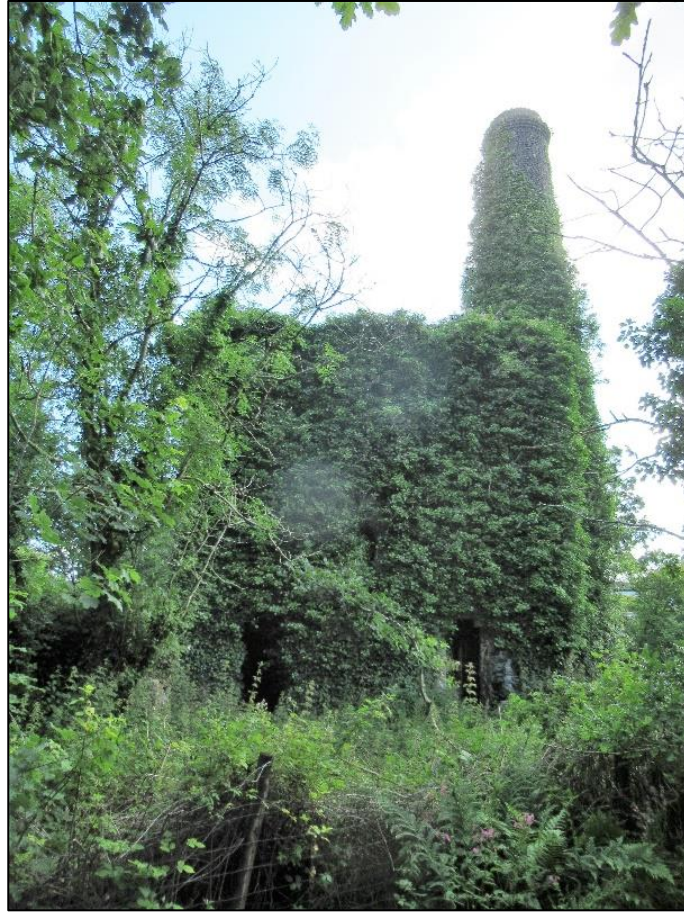
This elevation is very heavily covered with ivy growth. There are two ground level arched openings with brick/stone reveals, with the reveals to the central pier being splayed. These two lower-level openings are just visible in figure 23.02. The central opening is similarly brick arched, as is the probable opening above this central one, but the heavy ivy covering makes this difficult to verify. The original timber lintels to the northern opening have rotted out. The masonry appears to be generally reasonably stable; however, there are several original roof timbers hanging down from the top of the wall, some of which are potentially unsafe. There are also loose slates.

Figure 23.02 – West elevation showing two lower-level openings

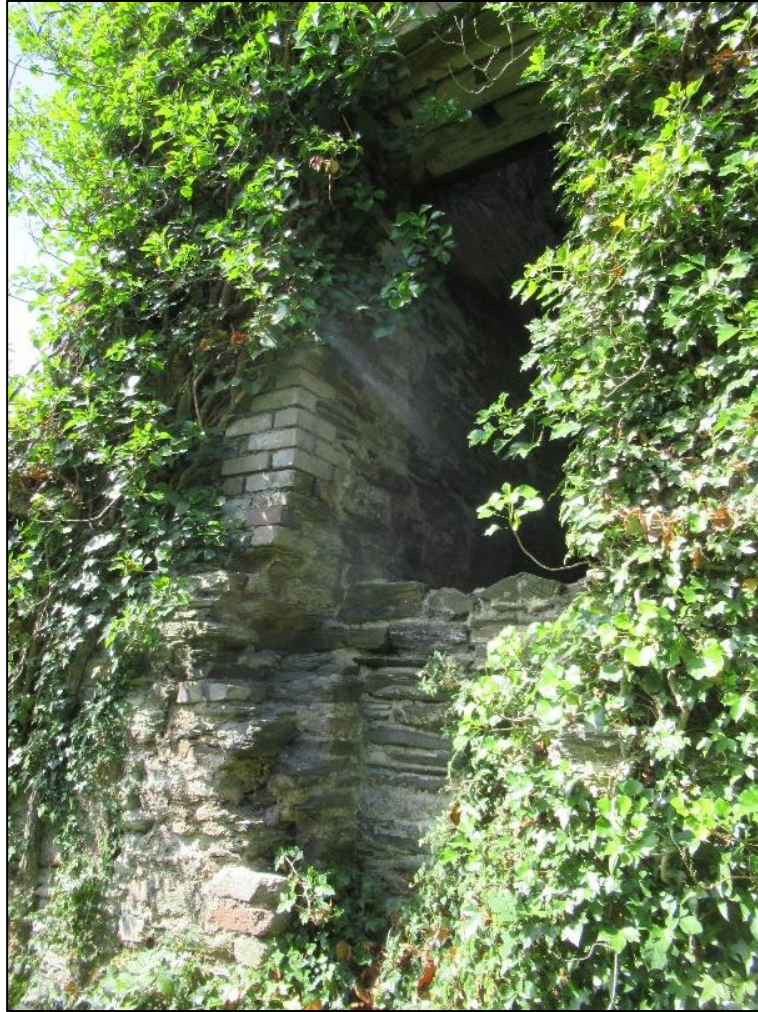
Figure 23.07 – East elevation intermediate opening

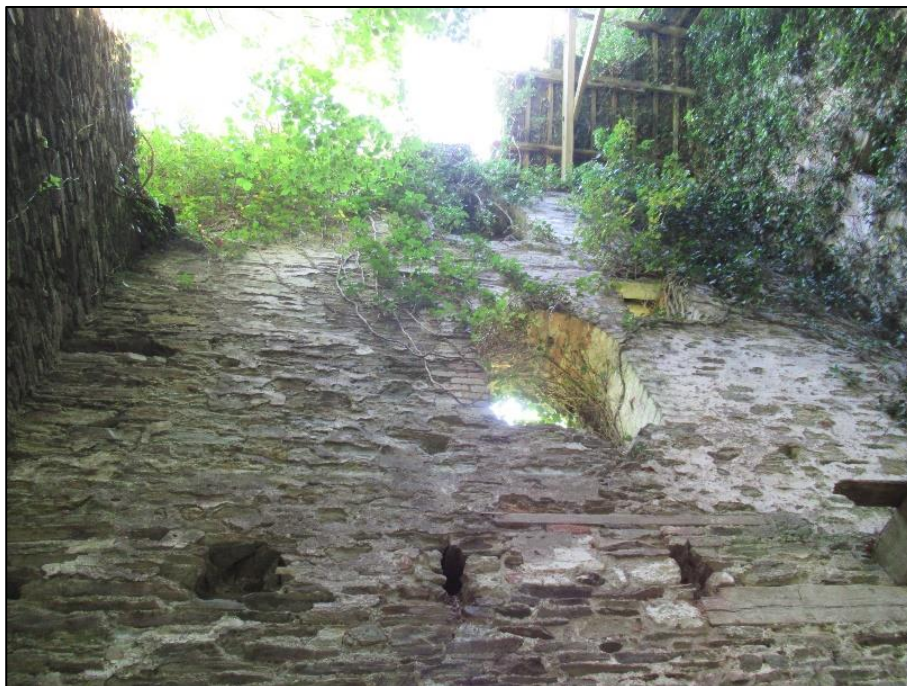
Figure 23.08 – East elevation openings, joist pockets, and lintel bearing for south intermediate level opening.

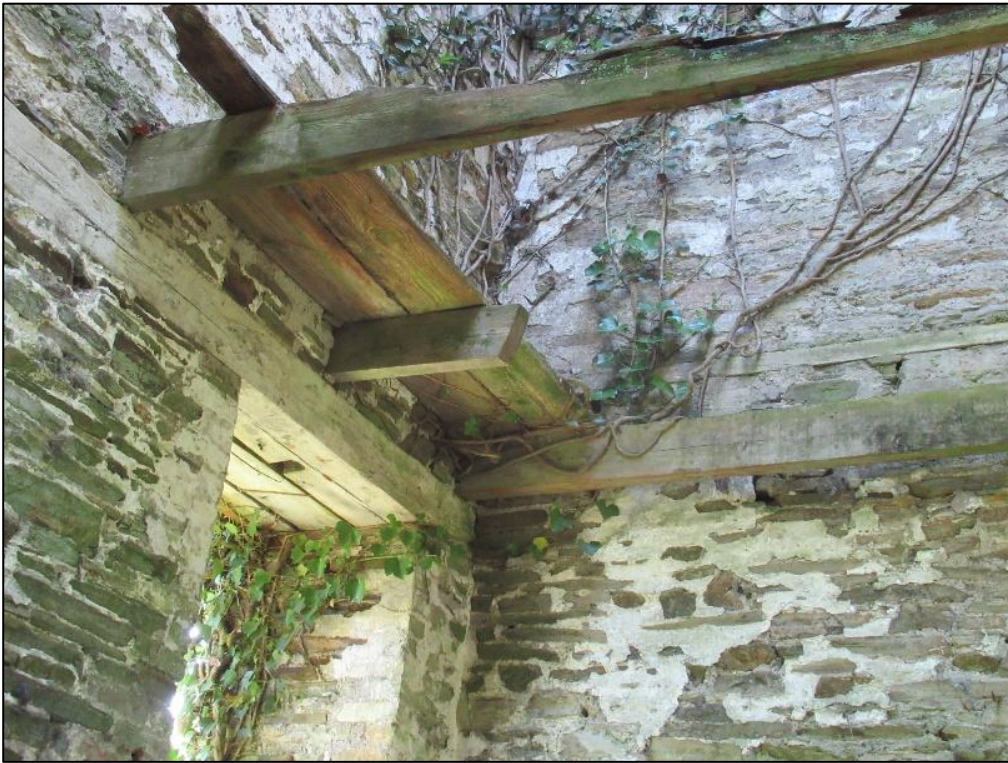
Towards the southern end of the building, part of the first floor remains with three joists and some of the original boards still in place, as seen in figure 23.09. These joists are in varying condition with one joist reasonably intact, one appears to have been cut off and one is mostly rotted.

Figure 23.09 – Internal of east elevation intermediate opening with timber lintels.

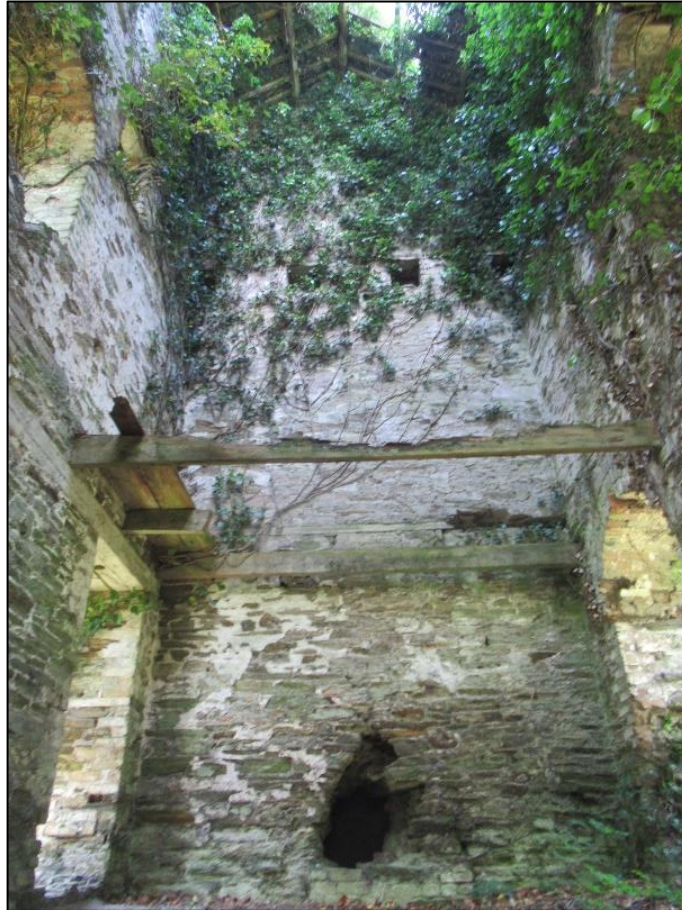
Just above first floor, there is a timber ground beam which has rotted to the western end, leaving stonework unsupported.

Figure 23.10 – Internal of south elevation and remaining floor structure.

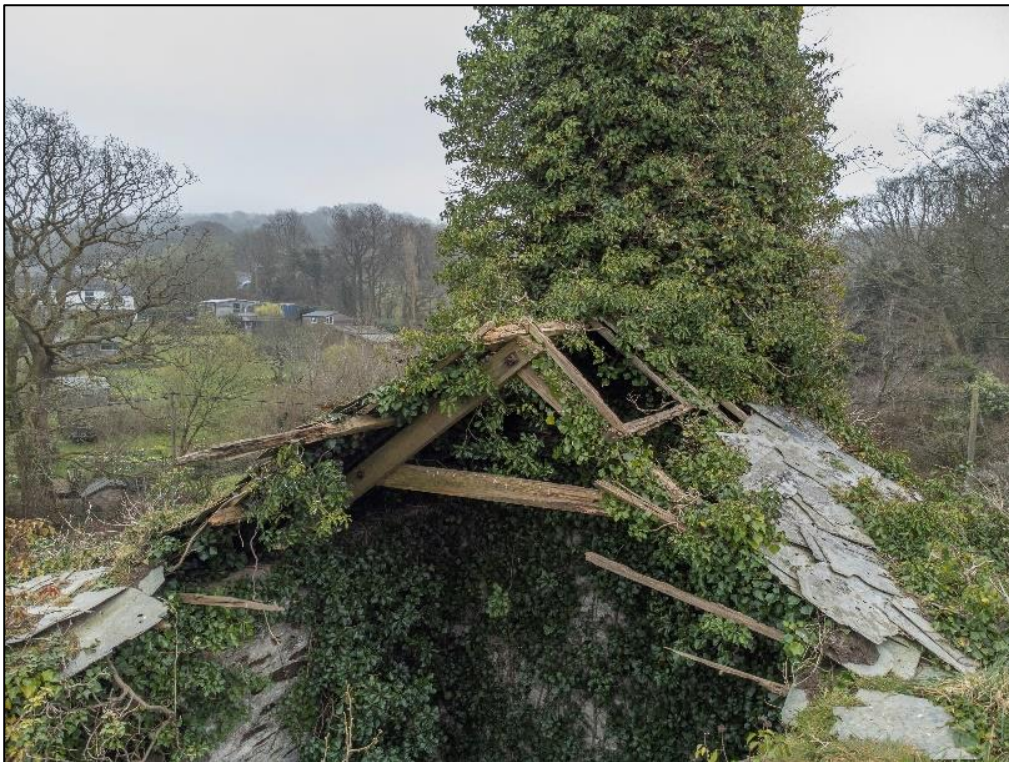
The roof pitches from east to west and was originally of a truss and purlin configuration. The 'A'-frame timber trusses included a half-lapped apex joint, collar and tie, with a ridge and two intermediate purlins per slope bearing off them. The roof structure that remains can be seen in figure 23.12 and consists of one principal A-frame truss at the southern end with purlins and some common rafters. Towards the north of the building the roof has failed completely. On the parts of the roof still remaining, some original roof slates are still in place on both east and west sides, with a greater number on the east side. Some of these could slip and drop at any time, with large slates and rotted roof timbers hanging out over the ivy, such as in figure 23.13. There are fallen slates and timbers evident on the engine house floor, some of which are shown in figure 23.14.

Figure 23.12 – Remaining roof structure.

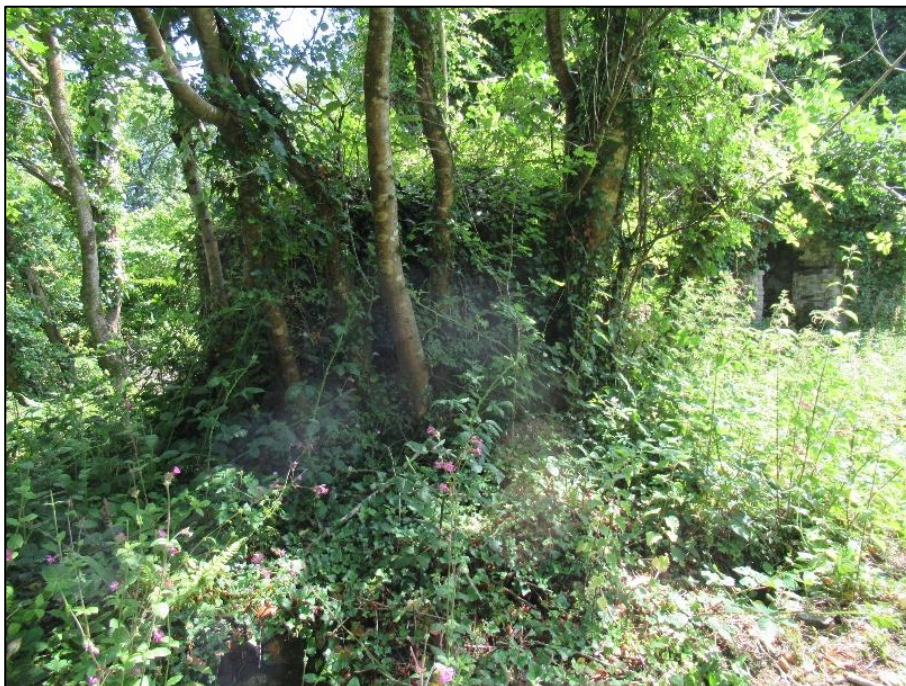
There are various trees surrounding the plinth and more growing from the top, clearly shown in figure 23.15. Otherwise, the structure is heavily covered in ivy and vegetation with the sides largely obscured. However, despite the vegetation growth, this structure appears to be reasonably stable.

Figure 23.15 – Trees on western side of plinth.

- Cut down trees and clear vegetation from around the structure
- Clear ivy and vegetation from the stonework
- Locally rebed loose stones and consolidate stonework where required
- Repoint open jointed stonework
- Monitor condition and control vegetation

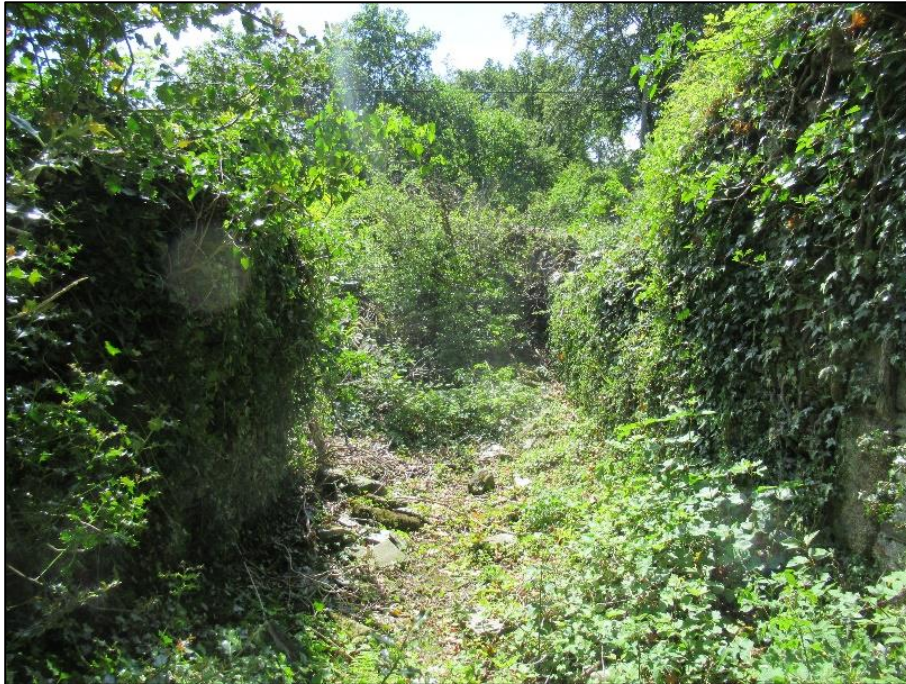
Figure 24.01 – Boiler House Internal.

24.01 1998 Recommendations:
 Vegetation, rubble, and tree clearance on house floor. Walls require vegetation clearance and stability check.

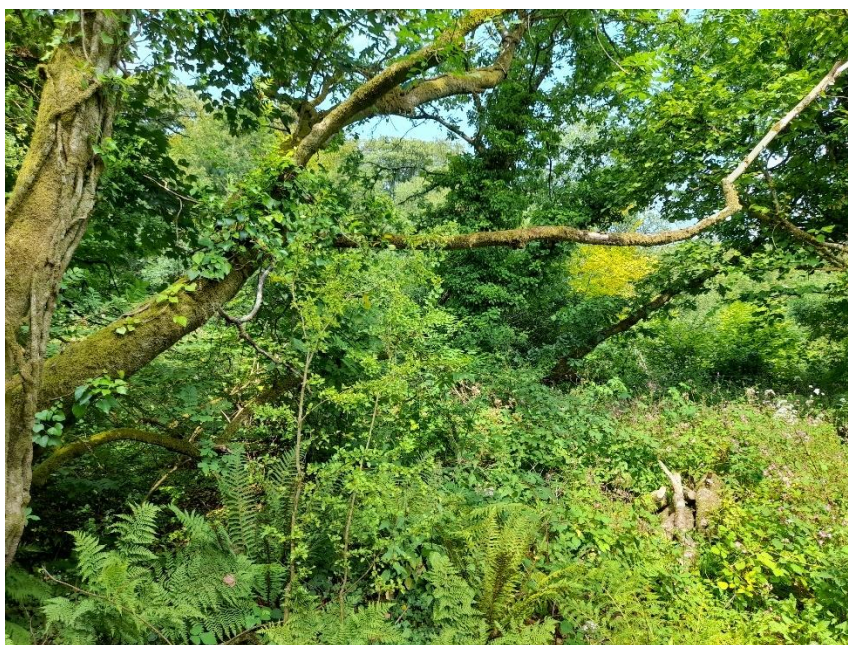
Woodland borders the northern and western edges of the site. The tree coverage comprises of mature and semi-mature trees, with scattered understory species. Species include Pedunculate oak, ash, sycamore, harts tongue fern, hawthorn, nettles, male fern, ivy, hazel, and bramble. Whilst not encroaching too much into the site, should any vegetation works take place within the site, mitigation is required to prevent any accidental damage to this habitat.

1. Woodland habitat encroaching into the site

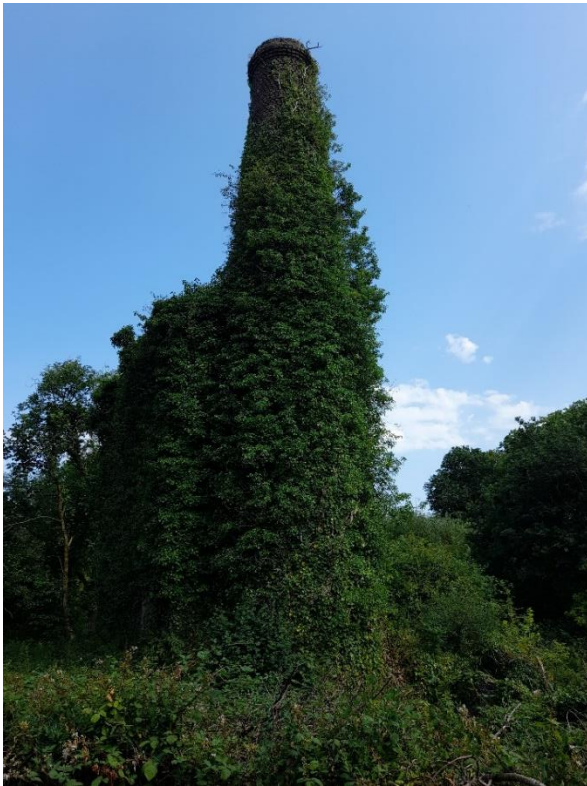
Part of the mining buildings remain in situ, with the Engine House and chimney being most prominent. Other building remnants, including the Boiler House and the Plinth, are little more than some stone walls, flooring and rubble. Much of the stonework is heavily covered in ivy,

with species such as bramble, nettles, elder, hazel, male ferns, harts tongue fern, red campion, hawthorn, nettles, ash saplings and ground elder growing at the base or emerging from it.

2. Engine House and chimney

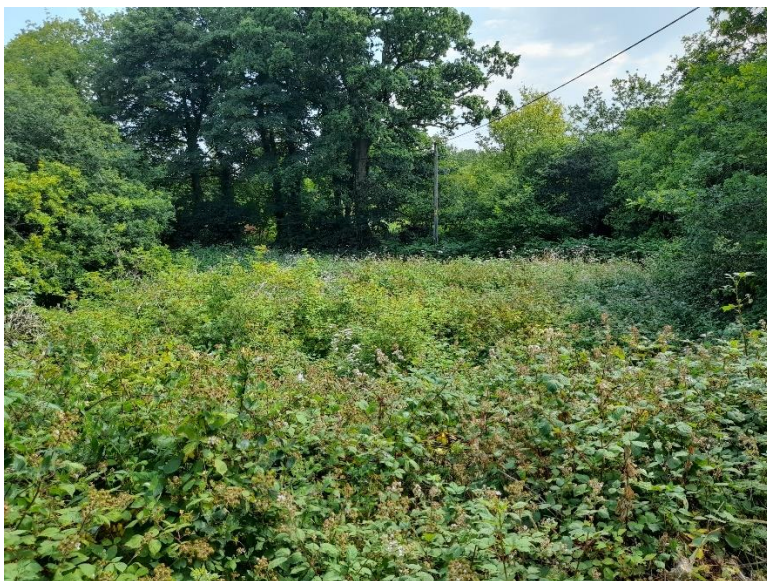
In the east and south of the site, thick scrub is dominated by bramble, nettles, ground elder, male fern, ivy, red campion, hawthorn, sycamore, hazel and marsh valerian. Some of the scrub is butting up against the building remnants.

3. Scrub on east of site

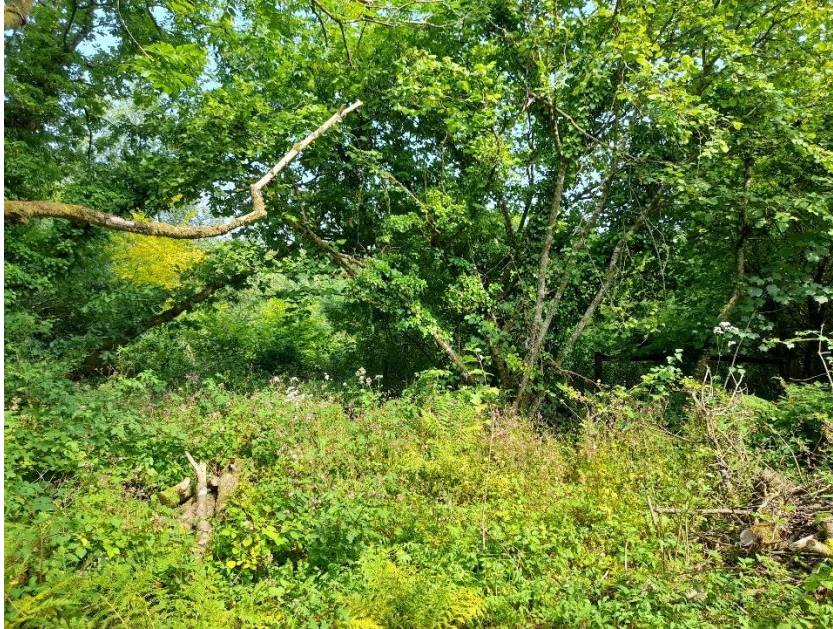
On the northern extent of the site, there is a line of hedgerow shrubs which is running along a post and wire fence. It doesn't form a hedgerow, as there are clear gaps between each plant. Hazel stands dominate with other species such as bramble, elder, nettles, ivy and male ferns growing at their base.

4. Hazel strip on fence line

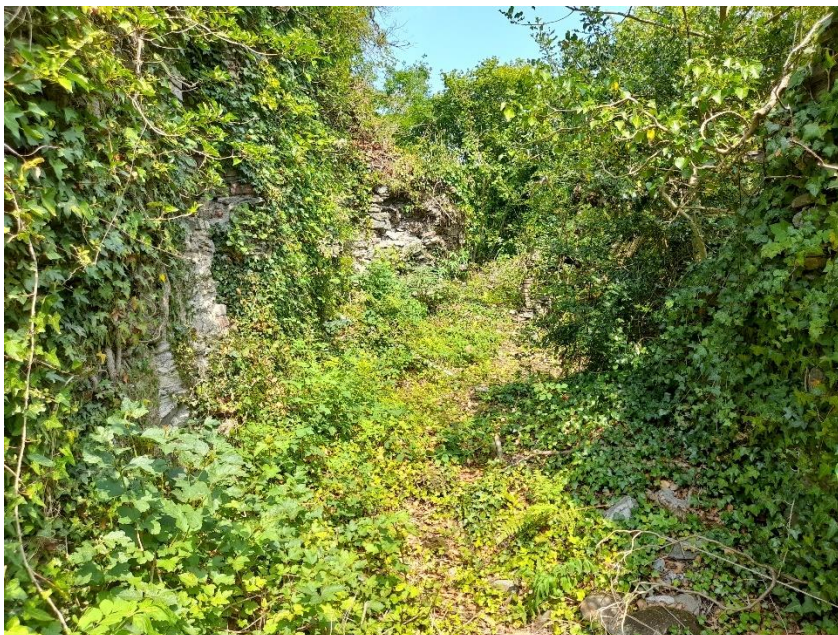
Some scattered ruderal plants are growing within the building footprints and around the edge of the site. Wood chippings from scrub clearance at the base of the buildings has suppressed much of the growth of some emergent species, which include male fern, red campion, nettles, marsh valerian, hogweed, ground elder and ivy.

5. Ruderal growth within building footprints

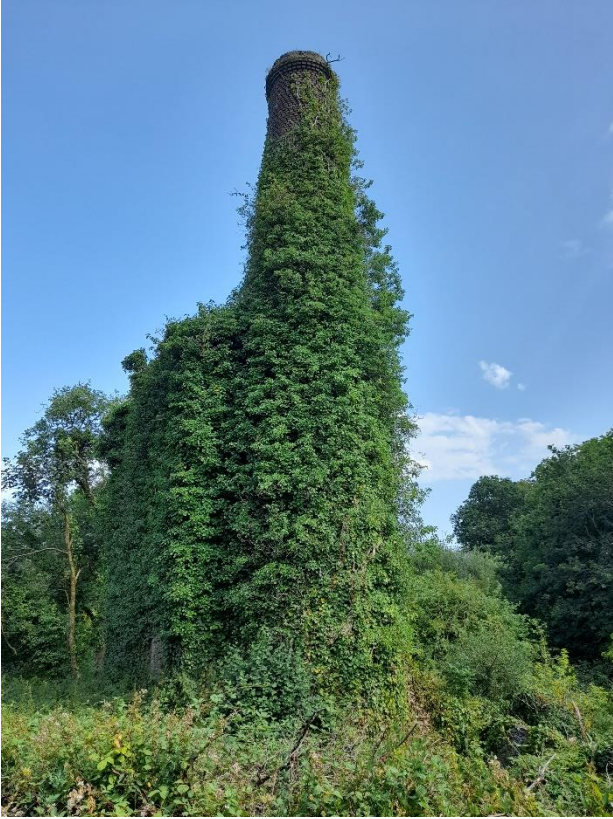
Feature name	Description of features with potential for bats	Potential for bats
Chimney and Engine House	The chimney is extensively covered in Ivy, which may conceal potential features. The brickwork exposed at the top may provide roosting opportunities.	Moderate
	The wheelhouse is also covered in thick ivy which may conceal potential roosting areas. Inside the structure, some cavities are visible, providing good roosting potential for bats	High
Boiler House	The remnants of the boiler house include the floor and the lower half of the walls with the rest of the building missing or in rubble. Very little in the way of potential for roosting bats.	Negligible
Plinth	A small remnant of a building to the west of the wheelhouse. Cavities present but they may be to exposed and low down to be of benefit to roosting bats.	Negligible

6.The Chimney and Engine House, viewed from the south

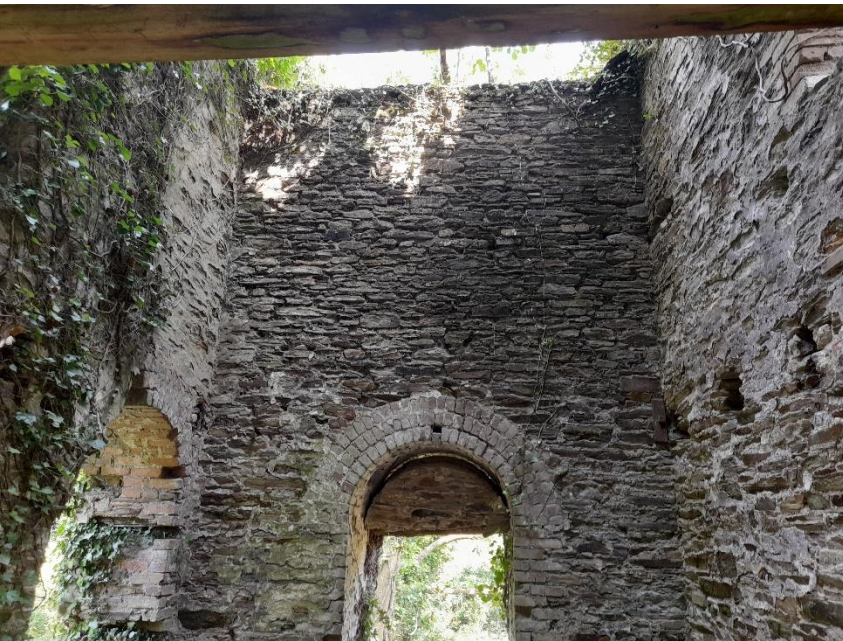
7.The interior of the Engine House

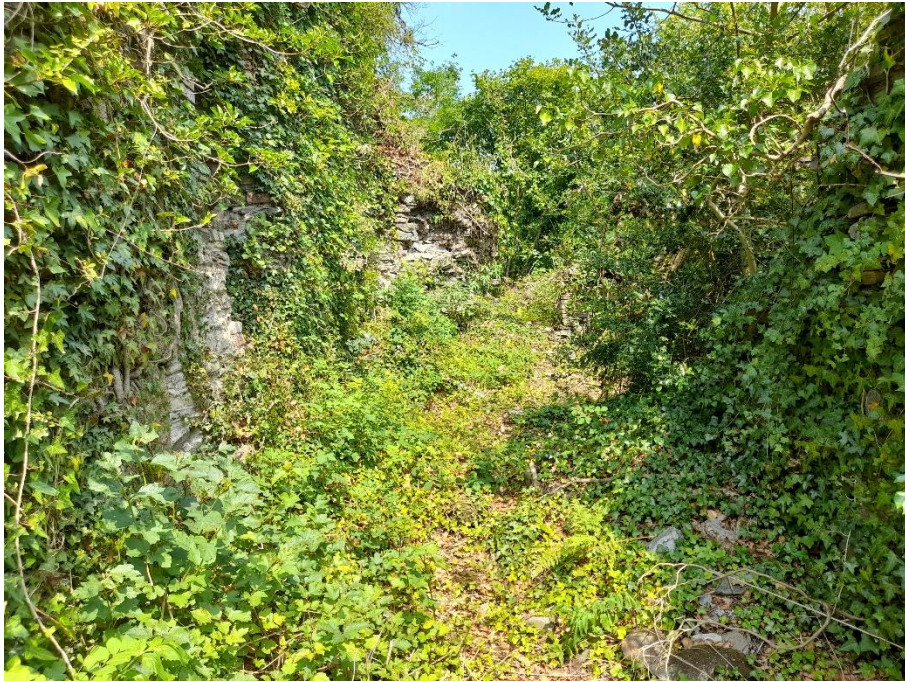
8. The Boiler House view south to north

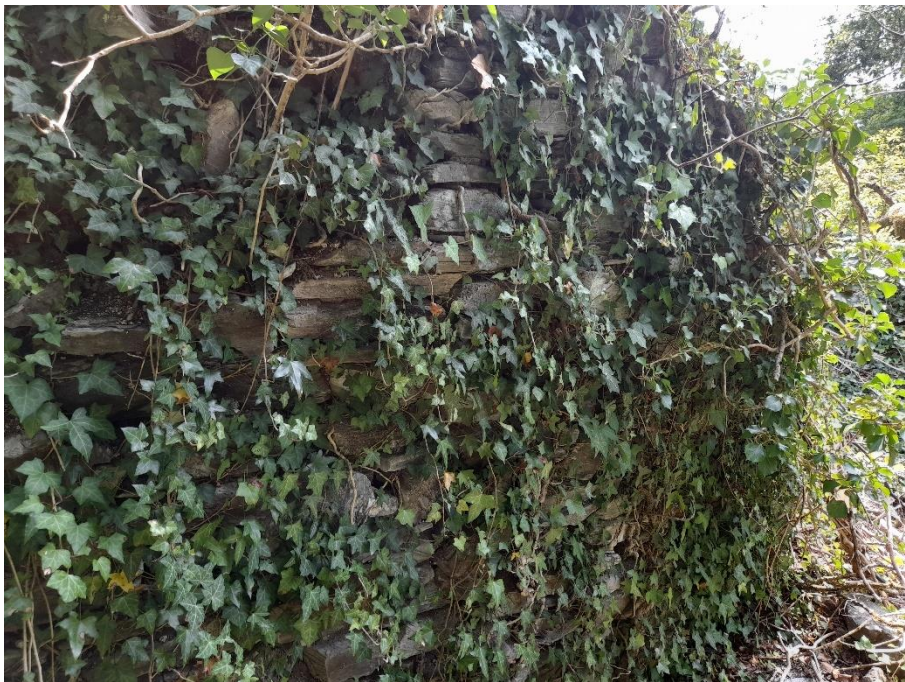
9. Part of the Boiler House wall left in situ

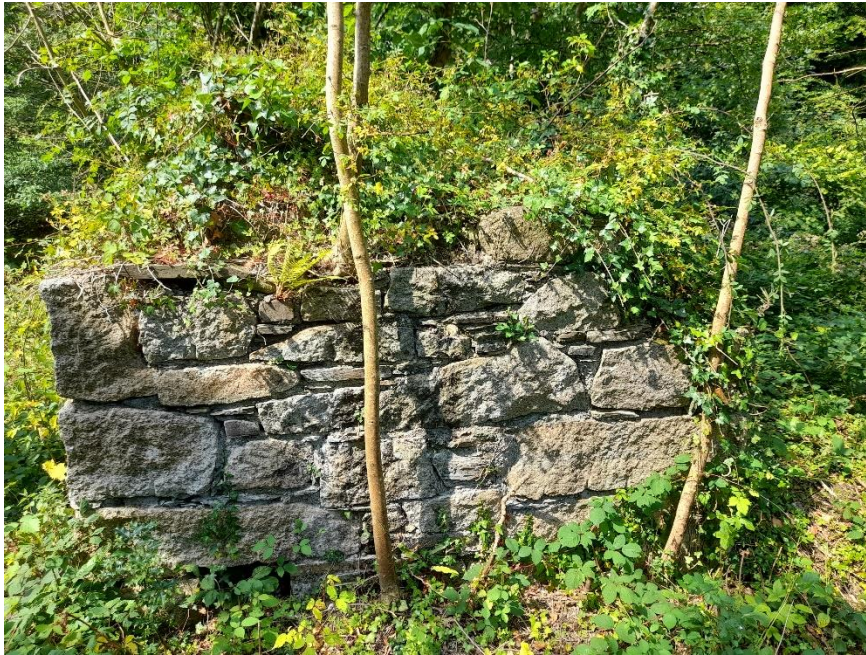
10. The Plinth
