**Hamilton Lodge
Parsons Hill
Great Bromley
Essex**

Level 2 Historic Building Recording

CA Project: SU0444

CA Report: SU0444_1

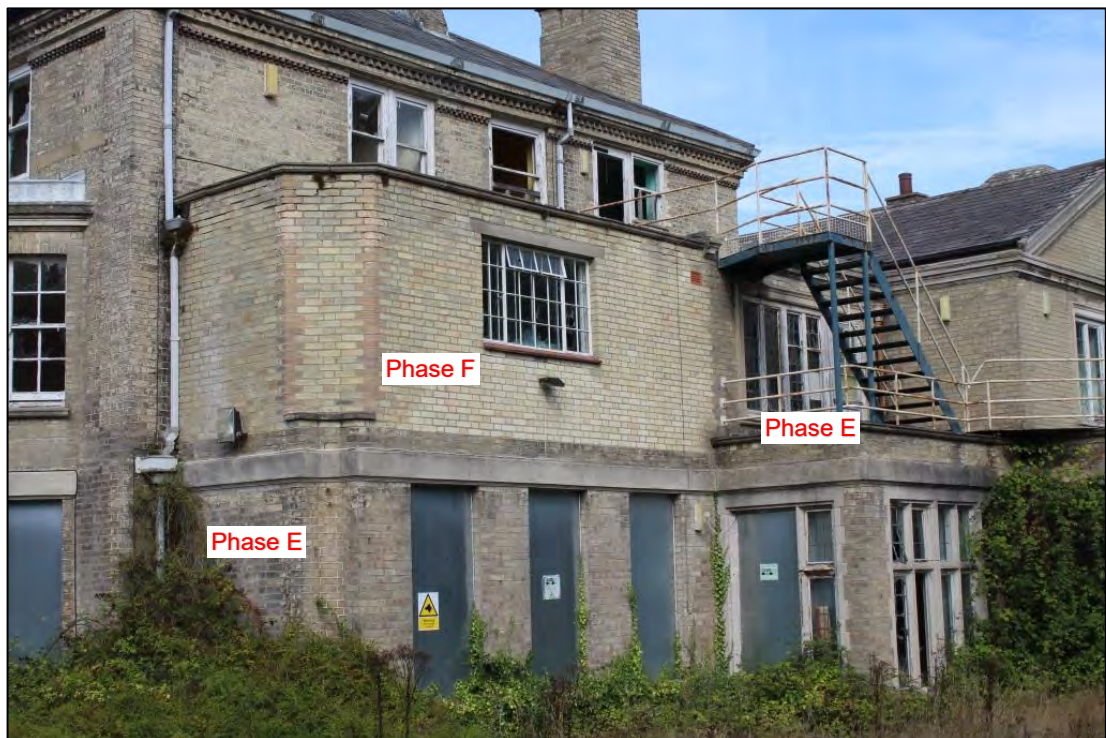
Photo 5: South-eastern elevation of the house

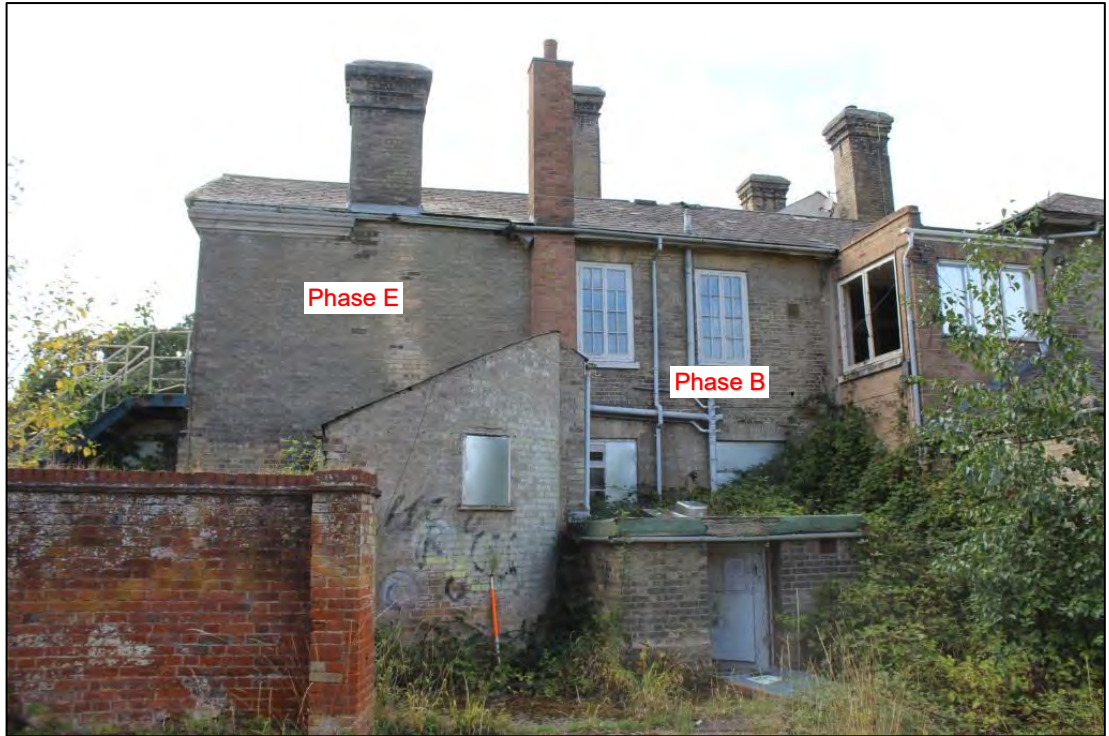
- 4.14. The rear (north-eastern) elevation of the building (Photos 7 and 8) incorporates a complex configuration of extensions and alterations that suggest an organic approach to the building's reconfiguration according to requirements of its operation. A particularly stark example is a clearly 20th-century boiler flue, which has been constructed in red brick, extending from a rear projection of the building (Photo 7). The central portion of the elevation may still incorporate elements from the building's earliest guise in the mid 19th century (Phase B) and features timber casement windows beneath lintels formed of shaped voussoir bricks.

Photo 7: Southern extent of north-eastern elevation

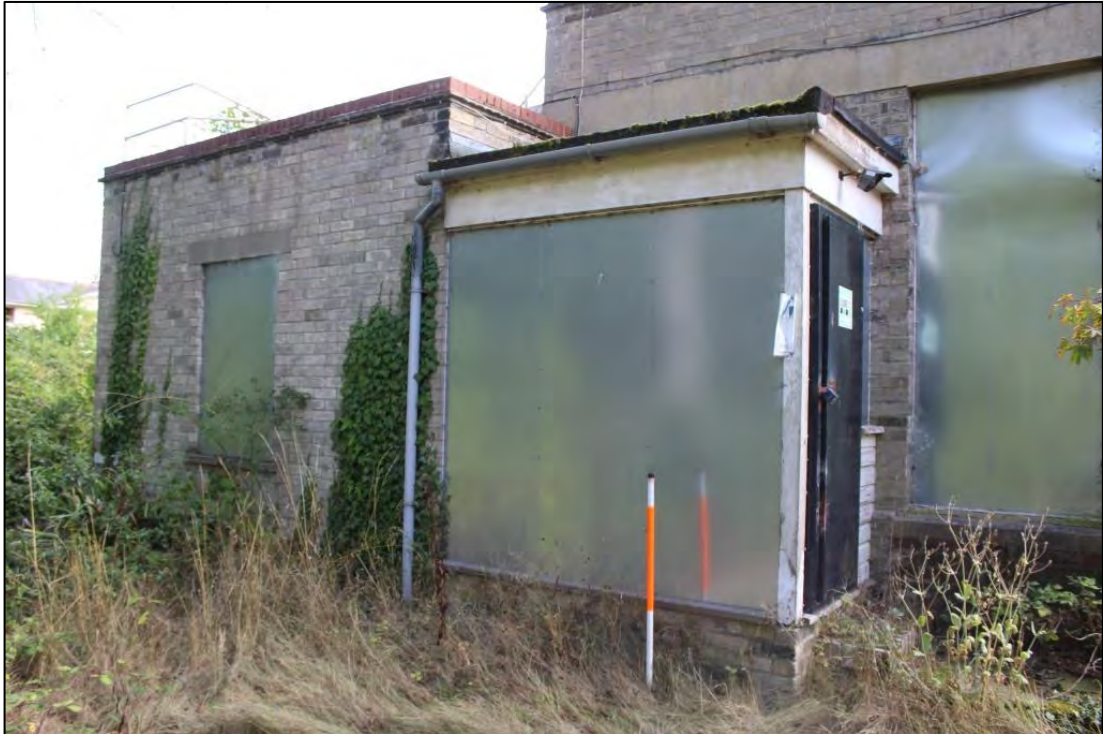
4.16. The visible portion of the north-western elevation (Photo 9) incorporates a pair of single-storey ancillary extensions that were constructed during the 20th century. The first-floor portions of the elevation (Photo 10) incorporate further elements of Phase

Photo 9: Partial view of north-western elevation

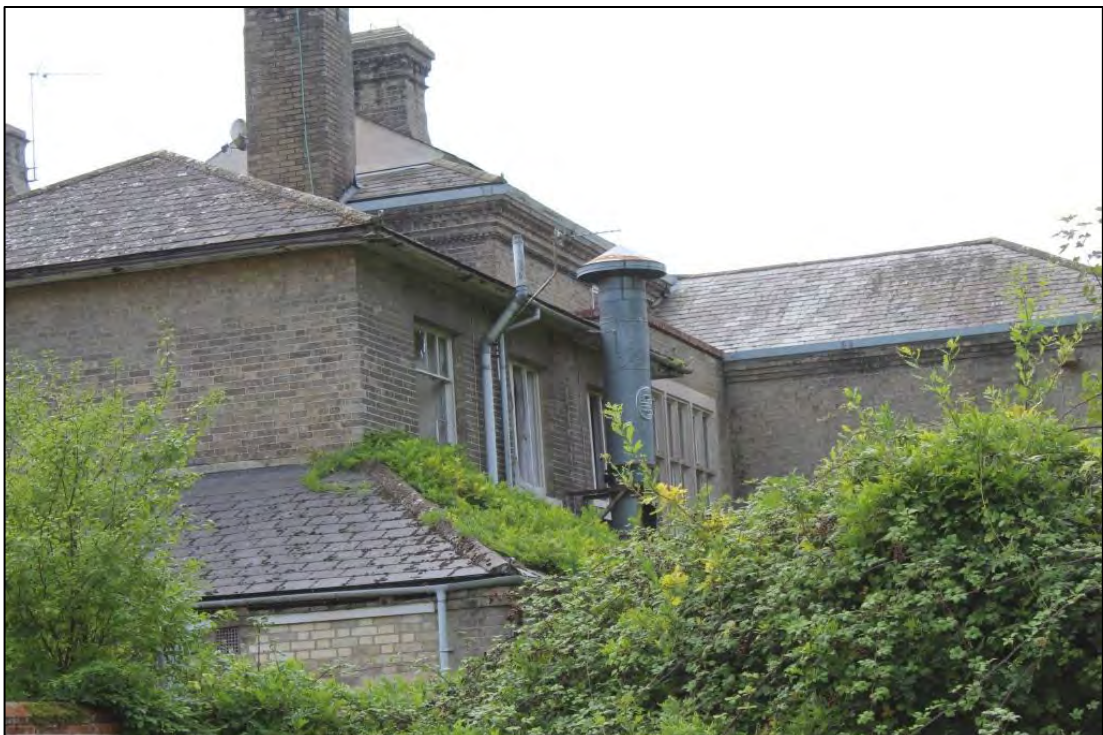
B and a continuation of the decorative dog-tooth and dentil brickwork, symbolising the visibility of this elevation as visitors approached the building from the west along the driveway.

Photo 10: Partial view of north-western elevation, upper storeys
