**MILLEND MILL
EASTINGTON
GLOUCESTERSHIRE**

**ARCHAEOLOGICAL BUILDING
RECORDING AND WATCHING BRIEF**

CA PROJECT: 2779
CA REPORT: 09138

JANUARY 2010

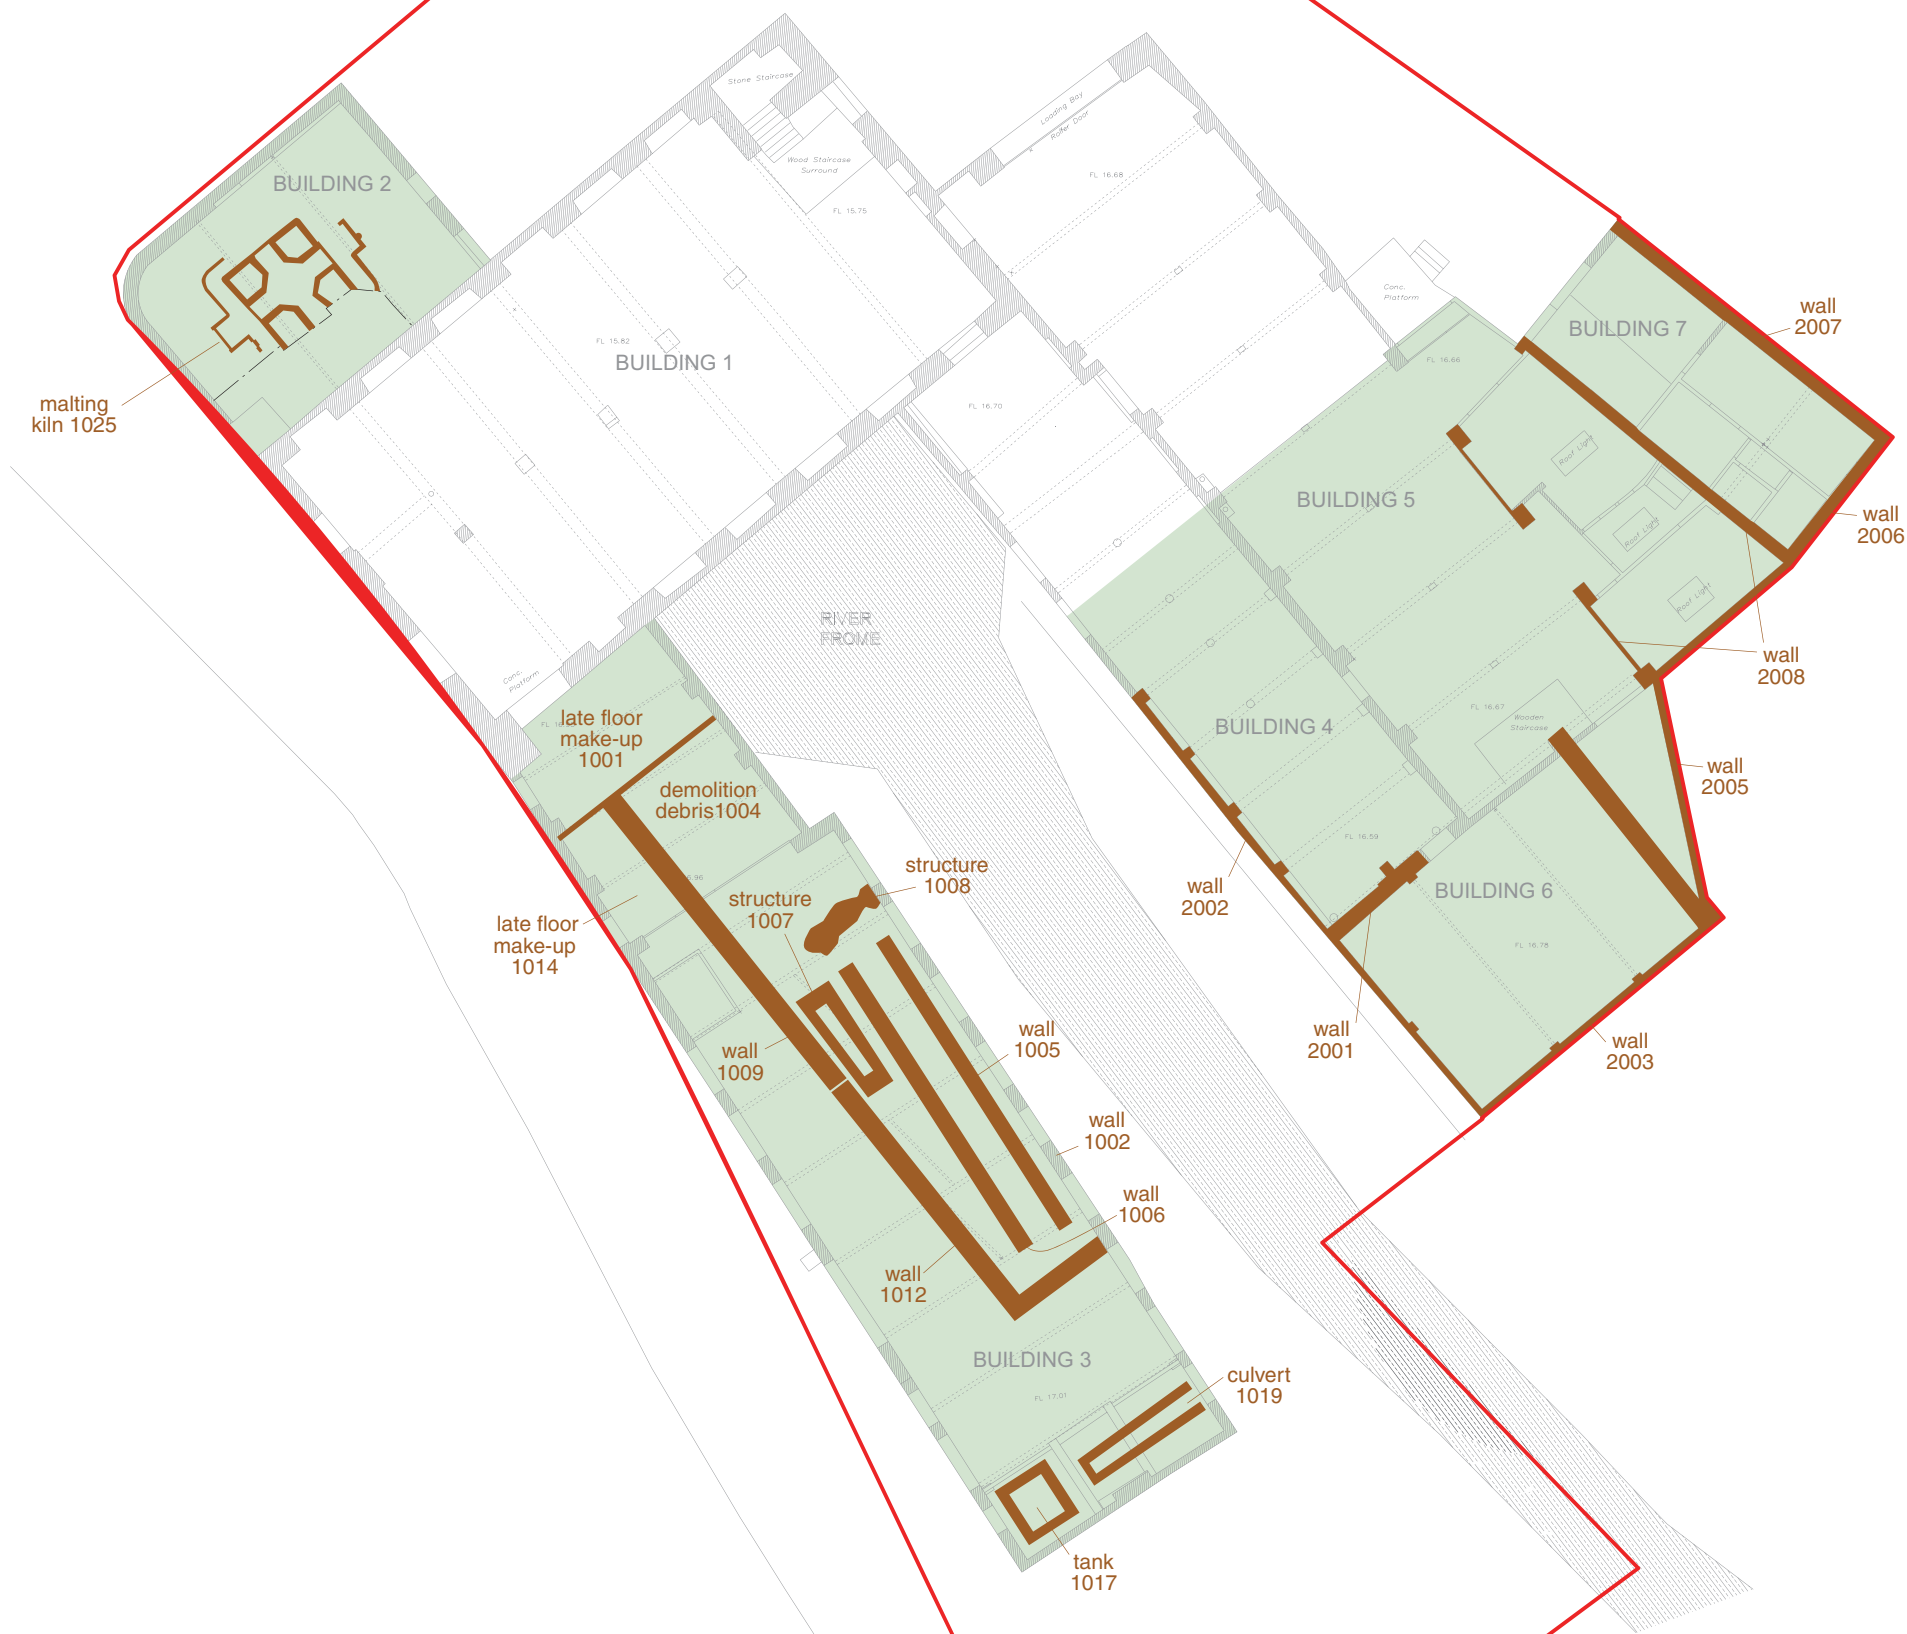
25 The malting kiln foundations seen from the scaffolding on the north side of Building 1, after the demolition of Building 2, looking north-east. Scales 1m
