The Templar Lodge Hotel,  
Gullane,  
East Lothian.

**April-May 2011**

**Carried out on behalf of Lorn MacNeal Architects**

connolly • heritage • consultancy

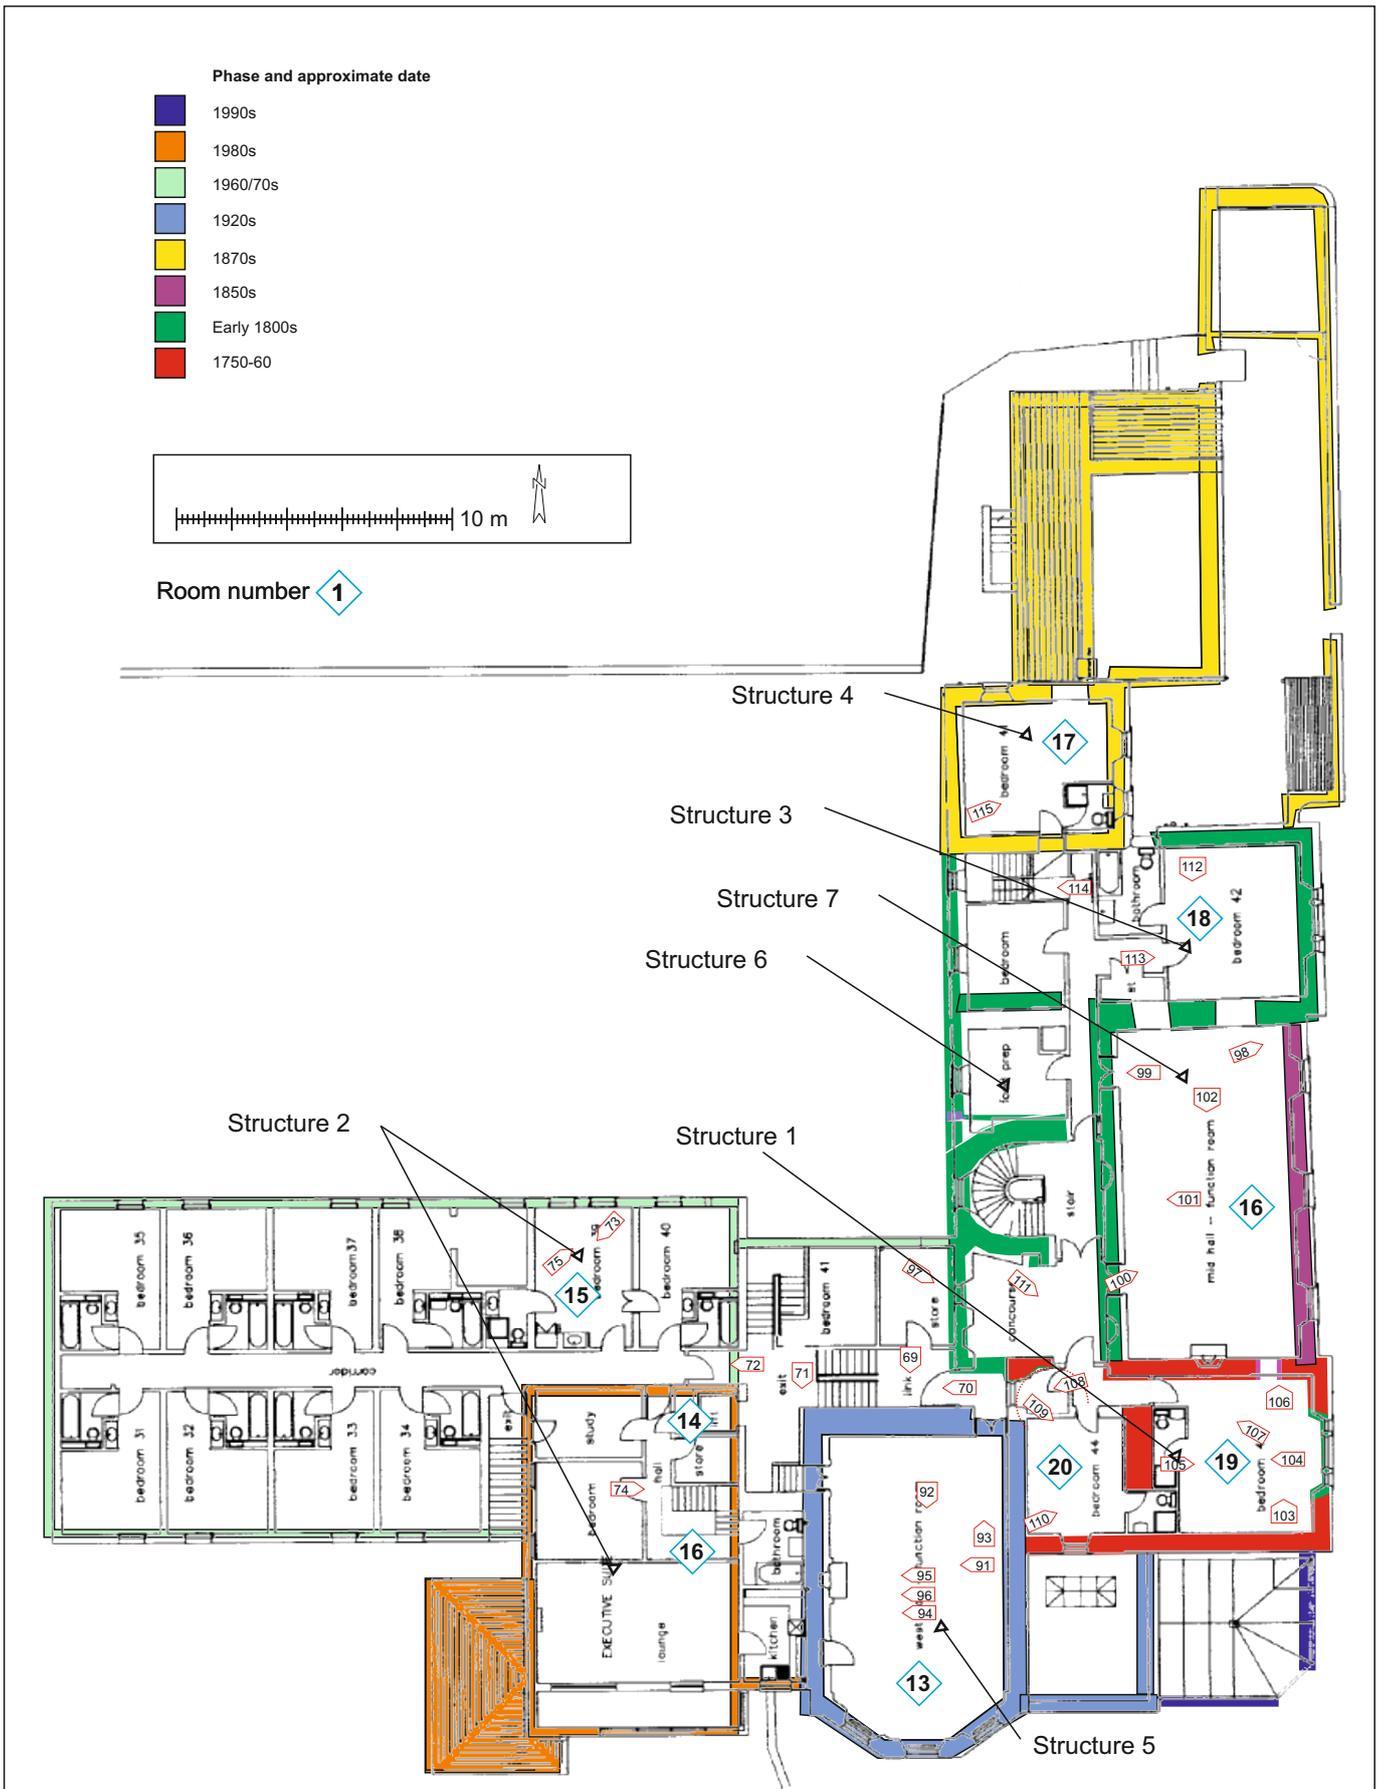
Figure 8: First Floor plan

Narrow floor boards in the east flanking pavilion. A similar tri-partite window with 6/6 sash does not have the Georgian surrounds found in the west wing. The surround on the door in the north wall also lacks the Georgian elegance found in the west wings. There is a blocked fireplace in the northwest corner of the west elevation evidenced by a white tiled hearth. In addition to a large walk in cupboard and bathroom to the north with a door from the concourse. This creates a discreet bedroom/living area.

Original stone rubble built construction with broad floorboards. Tri-partite window in south elevation and fireplace in north elevation (much enlarged). Doorway with Georgian surround has been slapped in Room 16 (mid hall) and subsequently blocked in the early 20<sup>th</sup> century. Similar surrounds are found into the rooms and
