Cheviot House Mill

Haddington, East Lothian.

January 2013

- 1.1 An archaeological buildings appraisal was required due to an archaeological condition placed on the development at The Cheviot House Mill, Haddington, East Lothian. The site is located, within an historic mill complex, and forms part of the largely demolished West Mills. (NMRS - NT57SW 82) (see Figure 1).

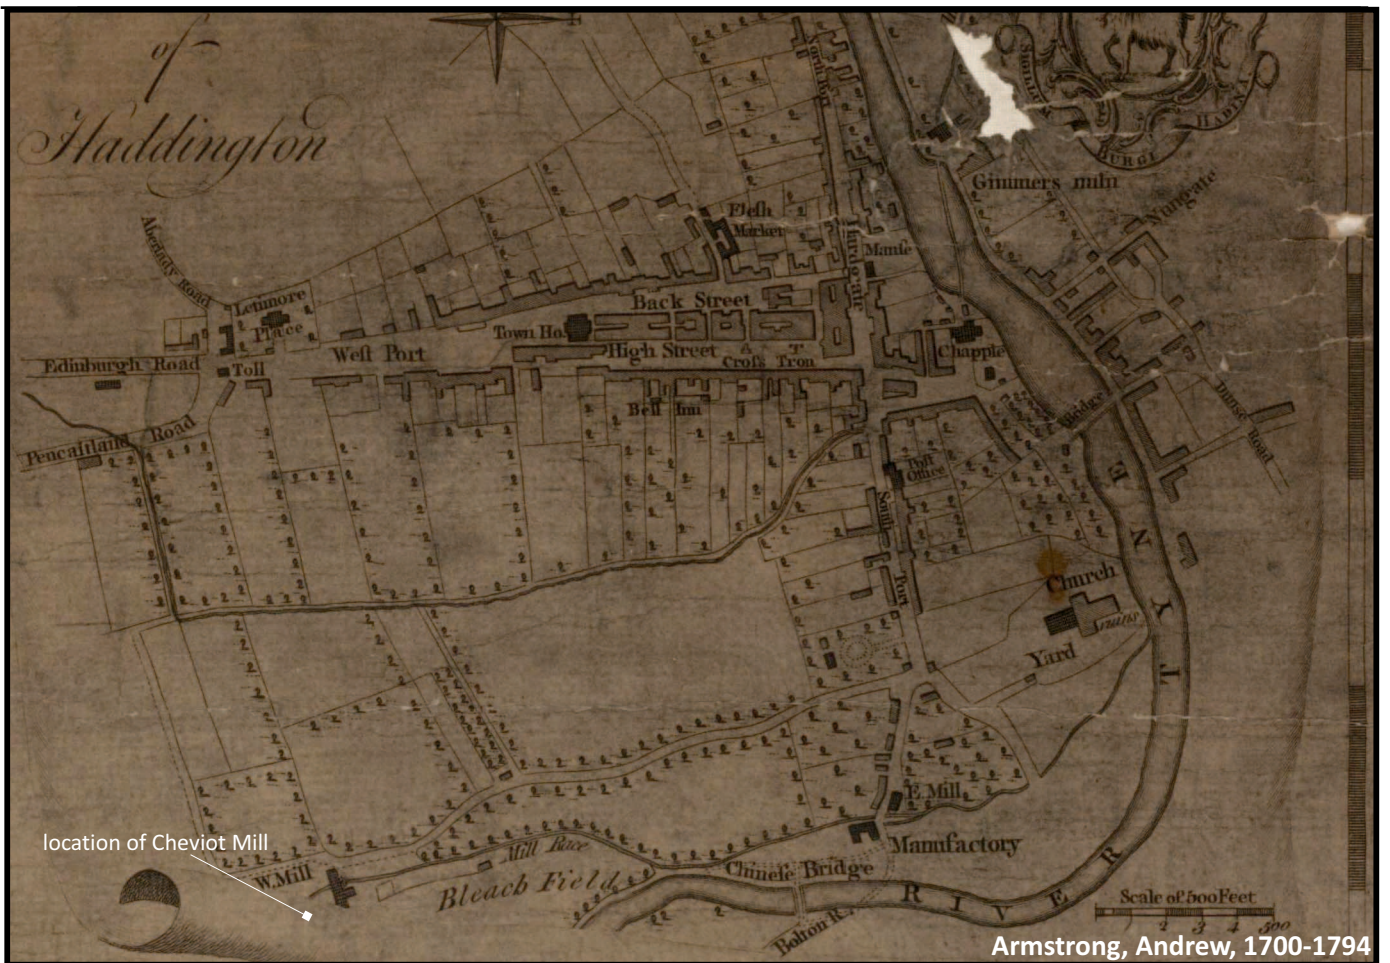
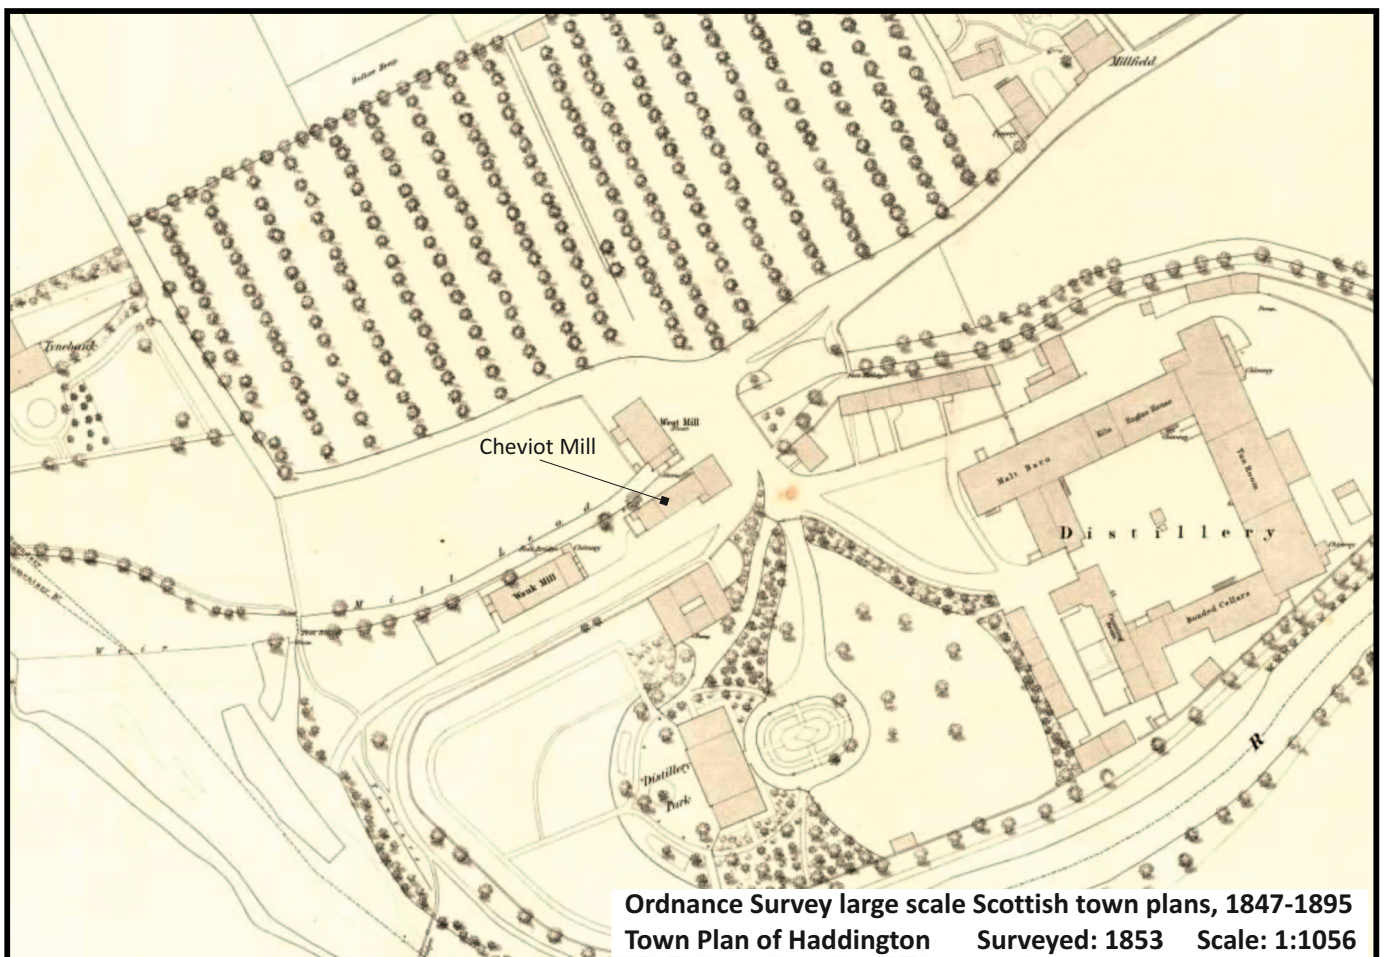
Figure 2: Historic maps of site

- 2.2.4. Map regression on the site was conducted and it is clear that there were no structures on the location of the Cheviot Mill until some point after 1770s and before the first OS maps in the 1850s. This seems consistent with the date of 1852/53 for construction of this and other buildings when it is established as a flour mill. The evidence from the cast iron beams seems to suggest a date no earlier than 1851 (Figure 2).

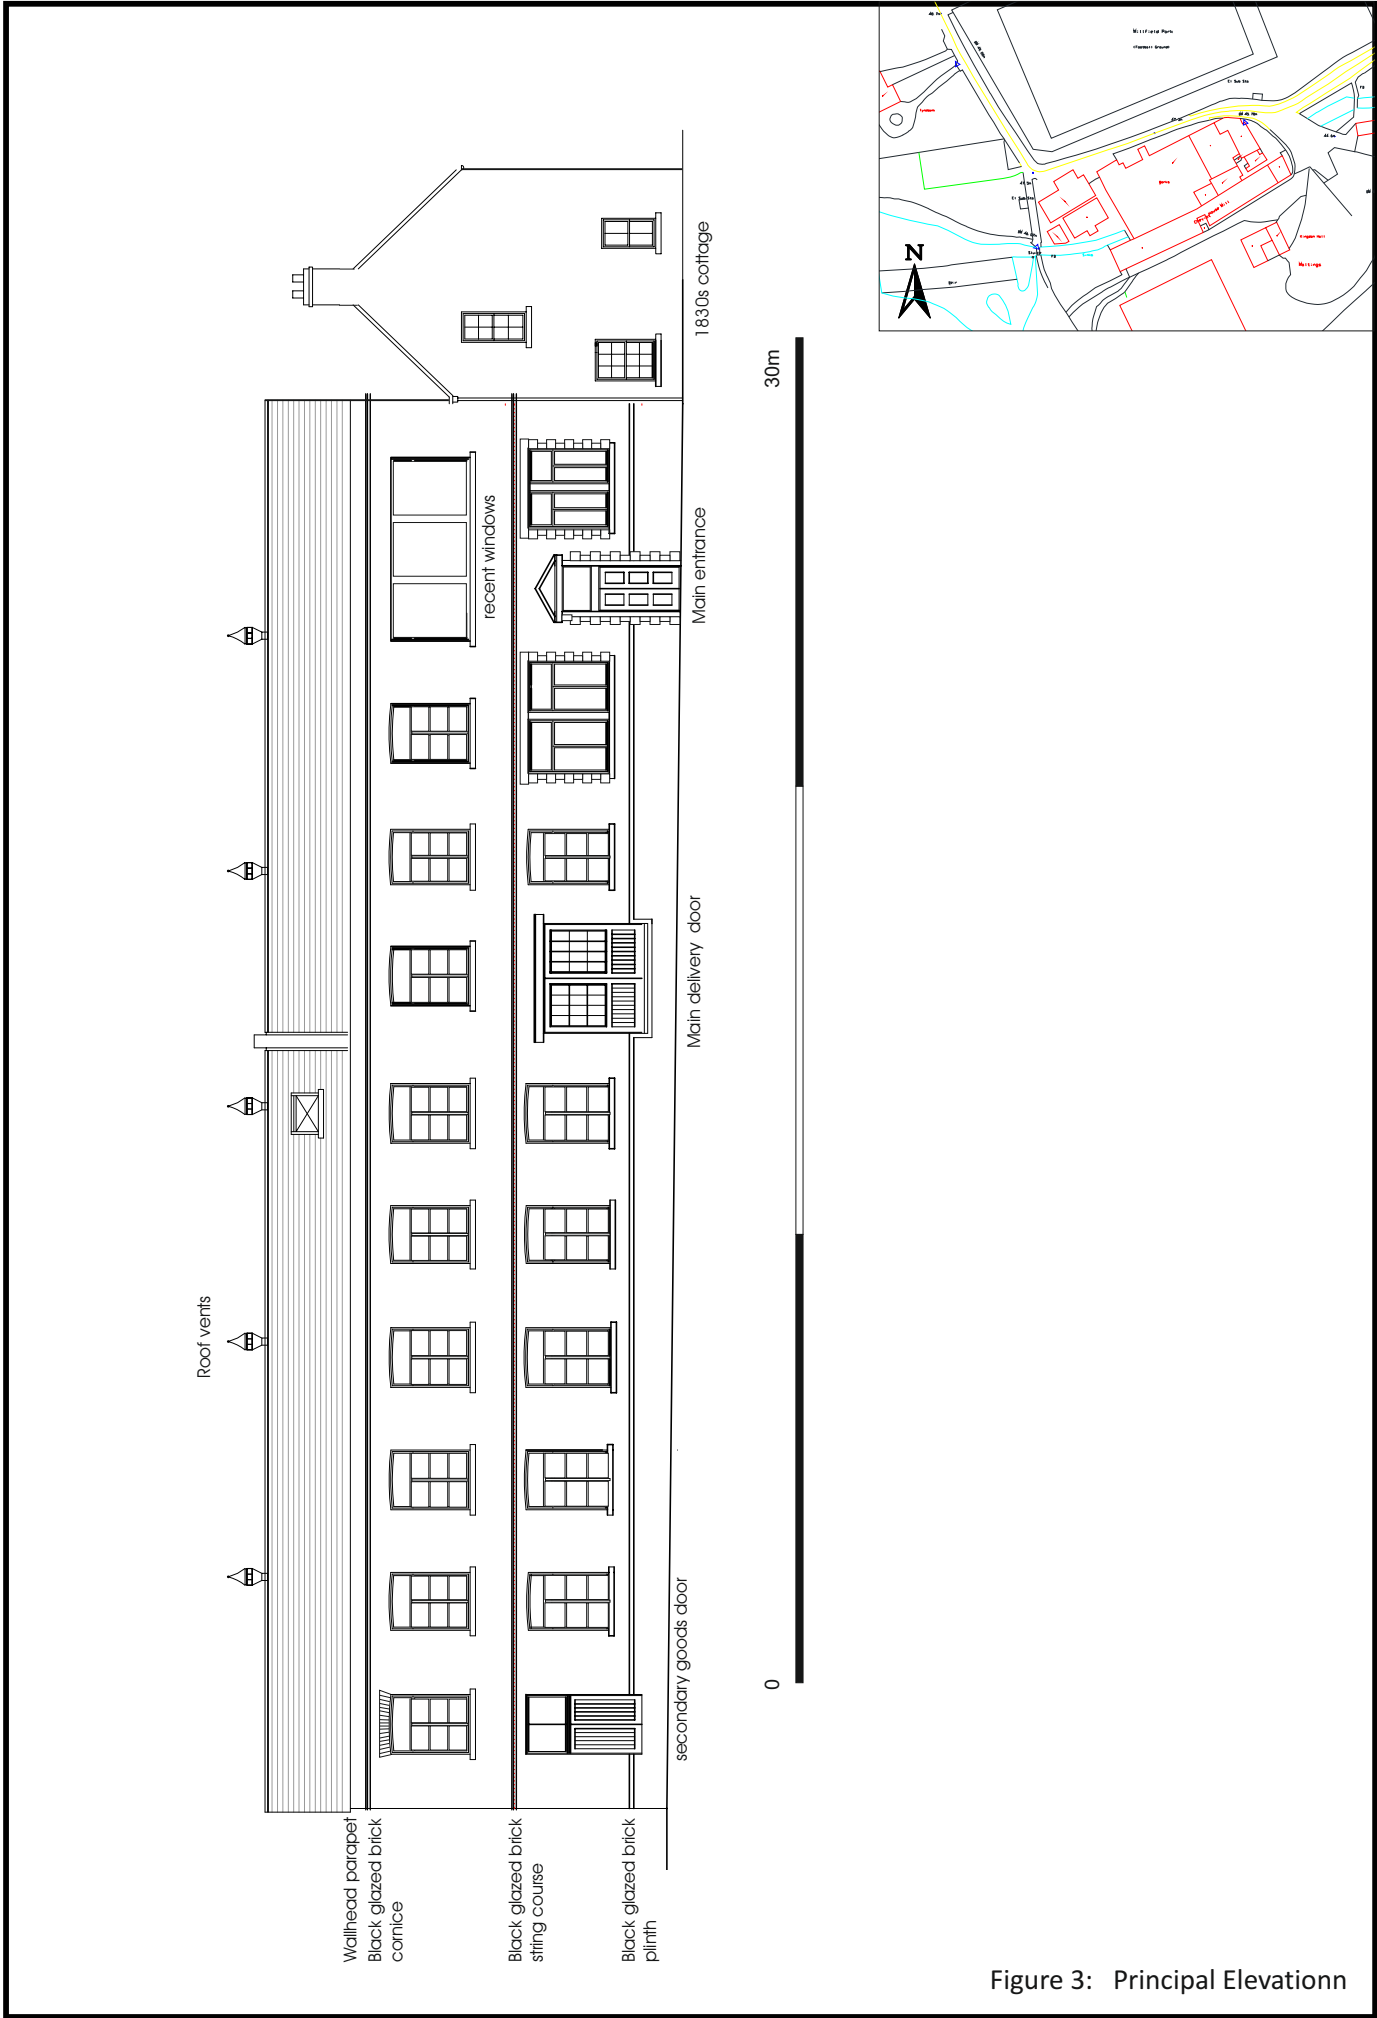
Figure 3: Principal Elevation

- 5.1.3 The Cheviot House Mill has a principal elevation to the south and consists of a two storey 11 bay structure with a glazed red brick façade (Plate 6/photo 62). The first floor originally consisted of 11 flat cambered brick arched windows, the eastern most 2 having been altered in the 20th century (photo 64) into a single long plate glass window with 4 equal divisions. The ground floor is divided into an east and west by a large central goods door that splits and slides parallel to the wall – with gas lamp fitting above - (Plate 7/photo 67) and is raised circa 0.80 metres above the ground surface. Consistent with the First floor, the windows to the west are all of similar style with a flat cambered arch.

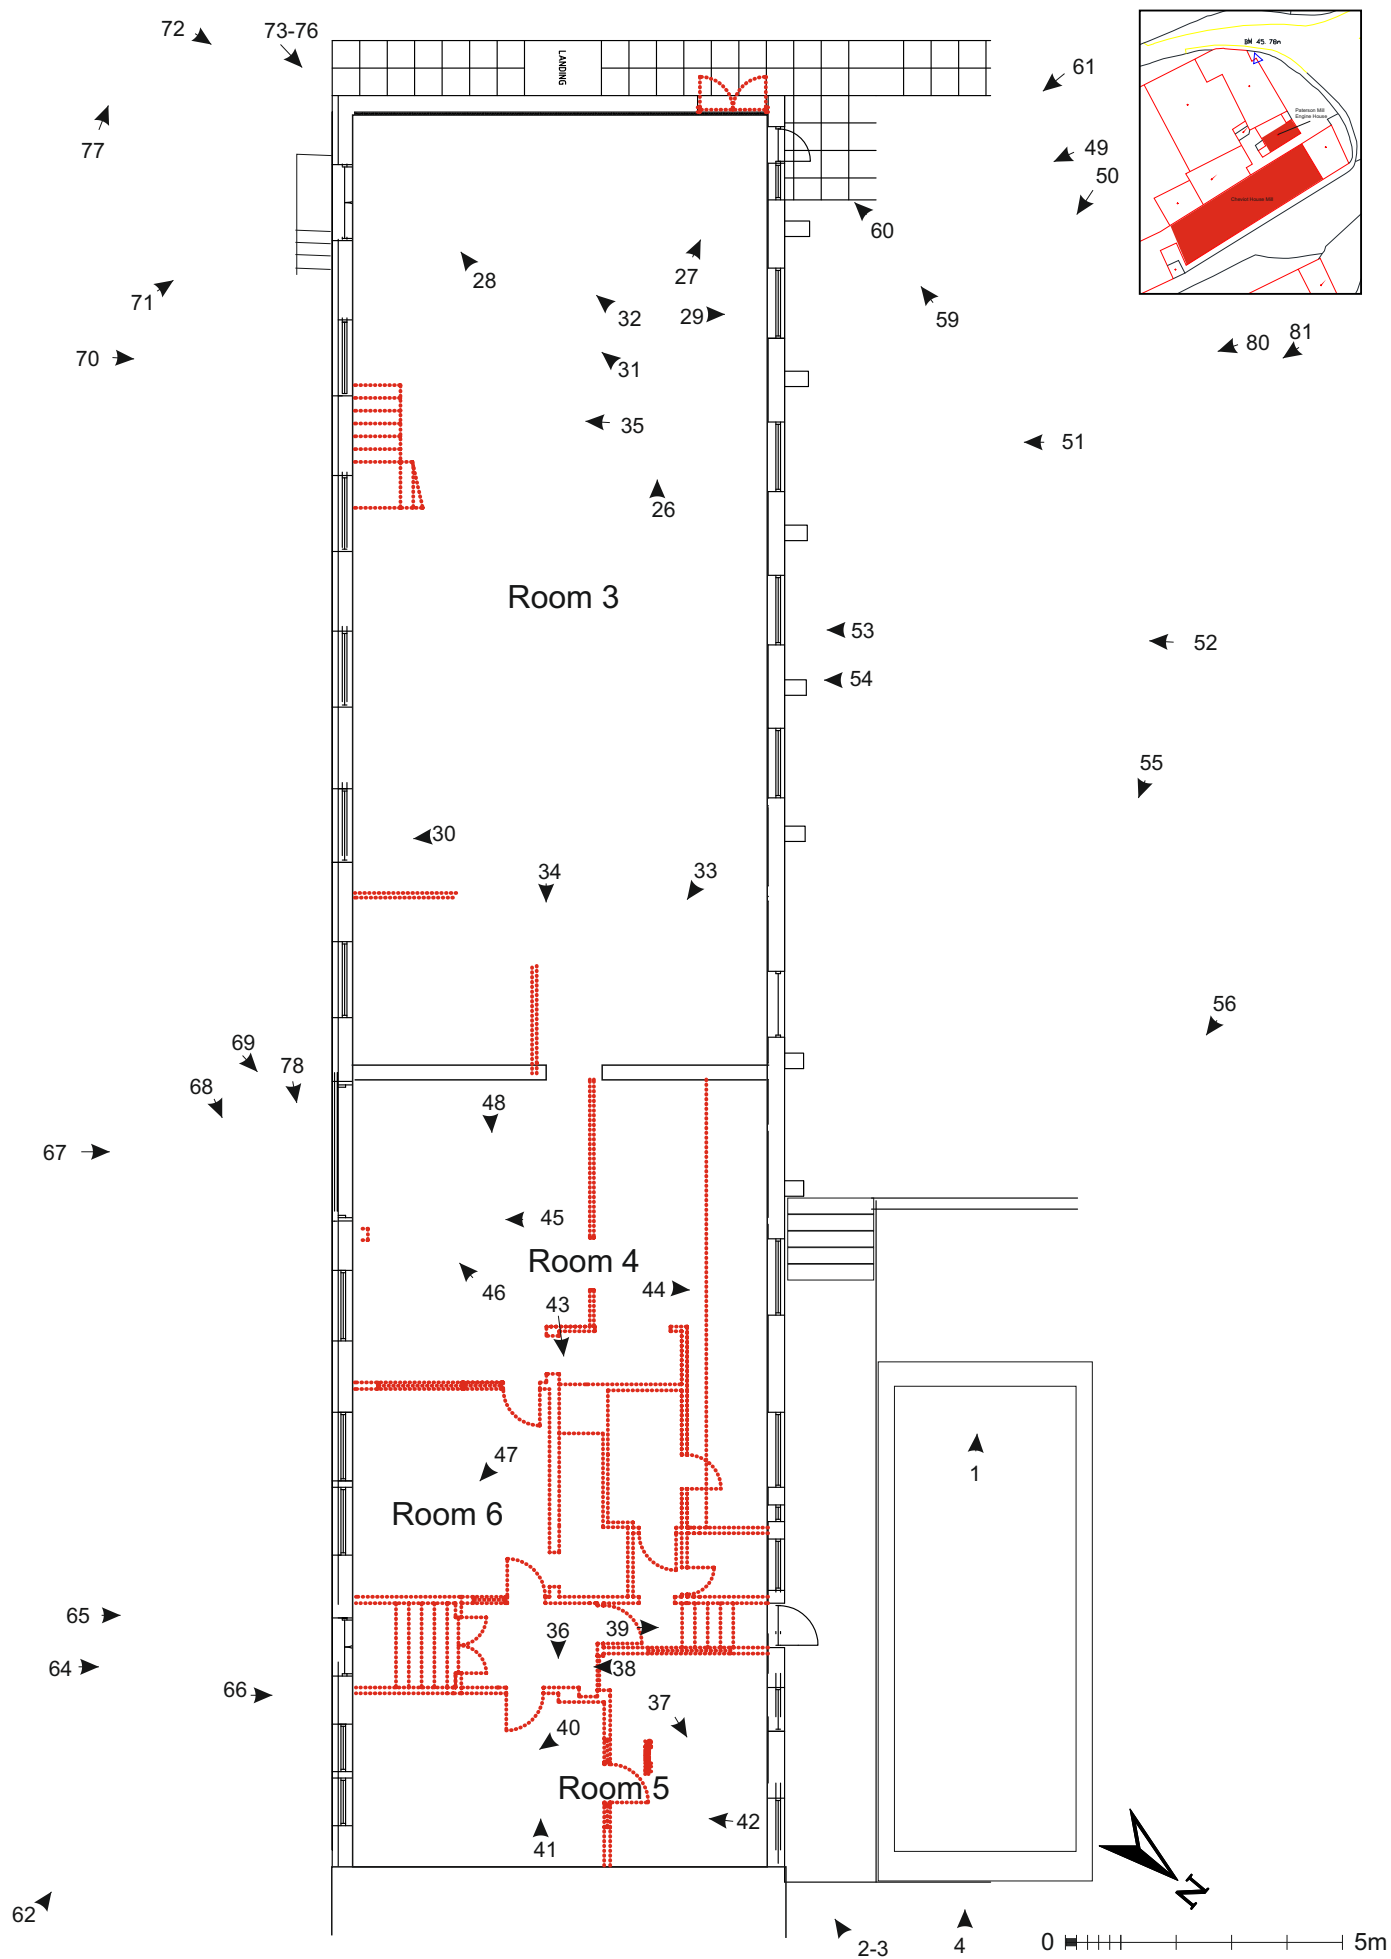
Figure 4: Ground Floor plan (with interior partitions) and photographic index

- 5.1.13 Room 3 is a large open rectangular space with a wooden staircase on the south wall (photo 35) leading to the First floor. Along the median line are 5 cast iron pillars supporting a single cast iron eye-beam (photo 26) that rests on projecting sandstone corbels (photo 26 & 34) in the west gable and east internal dividing wall. The name Skinninggrove (Plate 14/photo 33) is clearly visible on the beam and this relates to the manufacturer from the Iron and Steel works situated in Cleveland, northeast England. As the Skinninggrove Iron Foundry was only built in 1851, then the structure cannot have been built before this date.

- 5.1.14 The central dividing wall to the east has an enlarged opening with steel girder lintel (photo 34); however, the original opening size can be inferred as the flat corbelled arch is still visible above. The south wall has a cast iron L-plate bolted to the interior and further steel beams have been inserted from the north exterior to support every second wooden truss in this area (photo 28). The floor is of concrete which itself envelopes the base of each of the cast iron pillars (photo 32), however, an inspection trench clearly shows that the original surface was on solid footings unlike the floor to the east.

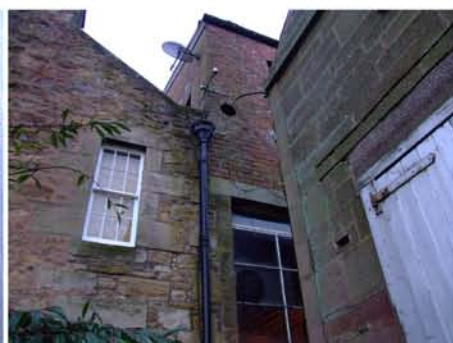
CvM13_03.JPG

- 5.1.10 The east elevation almost entirely consists of the rear elevation of the sandstone later 18th century cottage (photo 3 & 62). The first floor common brick of Cheviot House Mill extends beyond the wallhead and is penetrated by a later insertion of a small window to the north east.
- 5.1.11 The pitched roof is slated and has 5 equally spaced metal ventilation cowls (Plate 13/photo 80) along the ridge. There are also glazed window panels to the north.

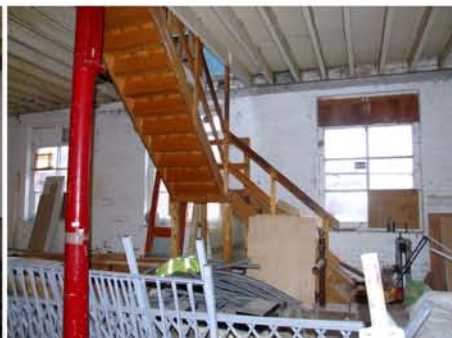
CvM13_34.JPG

Image	Frame	to	Description
CvM13_	34	East	Central wall partition from Room 3 and Room 4 beyond. Note girder lintel on widened doorway with Brick Flat Camber Arch visible above. Central girder sits on sandstone corbel.
CvM13_	35	South	Stairs up to Room 1 from Room 3 later addition.
CvM13_	36	East	Room 5 showing stone gable to the 1830s cottage with inserted corbel for central girder and brick repair to flue to right.
CvM13_	37	Northeast	Quoins of cottage with north elevation of mill extending to the left.
CvM13_	38	South	Stairs down to main entrance door in south elevation. Panelled office, Room 6 to right.
CvM13_	39	North	Within Room 5 stairs lead down to the lade passage behind stacked wood.
CvM13_	40	Southeast	Note brick repair in east elevation wall and butt joint between stone cottage and brickwork of mill.
CvM13_	41	West	Partition and door from Room 5 reception into the office Room 6. Note bottom left how floor level is supported on dwarf walls that raise the interior 1.10 metres above the exterior ground surface.
