Newhailes House Estate, Flower Garden Wall recording.

March 2007

Carried out on behalf of the National Trust for Scotland

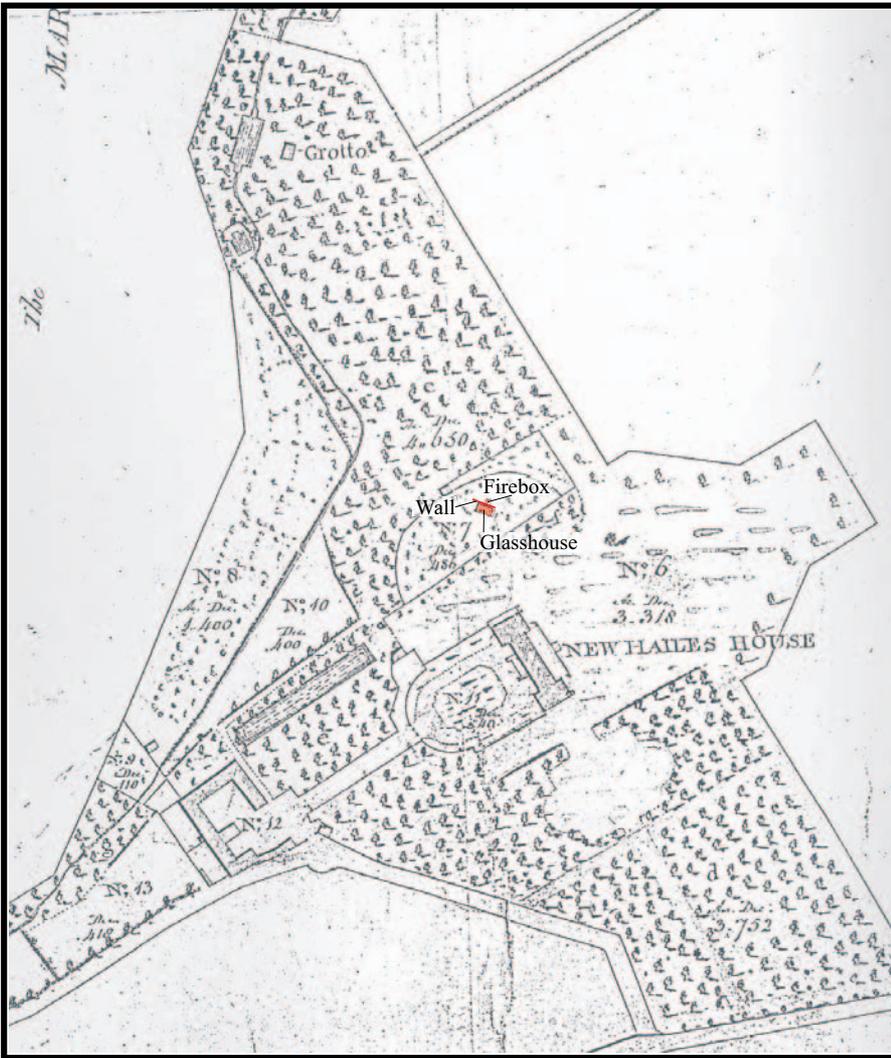
Figure 2: (Top) Bauchop, 1798 house and core estate - wall and glasshouse highlighted in red.
Figure 3: (Bottom) Hay proposals, 1818 - location of glasshouse highlighted in red.

The wall is divided into two sections – an east wall [001] (which was external) and a west wall [002] (which provided the rear of a glasshouse). This is confirmed by map regression (Bauchop, 1798 – (Fig. 2) and the 1893 Ordnance Survey map – (Fig. 4)). The Hay plan of 1818 shows a scheme that would have removed the structures to make way for an elaborate garden, but this was never implemented. It is likely the wall dates to the early to mid 18th century, based on the constructional techniques and brick type, and would have been part of the original walled garden.

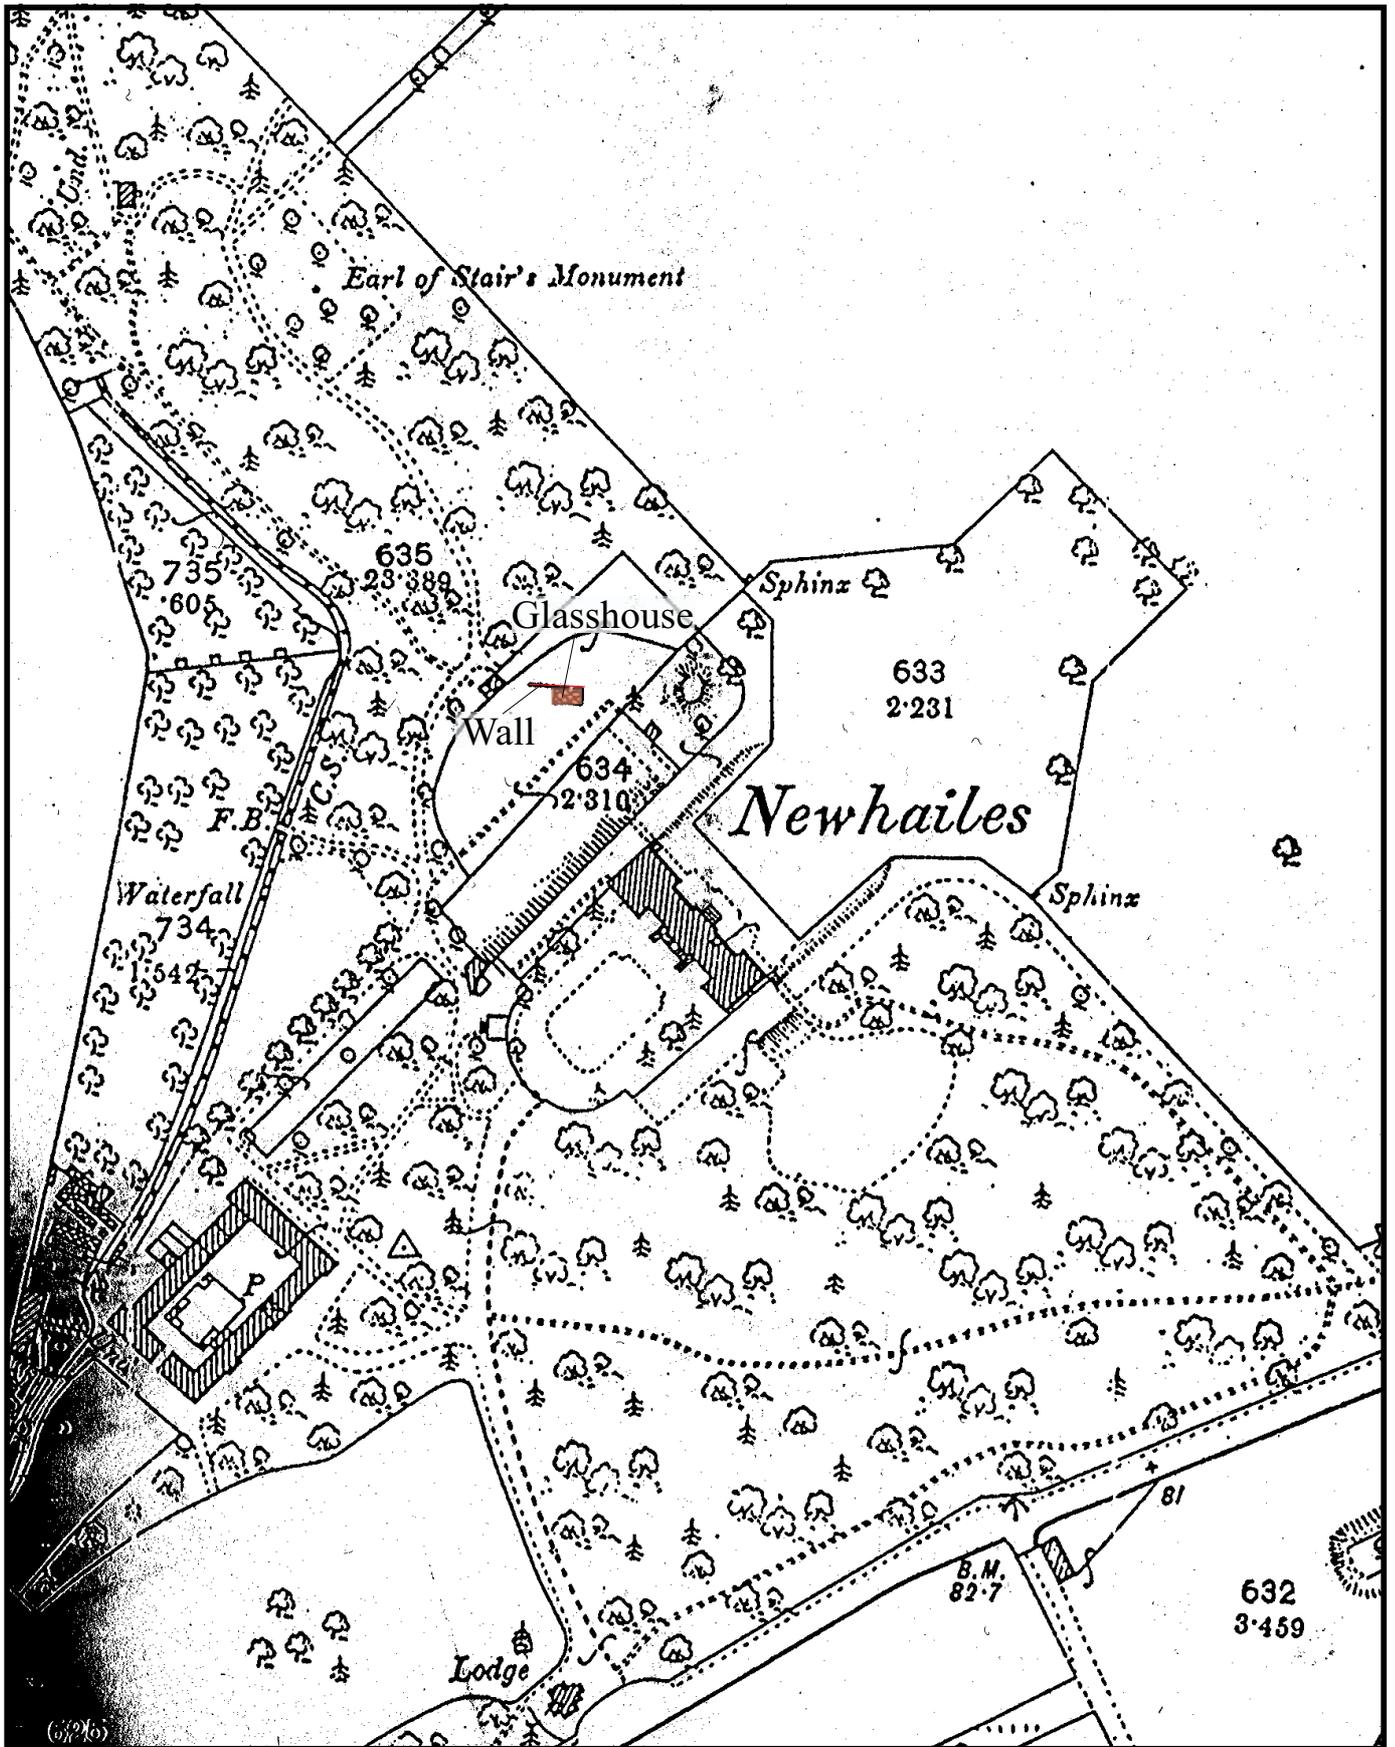
Figure 4: 1893 Ordnance Survey map, showing Newhailes estate and location of wall and glasshouse highlighted in red.
