High Crindledyke Farm, Carlisle, Cumbria **Standing Building Survey**

Report No. 1973

This report presents the results of a Level 3 standing building survey undertaken by CFA Archaeology Ltd (CFA) at High Crindledyke Farm, Kingmoor, Carlisle, Cumbria (NGR NY 3381 5604, Fig. 1) during October 2011. The work was commissioned by Story Homes Ltd.

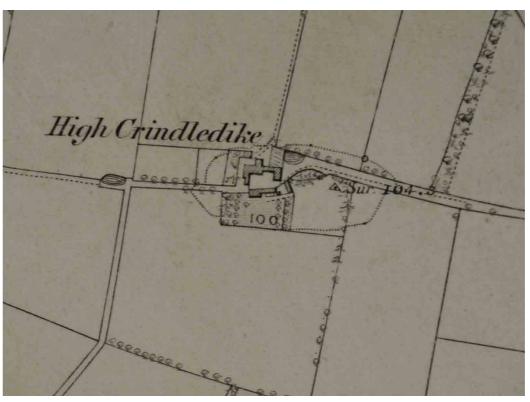
Fig. 2b - Ordnance Survey 1st Edition Map, 1865

The 1865 First Edition Ordnance Survey map (Fig 2b) depicts a formal courtyard steading with the principal ranges surrounding the farmyard. The north range comprises a linear range with right-angle returns at each end and an outshot building on the north side. The farmhouse is depicted with a narrow rectilinear building on its east side. A single detached building is present to the east.

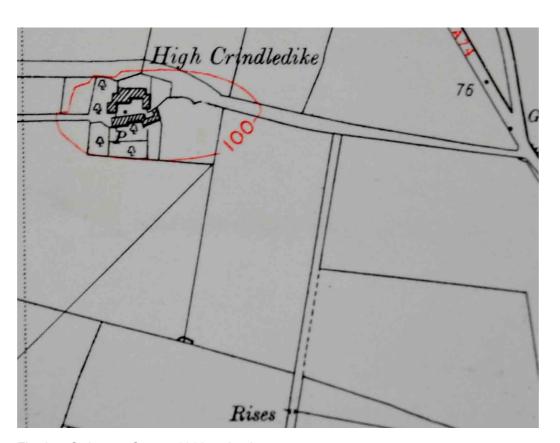
Fig. 2c - Ordnance Survey 1939 revised map

There are no notable changes on subsequent Ordnance Survey map editions. The 1901 Ordnance Survey map shows that the north range is unaltered while alterations have occurred at the east end of the south range with the addition of an L-shaped building. The 1939 revised Ordnance Survey map (Fig 2c) shows little further change, with extension northwards of the north range. There are some minor changes throughout its history in relation to ancillary buildings, probably lean-tos and sheds, around the core block but there is relatively little change in the basic layout of the steading since the mid 19th century. By 1974, the plan is the same as seen today.
