**Arcleoch Forest Wind Farm,
South Ayrshire**

**Programme of Archaeological
Mitigation Works**

Report no. 1637

Author	Phil Moore BA
Illustrator	Shelly Werner BA MPhil PhD
Editor	Bruce Glendinning BSc PgDip MifA
Commissioned by	ScottishPower Renewables
Date issued	December 2011
Version	0
Grid Ref	NX 173 791
OASIS ref	cfaarcha1-129197

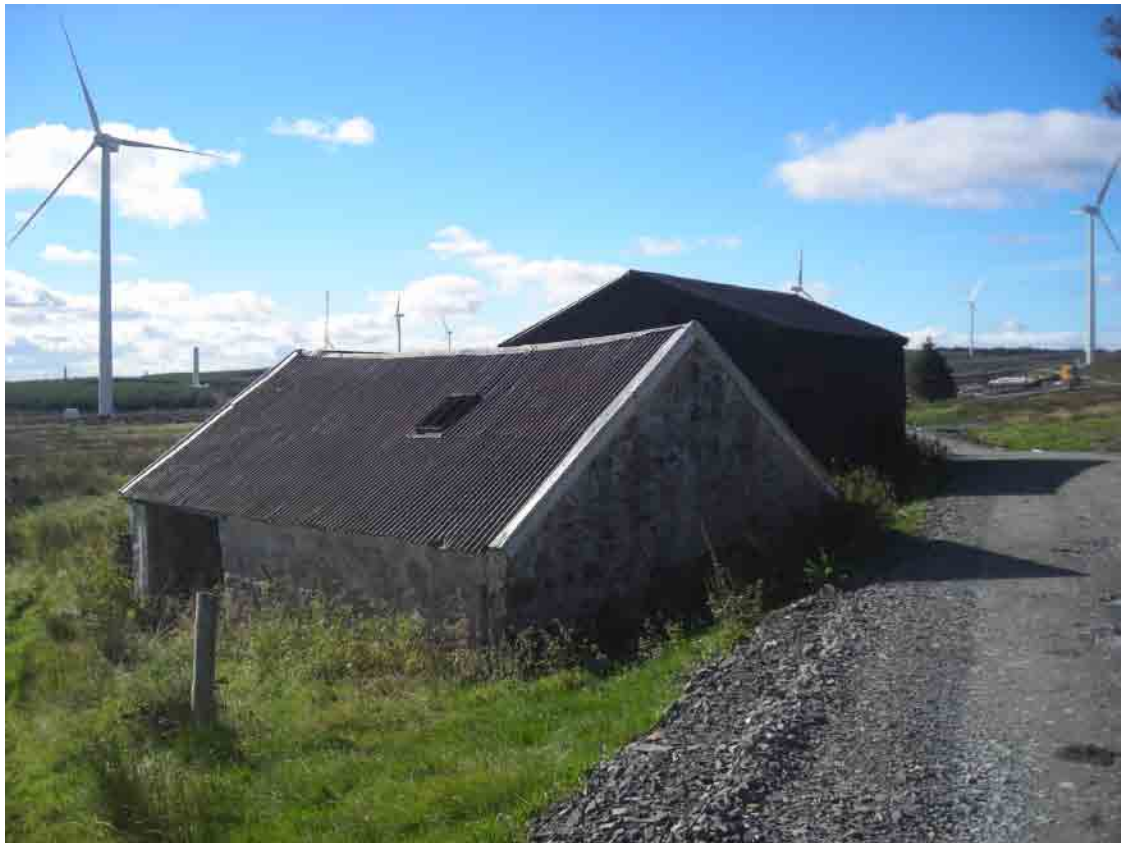
The site was divided by a forestry road into two parts. The eastern half of the site comprised three upstanding roofed farm buildings and a series of small enclosures (Fig. 25). The western part of the site contained a number of ruinous enclosures (Fig. 26). Both sides of the site were fenced off although a 10 metre buffer was not possible where the access road passed through the site.

Fig 25 - Shot of Site 83 east during demarcation works

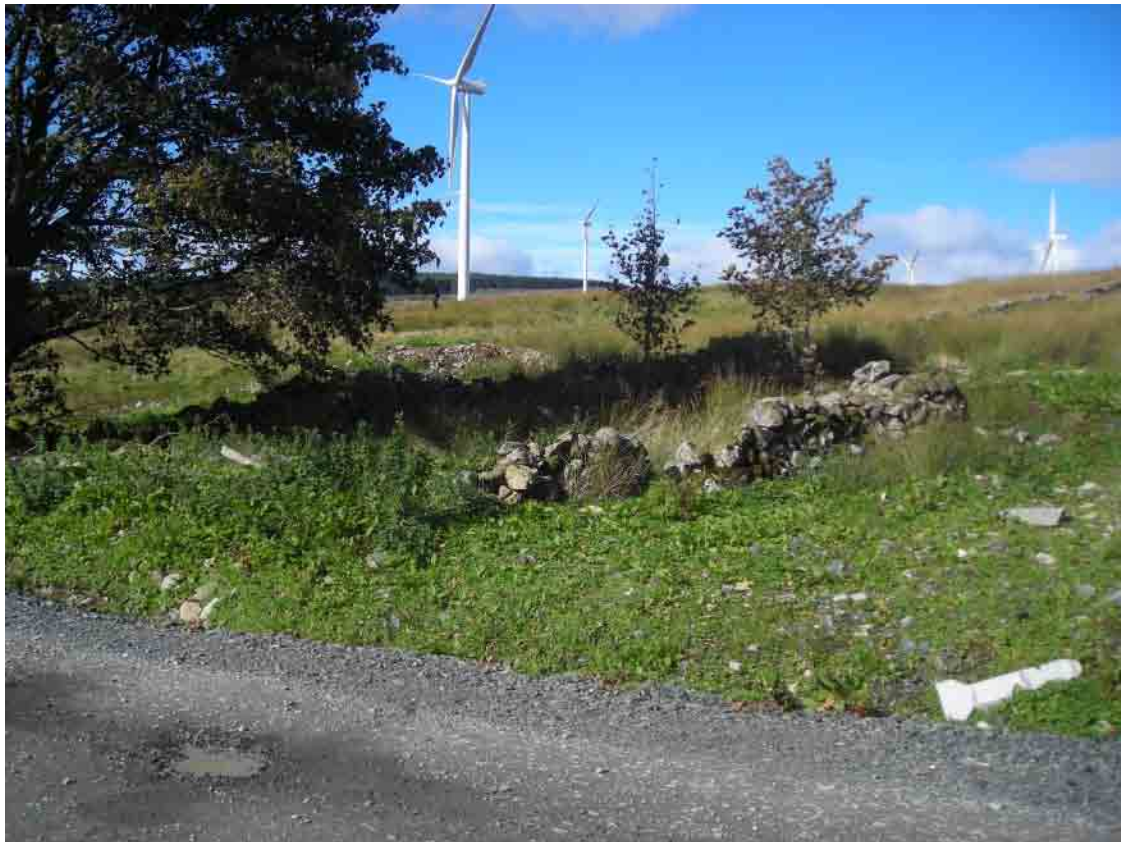
Fig 26 - Shot of Site 83 west during demarcation works

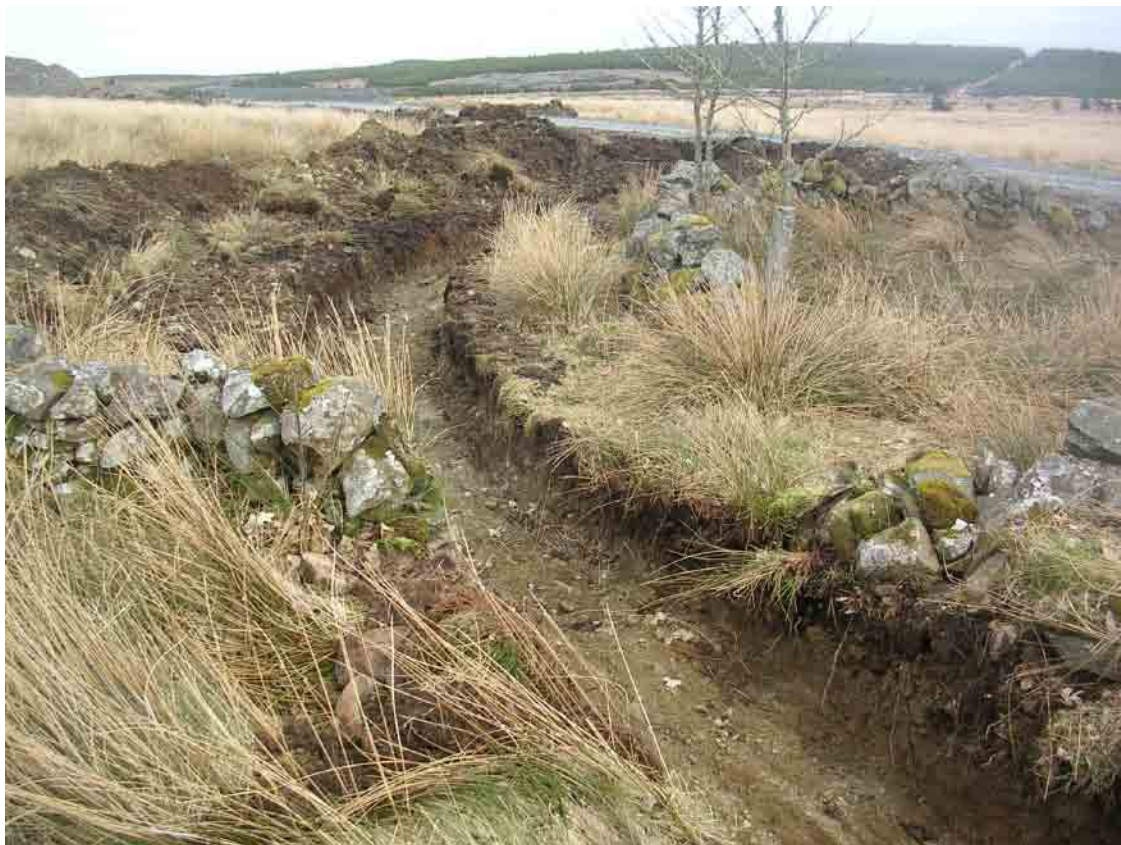
Programmed road widening in this area was highlighted as a construction activity that would affect the small enclosures but would avoid the structural remains of the farmstead to the east in their entirety. A programme of mitigation was agreed in advance with WoSAS which required an archaeological watching brief during these works (Fig. 27).

Fig 27 - Shot of Site 83 during watching brief on cable trenching

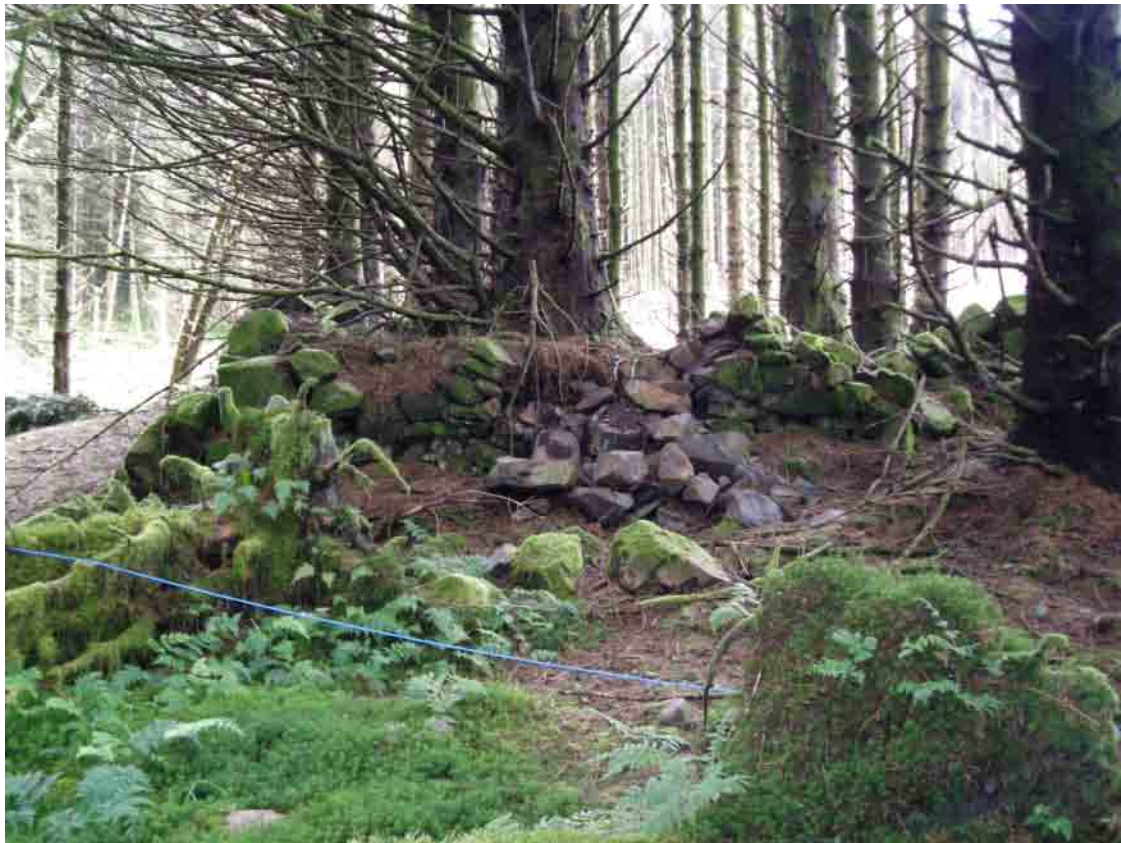
The previously unidentified remains of an enclosure, sheepfold and an upstanding rectangular structure with two denuded wings at each end were discovered by the Main Contractor. The site was located within an area of felling. The remains were demarcated by CFA and recorded in accordance with the WSI (Fig. 28, 30). Initially, the location of T40 and the route of the access tracks to T37, T29 and T40 were

Fig 28 - Shot of Site CFA 11 during demarcation works after on site consultations

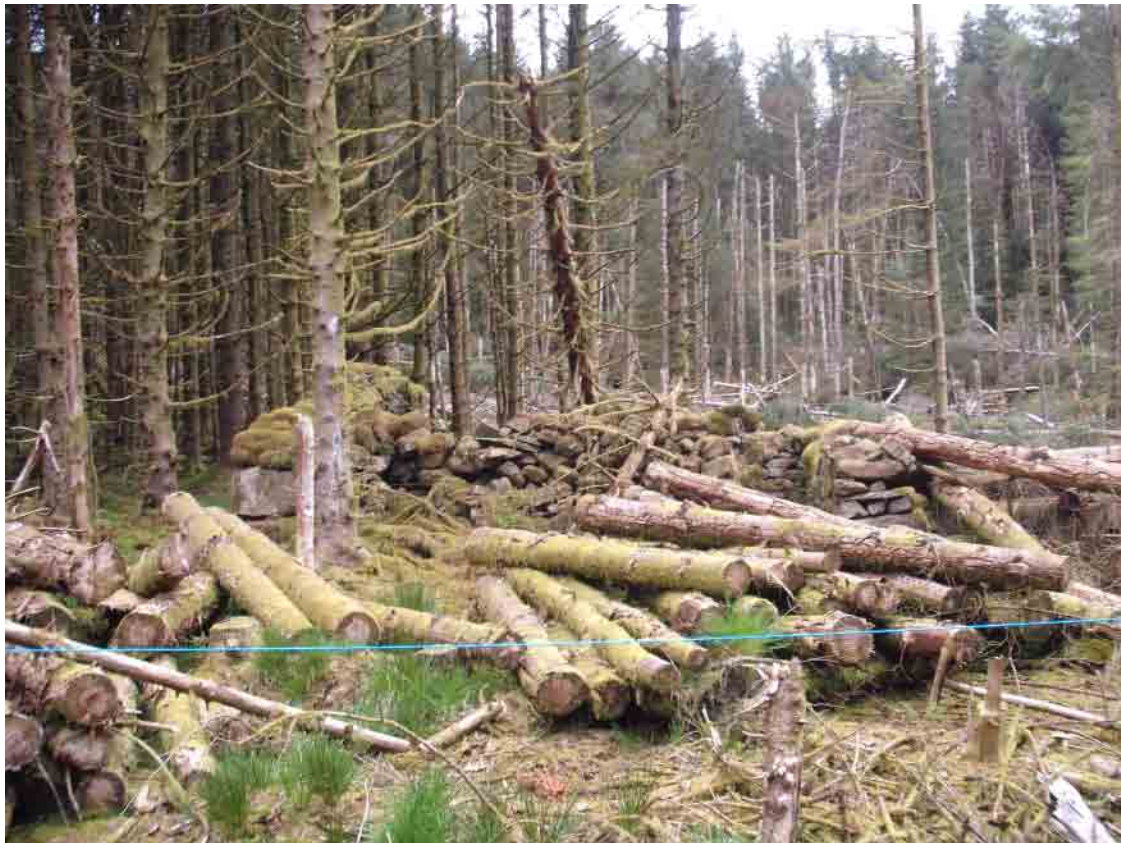
Fig 30 - Shot of Site CFA 12 during demarcation works after on site consultations

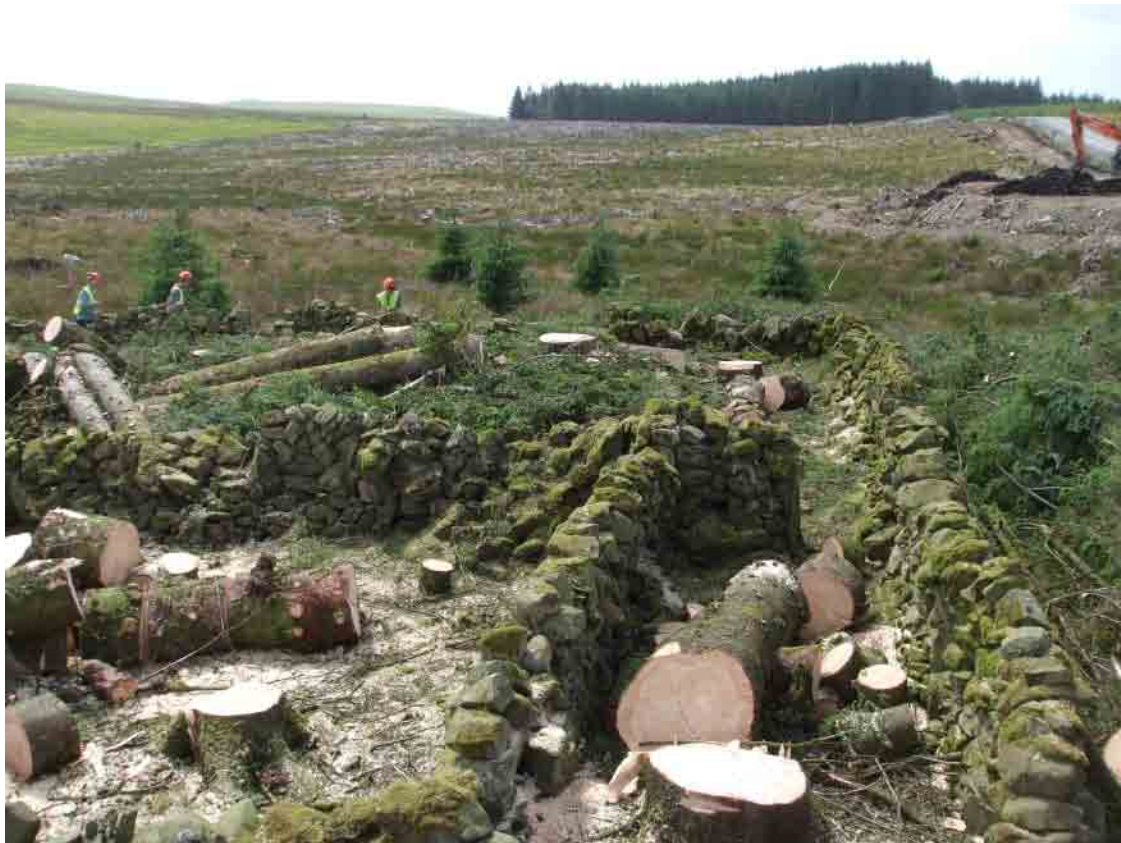
The well preserved remains of a sheepfold were fenced off due to the close proximity of T2 and the proposed improvement of an access track which passed to the north of this location (Fig. 21). Field survey noted the area around the site, which fell within the clearance circumference of T2, had already been felled by commercial forestry activity. A number of windblown trees had fallen into the interior of the site and these were removed in a controlled manner under archaeological supervision (Fig. 32). The post-construction site visit confirmed that no damage had occurred to the remains (Fig. 22).

Fig 32 - Shot of tree felling operation within Site 81 under watching brief conditions

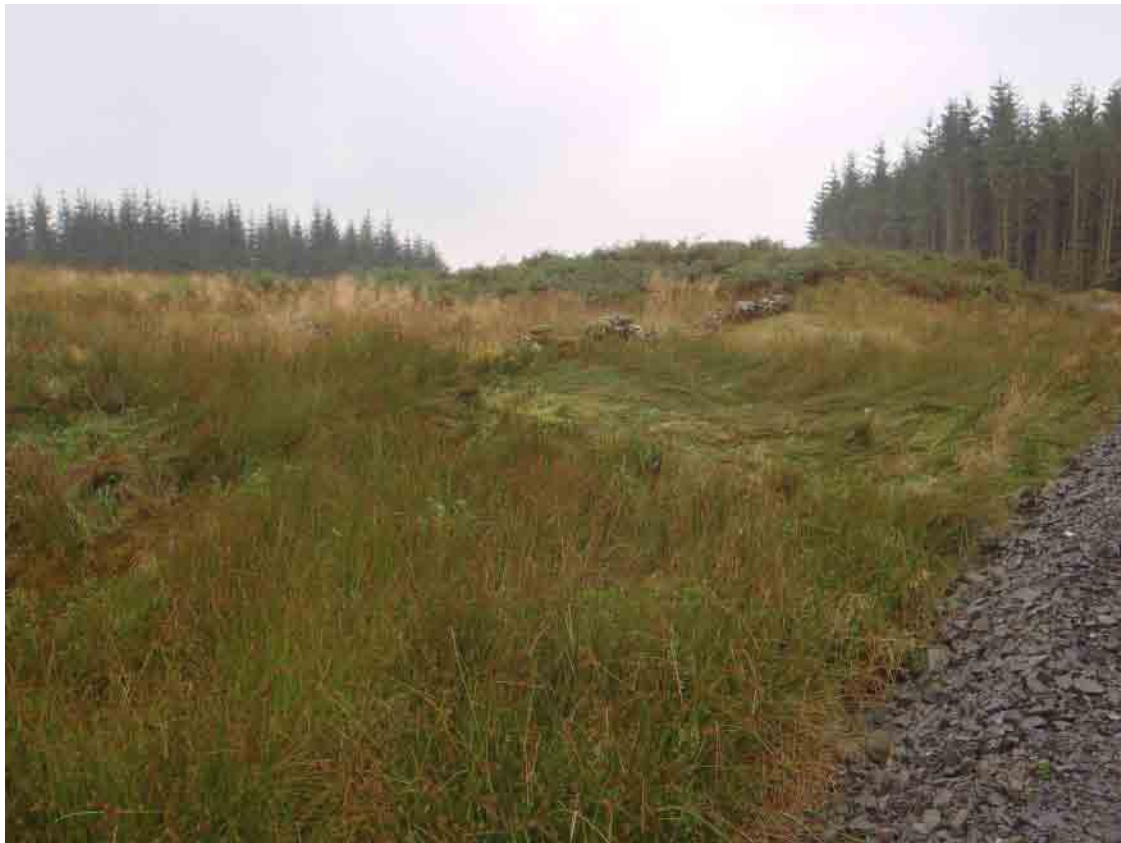
Fig 36 - Shot of Site CFA 1 enclosure after wind farm construction

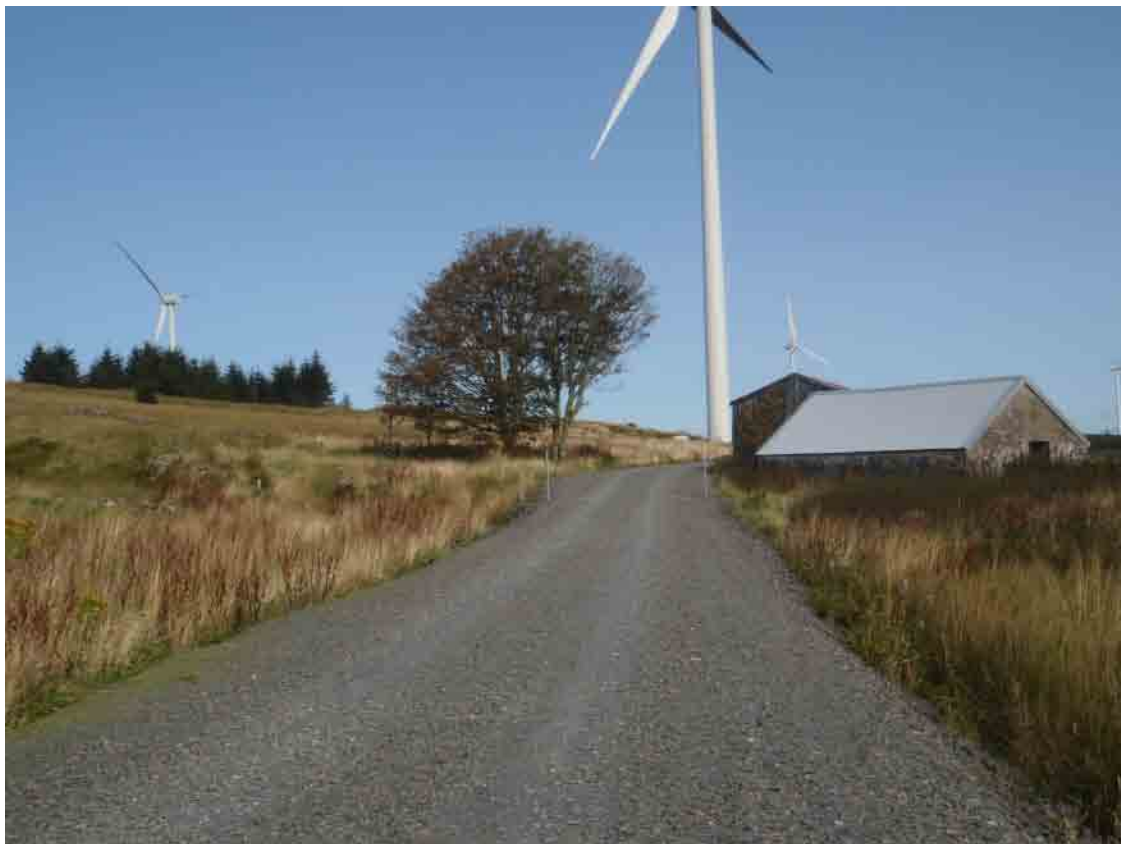
Two short sections of drystone wall were removed and recorded during the watching brief: no other features, deposits or artefacts were identified. The post-construction site visit confirmed that no impact, other than that described above, had occurred to the site (Fig. 37).

Fig 37 - Shot of Site 83 after wind farm construction

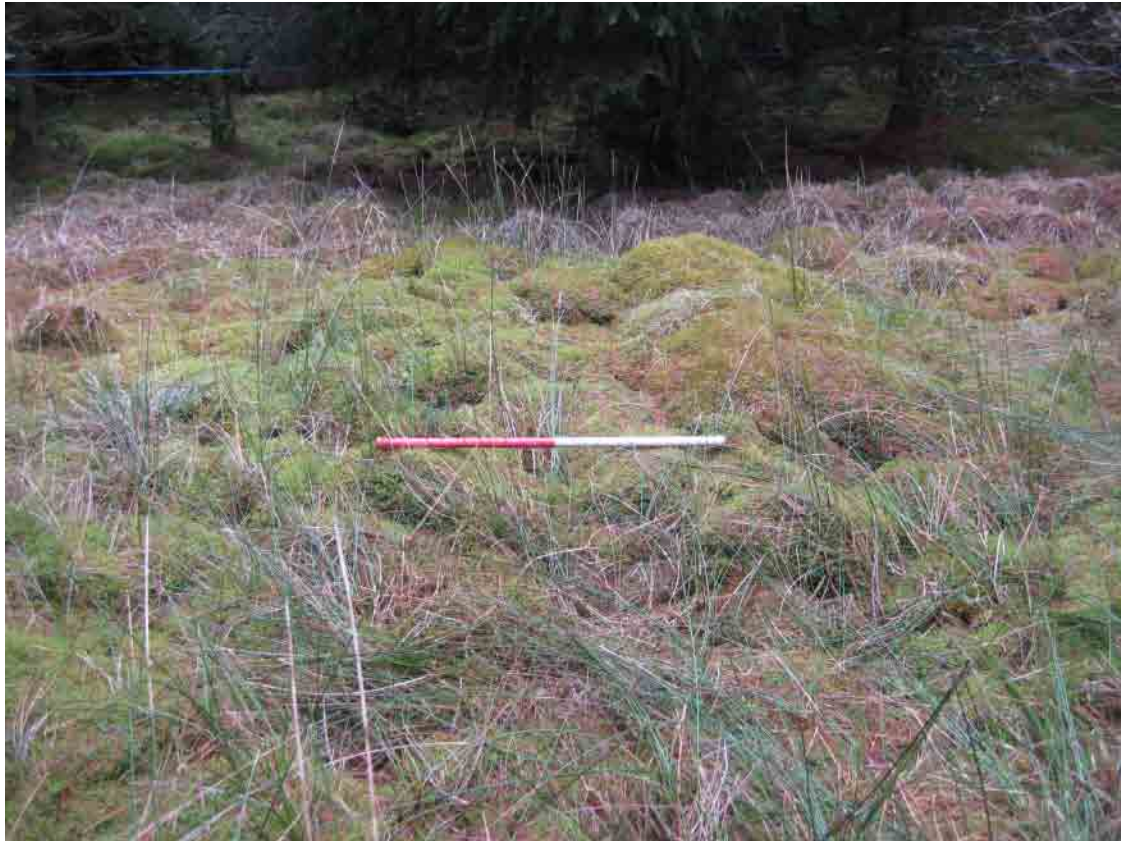
The location of a known cairnfield was cordoned off as a precaution against construction activity (Fig. 42). The site lay within the clearing of a conifer plantation, although the location was not affected by the wind farm construction. The post-construction site visit confirmed wind farm construction had not impacted on the remains.

Fig 42 - Shot of Site CFA 7 after demarcation works

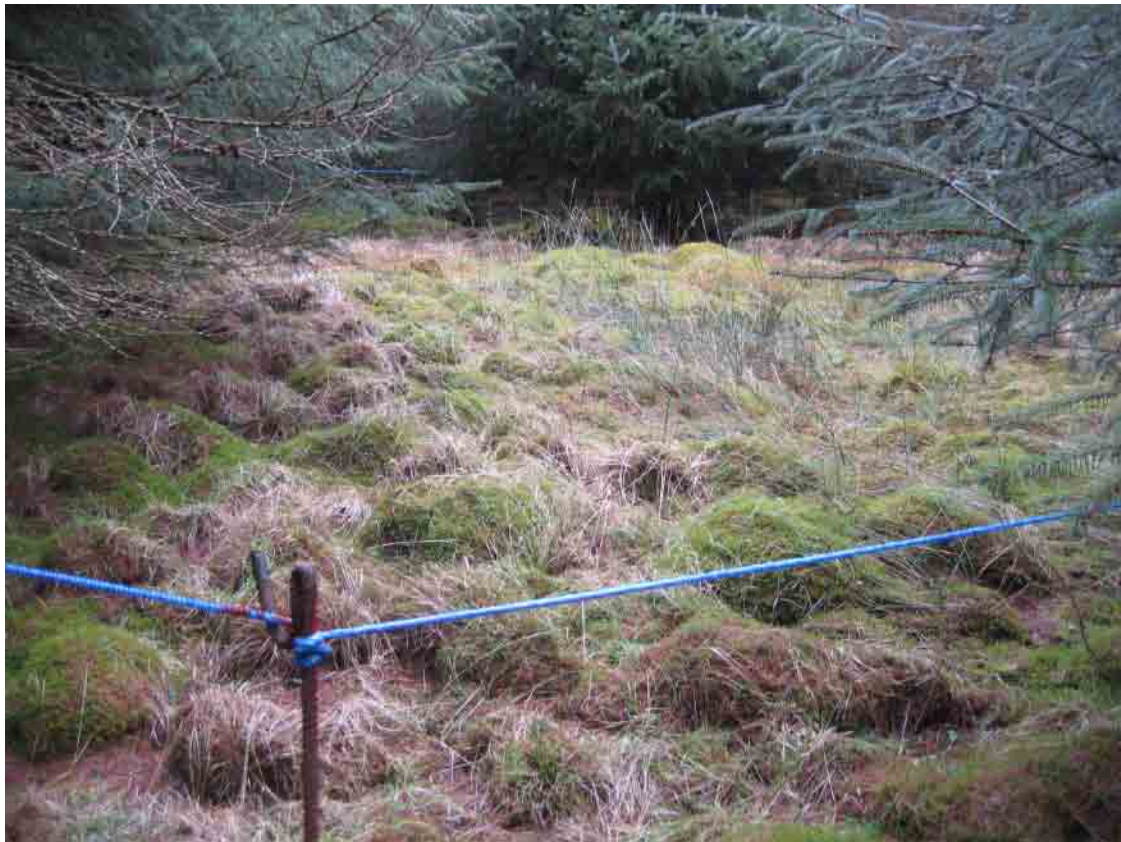
The site, which was cordoned off as a precaution, was purported to be the location of a hut circle within a small clearing in dense conifer plantation (Fig. 43). It was not affected by wind farm deforestation. The post-construction site visit confirmed wind farm construction had not impacted on the remains.

Fig 43 - Shot of Site CFA 8 after demarcation works

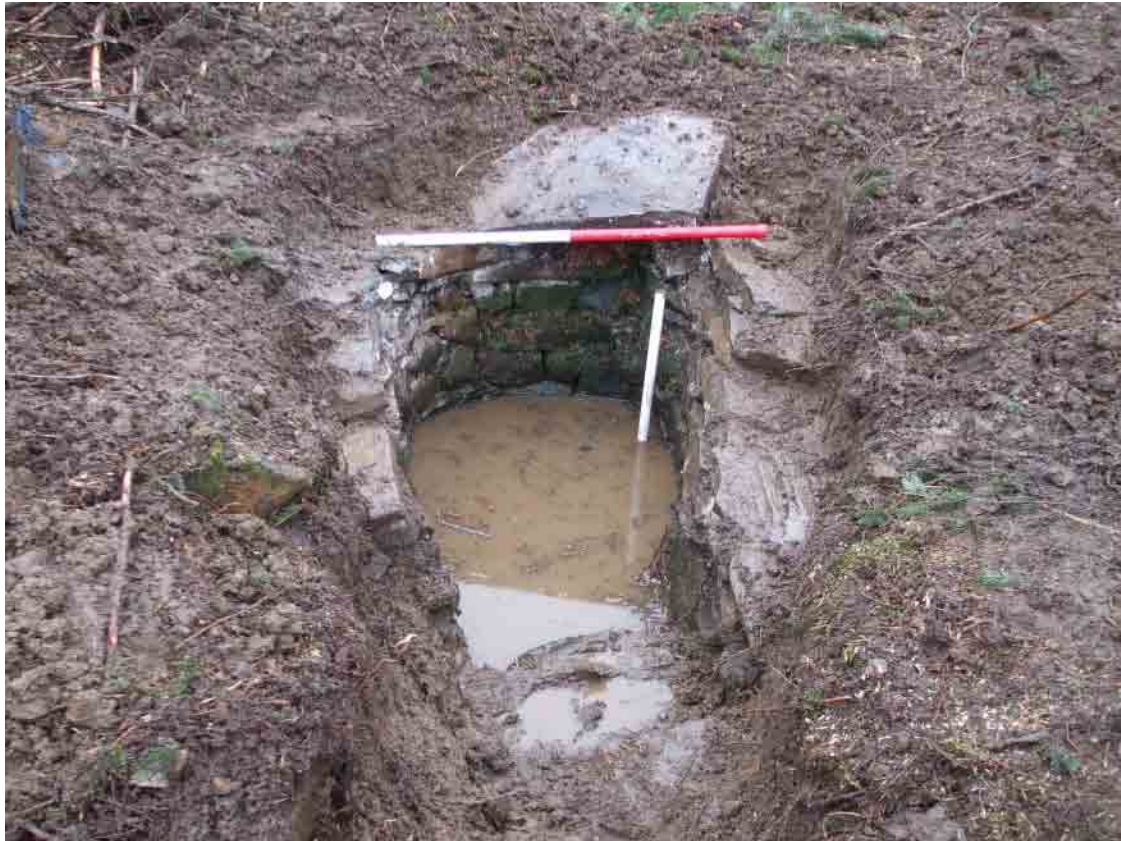
The remains of a well (Site CFA10) were identified within Borrow Pit 1 (Fig 44). Due to the location of the site, a programme of mitigation to preserve the structure by record was proposed and approved by WoSAS prior to its removal by the Main Contractor. This information comprised a written description, a detailed plan and profile as well as a thorough photographic record of the remains.

Fig 44 - Shot of mitigation recording of well Site CFA 10

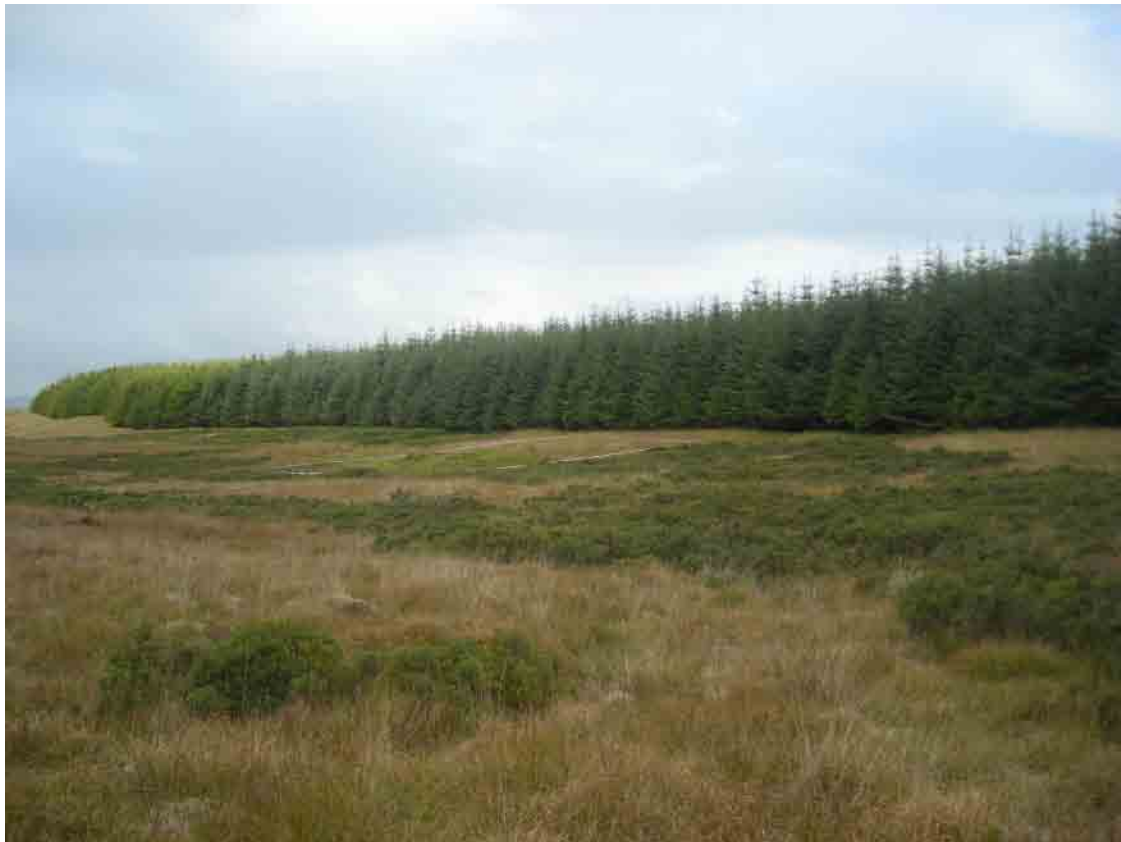
Additional field survey was carried out on the route of the 11kV Overhead Grid Connection Line. The field survey located two features which were demarcated in accordance with the WSI. The first site (Site CFA13) was two possible cairns located on a raised knoll adjacent to boggy ground (Fig. 45). The second site (Site CFA14) was a 25m long section of drystone wall (Fig. 46).

Fig 45 - Shot of Site CFA 13 after demarcation during walkover survey

The location of Site CFA13 was directly on the route of the proposed pylon locations. As a consequence CFA liaised with the Main Contractor and the pylon line was micro-sited away from the potential site and a watching brief was conducted on all groundbreaking works within the area. There were no archaeological remains discovered during the watching brief and the post-construction site visit confirmed that Sites CFA13 and CFA14 had not been affected by the construction work (Fig. 47).

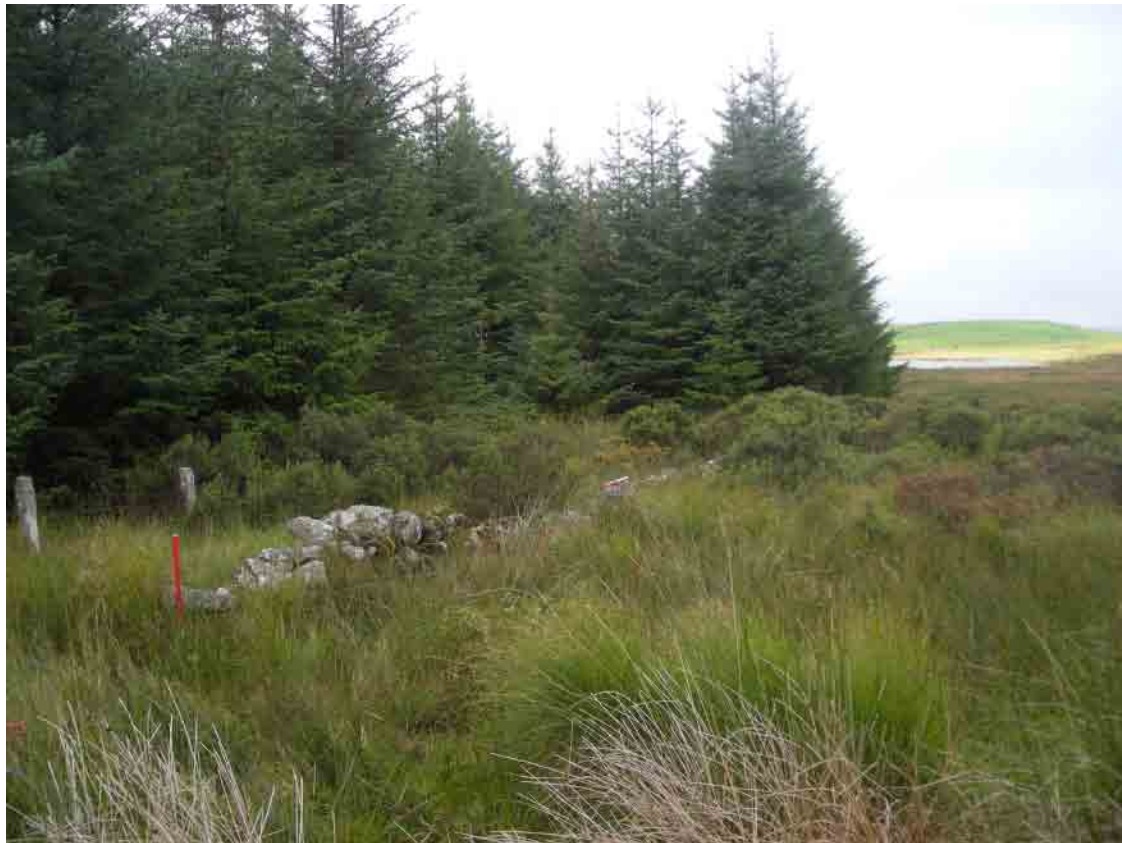
Fig 46 - Shot of Site CFA 14 after demarcation during walkover survey

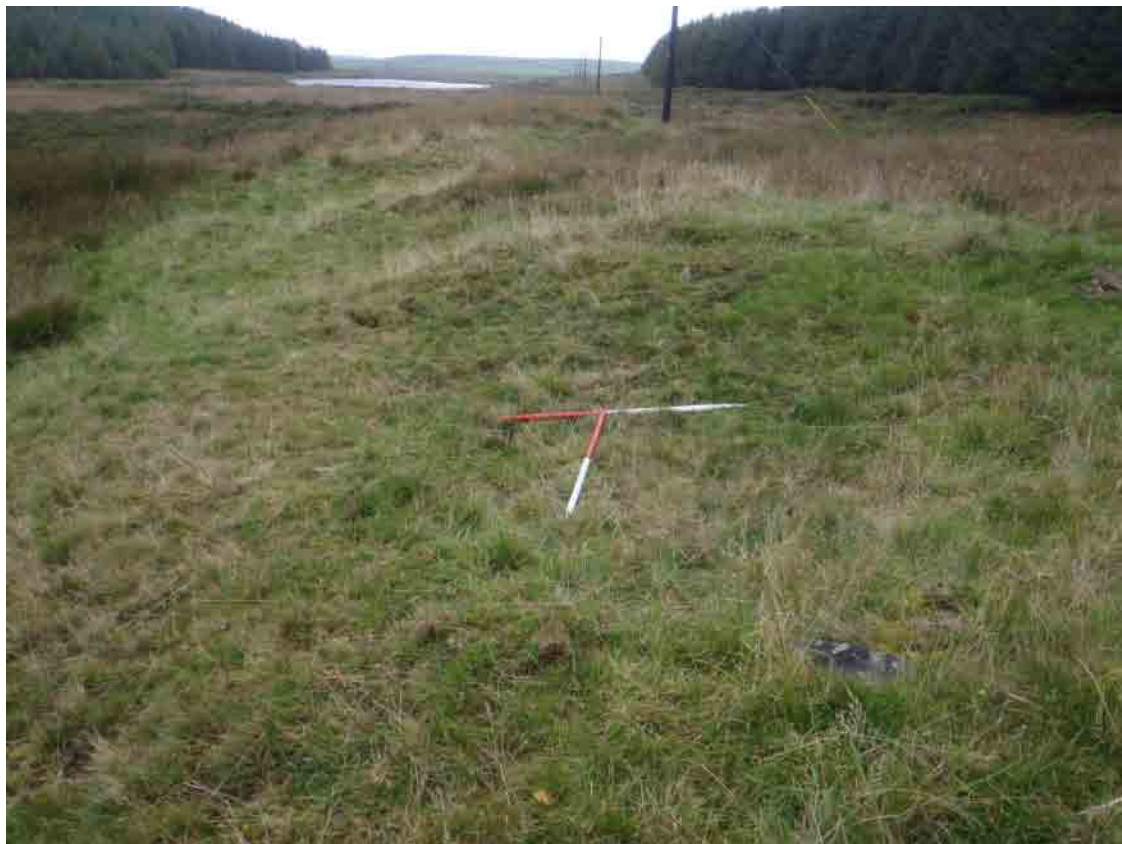
Fig 47 - Shot of Site CFA 13 after wind farm construction with overhead connection line in background
