The Mill Weir Bridge & General Tam's Smokehouse House of the Binns, West Lothian

Standing Building Recording Survey

Report No. 2133

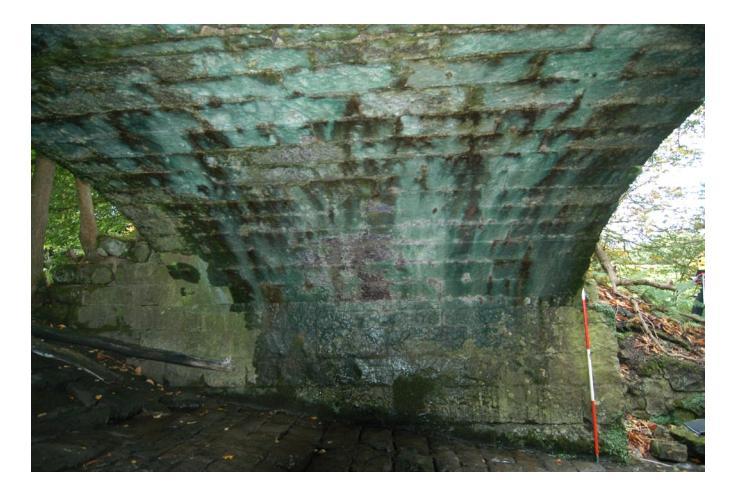
Plate 6: North abutment, south-facing ashlar stonework below the bridge and soffit stonework above

The north abutment (E1) comprises individual blocks of stugged sandstone measuring 0.5m long and 0.4m deep. Much larger blocks have been used to construct the abutment underneath the bridge deck (Plate 6). In order to revet the outside edge of the abutment, courses of sandstone were used to strengthen it but these have been displaced exposing the stonework in section (E2). The north spandrel (E3, Plate 4) above the abutment has been constructed using coursed blocks of sandstone bonded with lime mortar. Gaps have been formed between the blocks where the lime mortar has eroded. Two large voids have been formed where smaller stone fillets have fallen out. The segmented arch (E4, Plate 5) is in good condition comprising twenty-five blocks of fairly uniform size. The voussoirs making up the arch have been stugged. The south spandrel (E5, Plate 1) comprises coursed blocks of rubble and is in a poor condition having been impacted upon by a large fallen tree which has resulted in the displacement of several large blocks of stone at the immediate south end.

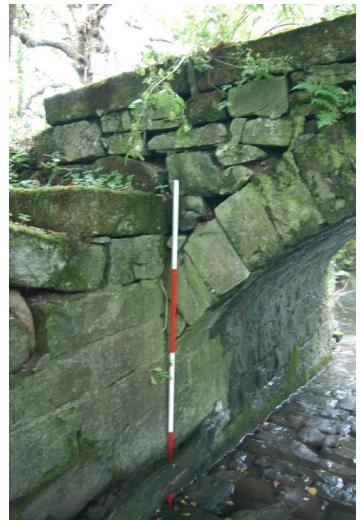
Plate 11: West-facing elevation, north side, spandrel fabric detail

The north abutment (W1) comprises seven courses of individual blocks of stugged sandstone measuring 0.6m x 0.4m x 0.4m (Plate 12). The top two courses are heavily impacted by a tree root. One block of stone is tilting upwards by the pressure of the root. The north spandrel (W2, Plate 11) comprises coursed rubble which has large gaps where the mortar has degraded. The exact number of segmented arch vouisors is

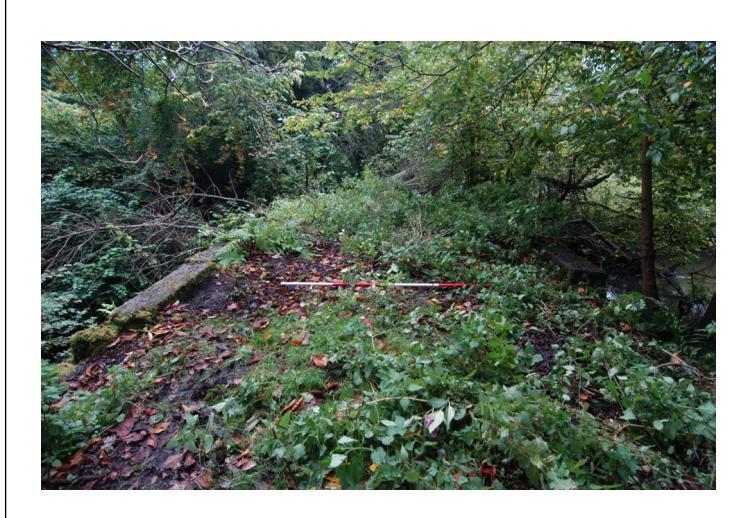
The deck of the bridge (Plate 13) measures approximately 13m long by 3.7m wide and is flanked by the coping stones that form a kerb on either side. The deck is covered with a dark friable loam. The track leading to the bridge is very overgrown. The track is flanked by a steep bank on its east side which is about 2m wide. On the west side the banks are much shallower and about 1m deep.

Plate 13: General view of the bridge deck looking south

It is recommended that further survey work should be undertaken once the dense vegetation masking the bridge has been cleared. This will allow recording of the missing elements that could not be recorded during the recent survey. This would include both sides of the box culvert and both spandrels at the south end of the bridge.

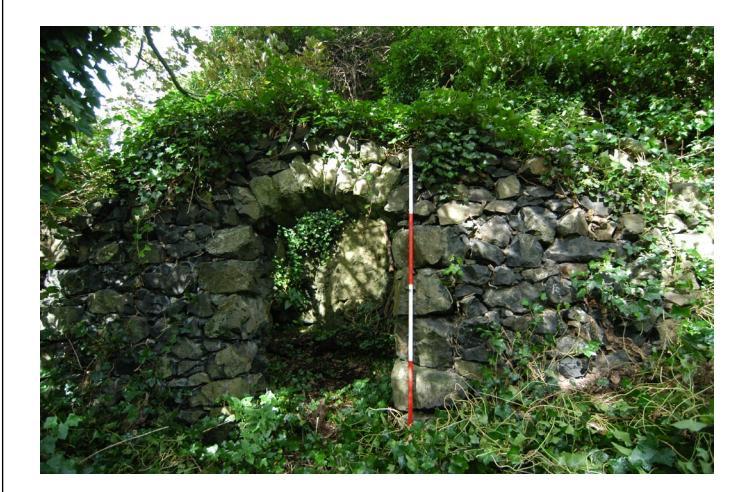
The south-facing elevation (S1, Plate 17) comprises a main build of sub-angular blocks of basalt (whinstone). The elevation measures 5.9m long and stands to a height of 1.4m at its east end and 1.5m at its west end. The wall (Plates 19-20) is essentially a double skin wall faced with basalt with a rubble core. The quoins (S2) framing the door opening comprise large sub-rounded dressed blocks of basalt (Plates 21-22). On average these measure $0.4m \times 0.3m \times 0.3m$. The segmented arch (S3) above the doorway comprises eight individual blocks of buff-coloured 'rattlebag' which is a very friable agglomerate and easily weathered. The top of the wall (S4) is very irregular and loose owing to the penetration of ivy roots.

Plate 17: General Tam's Smokehouse south-facing elevation

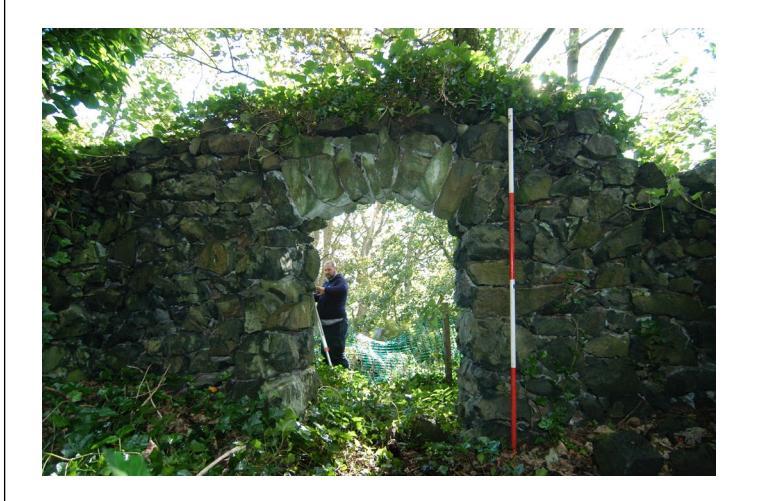
Plate 23: Interior north-facing elevation

The interior north-facing elevation (N1, Plate 23, 25-26) is constructed using the same stone as on the outer south-facing elevation. The interior door quoins (N2) are irregular and slightly more angular in character than those on the south-facing elevation. The interior segmented arch (N3, Plate 24) comprises eight 'rattlebag' stones, one of granite and one of sandstone. At the east and west ends of the wall its toe is abutted by infilling stonework (N4 and N5) that has been used to fill the gap formed between the rear wall and the sloping natural outcrop. The infilling stonework on the east side comprises medium sized blocks of angular basalt which almost resembles drystone walling (Plate 27). On the west side the infilling blocks are much larger (Plate 28). Both the infilling wall heads are overgrown with ivy.

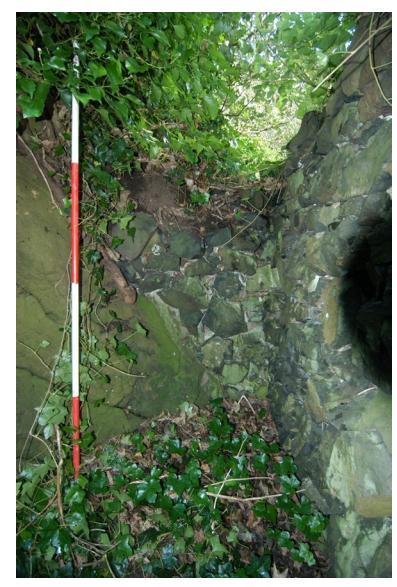
Plate 27: Infilling wall between the main interior elevation and natural rock (east side)

N4	Infill boundary	A V-shaped section of infilling wall between the north-facing elevation and the natural rock outcrop. The wall is c.1.3m high comprising angular fragments of basalt bonded with lime mortar.	<i>Fair</i> . Apart from root impact on top of the wall it is in good condition owing to its sheltered position.
N5	Infill boundary	A wide V-shaped section of infilling wall between the north- facing elevation and the natural rock outcrop. The stones are much larger than those in N4 and are bonded with lime mortar.	<i>Fair</i> . Ivy root penetration is affecting the top of the wall and its joints are deep where the mortar has eroded.

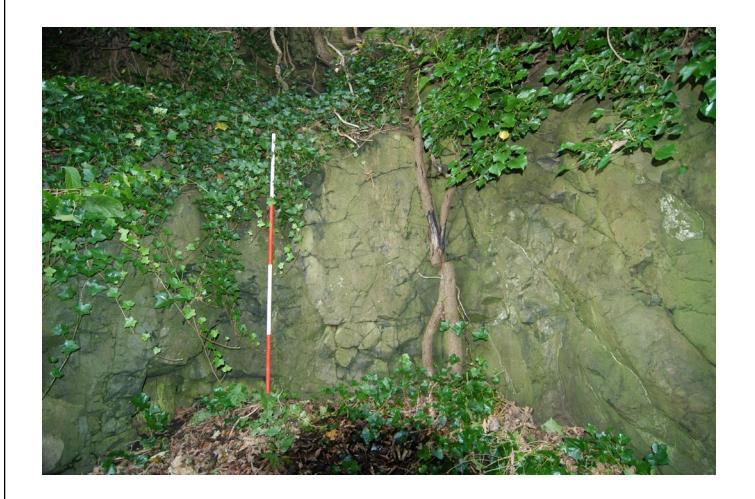
Plate 29: Interior rear natural rock wall

The floor plan is roughly triangular in shape with a slightly straighter base on the natural rock. The rock itself is a basalt outcrop (Plate 29). On the east side of the floor, the natural wall kinks inwards. The gap between the natural rock and the main elevation has been infilled with the aforementioned stonework (N4 and N5).
