## **Abbotsford House, Melrose, Scottish Borders**

### **Architectural recording and archaeological Watching brief**

**Report No. 2135**

## **CFA ARCHAEOLOGY LTD**

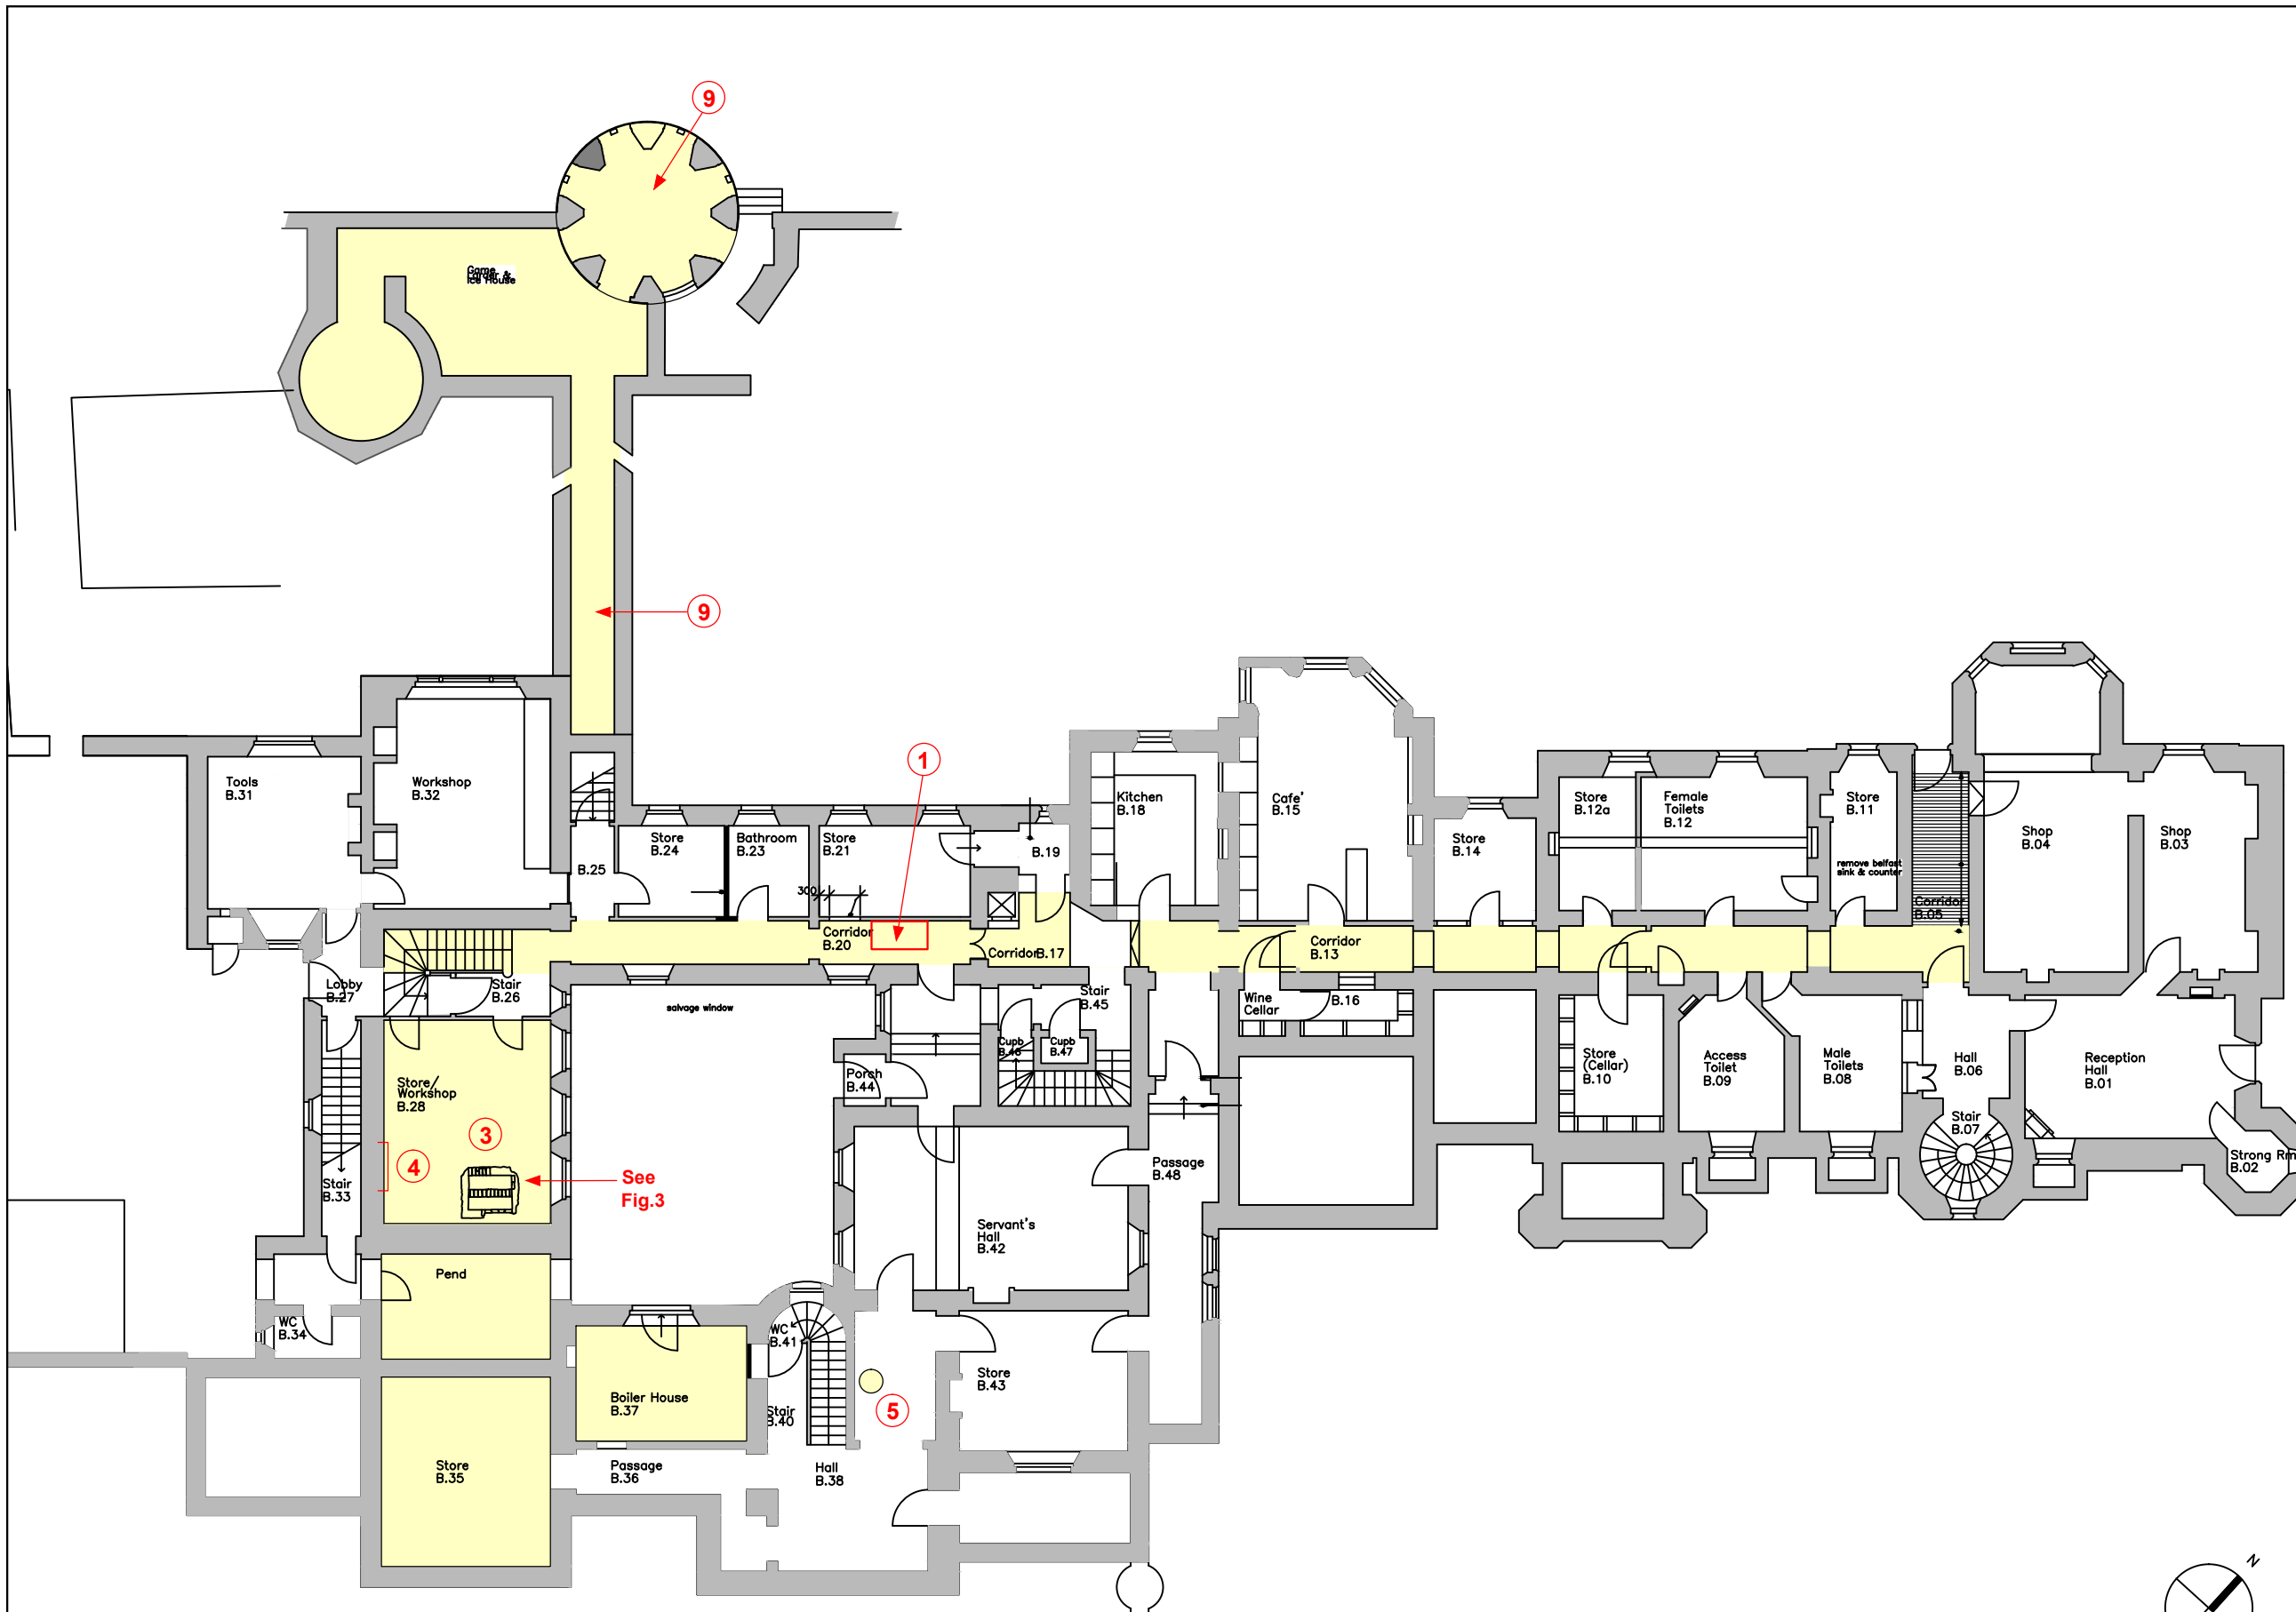
During the removal of the flagstone floor in the Store/Workshop B.28 the remains of the foundations for a domestic boiler were exposed in the south-east corner of the room (Fig 3). The feature comprised two brick-lined fire-boxes aligned east-west divided by a central section of brickwork with a combined measurement of 1.56m in length and 0.42m in width and 0.26m deep. The bricks measured 9 by 4½ inches and were laid in a crude stretcher bond. The interior of the boxes contained soot, cinder and fragments of coal. It is presumed that the foundations rose to about waist height and supported a cast-iron cauldron that would have been heated by coal to provide hot water suggesting that this may have been a washhouse.

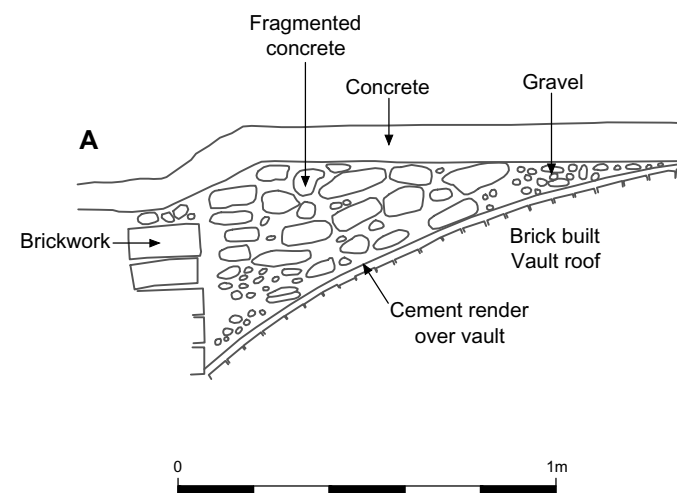
**Fig 4b**  
Section of the Capping material above the game Larder (Section A-B)

*Game Larder roof (Figs 4a & 4b Plates 25-26)*

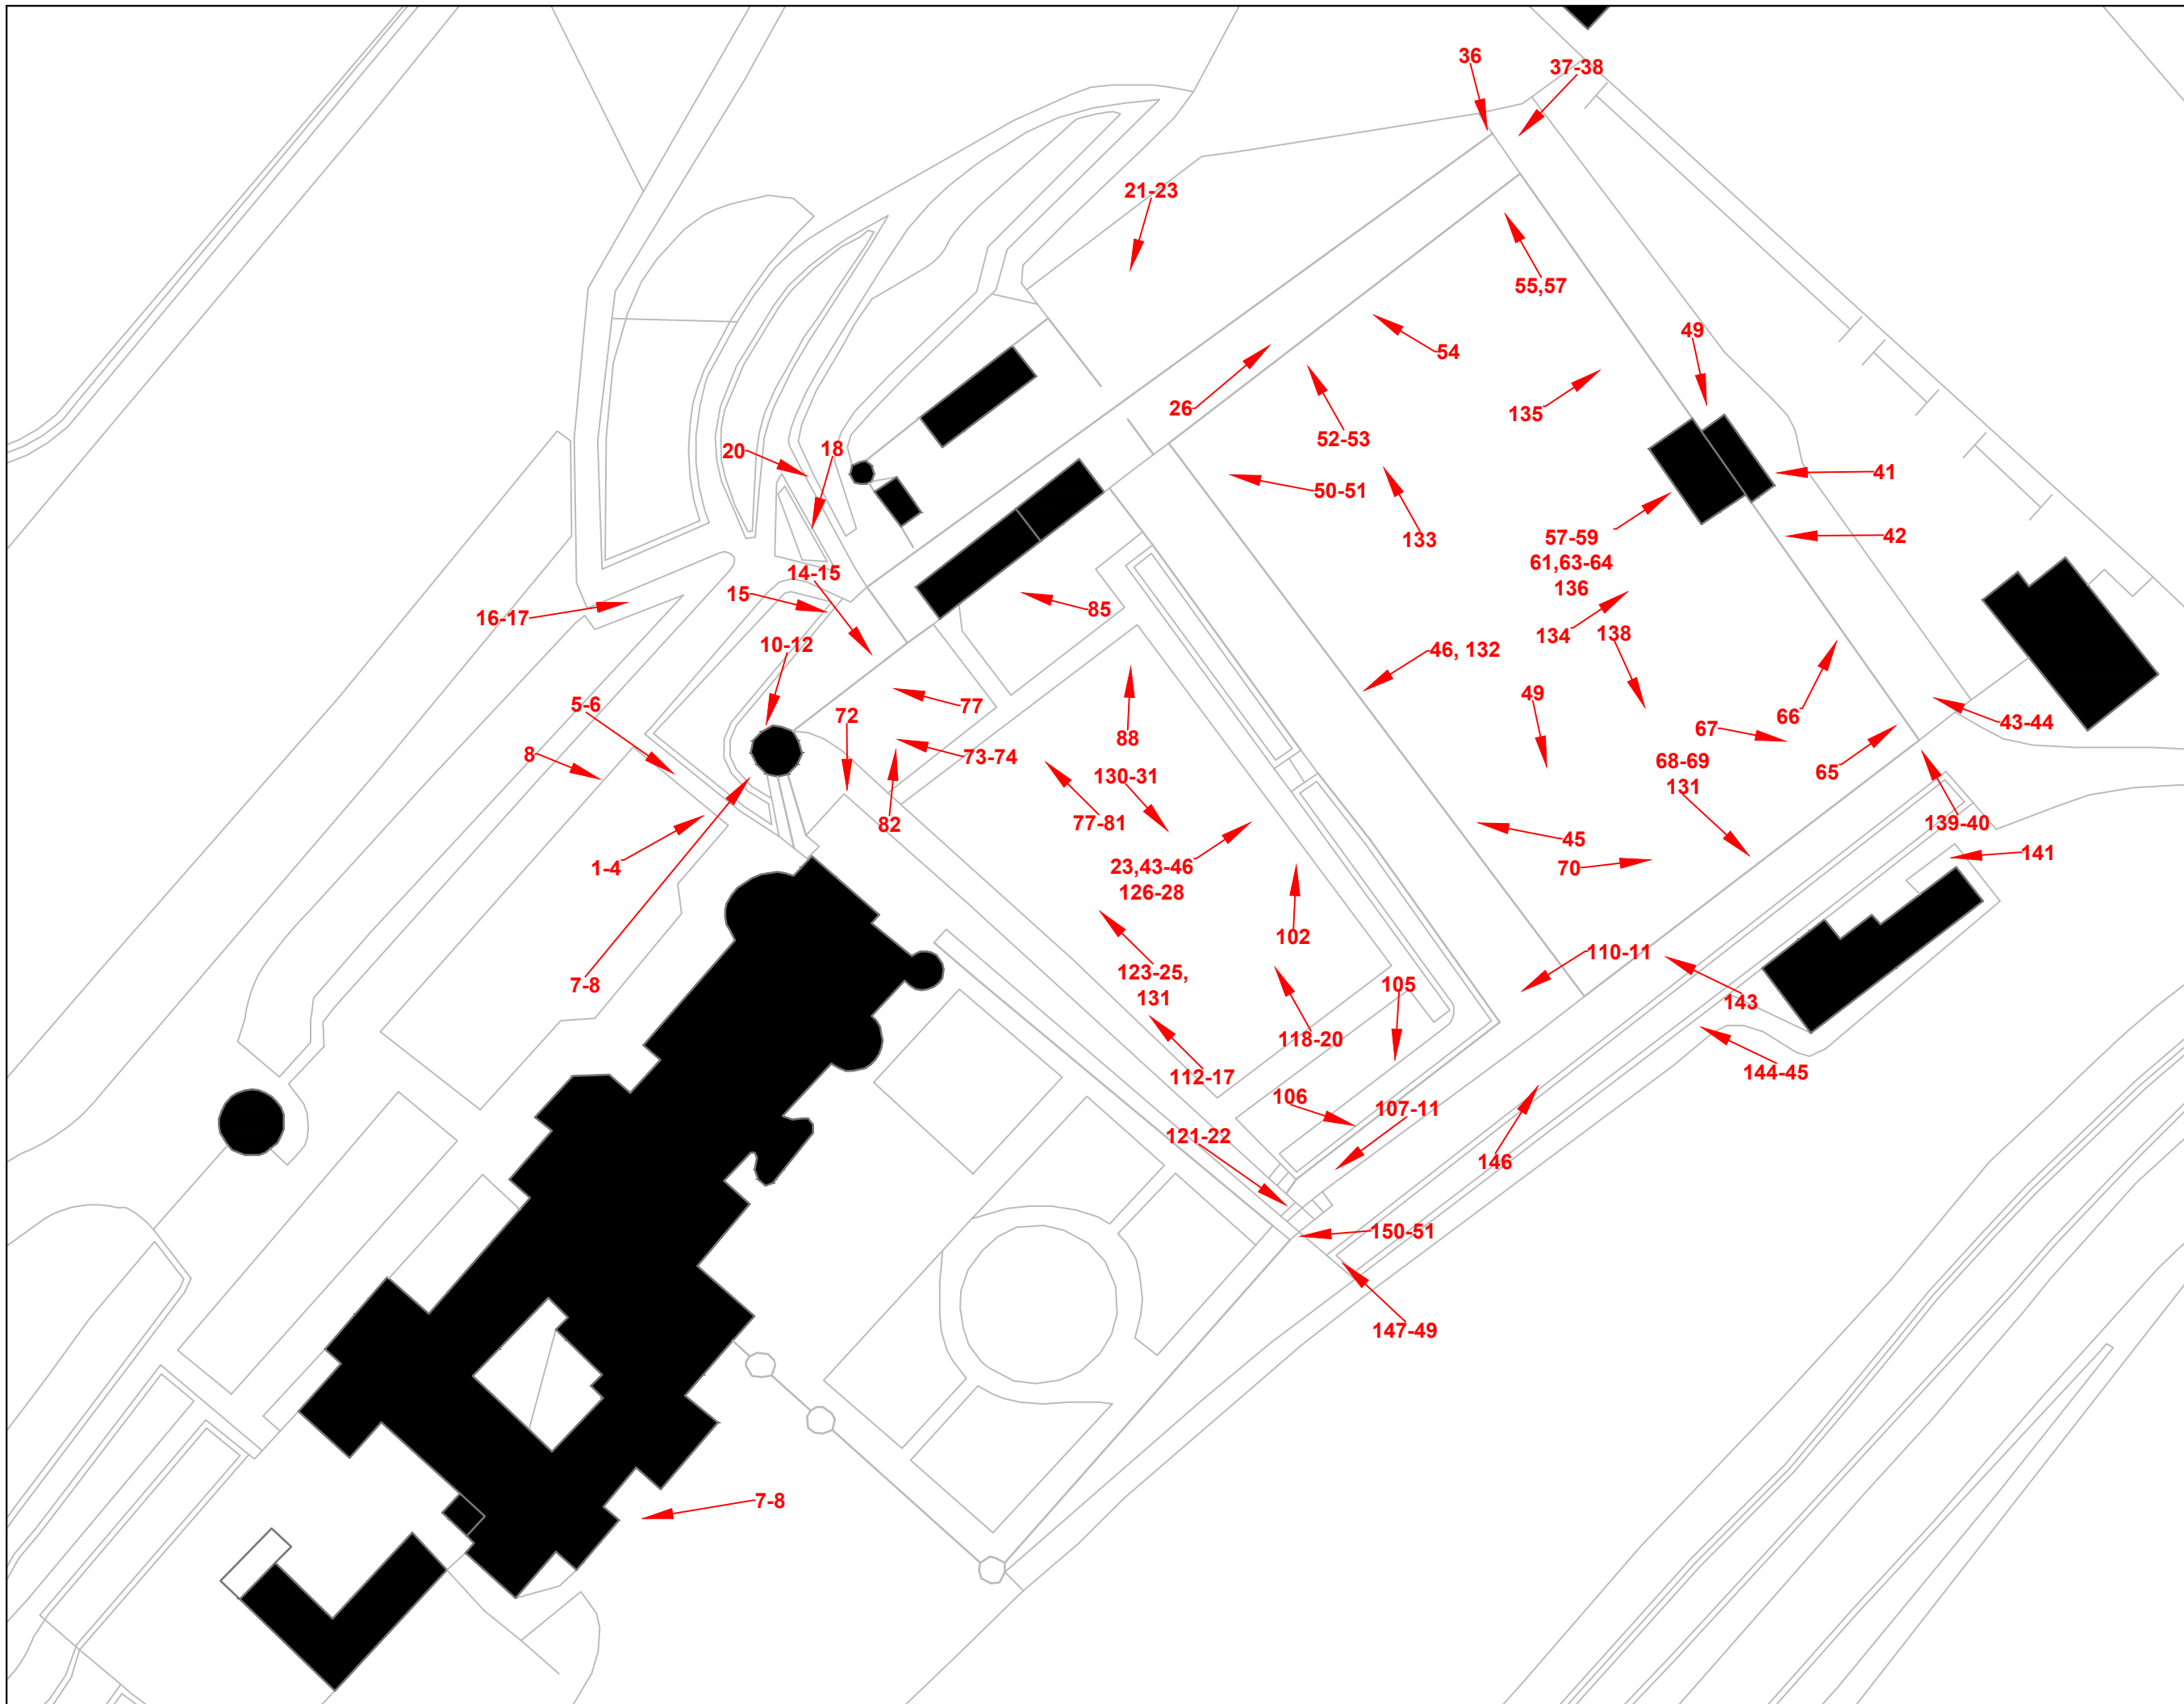
Fig. No:	5	Revision:	A
----------	---	-----------	---

The works on the garden walls focused on the retention of the maximum amount of original material. Prior to the repair work a survey was carried out to provide a photographic record of the walls. Figure 5 shows the orientation of the photographs taken.
