Howden House Level 2 Historic Building Survey Report

Report No. 2038

CFA ARCHAEOLOGY LTD

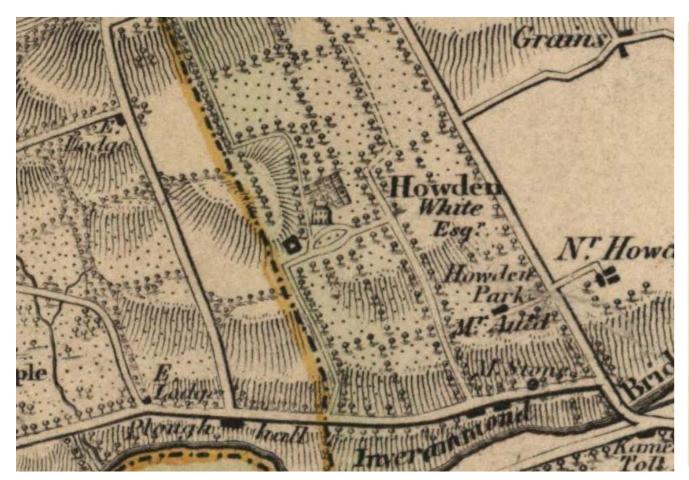
Fig 2a - Forest's 1818 map

William Forests map of 1818 (Fig 2a) shows Howden under the ownership of *White Esq.* The house is depicted as a two storey house with three bays on the north side of a carriage circle and a walled garden to the rear. The east and west wings are not shown.

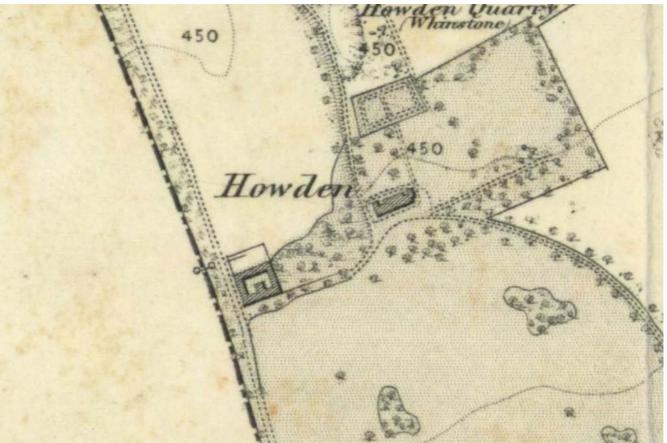
Fig 2b - Ordnance Survey 1st edition 1853

The 1853 First Edition Ordnance Survey map (Fig 2b) shows the footprint of Howden House as a rectangular building with two breaks in alignment on the north side. These relate to the two pavilions that were added to each end of the main core block. On the south side the east pavilion is depicted as having a right-angle return off the main south wall. The Ionic porch is not mapped so had yet to be built.

The single storey L-shaped annex on the east side of the East Wing housed a toilet on the north side and its large open plan suggests it may have been used in service capacity rather than domestic use. The toilet block was inserted into a gap in the rear wall, a feature that is shown on the 1853 Ordnance Survey map (Fig 2b) and later editions.

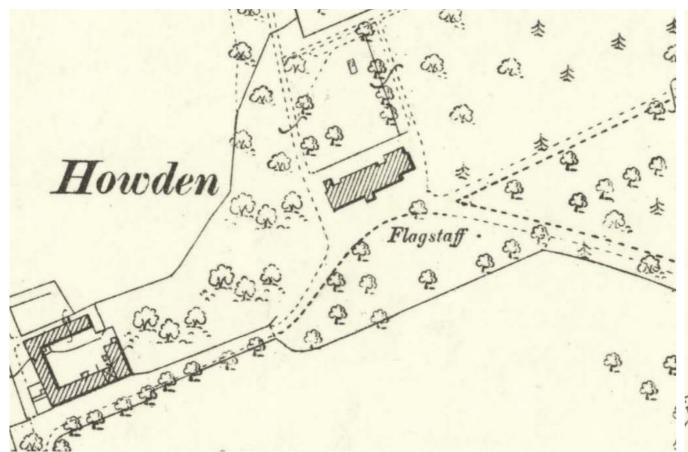
Fig 2c - Ordnance Survey 2nd edition 1893

The 1893 Second Edition Ordnance Survey map (Fig 2c) shows that the west pavilion had been enlarged slightly at the rear. The east pavilion has also been enlarged eastwards.

The map evidence (Figs 2b-c) shows that the grand Doric entrance on the south-facing elevation was constructed between 1853 and 1893.

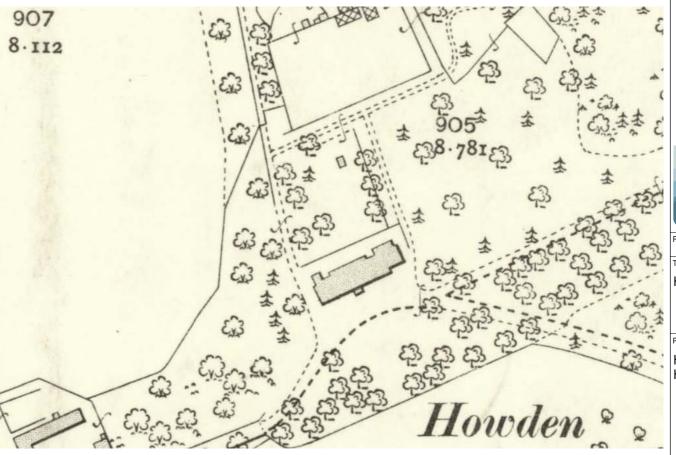
Fig 2d - Ordnance Survey 1907

The 1907 revised Ordnance Survey map (Fig 2d) shows the same detail as is depicted on the 1893 second edition map.
