Bridgehouse Mill, West Linton Scottish Borders

Standing Building Survey & Watching Brief

Report No. 3156

Author	Michael Cressey BA MSc PhD MifA FSA Scot
Illustrator	Kevin Hicks BA (Hons) FSA Scot
Editor	Bruce Glendinning BSc PgDip MifA
Commissioned by	Bergmark Architects Ltd on behalf of Mr and Mrs Wood
Date issued	July 2014
Version	0
Planning Ref	12/01527/FUL
Grid Reference	NT 1435 5240
Oasis Ref No.	cfaarcha1-178387

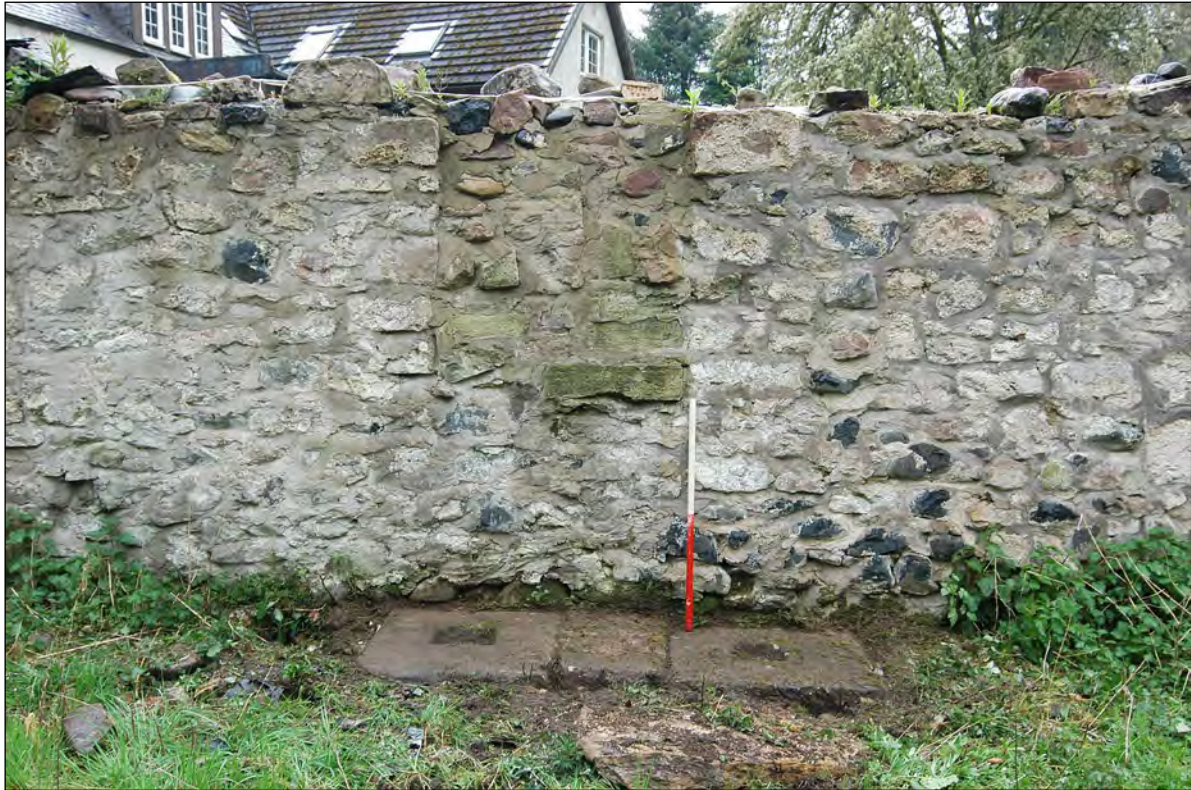
opening for a wheel shaft associated with a small cast-iron wheel. The presence of a waterwheel is supported by the presence of two Hurst frame plinths (see Fig 3, Plates 9, 13-14) that were in situ at the base of the wall and more or less in line with the blocked opening. Each plinth comprised hewn sandstone blocks measuring 0.75m by 0.70m and 0.85m by 0.75m respectively. At the centre of each was a square socket (0.2m x 0.2m) which had been carved to a depth of 0.05m.

Plate 9 – Internal east-facing elevation (mid-section)

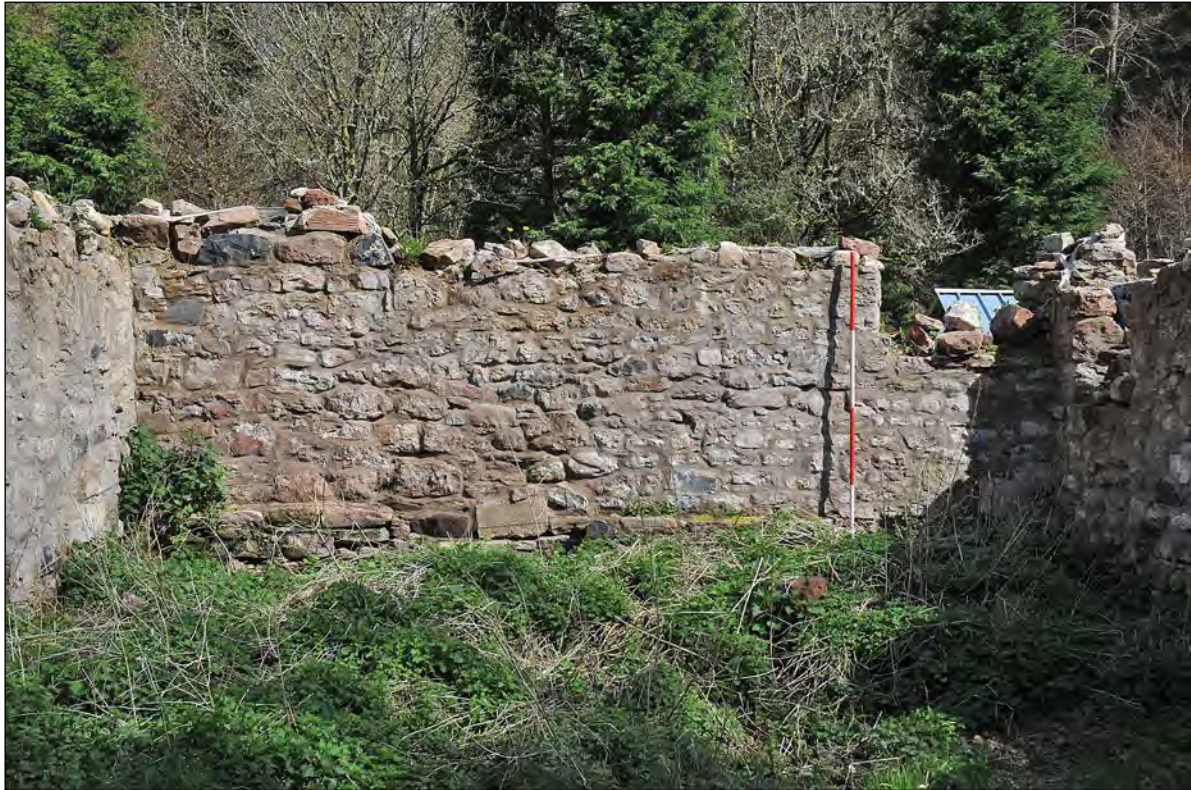
Plate 11 – Internal south-facing elevation

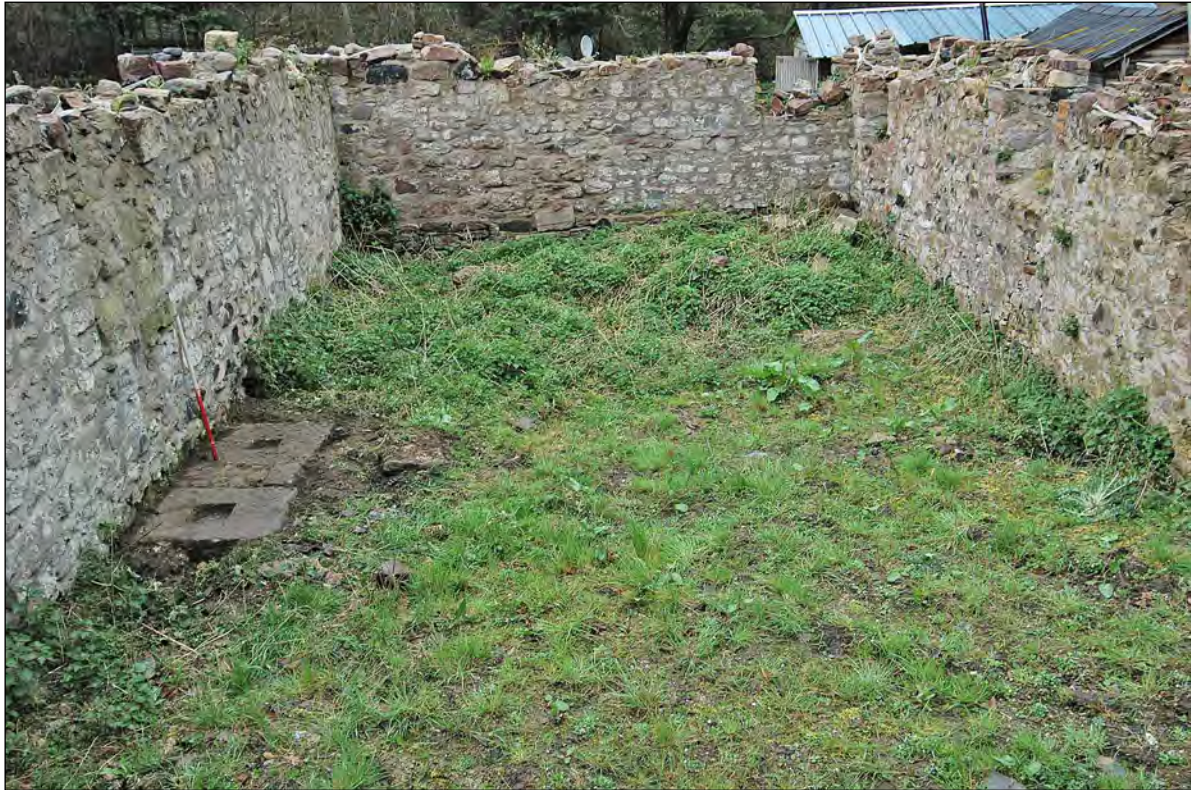
Plate 13 – Hurst plinths in relation to the building layout, looking north
