Pathbrae Maltings Building, Kirkliston Historic Building Survey & Demolition Watching Brief

Report No. 2007

Author	Michael Cressey HND BA MSc PhD MifA FSA Scot
Illustrator	Leeane Whitelaw BSc MifA
Editor	Bruce Glendinning Bsc PgDip MifA
Commissioned by	Turley Associates
Date issued	March 2012
Version	0
OASIS Reference	cfaarcha1-183526
Planning Application No	11/01589/LBC
Grid Ref	NT 12313 74254

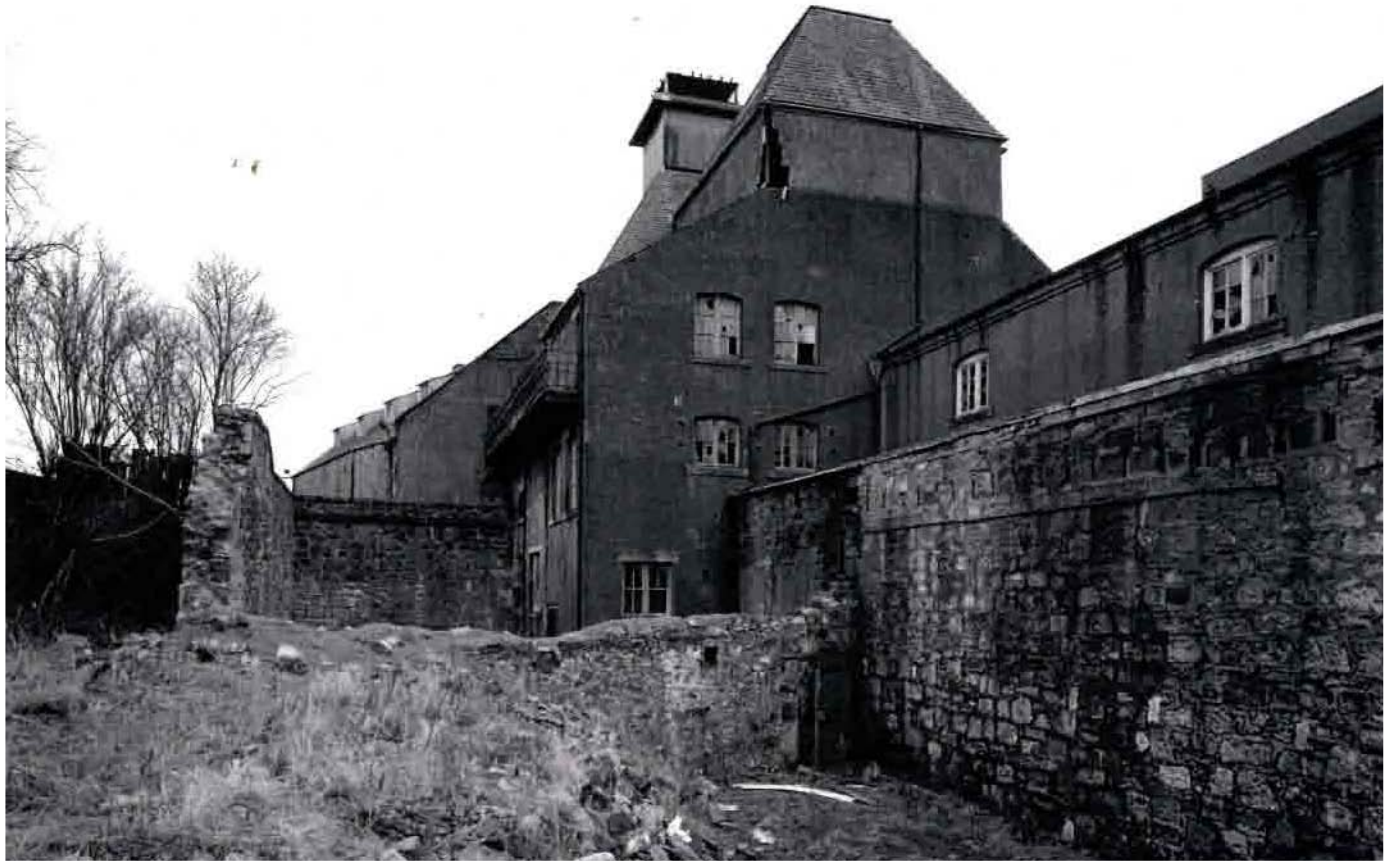
The west-facing elevation was almost entirely enveloped by an adjoining brick-built building that occupied most of the elevation. Figure 3 shows the adjoining building when it was still standing. The roof configuration of this three storey building is evident in the brickwork (**w17**) which has maintained its Mansard shape that stood above the gutter line of the former malting building. Access between this building was via the two steel fire doors (**w16**). The floor level below (**w15**) and a first floor level (**w11**) is extrapolated from the position of the floor joist sockets. The south side of the building had a lean-to roof which relates to Feature (**w12**) and the whitewashed wall below ran the full length of the interior ground floor. Access into the ground floor level kiln floor was via doorway **w6**.

Fig. 3 - View from the southwest along south side of floor maltings attached to the west elevation of the double kiln maltings building (Source: RCAHMS, 2001, photo no. E021167)

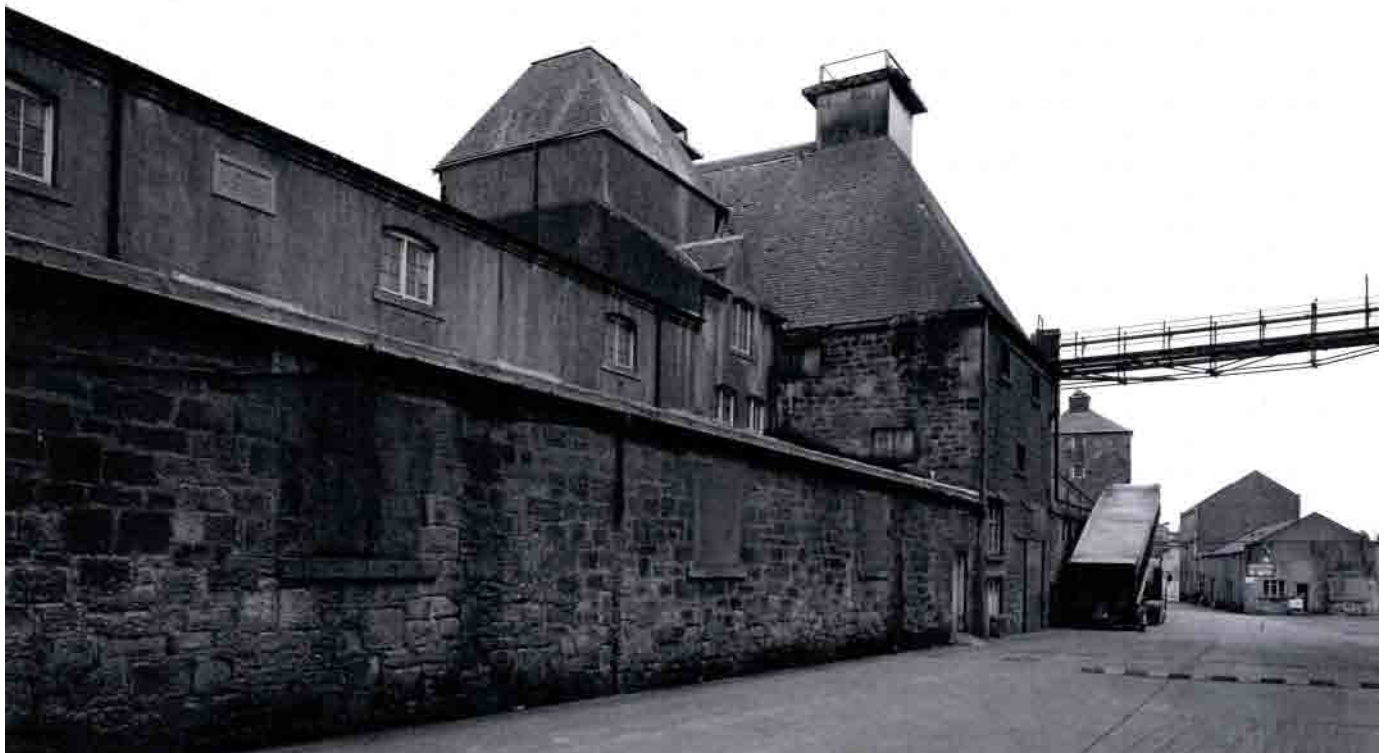
Fig. 4 - View from the northwest side of the floor malting and double kiln malting building (Source: RCAHMS, 2001, photo no. E021160)

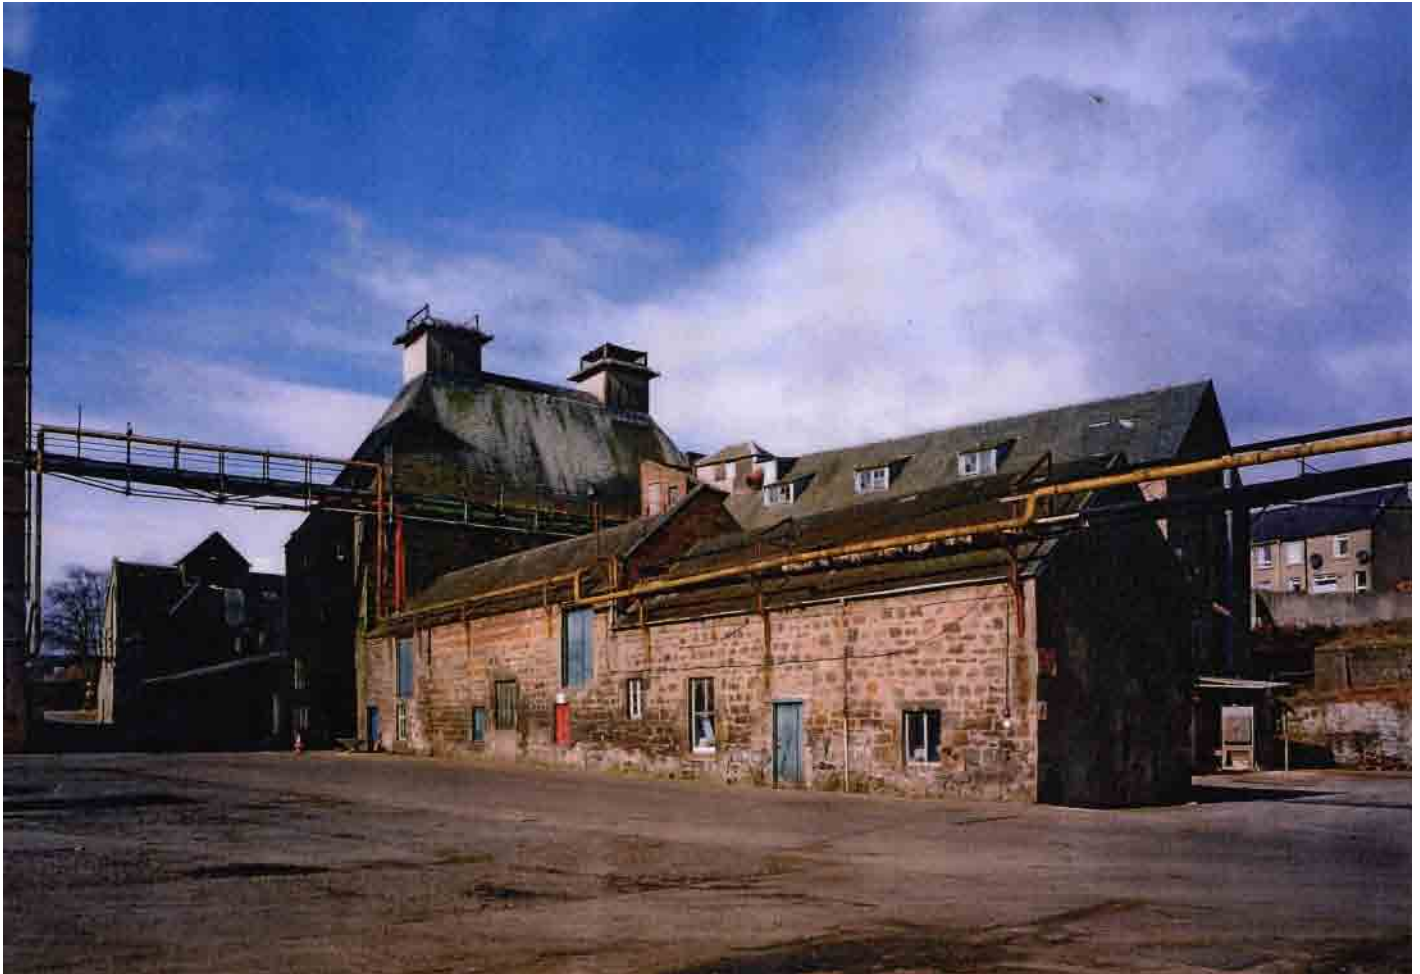
The east-facing elevation displays evidence for the presence of three attached structures that have left evidence of their presence in the form of former roof lines, floor-joist sockets and return wall stubs. Features (**e2-e4**) relate to an adjoining single storey lofted building with a pitched roof (Fig 5). This building was on the same alignment as the south-facing elevation and was approximately c.35m long, trending east to west and fronting a concrete yard. Features (**e6-e7**) relate to a series of pitched roof buildings that ran behind the building just described. Features **E8**, a return wall scar and the render finish (**e12**) mark the position of a stone-built malting building that was three-and-a-half stories high with a pitched roof. The building had a brick-built structure with a doorway providing access to a gantry that ran alongside the east-facing elevation at eaves level. The roof of this structure was roughly keyed into the east-facing elevation and brickwork (**e18**) is related to its adjoining wall.

Fig. 5 - View from the east end of the old malting block with stores buildings in the foreground
(Source: RCAHMS, 2001, photo no. E02145)

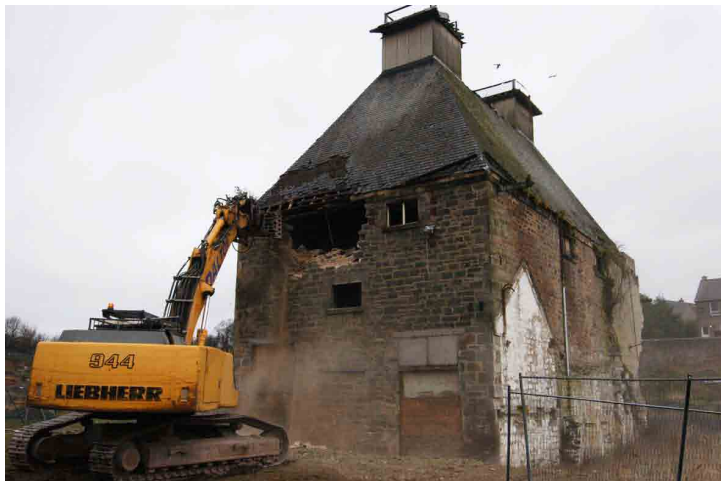
The demolition works were monitored under watching brief conditions (Figs. 15–21). During the demolition of the south-facing elevation a cross-section through the building was obtained. The principal features exposed are listed alphabetically in Table 6 and shown on Figure 8.

Fig. 15 - Demolition in progress on the south-facing elevation

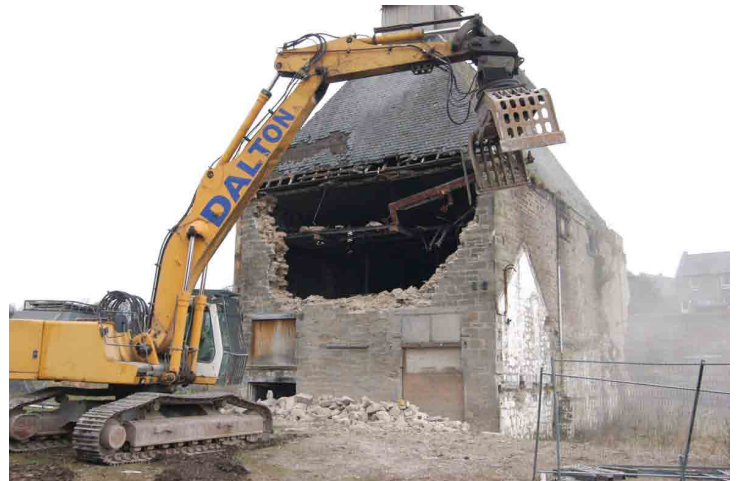
Fig. 16 - First floor steel work exposed
