## **The Brunt Steading, Near Spott, East Lothian Historic Building Survey**

**Report No. 3410**

Author	Michael Cressey HND BA MSc PhD MCifA FSA Scot
Illustrator	Graeme Carruthers MA MCifA
Editor	Bruce Glendinning BSc PG Dip MCifA
Commissioned by	W. N. Thompson & Co.
Date issued	March 2016
Version	1
Planning Ref	16/00114/P
NGR Ref No	NT 68569 73737
Oasis Ref No.	cfaarch1-245888

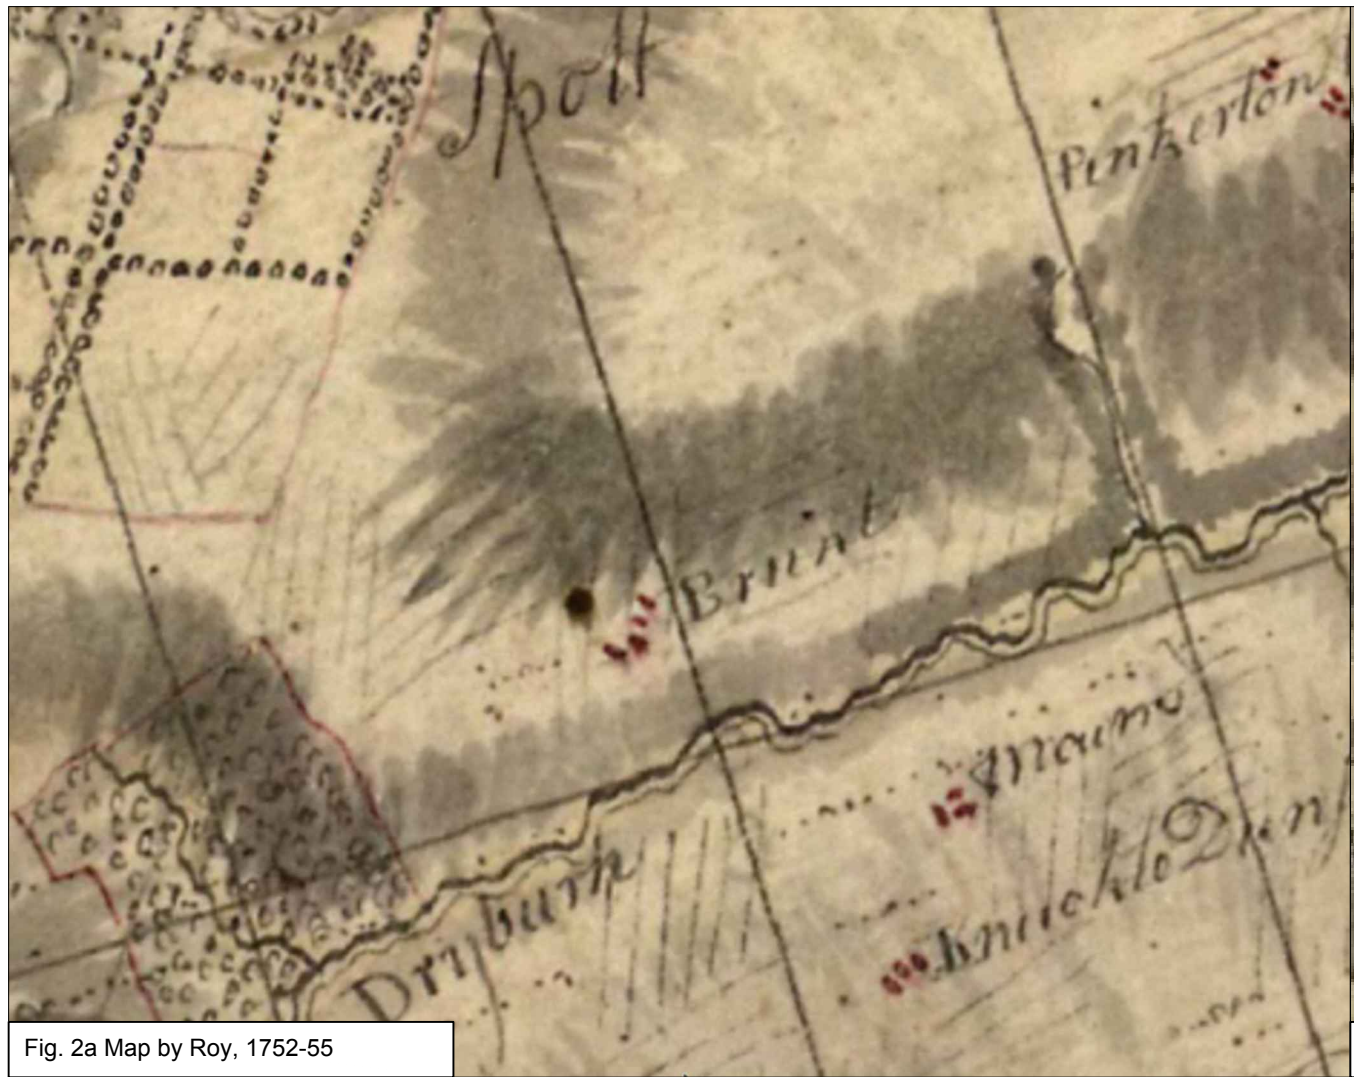
Fig. 2a Map by Roy, 1752-55

Brunt Steading first appears as a placename on General Roy's map of 1752-55 (Fig 2a) and is depicted as *Brunt*. The map shows four individual detached rectangular buildings. Armstrong's map of 1771 depicts *Brunts* as two buildings. William Forrest's map of 1802 (Fig 2b) depicts Brunt as an inverted U-shaped steading on the southern slope of Brunt hill.

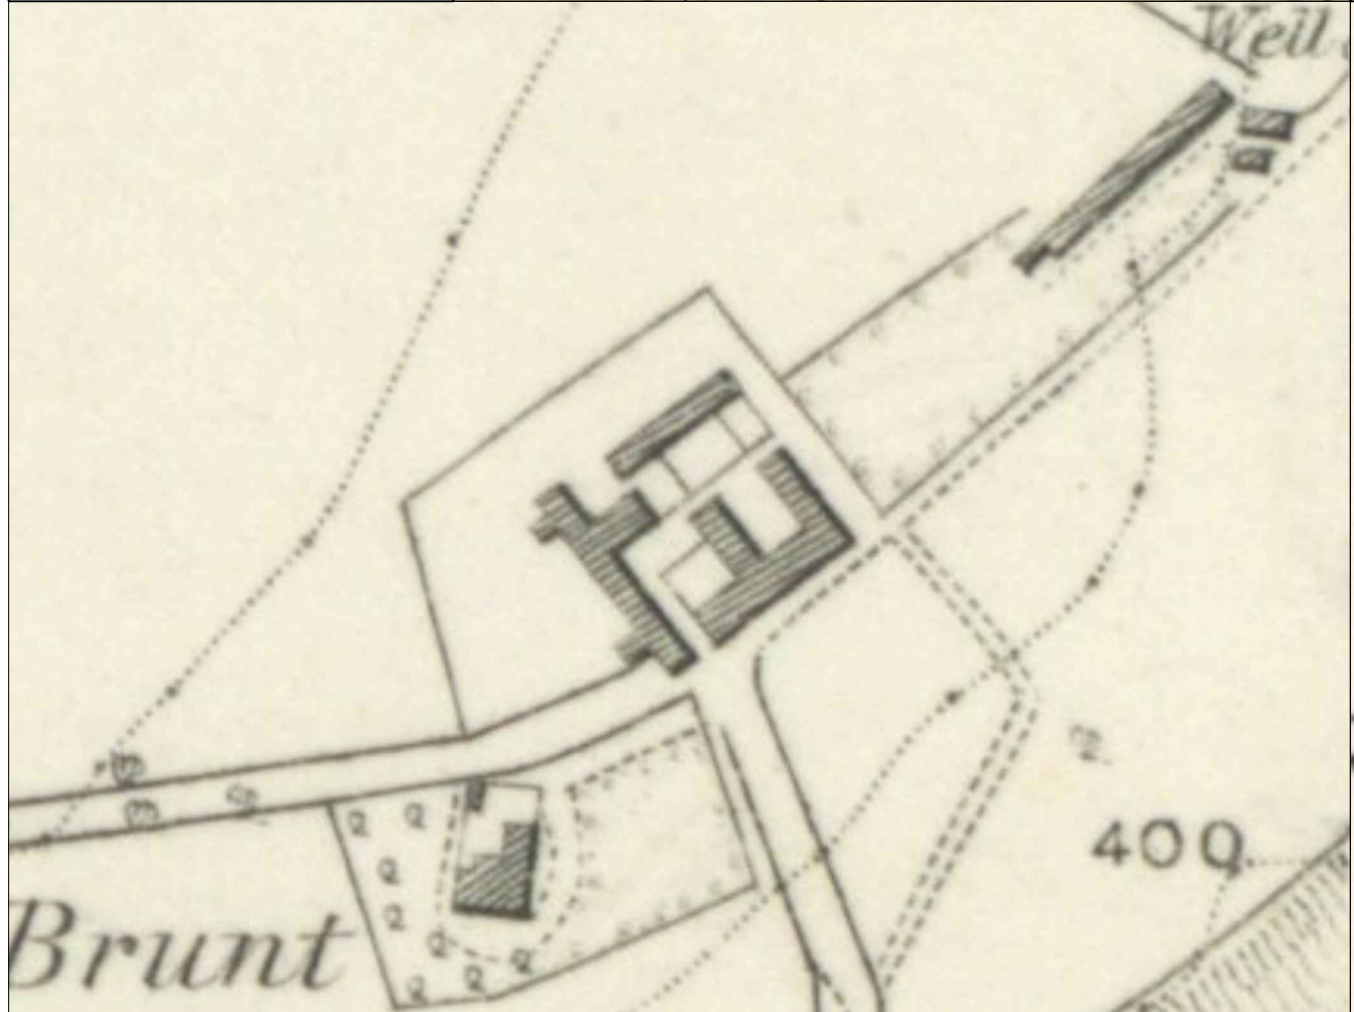
Fig. 2c Map by Ordnance Survey, 1855

The 1855 First Edition Ordnance Survey map (Fig 2c) shows Brunt with three individual units. On the north side there was a rectilinear building with enclosures. On the west side was a long T-shaped building with outshot buildings at each end. On the south side is an F-shaped building with an enclosure attached at its west end.

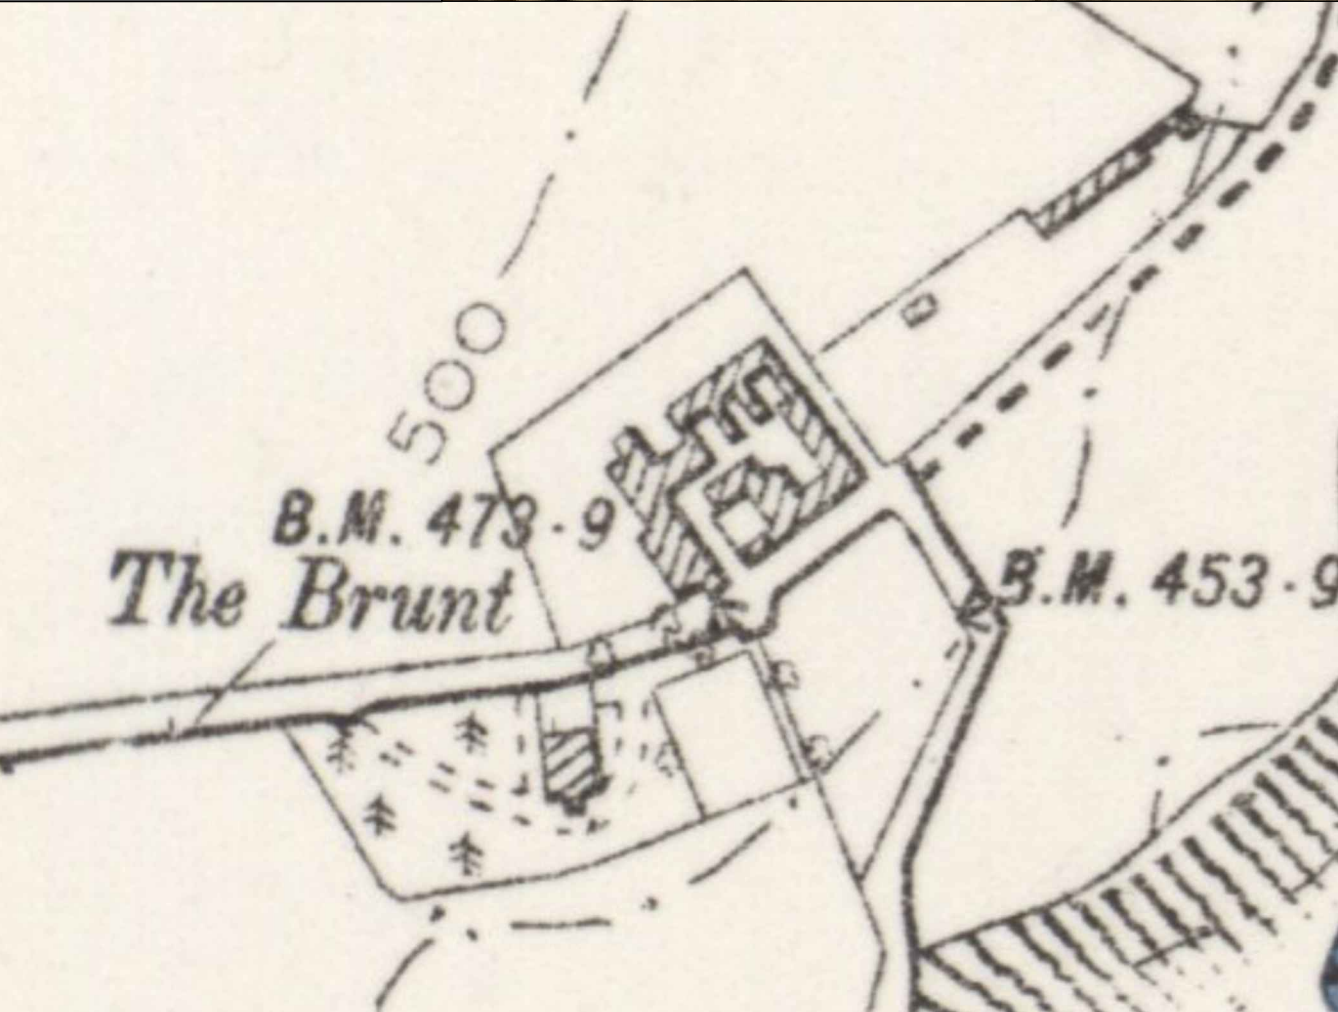
Fig. 2d Map by Ordnance Survey, 1894

The 1894 Second Edition map (Fig 2d) shows that Brunt had undergone a significant enlargement resulting in a formal courtyard arrangement with unification of the north, south and west ranges.

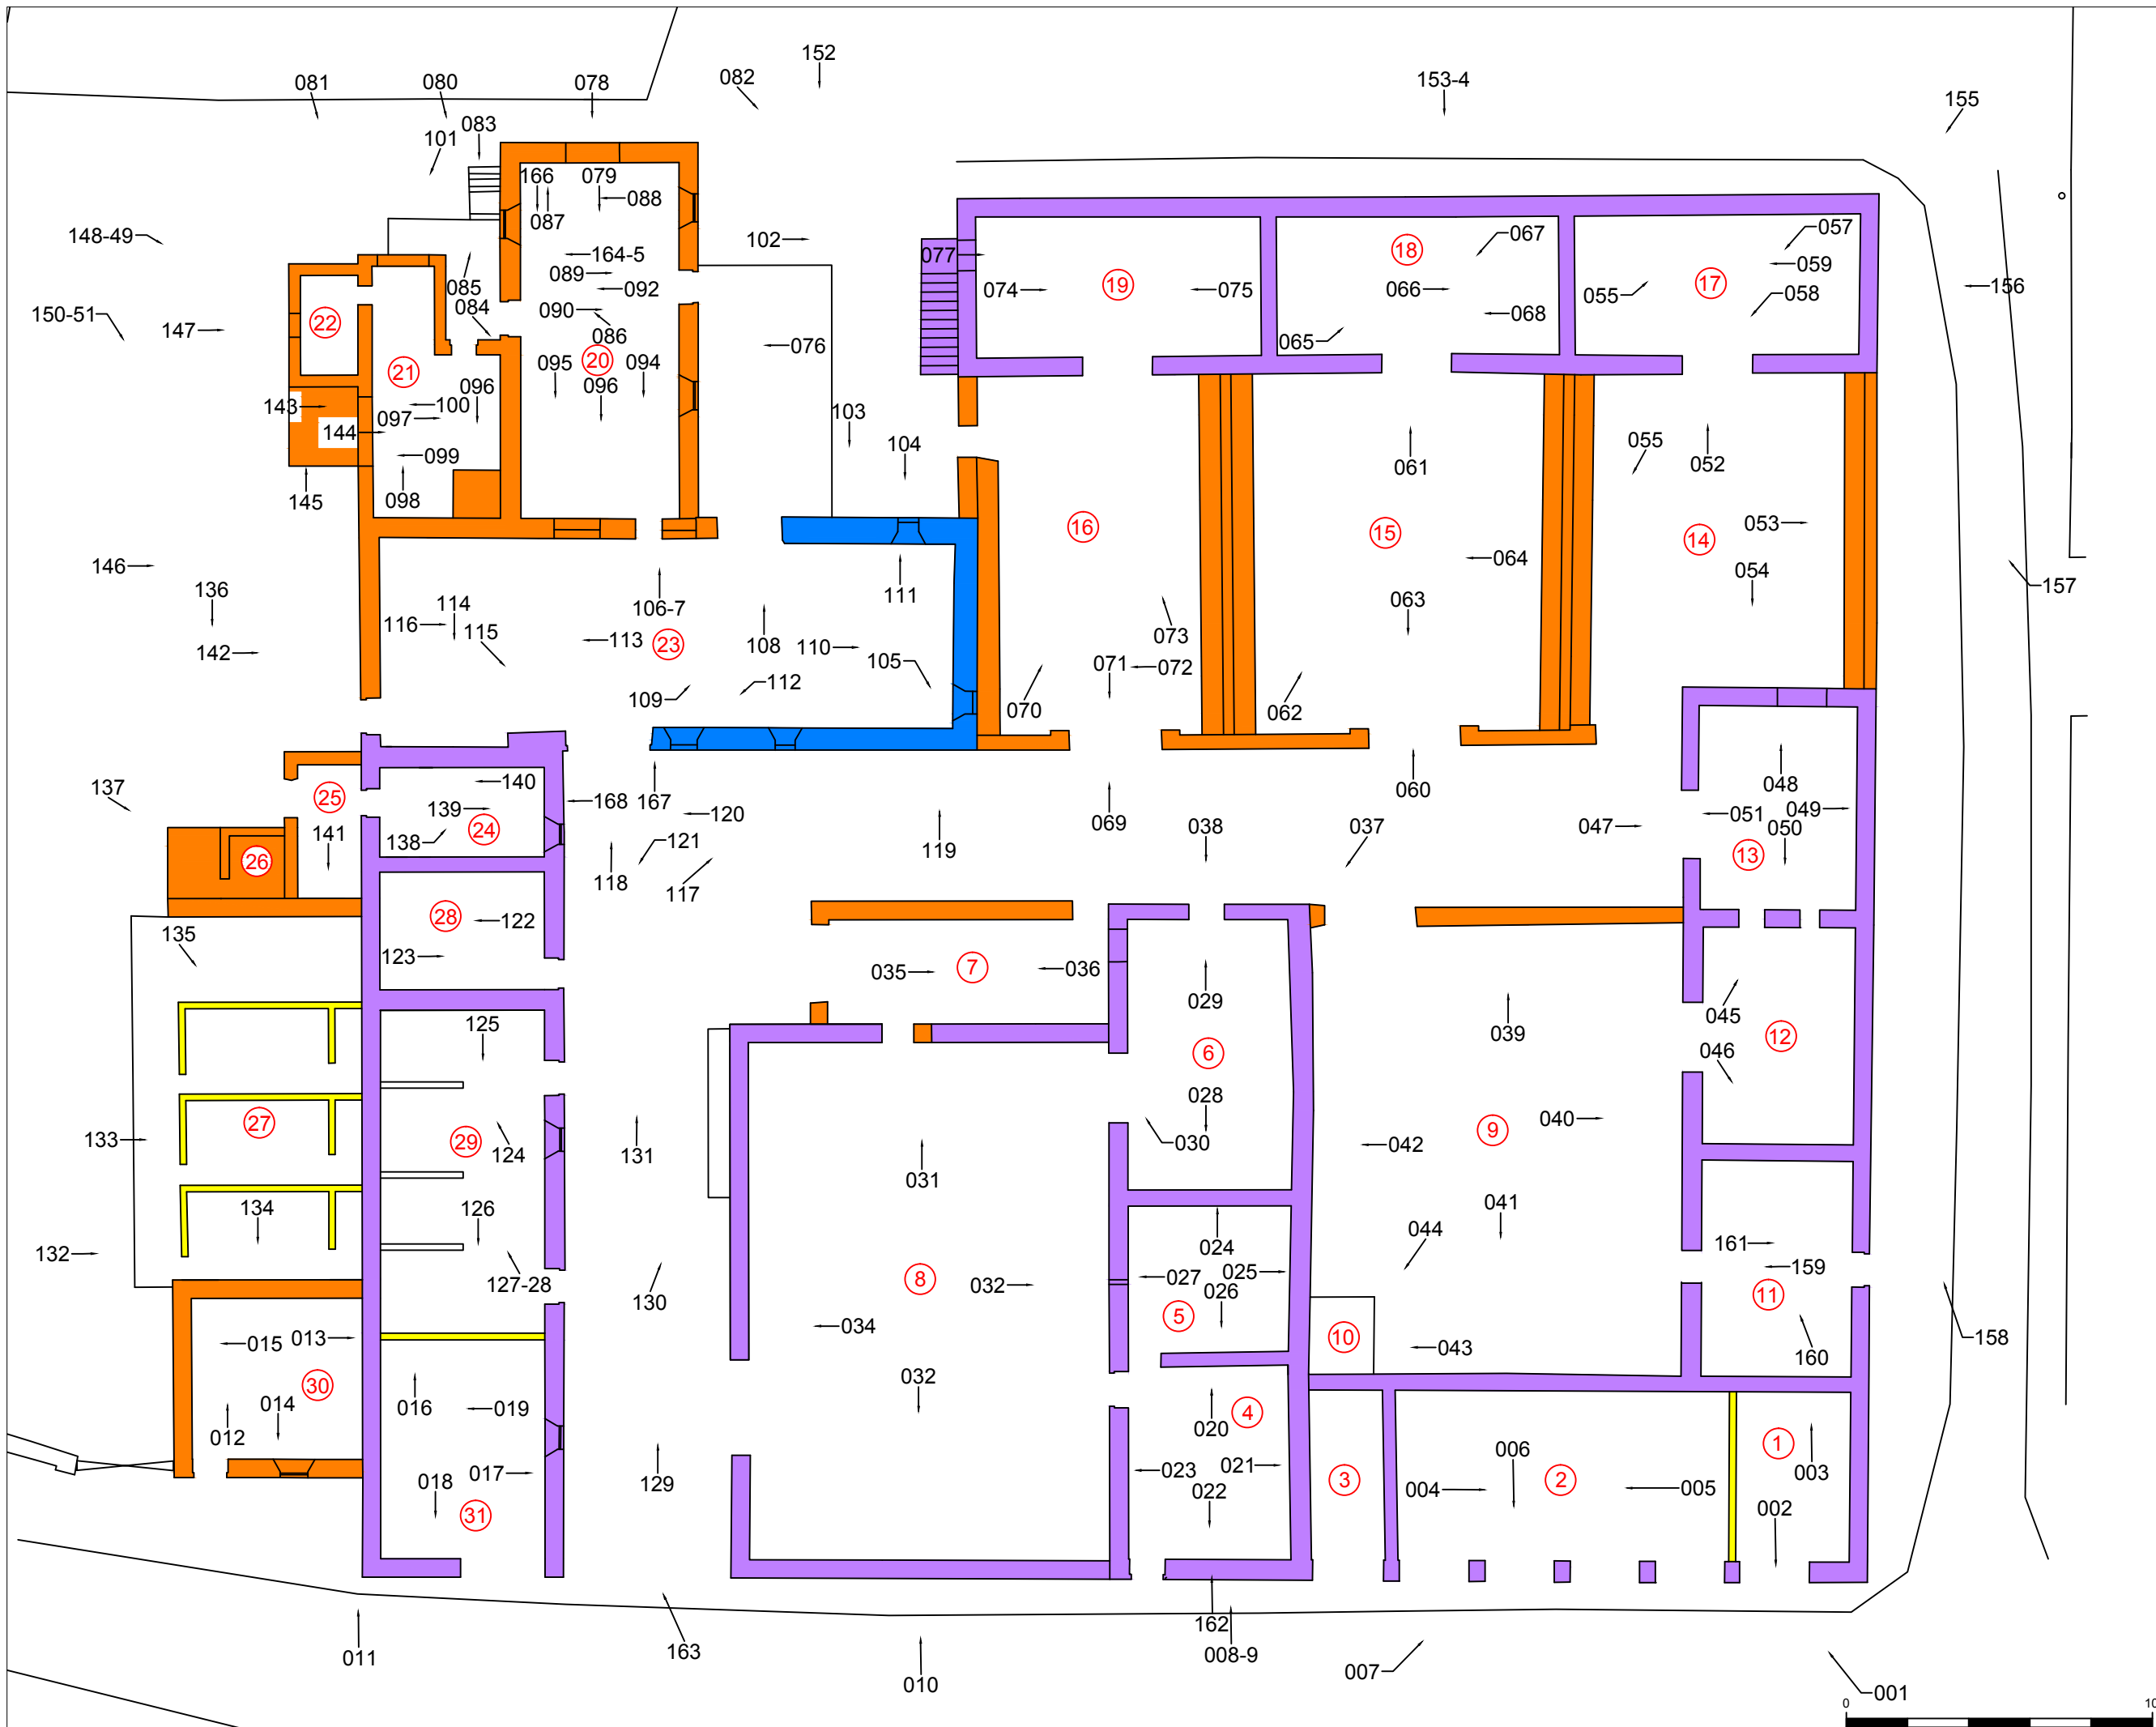
Report No: 3410	Fig. No: 3
--------------------	---------------

The architect's ground plans were checked for accuracy and have been amended where required using an industry standard EDM to plot salient missing features. A phased ground plan is produced as Figure 3.
