**4, 6, 8 Gilmerton Road, Edinburgh
Historic Building Survey**

Report No. 3429

Author	Michael Cressey, BA MSc PhD MCIfA FSA Scot
Illustrator	Graeme Carruthers MA MCIfA
Approver	Bruce Glendinning BSc PG Dip MCIfA
Commissioned by	NG Archaeology Services
Date issued	June 2017
Version	2
Grid Ref	NT 27198 70695
Oasis Ref No.	cfaarch1-250246

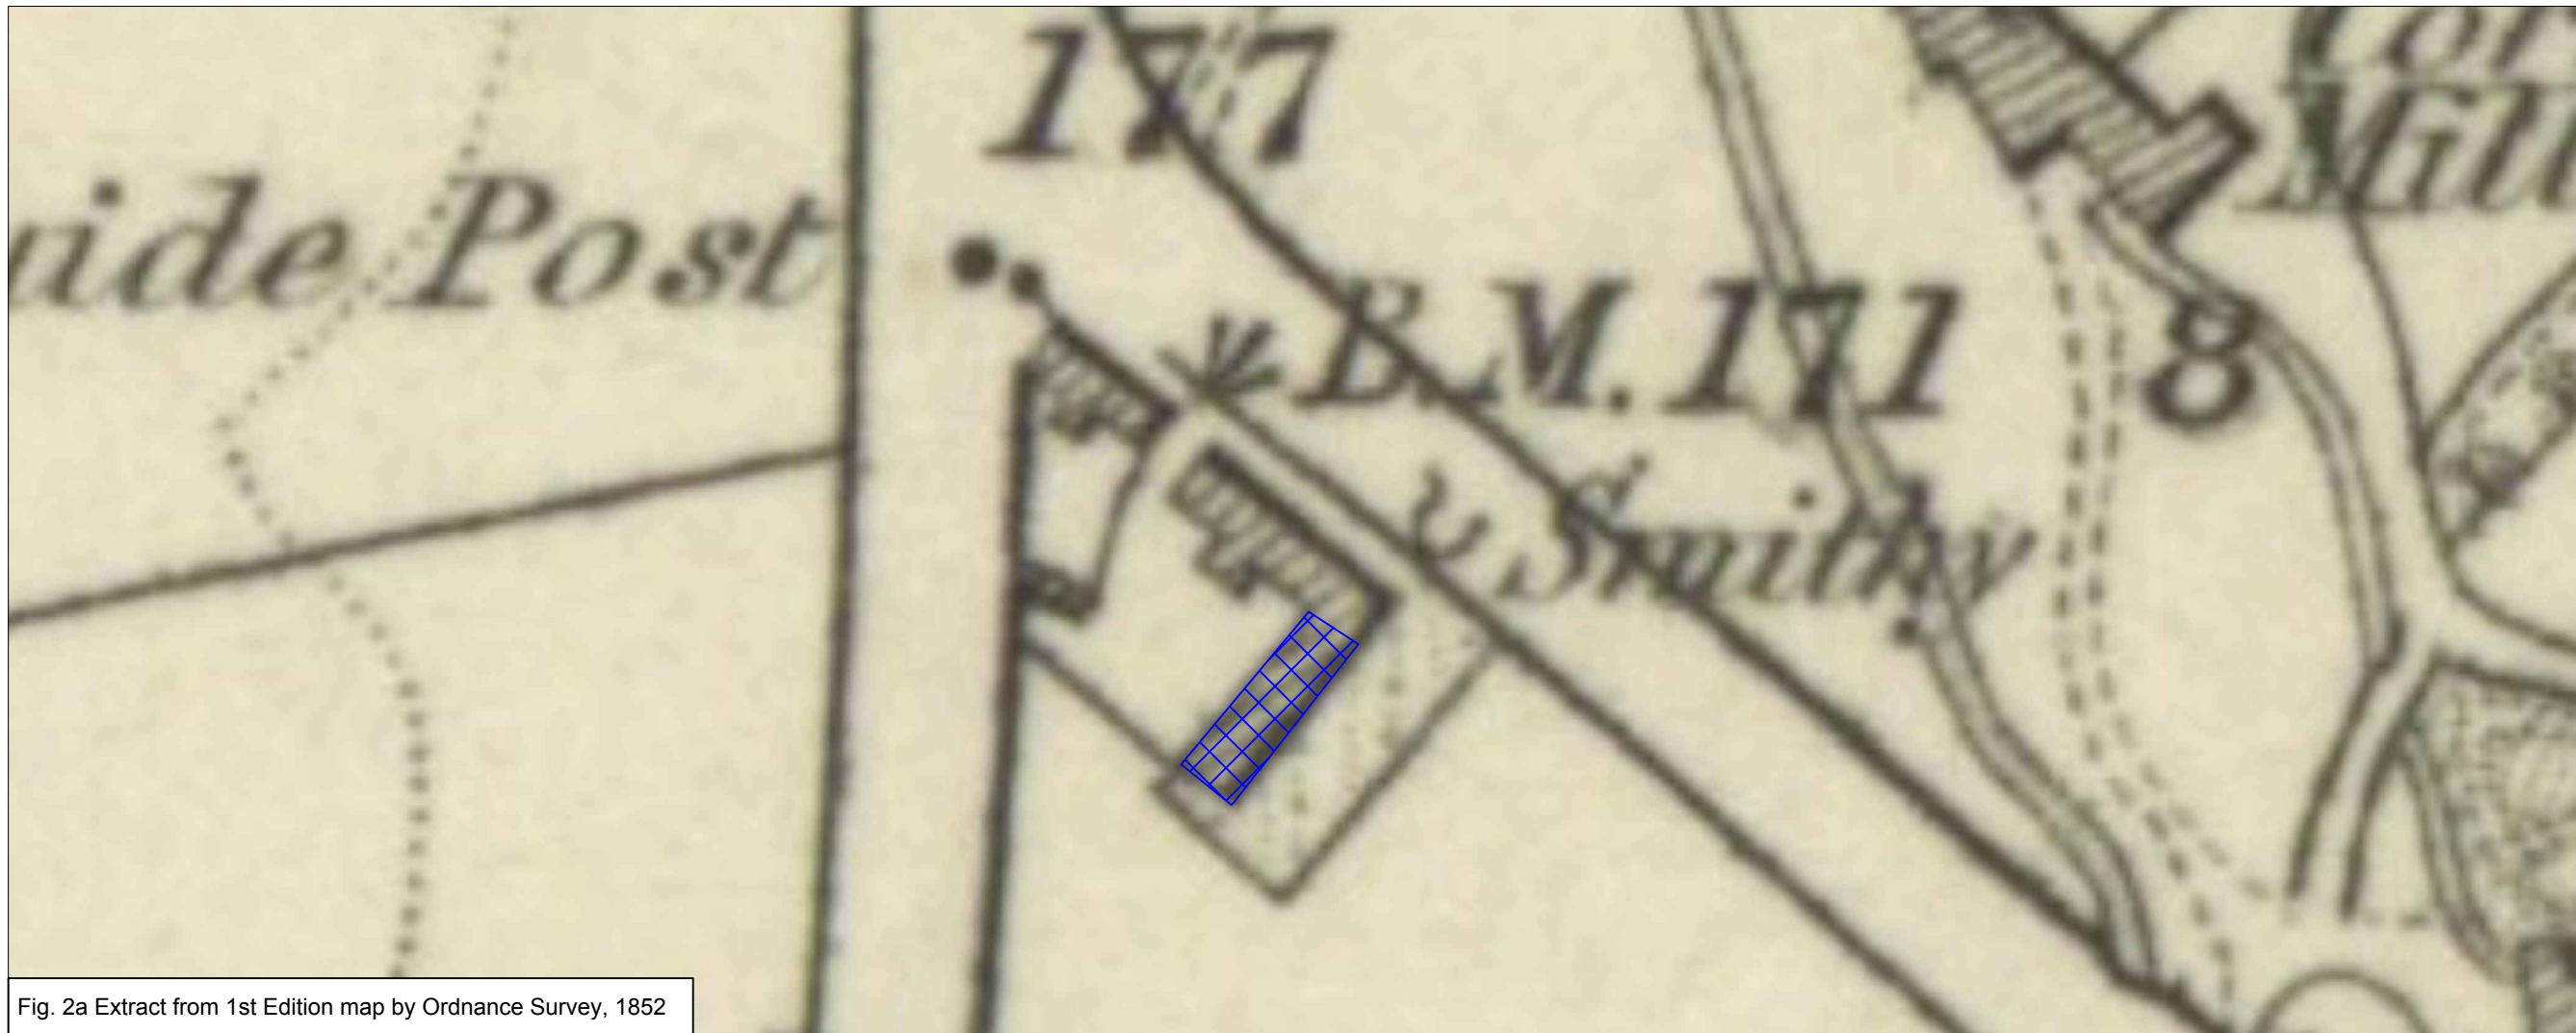
Fig. 2a Extract from 1st Edition map by Ordnance Survey, 1852

The 1855 First Edition Ordnance Survey map (Fig 2a) shows two sets of buildings on the south side of the junction of what is now Gilmerton and Liberton Road. The northernmost building is t-shaped with an attached property boundary. On its south-west side is a much larger set of buildings occupying an L-shaped footprint and labelled as a *Smithy*. The two cottages occupy the south-west side of the L-shaped arrangement (highlighted in blue).

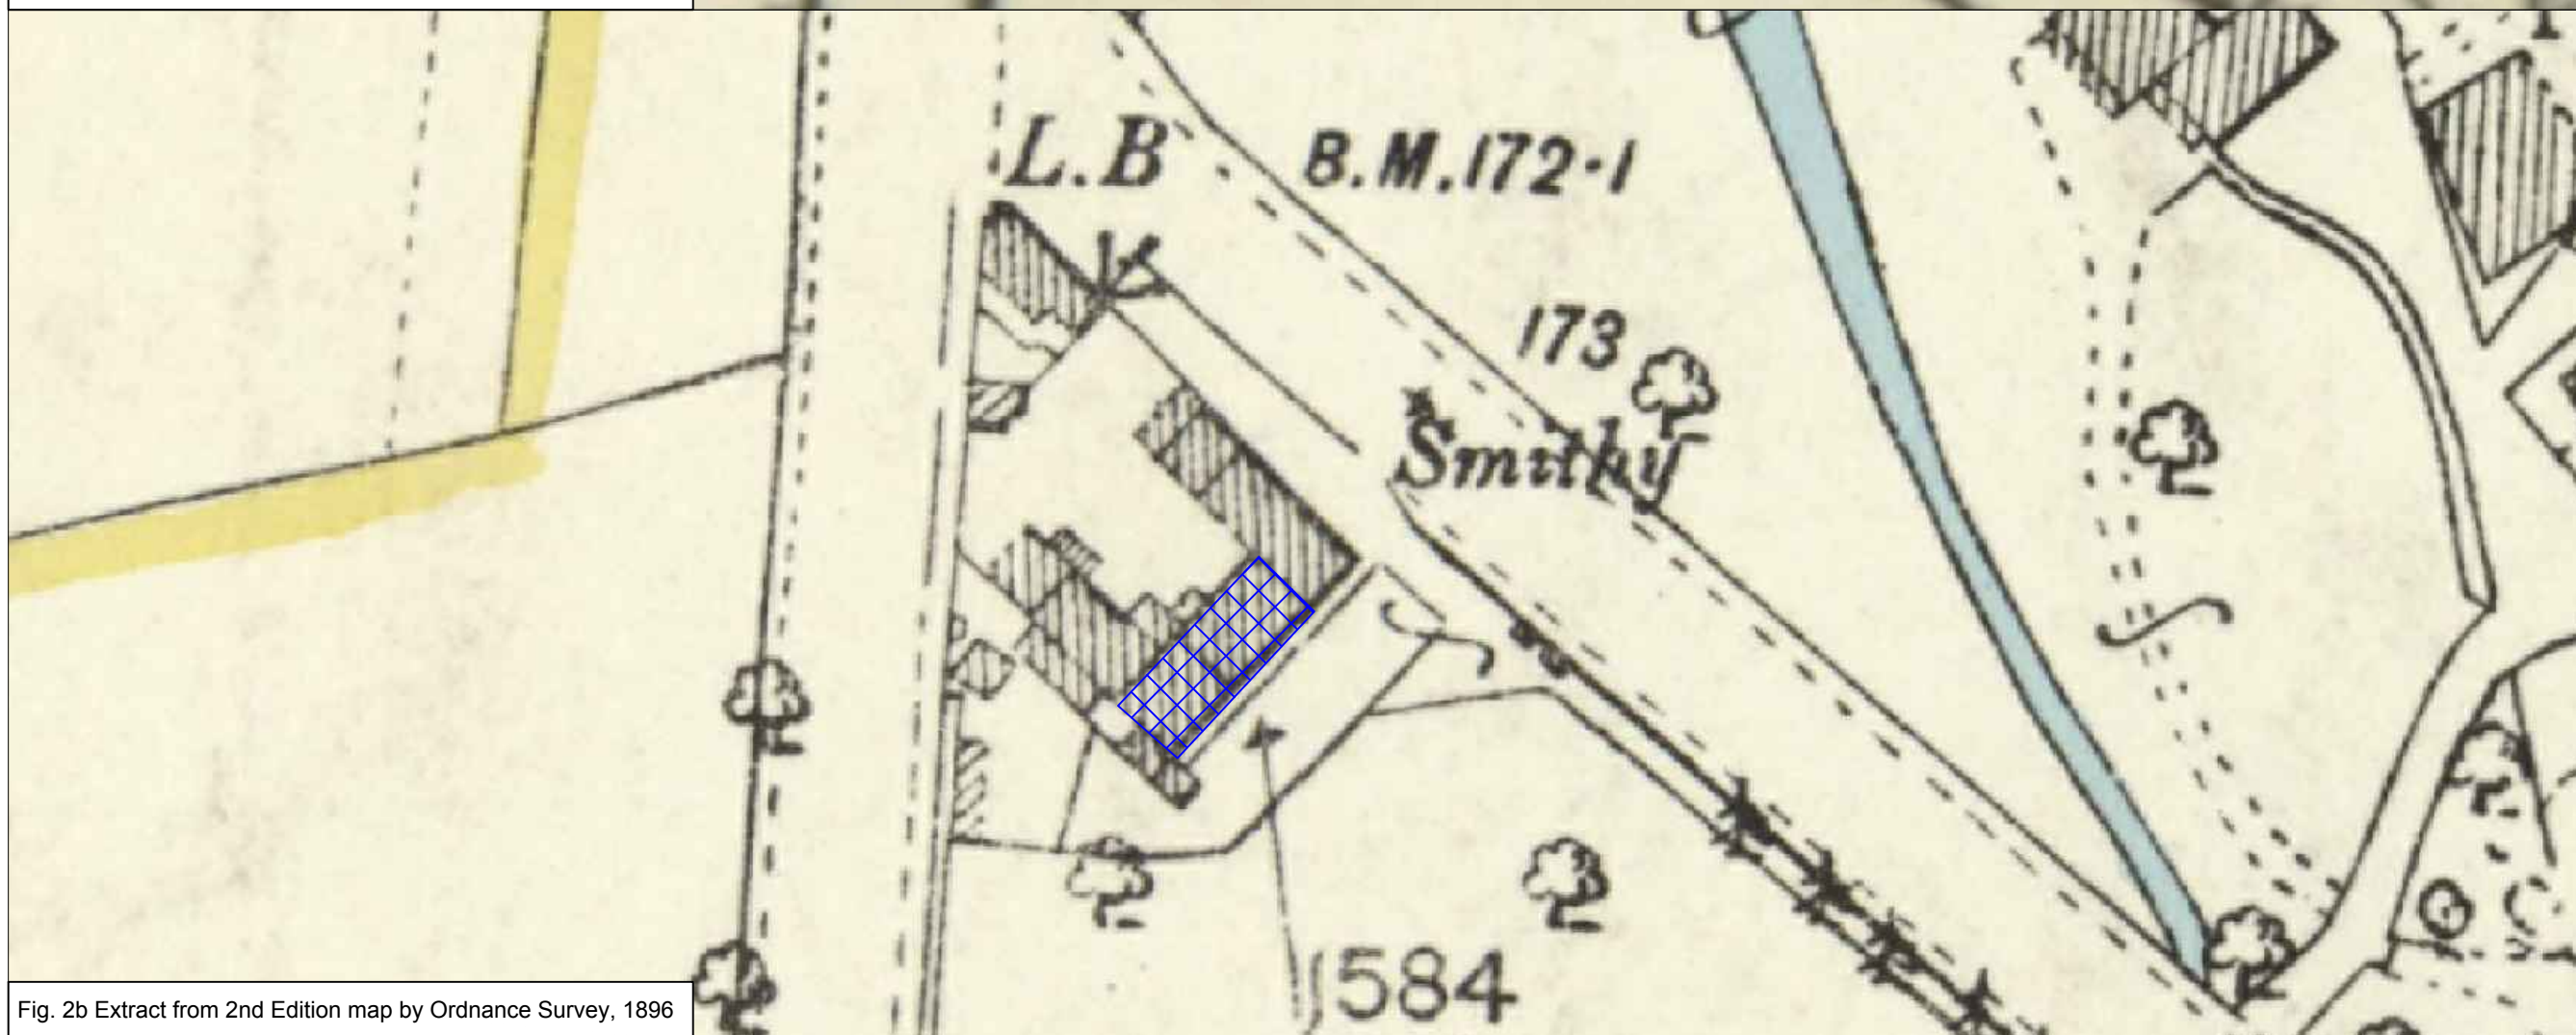
Fig. 2b Extract from 2nd Edition map by Ordnance Survey, 1896

The 1896 Second Edition Ordnance Survey map (Fig 2b) shows that the earlier L-shaped arrangement incorporating the footprint of the cottages has now been enlarged into a formal U-shaped courtyard arrangement of buildings. The two cottages are now depicted with two discrete units. A range with three units is still attached to the northeast-facing gable of the cottages.

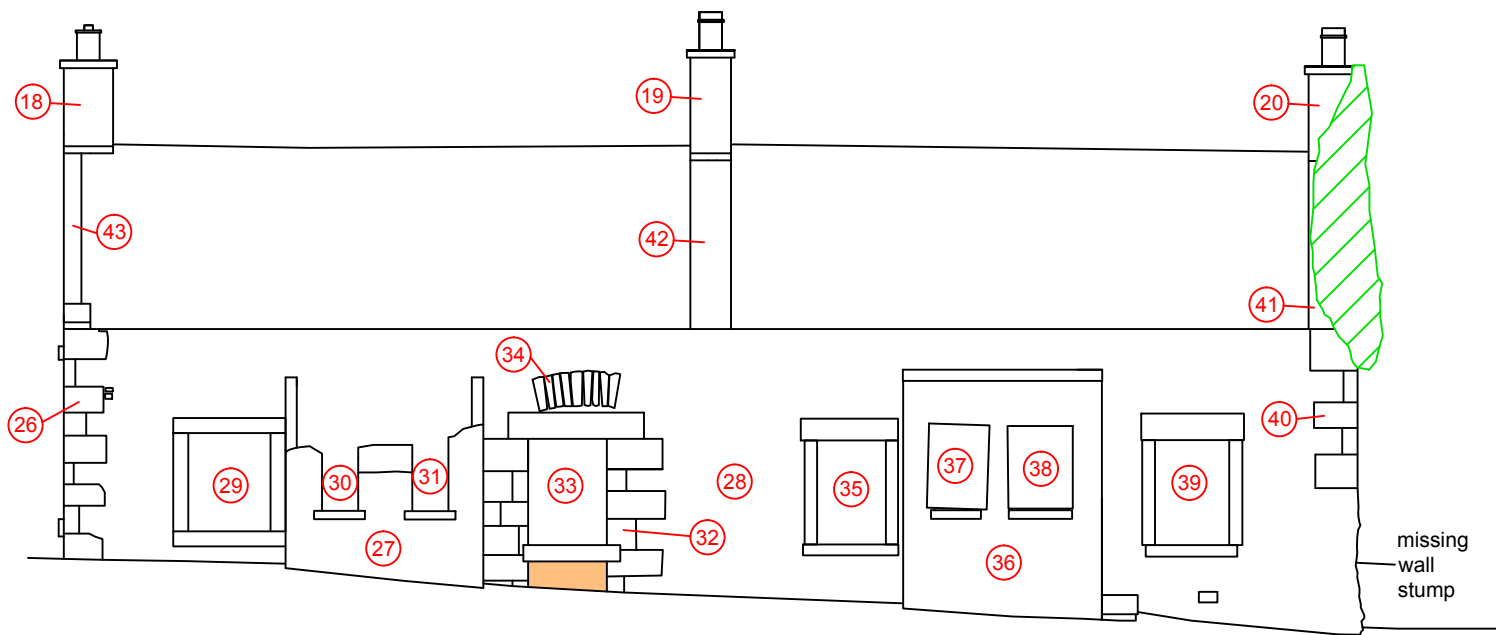
Fig. 4c Southeast-facing elevation

The southeast-facing elevation contained the interior blocking work of the arched openings (Figs 4a and 18). Each arch had had a window inserted into them when they were blocked up. Both had splayed reveals and were lined with lath and plaster. Remnants of the lath and plaster had survived the fire. The arch vousoirs contained floor joist sockets for the first floor. Above these, the wall head was constructed of coursed rubble. Two brick-built partition wall scars were also visible one was associated with a cupboard (Unit 7) and the wall that supported the box staircase (Fig 3a).

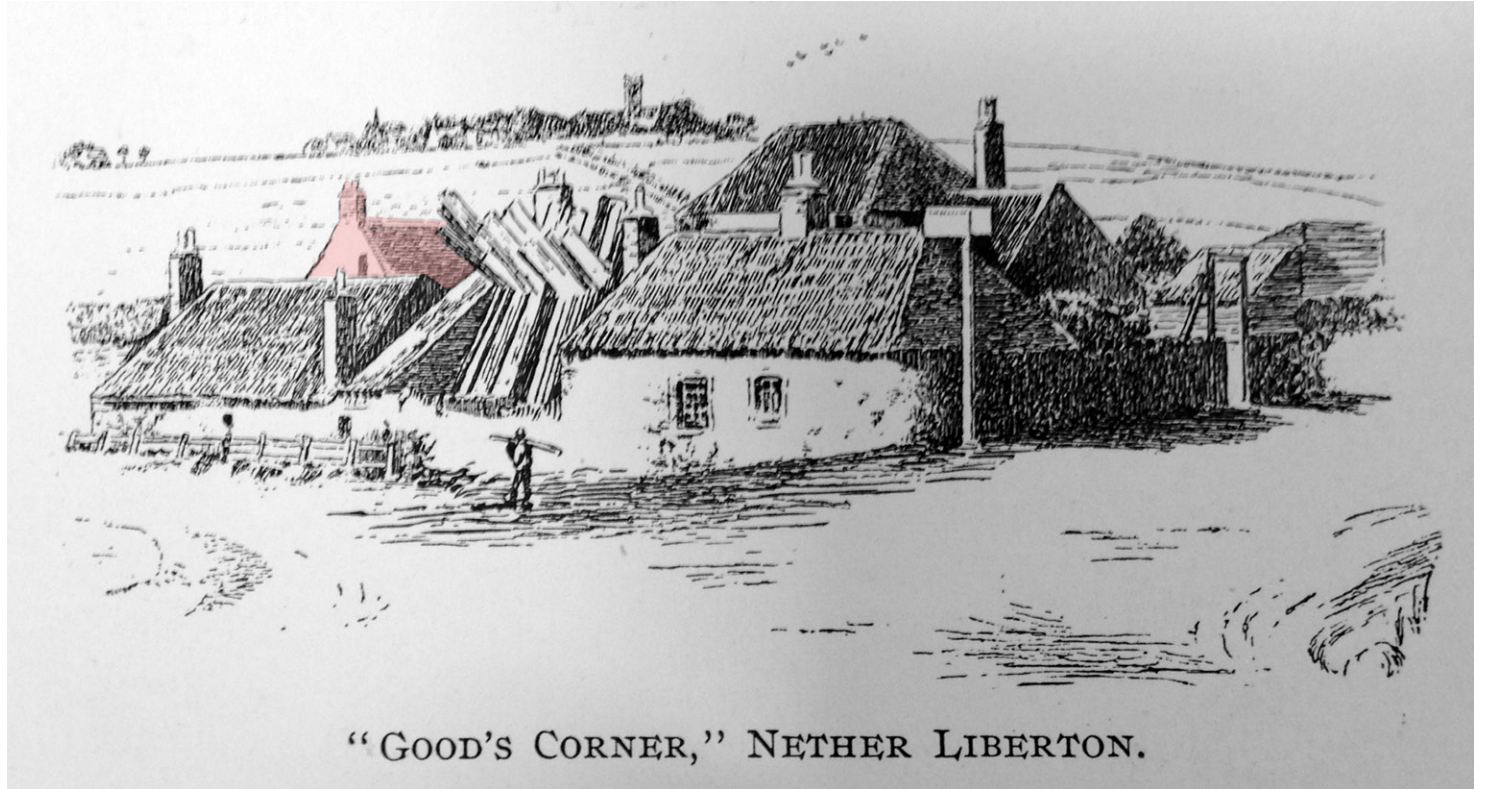
Fig. 5 Historical drawing of Goods Corner, 1892

In a book entitled *Craigmillar and Environs* (Speedy 1892) the Good's Corner cottages are shown behind a large stack of timber between two buildings (Fig 5). At the rear of the complex is a taller hipped roofed building with a pitched roof building attached to it.
