Milton Farmhouse and Steading, Logiealmond Estate, Perth & Kinross

Standing Building Survey
Report No. 3989

Author	Stuart Mitchell MA ACIfA
Illustrator	Rachel Kershaw MA PCIfA
Approver	Melanie Johnson MA PhD FSA Scot MCIfA
Commissioned by	Logiealmond Estate
Date issued	November 2020
Version	1
OASIS Reference	Cfaarcha1-408219
Planning Application No	20/00693/FLL
Grid Ref	NN 9707 2989

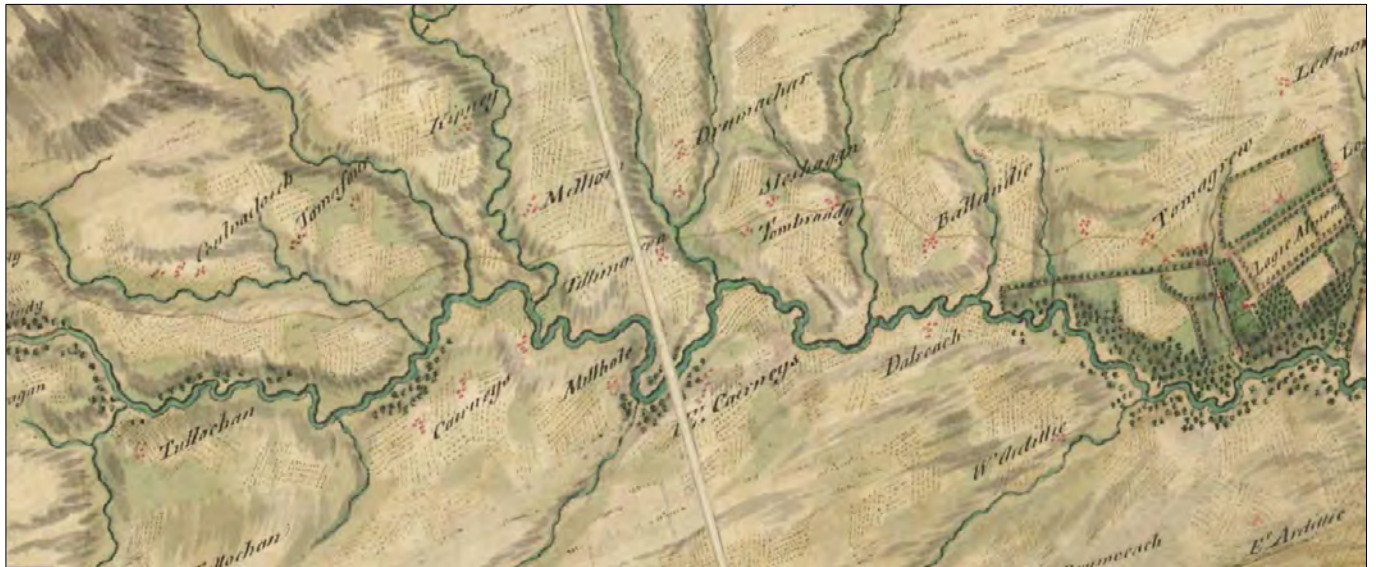
Fig 2a Roys Military Map 1747-52

General Roy's military map of 1747-52 (Fig 2a) depicts the placename *Miltown* which is the anglicized Milton, although a crease in the map has made it difficult to be certain. The map shows a dispersed settlement with five individual buildings.

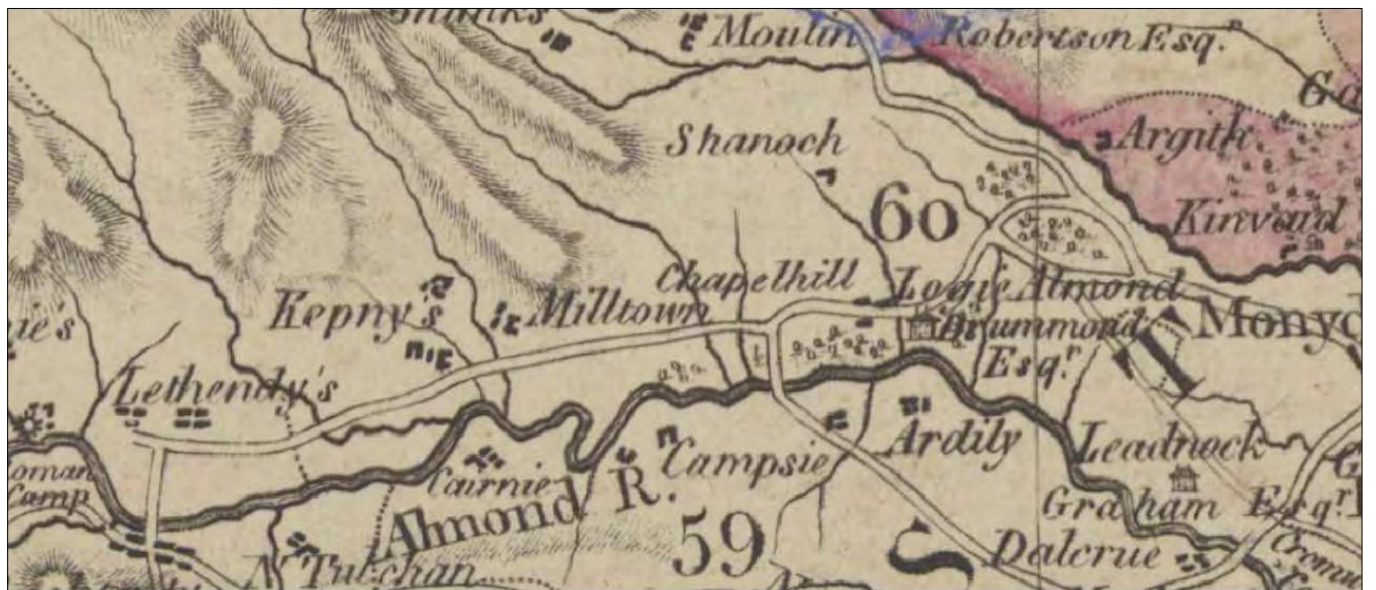
Fig 2b Stobies Map of 1787

Stobie's map of 1787 (Fig 2b) also depicts the placename *Milltown*. Now the farmhouse is shown as a C-shaped building with two detached buildings on its west side.

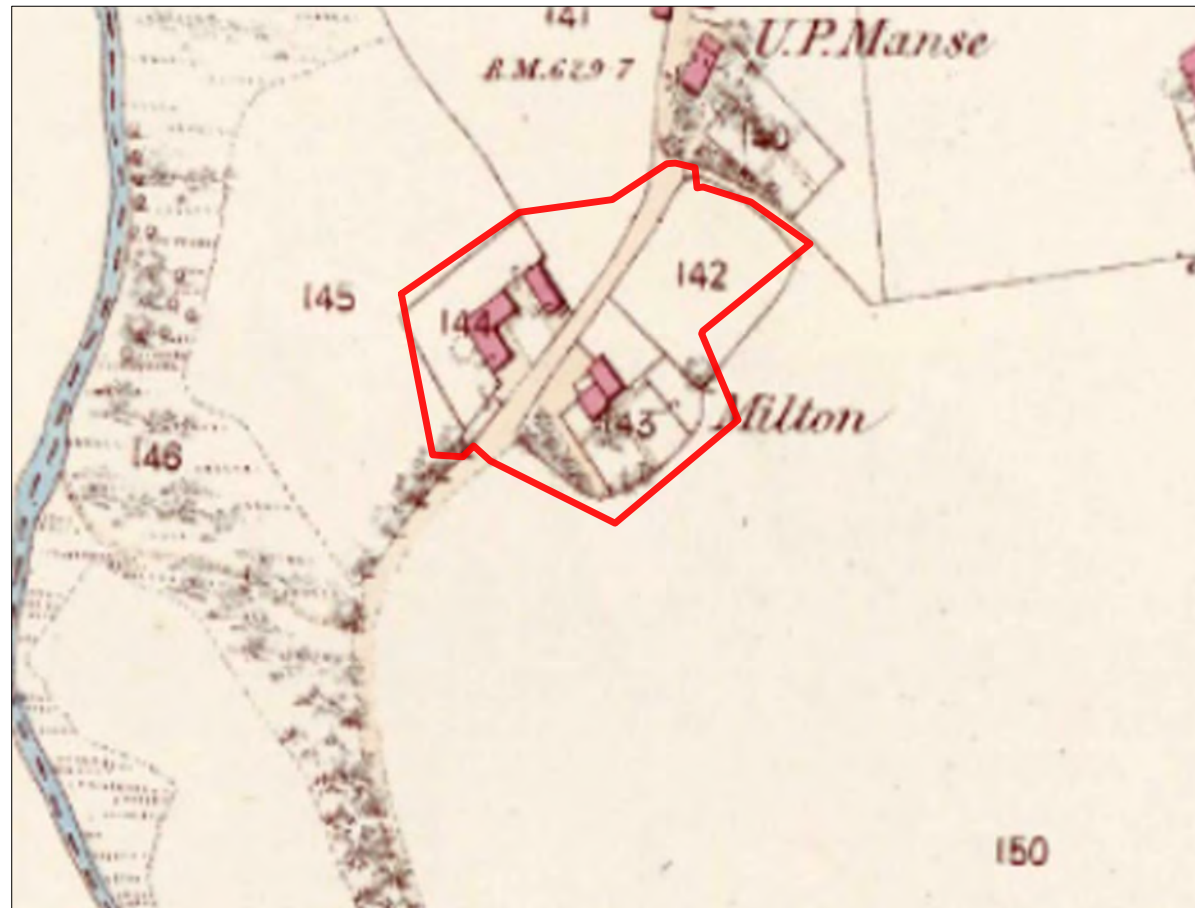
Fig 2c OS 1866 First Edition map

The 1866 Ordnance Survey First Edition map (Fig 2c) shows Milton with the farmhouse comprising two individual attached buildings. On the north-west side of a track are an L-shaped building and a detached rectangular building.

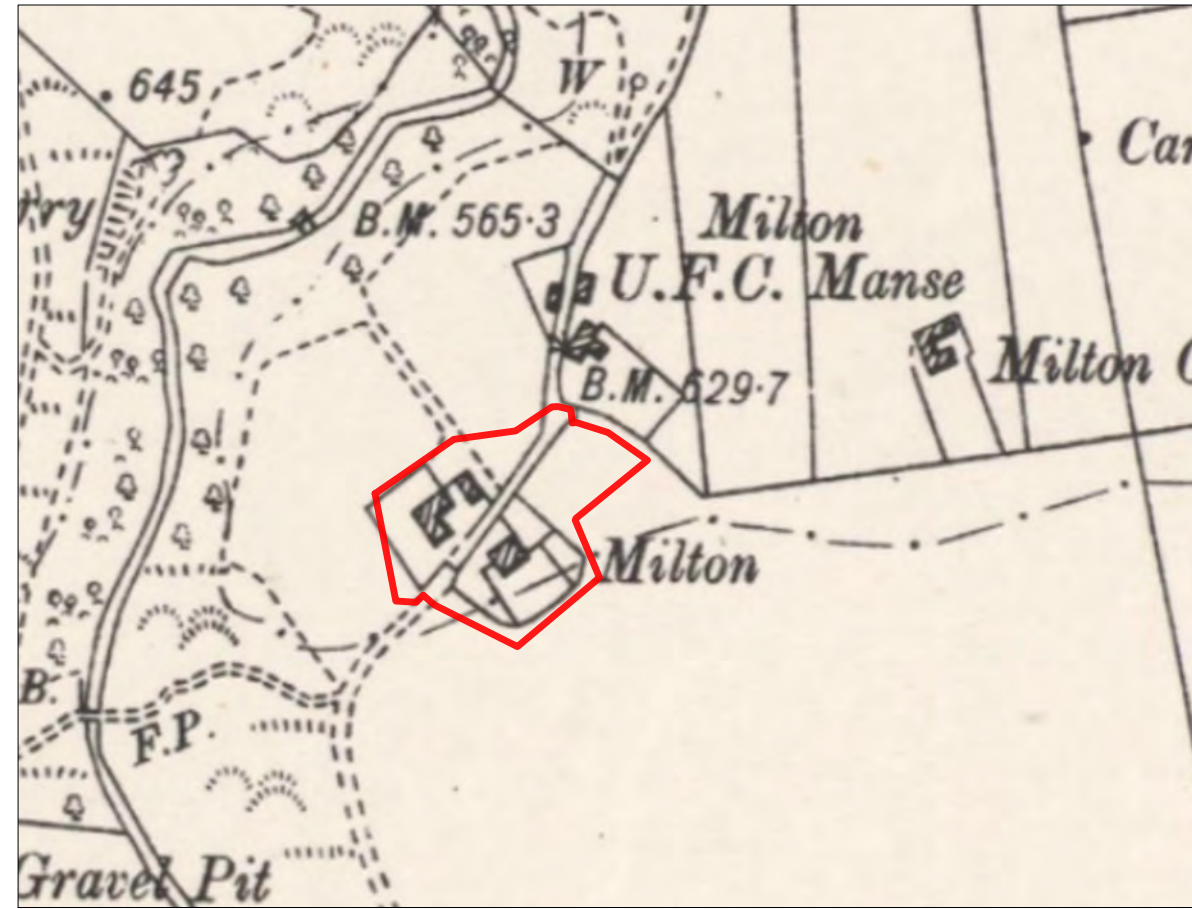
Fig 2d 1901 Ordnance Survey map

The 1901 Ordnance Survey map (Fig 2d) shows no major alterations had occurred to the footprint of the building: however, the farmhouse is now shown with a square plan which is schematic and not representative of its true layout.

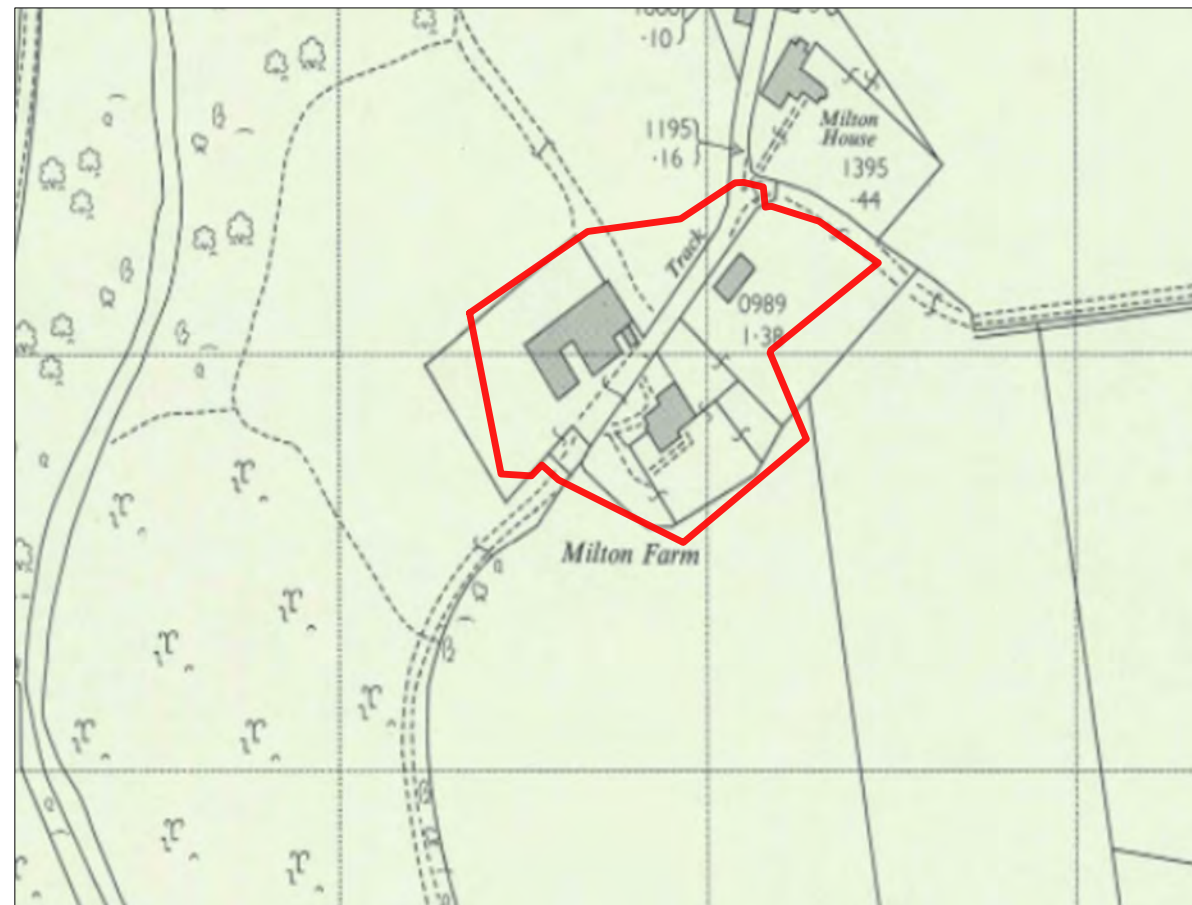
Fig 2e 1969 Ordnance Survey map

The 1969 Ordnance Survey map (Fig 2e) shows the present footprint, indicating that it has not undergone any external alteration since then.

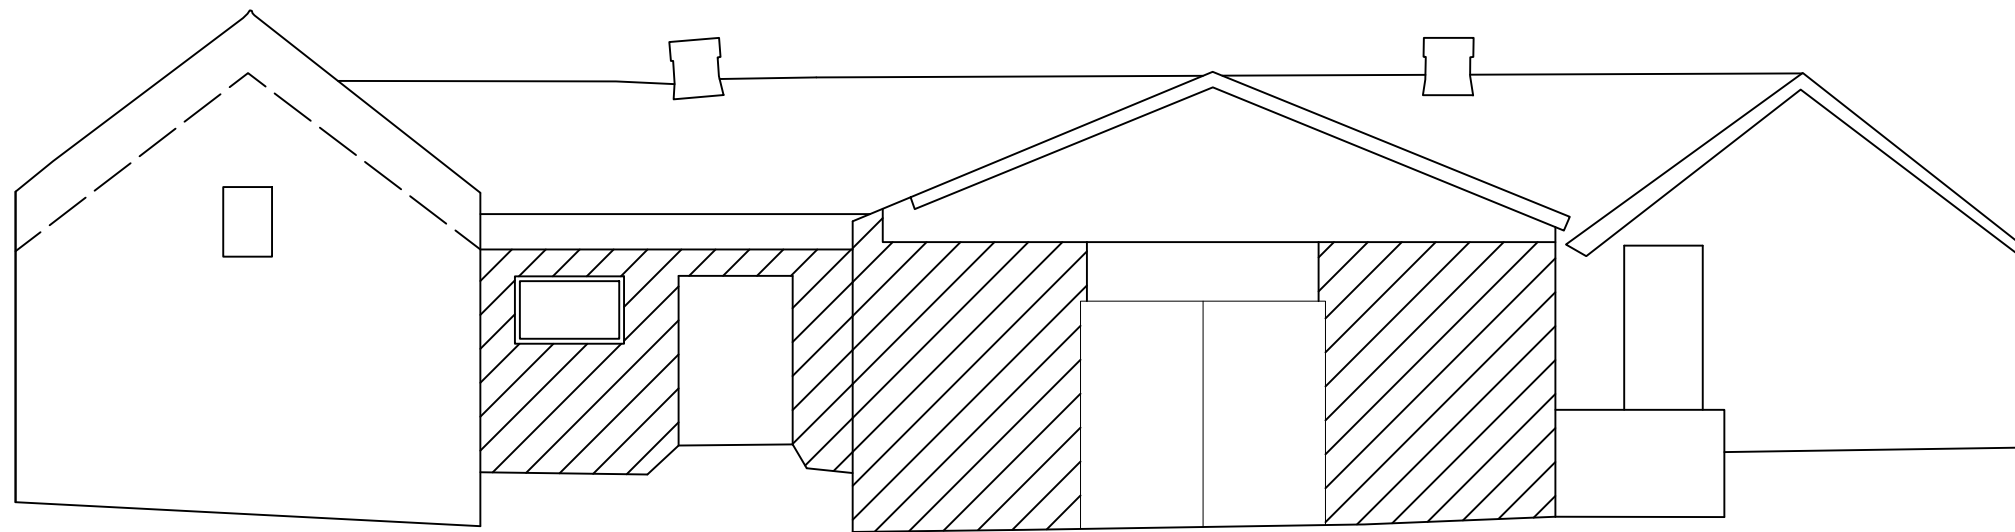
Fig.4e Steading SE elevation

The L-shaped barn was built of random rubble and had roughhewn long and short quoins. It had a pitched gable at its SE end with a single loft level window and small bricked up vent. There was a roof line indicating the building had been heightened (Fig 4e, 4f, 4i and 13). The SW elevation (Fig. 4f) formed the external side of the complex that also had evidence of heightening, representing a major conversion to create a loft (Unit 7). There was a central door into Unit 6 and a small loft window (Fig 14). A slit vent and small square vent or a small animal passage were also incorporated into the build.
