Standing Building Survey & Archaeological recording at Old House Point, Nr Cairnryan, **Dumfries & Galloway**

Report No. 1731

CFA ARCHAEOLOGY LTD

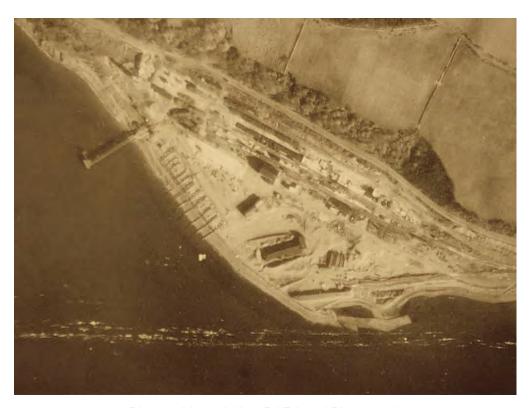
Plate 1 - Vertical 1945 RAF Aerial Photograph

5.31.1 The remains of ten wooden piles are visible within the inter-tidal area. The piles are round with a diameter of 0.45m. The piles are the remains of a wooden pier that is visible on the 1945 and 1946 aerial photographs (Plate 1 & 2). The pier was in use in 1943 when the Spud craft were being constructed as it is shown in the distance on Plate 7.

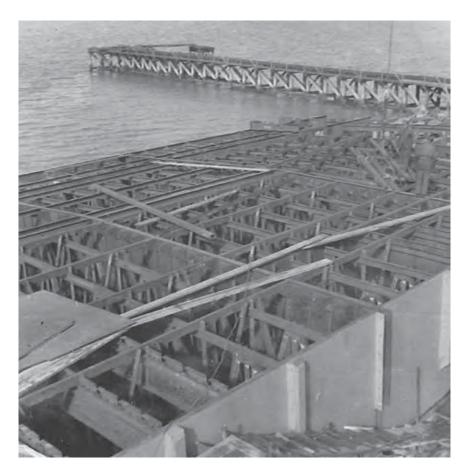
Plate 7: Bulkhead detail of the Spud Craft in the foreground with wooden pier in the distance

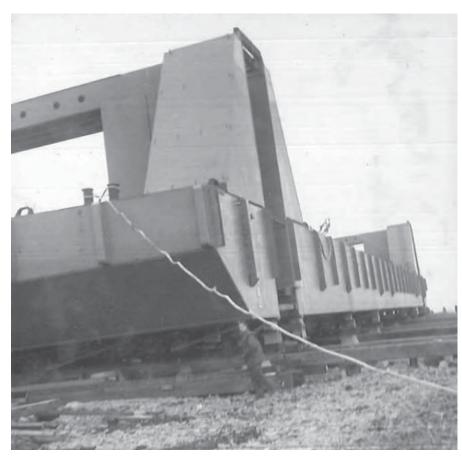
- 5.3.2 Feature 2 comprises a series of cast concrete blocks which supported the Spud pontoons during construction (Plates 25 & 26). The concrete plinths also carried a series of timber sleeper beams on which the Spud pontoons were launched (Plates 9 & 10). A total of 112 individual blocks were recorded. Of these, there are three different types surviving and these are categorised in Table 3.

Plate 9: Completed Spud pontoon (without its legs) resting on the slipway prior to its launching

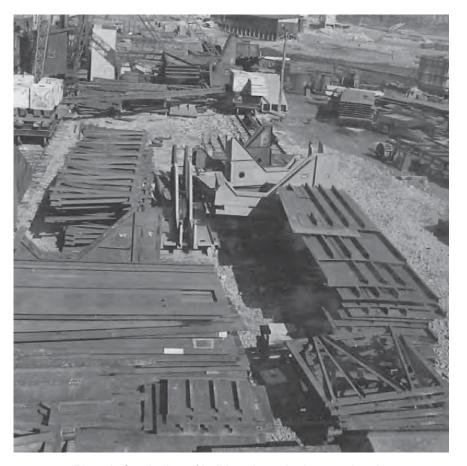
5.36.1 Situated to the south of the building foundations (Feature 15) is a dump of broken concrete pier parts. The most interesting feature among this group is a cast-concrete ballast block which measures c.1.2m by 1.2m and has an iron slinging loop at its centre. The block has been cast in a steel tank which has left an impression on its side. Plate 8 shows several of this type of ballast block on a mobile crane and others on a nearby bogie.

Plate 8: Stockpiles of bulkheads and other steelwork. Note ballast blocks on the mobile crane

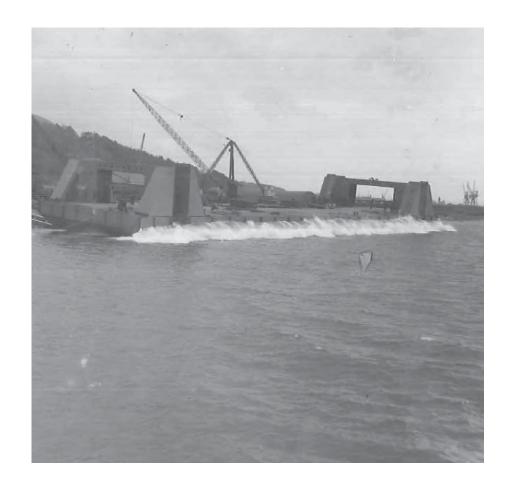
Plate 10: A Spud pontoon entering Loch Ryan
