Mill Wynd, East Linton Historic Building Appraisal

Report No. 1821

**Mill Wynd, East Linton
Historic Building Appraisal
Report No. 1821**

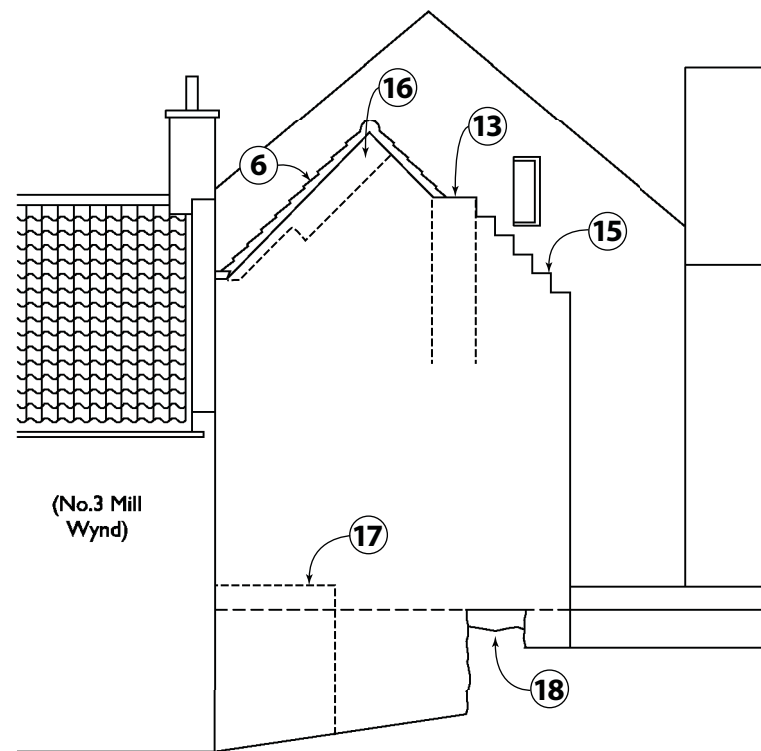
02 EAST ELEVATION
1:100

Exterior: East Elevation (Fig 1, Plates 1 & 2)

Context No.	Description	Summary	Dimensions (m)	Photo No.
14	Main build (Plate 1)	Random rubble coursed, mortar bonded and founded on large boulders.	4.7 x 8 (max)	15
15	Stepped roof on north side of roof (Plates 1 & 2)	Stepped sandstone skews leading to chimney (13)		16
16	Brick and stone repair to south side of gable end (Plates 1 & 2)	The upper section of the north side, the south side, and the apex of the roof takes the form of a standard pitched roof, not crow stepped like the lower part of the north side of the roof. This change in construction technique appears to be a later alteration as the new section has been built up with random rubble and bricks. .		15, 16, 19
17	Lean-to raggie (Plate 1)	Mortar raggie of former lean-to visible on lower left side of wall, and visible on wall of adjoining cottage.	1.6 x 2.3	17, 18
18	Garden wall (Plate 1)	Foundations of sandstone rubble wall in poor condition	4.5 x 0.6	15, 19
