Haggerston Dovecote, Ancroft, Northumberland Archaeological Watching Brief

Report No. 1822

Author	Stuart Mitchell MA AIfA
Illustrator	Graeme Carruthers MA MAAI&S and Shelly Werner
	BSc MPhil PhD
Editor	Melanie Johnson MA PhD FSA Scot MIfA
Commissioned by	Robin Kent Ltd on behalf of Marshall Leisure Ltd
Date issued	September 2011
Version	3
OASIS Reference	cfaarcha1-83194
Planning Application No	-
Grid Ref	NU 0352 4359

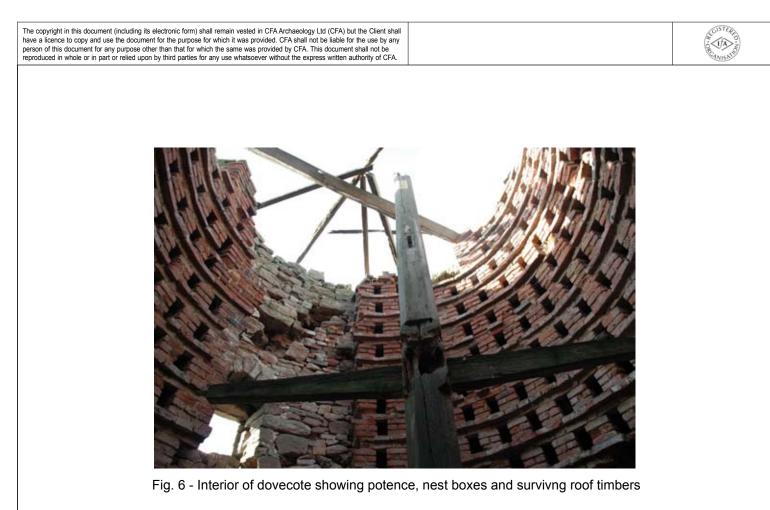
- 3.1.1 The dovecote is overall in fair condition (Figs 3-5). In profile it has a slight batter and is built in three faintly discernible tiers. The roof is missing and the top is incomplete; a few roof timbers survived in situ in 2010 but by 2011 these had fallen (Fig. 6). It has an entrance doorway facing to the east, and a second doorway facing to the west which has been partially blocked to form an open window. Both doorways are framed by rough quoins and have exterior lintels with overhead relieving arches (Fig. 7). Both have interior rebates forming door-checks which indicate that their doors would have opened inwards. Seven small windows, three of which are blocked, are present around the building. Similar tooled rebates are present in the visible interior window frames which suggest that they were once fitted with windows or shutters which opened inwards.

Fig.5 Exterior view of dovecote from the south-west
