**Historic building recording at  
Frogs Hall Farm,  
Bambers Green Road,  
Takeley, Essex, CM22 6PE**

**November 2019**

**CAT Report 1540**  
April 2020

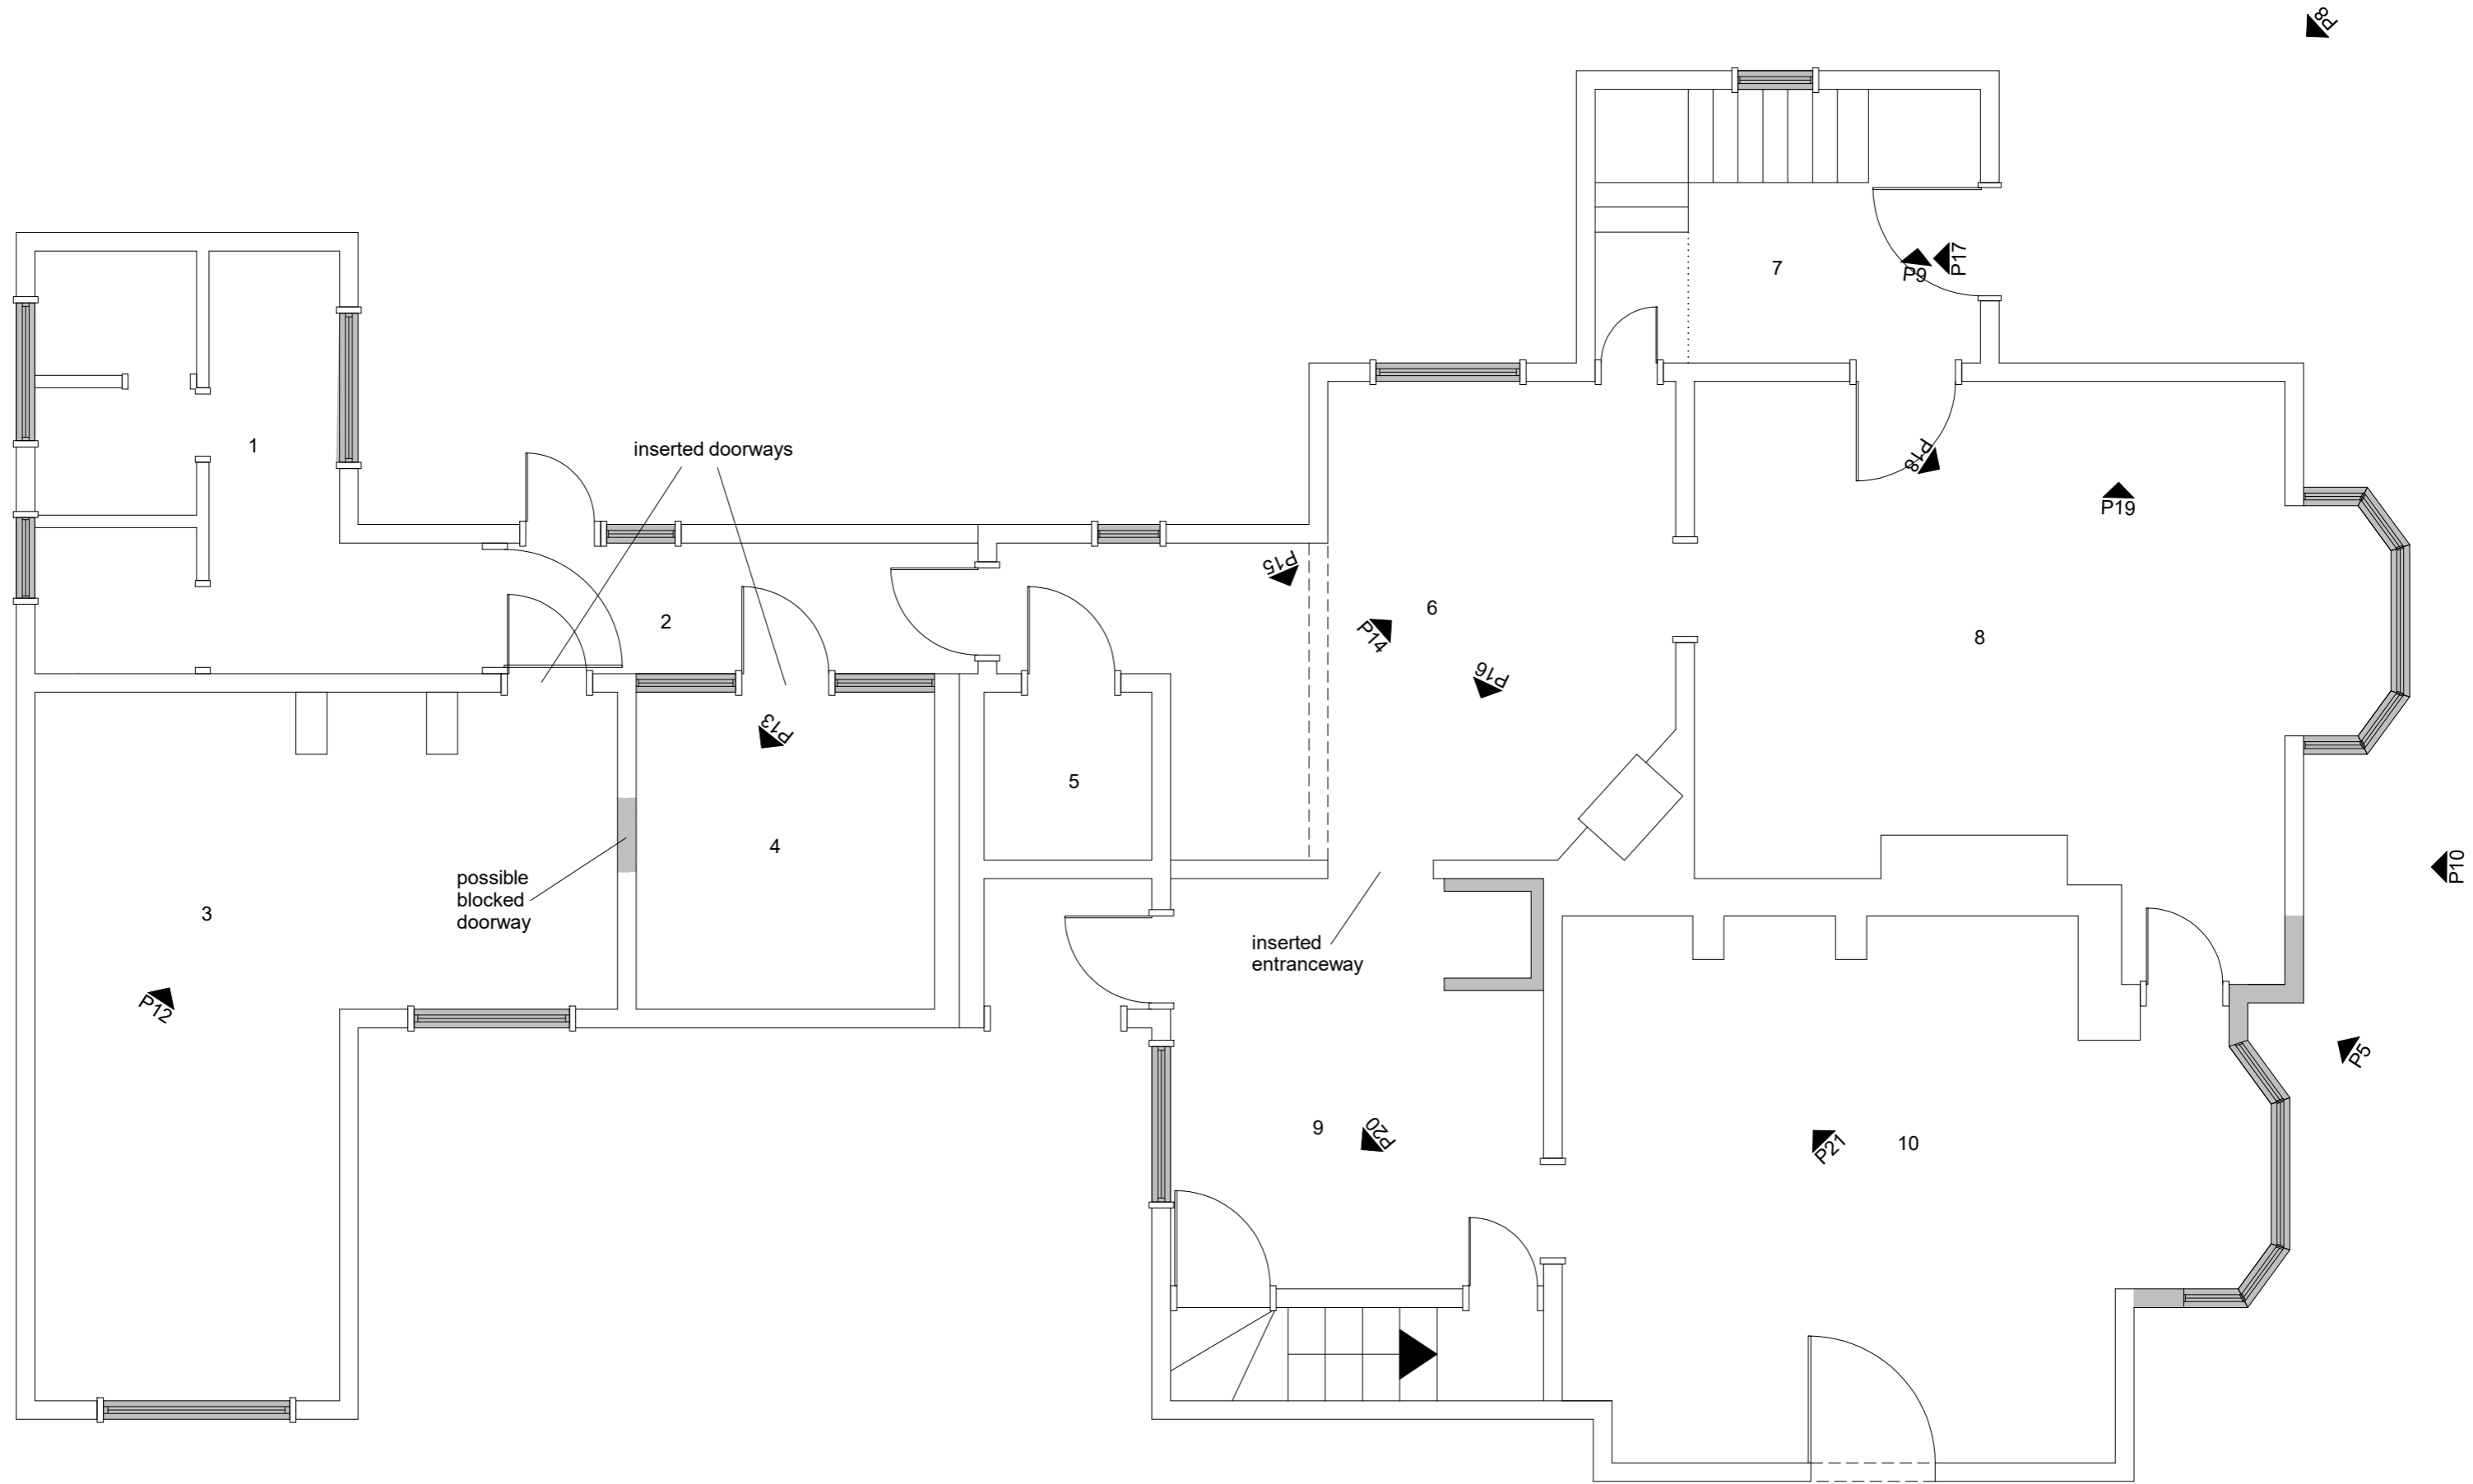
Fig 2 Ground-floor plan of building. Location and direction of photographs reproduced in text shown.

This room is a corridor in the brick-built range, connecting rooms 1, 3 and 4 with room 6 of the main building (Fig 2). It has a tiled-floor and the doors leading to the adjacent rooms are all modern and vertically-planked.

Rooms 6 and 8 are both accessed by doorways in the southern wall of this room (Fig 2). Both doorways contain four-panel unvarnished wooden doors, although the one leading to room 6 is significantly smaller in size (Photograph 17).

The north-east corner of the room contains a small boiler cupboard (Fig 2).

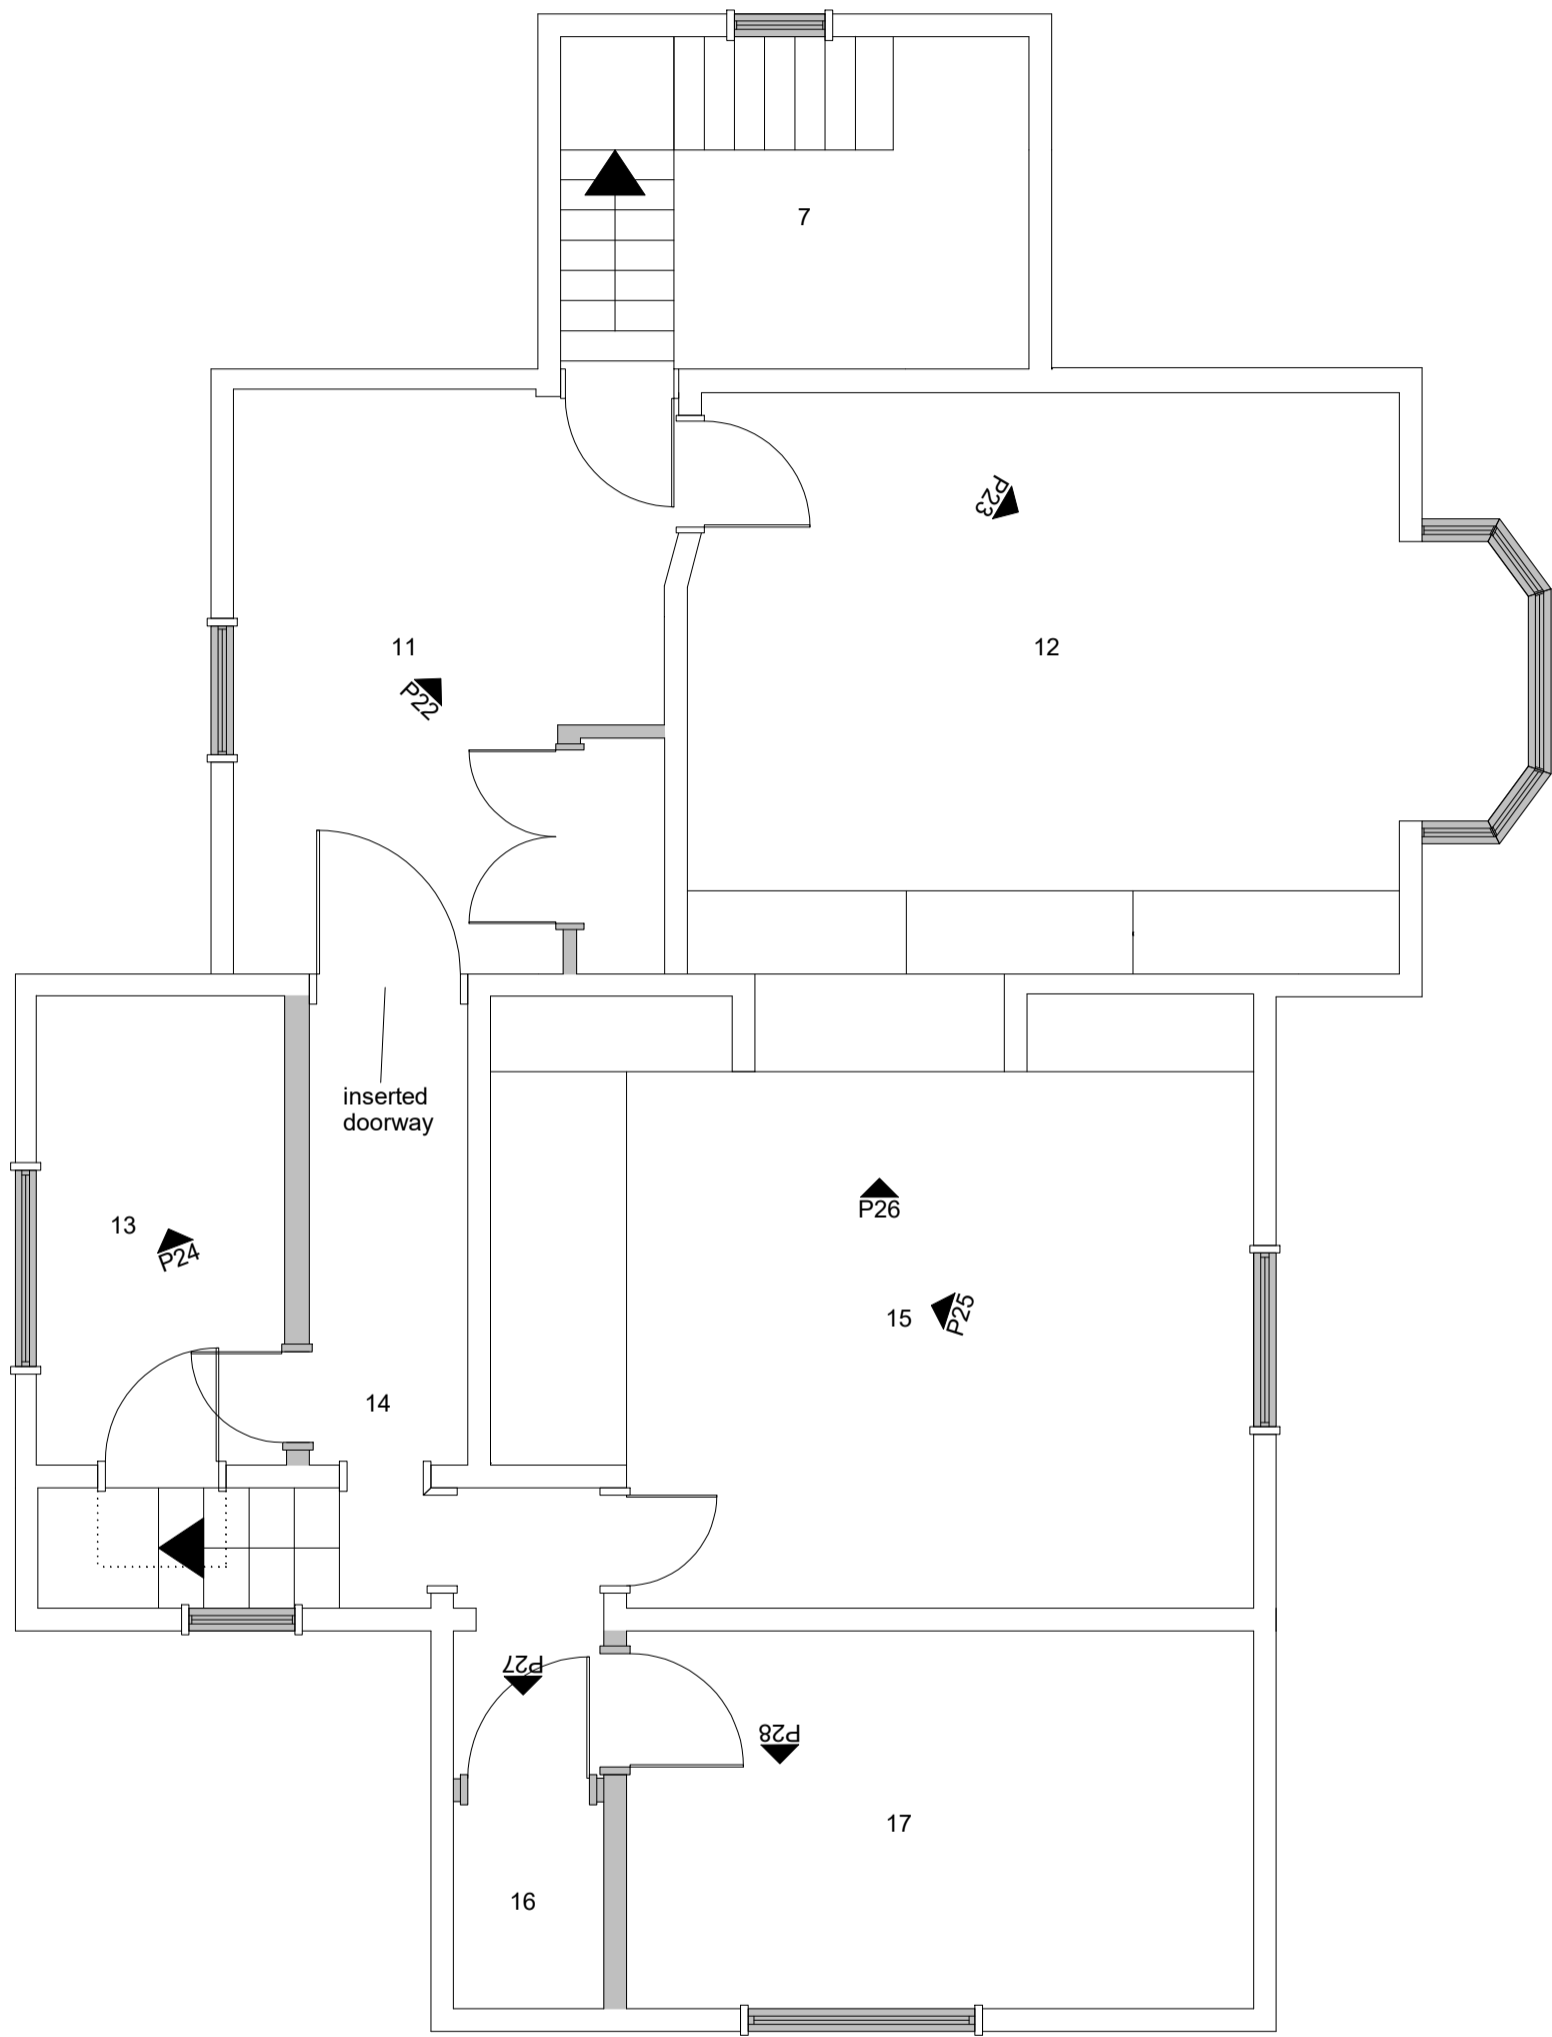
Fig 3 First-floor plan of building. Location and direction of photographs reproduced in text shown.

This room has an inserted cupboard within it, partially obscuring the chimney-stack rising from the ground-floor (Fig 3).

This room is currently outfitted as a bathroom, and is dominated by a large cast iron free-standing bath in its northern half, presumably the same one as mentioned in the 1986 sales catalogue (Photograph 24). The vertical-planked door to room 14 is modern, and indeed the entire dividing wall between rooms 13 and 14 is probably a later insertion (Fig 3).

This room is part of the suspended section of the first-floor, over the veranda at the south end of the building (Fig 3). It is a small, walk-in, cupboard with hooks on its southern wall. This room has suffered significant damage as the roof above it has partially collapsed, resulting in severe water damage particularly to its western wall (Photograph 27). The dividing wall between this room and room 17 is probably a later addition.

This room, like room 16, is suspended above the veranda at the south of the building (Fig 3). A significant section of the plaster has collapsed from the ceiling, exposing the lath and plaster beneath (Photograph 28).

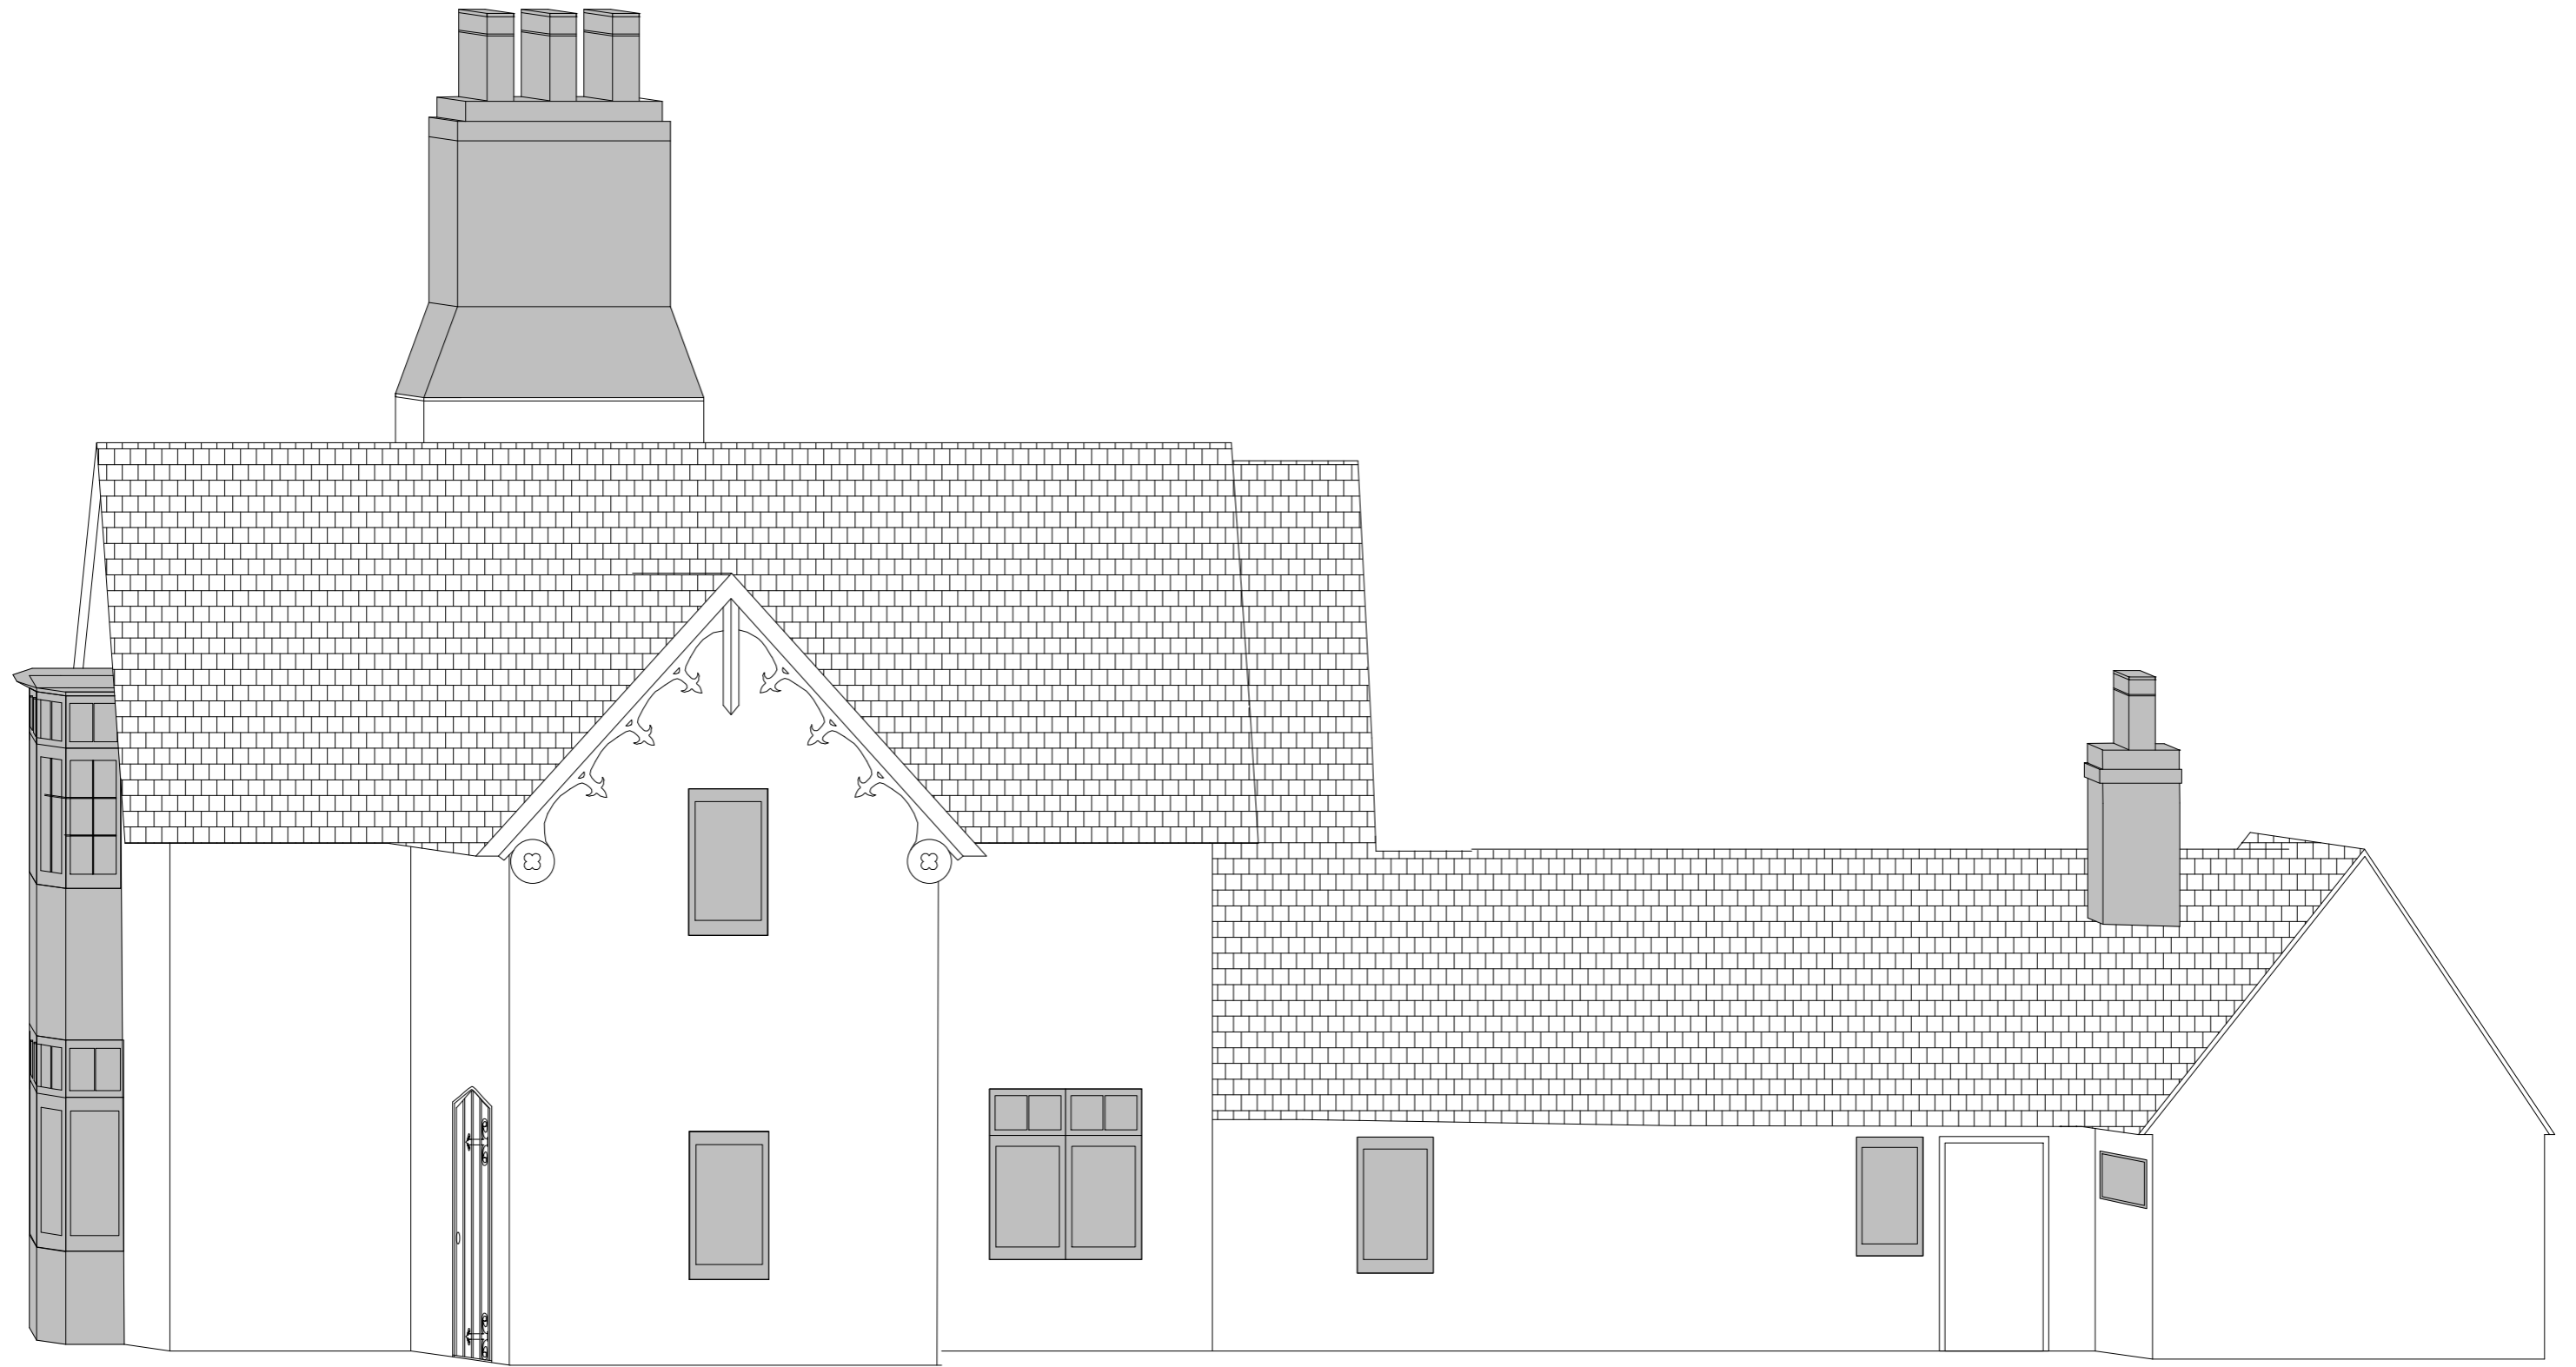
Fig 6 Northern elevation of building.

The northern elevation of the house has two windows on the single-storey range; only the frames survive so their exact form is unclear. Also on the single-storey range is a doorway containing a damaged vertically-planked modern door (Fig 6). On the two-storey, north-facing gable end are two more windows, again with only the frames

remaining (Photograph 8). This northern facing gable of the two-storey range has damaged decorative bargeboards containing *fleurs-de-lys* patterns (Photograph 8). A six-light casement/awning window survives on this elevation to the west of the north-facing gable (Fig 6).
