**Historic building recording at
Princes Halfyards,
Stebbing Road, Felsted,
Essex CM6 3LG**

**report prepared by
Mark Baister**

CAT project ref.: 2020/07n
NGR: TL 68245 22072 (c)
Planning reference: UTT/19/1235/FUL
ECC code: PHFL20
OASIS project id: colchest3-400269

CAT Report 1601
October 2020

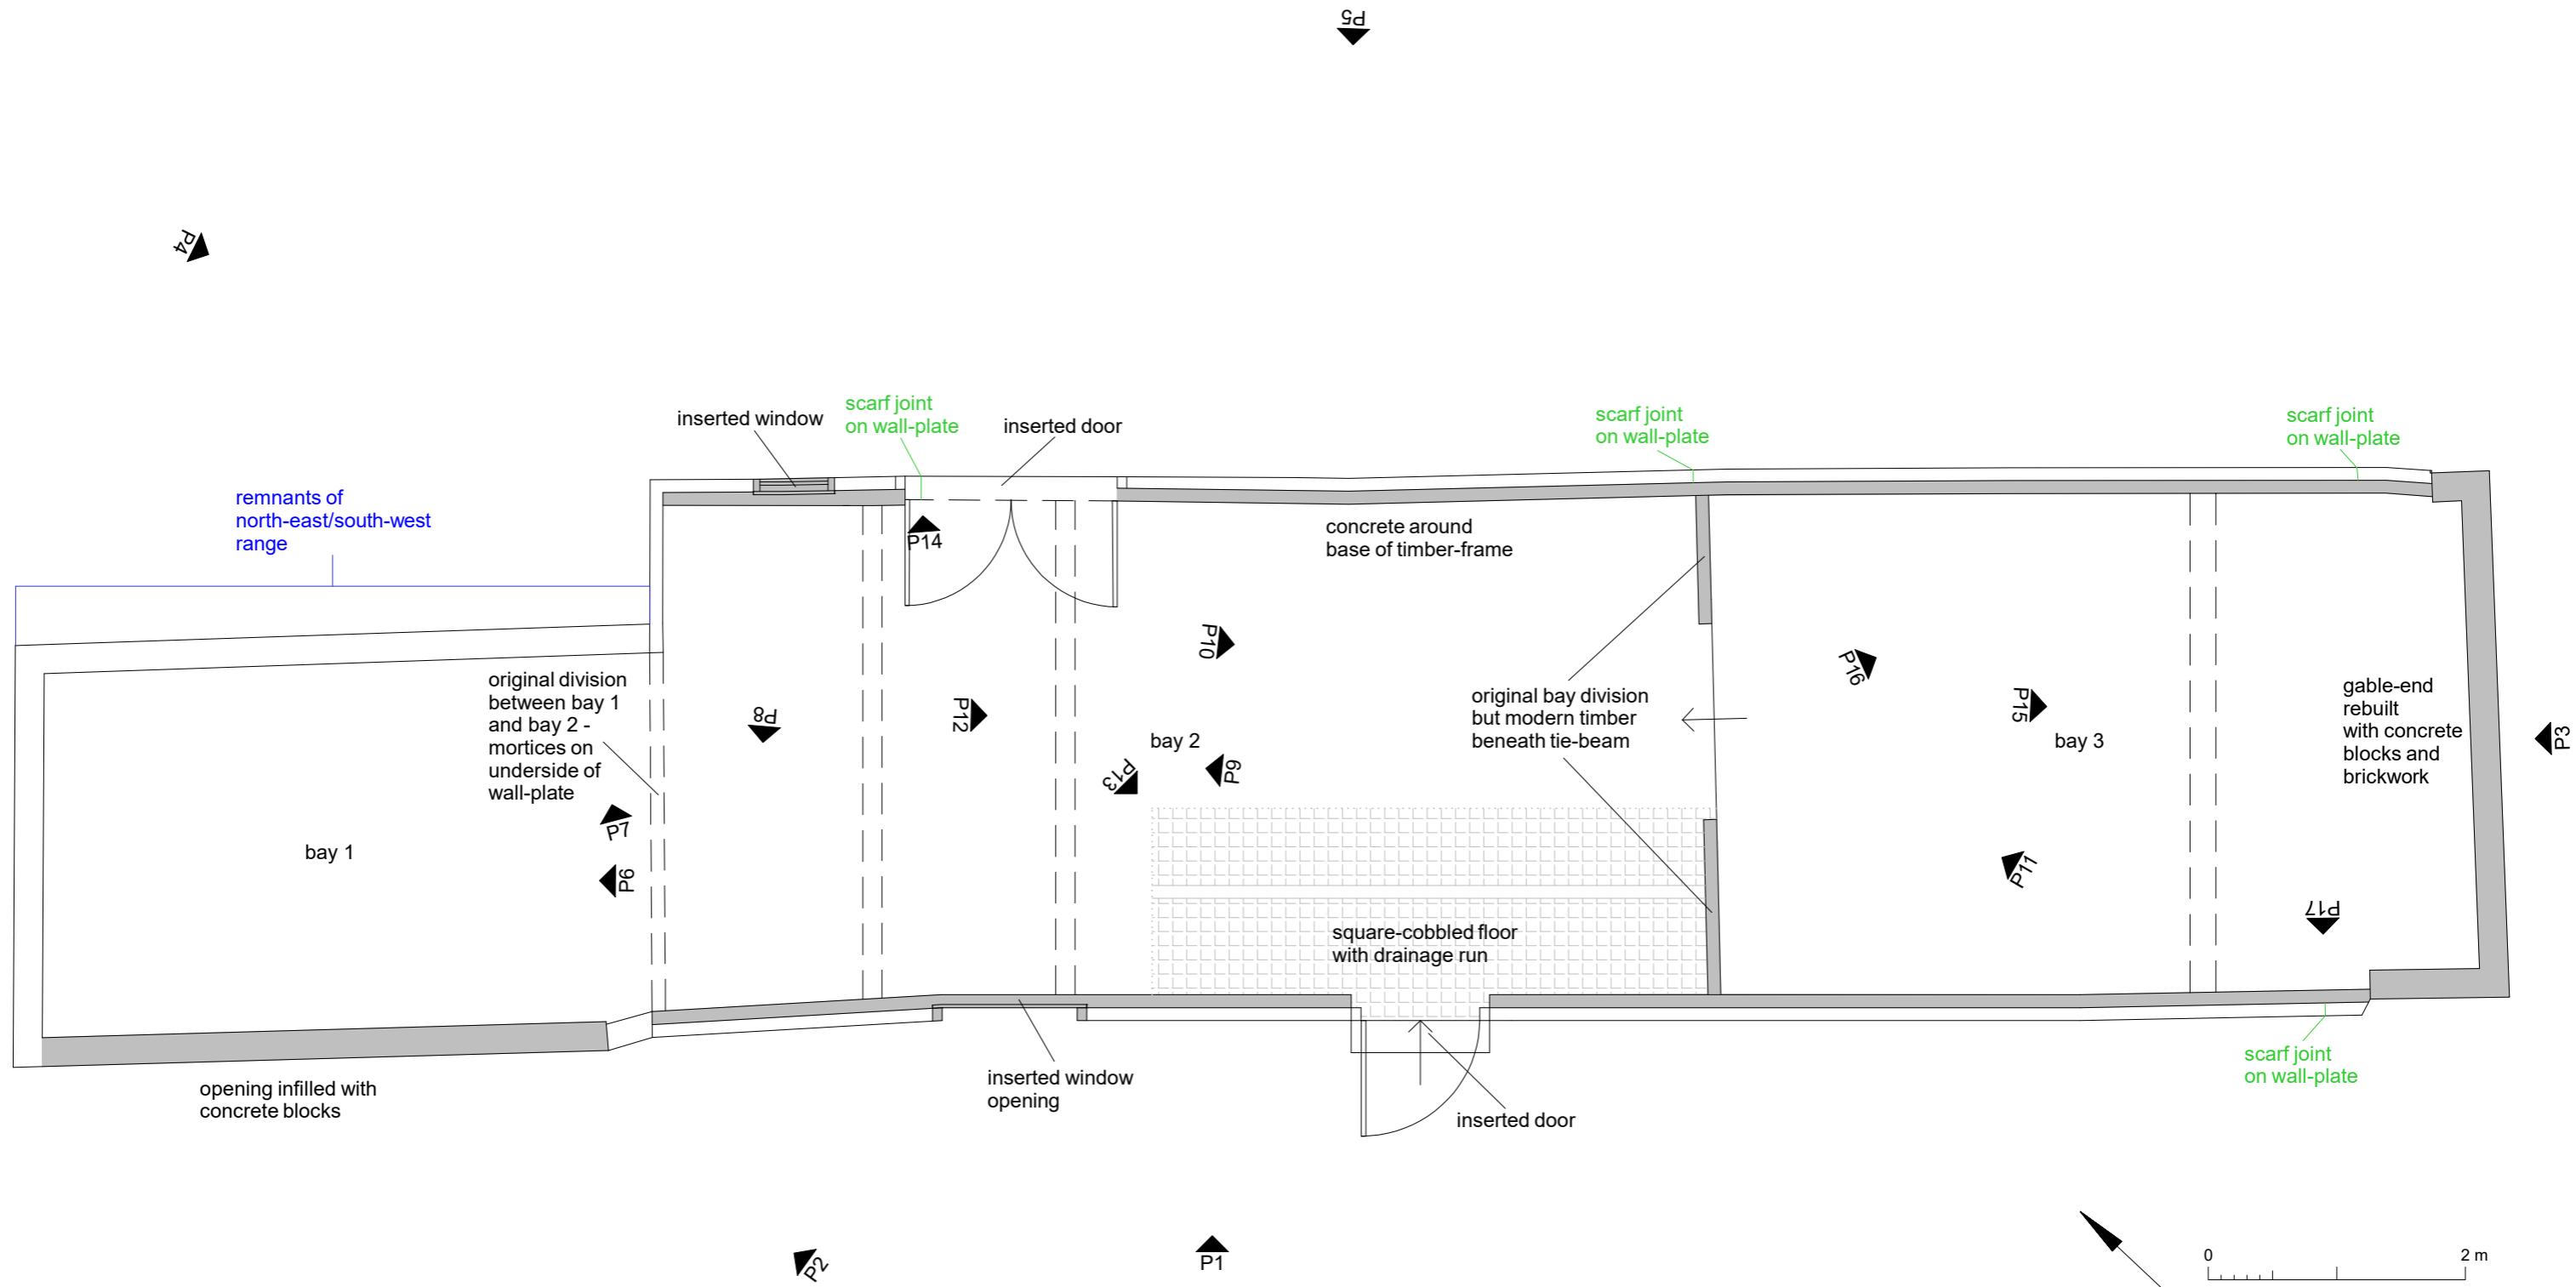
Fig 2 Ground-floor plan of outbuilding, with location and directions of photographs reproduced in text shown. Modern additions in grey.

Although, as discussed above, the northern element of this building clearly used to belong to a separate structure, for the ease of description the outbuilding has been divided into 3 bays, all of which vary in their construction methods (Fig 2).

Two scarf joints were observed on the wall-plates of this bay. One is above the double-door on the north-east elevation and, although partially obscured, appears to be a face-halved and bladed scarf with two edge-pegs (Photograph 14). The other scarf joint is just to the north of the tie-beam separating bays 2 and 3, and is a much more rudimentary edge-halved scarf with square abutments (Fig 2).

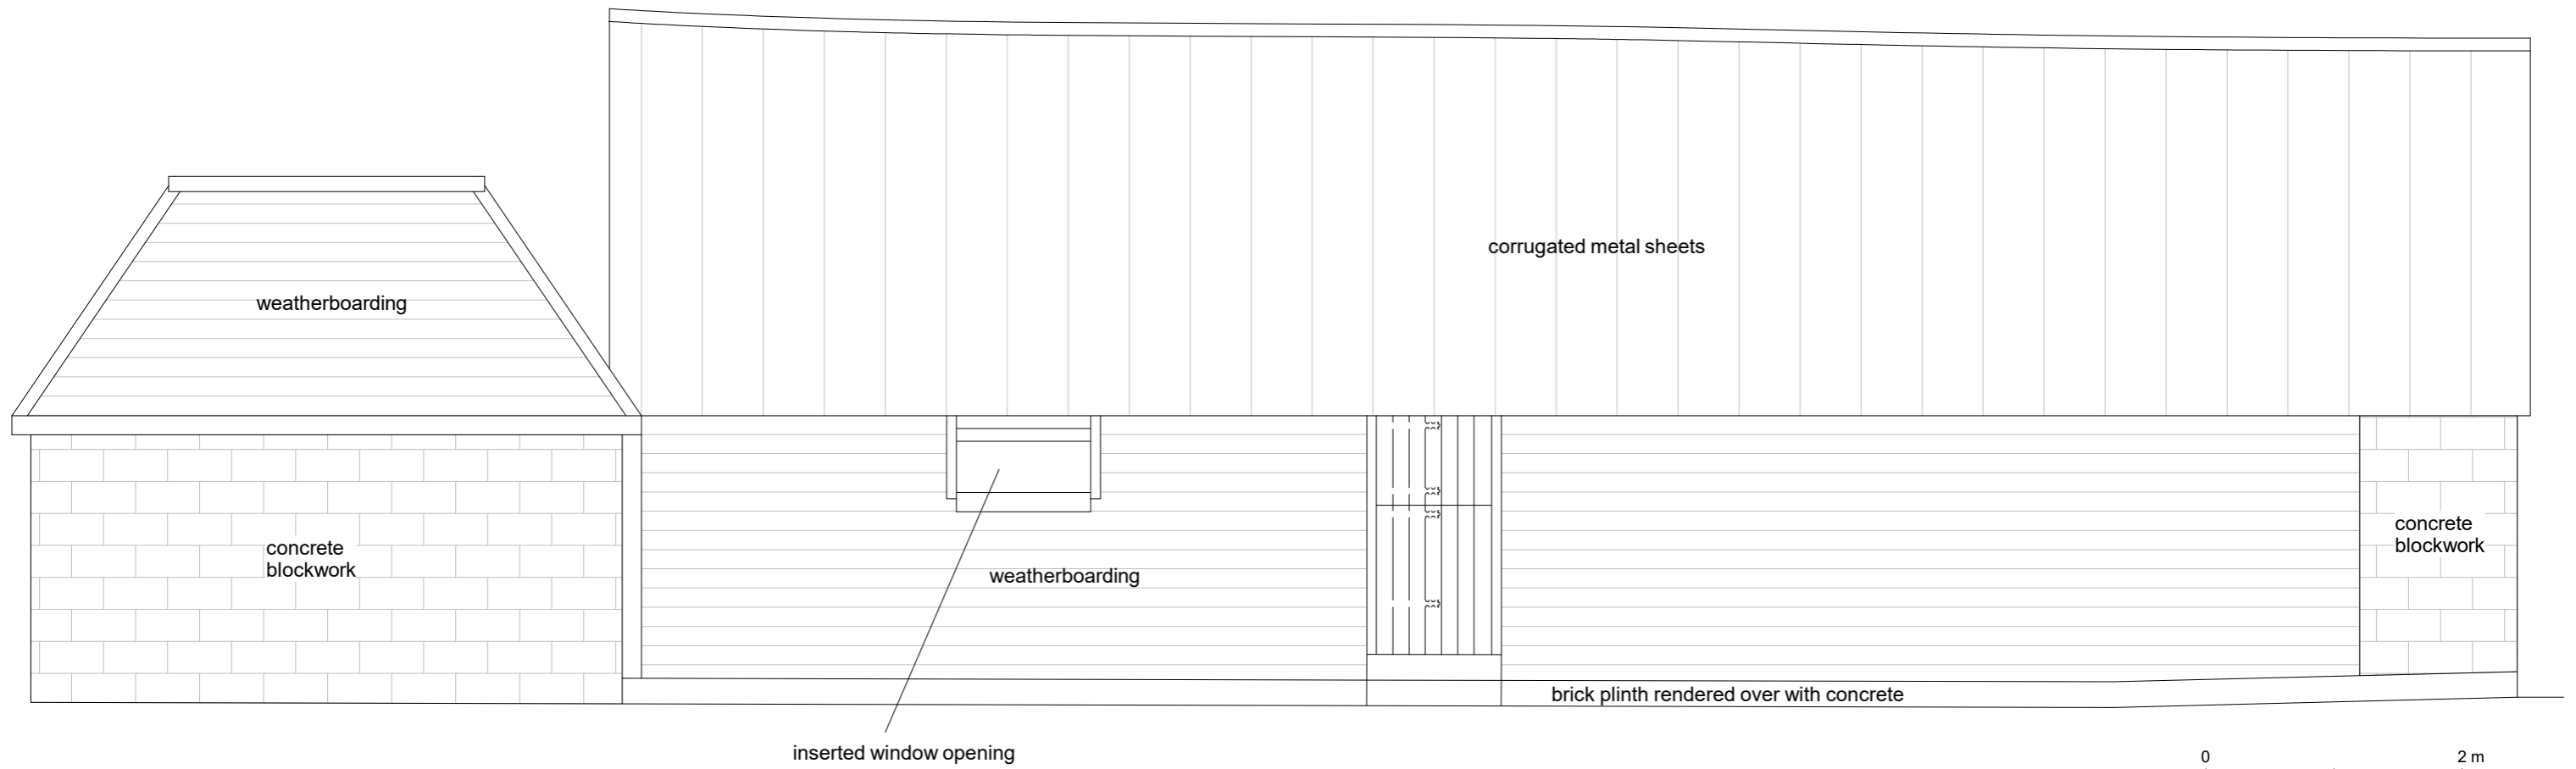
Fig 3 South-west elevation of outbuilding.

The structure is in significant disrepair and has been the subject of at least one phase of rebuilding, with the south-east gable-end having been almost completely replaced with concrete blocks and brickwork (Photograph 3). In addition, the south-west elevation of the building's northern bay (where originally it would have joined with the since demolished range; see above) has been in-filled, again with concrete blocks (Photograph 2).

The weatherboarding attached to the timber-frame is in quite a dilapidated state. In many places it has fallen away entirely, exposing studs and posts which are themselves quite damaged, particularly to the south of the building (Photograph 1). The south-west elevation of the outbuilding has a stable-door filled entrance and an internally boarded up window opening (Photograph 1). The plinth on this elevation is almost entirely obscured and covered by concrete.

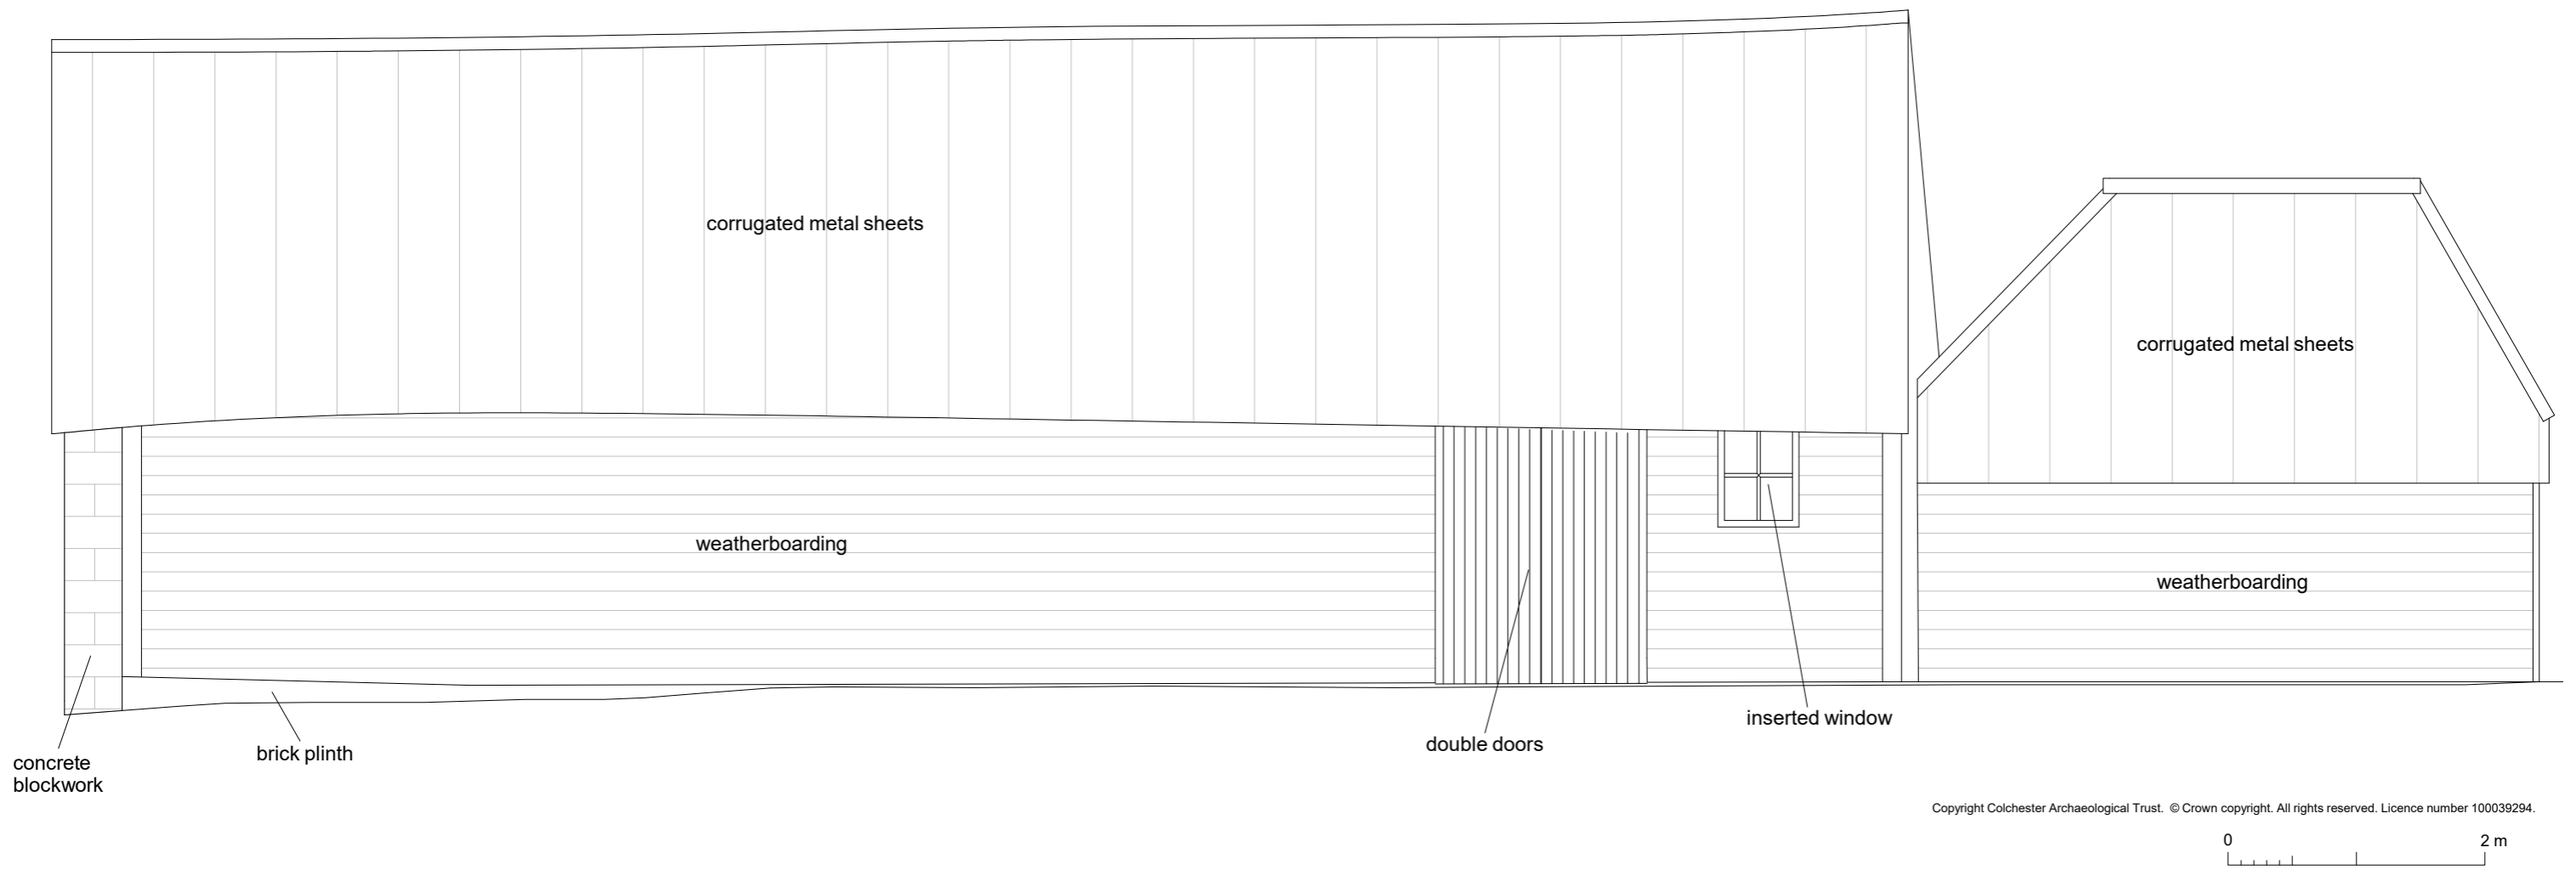
Fig 4 North-east elevation of outbuilding.

The north-east elevation of the outbuilding (Photograph 5) has an entrance filled with a vertically-planked double door, adjacent to a small inserted four-light window (which is boarded up internally).

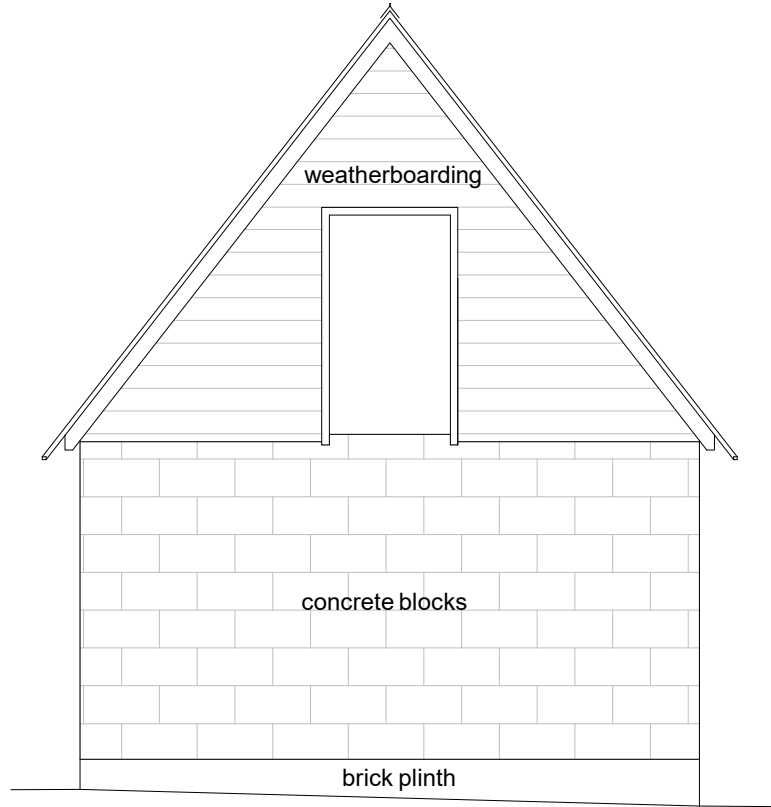
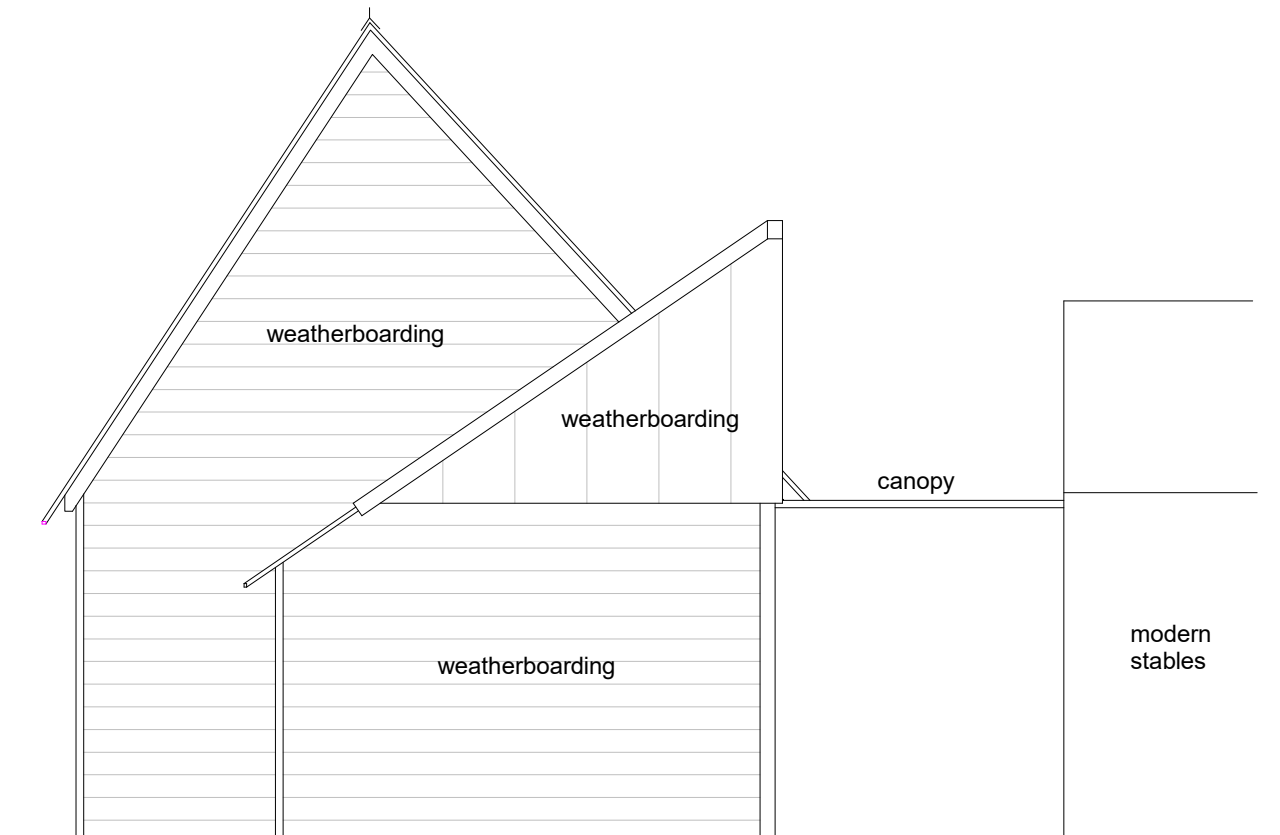
Fig 5 North-west and south-east elevations of outbuilding.

The lower register of the south-east elevation of the outbuilding is entirely constructed of concrete blocks and brickwork, and in the weatherboarded gable is a window opening covered in corrugated plastic (Photograph 3).

The north-west elevation of the outbuilding is largely obscured by overgrowth, but appears to be featureless (Photograph 4; Fig 5).
