**Historic building recording  
of Maldon Wycke Barn,  
Spital Road, Maldon,  
Essex, CM9 6SQ**

**April 2021**

**CAT Report 1675**  
May 2021

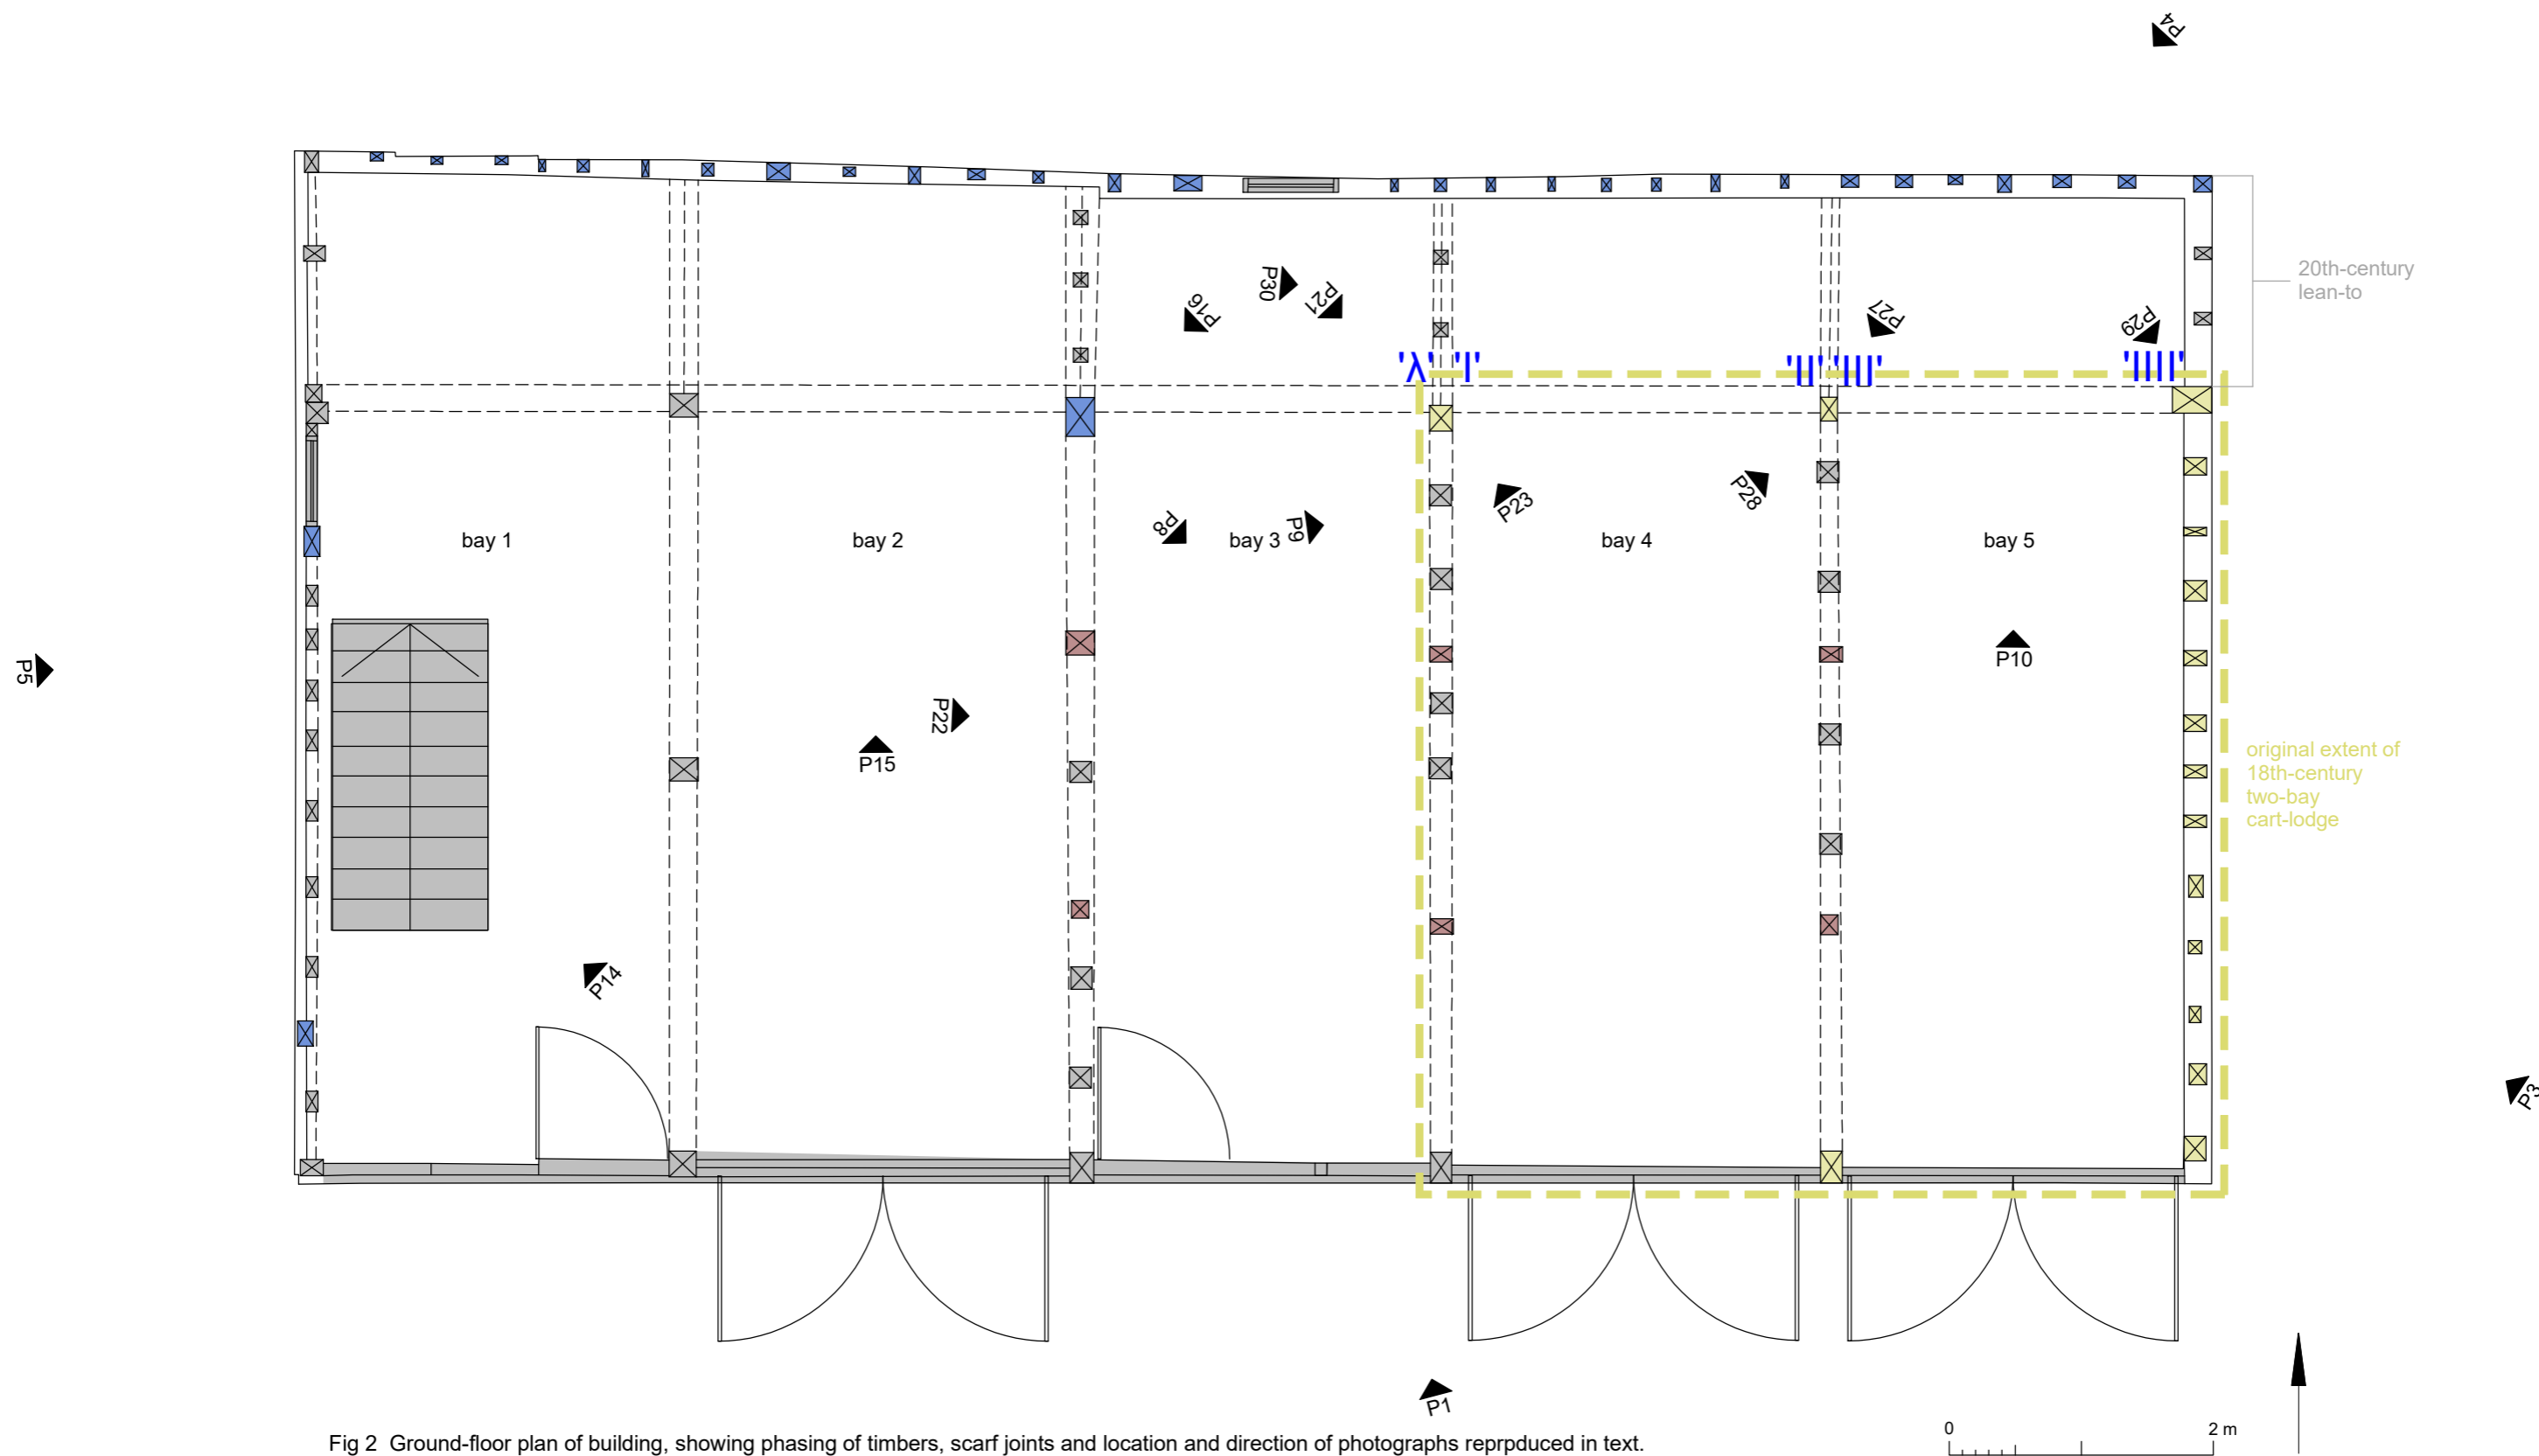
The principal-post on the northern elevation between bays 3 and 4 has two carpenter's marks on its northern face. There is a 'I' on its eastern side, corresponding with the brace going into bay 4, and a 'λ' on its western side (Fig 2). Present on the southern face of this post is an empty mortice that would probably have been in use before the building's extension (Photograph 23).

Of note, however, is that these features only appear within the eastern two bays (bays 4 and 5). Additionally, the carpenter's marks visible on the northern principal-posts in these bays are sequential and appear original, and do not continue beyond the post between bays 3 and 4 (pg 14, Fig 2). Based on this, it seems likely that the original cart-lodge, prior to its extension and the addition of a second-storey, was only two bays wide (i.e. it only consisted of bay 4 and 5; Fig 2). The subsequent extension of the building added bays 1-3, and the entire second-storey, along with a trapdoor access in bay 3 (pg 13).

Fig 2 Ground-floor plan of building, showing phasing of timbers, scarf joints and location and direction of photographs reproduced in text.

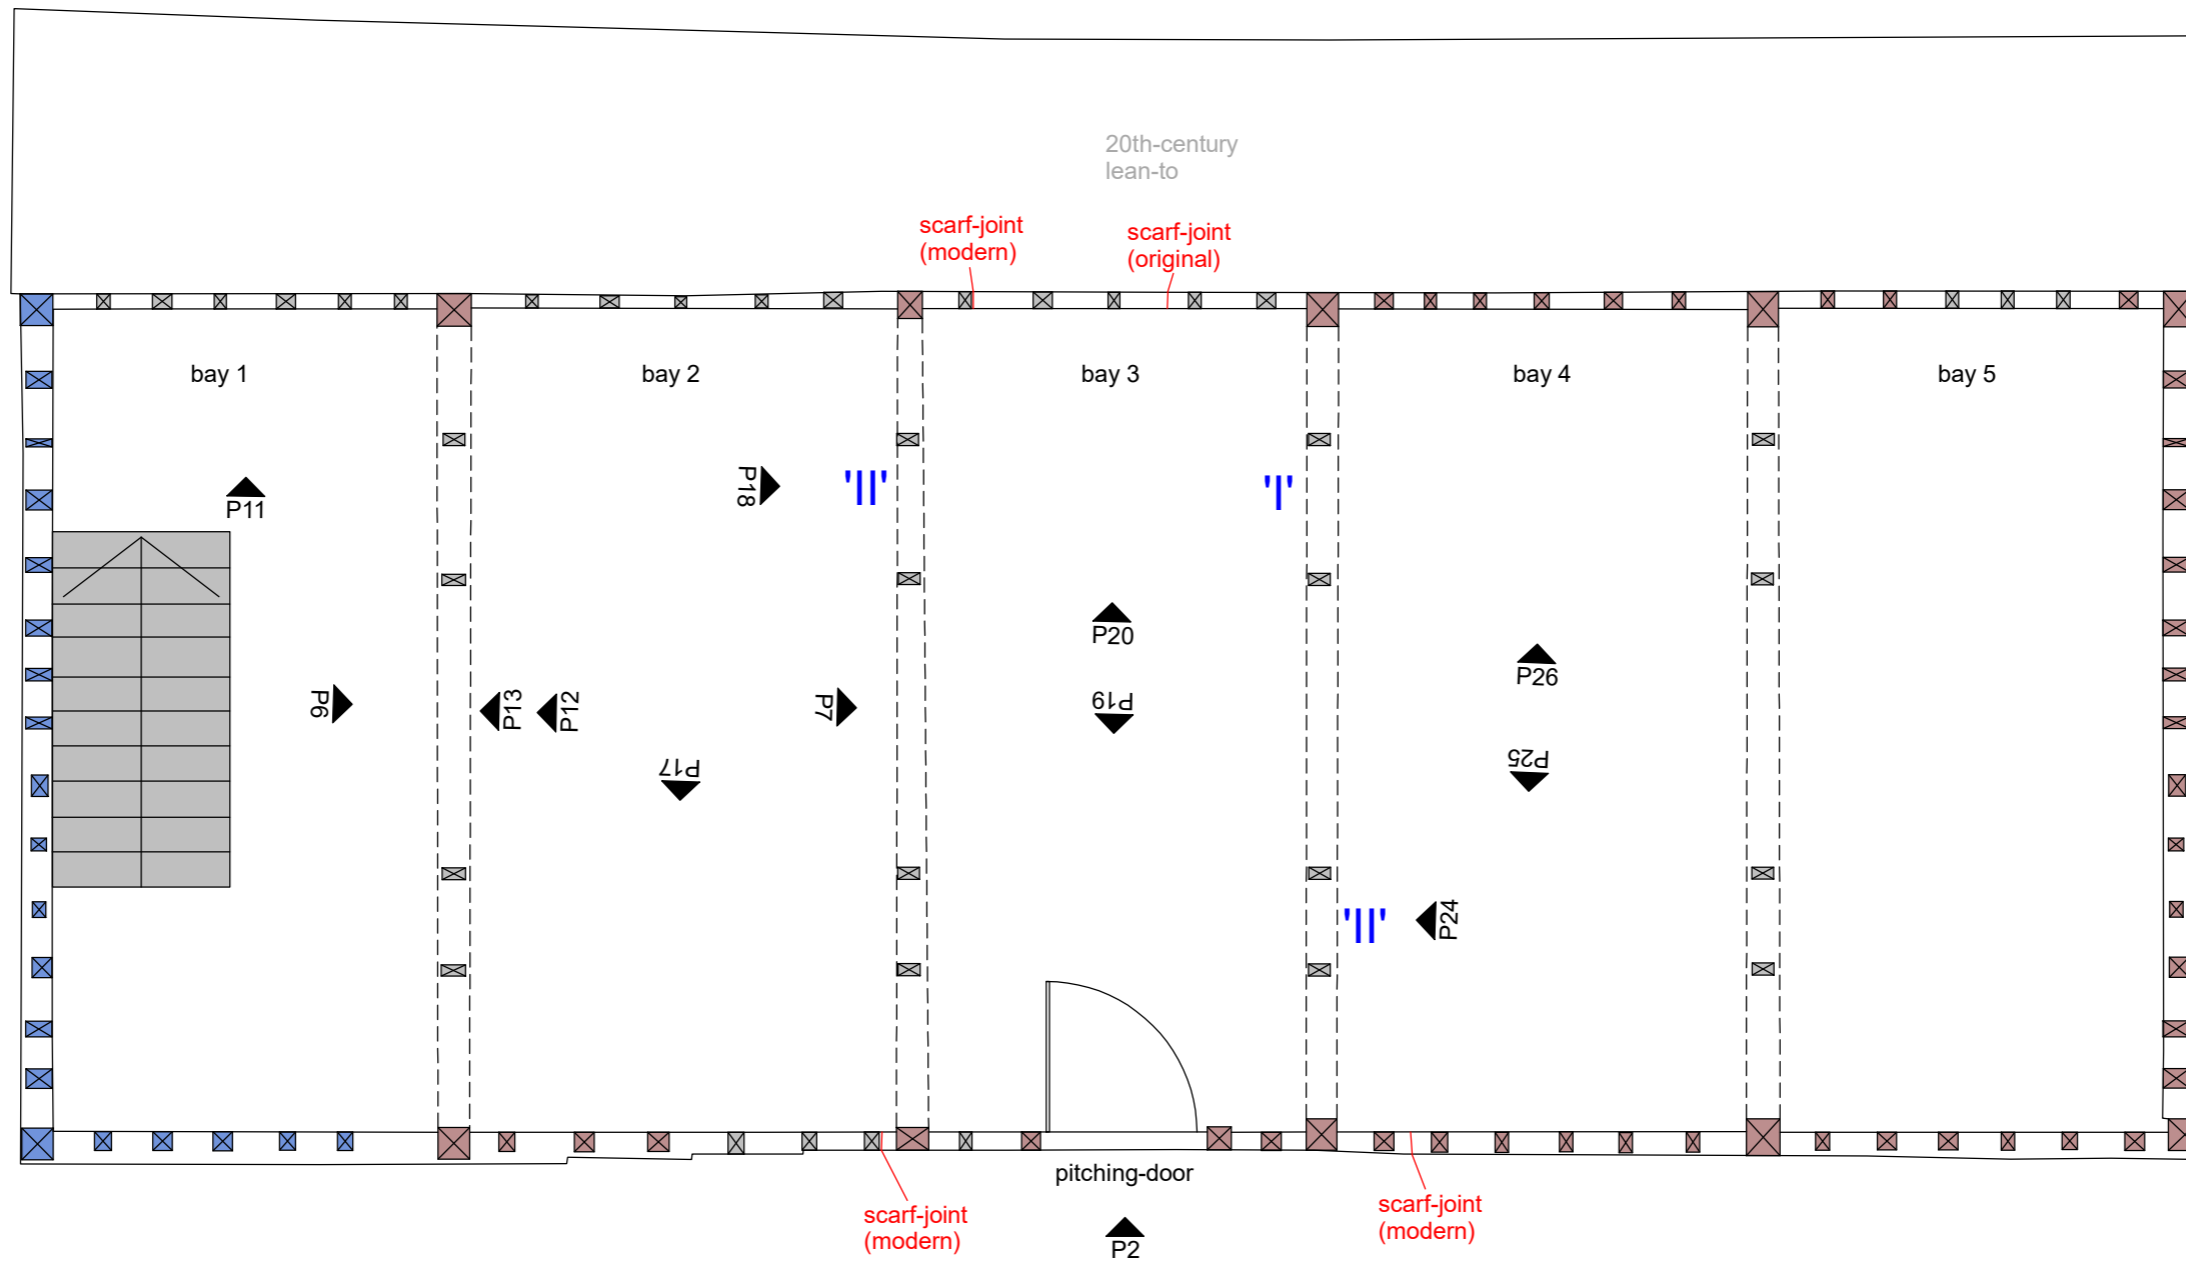
Fig 3 First-floor plan of building, showing phasing of timbers, scarf joints and location and direction of photographs reproduced in text.

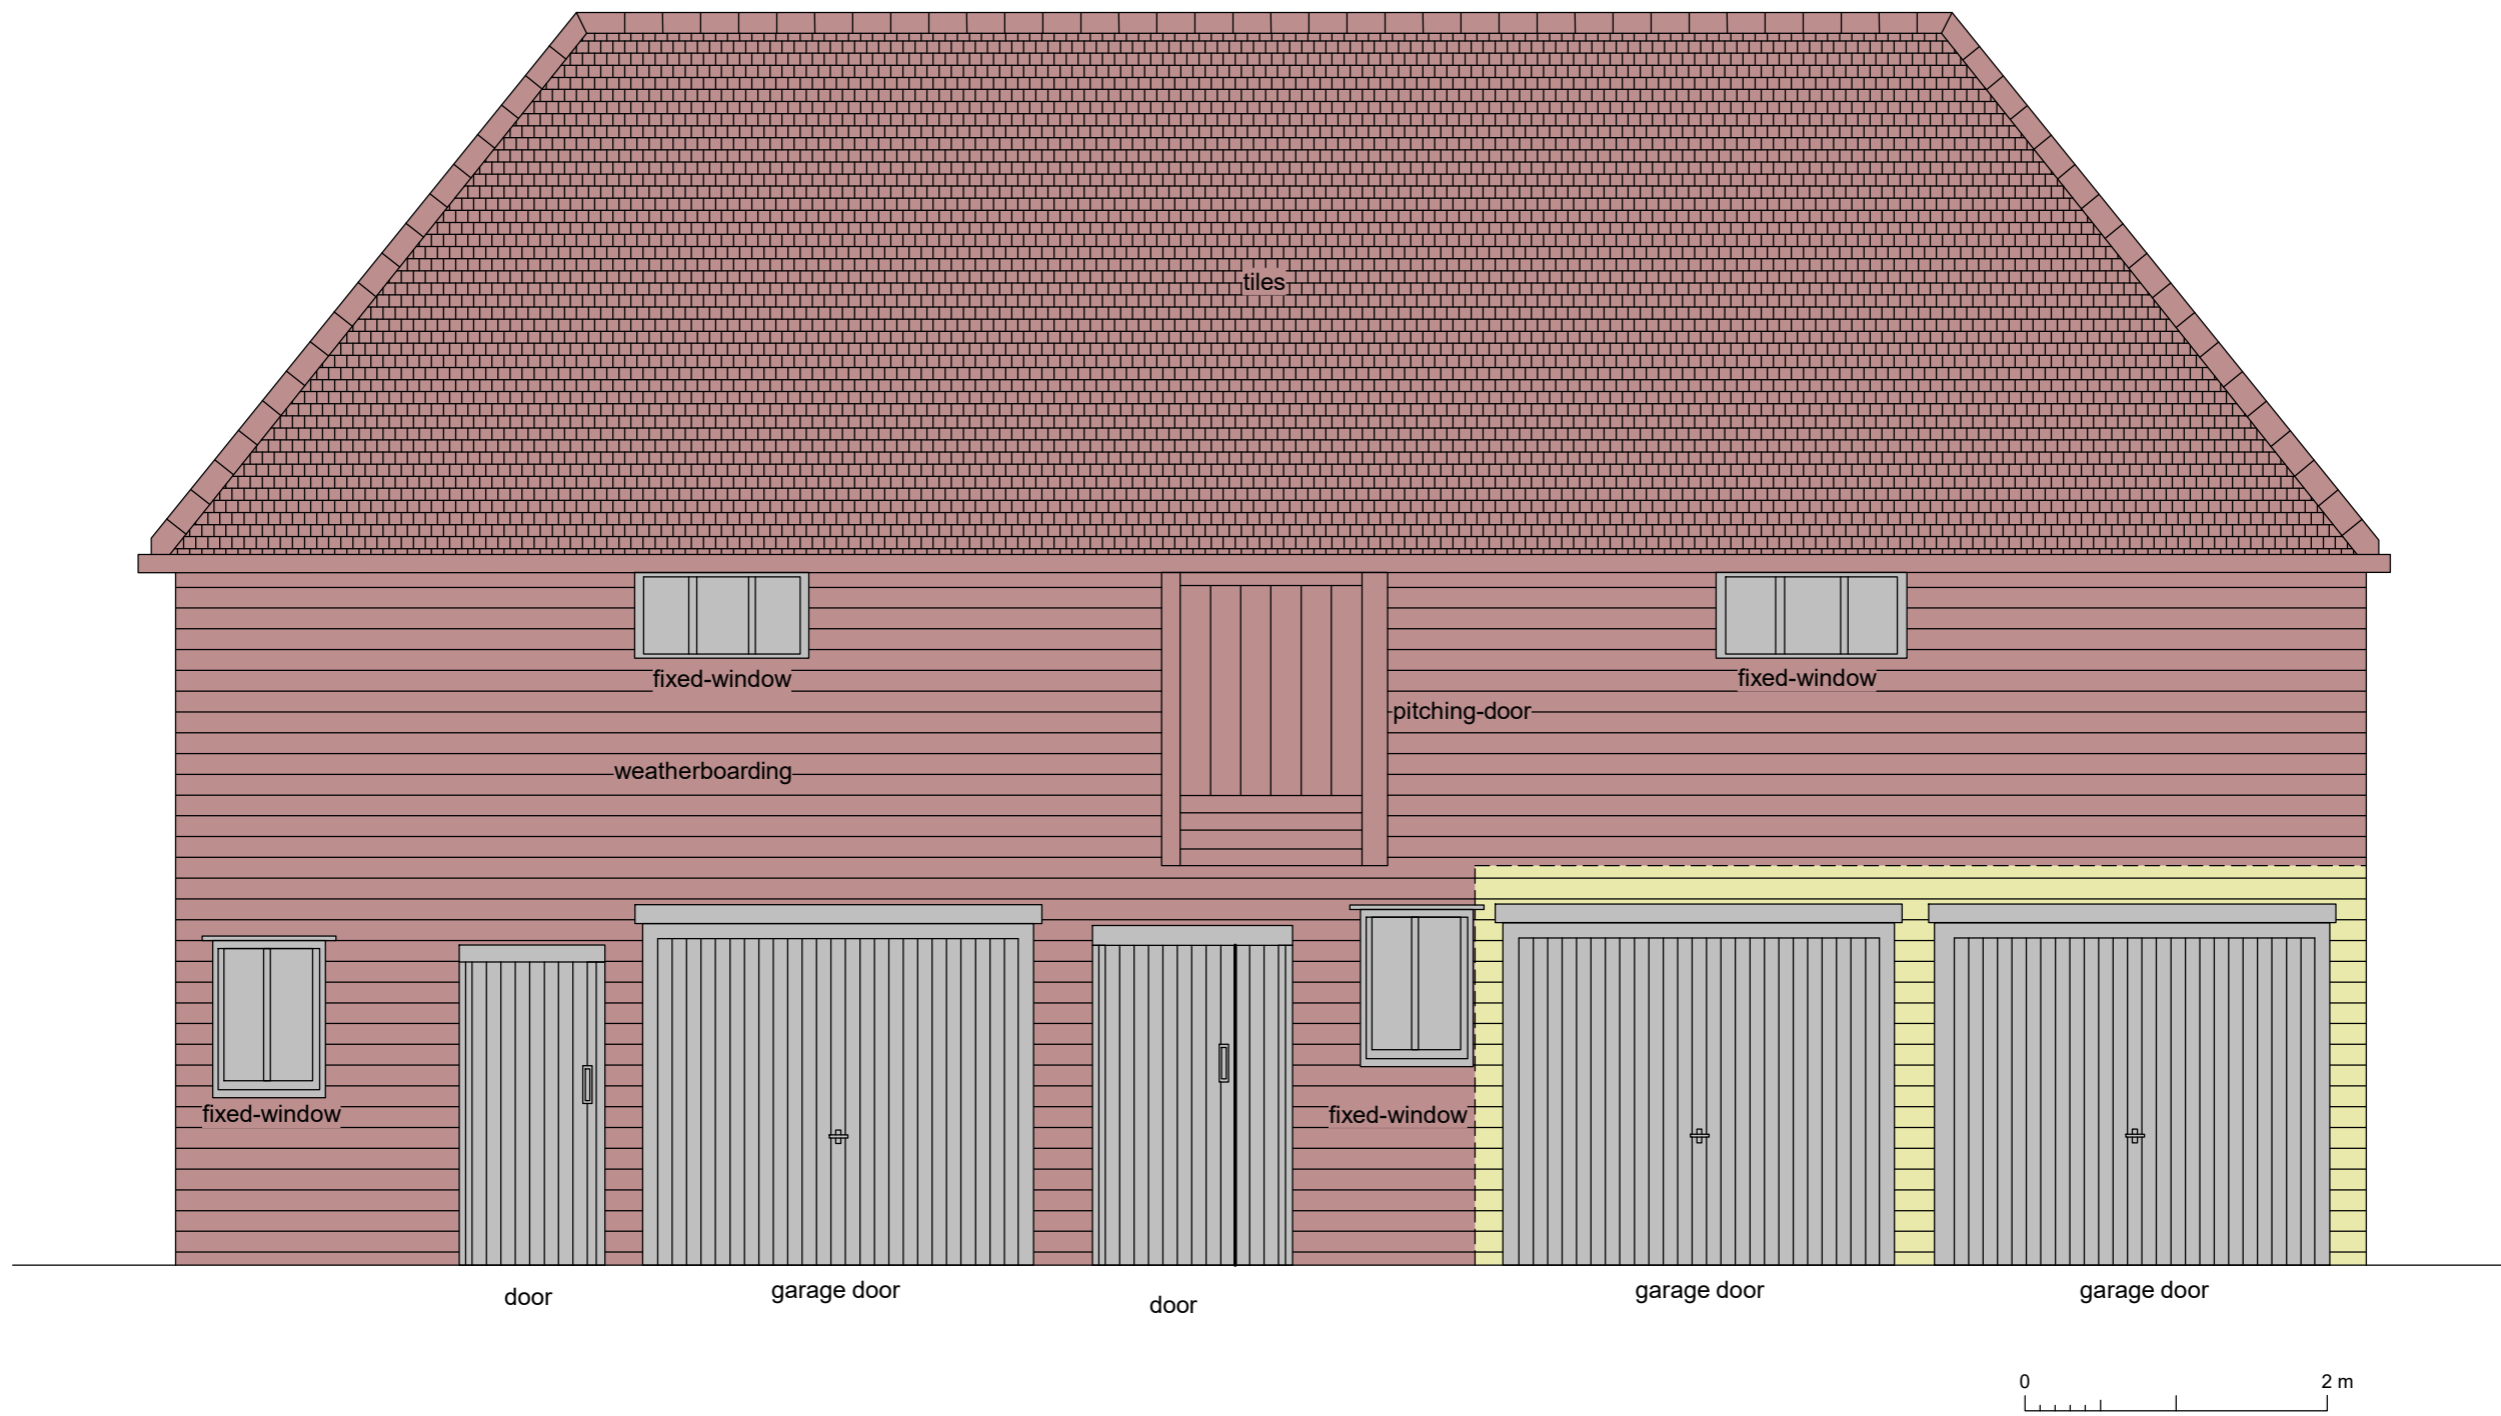
Bay 4 is largely constructed of hand-sawn, original, timber. It does, however, contain an inserted garage door on its southern elevation (Fig 4). A rudimentary modern edge-halved scarf joint on the southern elevation joins a modern machine-cut timber to an original hand-sawn one to form the wall-plate (Photograph 25). Also present on the southern elevation at the first-floor level is a modern fixed window. The northern elevation at this level also contains a modern window opening, but it has since been weatherboarded over (Photograph 26).

Fig 4 Southern elevation of building, with phasing (phasing shows dates of the structural elements, not the weatherboarding).

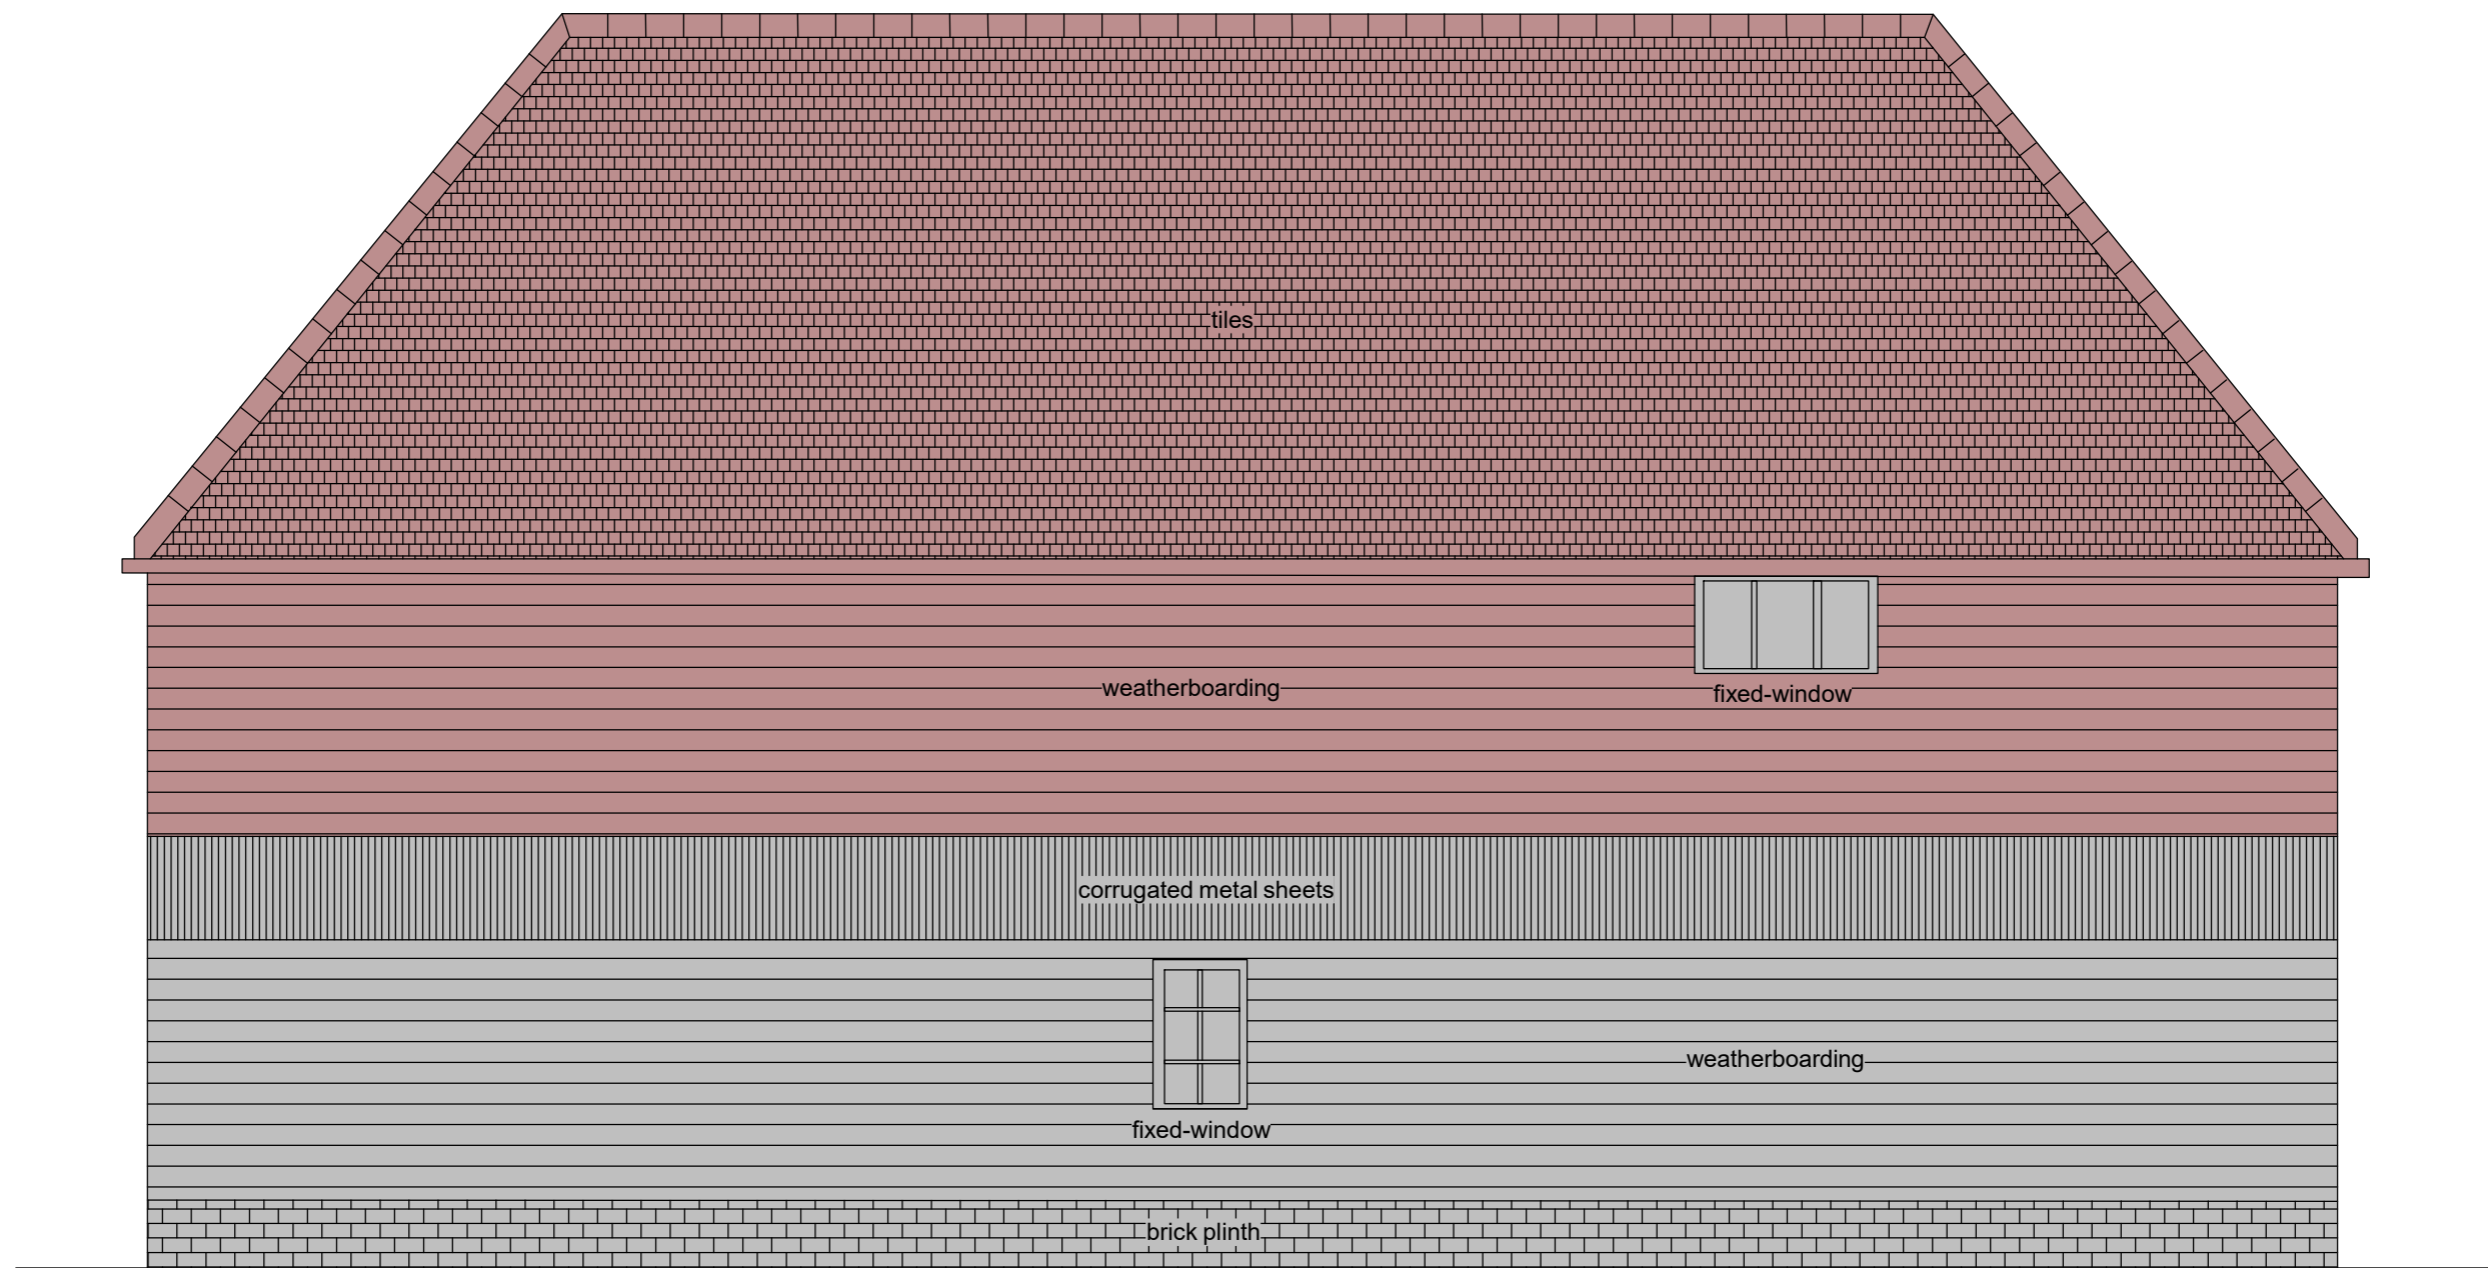
Fig 5 Northern elevation of building, with phasing (phasing shows dates of the structural elements, not the weatherboarding).

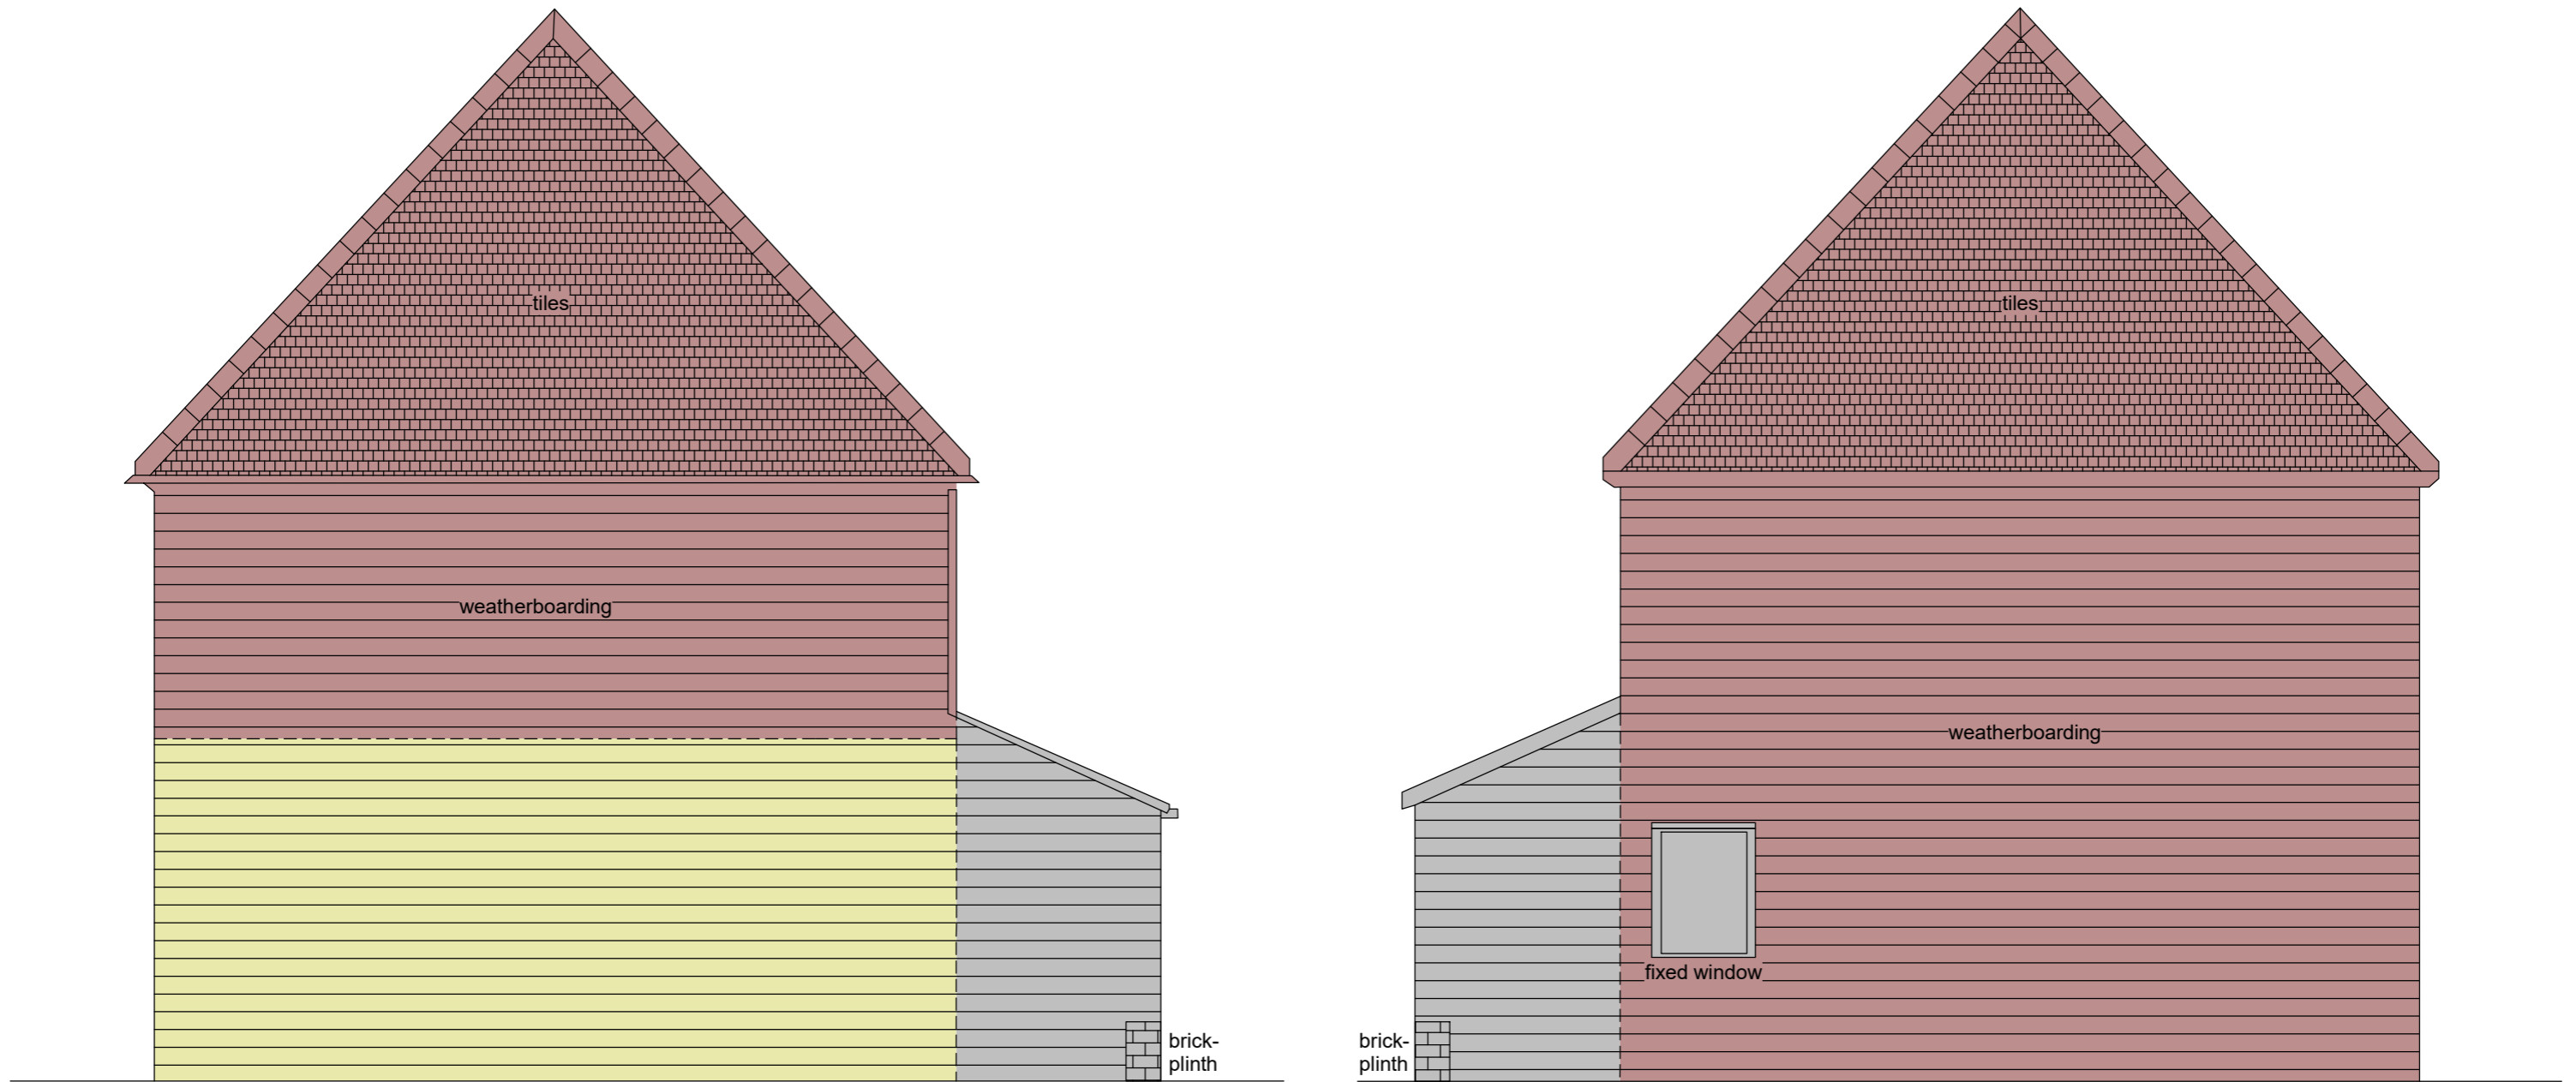
Fig 6 Eastern and western elevations of building, with phasing (phasing shows dates of the structural elements, not the weatherboarding).

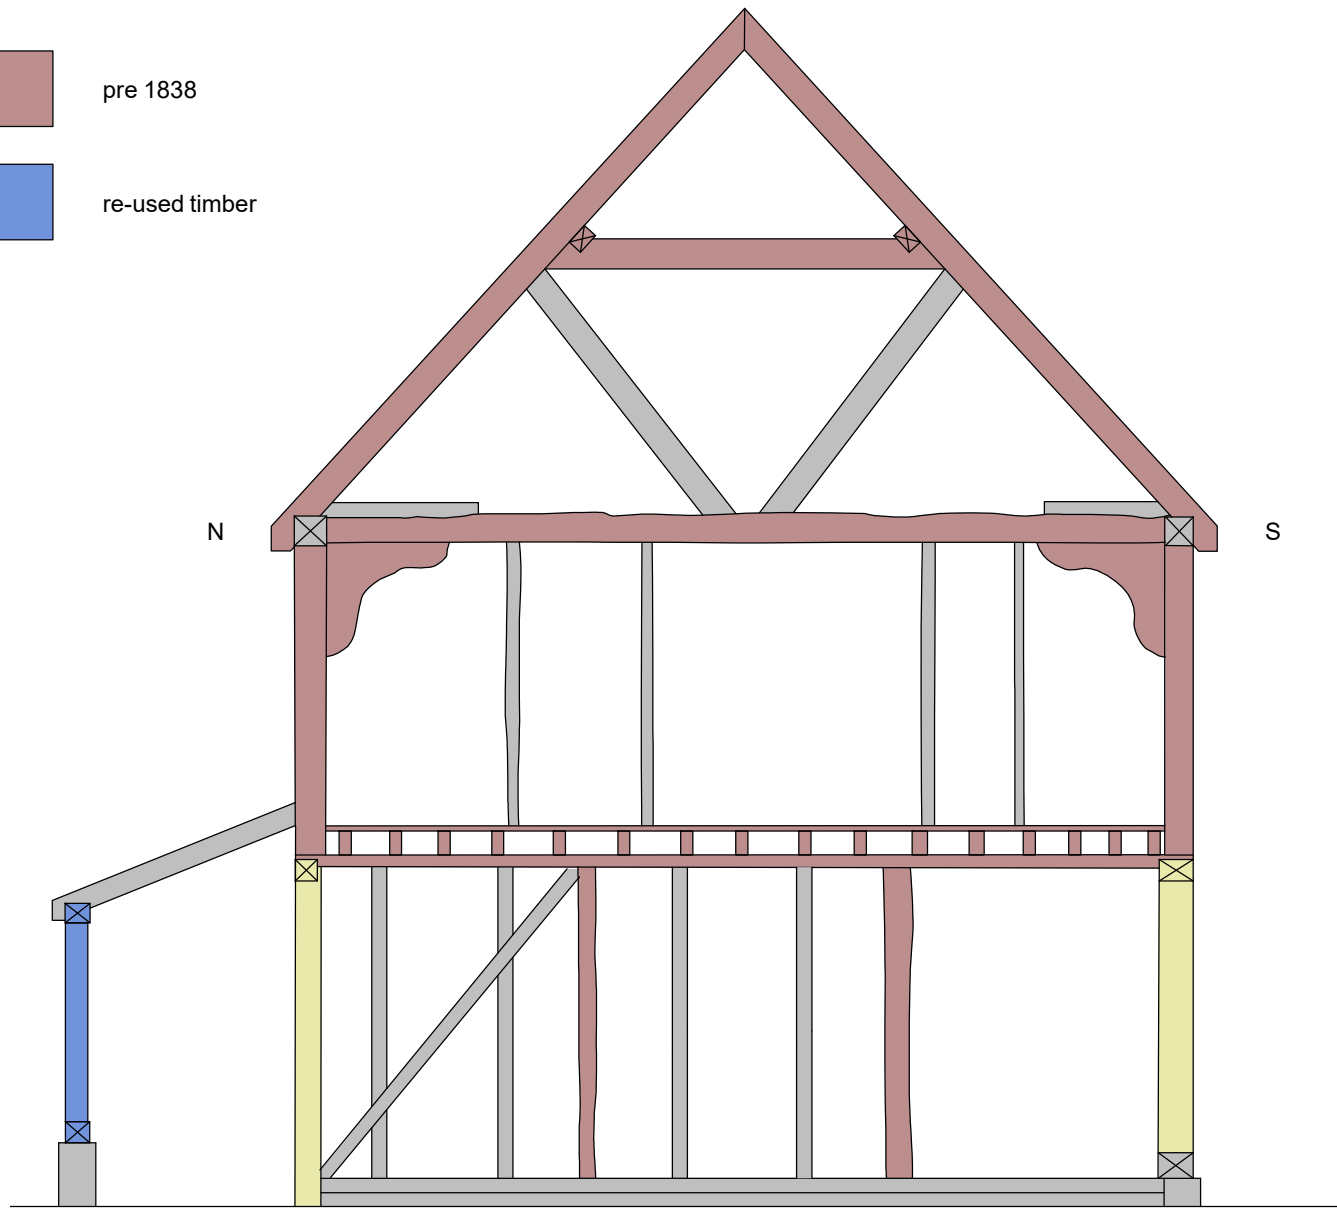
Fig 7 Truss between bays 4 and 5, with phasing.
