**Historic building recording
at Old Lodge Farm,
White Hart Lane,
Springfield, Essex
May 2013**

CAT project ref: 13/04i
NGR: TL 7289 0990 (c)
ECC HEM code: SFOLF13
Chelmsford Museum
accession code: CHMER 2013.077

CAT Report 705
May 2013

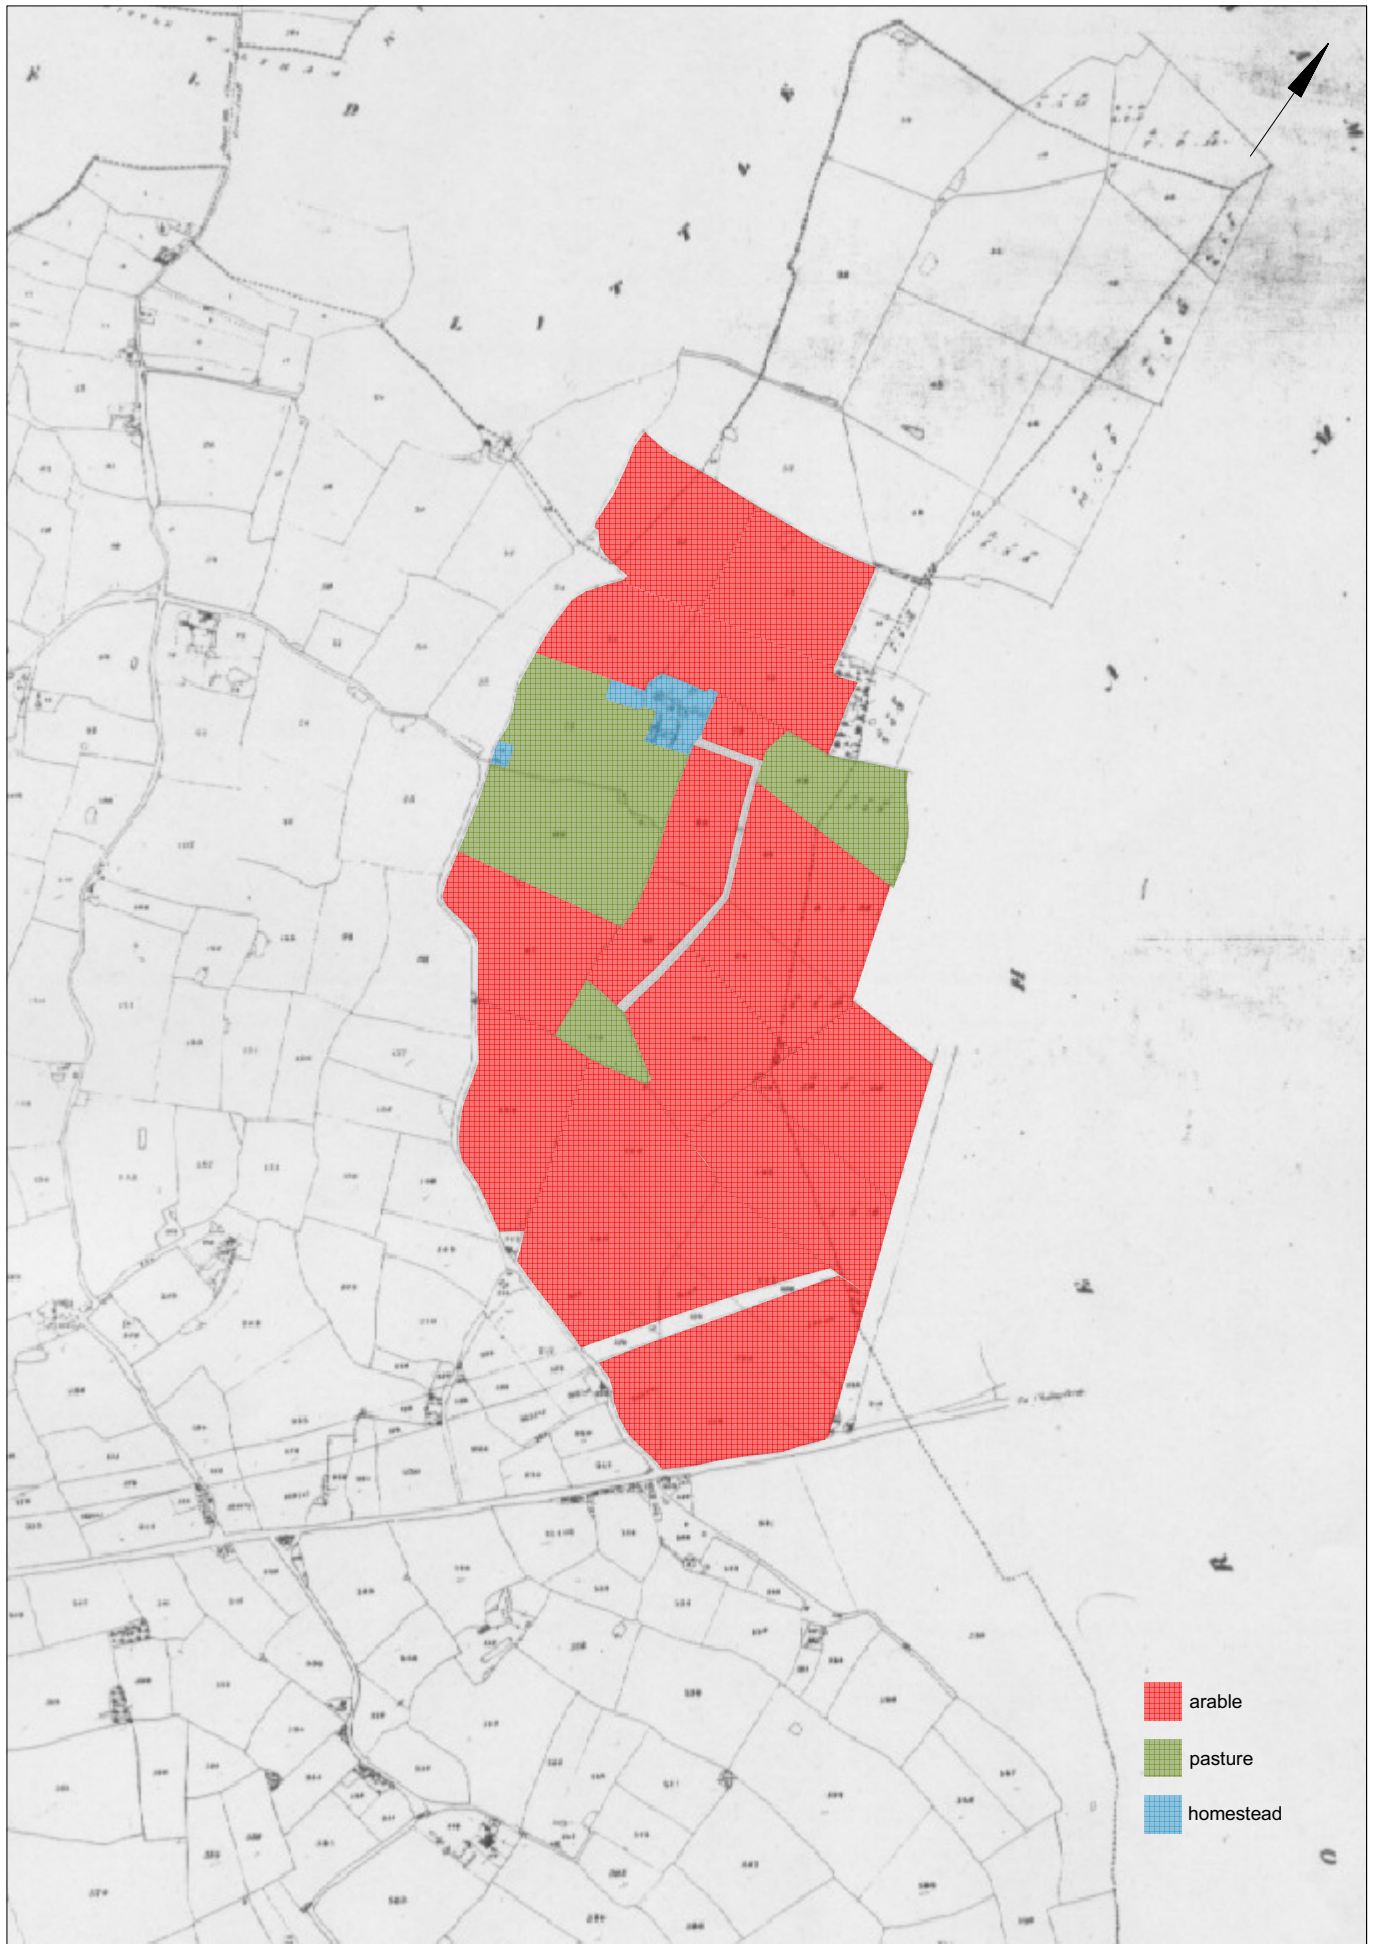
Fig 5 Site location and block plan.

The farm buildings comprise ten distinct structures constructed in approximately nine phases. These structures have been identified by a number in the following text which corresponds to those on the block plan (Fig 5).
