**Historic building recording at B Mess,  
formerly the Officers' Quarters,  
Le Cateau Barracks, Colchester,  
Essex,  
November 2013 and December 2019**

**report prepared by  
Chris Lister and Mark Baister**

NGR: TL 9935 2455 (c)  
Planning reference: 173017  
CAT project ref: 2019/11h  
CHER ref: ECC4408  
OASIS reference: colchest3-375264

**CAT Report 1512**  
February 2020

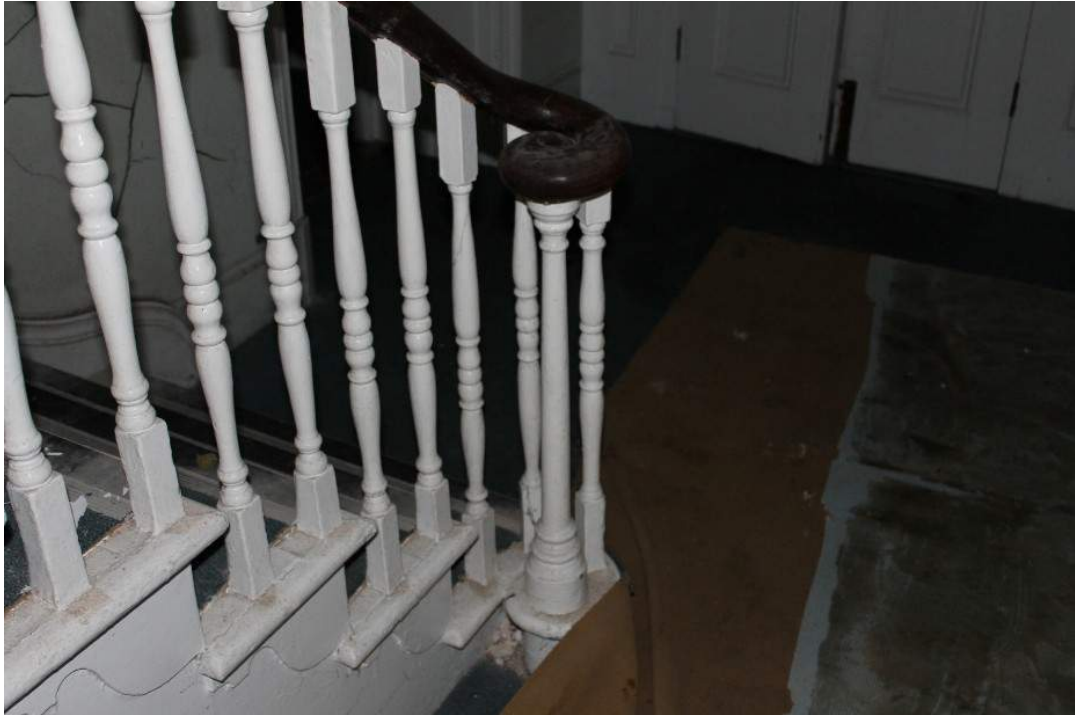
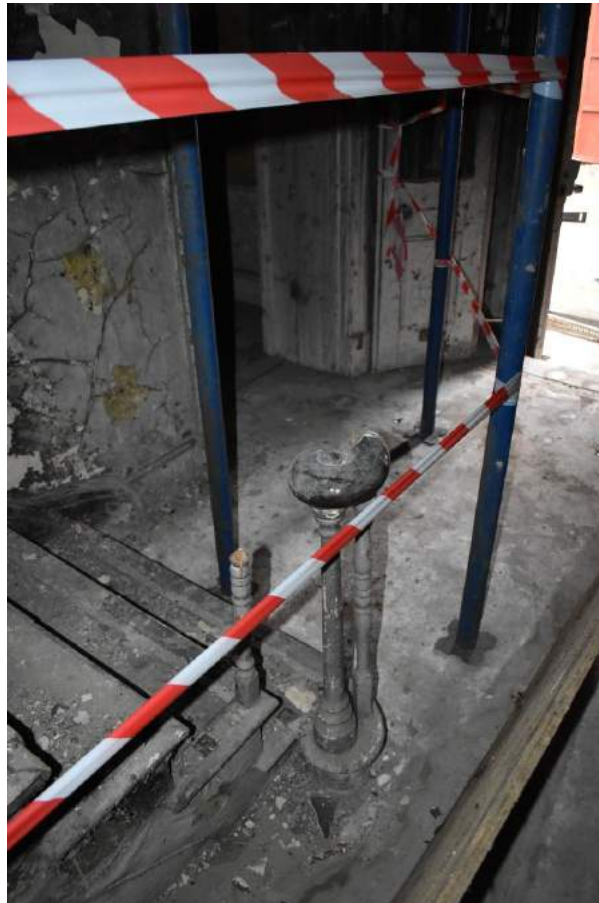
**Plate 2** Stairwell *iv*, showing the original staircase, coat hooks and the entrance to the 1904 lavatory – view north-west. Photo from November 2013 above, photo from December 2019 below.

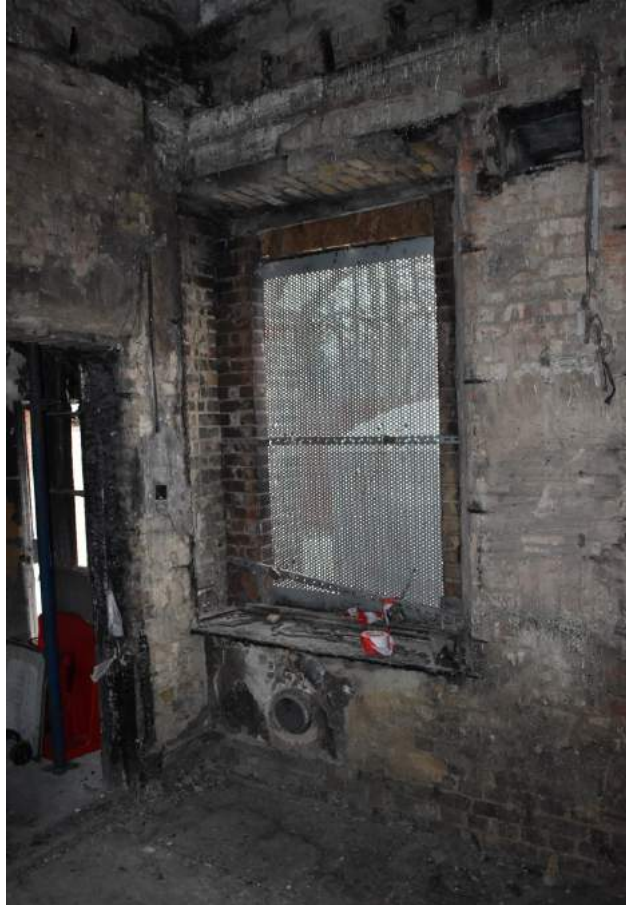
**Plate 22** Rooms 39 and 38, the former kitchen and mess manager's room, with the dividing wall removed and a doorway inserted through one of the windows of the mess manager's room – view south. Photo from November 2013 above, photo from December 2019 below.

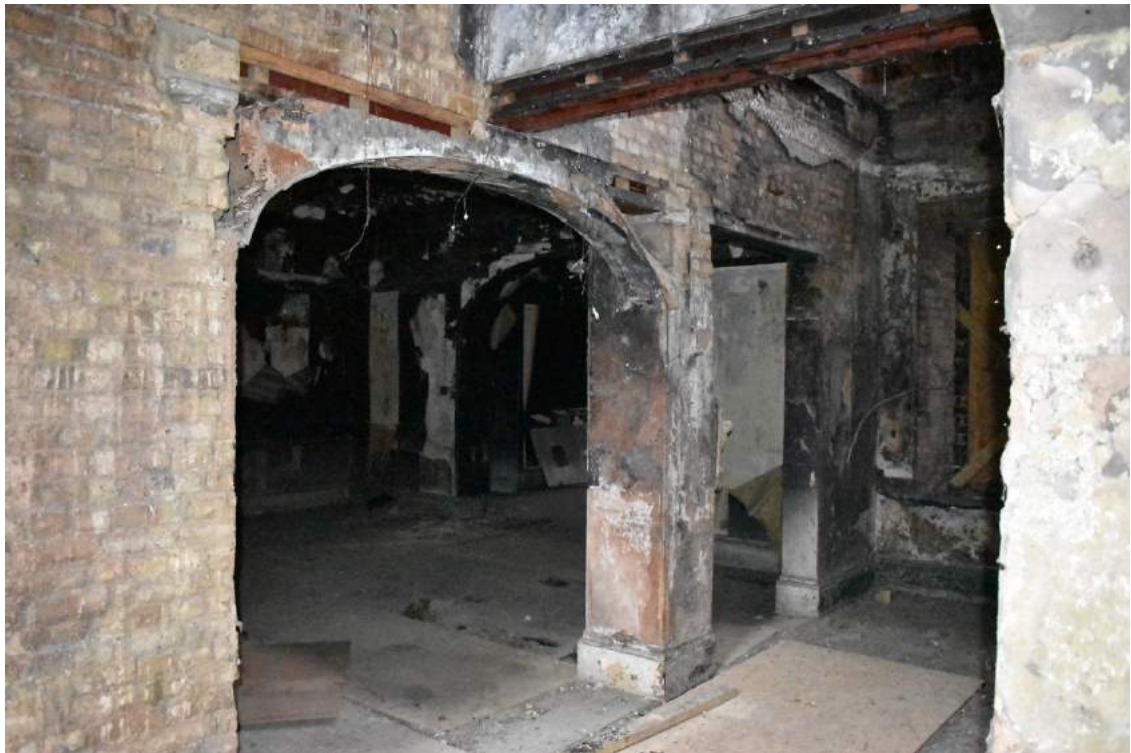
*From the bar eastwards is the section of the Officers' Quarters most severely damaged by the 2014 fire, and many of the features described above no longer survive, or, if they do, are in a significantly dilapidated state. Most of the wallpaper has burnt away and the flooring is heavily damaged, with several holes exposing the brick plinths below (Plate 24). In addition, the first-floor above the eastern rooms only partially survives, with a large section of ceiling above the bar completely absent. This has exposed the bridging beams and shown them to be constructed of metal, rather than timber. Similarly, the beams supporting the inserted archways are also shown to be of metal construction (Plates 25 and 26).*

**Plate 25** Metal beam that would have supported the floor of room 22 prior to the fire. Herringbone strutting visible behind - view south-east.

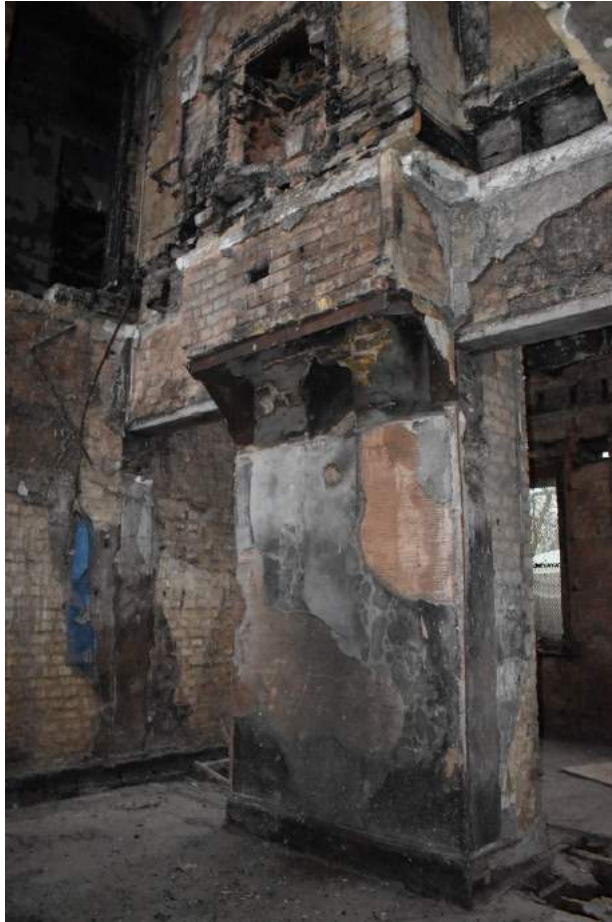
**Plate 26** Inserted arch leading into bar with removed wall to right, both supported by metal beams - view west.

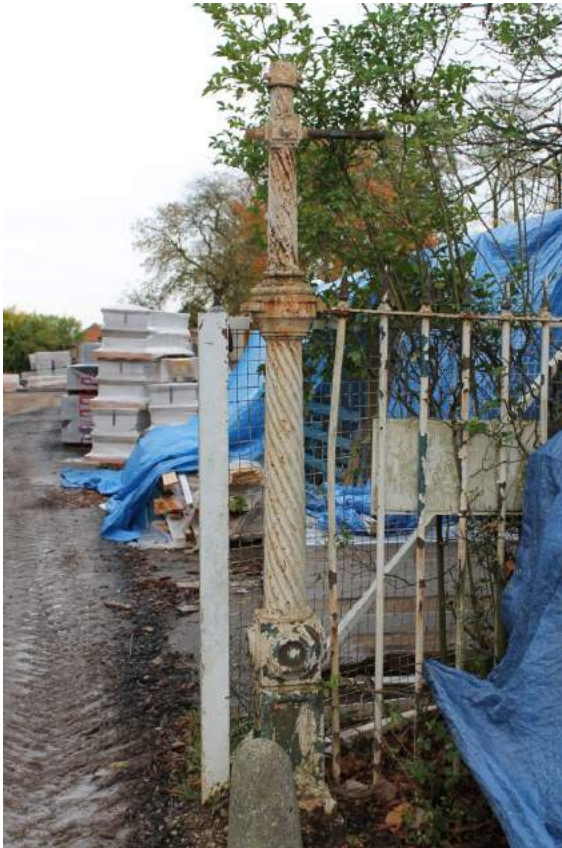
The perimeter fence of the Royal Artillery Barracks has long since been removed, with only the section surrounding the garden in front of the Officers' Quarters surviving. Probably at the same time as the 1904 alterations were carried out (or shortly after) the Officers' Quarters was enclosed in its own iron fence, joined to the earlier palisade and provided with gates formed by iron barley-twist posts incorporating gas lamps. Although the gates themselves have since been replaced, all four of the gate posts and short sections of the fence have survived. *Only three of the gate posts are now extant; the northern one on the western entrance is missing. The surviving posts, however, are in the same condition they were six years ago (Plates 33 and 34). The fence has since been entirely replaced.*

**Plate 33** Surviving gate posts with gas lamps at eastern entrance to site. Note missing top of right post. Photo from November 2013 above, photo from December 2019 below.
