**Historic building recording
at King's Farm Barn, Bishops Lane,
Alphamstone, Essex
March 2014**

**report prepared by
Chris Lister**

CAT Report 767
May 2014

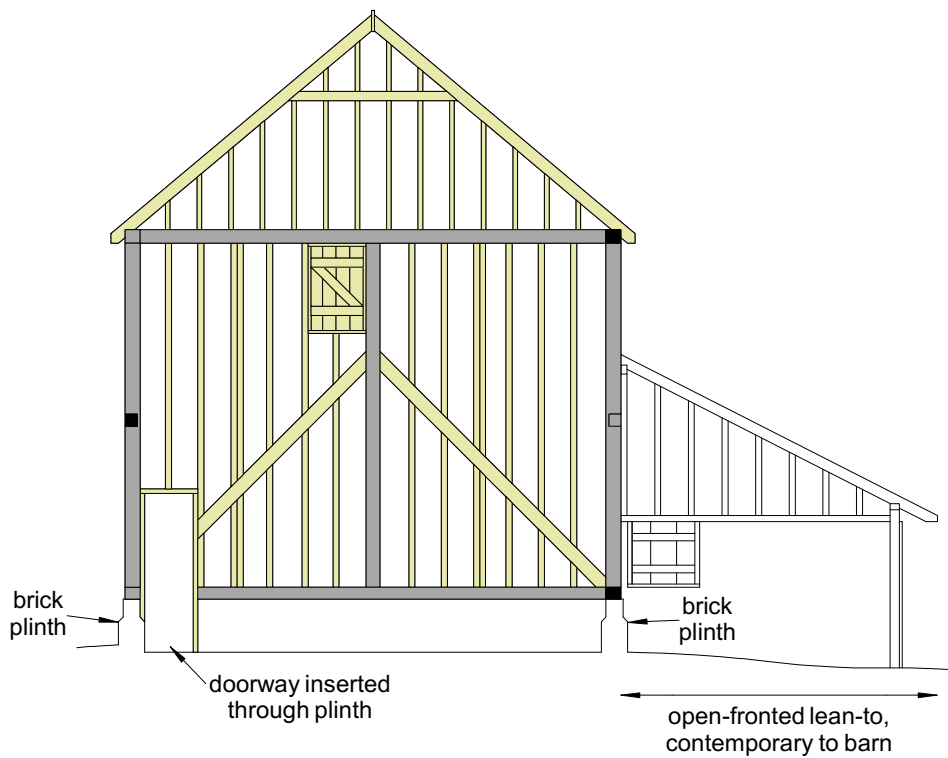
Fig 6 Frame drawing of south-west elevation, indicating the locations of original, re-used and replacement timbers.

4). The frame of the south-west gable end has been completely rebuilt due to collapse. Although the wall plate, sill beam and the corner posts have been salvaged, the latter needing new bases scarfing to the main body of the post, the studding has been replaced with modern machine-cut timbers, reinforced with nailed plank bracing (Fig 6, Plate 8). This collapse was probably caused by pressure placed upon the frame when the sill beam and plinth was cut by the insertion of the doorway at the south-east corner.

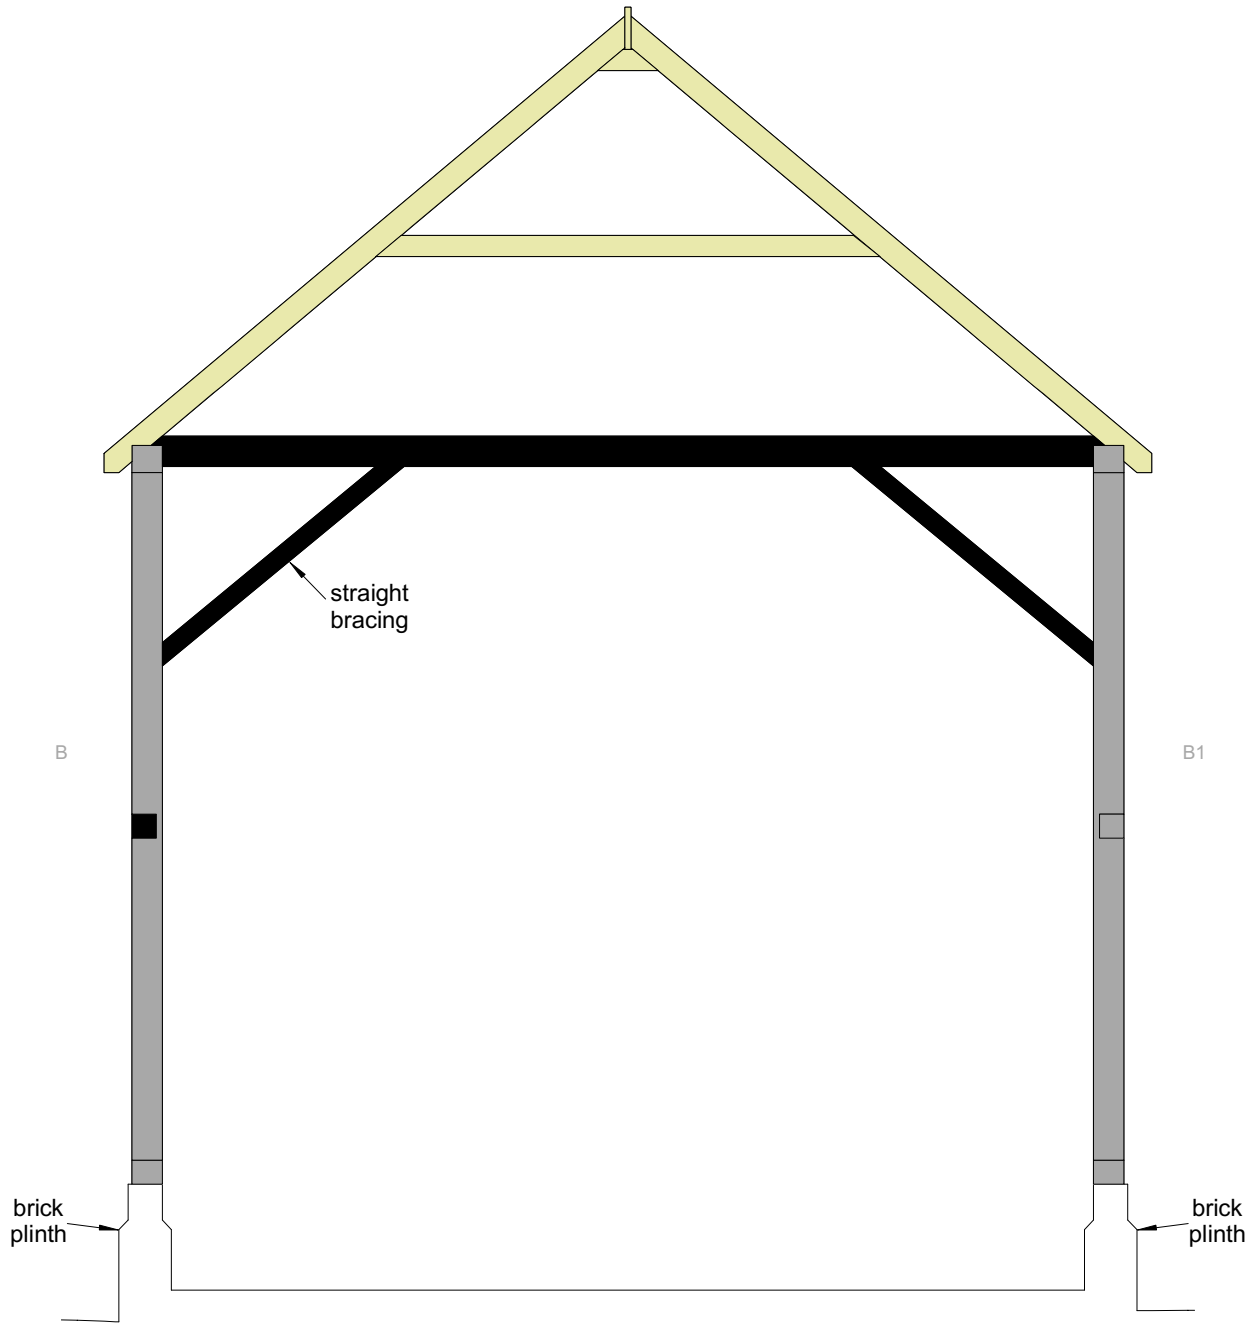
Fig 7 Cross-section of truss B.

The tie beams are original to the building and, although machine-cut, illustrate the difficulty in obtaining straight timbers long enough to span a structure of this width (Plate 9). Several of the tie beams have a sinuous profile, indicating that smaller trees were chosen to provide the timbers, rather than those with a continuous square section which were sourced from larger trees. Straight braces, attached to the intermediate posts and the tie beams by a bolt and two nails, support the tie beams (Fig 7). The heads of each tie are strengthened by iron strapping.
